RE: ASBESTOS ASSESSMENT REPORT-ALLEGHENY CENTER

SUBJECT: ASBESTOS ASSESSMENT REPORT

**ASBESTOS ASSESSMENT REPORT**

**JANUARY 1989**

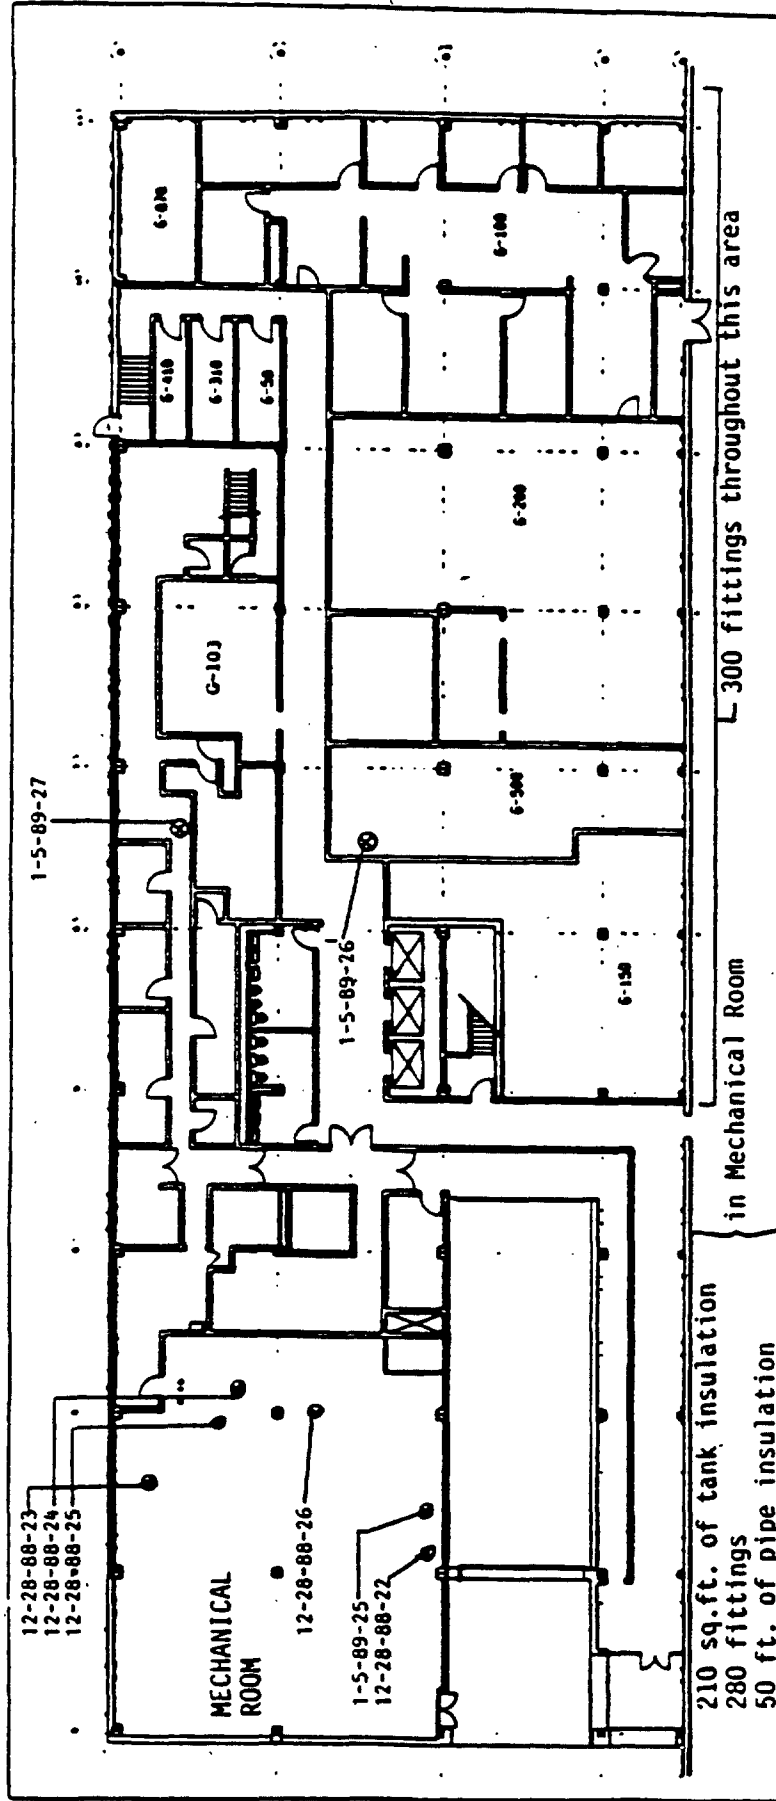
| SUITE # | EXP. DATE | RENTABLE Sq. Ft. | TENANT'S NAME | ONE ALLEGHENY CENTER Ground Floor |

NOTE: SPRAYED-ON FIREPROOFING THROUGHOUT ON BEAMS

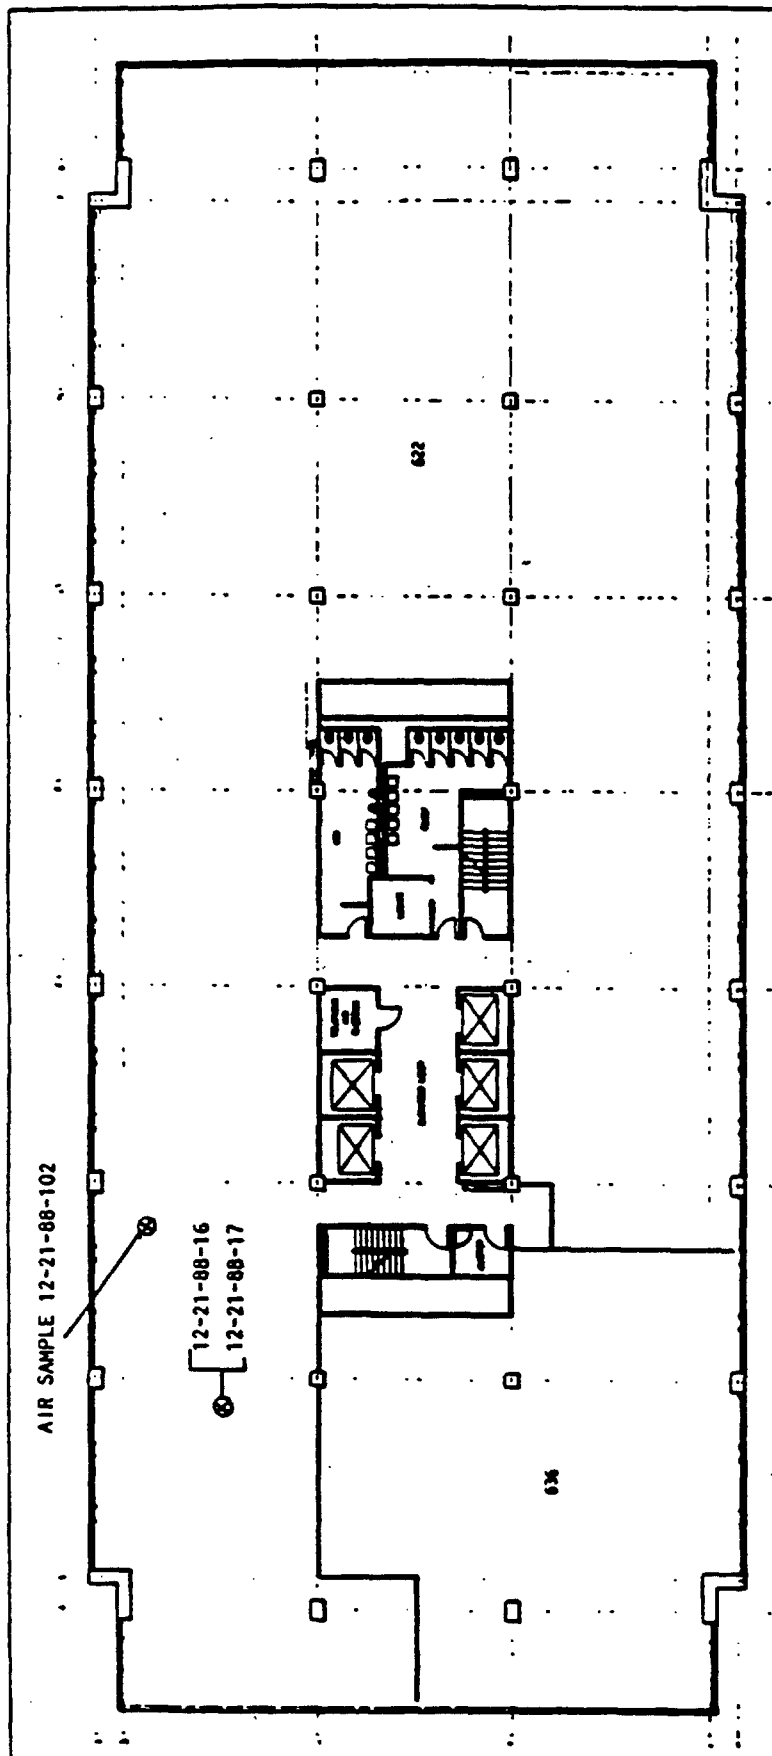
| SUITE # | EXP. DATE | RENTABLE Sq. Ft. | TENANT'S NAME | TWO ALLEGHENY CENTER<br>6th Floor |

NOTE: SPRAYED-ON FIREPROOFING THROUGHOUT ON BEAMS AND DECKING  
 VAT THROUGHOUT (EXCEPT IN STAIRWELLS AND BATHROOMS - SEE DEETER AND RITCHEY DRAWING A-20 for details)  
 FITTINGS SPOTCHECKED WERE ALL FIBERGLASS

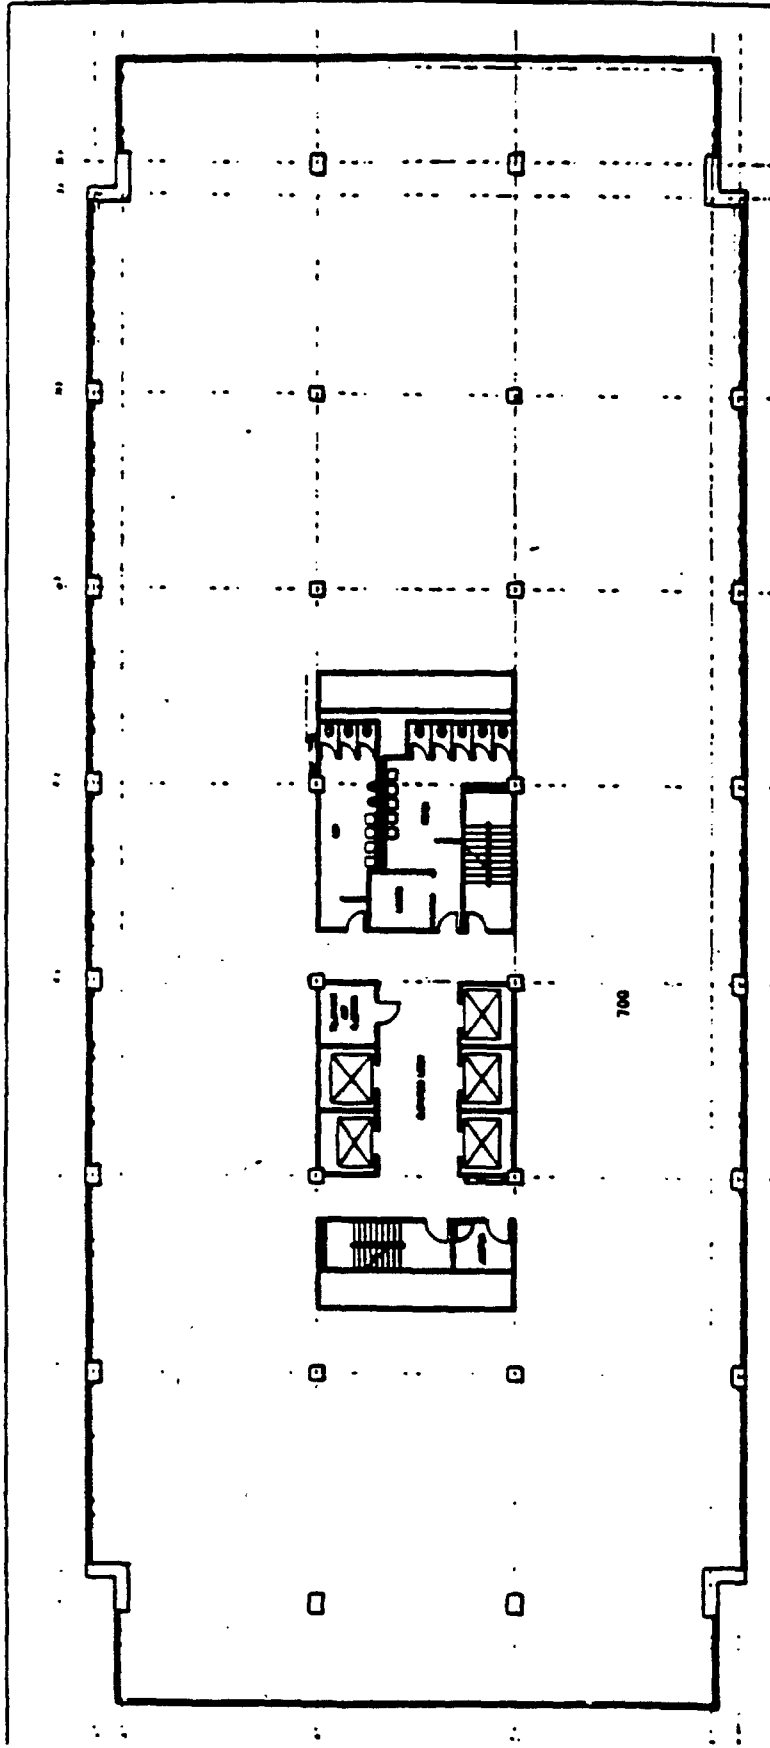
| SUITE # | EXP. DATE | RENTABLE Sq. Ft. | TENANT'S NAME | TWO ALLEGHENY CENTER 7th Floor | |

NOTE: SPRAYED-ON FIREPROOFING THROUGHOUT ON BEAMS AND DECKING  
 VAT THROUGHOUT (EXCEPT IN STAIRWELLS AND BATHROOMS - SEE DEETER AND RITCHEY DRAWING A-20 for details)  
 FITTINGS SPOTCHECKED WERE ALL FIBERGLASS

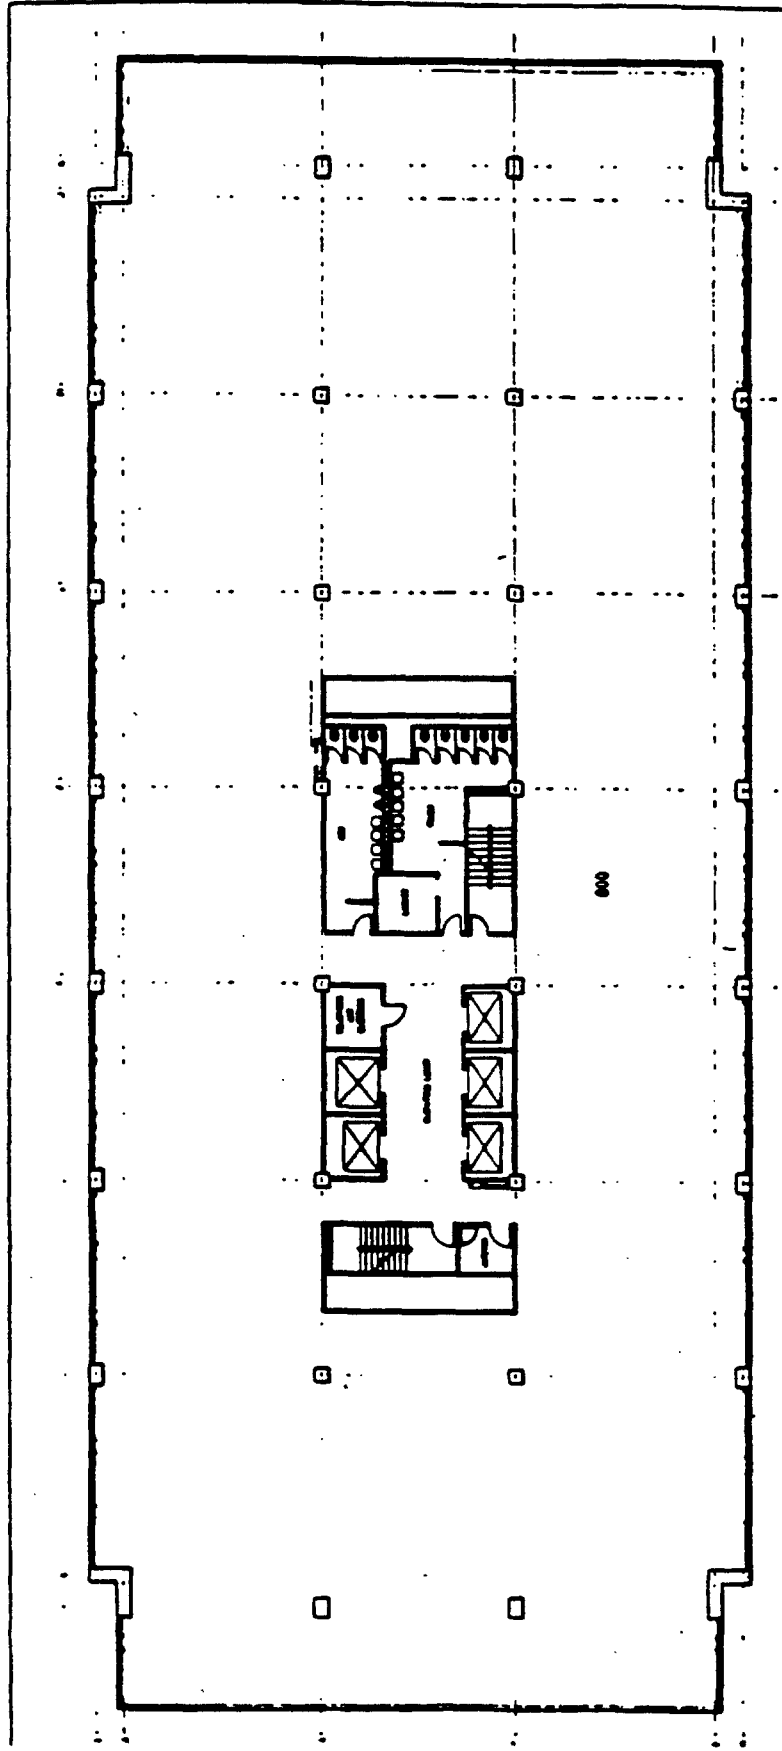
| JITE # | EXP. DATE | RENTABLE Sq. Ft. | TENANT'S NAME | TWO<br>ALLEGHENY<br>CENTER<br>8th Floor | |

NOTE: SPRAYED-ON FIREPROOFING THROUGHOUT ON BEAMS AND DECKING  
 VAT THROUGHOUT (EXCEPT IN STAIRWELLS AND BATHROOMS - SEE DEETER AND RITCHEY DRAWING A-20 for details)  
 FITTINGS SPOTCHECKED WERE ALL FIBERGLASS

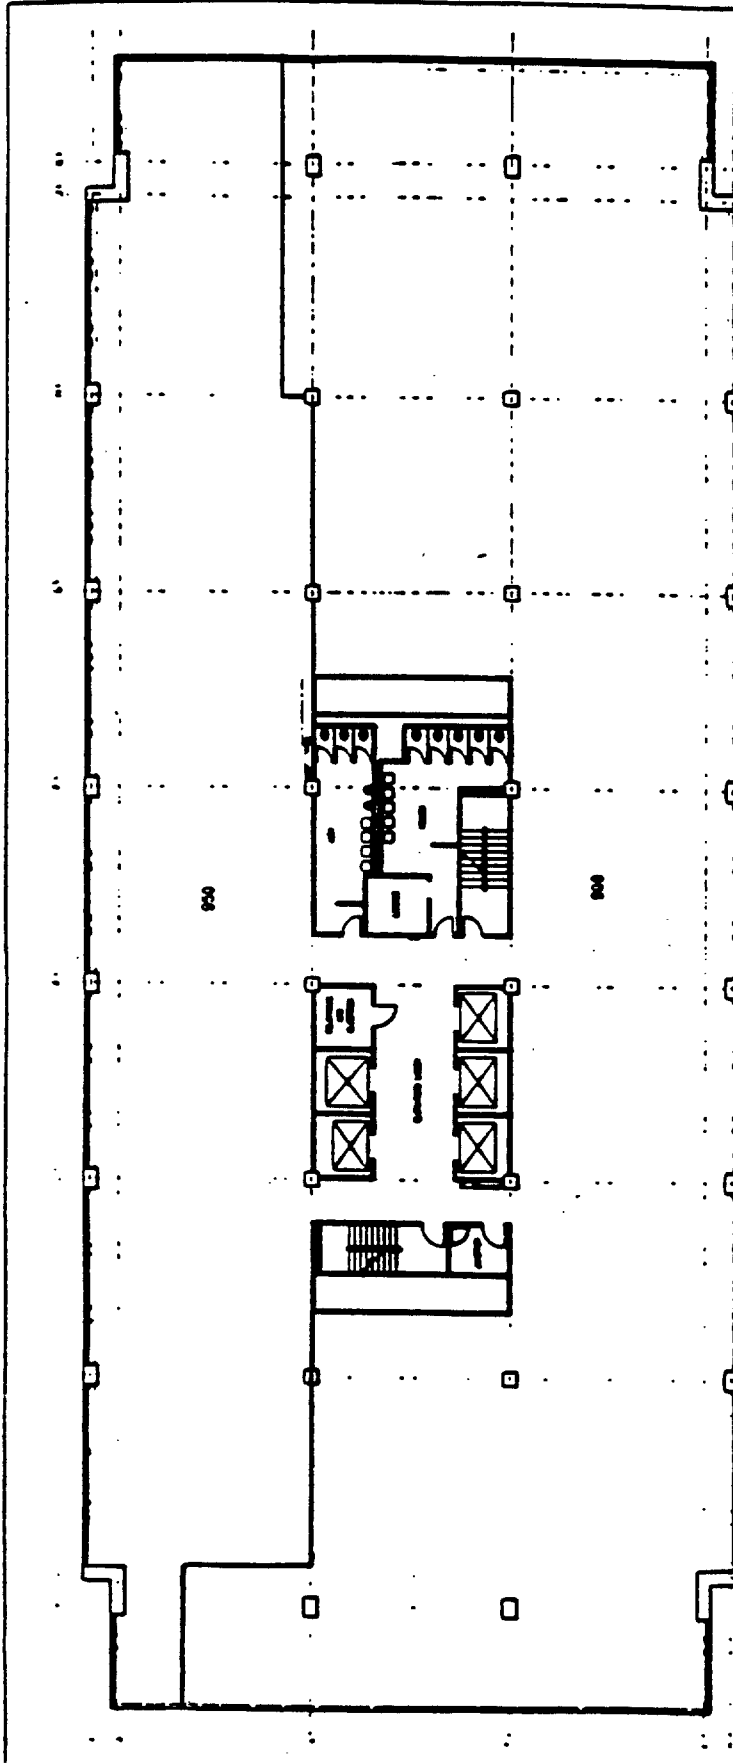
| UNIT # | EXP. DATE | RENTABLE Sq. Ft. | TENANT'S NAME | TWO ALLEGHENY CENTER 9th Floor |

NOTE: SPRAYED-ON FIREPROOFING THROUGHOUT ON BEAMS AND DECKING  
 VAT THROUGHOUT (EXCEPT IN STAIRWELLS AND BATHROOMS - SEE DEETER AND RITCHEY DRAWING A-20 for details)  
 FITTINGS SPOTCHECKED WERE ALL FIBERGLASS

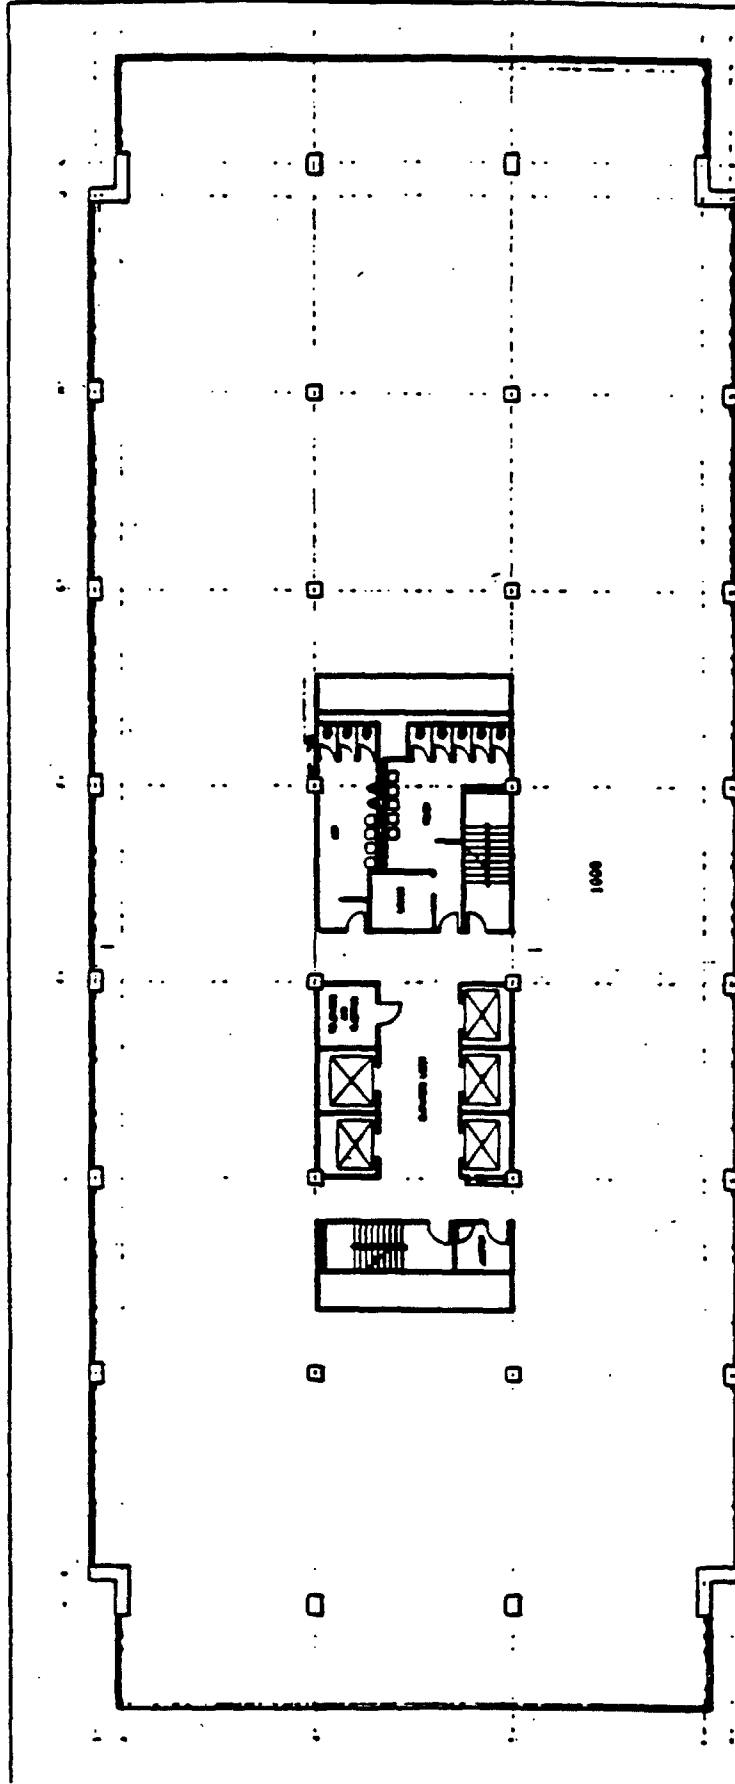
| SUITE # | EXP. DATE | RENTABLE Sq. Ft. | TENANT'S NAME | TWO<br>ALLEGHENY<br>CENTER<br>10th Floor |

NOTE: SPRAYED-ON FIREPROOFING THROUGHOUT ON BEAMS AND DECKING  
 VAT THROUGHOUT (EXCEPT IN STAIRWELLS AND BATHROOMS - SEE DEETER AND RITCHEY DRAWING A-20 for details)  
 FITTINGS SPOTCHECKED WERE ALL FIBERGLASS

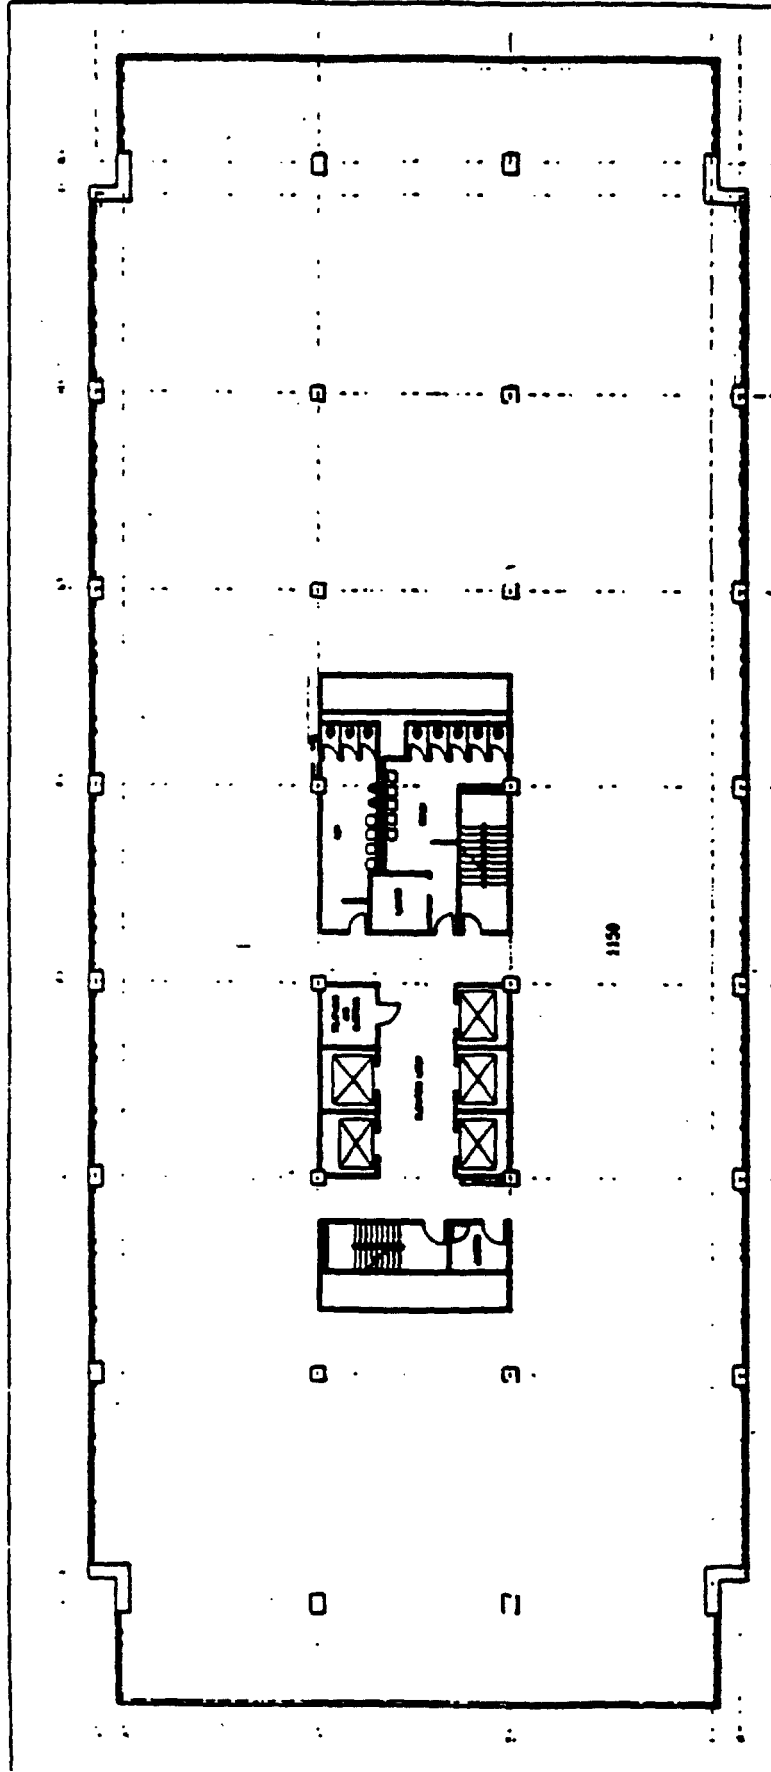
| SUITE # | EXP. DATE | RENTABLE Sq. Ft. | TENANT'S NAME | TWO ALLEGHENY CENTER<br>11th floor |

NOTE: SPRAYED-ON FIREPROOFING THROUGHOUT ON BEAMS AND DECKING  
 VAT THROUGHOUT (EXCEPT IN STAIRWELLS AND BATHROOMS - SEE DEETER AND RITCHEY DRAWING A-20 for details)  
 FITTINGS SPOTCHECKED WERE ALL FIBERGLASS

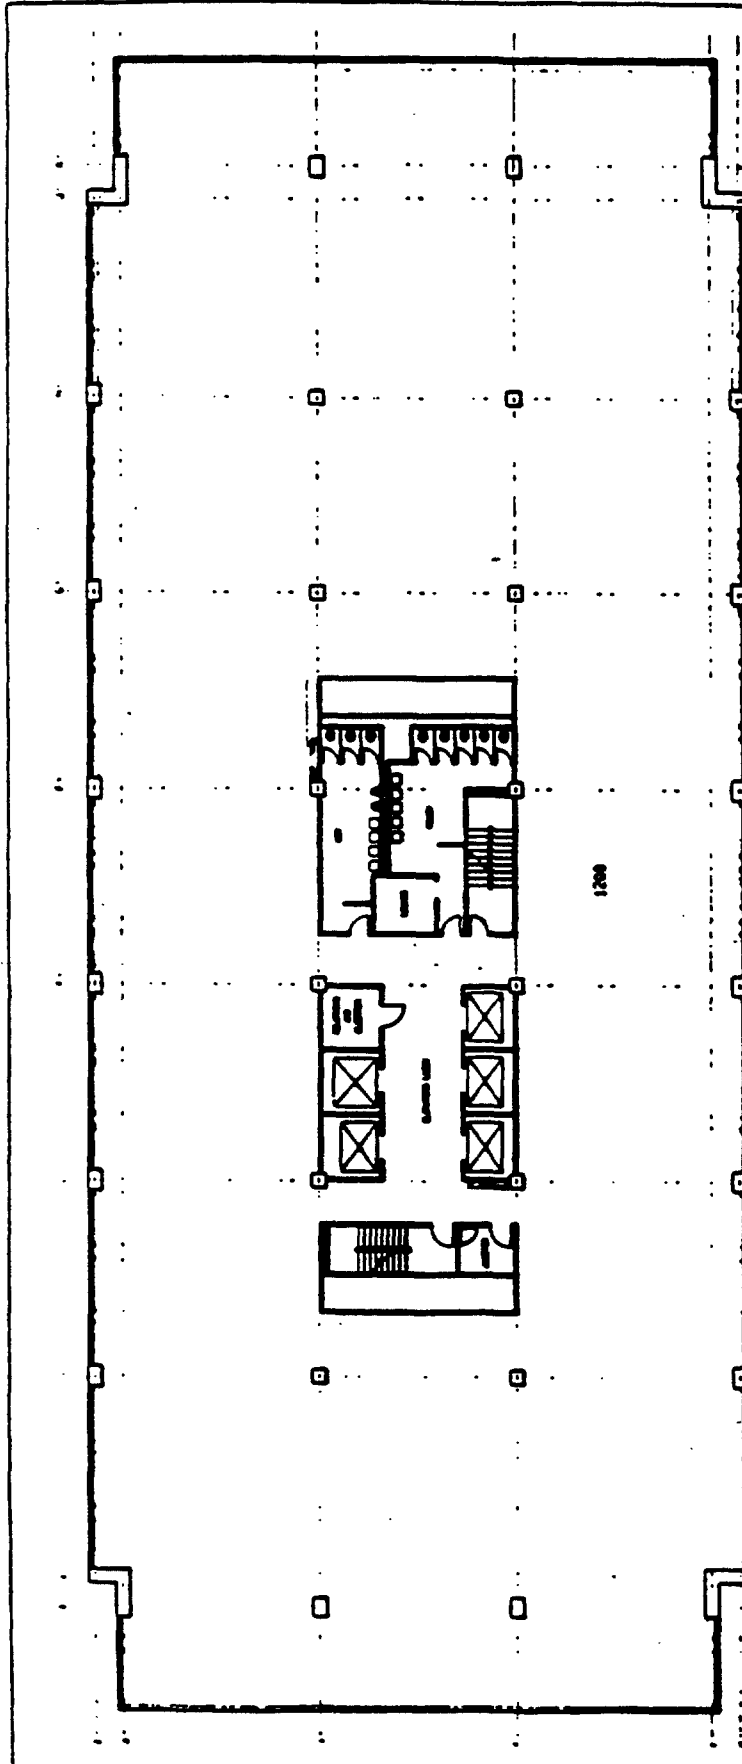
| SUITE # | EXP. DATE | RENTABLE Sq. Ft. | TENANT'S NAME | TWO<br>ALLEGHENY<br>CENTER<br>12th Floor |

NOTE: SPRAYED-ON FIREPROOFING THROUGHOUT ON BEAMS AND DECKING  
 VAT THROUGHOUT (EXCEPT IN STAIRWELLS AND BATHROOMS - SEE DEETER AND RITCHEY DRAWING A-20 for details)  
 FITTINGS SPOTCHECKED WERE ALL FIBERGLASS

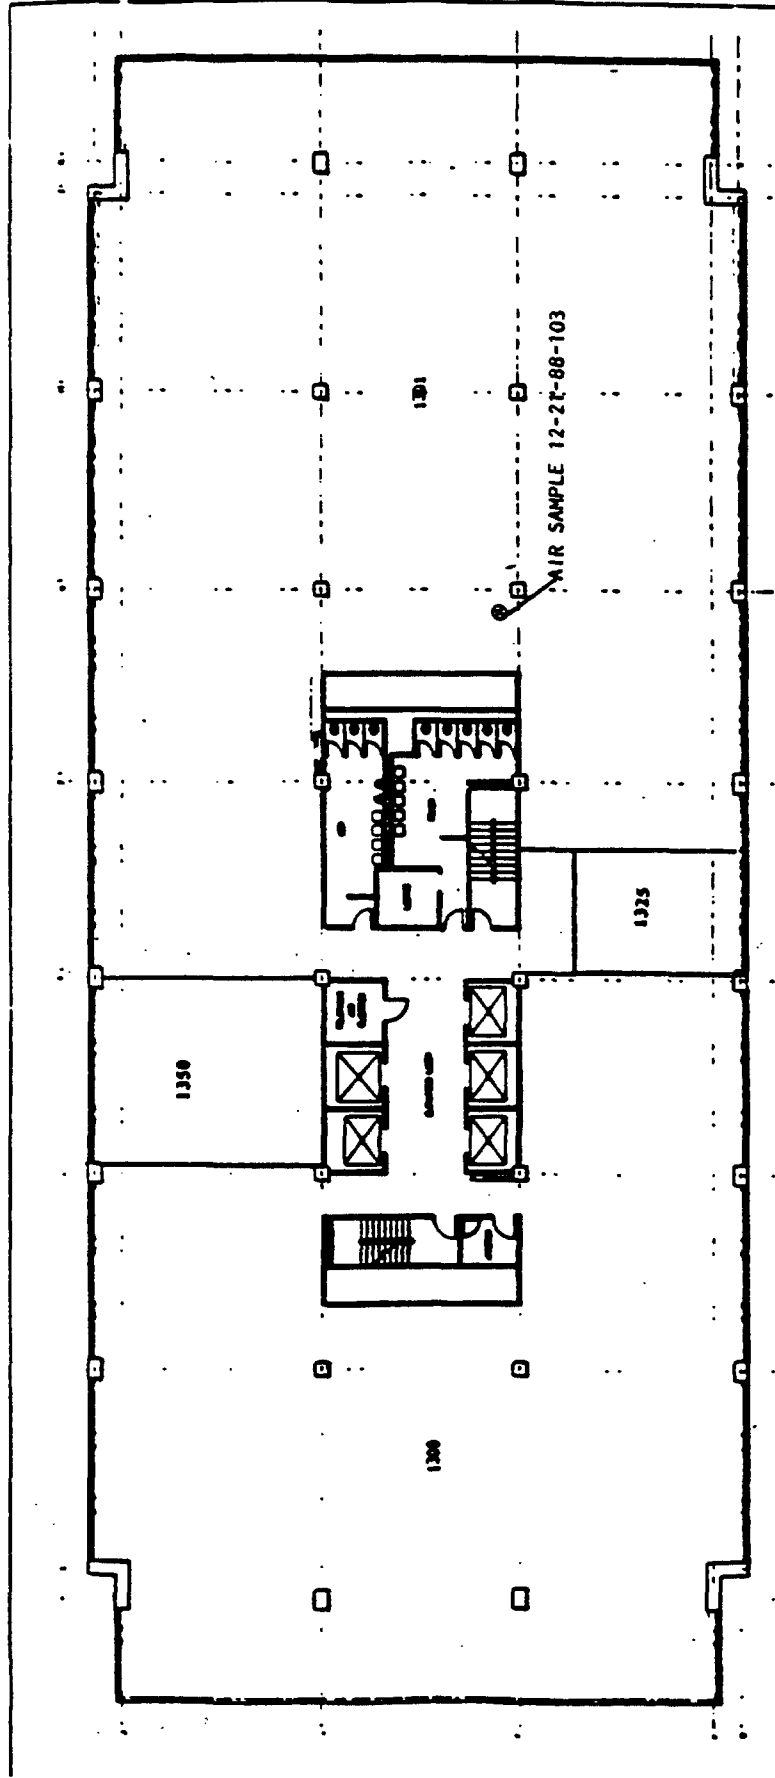
| SUITE # | EXP. DATE | RENTABLE Sq. Ft. | TENANT'S NAME | TWO<br>ALLEGHENY<br>CENTER<br>13th Floor |

NOTE: SPRAYED-ON FIREPROOFING THROUGHOUT ON BEAMS AND DECKING  
 VAT THROUGHOUT (EXCEPT IN STAIRWELLS AND BATHROOMS - SEE DEETER AND RITCHEY DRAWING A-20 for details)  
 FITTINGS SPOTCHECKED WERE ALL FIBERGLASS

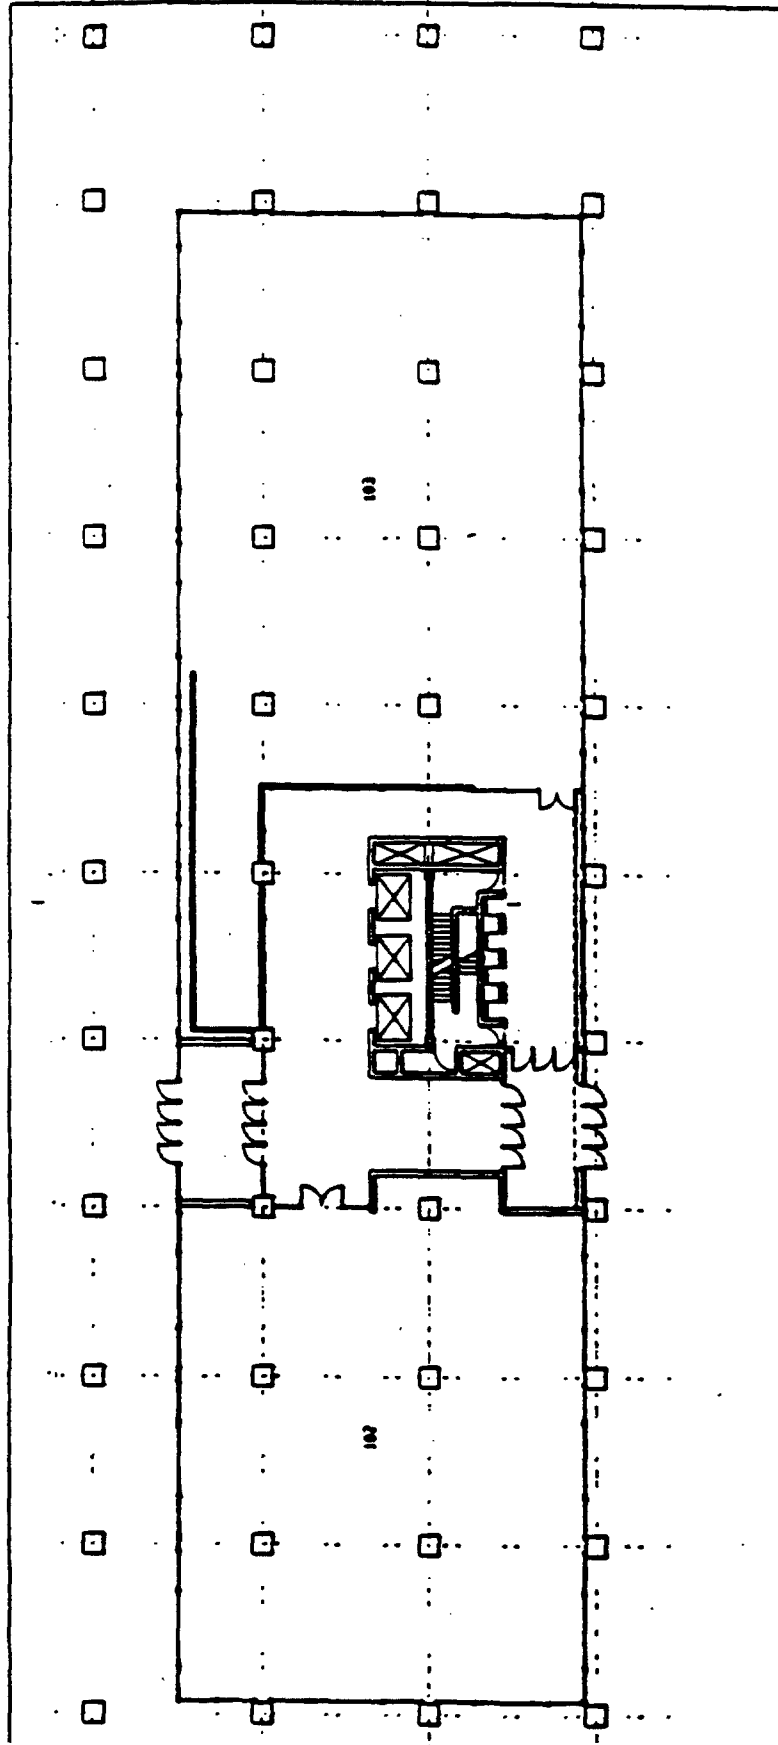
| JITE # | EXP. DATE | RENTABLE Sq. Ft. | TENANT'S NAME | ONE ALLEGHENY CENTER 1st Floor | |

NOTE: SPRAYED-ON FIREPROOFING THROUGHOUT ON BEAMS

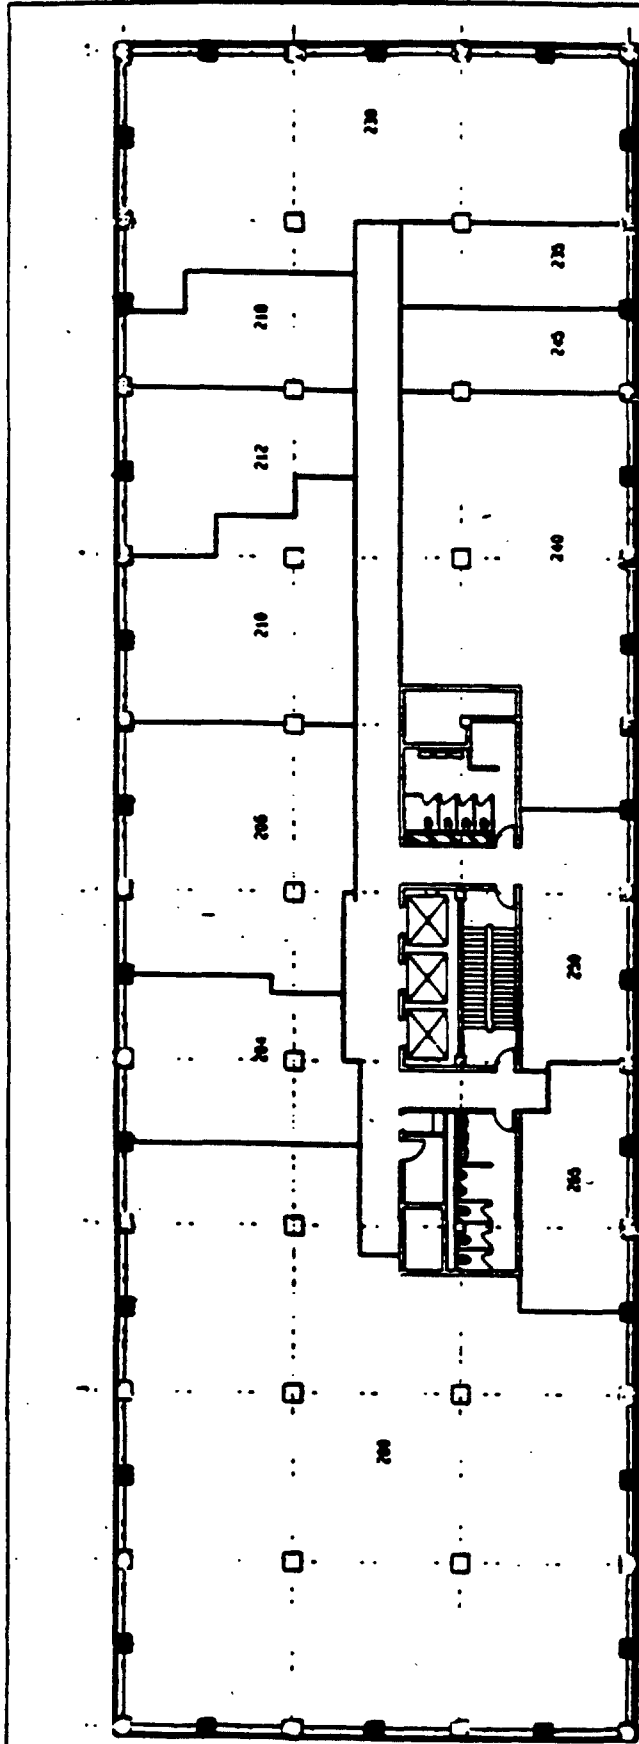
NOTE: SPRAYED-ON FIREPROOFING THROUGHOUT ON BEAMS  
 ■ PIPE CHASE (10 FITTINGS)  
 ■ WET COLUMNS (5 FITTINGS IN EACH ONE)

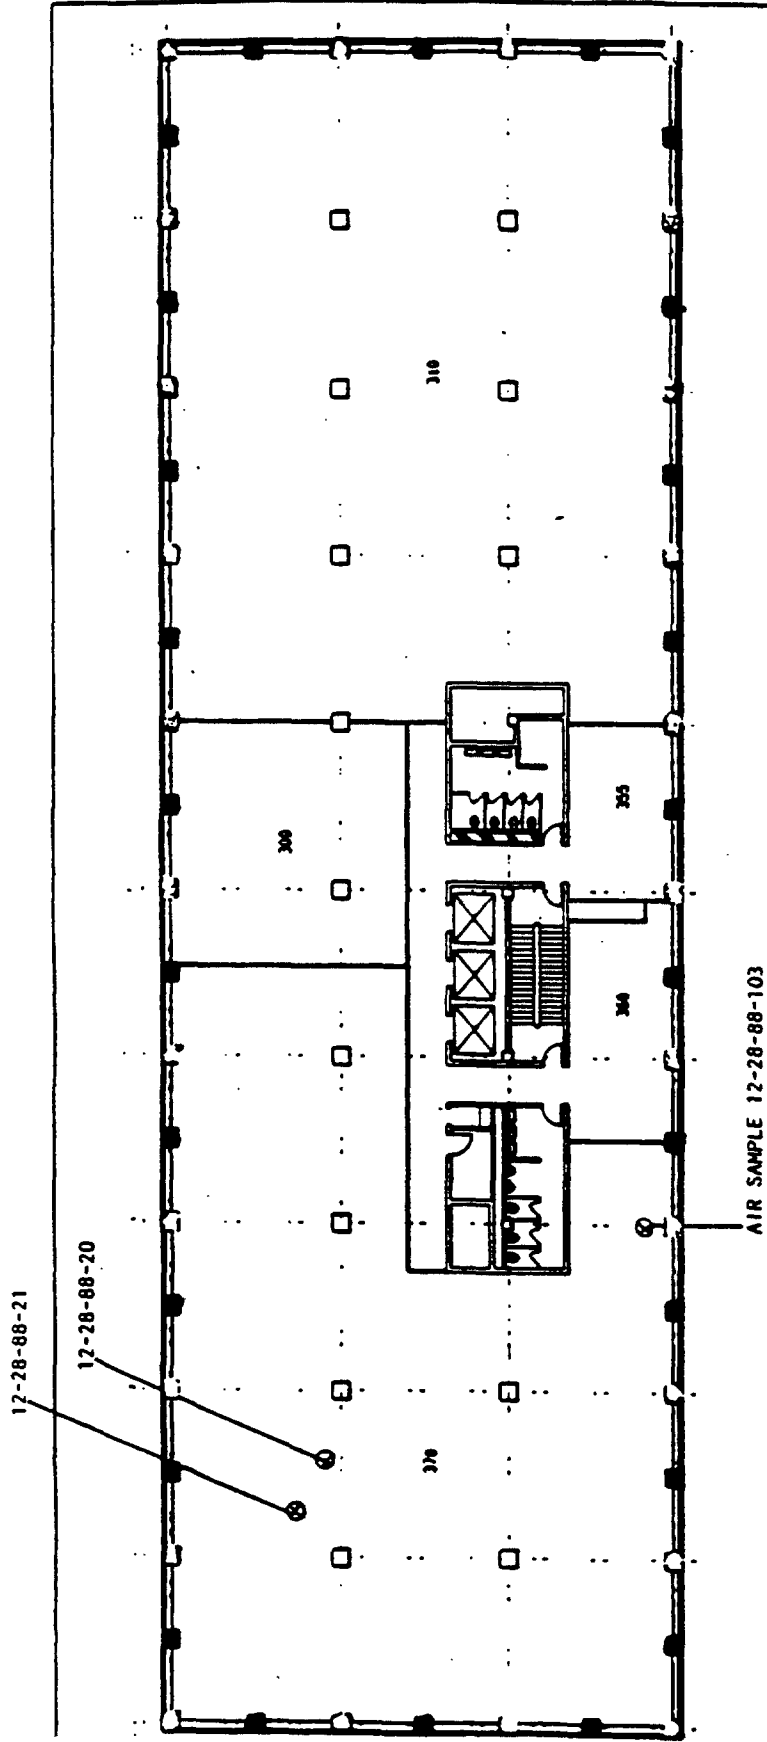
| ITE # | EXP. DATE | RENTABLE Sq. Ft. | TENANT'S NAME | ONE ALLEGHENY CENTER 3rd Floor |

NOTE: SPRAYED-ON FIREPROOFING THROUGHOUT ON BEAMS  
 [ ] PIPE CHASE (10 FITTINGS)  
 [ ] WET COLUMNS (5 FITTINGS IN EACH ONE)

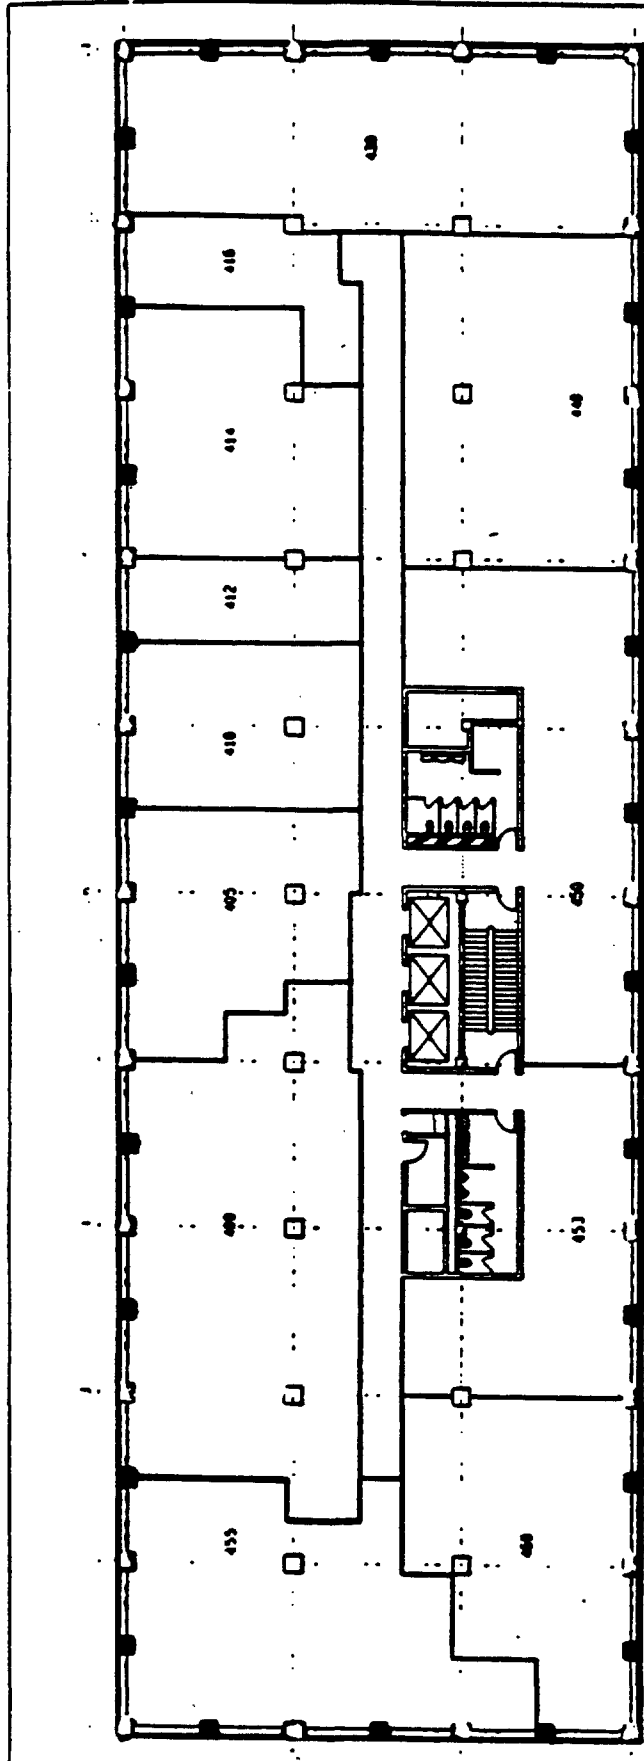
| SUITE # | | EXP. DATE | RENTABLE Sq. Ft. | TENANT'S NAME | ONE ALLEGHENY CENTER 4th Floor |

NOTE: SPRAYED-ON FIREPROOFING THROUGHOUT ON BEAMS  
☒ PIPE CHASE (10 FITTINGS)  
☒ WET COLUMNS (5 FITTINGS IN EACH ONE)

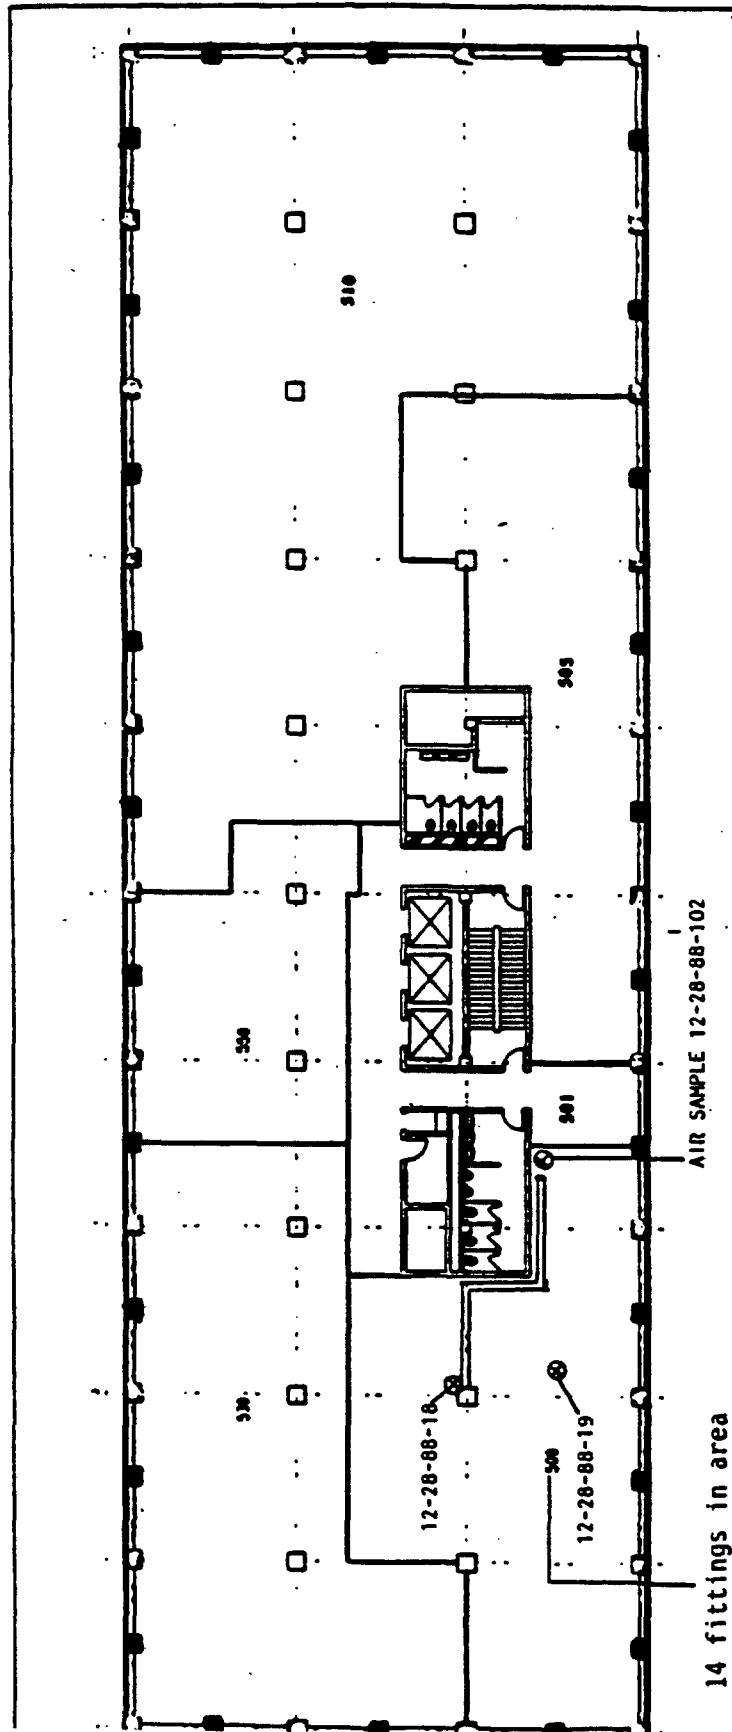
| ITE # | EXP. DATE | RENTABLE Sq. Ft. | TENANT'S NAME | ONE<br>ALLEGHENY<br>CENTER<br>5th Floor |

NOTE: SPRAYED-ON FIREPROOFING THROUGHOUT ON BEAMS  
 ■ PIPE CHASE (10 FITTINGS)  
 ■ WFT COLUMNS (5 FITTINGS IN EACH ONE)

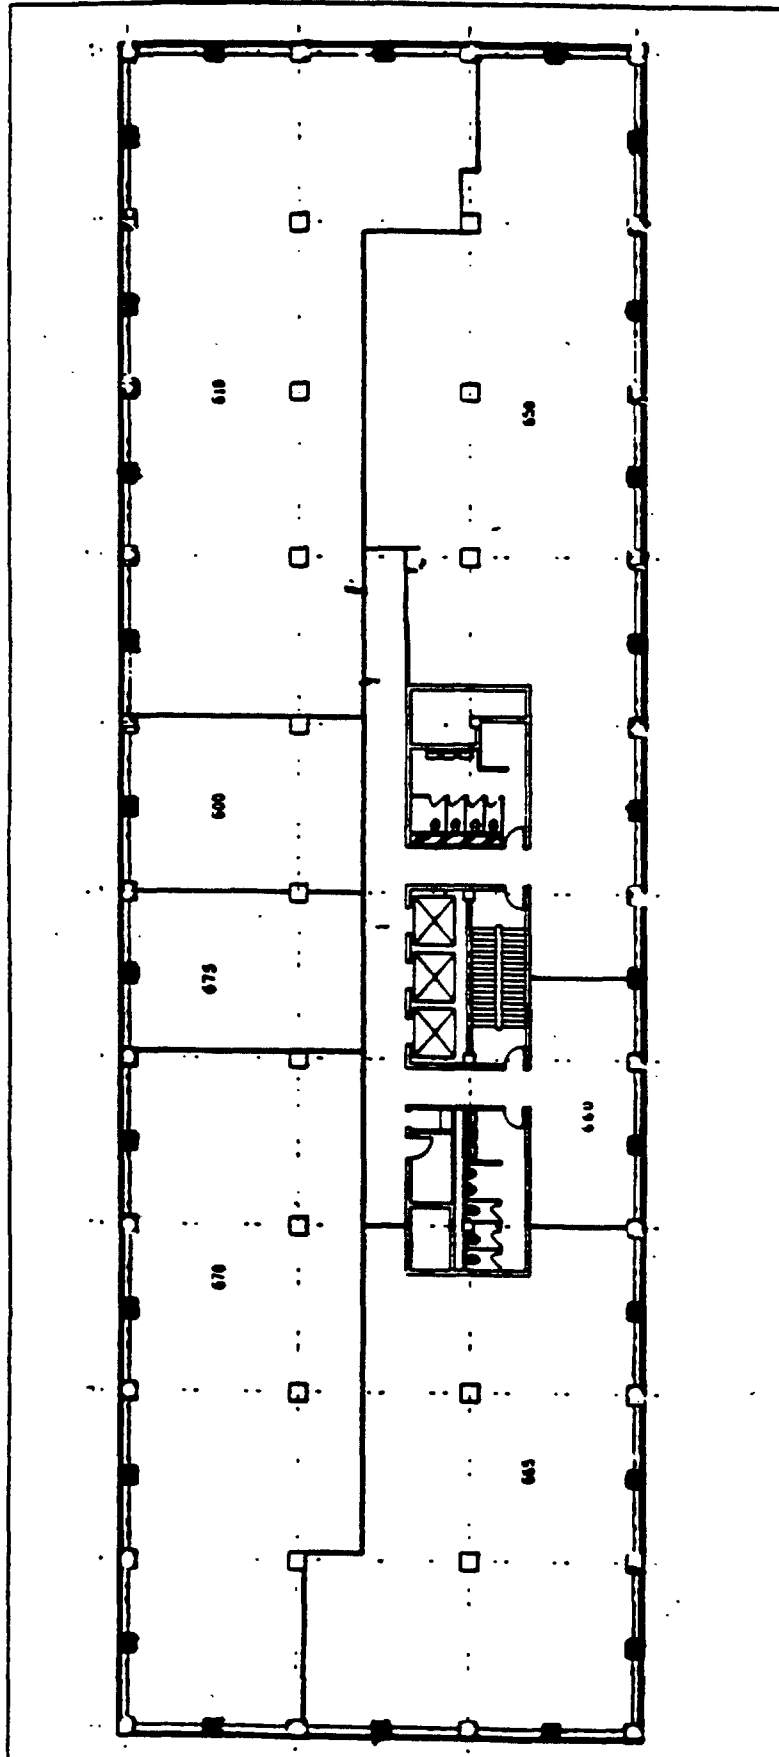
■ WET COLUMNS (5 FITTINGS IN EACH ONE)

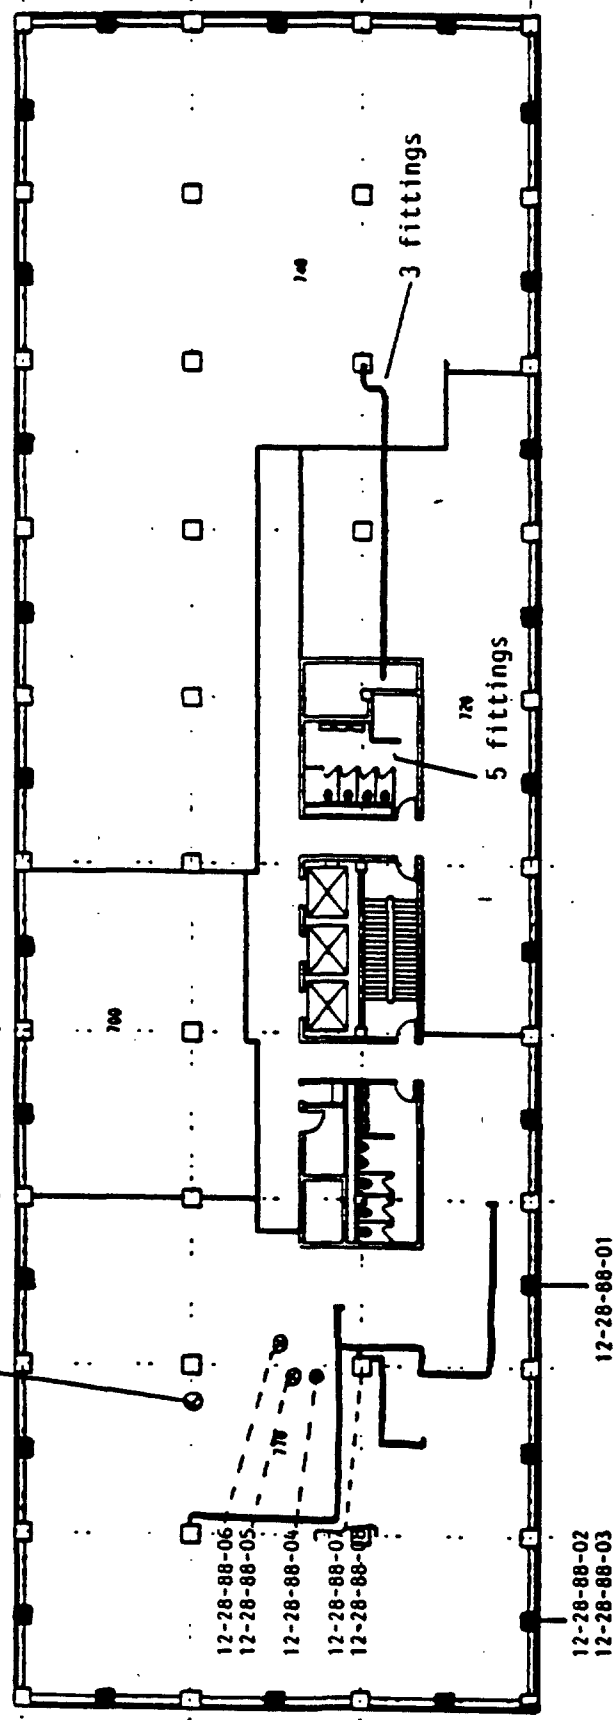
| SUITE # | EXP. DATE | RENTABLE Sq. Ft | TENANT'S NAME | ONE ALLEGHENY CENTER<br>7th Floor |

NOTE: SPRAYED-ON FIREPROOFING THROUGHOUT ON BEAMS  
☒ PIPE CHASE (10 FITTINGS)  
☒ WET COLUMNS (5 FITTINGS IN EACH ONE)

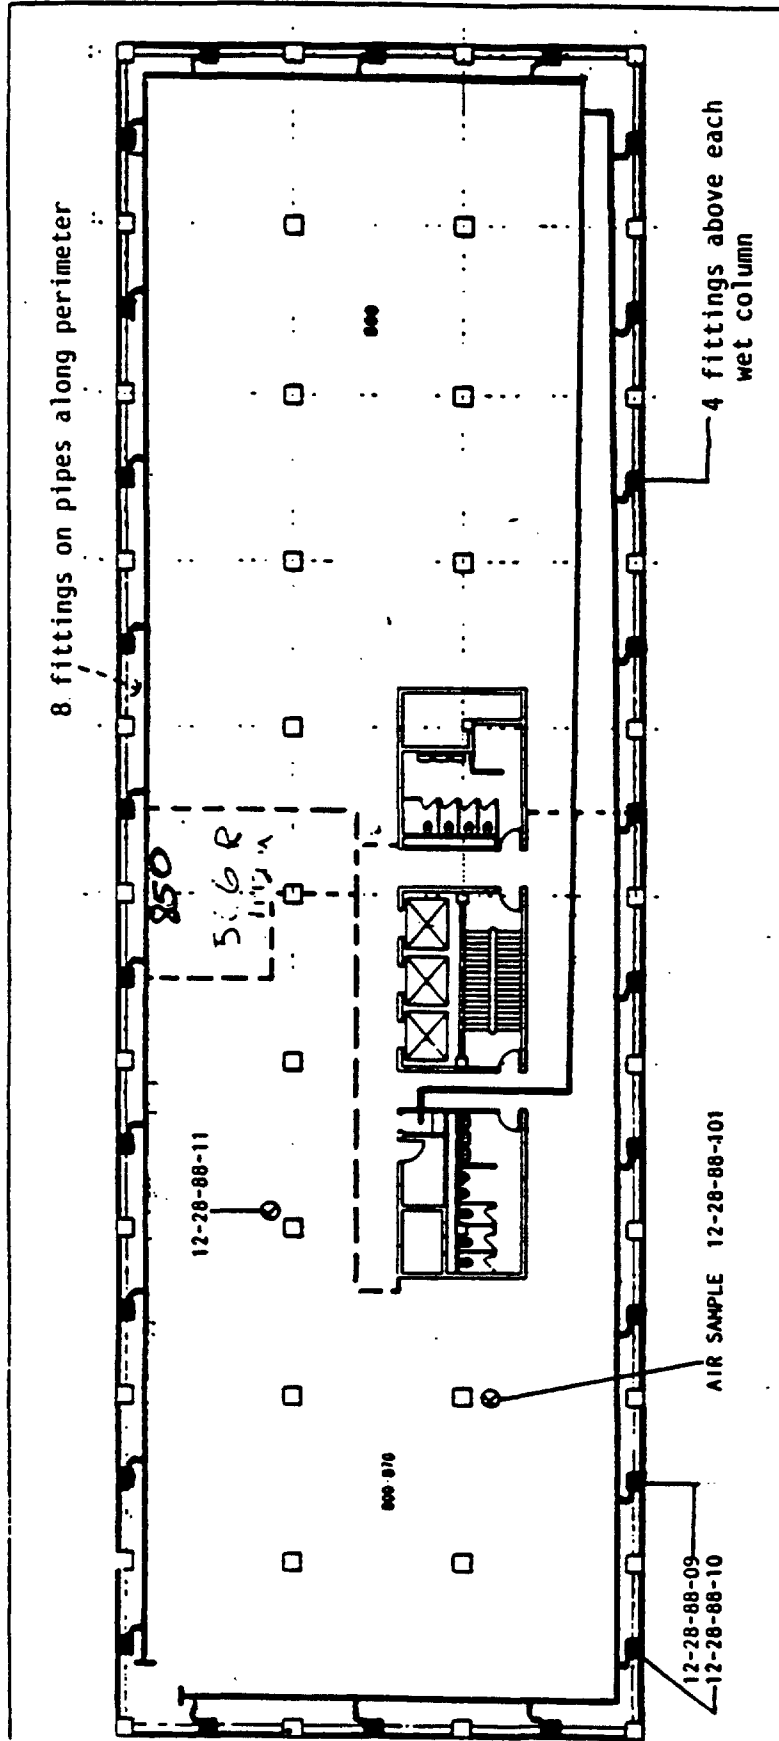
| LINE # | EXP DATE | RENTABLE Sq. Ft. | TENANT'S NAME | ONE ALLEGHENY CENTER 8th Floor |

■ WFT COLUMNS (5 FITTINGS IN EACH ONE) AND 4 FITTINGS ABOVE EACH ONE
