RE: ASBESTOS ASSESSMENT REPORT-ALLEGHENY CENTER

SUBJECT: ASBESTOS ASSESSMENT REPORT

**ASBESTOS ASSESSMENT REPORT**

**JANUARY 1989**

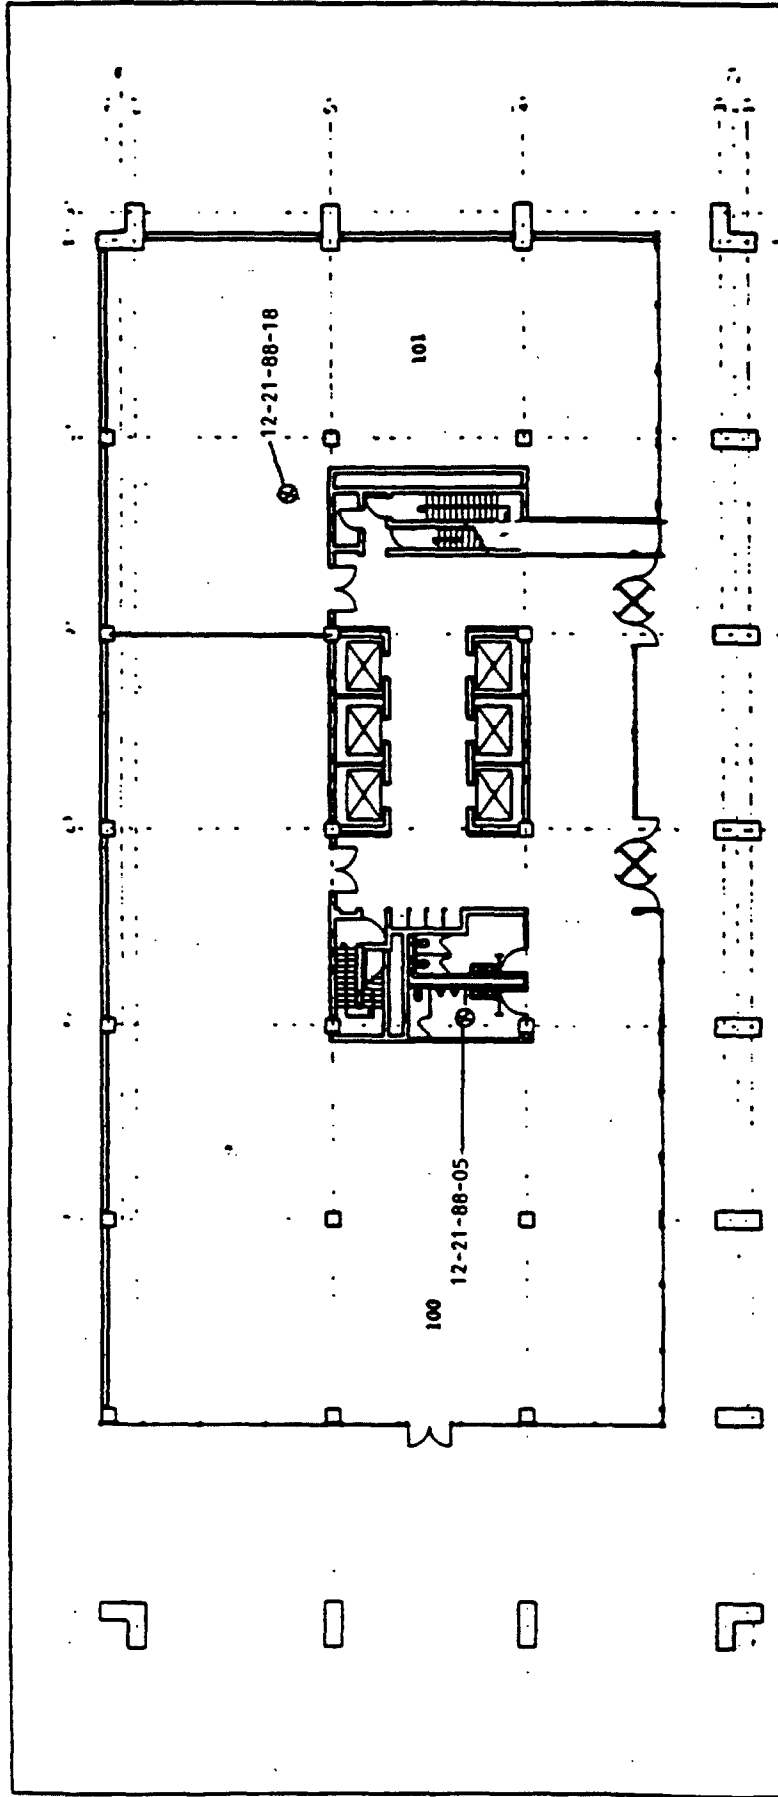
| SUITE # | EXP. DATE | RENTABLE Sq. Ft. | TENANT'S NAME | TWO ALLEGHENY CENTER 1st Floor |

NOTE: SPRAYED-ON FIREPROOFING THROUGHOUT ON BEAMS AND DECKING  
VAT THROUGHOUT (EXCEPT IN STAIRWELLS AND BATHROOMS - SEE DEETER AND RITCHEY DRAWING A-20 for details)  
FITTINGS SPOTCHECKED WERE ALL FIBERGLASS

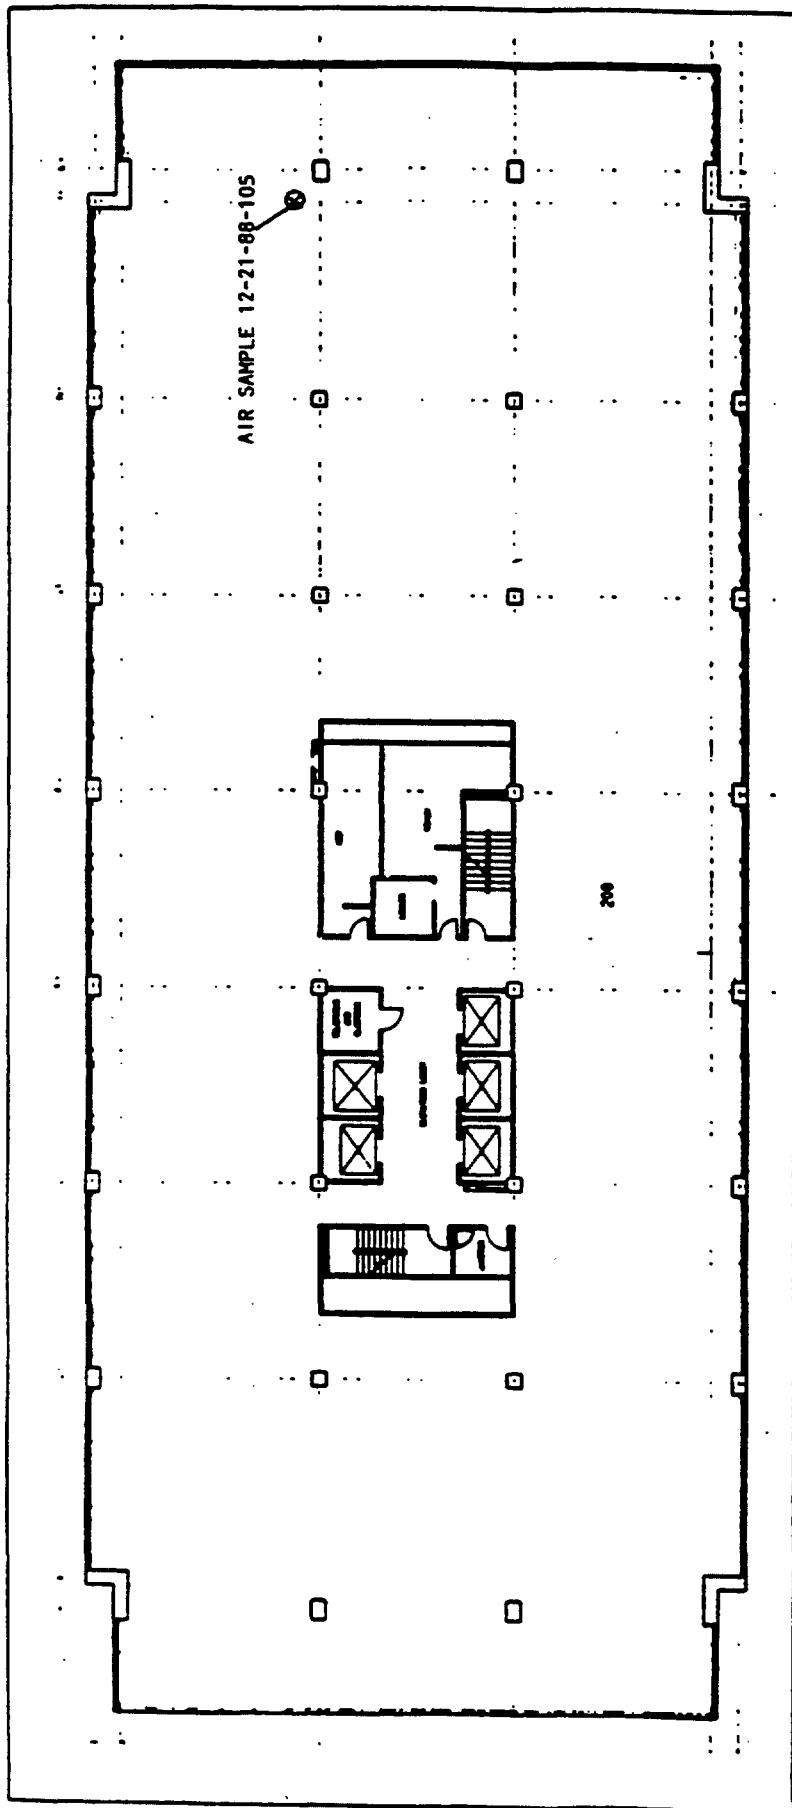
| SUITE #<br><br>200 | EXP. DATE<br><br>12/31/90 | RENTABLE Sq. Ft.<br><br>11,700 | TENANT'S NAME<br><br>AMCS | TWO<br>ALLEGHENY<br>CENTER<br>2nd Floor | <br>Allegheny<br>Center |

NOTE: SPRAYED-ON FIREPROOFING THROUGHOUT ON BEAMS AND DECKING  
 VAT THROUGHOUT (EXCEPT IN STAIRWELLS AND BATHROOMS - SEE DEETER AND RITCHEY DRAWING A-20 for details)  
 FITTINGS SPOTCHECKED WERE ALL FIBERGLASS

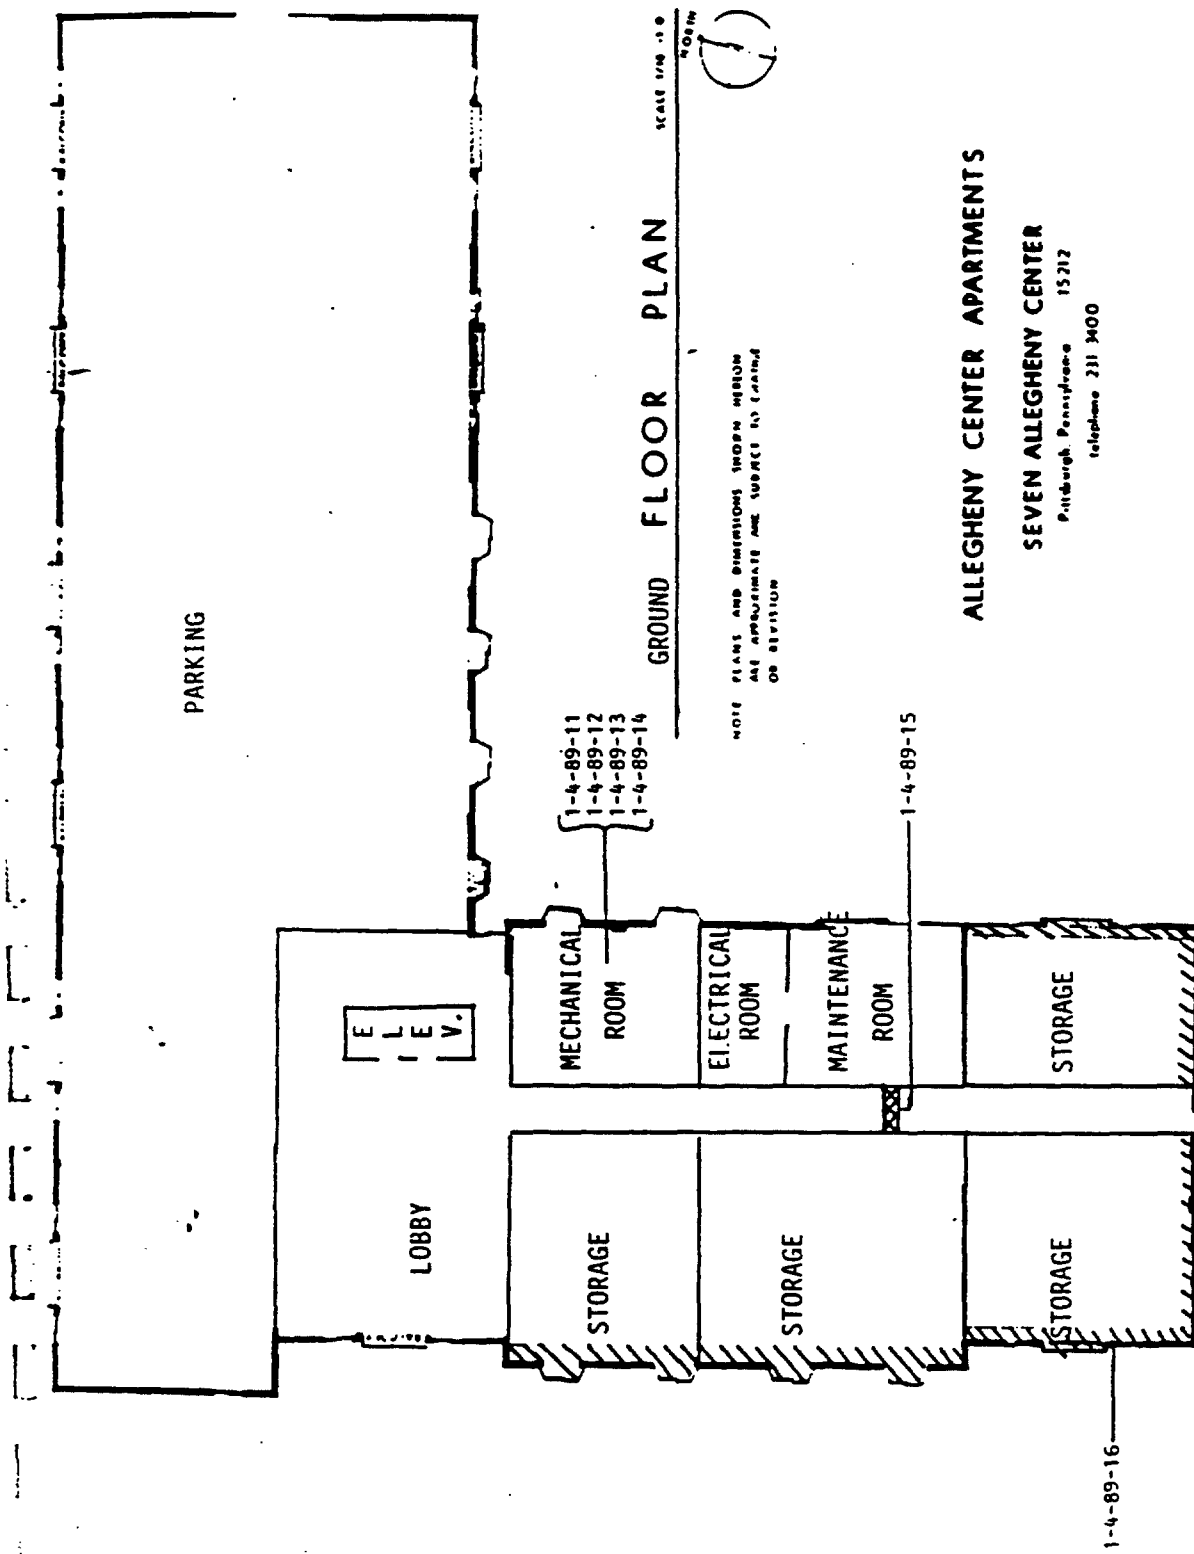
- ☒ TRANSITE WALL PANELS
- ☒ SPRAYED-ON FIREPROOFING (ON BEAM ABOVE PLASTER CEILING)

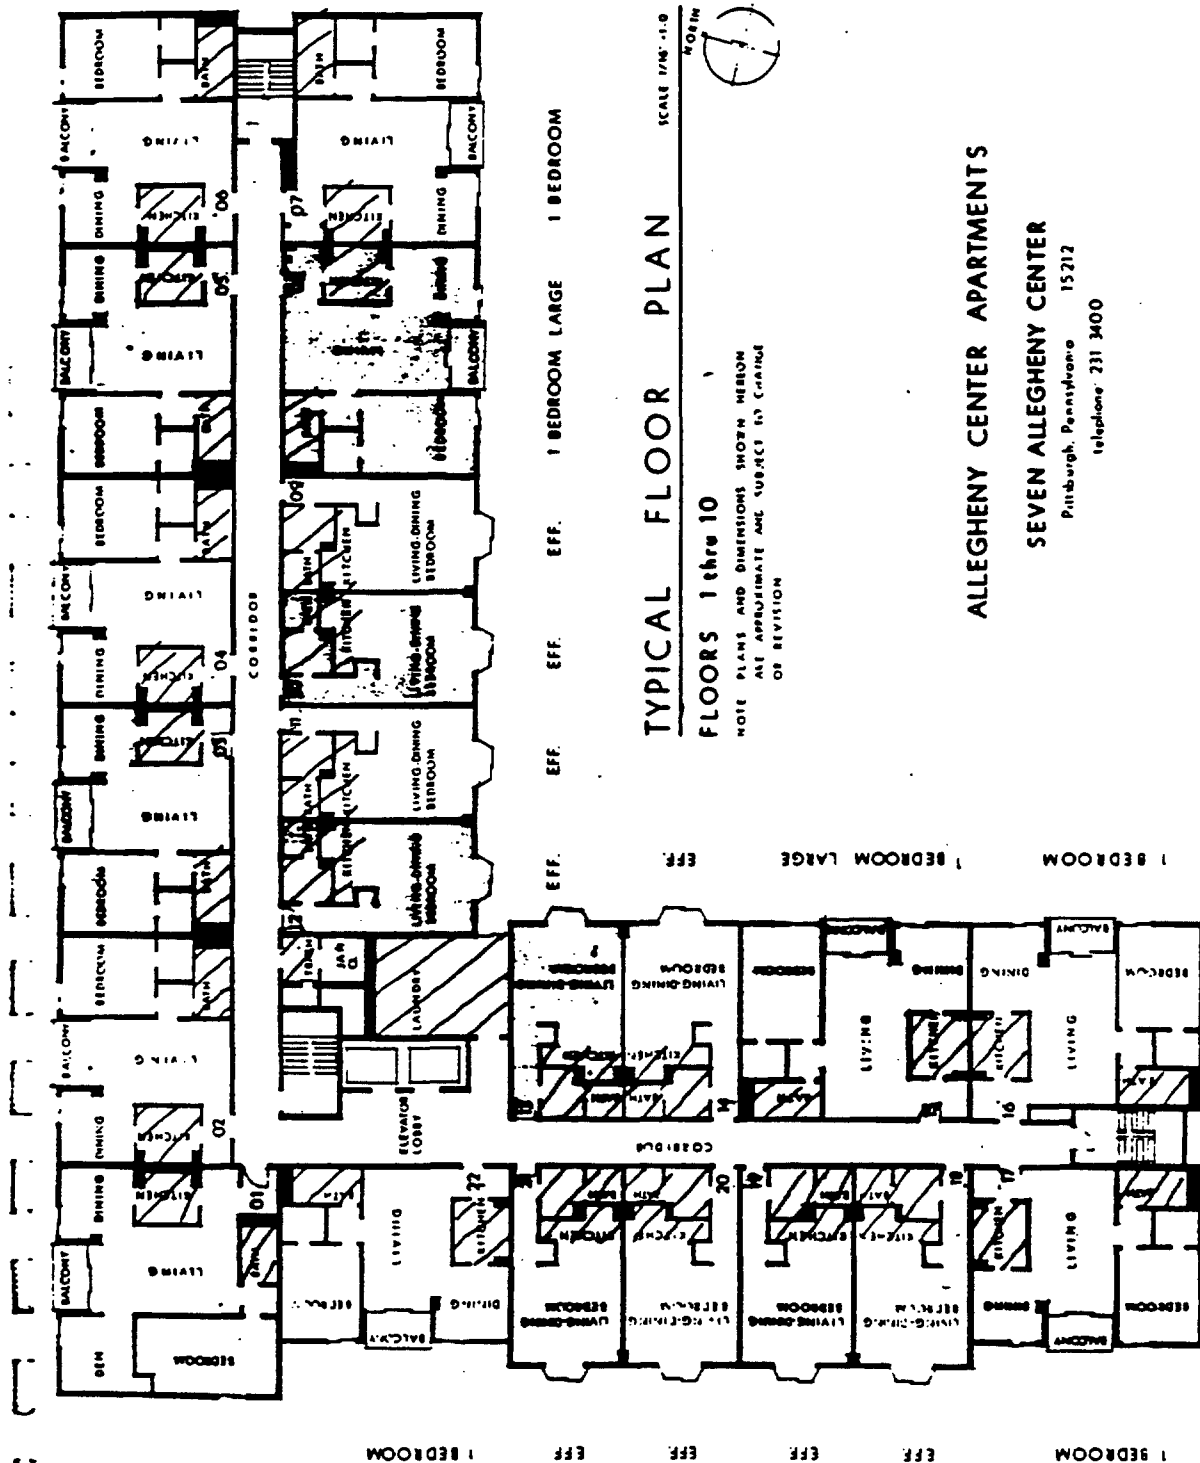
VINYL ASBESTOS FLOOR TILE (9" SQUARES)

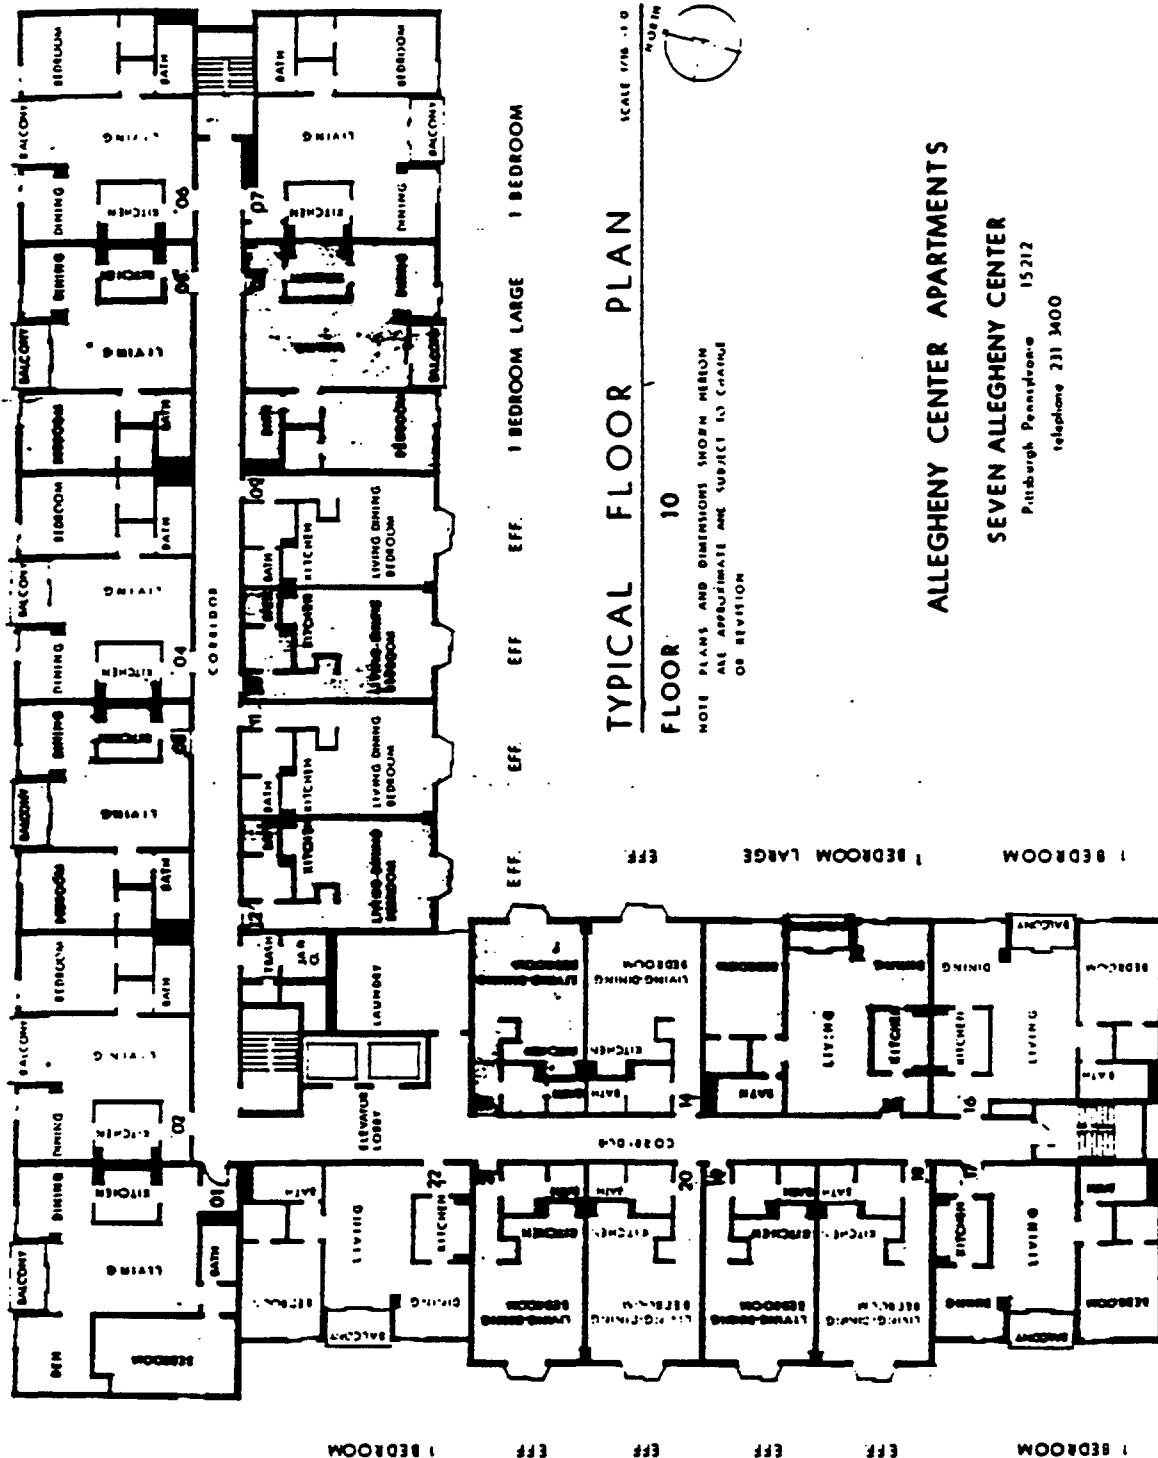
NOTE: FIREPROOFING ON DUCTS ABOVE PLASTER CEILINGS  
SEE COLLINS AND KRENSTADT DRAWING M-3 FOR LOCATIONS

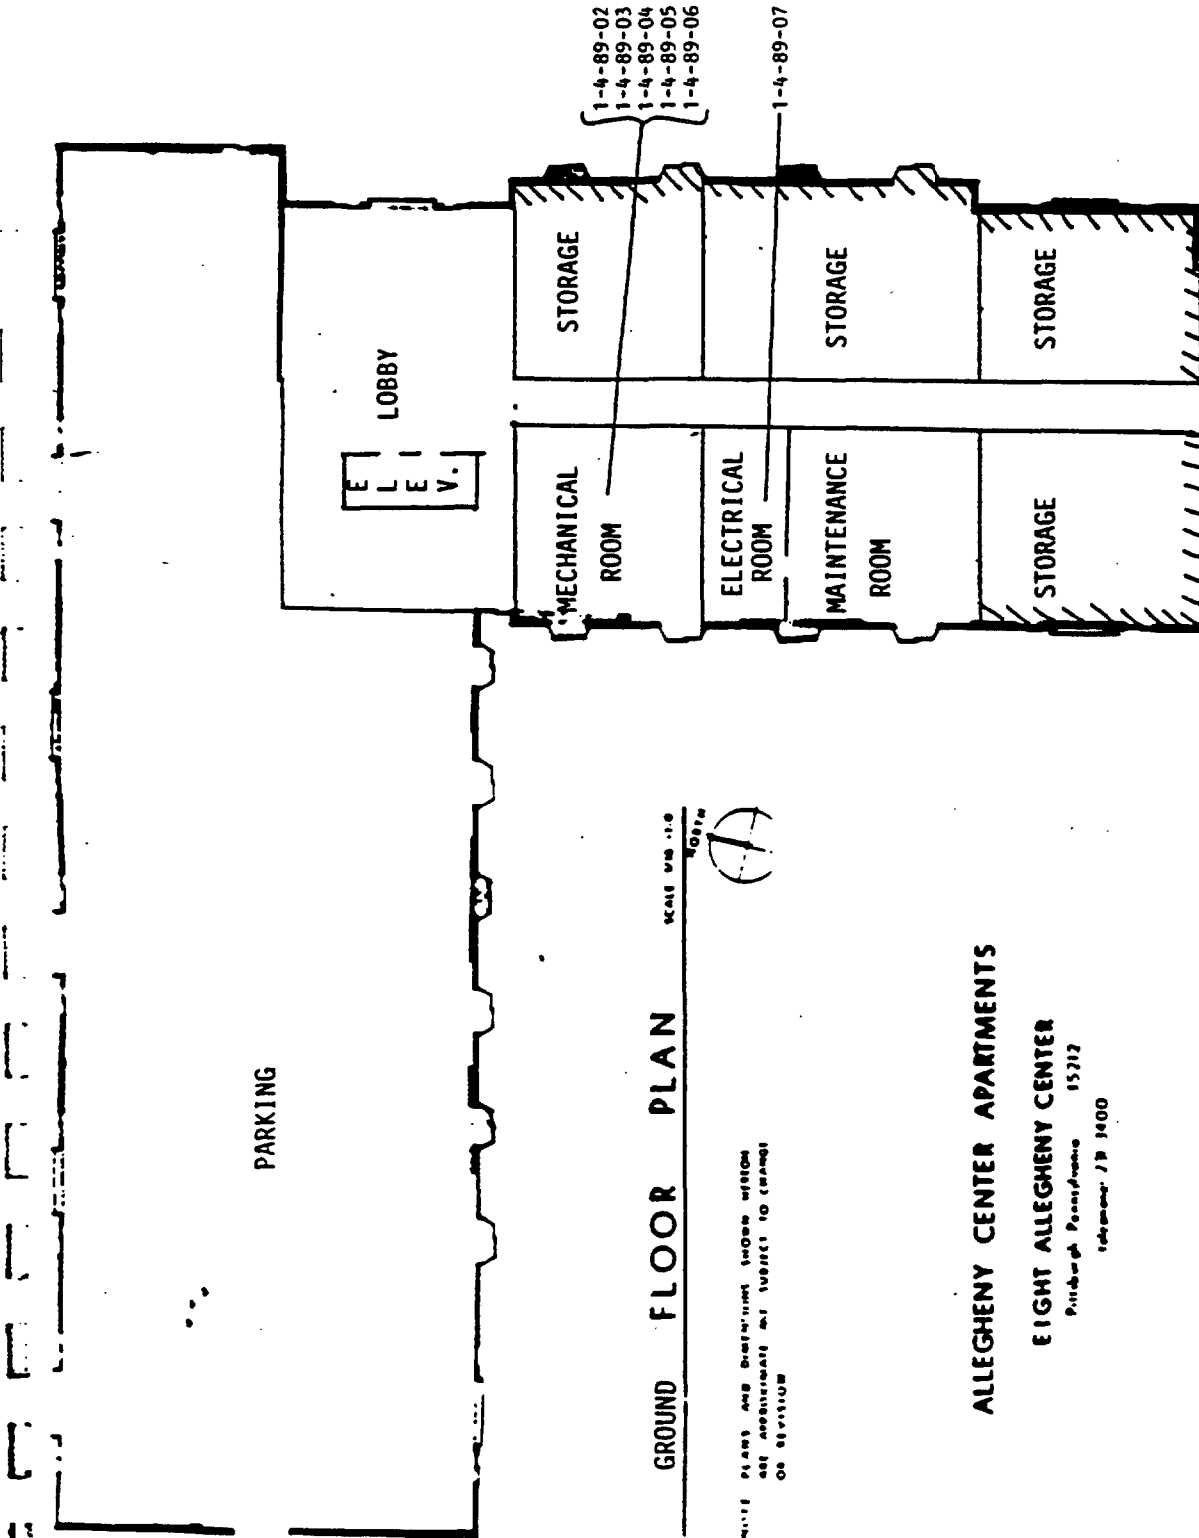
GROUND FLOOR PLAN SCALE 1/8" = 1'-0"

TRANSITE WALL PANELS

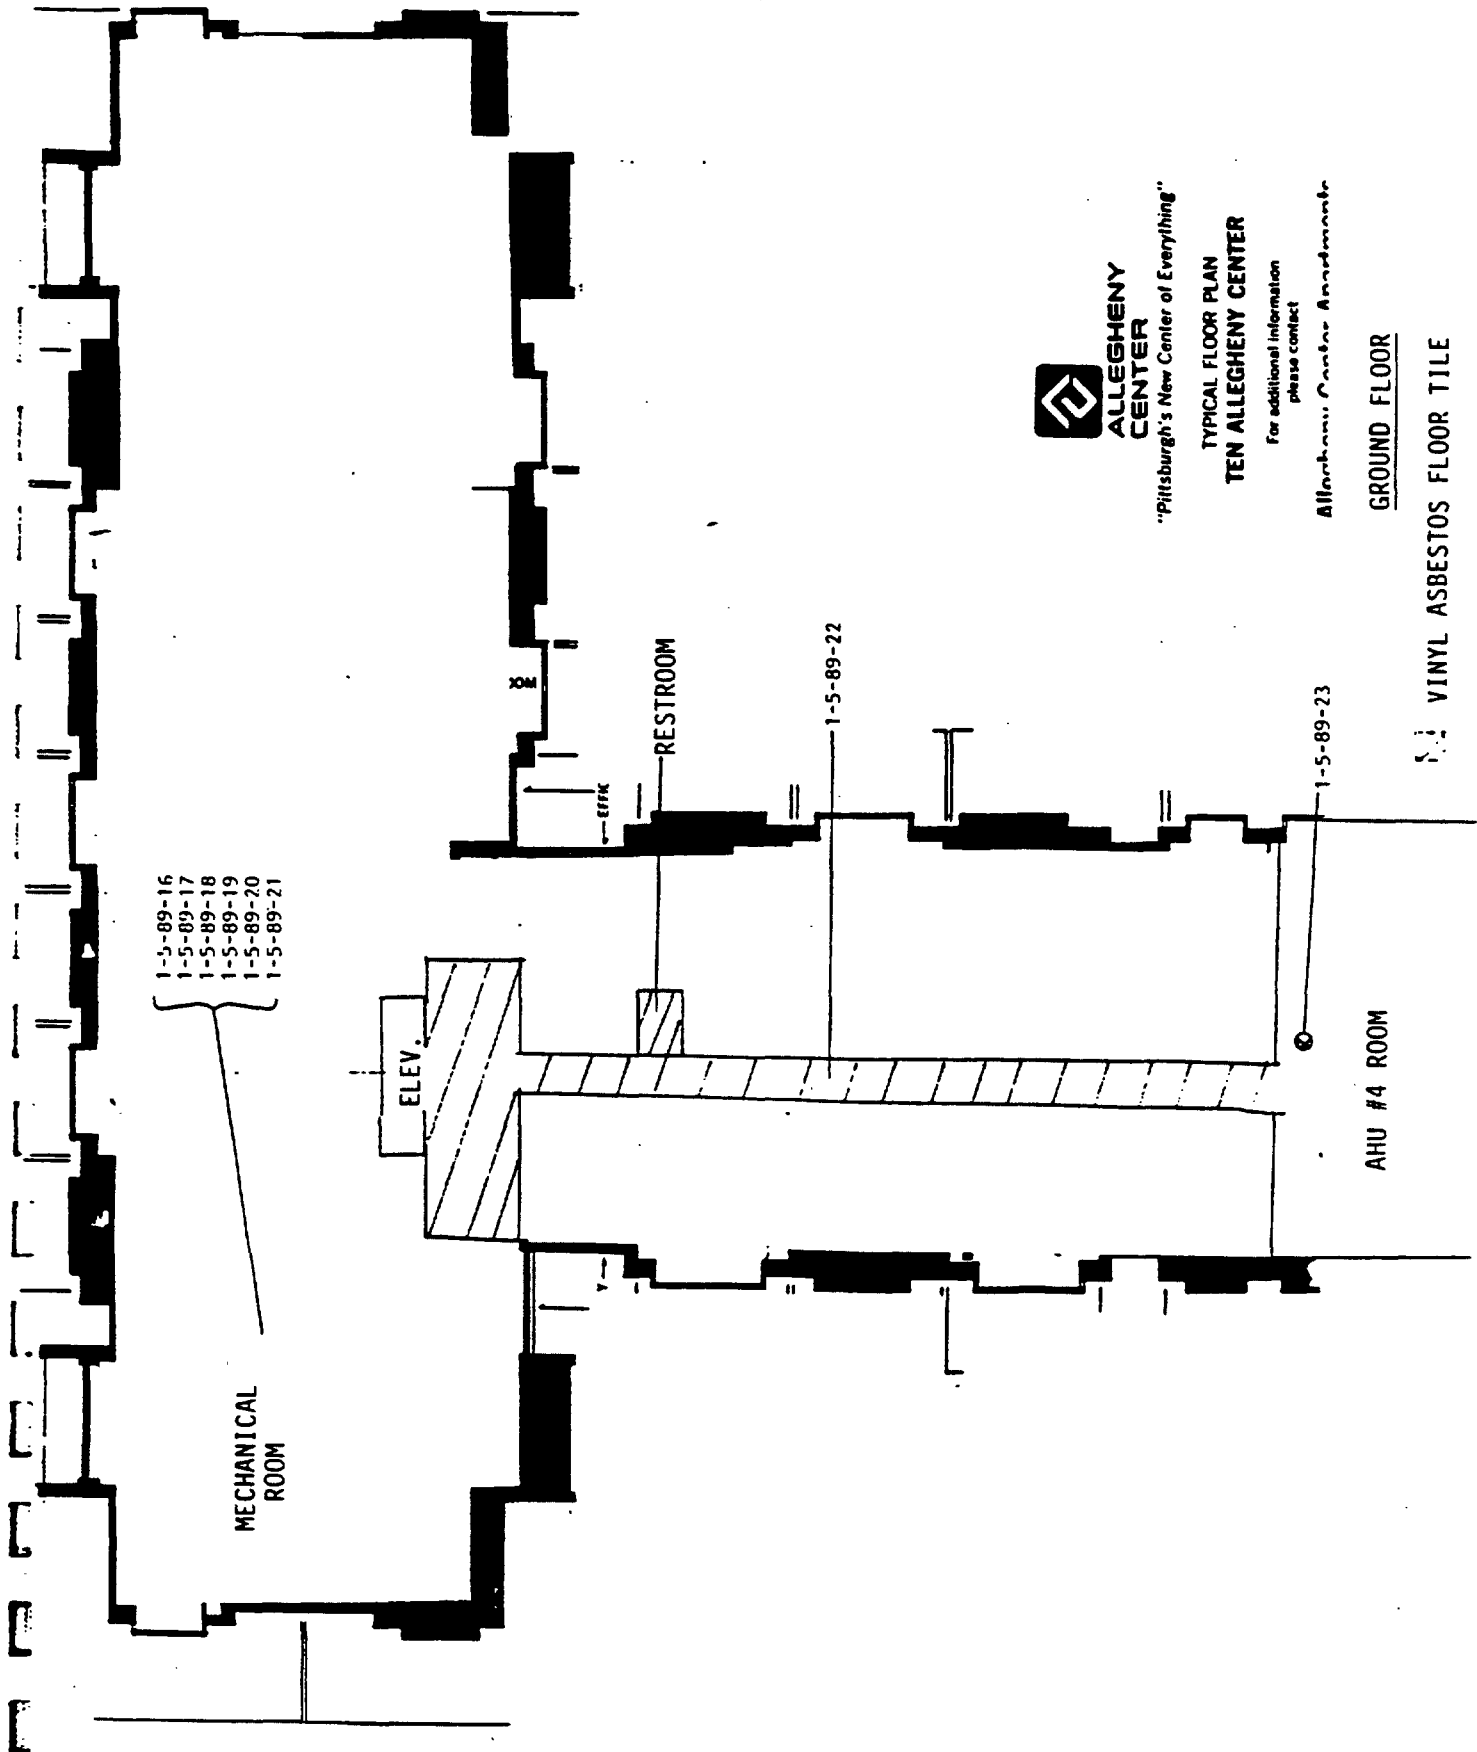
GROUND FLOOR

VINYL ASBESTOS FLOOR TILE

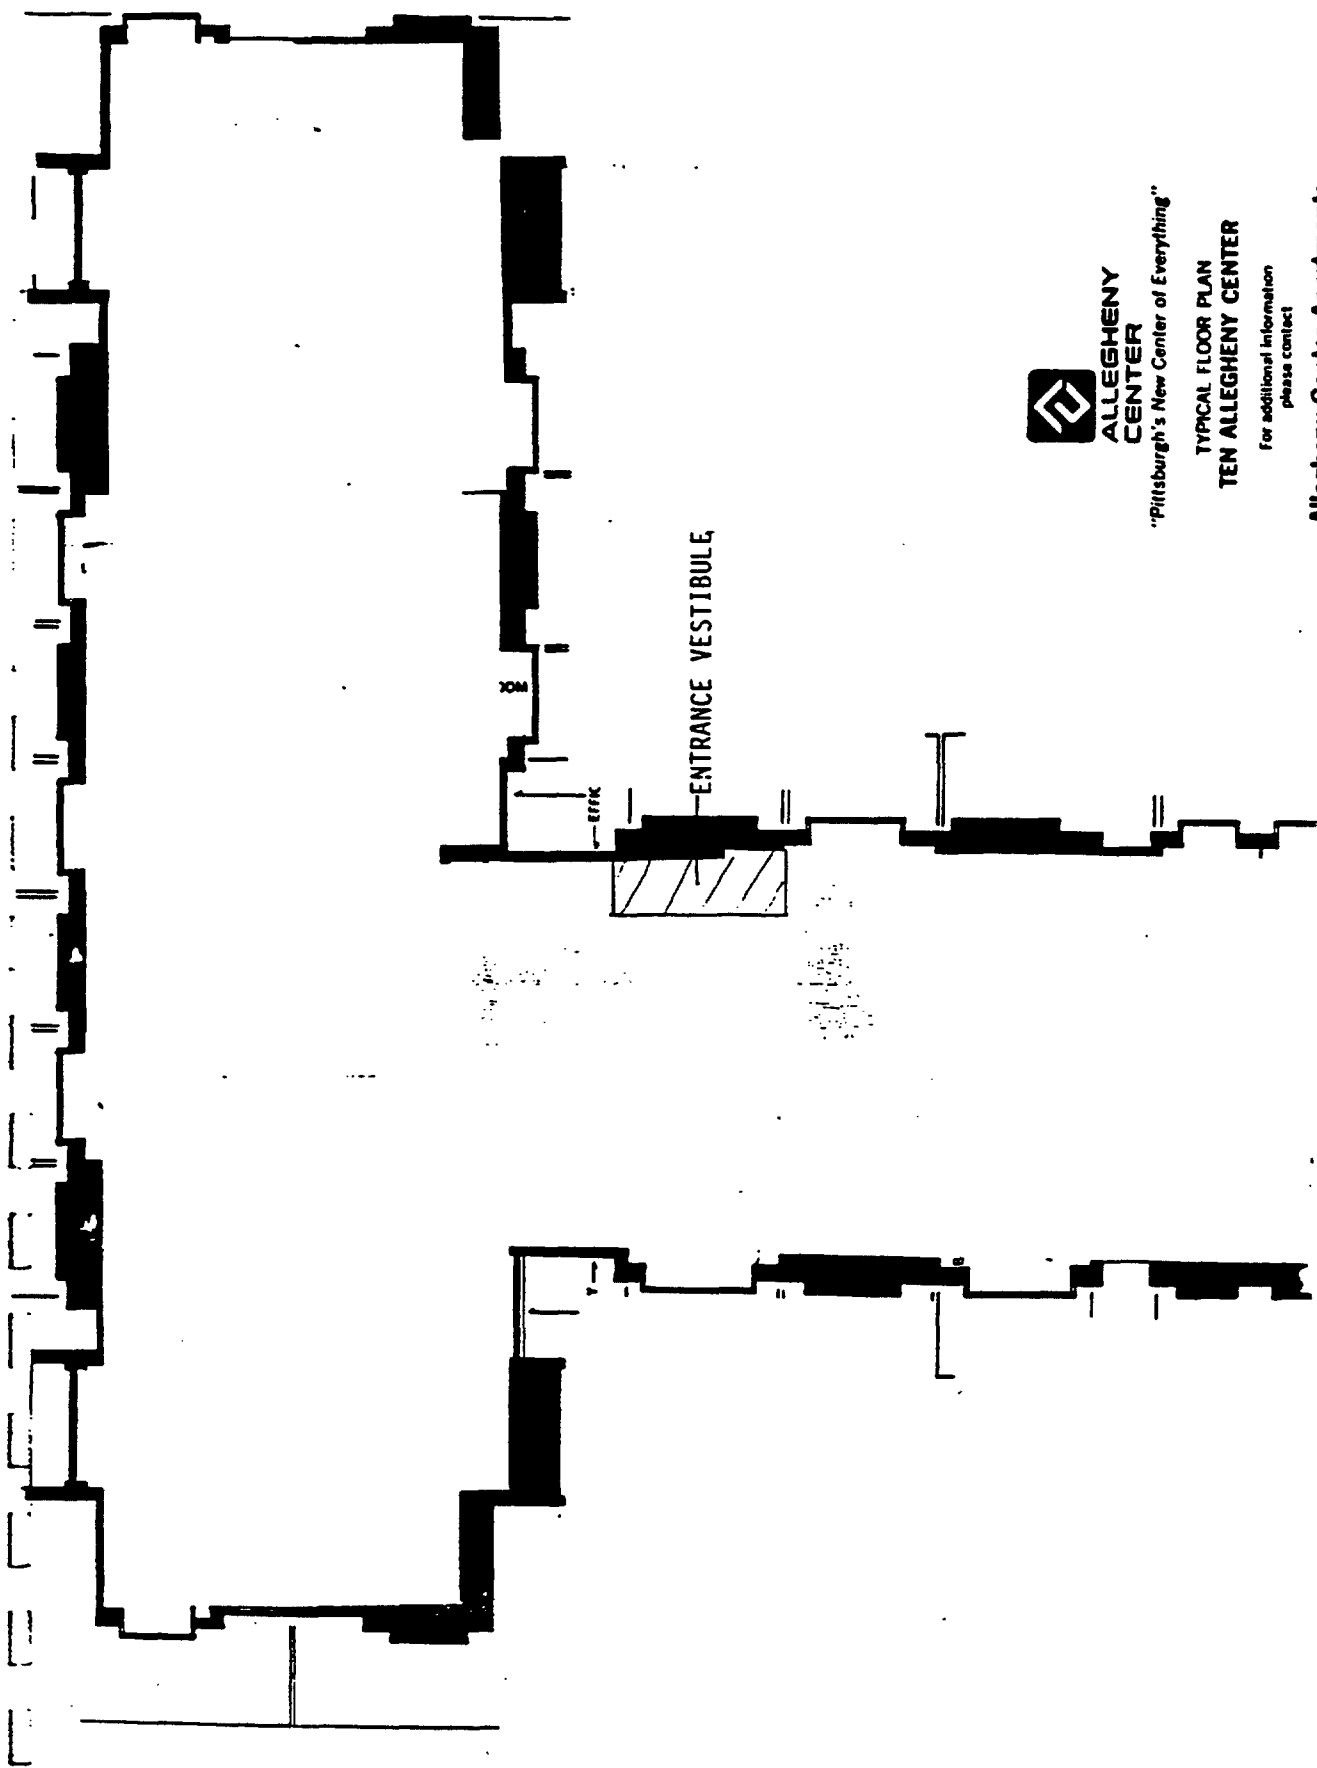
LOBBY FLOOR

VINYL ASBESTOS FLOOR TILE
