**Region 6 - Enforcement & Compliance Assurance Division**  
**INSPECTION REPORT**

| Inspection Date(s): | 06/27/2022 | |
| Company Name: | McCann Resources, Inc | |
| Facility Name: | Bowring Lease | |

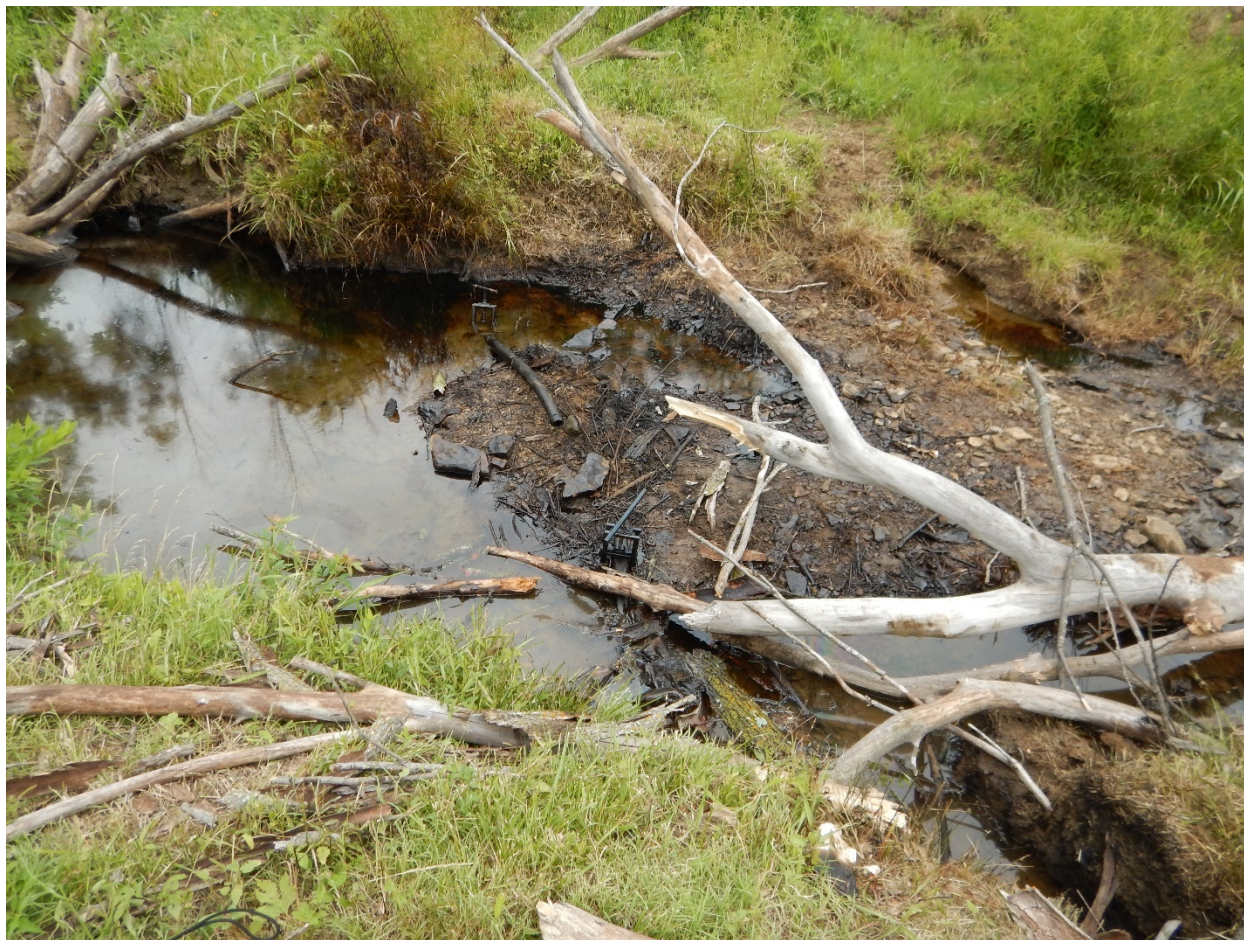
During the inspection, I observed the Release Point and the Point of Entry (POE) into the main channel of an unnamed tributary of Mission Creek. I observed 3 men, employees of McCann Resources Inc, and a tank truck working to remove oil from the impacted tributary near the POE. The release point and POE were the same location (GPS 36.871074, -96.125656). The release point and POE are documented in Appendix 1 (photo log), Photo No. 1. I observed a 2-inch diameter poly flowline which had pulled apart at a collar connection in the middle of the streambed. At the time of the inspection there was a pinch-off tool installed on each end of the damaged flowline to prevent the release of additional produced water and oil. I observed crude oil floating on the water in the tributary and oil-stained rocks, soil and vegetation were present at the POE. Each of the POE observations are documented in Photo No. 1 (GPS 36.871074, -96.125656). Using a properly calibrated YSI Pro 30 conductivity meter, I observed an elevated Total Dissolved Solids (TDS) field reading of 54,136 mg/L in the main channel of the impacted tributary at the POE, this was the highest TDS field reading observed during the inspection, this was documented in Photo No. 2 (GPS 36.871105, -96.125708).

**Description:** This was the Release Point and the Point of Entry (POE) of the spill. The 2-inch diameter poly flowline was parted in the middle of the streambed. There was a pinch-off tool installed on each side of the damaged flowline to prevent additional fluid release from the flowline. Crude oil was floating on the surface of the water and crude oil stains were on the rocks, soil, and vegetation in and around the tributary. This unnamed tributary was a tributary of Mission Creek.

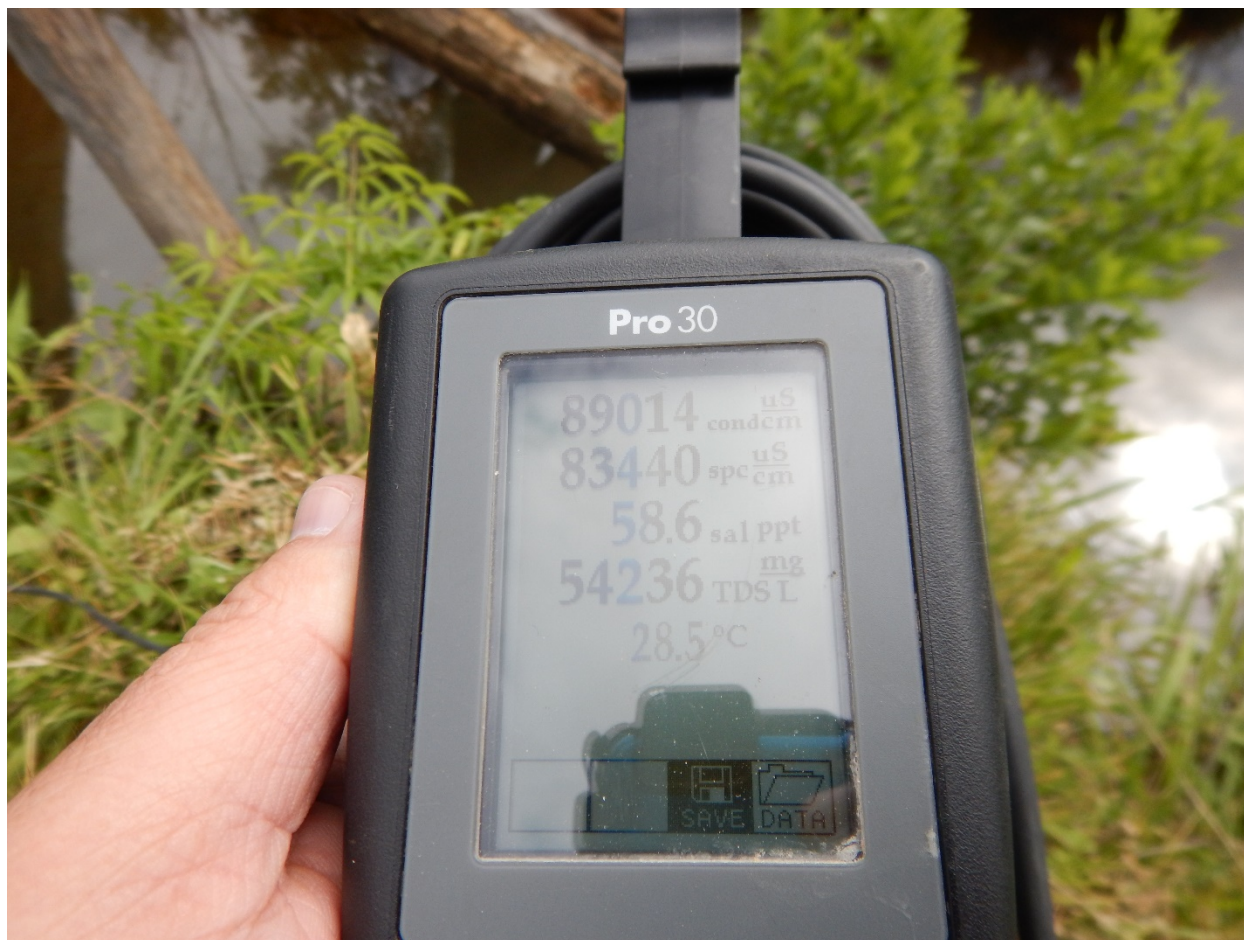
Photo No. 2

**Description:** This was an elevated Total Dissolved Solids (TDS) field reading of 54,236 mg/L taken in the pool where the produced water entered the tributary (POE). This field reading and all others included in this report/photo log were taken with a properly calibrated YSI Pro 30 conductivity meter.

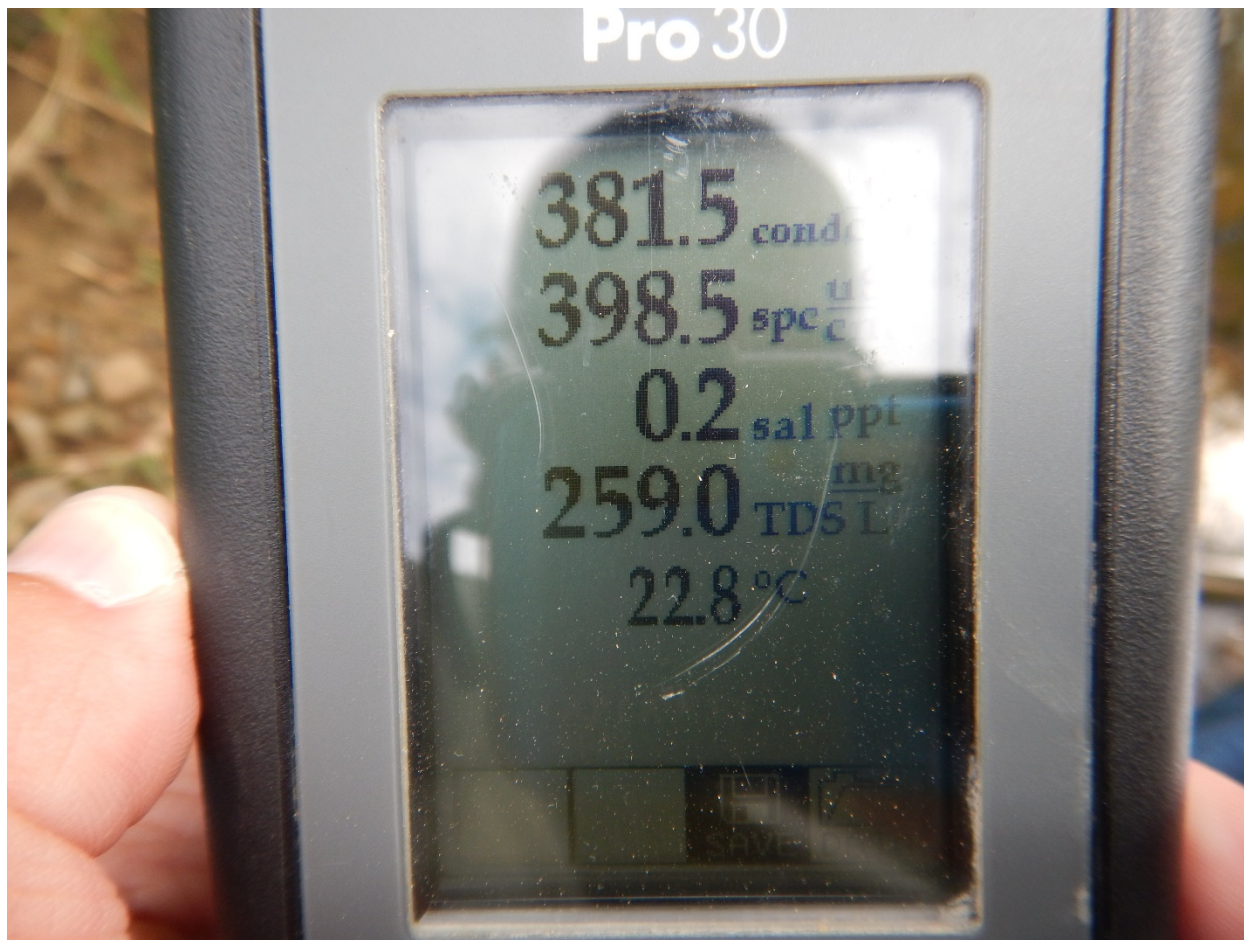
I observed a “background” TDS field reading approximately 150 feet upstream from the POE along the main channel of the impacted tributary, the background reading was taken in a pool of water which was not impacted by the spill and can be seen in Photo No. 3 (GPS 36.871470, -96.125860). I observed oil floating on the surface of the water in the impacted tributary approximately 100 feet upstream from the

**Description:** This was a "background" TDS field reading of 259.0 mg/L taken approximately 150 feet upstream from the POE. This field reading was taken in a pool of water along the main channel of the tributary which was not impacted by the spilled fluids.

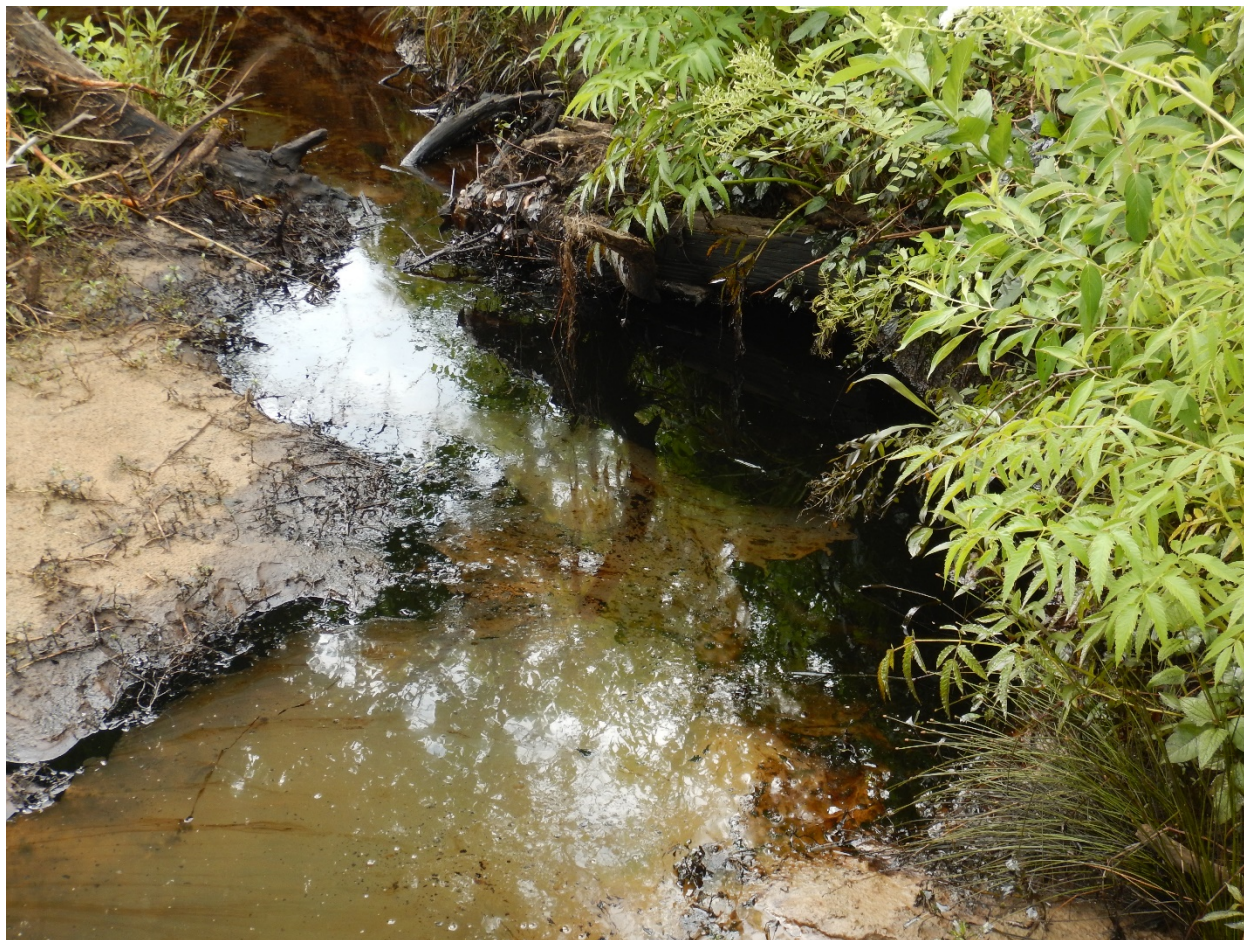
POE, oil staining was present on the banks and vegetation at the same location, this can be seen in Photo No. 4 (GPS 36.871202, -96.125883).

**Description:** This was a photo of oil floating on the surface of the impacted tributary, oil staining was also present on the banks and vegetation. This photo was taken approximately 100 feet upstream from the POE in the same pool of water as the POE, oil was blown west/upstream by wind across the surface of the pool.

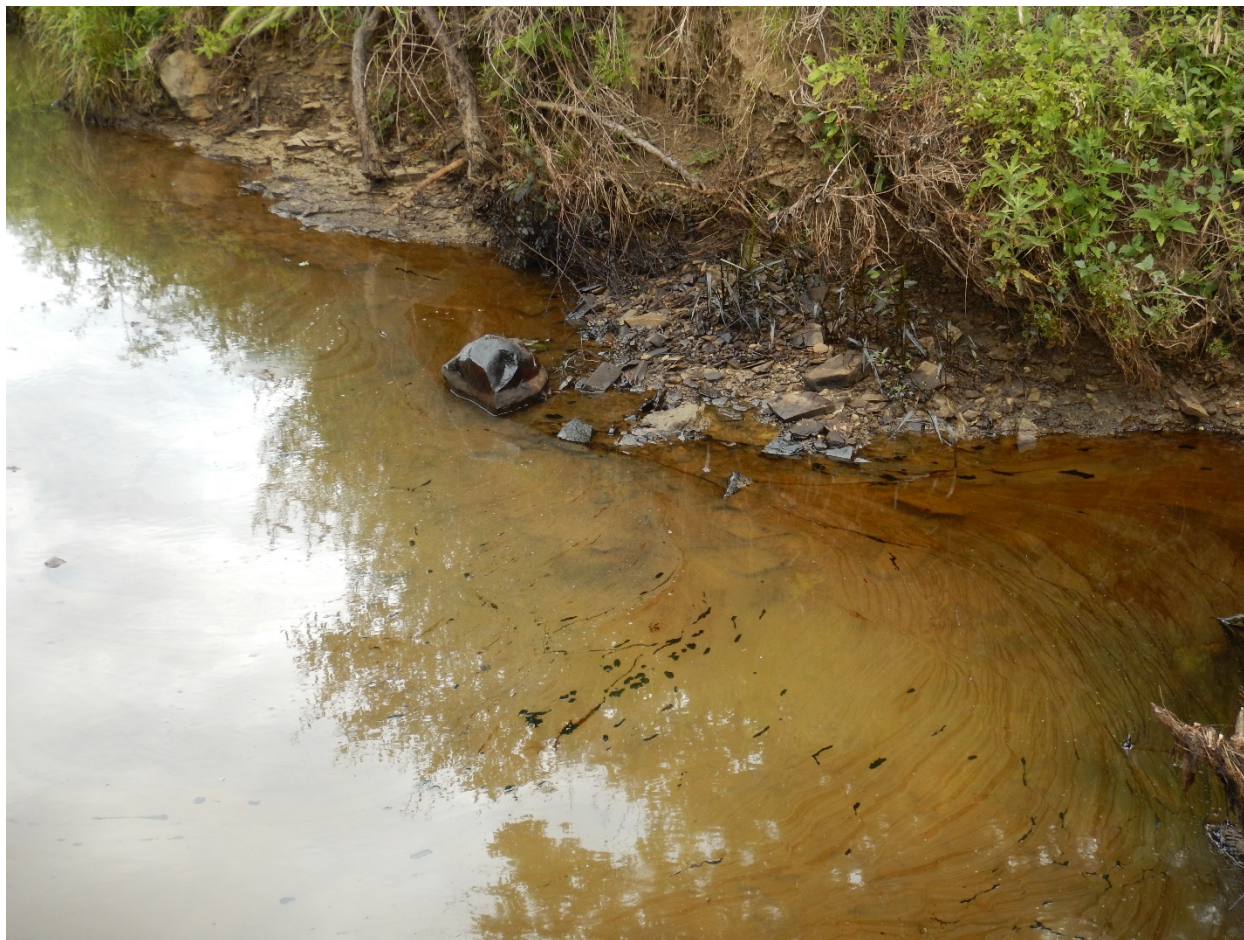
I observed oil on the surface of the tributary and oil stains which showed a high-water mark along the bank of the tributary, this was documented in Photo No. 5 (GPS 36.871202, -96.125883) and was located approximately 75 feet upstream from the POE. Approximately 25 feet downstream from the POE, in the first downstream pool of water I observed a large smoldering log. I observed charred logs and vegetation in and along the tributary as well as thick black oil on the surface of the tributary, which appeared to have been burned in-situ. I also observed an elevated TDS field reading of 2,242 mg/L at the same location, these observations can be seen in Photos No. 6 and 7 (GPS 36.870984, -96.125552).

**Description:** This was a photo showing oil stains along a high-water mark on the bank of the tributary. Oil was also floating on the surface of the tributary. This photo was taken approximately 75 feet upstream from the POE in the same pool of water as the POE.

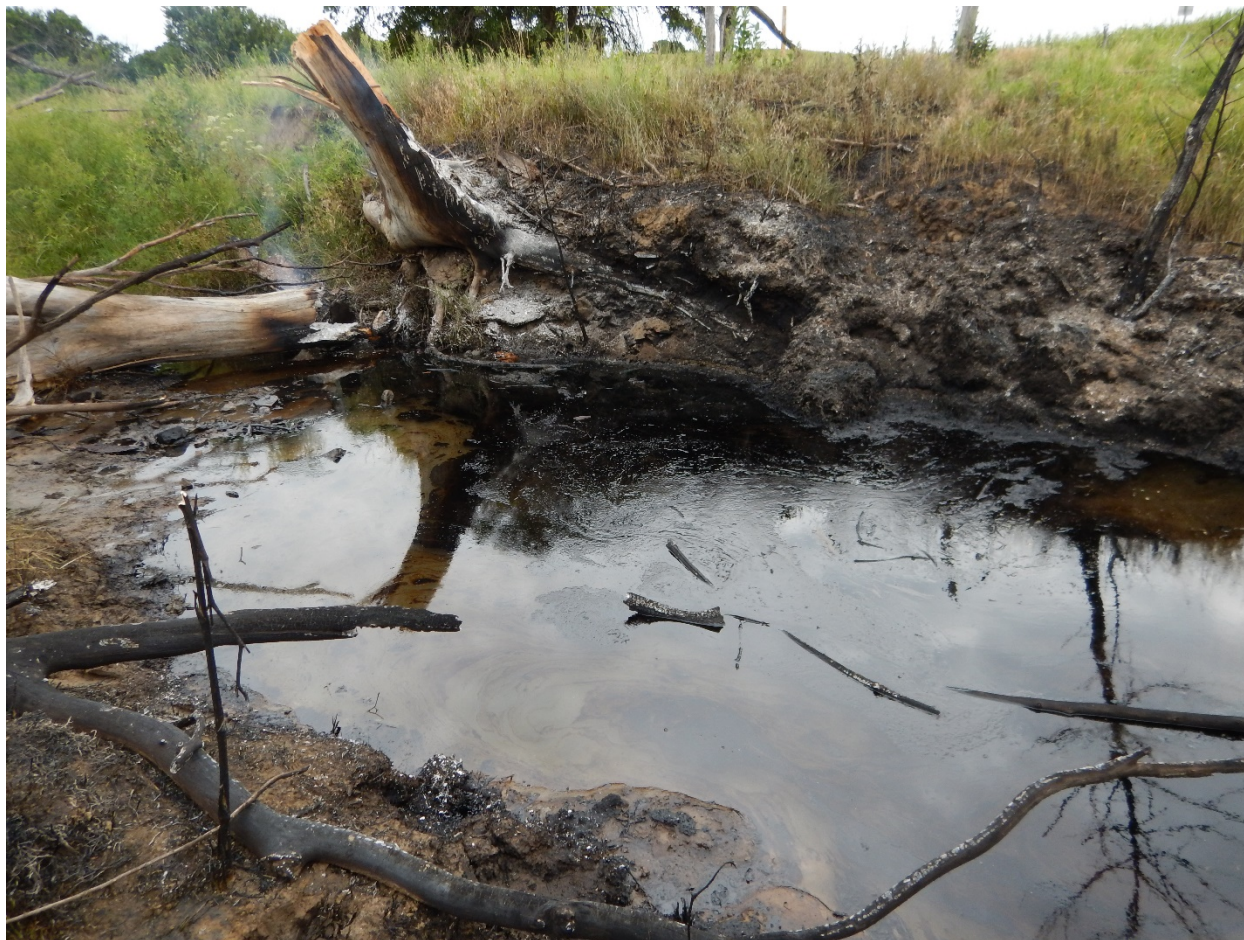
Photo No. 6

**Description:** This photo was taken approximately 25 feet downstream from the POE in the first downstream pool from the POE. There was smoke coming from the log in the upper left corner of the photo. A large dead tree was burned and the oil floating on the surface of the water in the tributary was dark black and thick, and appeared to have been burned in-situ.

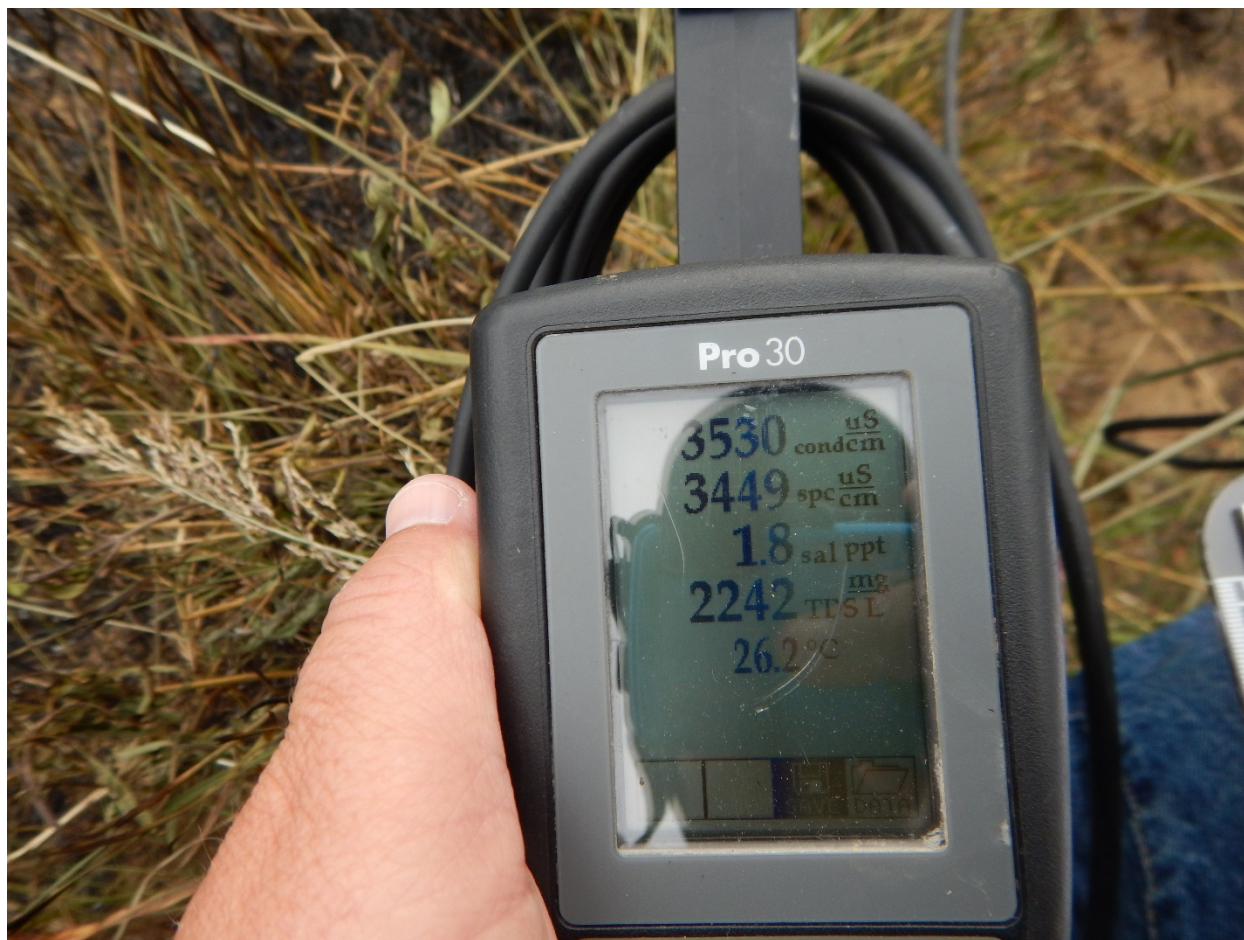
Photo No. 7

**Description:** This was an elevated TDS field of 2,242 mg/L reading taken in a shallow portion of the first pool of water downstream from the POE, this reading was taken approximately 25 feet downstream from the POE.

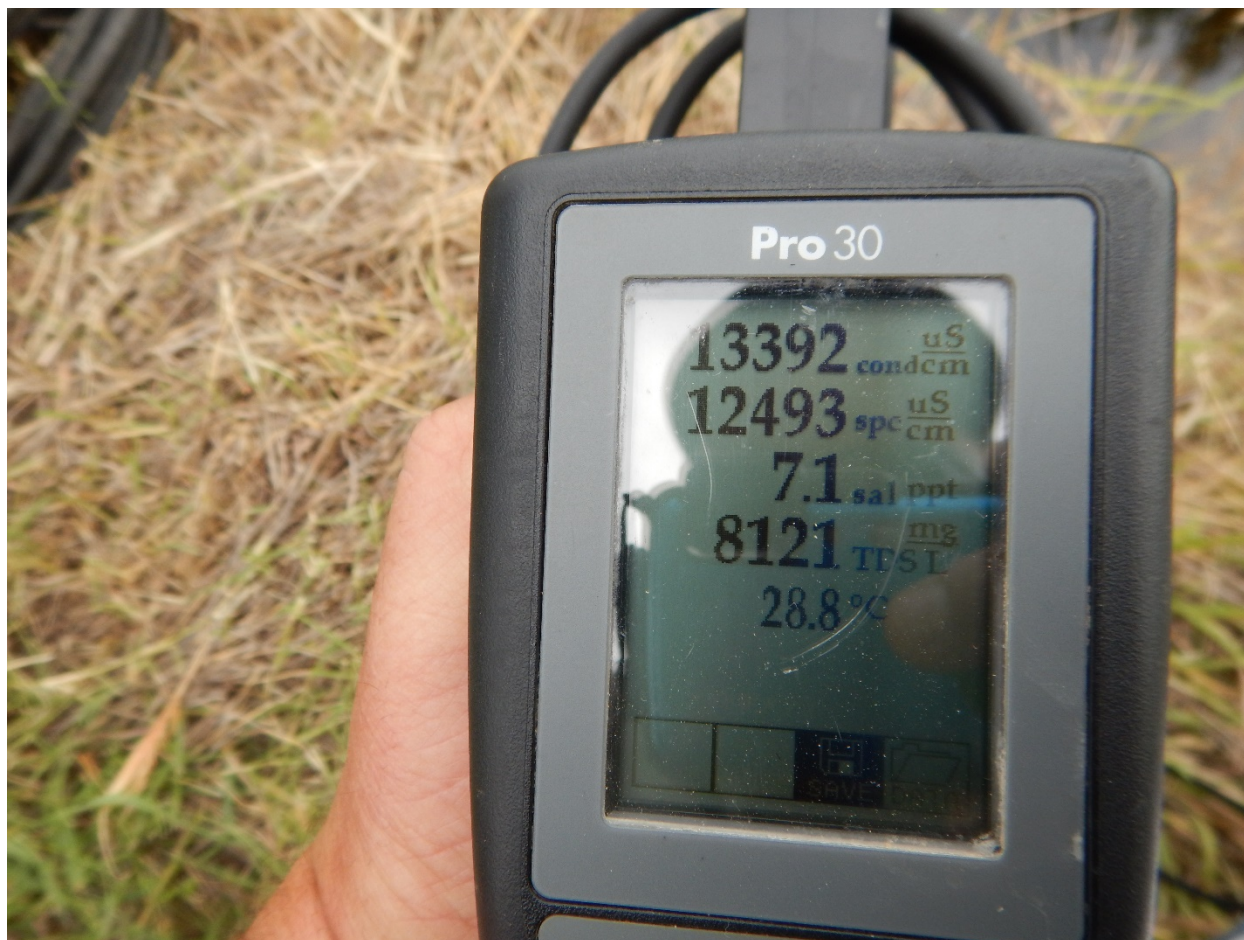
Photo No. 8

**Description:** This was an elevated TDS field reading of 8,121 mg/L taken approximately 75 feet downstream from the POE in the first pool of water downstream from the POE. This reading was taken in a deeper section of the main channel of the impacted tributary.

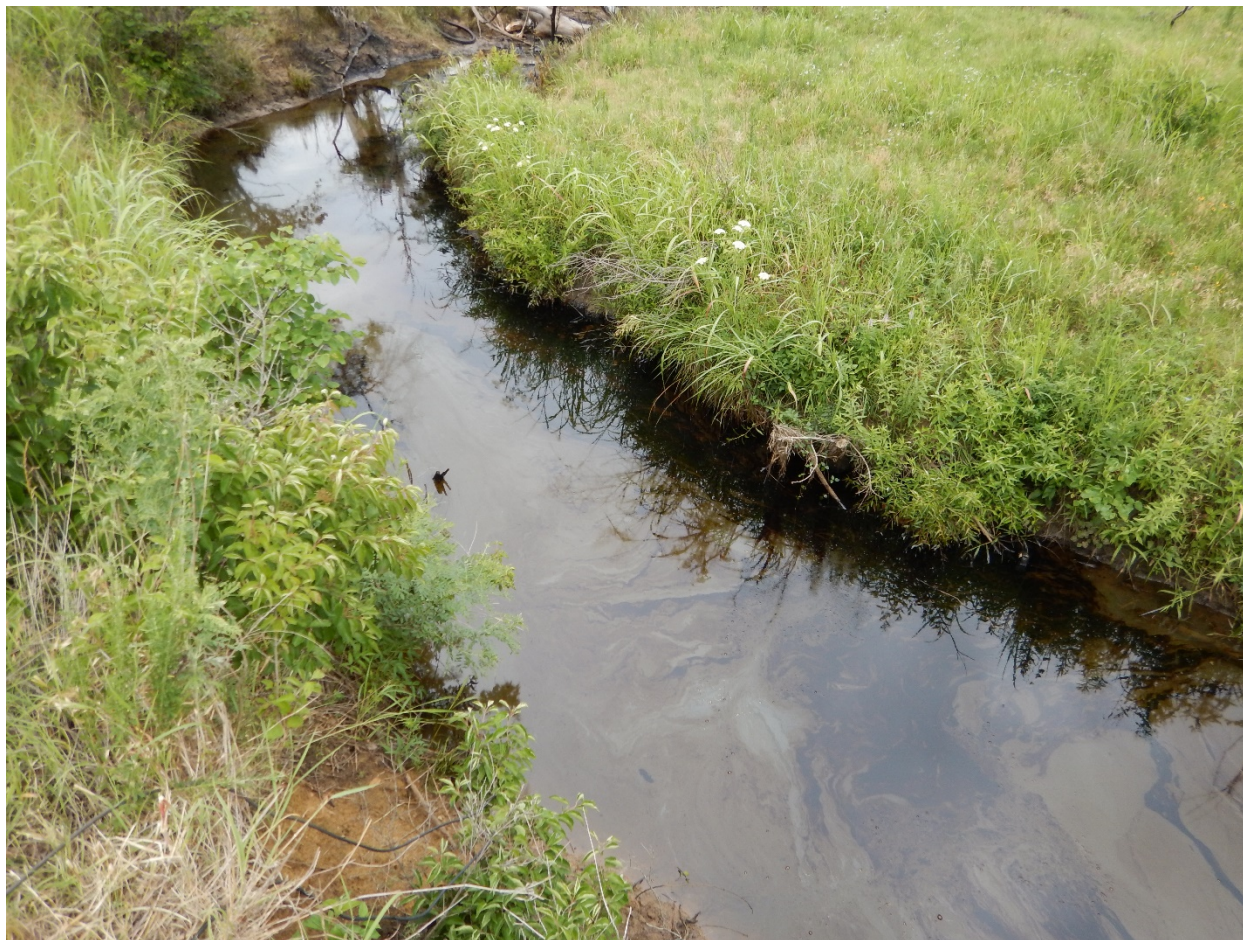
Photo No. 9

**Description:** This was a photo showing the bed and bank features of the tributary. This photo was taken from a location approximately 75 feet downstream from the POE with a view looking to the west/upstream toward the POE. Oil was present on the surface of the water and on the vegetation along the banks of the tributary. The elevated TDS field reading of 8,121 mg/L was taken at this location.

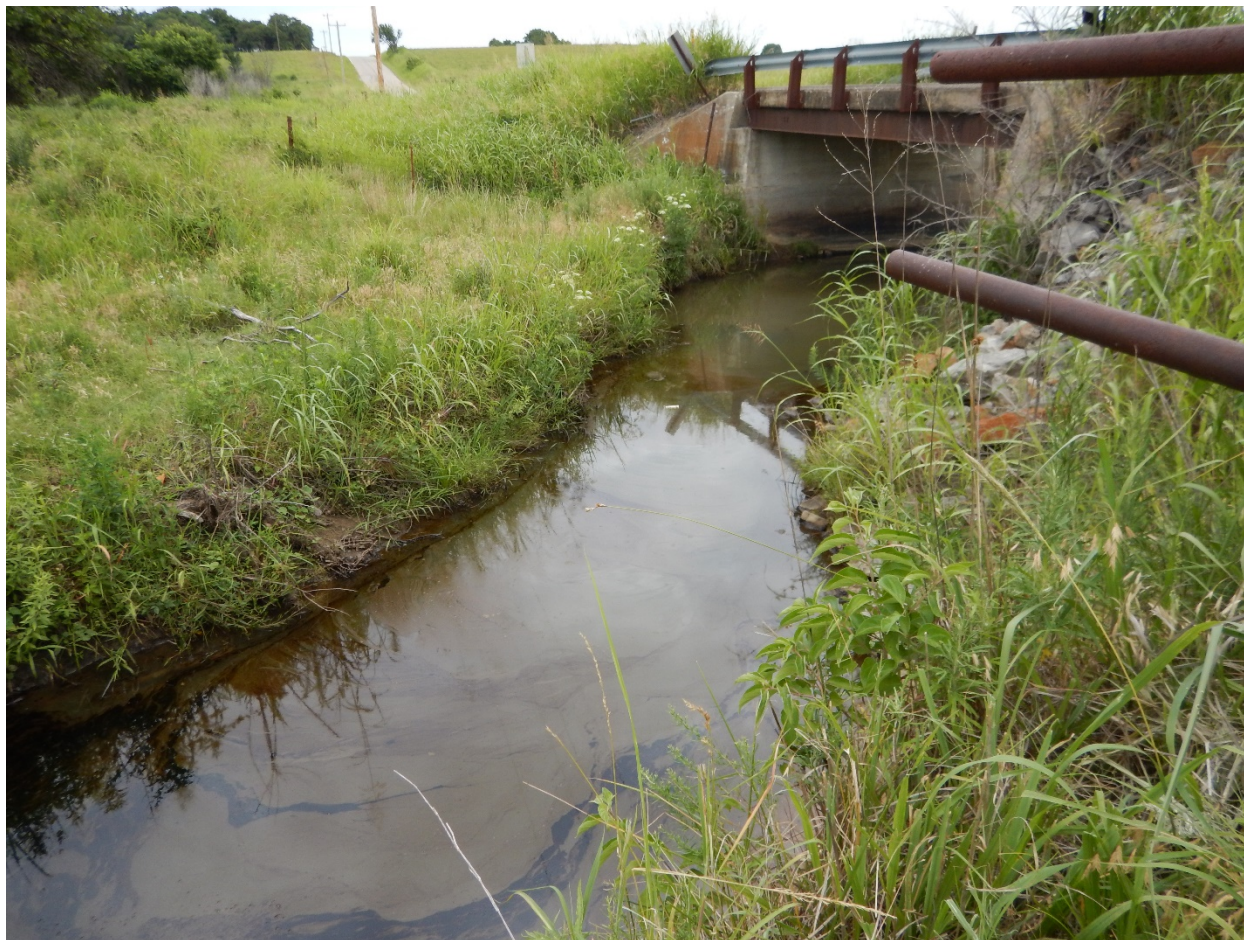
Photo No. 10

**Description:** This was a photo showing the bed and bank features of the tributary. This photo was taken from a location approximately 75 feet downstream from the POE with a view looking to the northeast/downstream from the POE. Oil was present on the surface of the water and on the vegetation along the banks of the tributary. The elevated TDS field reading of 8,121 mg/L was taken at this location.

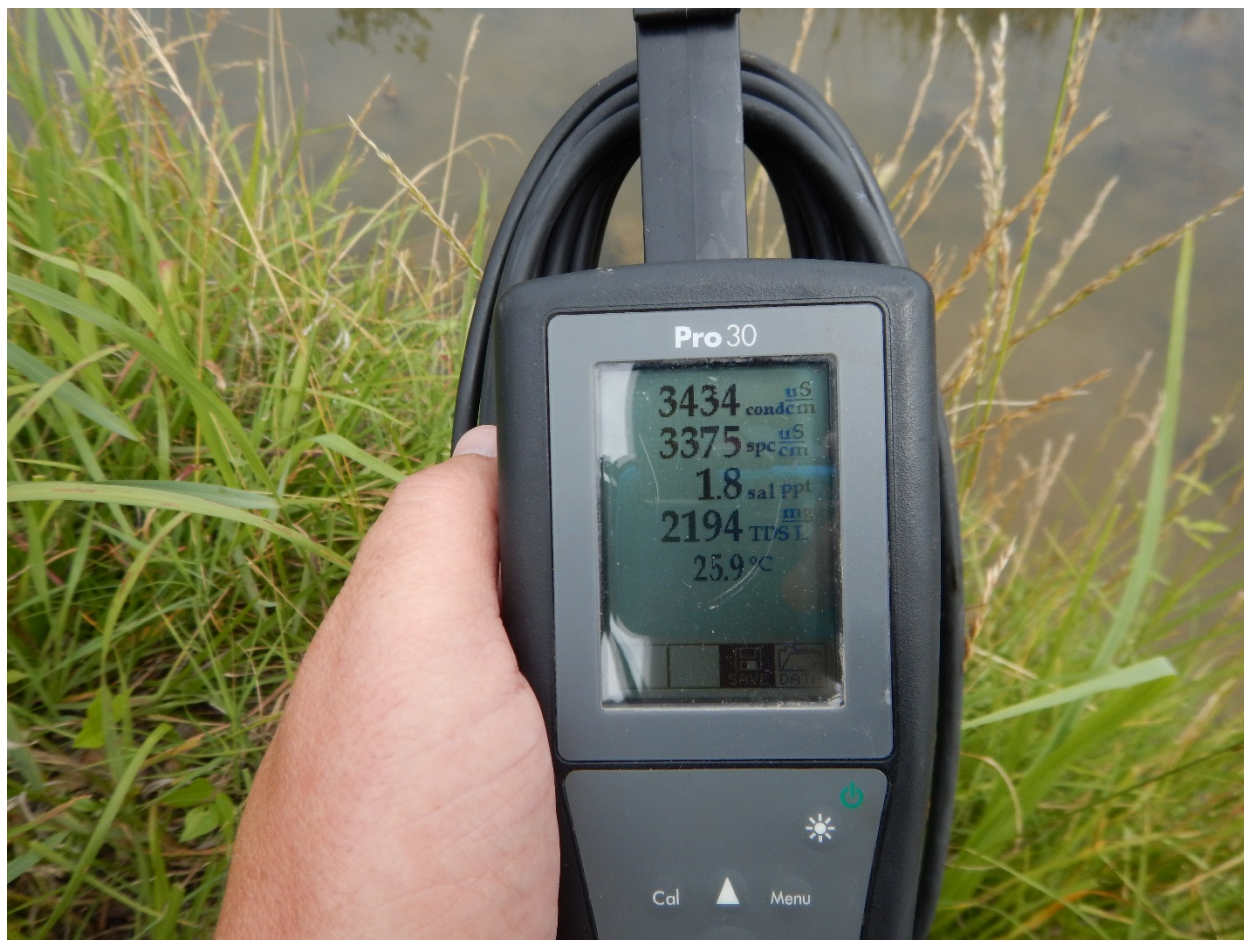
Photo No. 11

I observed an elevated TDS field reading of 2,194 mg/L as well as a floating oil absorbent containment boom approximately 150 feet downstream from the POE, these observations were documented in Photos No. 11 & 12 (GPS 36.871095, -96.125060).

**Description:** This was an elevated TDS field reading of 2,194 mg/L taken at lower end of the first downstream pool. This reading was taken approximately 150 feet downstream from the POE.

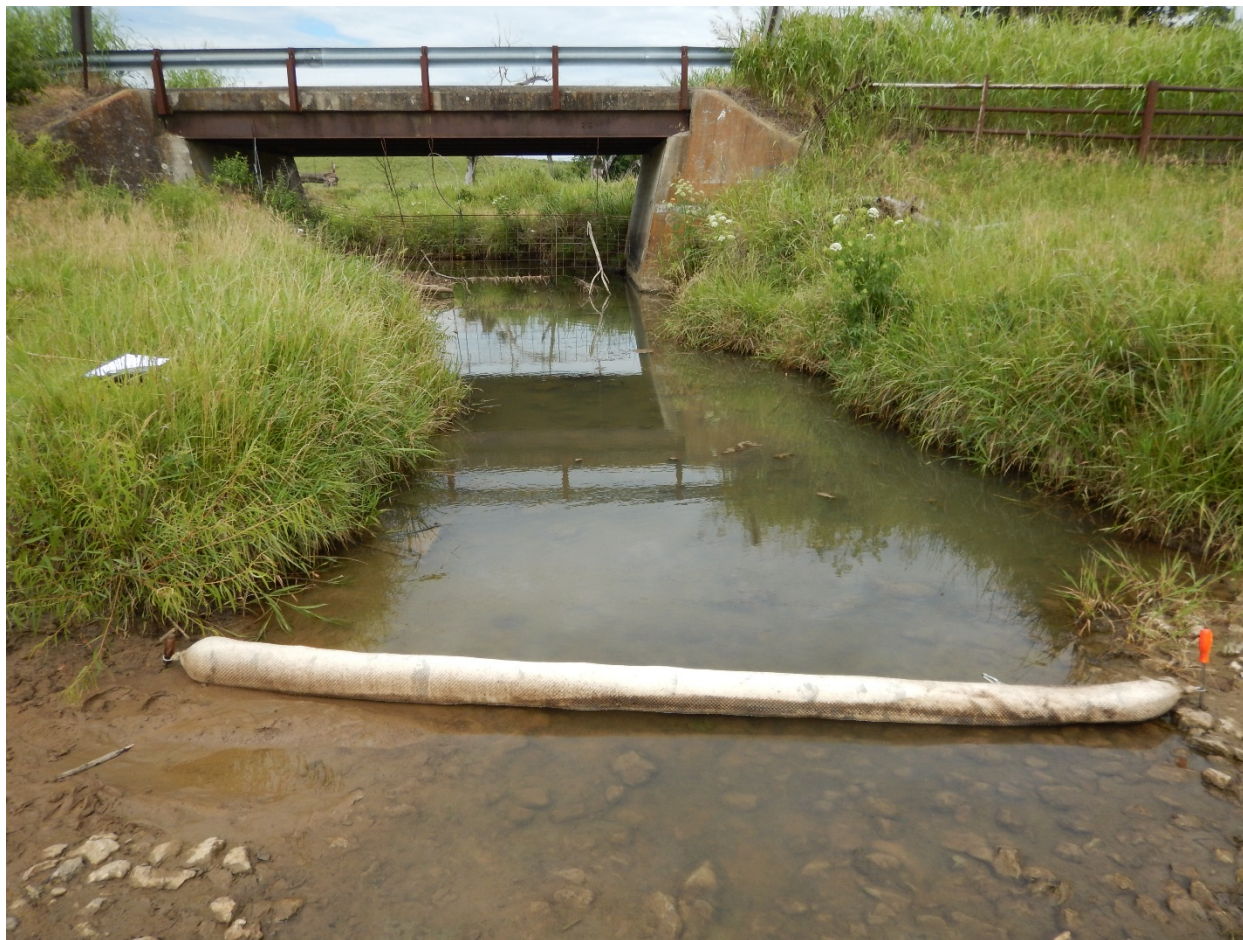
Photo No. 12

**Description:** This was a floating oil absorbent boom which had been placed across the tributary by the operator to prevent migration of oil downstream.

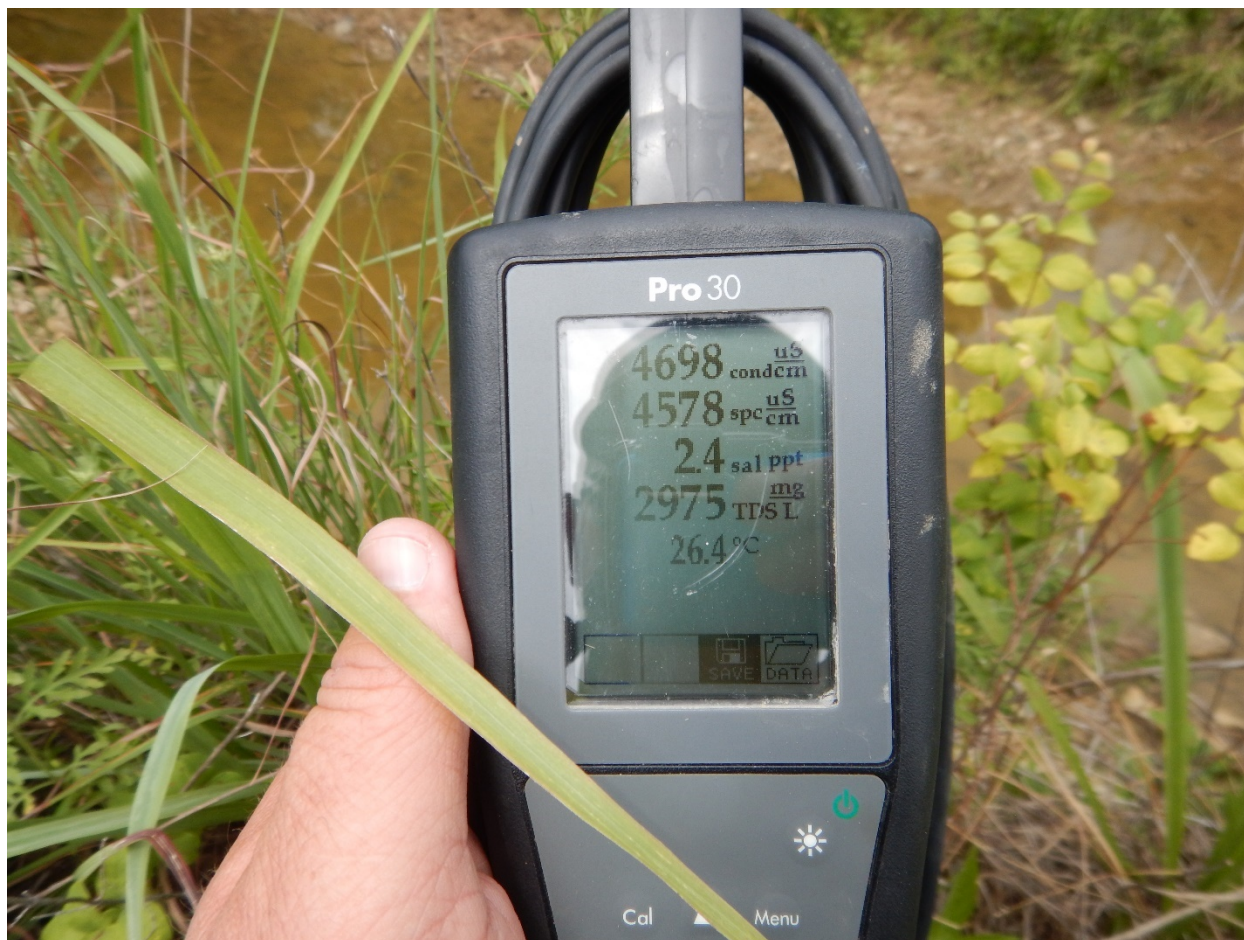
Photo No. 13

Approximately 0.25 miles downstream from the POE, I observed an elevated TDS field reading of 2,975 mg/L and documented the physical characteristics of the tributaries' bed and bank features, these observations were documented in Photos No. 13, 14 and 15 (GPS 36.869907, -96.122289).

**Description:** This was an elevated TDS field reading of 2,975 mg/L taken in the main channel of the impacted tributary approximately 0.25 miles downstream from the POE.

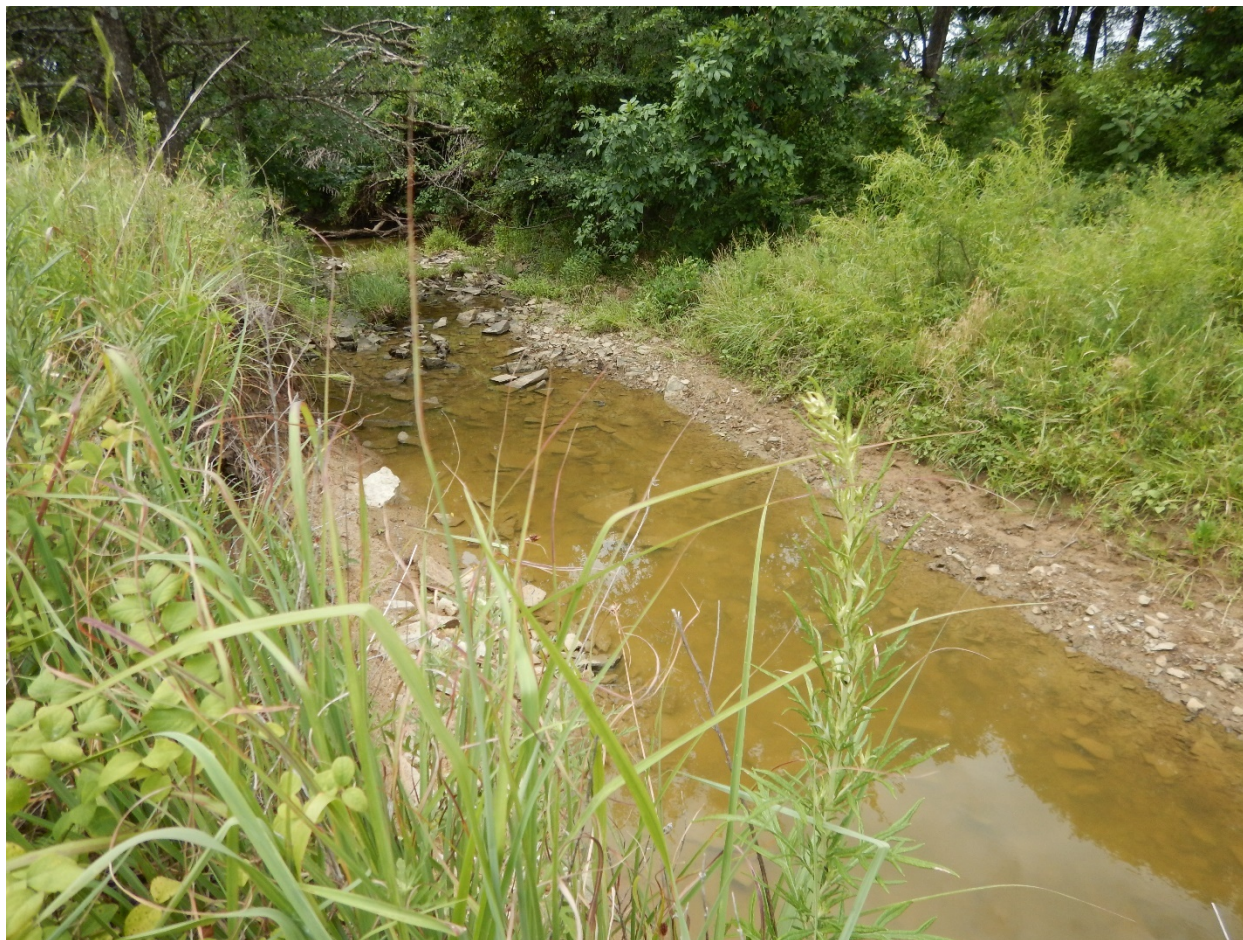
Photo No. 14

**Description:** This was a view looking southeast/downstream from the same location as Photo No 13. This photo was an accurate representation of the bed and bank features of the tributary.

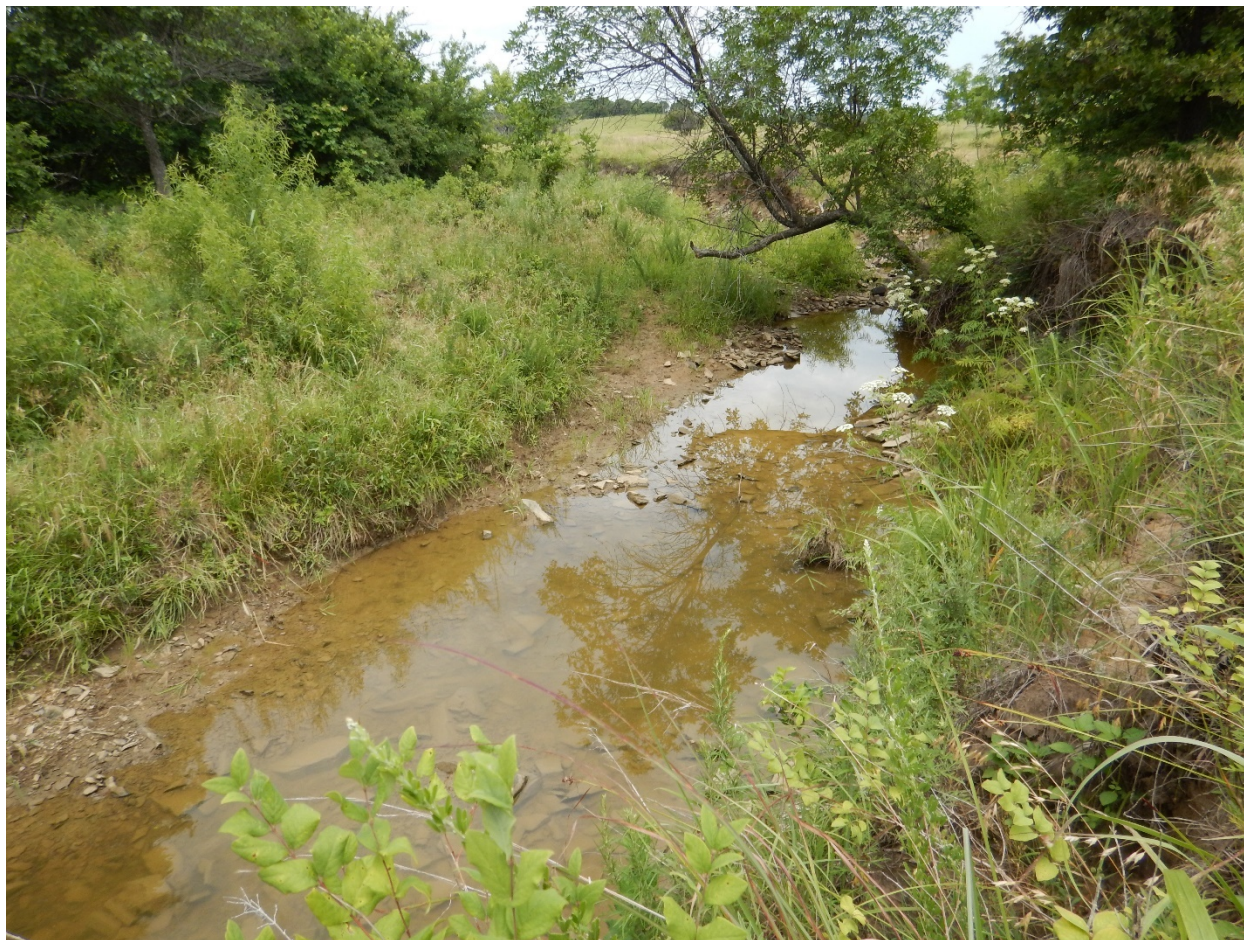
Photo No. 15

**Description:** This was a view looking west/upstream from the same location as Photo No 13. This photo was an accurate representation of the bed and bank features of the tributary.

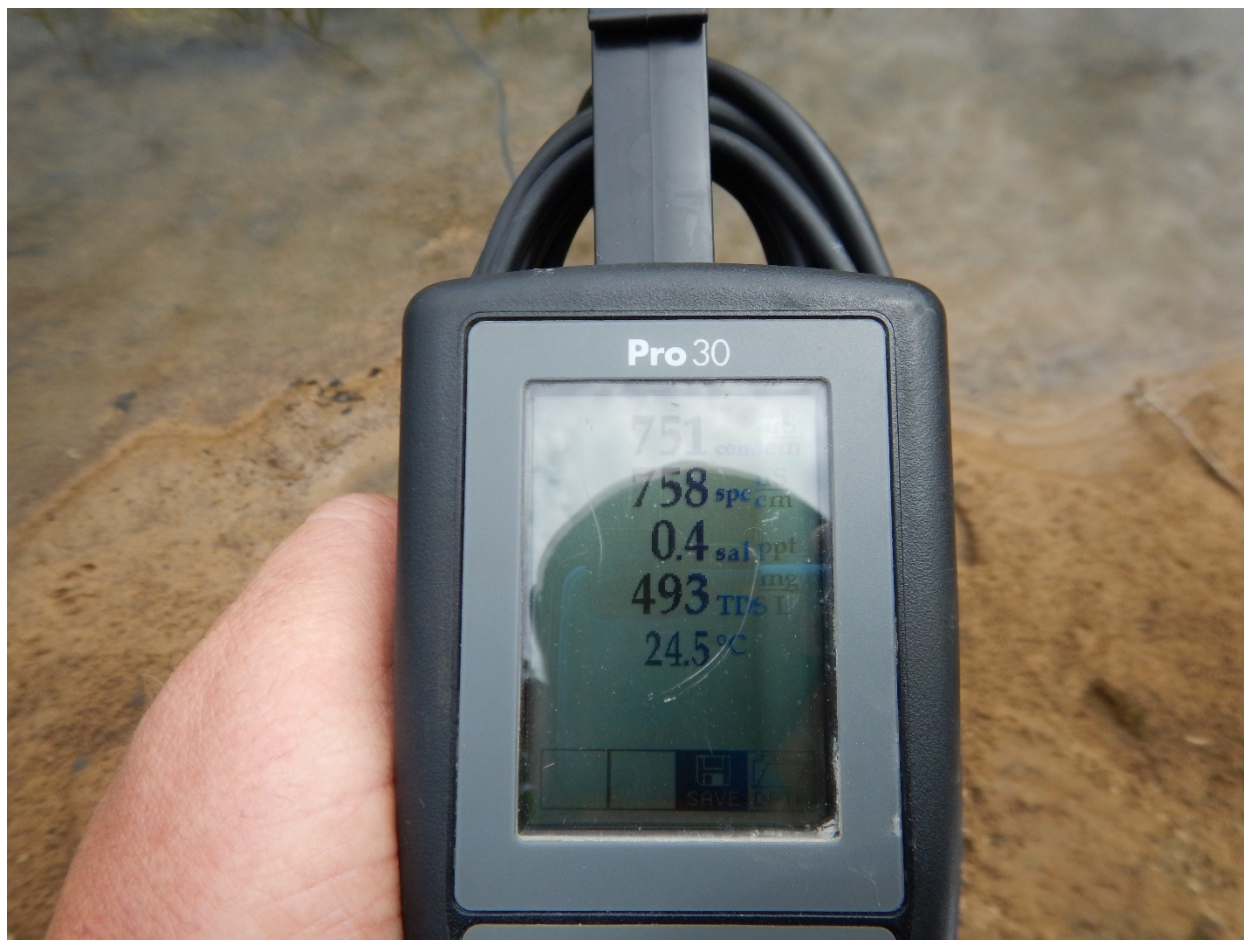
Photo No. 16

**Description:** This was an elevated TDS field reading of 493 mg/L, this was the last "pool" of water along the impacted tributary before the tributary flowed into Mission Creek.

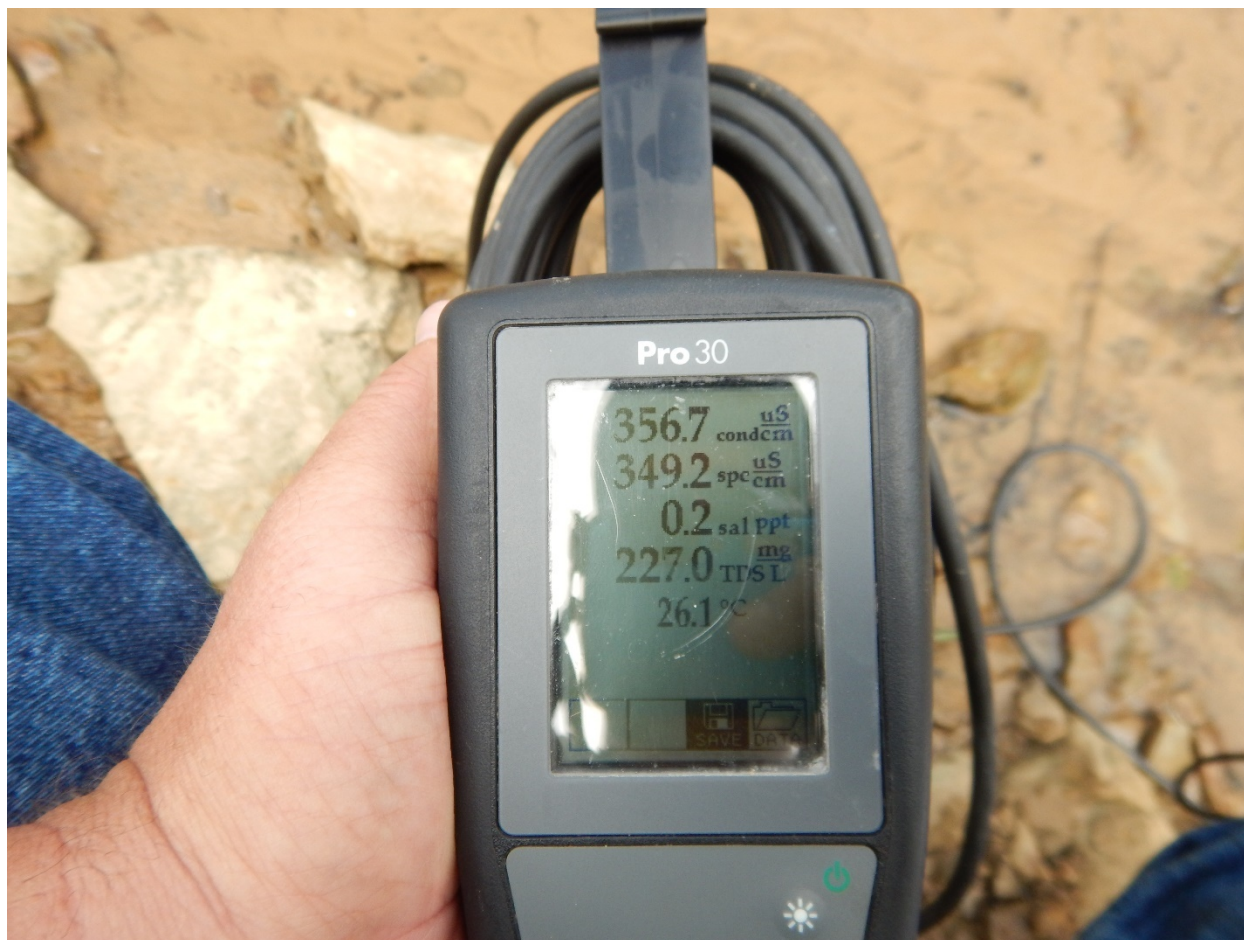
Photo No. 17

**Description:** This was a TDS field reading taken in a section of the tributary where the water depth was approximately 2 inches deep. This measurement was taken approximately 30 feet upstream in the impacted tributary before the confluence with Mission Creek.
