**Region 6 - Enforcement & Compliance Assurance Division**  
**INSPECTION REPORT**

| Inspection Date(s): | 06/27/2022 | |
| Company Name: | McCann Resources, Inc | |
| Facility Name: | Bowring Lease | |

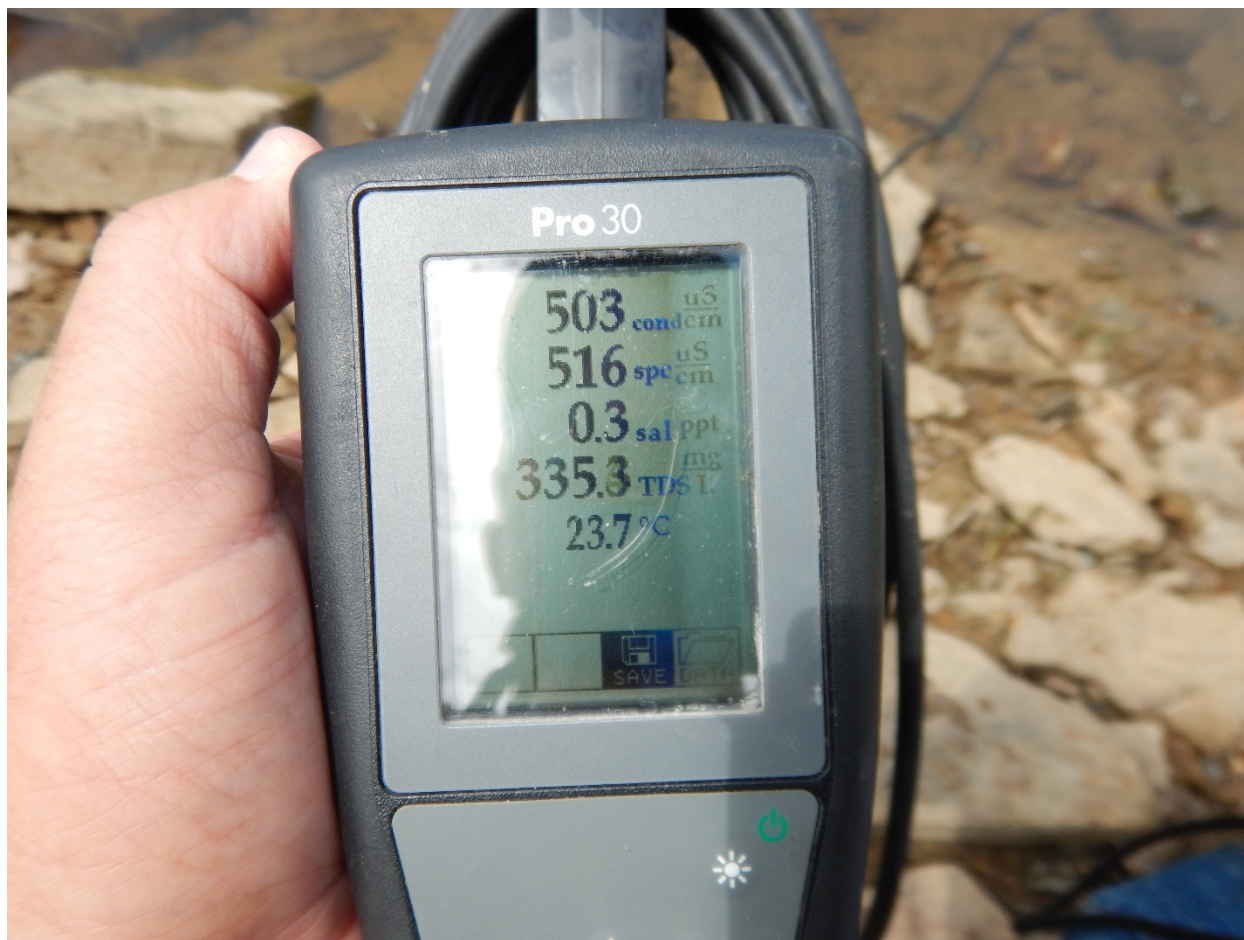
I observed a TDS field reading of 335.3 mg/L in Mission Creek at the confluence of the impacted tributary and Mission Creek, which was documented in Photo No. 18 (GPS 36.866379, -96.119401). I observed and documented the impacted tributary as it flowed into Mission Creek, this was documented in Photo No. 19 (36.866379, -96.119401). I observed the streambed and bank of Mission Creek with a view looking southeast from the confluence of the impacted tributary with Mission Creek, this observation was documented in Photo No. 20 (36.866379, -96.119401). I did not observe any temporary containment structures at the time of the inspection to prevent the downstream migration of brine contaminated waters.

**Description:** This was a TDS field reading of 335.3 mg/L taken in Mission Creek at the confluence with the impacted tributary.

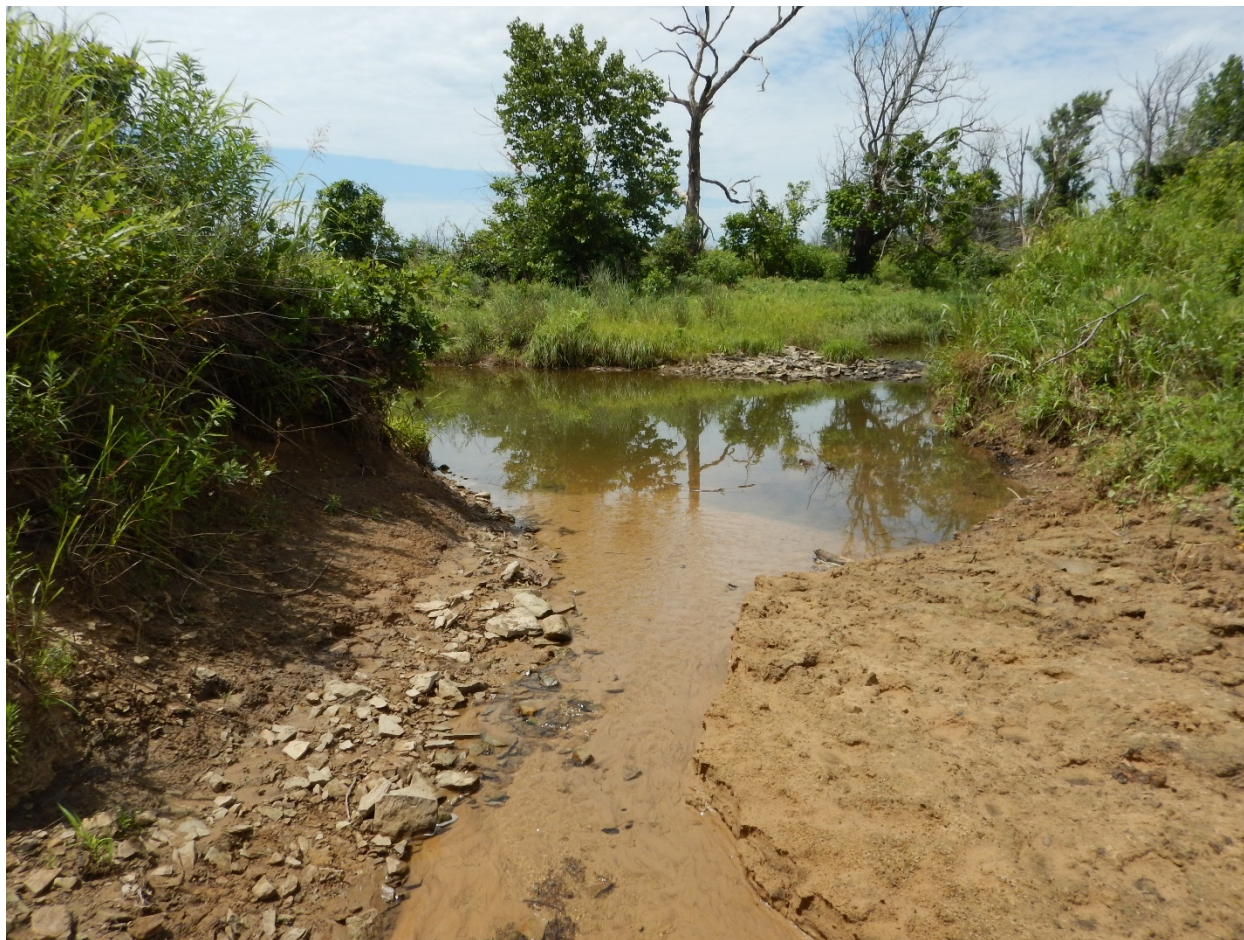
Photo No. 19

**Description:** This was a photo taken while standing in the impacted tributary. The impacted tributary flowed from the bottom of the photo, north to south, into the large pool of water. The large pool of water was Mission Creek. Mission Creek flowed from right to left in the photo, or west to east.

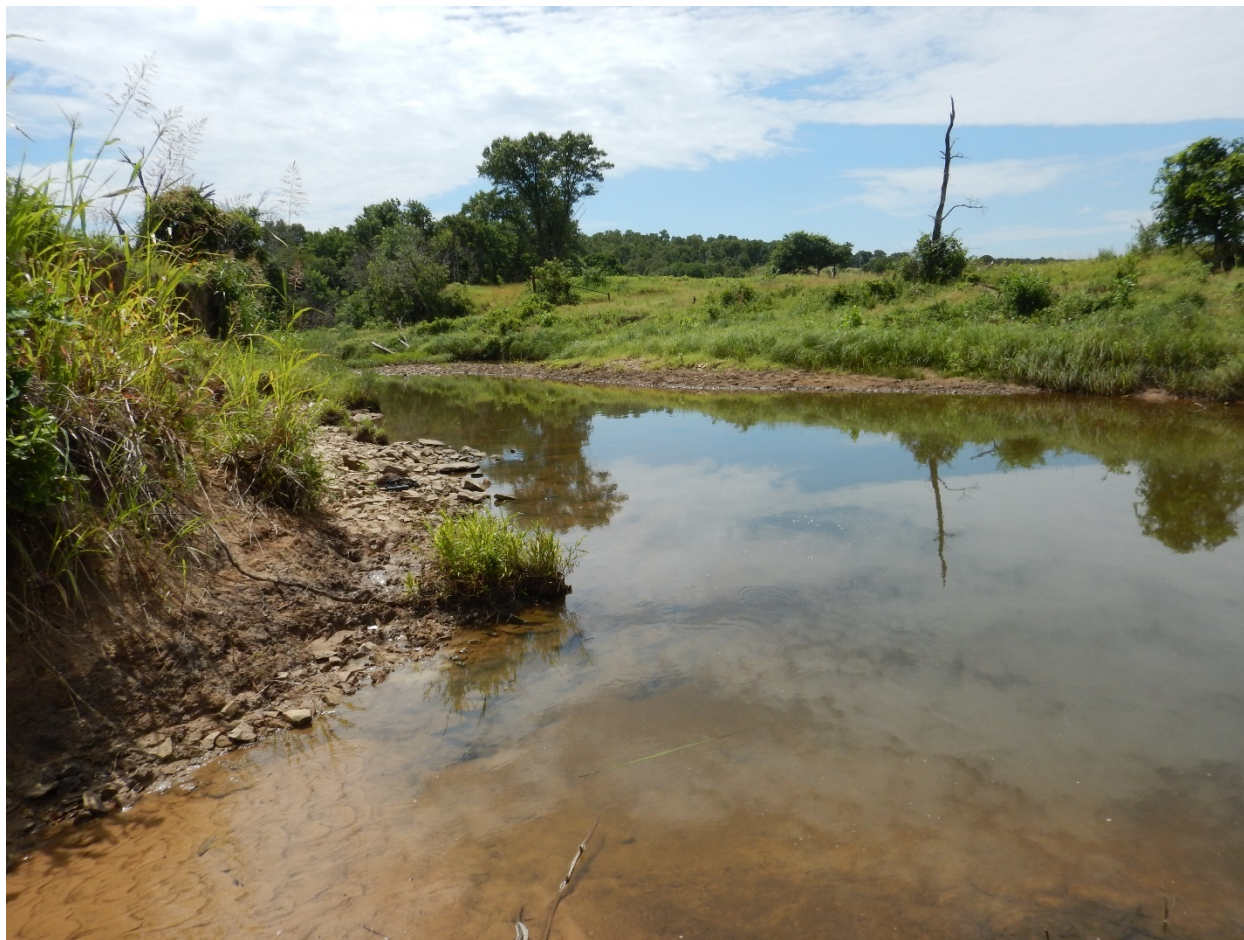
Photo No. 20

**Description:** This was a photo taken at the confluence of the impacted tributary and Mission Creek. The photo provided a view to the southeast and looked downstream along Mission Creek. Mission Creek flowed from right to left, or west to east in this photo. The impacted tributary flowed into Mission Creek from the lower left corner of the photo.
