INSPECTION REPORT

| Type of Inspection | Compliance Evaluation Inspection (CEI) | | |
| Company Name | Portland Bolt & Manufacturing Company, Inc. | | |
| Type of Operation | Manufacturer of large, nonstandard anchor bolts and construction fasteners | | |

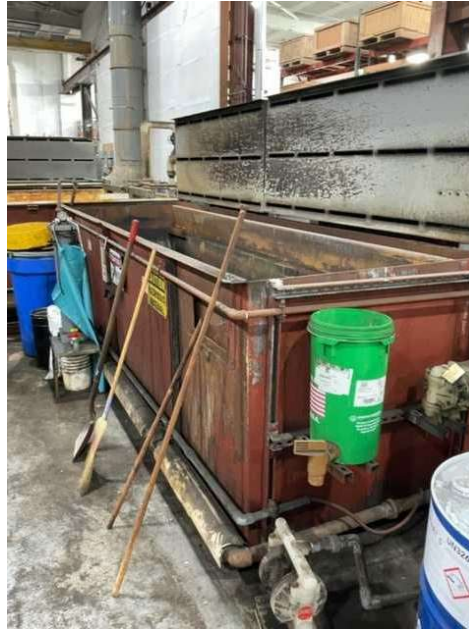
| [Title] | | | IMG-20240829092107217110798.jpg |

| View of the old caustic tank. | | | |

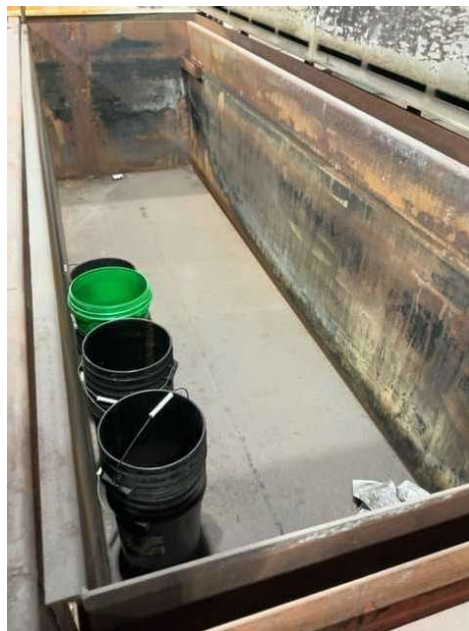
| [Title] | | | IMG-20240829092124212485967.jpg |

| Another view of the old caustic tank. | | | |

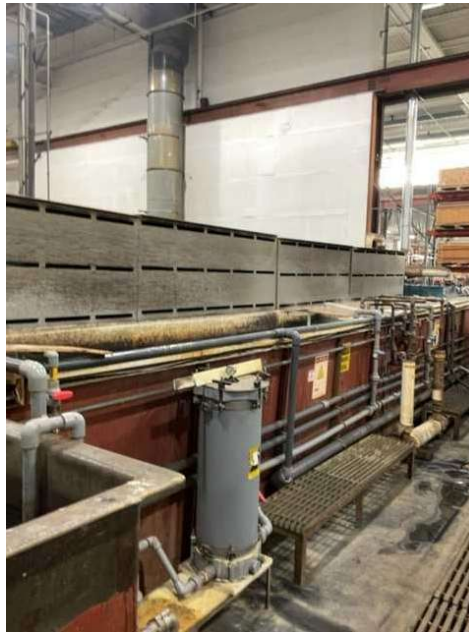
| [Title] | | | IMG-2024082909310931991842.jpg |

The sulfuric acid waste designates for corrosivity (D002), chromium (D007), and lead (D008). A copy of the disposal paperwork for the last shipment was provided by the facility and included in the Document Log of this report. A map of the area and description of the tanks is included as an attachment to the facility's Contingency/Response Plan that was provided following the inspection and is also included in the Document Log of this report. No areas of concern were identified in the area of the sulfuric acid tanks.

| View of the sulfuric acid tanks, seen here in tandem. | | | |

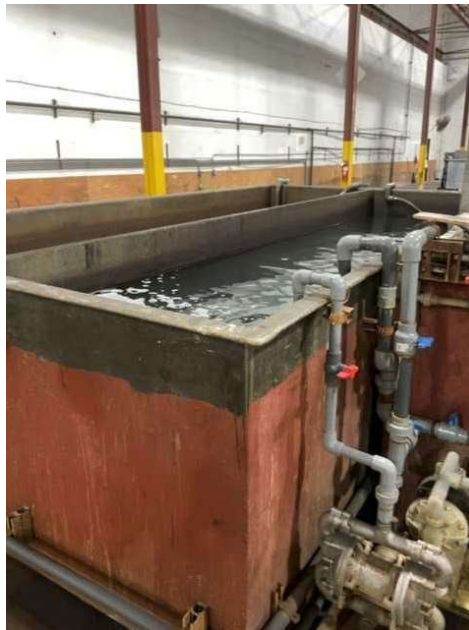
| [Title] | | | IMG-20240829093150315079251.jpg |

| View of the rinse tank. | | | |

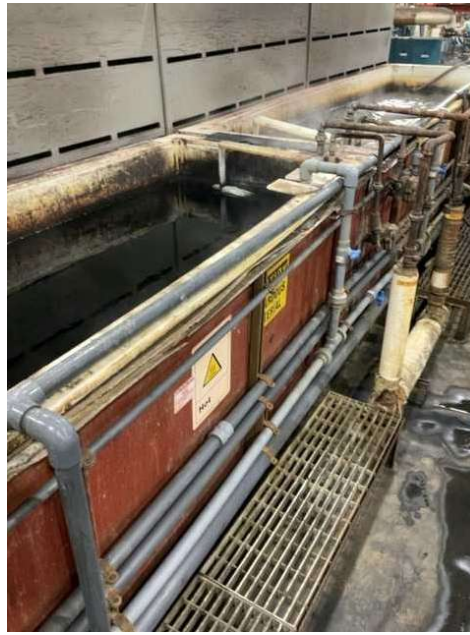
| [Title] | | | IMG-202408290932203220111271.jpg |

| Another view of the sulfuric acid tanks. | | | |

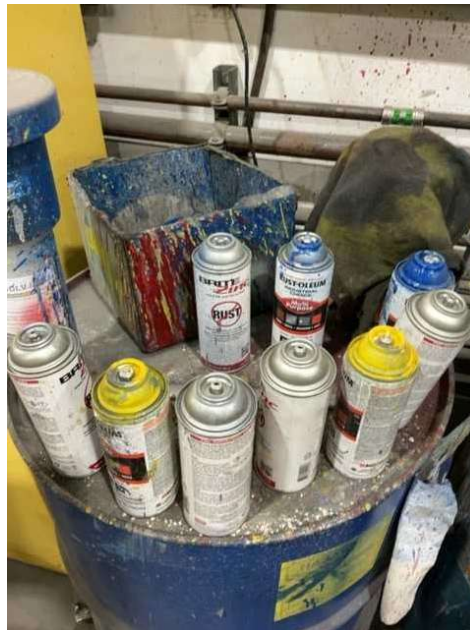
| [Title] | | | IMG-202408290943534353107511.jpg |

- There were nine waste aerosol cans on top of the 55-gallon SAA container which had not yet been processed through the waste aerosol can popper. These waste aerosol cans were not labeled with the words "Hazardous Waste" or marked with hazard indicators.
- The 55-gallon SAA drum of waste aerosol can residue was not visibly labeled with the words "Hazardous Waste." There was a hazardous waste label on the container; however, it was very faded and covered with paint overspray to make it unreadable.
- The 55-gallon SAA container was not marked with a hazard indicator.

| Nine waste aerosol cans on top of waste aerosol residue SAA container not labeled with the words “Hazardous Waste” or marked with hazard indicators. | <b>Regulations:</b> | <b>Sections:</b> |

| View of nine, unpunctured and unlabeled, waste aerosol cans seen here on top of the 55-gallon SAA waste aerosol residue container. | | | |

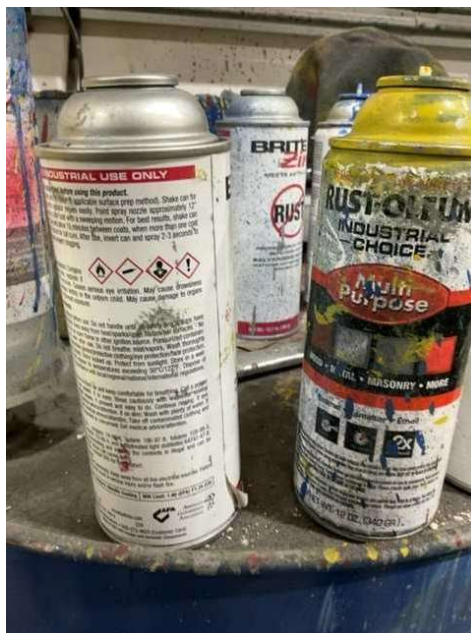
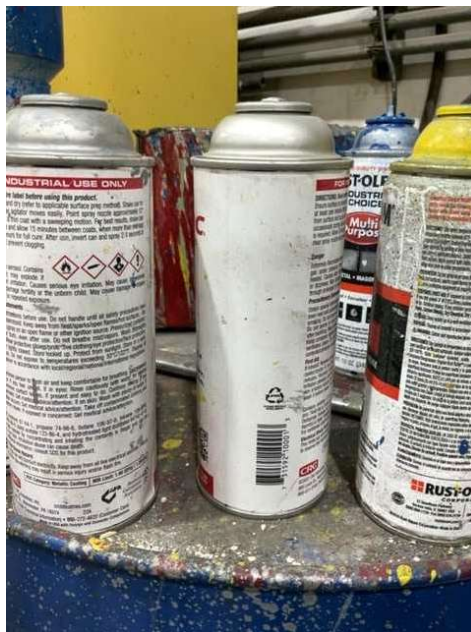
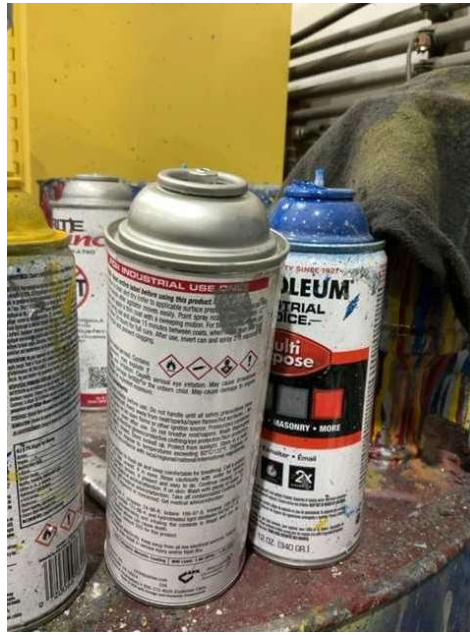
| A close-up view of the labeling on some of the nine waste aerosol cans seen in the previous photo. | | | |

| Another close-up view of the labeling on some of the nine waste aerosol cans seen in the previous photo. | | | |

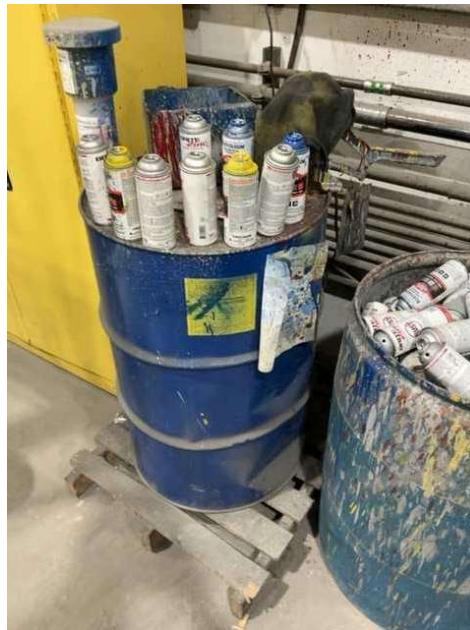
| [Title] | | | IMG-202408290944464446101015.jpg |

| Another view of the nine, unpunctured, waste aerosol cans on top of the 55-gallon SAA waste aerosol residue container, seen here without a hazard indicator and not labeled with the words "Hazardous Waste." | | | |

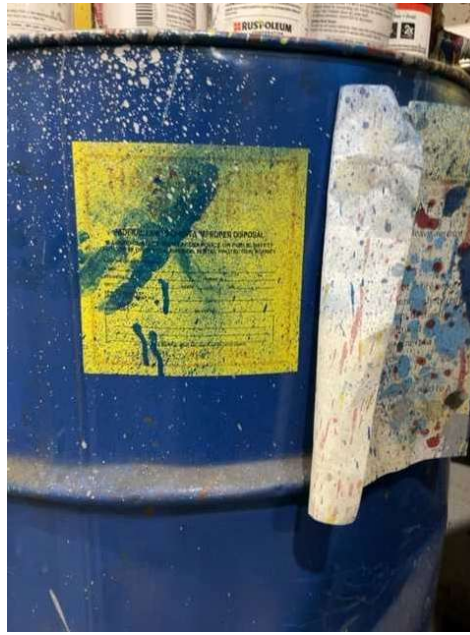
| [Title] | | | IMG-202408290944514451110687.jpg |

| 55-gallon waste aerosol can residue SAA container was not labeled with the words “Hazardous Waste.” | <b>Regulations:</b> | <b>Sections:</b> |

| Close-up view of the labeling on the 55-gallon SAA container, showing that paint overspray and fading rendered the label illegible. | | | |

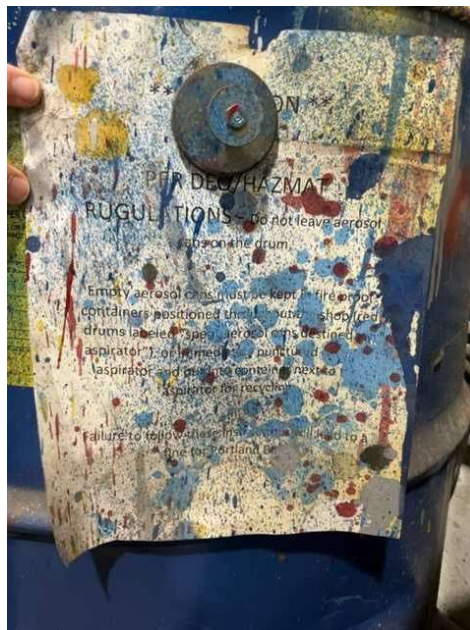
| [Title] | | | IMG-202408290945124512143324.jpg |

| View of a facility notice, that is seen here affixed to the container, instructing facility personnel not to place waste aerosols in the area without puncturing them. | | | |

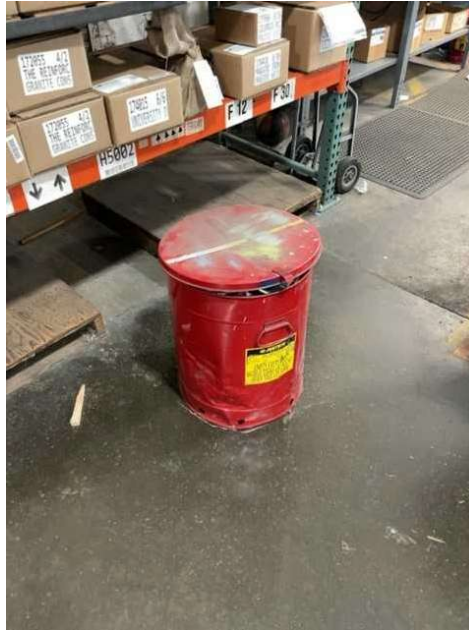
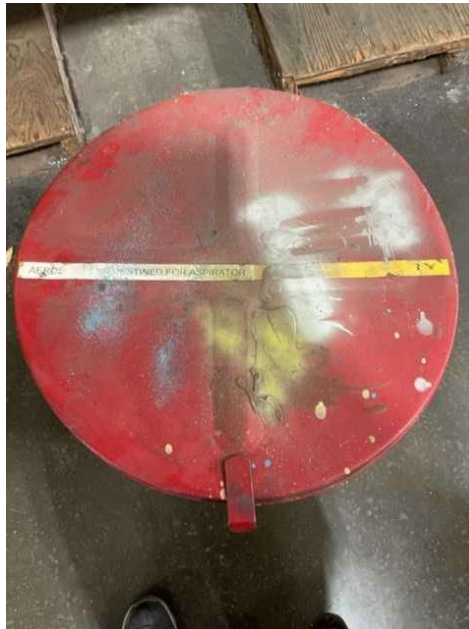
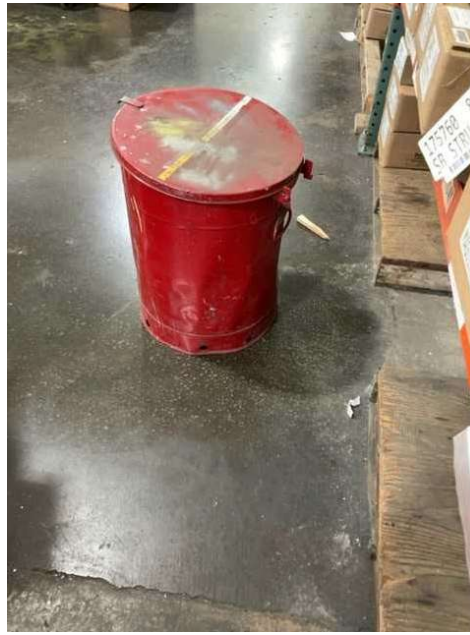
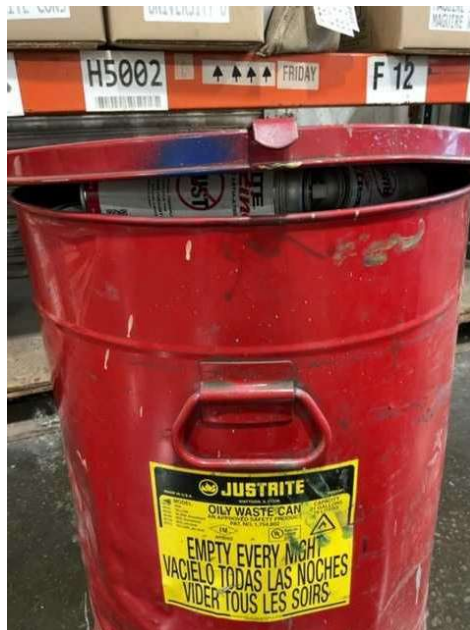
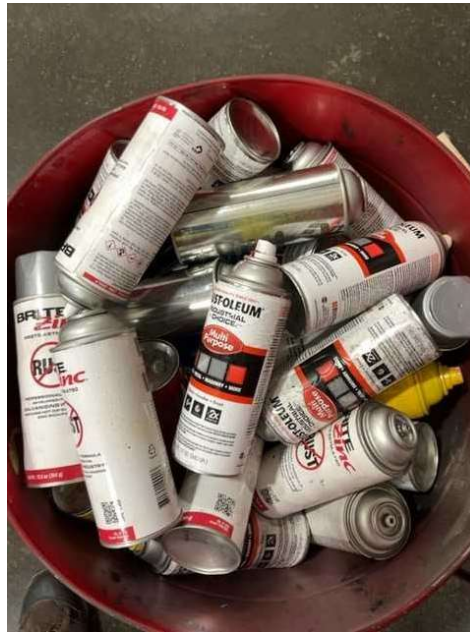
| <p>While in the Packaging Department, I saw a 20- gallon step-can that held waste aerosol cans. The step-can lid was labeled "AEROSOL CANS DESTINED FOR THE ASPIRATOR." At the time of the inspection, the waste aerosol SAA container was not closed, due to having too many waste aerosol cans inside the container. The SAA container was also not labeled with the words "Hazardous Waste" or marked with a hazard indicator.</p> | | | |

| A waste aerosol SAA Step-can was not closed, not labeled with the words “Hazardous Waste,” and not marked with a hazard indicator. | <b>Regulations:</b> | <b>Sections:</b> |

| View of a waste aerosol can SAA step-can that is not closed, not labeled with the words "Hazardous Waste," and not marked with a hazard indicator. | | | |

| Top view of a waste aerosol can SAA step-can that is not closed, not labeled with the words "Hazardous Waste," and not marked with a hazard indicator. | | | |

| Another view of a waste aerosol can SAA step-can that is not closed, not labeled with the words "Hazardous Waste," and not marked with a hazard indicator. | | | |

| Close-up view showing that the container is not closed. | | | |

| View of the waste aerosol cans inside the SAA step-can. | | | |

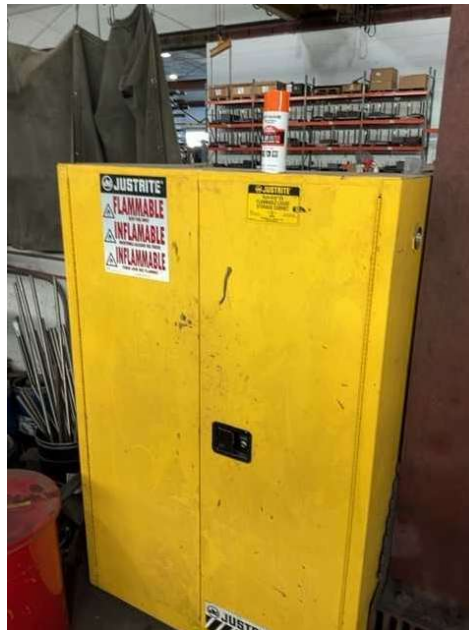
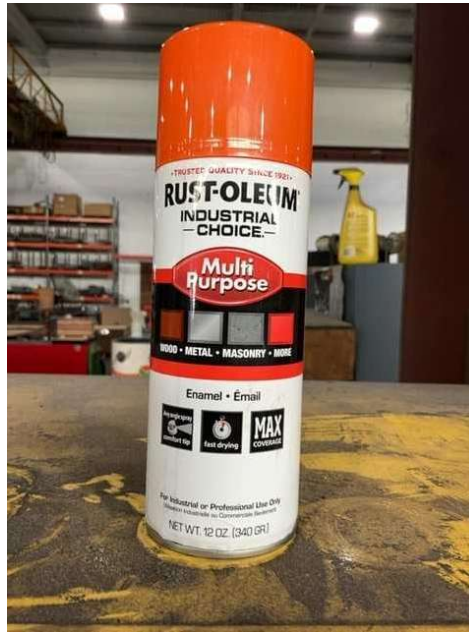
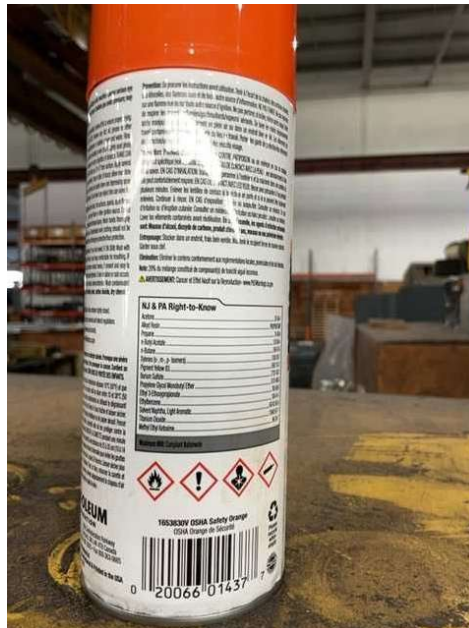
| <p>While in the Cutting Department, I saw an aerosol can on top of a yellow flammable storage cabinet. I picked up the aerosol can, shook it, and identified it as a waste aerosol can. Mr. Tucker verified that it was a waste aerosol can.</p> <p>I opened the flammable storage cabinet and found another waste aerosol can inside which was verified by Mr. Tucker as being a waste aerosol can.</p> <p>At the time of the inspection, the two waste aerosol cans were not labeled with the words "Hazardous Waste" or marked with a hazard indicator. Mr. Tucker placed the waste aerosol cans into the SAA during the inspection.</p> <p>Adjacent to the flammable storage cabinet, I saw another 20-gallon waste aerosol SAA step-can that held waste aerosol cans. At the time of the inspection, the SAA step-can was not closed (step-can lid was not making a complete seal with the container) and not marked with a hazard indicator.</p> | | | |

| A waste aerosol can on top of a yellow flammable storage cabinet was not labeled with the words "Hazardous Waste," and not marked with a hazard indicator. | <b>Regulations:</b> | <b>Sections:</b> |

| View of a waste aerosol can, seen here on top of the yellow flammable storage cabinet. | | | |

| Close-up view of the waste aerosol can on top of the storage cabinet. | | | |

| A close-up view of the hazard labeling on the back of the waste aerosol, seen in the previous photo. | | | |

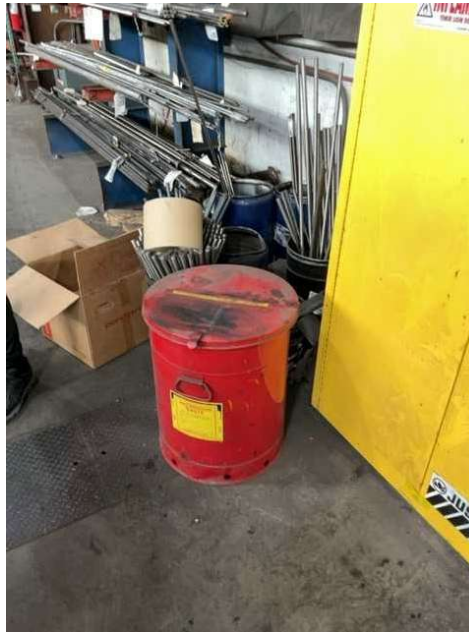
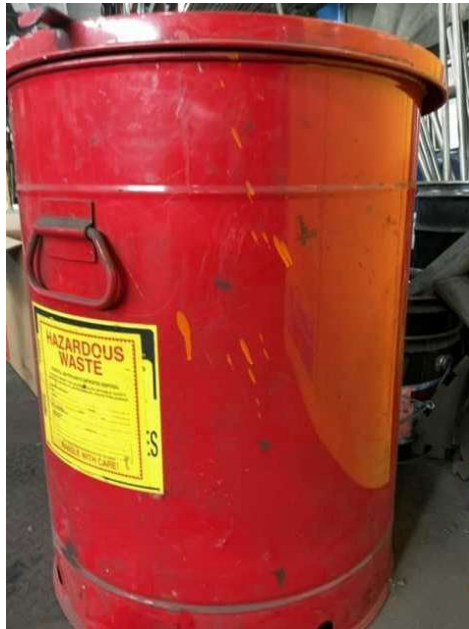
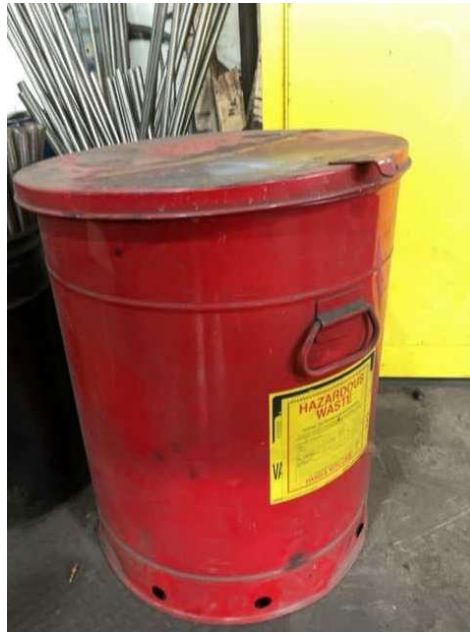
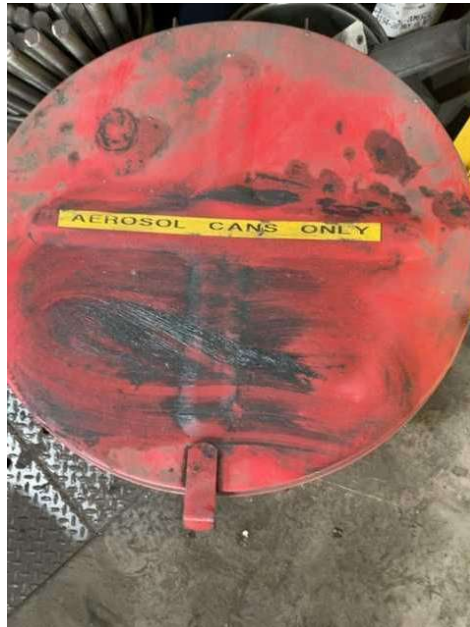
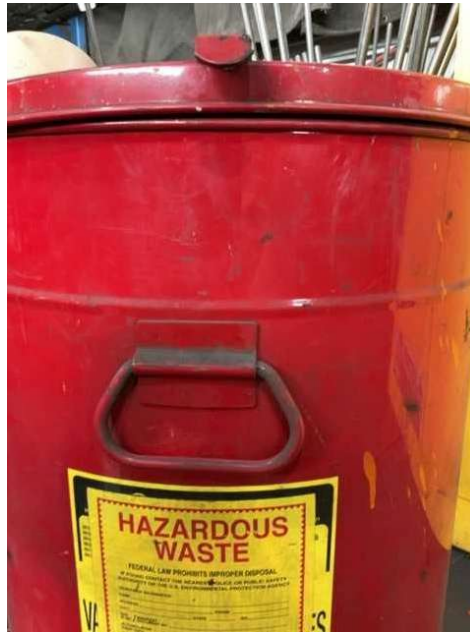
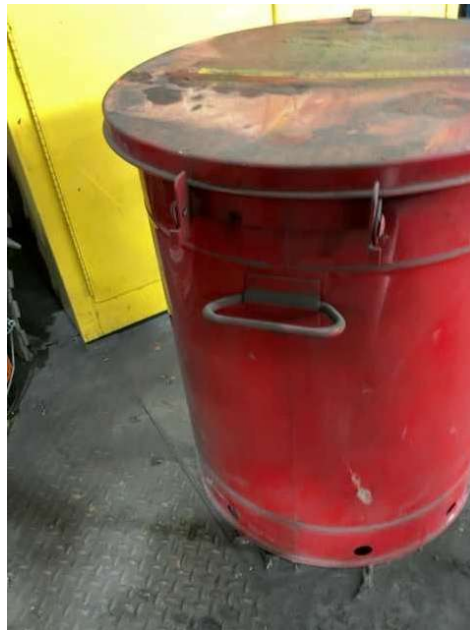
| A waste aerosol can SAA Step-can was not closed, and not marked with a hazard indicator. | <b>Regulations:</b> | <b>Sections:</b> |

| View of waste aerosol SAA step-can adjacent to the yellow flammable storage cabinet, seen here without a hazard indicator. | | | |

| Another view of waste aerosol SAA step-can, seen here without a hazard indicator and showing that the lid is not making contact with the container. | | | |

| Top view of the same SAA step-can, seen in the previous photos. | | | |

| Close-up view of the same SAA step-can, showing that the container is not closed. | | | |

| Another view of the same SAA step-can, showing there is no hazard indicator. | | | |

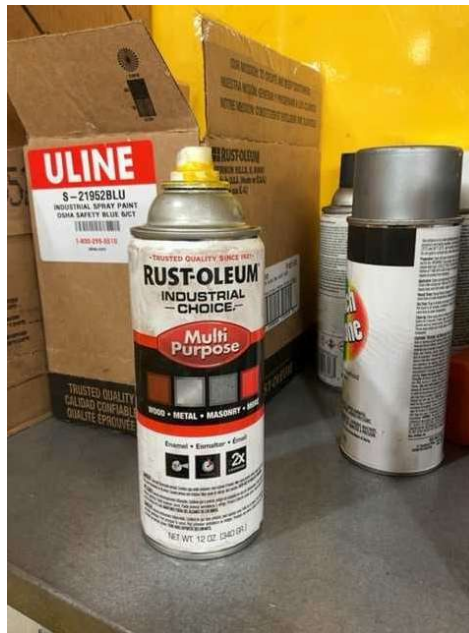
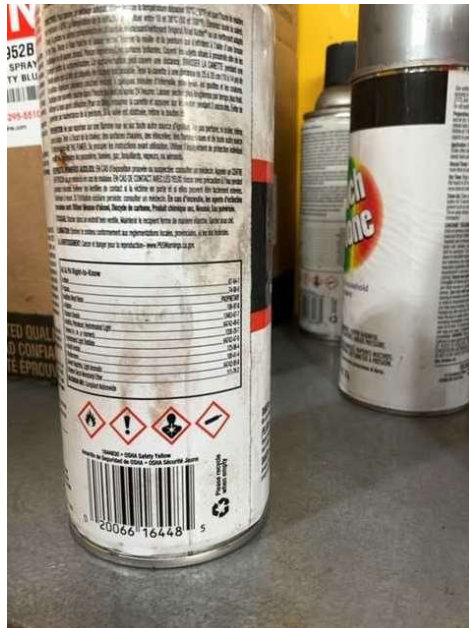
| A waste aerosol can in a storage cabinet was not labeled with the words "Hazardous Waste," and not marked with a hazard indicator. | <b>Regulations:</b> | <b>Sections:</b> |

| View of waste aerosol can in yellow flammable storage cabinet. | | | |

| Close-up view of the labeling on the back of the waste aerosol can, seen in the previous photo. | | | |

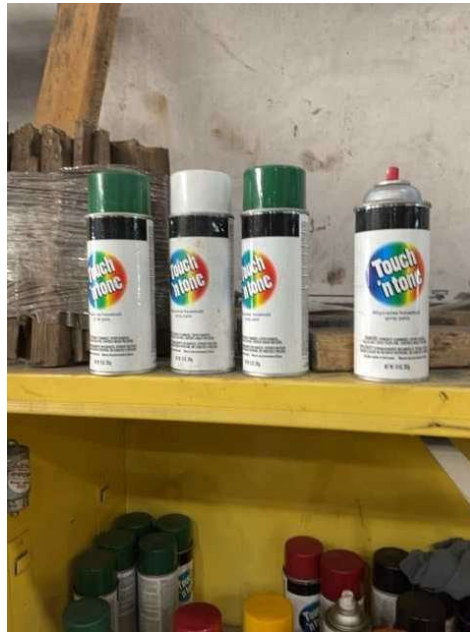
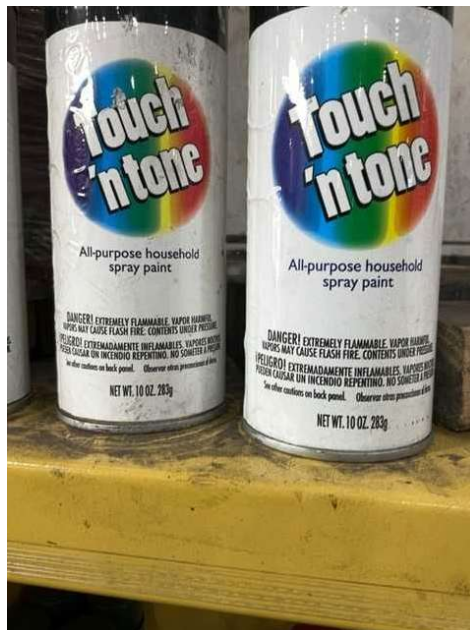
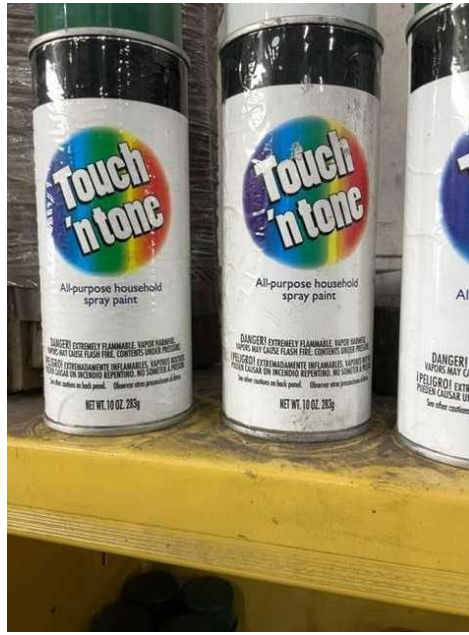
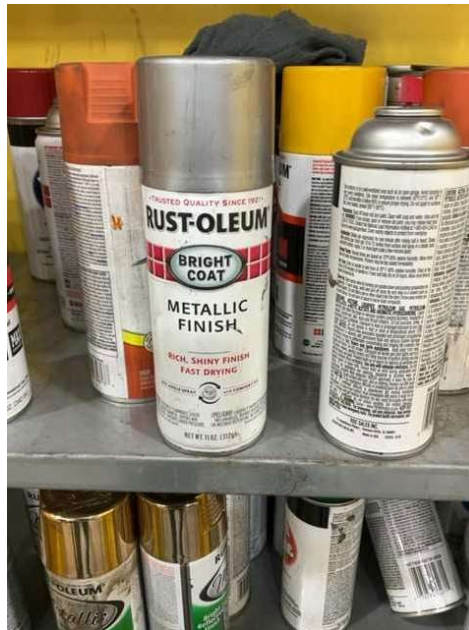
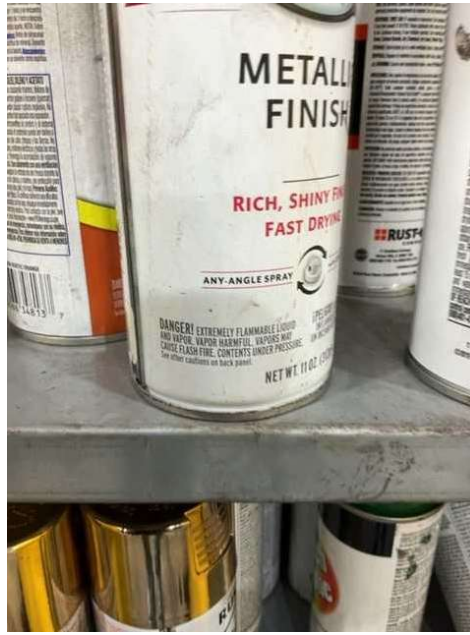
| <p>While inspecting the area, I saw a yellow flammable storage cabinet that had some aerosol cans up on top of the cabinet. Upon further inspection, I saw that there were four waste aerosol cans on top of the cabinet and one waste aerosol can inside of the cabinet. Mr. Tucker verified that all five aerosol cans were waste aerosol cans.</p> <p>At the time of the inspection, all five waste aerosol cans were not labeled with the words "Hazardous Waste" and not marked with hazard indicators.</p> <p>During the inspection, Mr. Tucker removed the waste aerosol cans from the area and placed them into a waste aerosol SAA container.</p> | | | |

| Four waste aerosol cans on top of cabinet, and one waste aerosol inside a cabinet were not labeled with the words "Hazardous Waste," and not marked with a hazard indicator. | <b>Regulations:</b> | <b>Sections:</b> |

| View of four waste aerosol cans on top of another yellow flammable storage cabinet. | | | |

| Close-up view of the labeling on two of the four waste aerosol cans on top of cabinet. | | | |

| Another close-up view of the labeling on the waste aerosol cans. | | | |

| View of a waste aerosol can inside the flammable storage cabinet. | | | |

| Close-up view of the labeling on the waste aerosol can, seen in the previous photo. | | | |

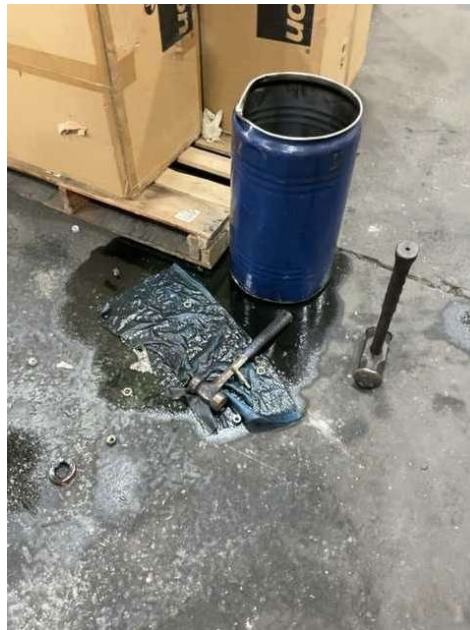
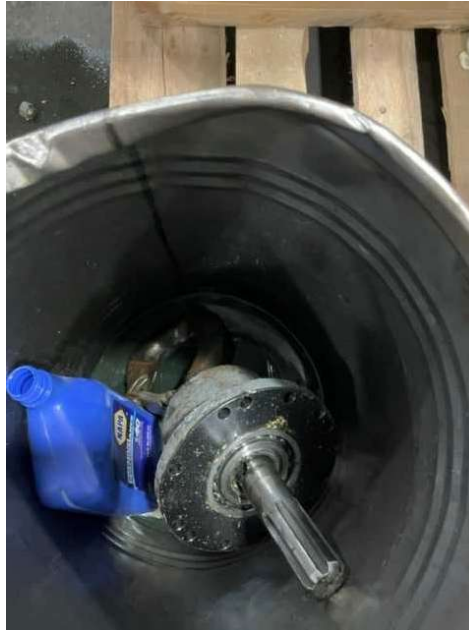
| View of a used oil spill that occurred the previous day and was not manage properly. | | | |

| Close-up view of the oily contents inside the container seen in the previous photo. | | | |

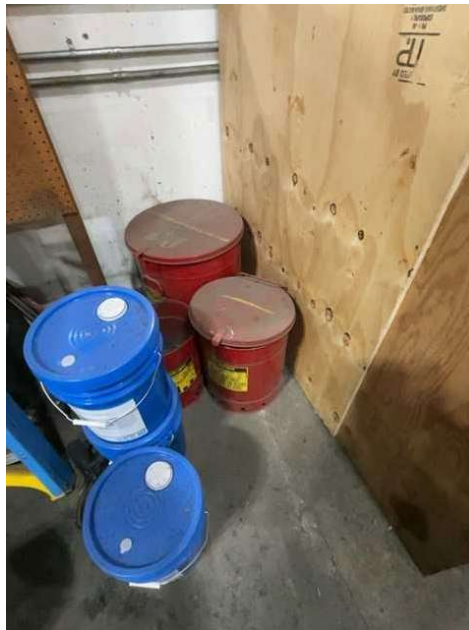
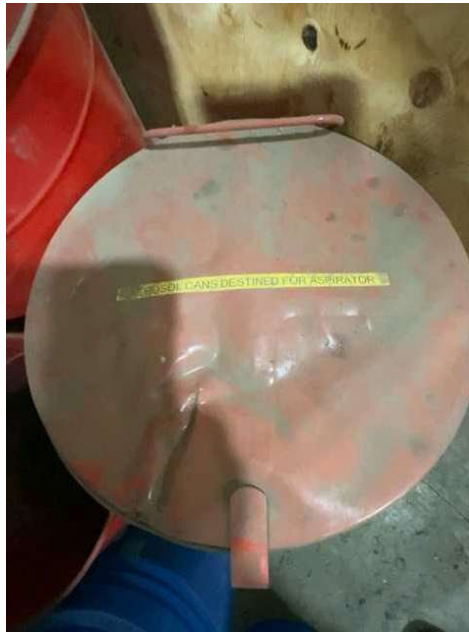
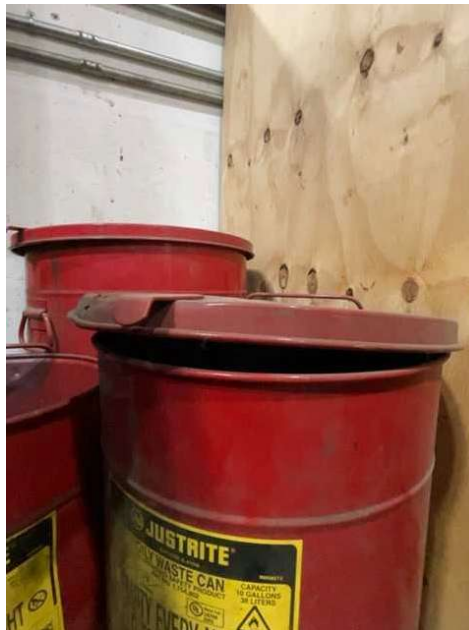
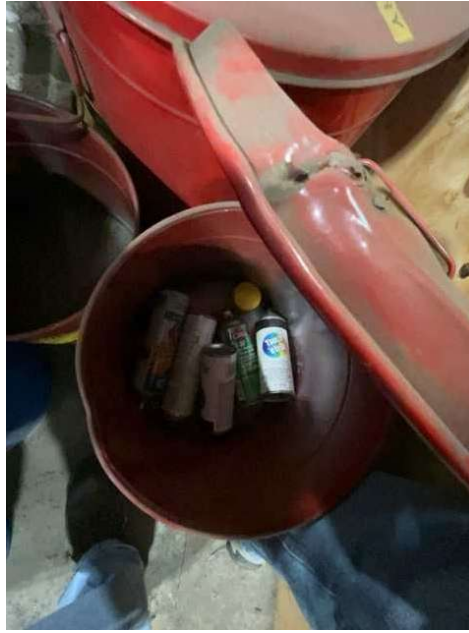
| <p>While still in the Maintenance Department, I saw a ten-gallon SAA step-can that held waste aerosol cans. At the time of the inspection, the step-can lid did not make a complete seal with the step-can and was not closed. The SAA step-can was also not labeled with the words "Hazardous Waste" and was not marked with a hazard indicator.</p> | | | |

| View of a waste aerosol SAA step-can that is not closed, not labeled with the words "Hazardous Waste," and not marked with a hazard indicator. | | | |

| Top view of the waste aerosol SAA step-can, seen in the previous photo. | | | |

| Close-up view of the same waste aerosol SAA step-can that is not closed, not labeled with the words "Hazardous Waste," and not marked with a hazard indicator. | | | |

| View of the waste aerosol cans inside of the SAA step-can. | | | |

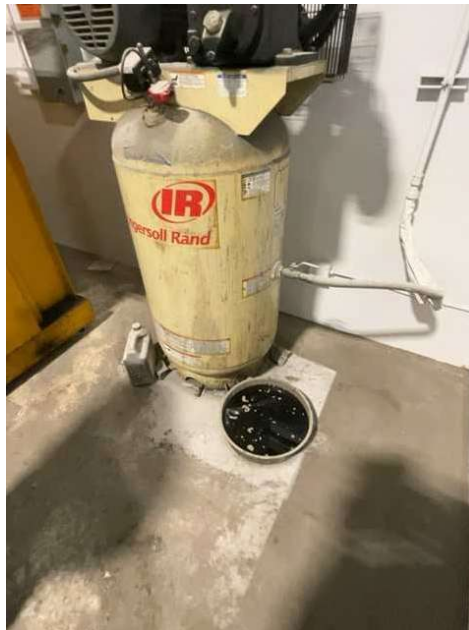
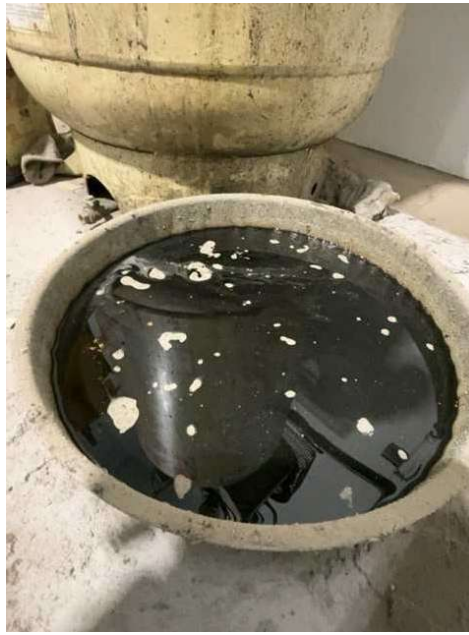
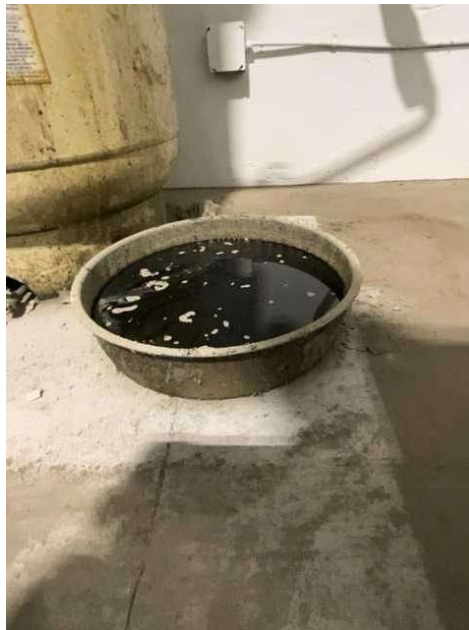
| Failure to make a hazardous waste determination at the point of generation for the contents of a pan that held a thick, dark colored unknown liquid. | <b>Regulations:</b> | <b>Sections:</b> |

| View of a pan that contains a thick, dark colored unknown liquid, seen here next to compressor. | | | |

| Close-up view of pan that contains a thick, dark colored unknown liquid. | | | |

| Another close-up view of pan that contains a thick, dark colored unknown liquid. | | | |

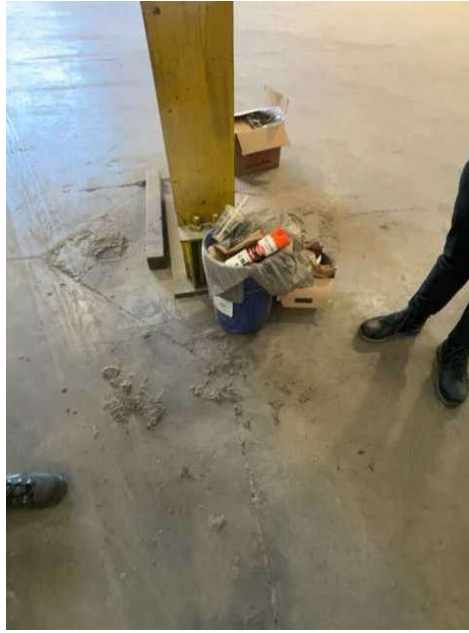
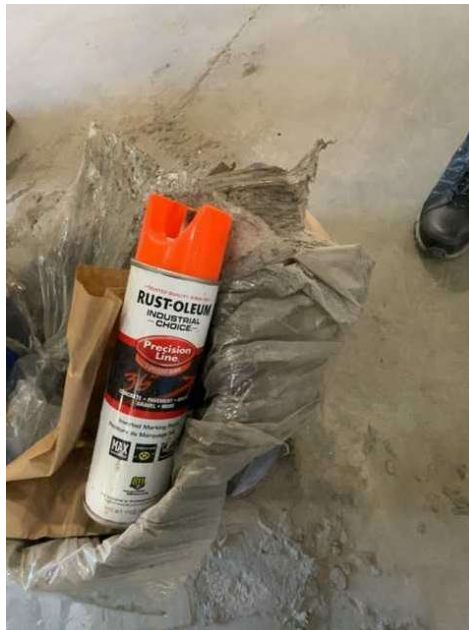
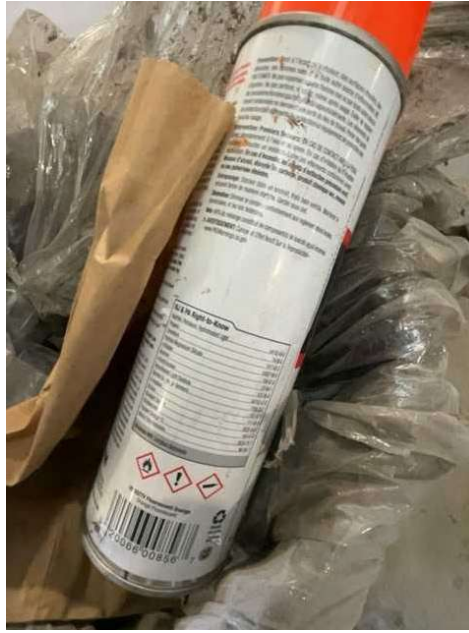
At the time of the inspection, the waste aerosol can in the trash was not labeled with the words "Hazardous Waste" and was not marked with a hazard indicator.

| Waste aerosol was found in a trash can and was not labeled with the words "Hazardous Waste," and not marked with a hazard indicator. | <b>Regulations:</b> | <b>Sections:</b> |

| View of a waste aerosol can, seen here inside of a trash can. | | | |

| Close-up view of the waste aerosol can. | | | |

| Close-up view of the labeling on the waste aerosol can. | | | |

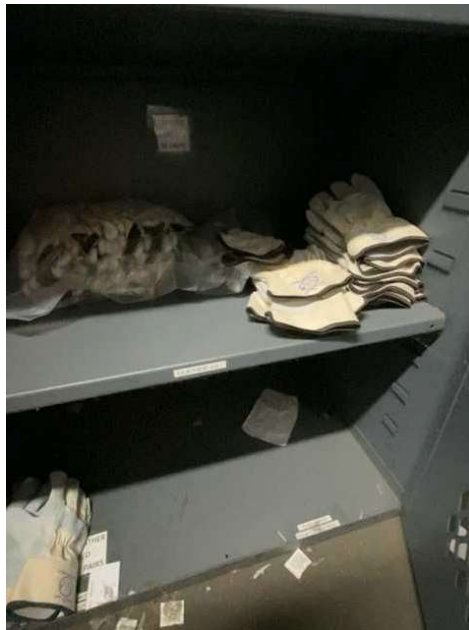
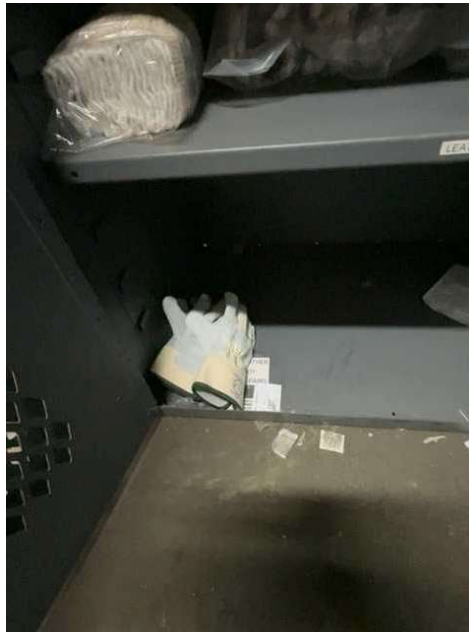
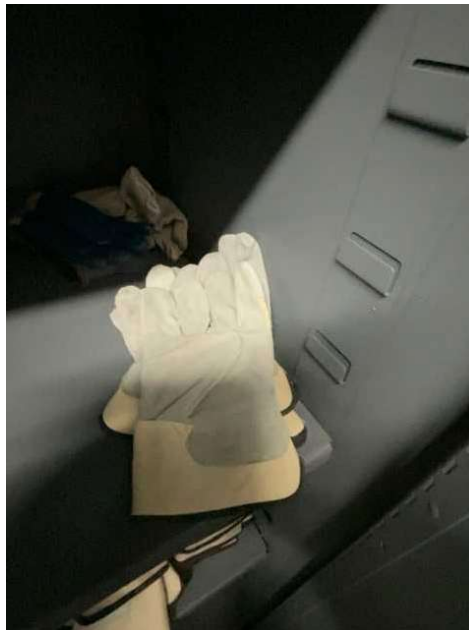
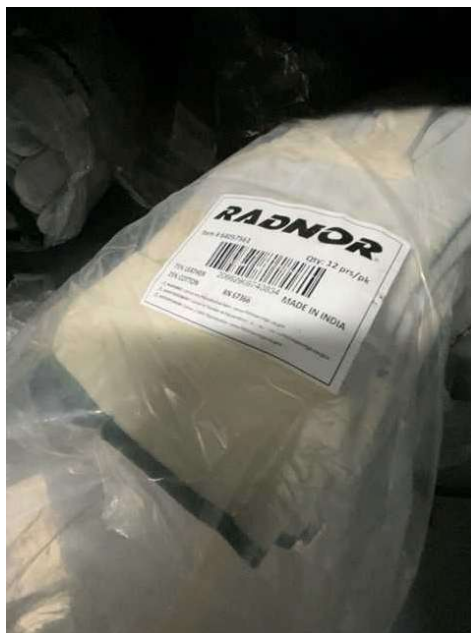
During the inspection, I asked Mr. Tucker if the facility provided any PPE to employees that were made of leather (i.e., leather gloves, welding chaps, or work boots). Mr. Tucker did tell me that they supply leather gloves to their employees. I asked to see the area where the gloves were kept prior to being issued or provided to the employees. Upon arriving at the Lower Mezzanine Storage area, I saw some shelves where the gloves were being stored prior to use. I explained to Mr. Tucker that the gloves typically fail TCLP for chrome and that his facility would need to make a waste determination for waste leather gloves.

| Failure to make a hazardous waste determination at the point of generation for leather gloves. | <b>Regulations:</b> | <b>Sections:</b> |

| View of the leather gloves that are provided to facility personnel. | | | |

| Another view of the leather gloves that are provided to facility personnel. | | | |

| Close-up view of the leather gloves that are provided to facility personnel. | | | |

| Close-up view of the labeling on the leather gloves. | | | |

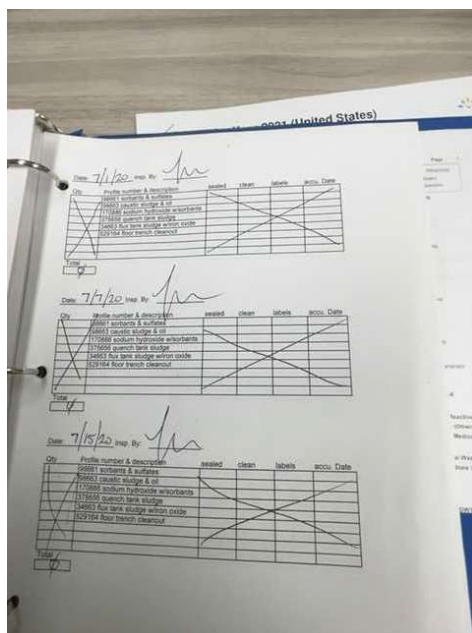
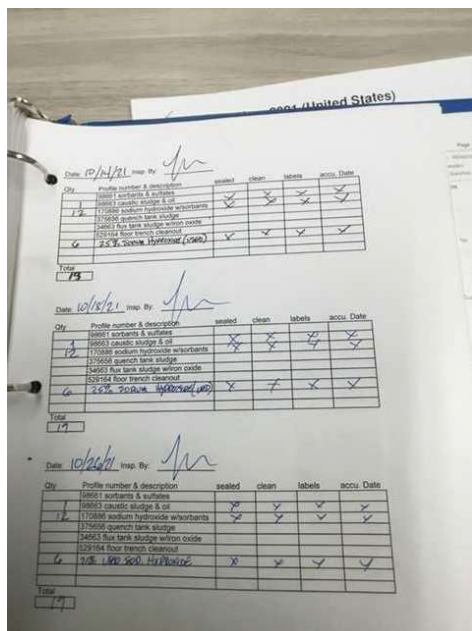
I inspected weekly hazardous waste inspections for the period from August 29, 2021, through December 31, 2021. During this period, I saw that there were no inspections that were conducted from August 29, 2021, through October 9, 2021, for a total of six weeks.

| No weekly hazardous waste inspections were conducted from 8/29/21 through 10/09/21 for a total of six weeks. | <b>Regulations:</b> | <b>Sections:</b> |

| A view of the inspection logs showing the inspections that were conducted prior to the period from 8/29/21 through 10/09/21 when no inspections were conducted. | | | |

| A view of the inspection logs showing the inspections that were conducted following the period from 8/29/21 through 10/09/21 when no inspections were conducted. | | | |

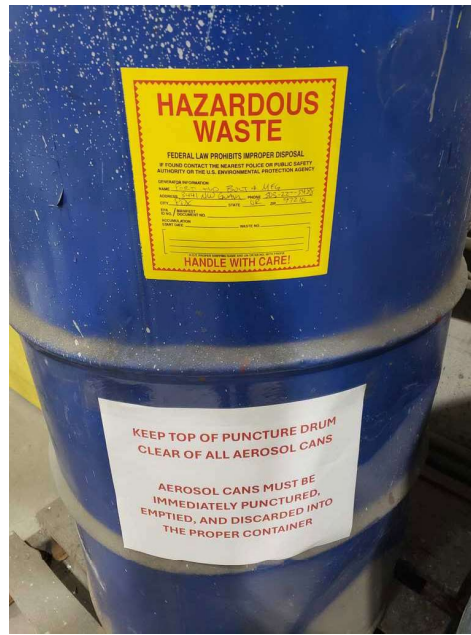
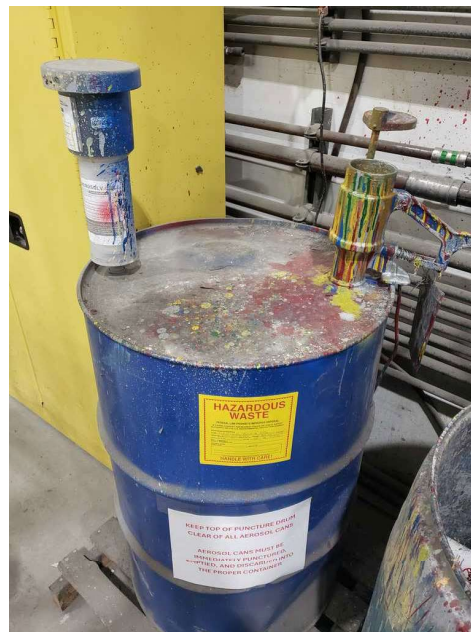
Photos of the 55-gallon waste aerosol residue SAA container showed that it had been relabeled with a legible hazardous waste label but had not been marked with a hazard indicator. In the photo provided, the container was also not closed.

| Photo provided by the facility that shows they have re-labeled their 55-gallon SAA container of waste aerosol can residue with a new hazardous waste label and facility notice; however, there is no hazard indicator. | | | |

| This wide-angle view of the container seen in the previous photo, provided by the facility following the inspection, not only shows no hazard indicator was affixed to the container, but also shows that the container is not closed. | | | |
