## **1.0 BACKGROUND**

The purpose of this report is to describe, evaluate, and document the Naval Surface Warfare Center, Crane (Crane) compliance with the Clean Water Act (CWA) at its installation in Martin County, Indiana. The compliance status of the facility was evaluated during an inspection beginning September 22, 2020 through September 24, 2020.

The operations at Crane are covered by the National Pollutant Discharge Elimination System (NPDES) Permit No. IN0021539 with effective date October 1, 2017 and expiration date September 30, 2022. At the time of the inspection, the most recent modification occurred in July 2020 and added the new Outfall 018, which was not yet constructed at the time of the inspection.

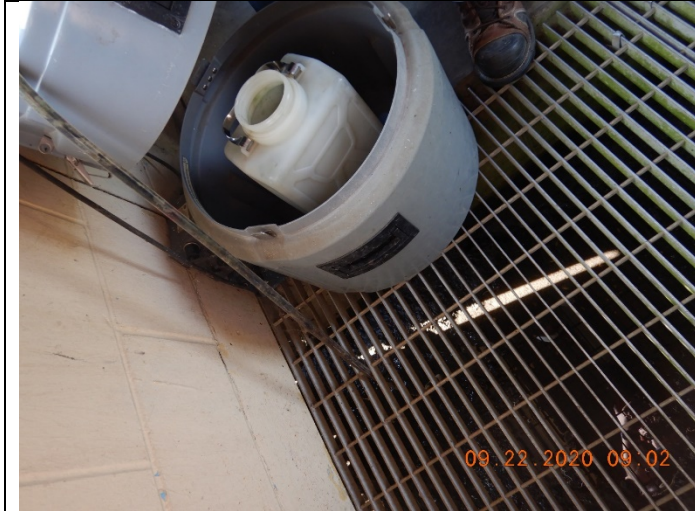
1: DSCN0037.JPG

Wastewater is then pumped to a set of hydrosieves which remove more grit. An automatic sampler is present at the hydrosieves and is shown in Photo 1. Mr. Huff said that compliance samples are taken at this location using a time-proportional composite and analyzed for pH, ammonia, biochemical oxygen demand (BOD), and total suspended solids (TSS).

Location: Crane Naval Surface Warfare Center  
Photographer: Jonathan Moody  
Date/Time: 9/22/2020 9:02 AM  
Camera Direction: Inside  
Description: Automatic sampler at the hydrosieve screens. Per the facility representative, this is a time-based composite where pH, Ammonia, BOD, TSS is monitored for what is called the 'pre-plant' measurement.

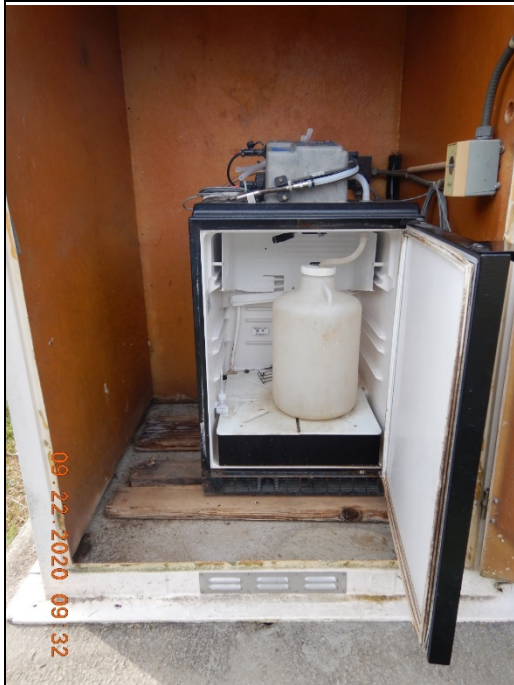
2: DSCN0038.JPG

At the downstream end of the UV system was a composite sampler in a refrigerator, as shown in Photo 2. A NIST-traceable thermometer was present and appeared to show a temperature slightly above zero degrees Celsius. Mr. Huff said this was the location where composite

Location: Crane Naval Surface Warfare Center  
Photographer: Jonathan Moody  
Date/Time: 9/22/2020 9:32 AM  
Camera Direction: South  
Description: Autosampler at the effluent channel at the UV treatment system. Per the facility representative, TSS, D.O., BOD, Ammonia, and some metals are collected at this location.

A NIST thermometer was present, and at the time of the inspection the reading was just above 0 degrees C.

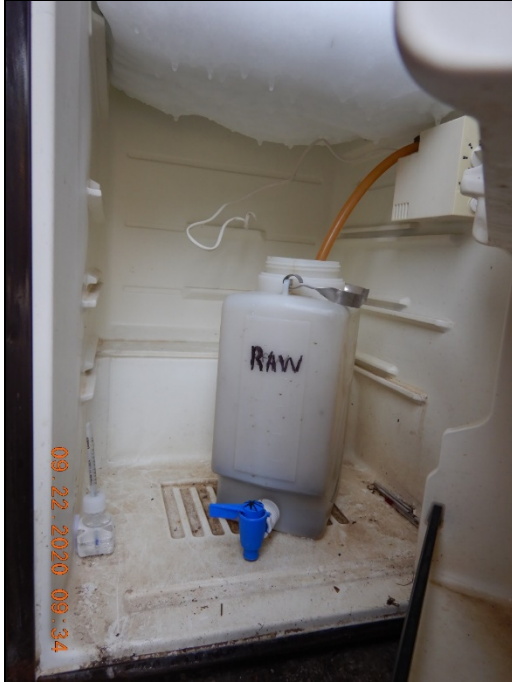
3: DSCN0039.JPG

Jonathan Moody and Cher Benisek began the field portion of the inspection at 8:30 am on September 22, 2020. Mr. Moody presented credentials to Heather Baladi, the Environmental Protection Manager. Crane provided a summary overview of its history and operations before the inspection moved to the WWTP. At the WWTP, Mr. Huff provided information on the treatment equipment and compliance monitoring activities. Flows enter the WWTP at an equalization pit. Samples of the influent are collected from the grit cell at the front end of the equalization pit using the automatic sampler shown in Photo 3 in the photolog in Appendix E.

The sample bottle is contained in a refrigerator with a National Institute of Standards and Technology (NIST)-traceable thermometer. The thermometer could not be read at the time of the inspection since it was not facing forward, but ice was present on the inside of the refrigerator. Mr. Huff said this was the location where NPDES compliance samples are collected for the influent measurements at Outfall 001.

Description: Automatic sampling at the influent location just west of the grit chamber and pulling flow out of the first cell in the grit chamber. Per the facility representative, pH was collected from a grab from the first cell.

A NIST thermometer was present, and at the time of the inspection the reading was just above 0 degrees C.

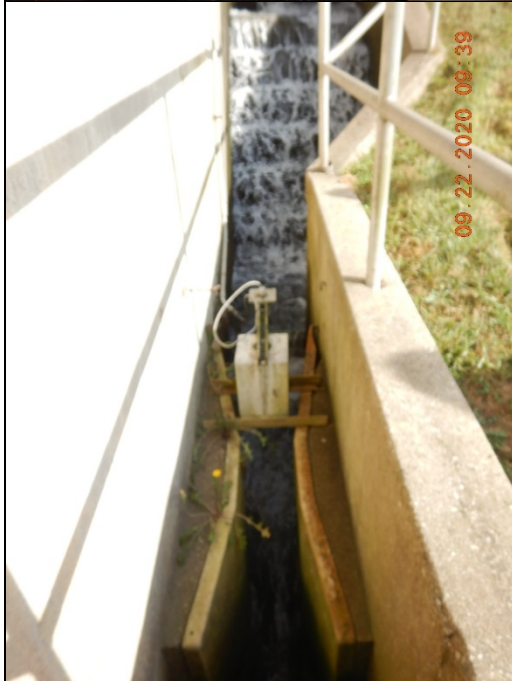
4: DSCN0040.JPG

Description: At the flume, downstream of the sand filters, where flow is monitored. Looking upstream at a step aeration system.

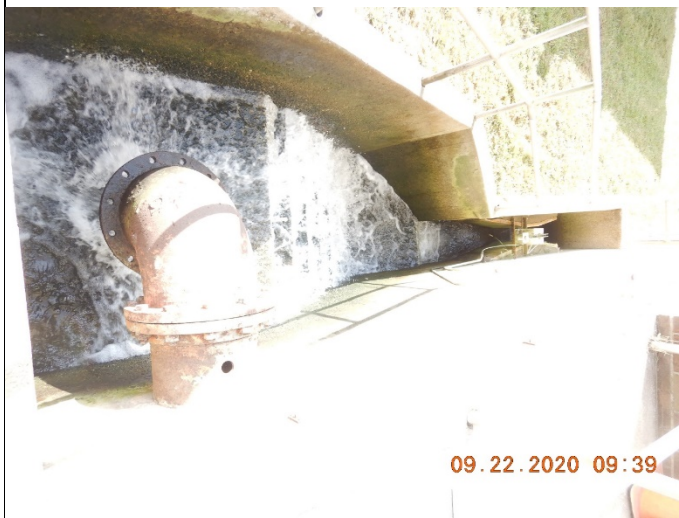
samples are taken for the NPDES compliance samples for the effluent at Outfall 001. Mr. Huff also said that pH might be taken from this location by collecting pH measurements out of the bottle used for the composite sample. Mr. Huff clarified that the pH compliance sample is collected as a grab sample from the top of the step aeration channel shown in Photo 5.

5: DSCN0041.JPG  
Location: Crane Naval Surface Warfare Center  
Photographer: Jonathan Moody  
Date/Time: 9/22/2020 9:39 AM  
Camera Direction: South  
Description: At the flume, downstream of the sand filters, where flow is monitored. Looking downstream at a step aeration system.

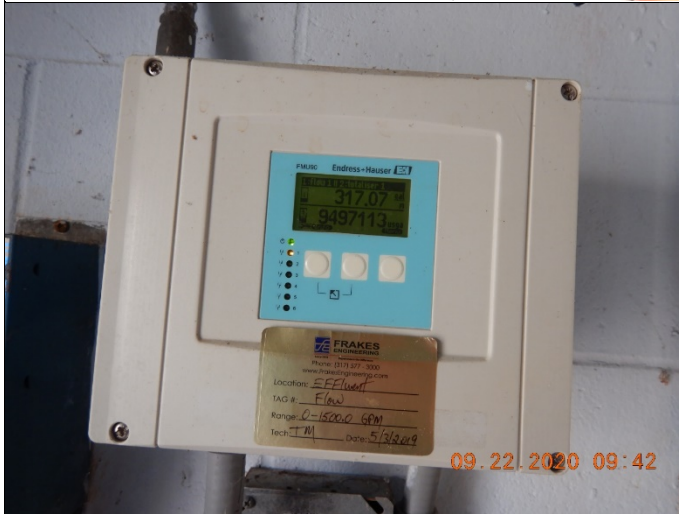
The flow measurement for compliance purposes is taken at a flume located east of the building with the sand filters and at the base of the step aeration channel. There was turbulence at the upstream end of the flume near the location where depth is measured. A readout for the flume flow measurement was present inside the filter building. At the time of the inspection, the readout was showing approximately 317 gallons per minute (GPM), which is approximately 456,000 gallons per day.

2. The flow at the UV channel appeared to be different than the flow rate measured at the flume. The operator also did not know how the UV system determined flow, and if the system had its own flow measurement capability. Turbulence at the flume can contribute to inaccurate flow measurements. Per Mr. Huff, the flow measurement at the flume was the flow measurement reported for NPDES compliance purposes. At the time of the inspection, the UV system was displaying a flow rate of 0.04 MGD, and the readout at the flume was displaying over 0.40 MGD. Both readings were taken during low flow at the WWTP when water was not flowing over the weirs of the secondary clarifiers.

6: DSCN0042.JPG  
Location: Crane Naval Surface Warfare Center  
Photographer: Jonathan Moody  
Date/Time: 9/22/2020 9:42 AM  
Camera Direction: Inside, South  
Description: Inside the building with the filters with the readout from the flow measurement flume shown in DSCN0039.JPG and DSCN0040.JPG. At the time of the inspection, the reading was fluctuating around 317 GPM, or 456,000 Gallons/day.

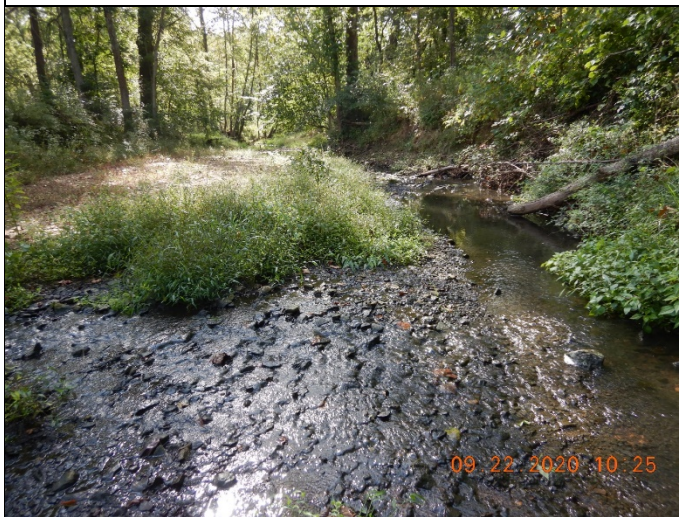
7: DSCN0043.JPG  
Location: Crane Naval Surface Warfare Center  
Photographer: Jonathan Moody  
Date/Time: 9/22/2020 10:25 AM  
Camera Direction: South  
Description: Looking at the receiving channel at Outfall 001. This is Boggs Creek, and the flow is away from the camera.

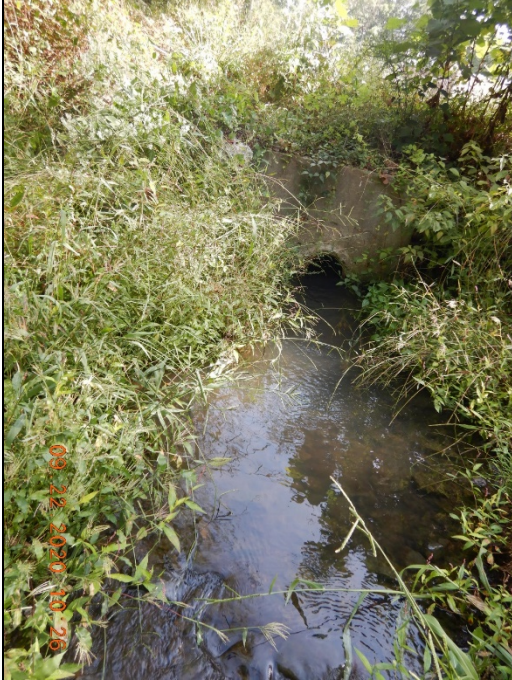
8: DSCN0044.JPG

The inspection of the WWTP ended at Outfall 001. This is the concrete pipe shown in Photo 8.

Location: Crane Naval Surface Warfare Center  
Photographer: Jonathan Moody  
Date/Time: 9/22/2020 10:26 AM  
Camera Direction: Northeast  
Description: Outfall 001.

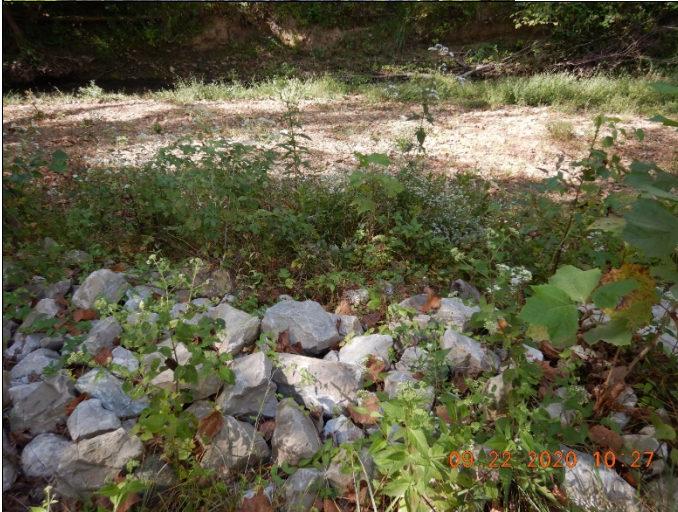
9: DSCN0045.JPG

Location: Crane Naval Surface Warfare Center  
Photographer: Jonathan Moody  
Date/Time: 9/22/2020 10:27 AM  
Camera Direction: Northeast  
Description: Riprap and discoloration in the stream bed near outfall 001.

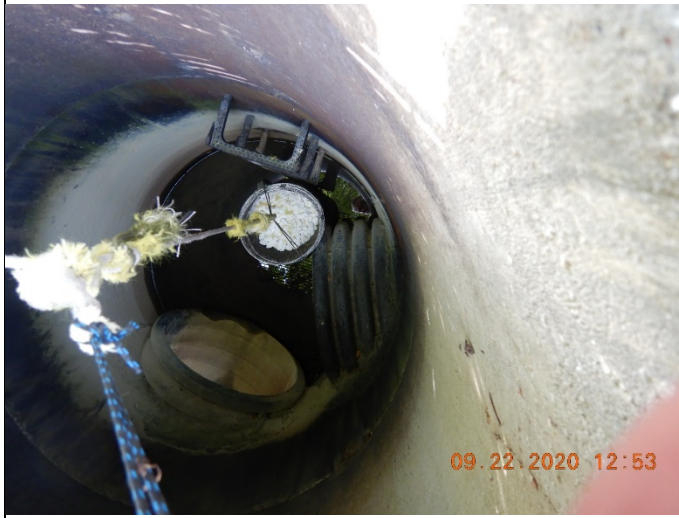
10: DSCN0046.JPG

Location: Crane Naval Surface Warfare Center  
Photographer: Jonathan Moody  
Date/Time: 9/22/2020 12:53 PM  
Camera Direction: Inside  
Description: In the discharge structure at Pond 2, Outfall 002. The hanging bucket has holes drilled in it and soda ash is placed in the buckets to mix with the wastewater discharge. This location is downstream of the sediment basin.

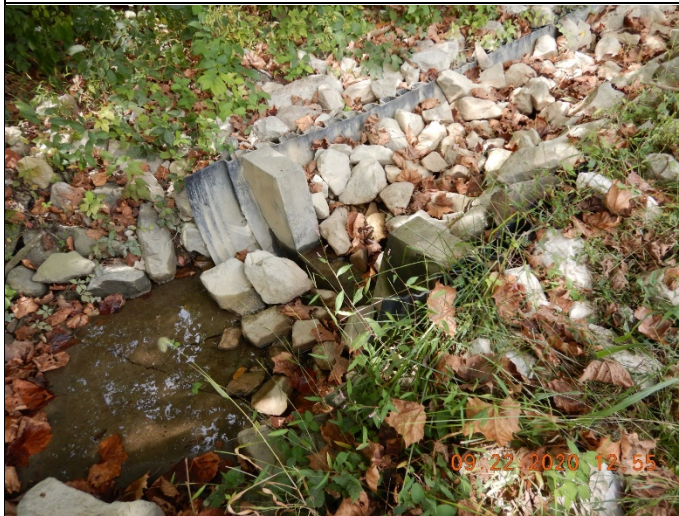
11: DSCN0047.JPG

Location: Crane Naval Surface Warfare Center  
Photographer: Jonathan Moody  
Date/Time: 9/22/2020 12:55 PM  
Camera Direction: Southwest  
Description: At the discharge channel at Outfall 002. This is the location where grab samples are taken.

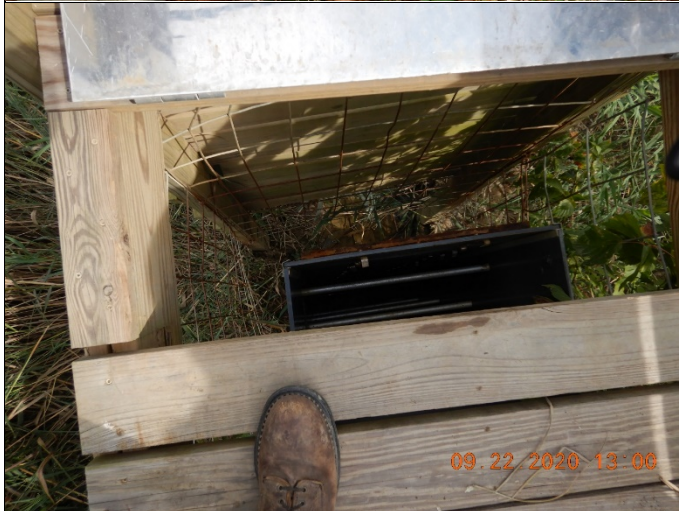
12: DSCN0048.JPG

Location: Crane Naval Surface Warfare Center  
Photographer: Jonathan Moody  
Date/Time: 9/22/2020 1:00 PM  
Camera Direction: Down, Northeast  
Description: Pond 2, Riser, or weir structure. The camera is looking down at the removable baffle weir system used to control the flow from Pond 2, Outfall 002. This the location where flow is measured. At the time of the inspection, no discharge was occurring.

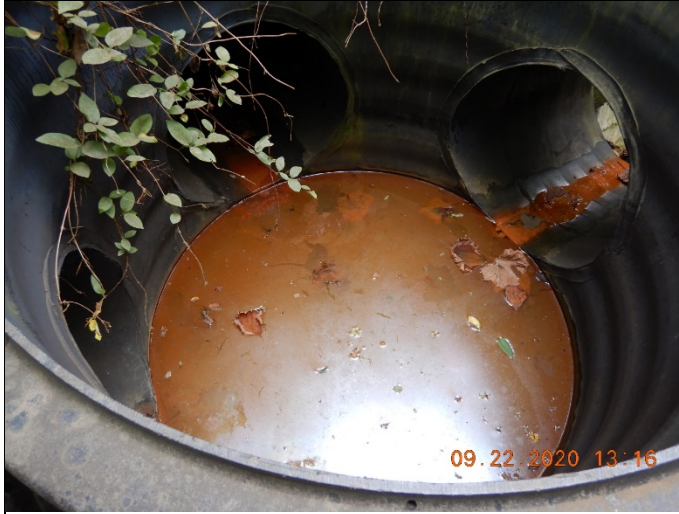
13: DSCN0049.JPG

During the inspection, there was red-brown discolored water in the manhole structure downstream of the sediment pond for Outfall 008 and upstream of where compliance samples are collected. Staining was present in the invert of the discharge pipe, and small pools of discolored water were present at various locations along the channel. These conditions can be seen in Photos 13 through 16.

Description: looking inside the manhole downstream of Pond 8. Flow enters this manhole from the center pipe and exits out the two side pipes. If soda ash treatment is needed, it is done in this manhole using a suspended bucket similar to Outfall 002. At the time of the inspection, this discharge was not flowing, but the water in the

manhole and water in the downstream channel had an orange discoloration.

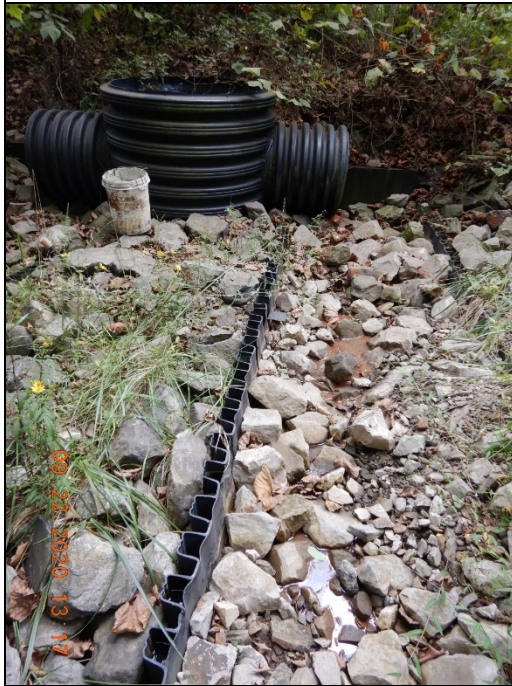
14: DSCN0050.JPG

Description: Looking upstream in the discharge channel at Outfall 008. The manhole downstream of Pond 8. At the time of the inspection, this discharge was not flowing, but the water in the discharge channel had an orange discoloration.

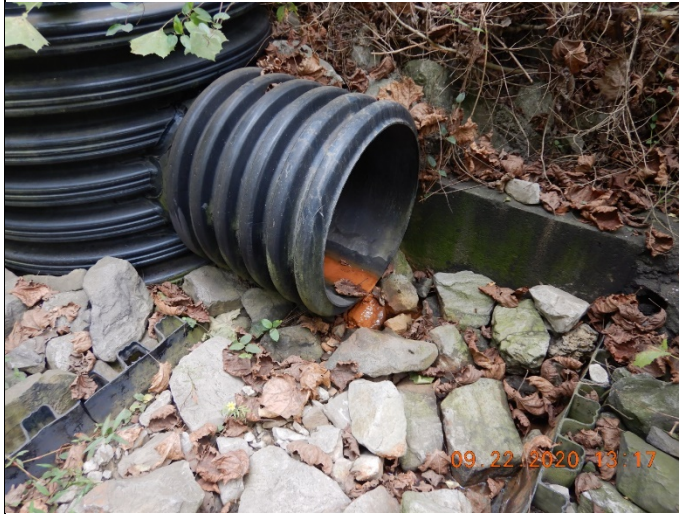
15: DSCN0051.JPG

Location: Crane Naval Surface Warfare Center  
Photographer: Jonathan Moody  
Date/Time: 9/22/2020 1:17 PM  
Camera Direction: North  
Description: Looking at the manhole and discharge pipe at Outfall 008. This manhole is downstream of pond 8. At the time of the inspection, this discharge was not flowing, but the water in the discharge channel had an orange discoloration.

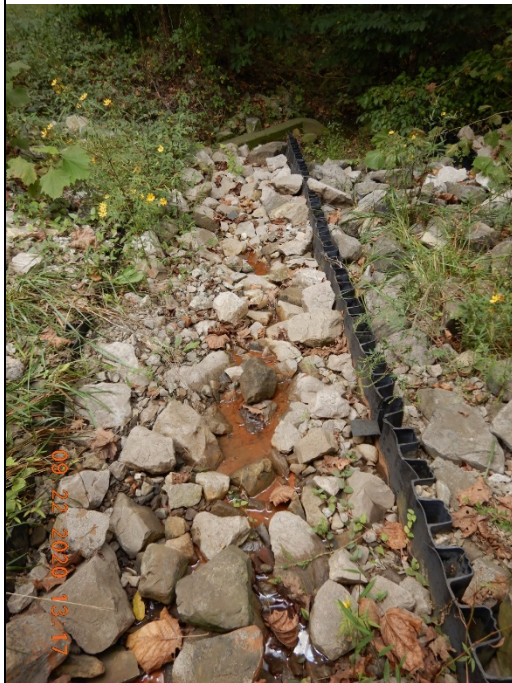
16: DSCN0052.JPG

Location: Crane Naval Surface Warfare Center  
Photographer: Jonathan Moody  
Date/Time: 9/22/2020 1:17 PM  
Camera Direction: West  
Description: Looking downstream in the discharge channel at Outfall 008. At the time of the inspection, this discharge was not flowing, but the water in the discharge channel had an orange discoloration.

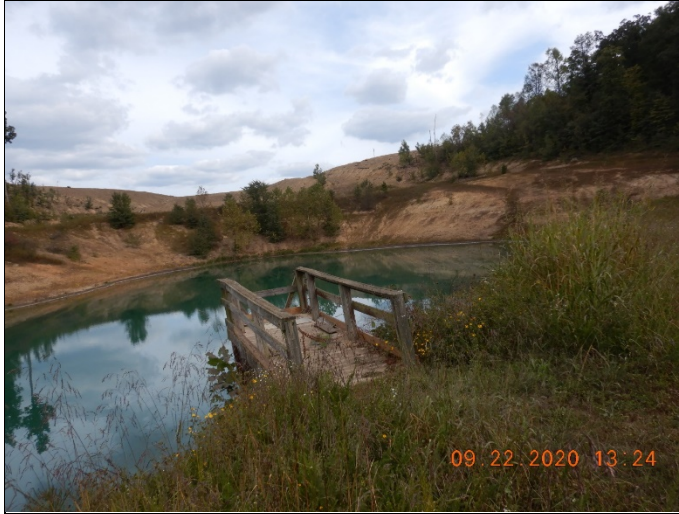
17: DSCN0053.JPG

Location: Crane Naval Surface Warfare Center  
Photographer: Jonathan Moody  
Date/Time: 9/22/2020 1:24 PM  
Camera Direction: East  
Description: At Pond 8, looking at the discharge riser system for controlling the discharge to Outfall 008. At the time of the inspection, Pond 8 was not discharging.

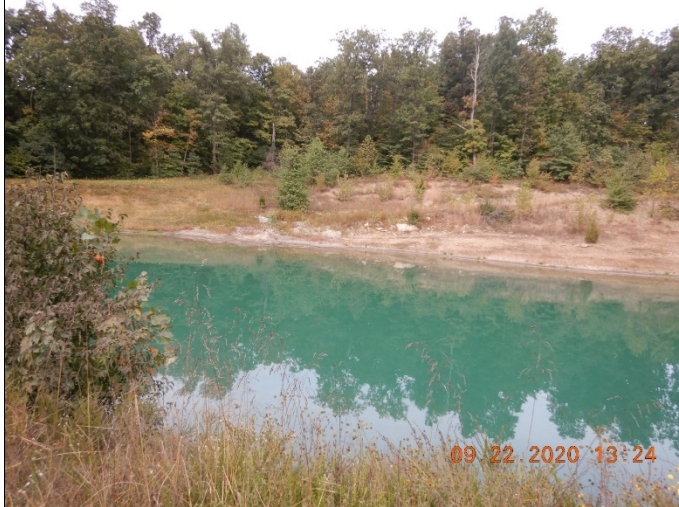
18: DSCN0054.JPG

Location: Crane Naval Surface Warfare Center  
Photographer: Jonathan Moody  
Date/Time: 9/22/2020 1:24 PM  
Camera Direction: Northwest  
Description: At Pond 8. At the time of the inspection, Pond 8 was not discharging.

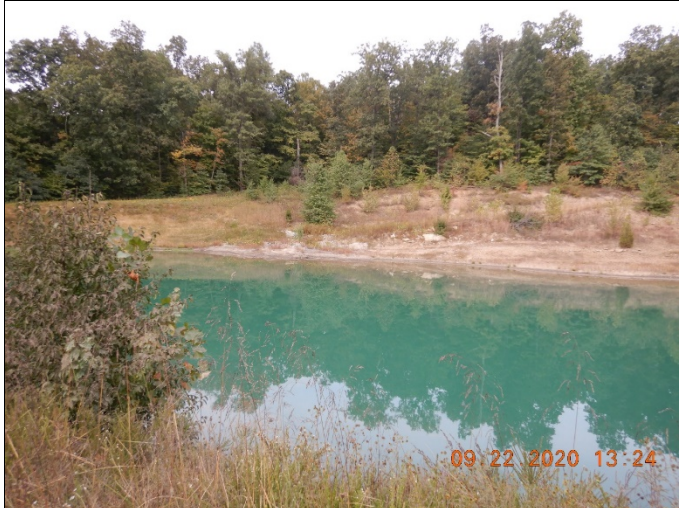
19: DSCN0055.JPG

Location: Crane Naval Surface Warfare Center  
Photographer: Jonathan Moody  
Date/Time: 9/22/2020 1:24 PM  
Camera Direction: Northwest  
Description: At Pond 8. At the time of the inspection, the pond was not discharging.

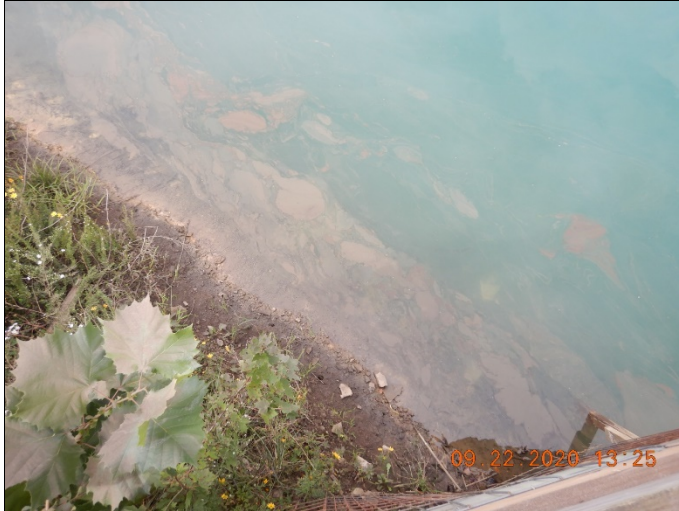
20: DSCN0056.JPG  
Location: Crane Naval Surface Warfare Center  
Photographer: Jonathan Moody  
Date/Time: 9/22/2020 1:25 PM  
Camera Direction: Down, Northwest  
Description: At Pond 8. At the time of the inspection, Pond 008 was not discharging. A pH measurement at this location was 6.71 S.U.

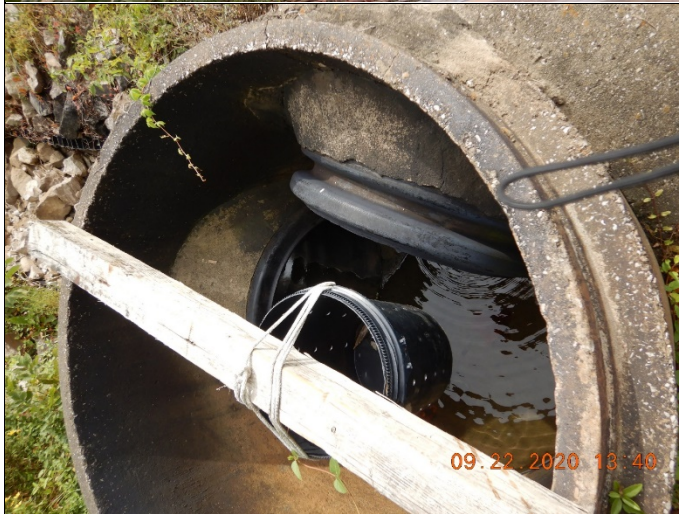
21: DSCN0057.JPG  
Location: Crane Naval Surface Warfare Center  
Photographer: Jonathan Moody  
Date/Time: 9/22/2020 1:40 PM  
Camera Direction: Down, South  
Description: At Outfall 012 from Pond 4. At the time of the inspection, this outfall was not discharging.

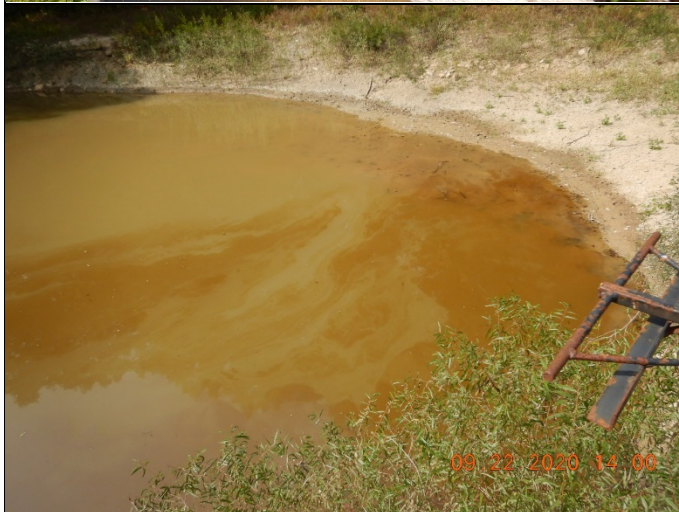
22: DSCN0058.JPG  
Location: Crane Naval Surface Warfare Center  
Photographer: Jonathan Moody  
Date/Time: 9/22/2020 2:00 PM  
Camera Direction: West  
Description: Pond 3, which drains to Pond 3A with Outfall 003. At the time of the inspection, the pH of Pond 3 was 8.00 S.U.

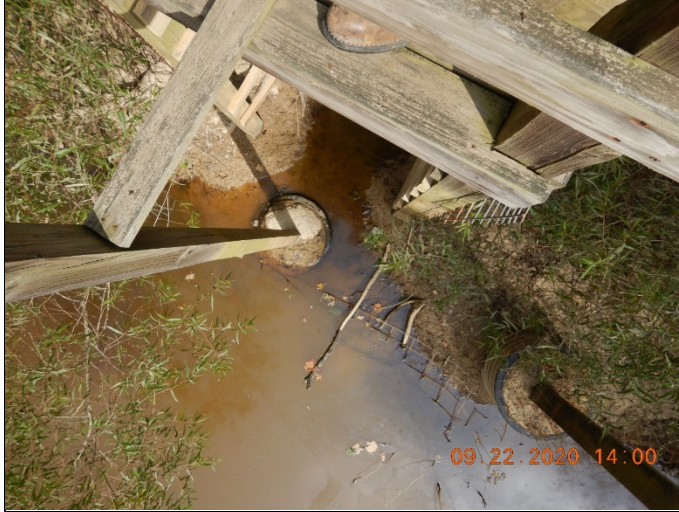
23: DSCN0059.JPG  
Location: Crane Naval Surface Warfare Center  
Photographer: Jonathan Moody  
Date/Time: 9/22/2020 2:00 PM  
Camera Direction: Down  
Description: The control structure at Pond 3 which drains to Pond 3A. At the time of the inspection, the trash rack was off the control structure.

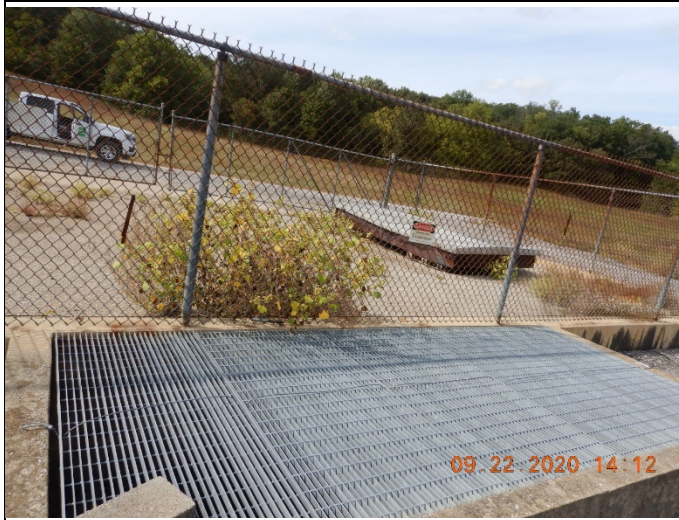
24: DSCN0060.JPG  
Location: Crane Naval Surface Warfare Center  
Photographer: Jonathan Moody  
Date/Time: 9/22/2020 2:12 PM  
Camera Direction: Northwest  
Description: Pit #1 and Pit #3 where ammunition boxes and treated wood are burned. Runoff from these sites flows into the blind sump under the grate in the foreground. Outfalls 016 and 017 are monitored when the sumps are emptied.

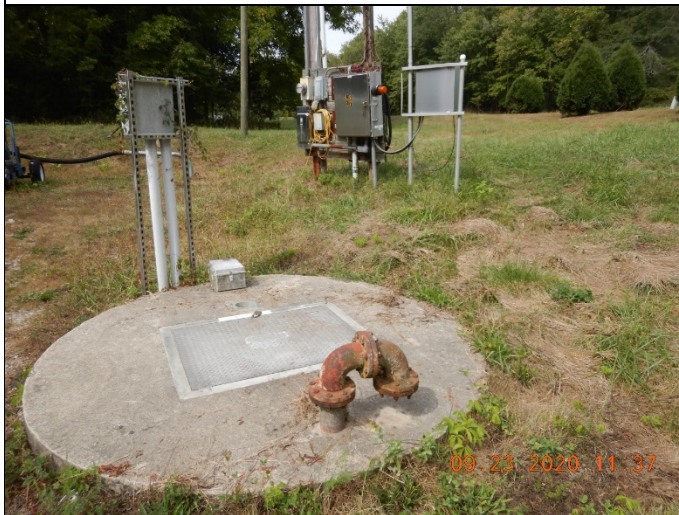
25: DSCN0061.JPG  
Location: Crane Naval Surface Warfare Center  
Photographer: Jonathan Moody  
Date/Time: 9/23/2020 11:37 AM  
Camera Direction: West  
Description: Lift Station 17, located on the southside of Highway 5 and ½ mile west of the Crane Naval Surface Warfare gate.

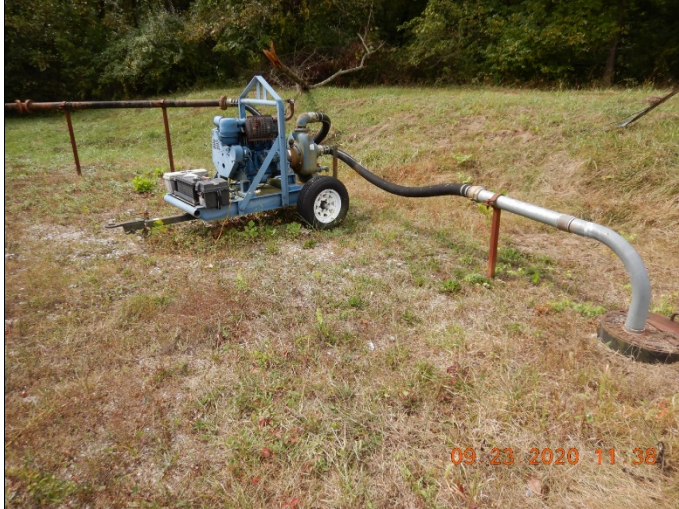
26: DSCN0062.JPG

There is a bypass pump connected to Lift Station 17 and shown in Photo 26. Per the facility representative, the pump is activated manually when there are high flows at Lift Station 17, and an operator will stay at the pump while it is in operation. The lift station is connected to an alarm. The pump will fill a bladder contained in a shallow box as shown in Photo 27. Crane estimates the volume of the bladder to be 100,000 gallons. After the high flow subsides, the bladder can be drained back into Lift Station 17. Mr. Moody walked around the perimeter of the box containing the bladder and did not find any flow paths, nor signs of erosion around the box. Culpepper Creek runs along the south side of the box and had a pronounced red or brown discoloration as shown in Photo 29. The discoloration appeared to start at a location upstream of the bladder located at Lift Station 17.

Location: Crane Naval Surface Warfare Center  
Photographer: Jonathan Moody  
Date/Time: 9/23/2020 11:38 AM  
Camera Direction: South  
Description: Pump at Lift Station 17. This pump is activated manually during wet weather to bypass Lift Station 17 and fill a 'bladder' used for equalization.

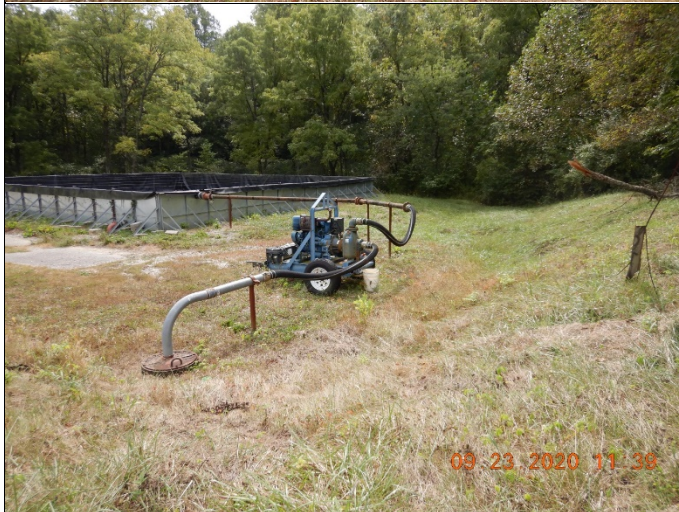
27: DSCN0063.JPG

Location: Crane Naval Surface Warfare Center  
Photographer: Jonathan Moody  
Date/Time: 9/23/2020 11:39 AM  
Camera Direction: South  
Description: Looking at the bypass pump at Lift Station 17 and the containment 'bladder'.

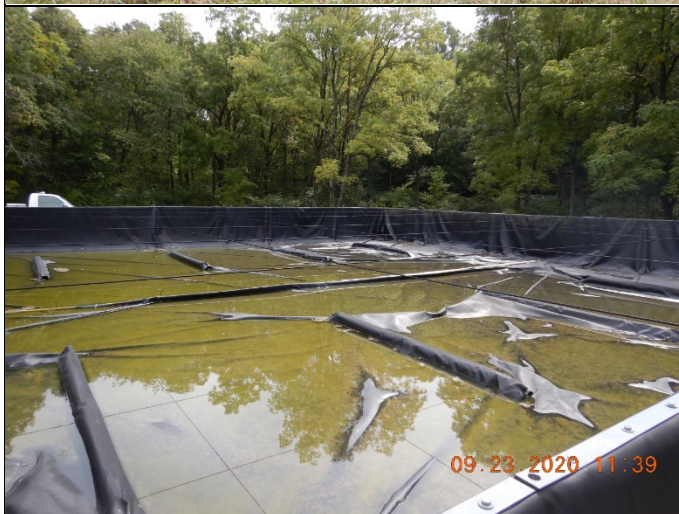
28: DSCN0064.JPG

Location: Crane Naval Surface Warfare Center  
Photographer: Jonathan Moody  
Date/Time: 9/23/2020 11:39 AM  
Camera Direction: South  
Description: Looking over the edge of the walls containing the 'bladder' used for equalization volume at Lift Station 17. This is the top of the 'bladder,' the water on the surface is from precipitation.

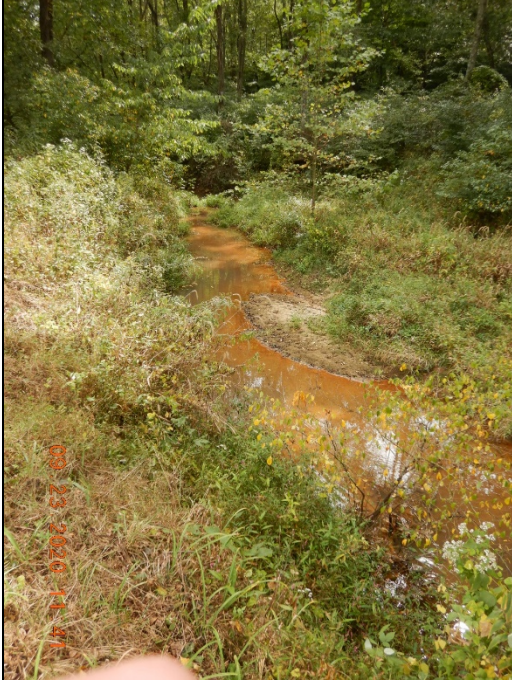
29: DSCN0065.JPG

Description: Culpepper Creek, looking downstream. This creek flowed to the south of Lift Station 17. At the time of the inspection, the creek had a red/brown discoloration which started at some location upstream of Lift Station 17.
