**Well Inspection**  
**Osage DNR / Environmental Protection Agency**  
**1201 Elm Street, Suite 500**  
**Dallas, Texas 75270**

| | | <b>Well ID</b> | GALE 14 | | |
| <b>Inspection Reason</b> | MIT | | <b>Responsible Company at Time of Inspection</b> | Contango Resources | |

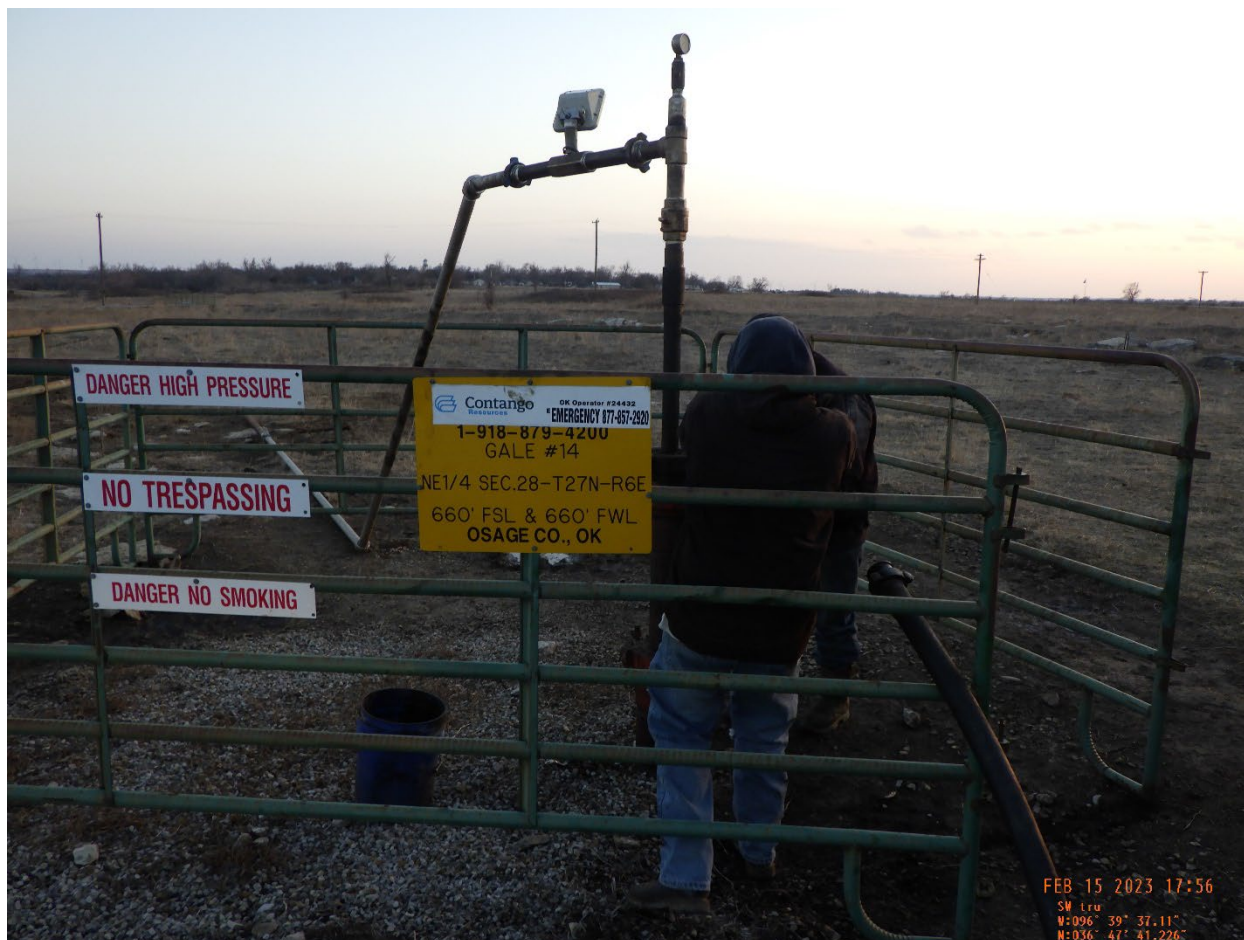
Photo No. 1

Description: This was well OS4106000 at the time of the inspection.
