## U.S. EPA Region 8 NPDES Inspection Report

| National Database Information | |
|---|---|
| Inspection Date: <b>May 14, 2024</b> | Inspection Type: <b>Compliance Evaluation and Assistance Inspection</b> |

| Site/Facility Location Information | |
|---|---|
| Site/Facility Name & Location:<br><b>Schaff Sand and Gravel Mine</b><br><b>45.637826, -107.6744</b><br><b>Big Horn County, Montana</b> | Email Report to:<br><b>Stacy Hill, Environmental Administrator</b><br><b>Riverside Contracting, Inc.</b><br><b><a href="mailto:sjhill@riversidecontracting.com">sjhill@riversidecontracting.com</a></b> |

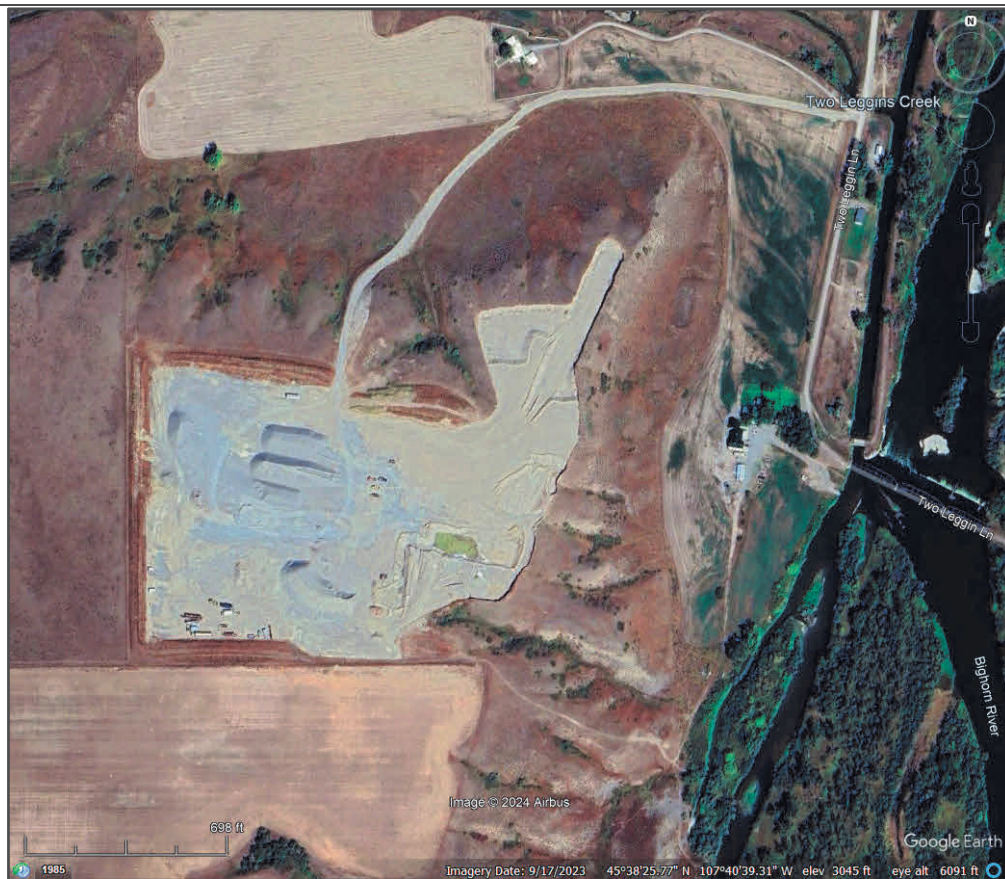
Figure 1. Aerial image of the site and surroundings  
 Imagery Date: September 17, 2023  
 Source: Google Earth Pro

A 2023 aerial image of the site is shown in Figure 1. Based on estimates made using the “Polygon” measurement tool and aerial imagery available in Google Earth Pro, approximately 30-35 acres have been disturbed at the site. Based on a cursory review of limited historical aerial imagery, the site appears to have been generally undeveloped prior to the commencement of mining activities, which appear to have begun sometime between April 2019 and August 2022.
