**SUBJECT:** CLEAN AIR ACT INSPECTION REPORT  
Bell Lumber and Pole Company, New Brighton, Minnesota

**Facility Name:** Bell Lumber and Pole Co.

**Date of Inspection:** April 29, 2022

**Facility Type:** Wood Preserving

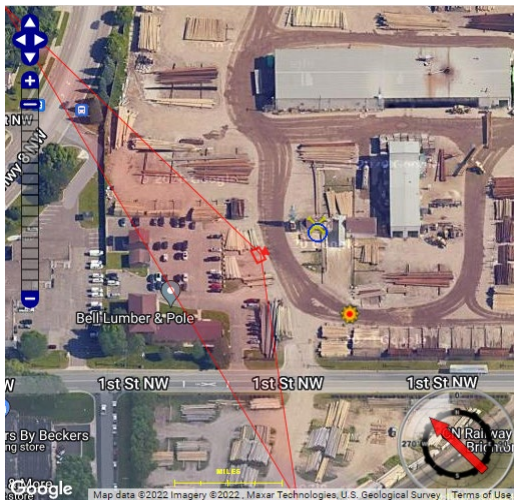
EPA performed USEPA Method 082 on the fugitive emissions from the shaver. The shaver was not routing to the cyclone since it was routing to an enclosed trucking container. EPA observed no visible emissions from the shaver while it was being operated in this fashion. Results were 0% opacity over a six-minute average.

| 3 | 0 | 0 | 0 | 0 | 6-minute avg = 0% | |
