## NPDES Inspection Report – Water Treatment Plant

| National Database Information | |
|---|---|
| Inspection Date: May 14, 2024 | Inspection Type: Water Treatment Plant |

| Facility Location Information | |
|---|---|
| Site/Facility Name & Location:<br><b>Hardin Water Treatment Plant</b><br><b>101 East 4<sup>th</sup> Street</b><br><b>Hardin, Montana 59034</b><br><b>Facility: 45.7325975°N; -107.6040161°W</b><br><b>Outfall: 45.732771°N; -107.580924°W</b> | Email Report to:<br><b>Michael Hurff – Public Works Director</b><br><b>City of Hardin</b><br><a href="mailto:publicworks@hardinmt.com">publicworks@hardinmt.com</a> |

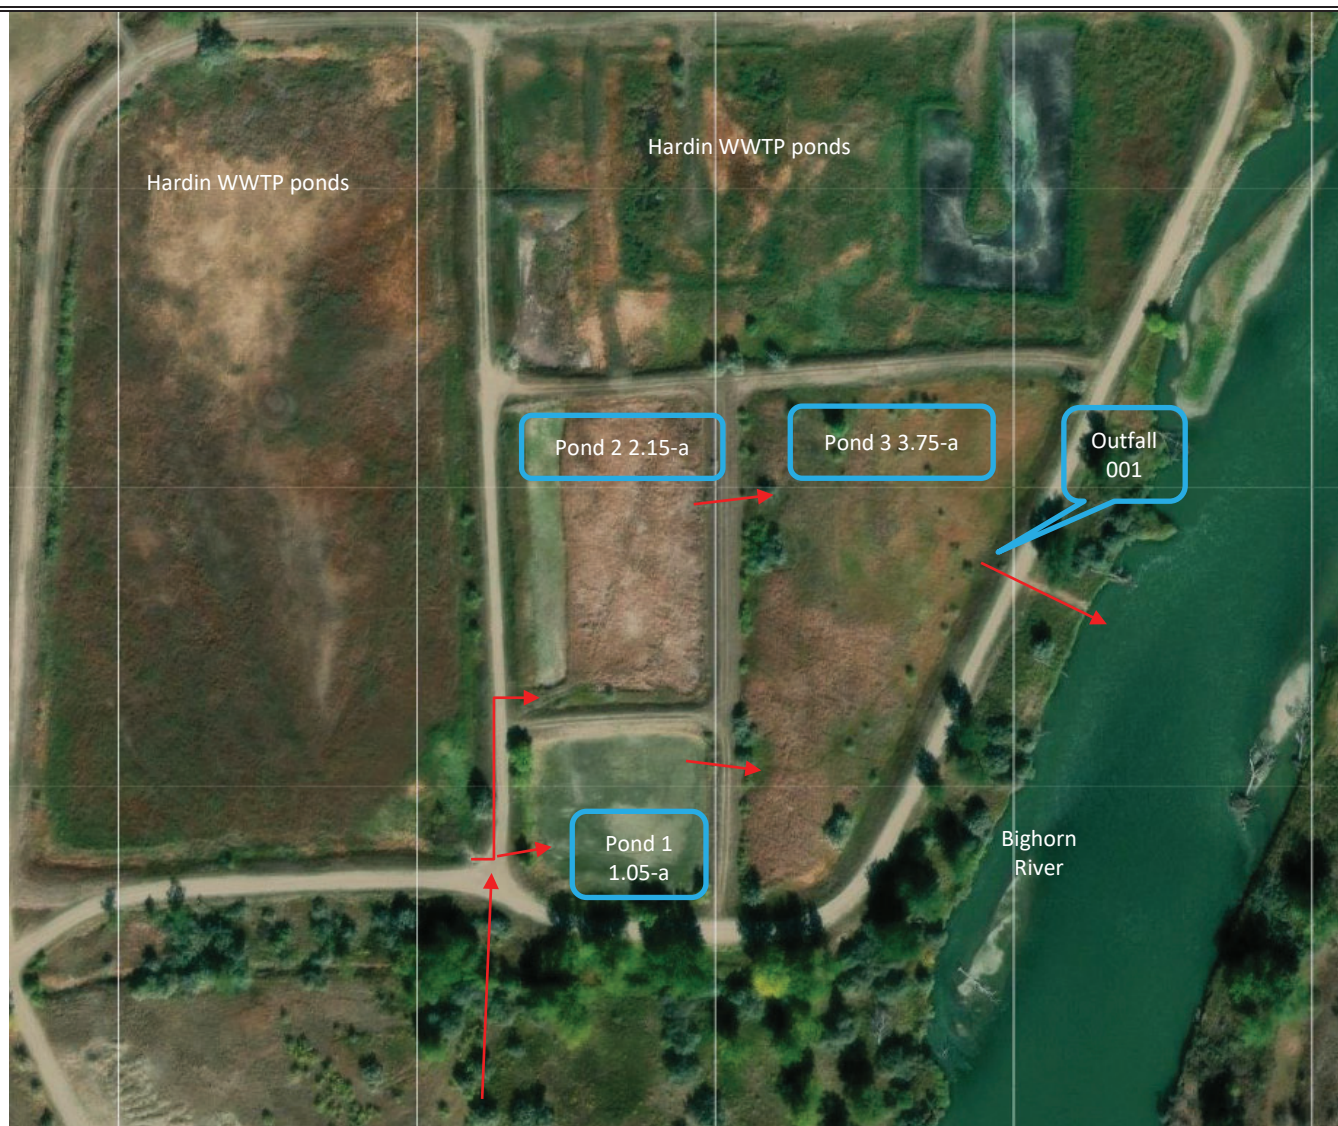
Figure 1. Hardin WTP waste ponds and outfall.

The facility has a total of three backwash ponds. Waste streams from the facility can be pumped either to Pond 1 (photo 25) or Pond 2 (photo 26), depending on the season. At the time of the inspection, the facility was discharging to Pond 1. Direction of the backwash ponds' influent into either Pond 1 or Pond 2 is controlled manually with gates. The ponds typically operated where Ponds 1 and 2 are parallel and both have the ability to discharge to Pond 3. The total surface area of all 3 ponds is 6.95-acres (see figure 1). Backwash usually infiltrates or evaporates before it reaches the overflow to Pond 3. If Backwash Pond 3 were to reach its storage capacity, wastewater can be discharged on the northeast side through a pipe to the Bighorn River via Outfall 001 (photos 23 & 24). However, the system is designed not to discharge during normal operation and there has been no reported discharge. Facility representatives indicated solids are removed from the ponds (1 and 2) every 7 to 8 years and landfilled; the last sludge removal was in Fall of 2018.
