**Report Memorandum**

**Subject:** Pretest Observation Report – Trelleborg Coated Systems US, Inc.

A. Facility Name: Trelleborg Coated Systems US, Inc.  
B. Facility Location: 30 Lenox St., New Haven, CT 06513  
C. Facility Contact: Brian Franco, General Manager  
D. ICIS-Air #: CT0000000900903003

A. Date of inspection: October 28, 2021  
B. US EPA Representative(s): William Osbahr, Alysha Murphy, Tyler Kotsifas  
C. Inspection Purpose: Follow-up Inspection - Pretest Meeting for proposed emission testing and Coating Line Enclosure Monitoring Inspection for ECAD

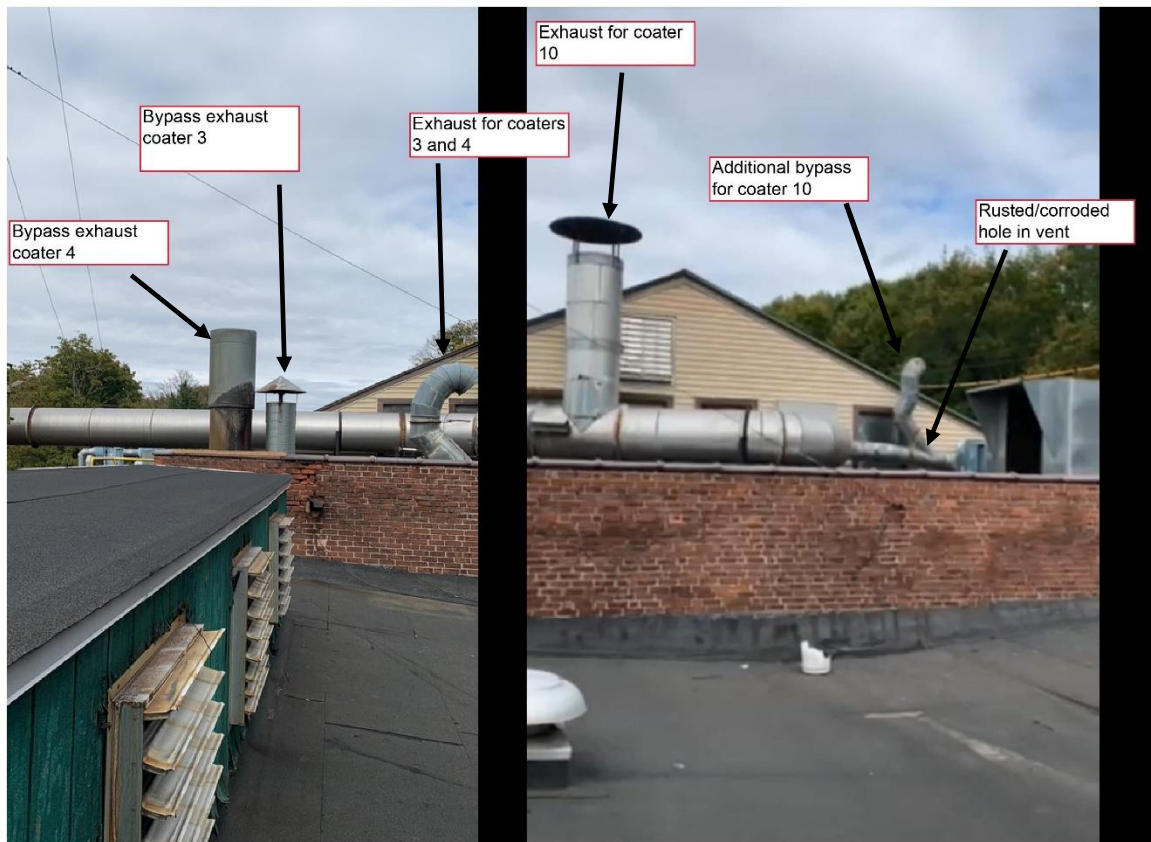
The EPA Team showed Mr. Franco and Mr. Turner the recorded FLIR videos indicating clearly where the VOC fugitive emissions from the bypass ducts were occurring. Mr. Osbahr explained how such videos demonstrated VOC fugitive emissions leaks associated with Trelleborg's capture system. Leaks were identified from:

1. Bypass Exhaust for Coater 4
2. Bypass Exhaust for Coater 3
3. Bypass Exhaust for Coater 3 / 4
4. Bypass Exhaust for Coater 10
5. Additional Bypass Exhaust for Coater 10. Leaks detected on camera, but no recordings taken due to the intermittent nature of that duct's emissions.
6. Rusted/Corroded Hole in Coater 10 duct. Leaks detected on camera, but no recordings taken due to the intermittent nature of the hole's emissions.

All of the above locations can be seen in Attachment A, Photo 1.

While on the roof, Mr. Osbahr stated to Mr. Moore and Mr. Turner that the bypass ducts appeared to be not in a fully closed position initially and that several of the pneumatic actuator pistons designed to open and close the ducts were in various states of disrepair. He also pointed out damaged, broken, or pinched pneumatic lines leading to these actuators.

**Photo 1.** Trelleborg bypass ducts up on flat roof.

Mr. Franco stated that Trelleborg would cut out and fully cap all the bypass ducts at the facility over the weekend and into the following week. He stated that Trelleborg would reach out to the EPA Team once the bypass ducts have been removed from the system.

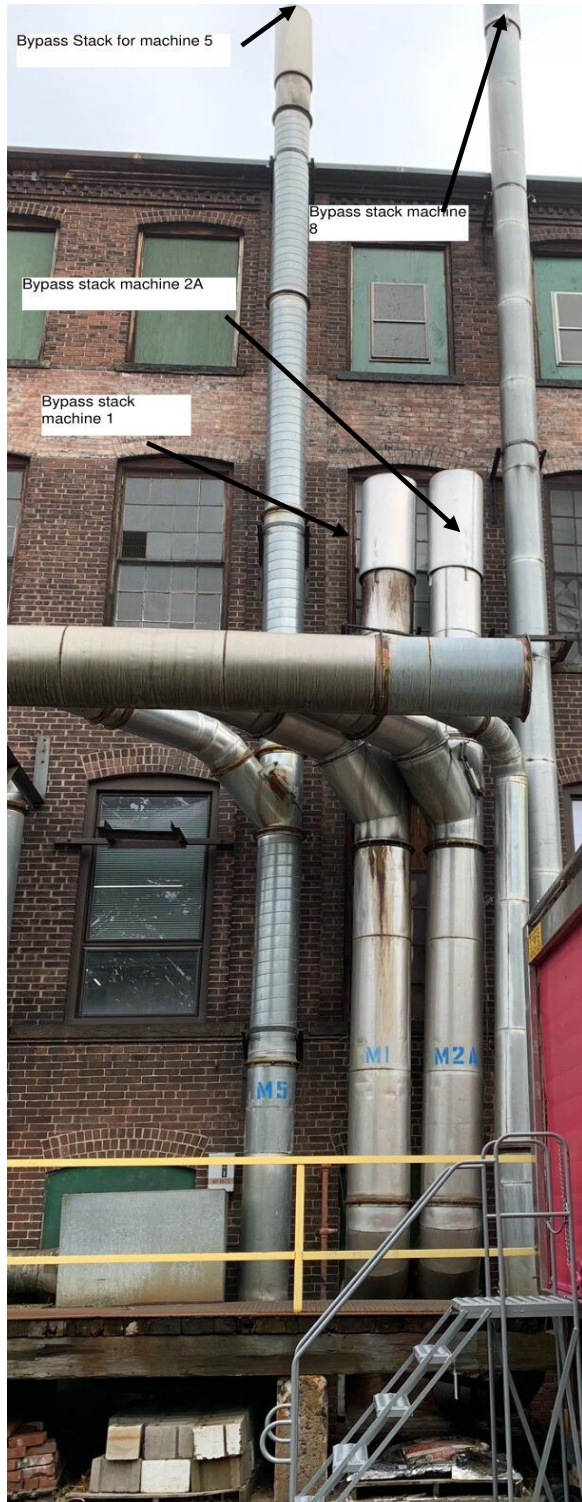
Mr. Franco asked Mr. Osbahr to use the FLIR camera to survey the ducting that runs along the back outside wall (Photo 2) of the Trelleborg facility. He stated the Trelleborg would like to close all possible leaks in the system when they perform their repairs.

The EPA Team surveyed those lines and found significant sources of fugitive VOC emissions out of 2 bypass ducts on the side of the building. The FLIR videos revealed significant VOC emissions coming out of the bypass exhaust stacks for Coater 1 and 2.

The EPA Team couldn't properly assess bypass stacks 5 and 8 with the FLIR camera. The extreme height and close quarters within the back alleyway of Trelleborg would not afford proper camera viewing.

**Photo 2.** Trelleborg back wall bypass ducts.

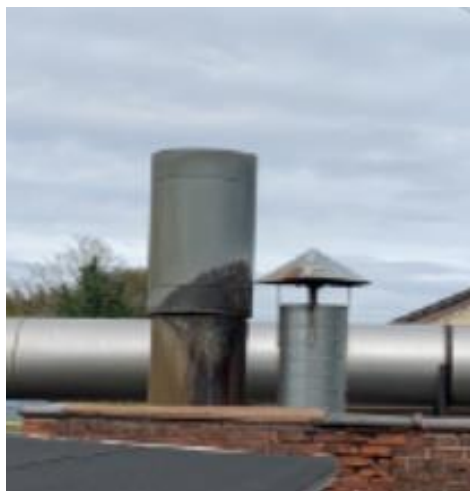
Bypass Exhaust Coaters 3 and 4 (Visible Light)

**Photo Series A.** Trelleborg fugitive VOC emissions from Bypass Exhaust Coaters 3 and 4 as compared with FLIR frozen frame photos. Note: HSM stands for Hight Sensitivity Mode.

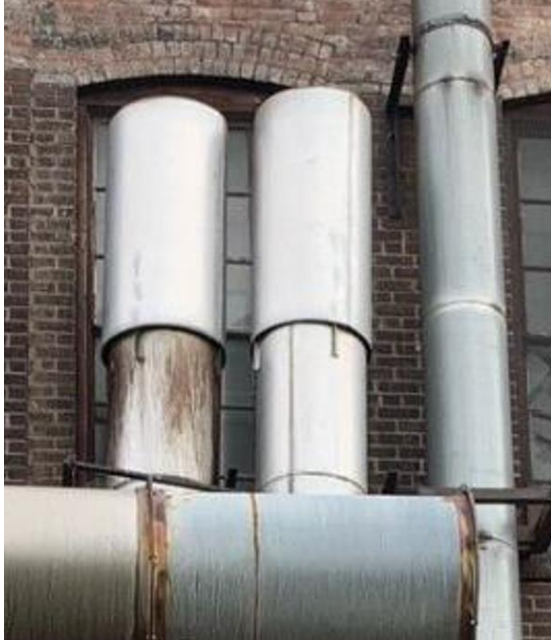
Bypass Exhaust Coater 1 and 2 (Visible Light)

**Photo Series B.** Trelleborg fugitive VOC emissions from Bypass Exhaust Coaters 1 and 2 as compared with FLIR frozen frame photos
