## Region 6 - Enforcement & Compliance Assurance Division

### INSPECTION REPORT

| Company Name: | Northcote Cleveland LLC | |
| Facility Name: | Osage B Lease | |

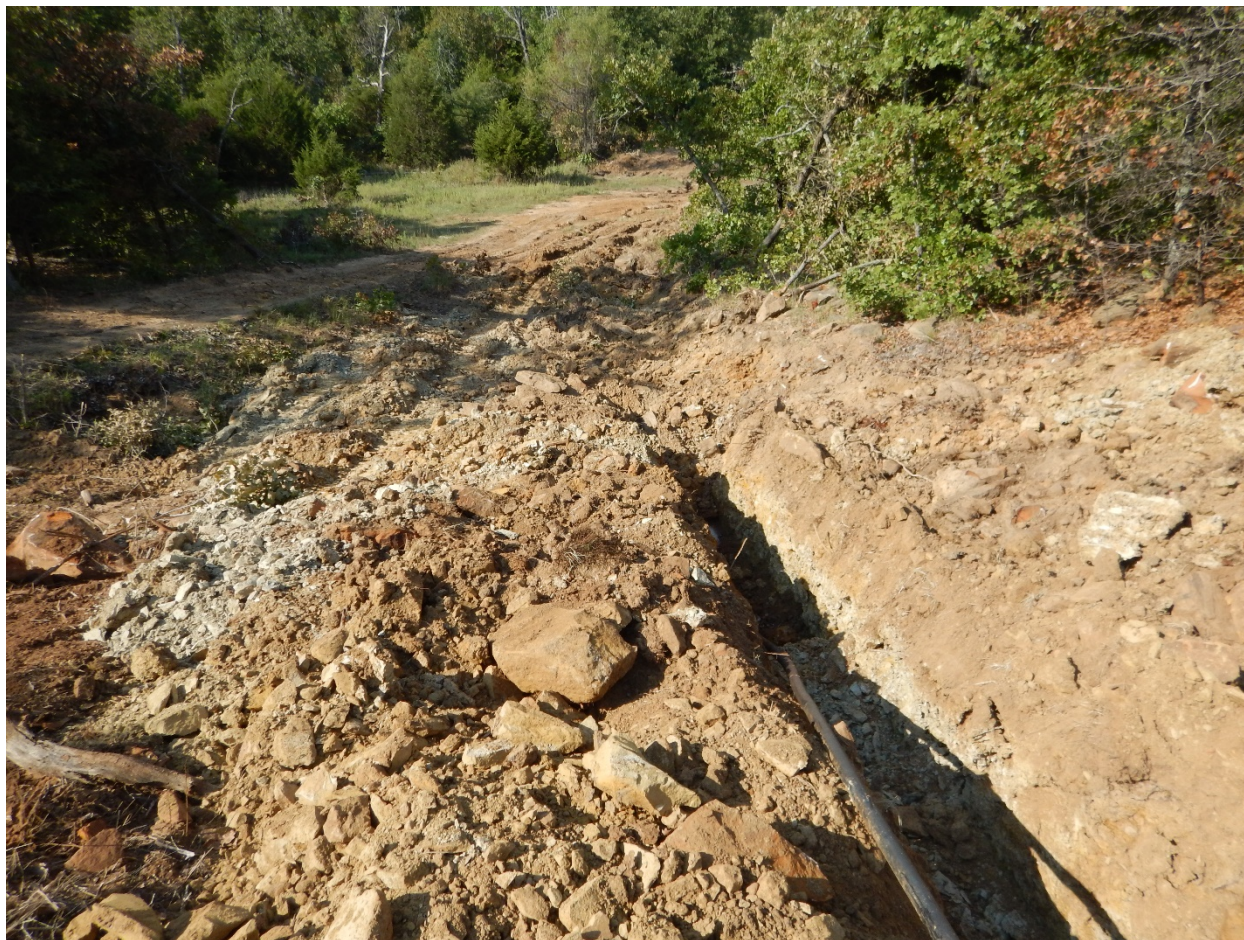
Photo No. 1

At the release point, I observed a ditch/trench where the repaired flowline was being buried to prevent recurrence of the spill event, see photo No. 1. I observed the flowpath from the release point to the point of entry (POE), the flowpath had been disturbed by heavy equipment during other cleanup activities, but residual salt was visible on the surface of the soil and the flowpath had not been cleaned or remediated at the time of the inspection (see photo No. 2)

**Description:** This was the release point of the spill. A trench had been dug to bury the repaired flowline to prevent recurrence of the spill.

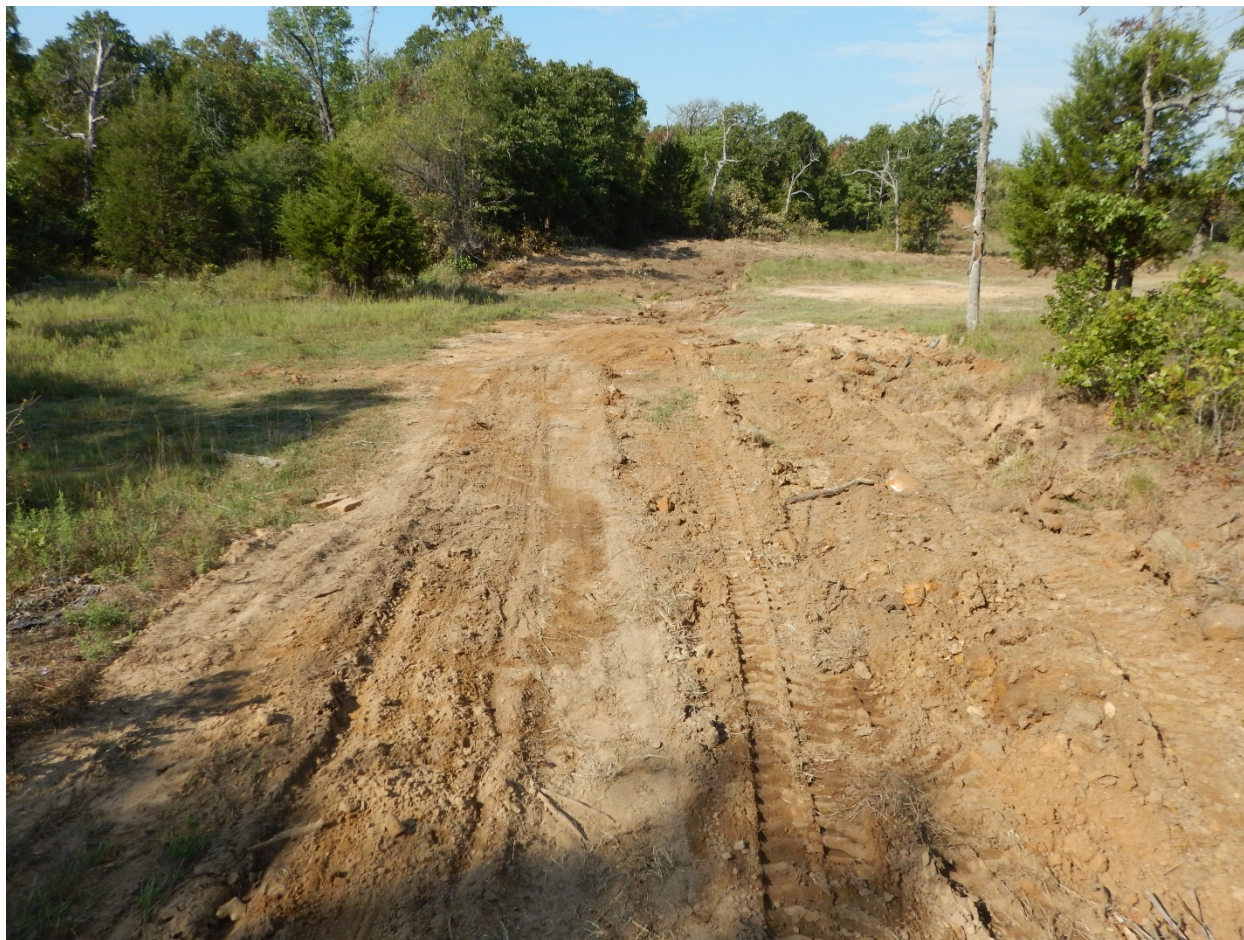
Photo No. 2

**Description:** This was the flowpath of the spill, the dirt had been disturbed by equipment moving around the area but the flowpath had not yet been cleaned or remediated at the time of inspection.

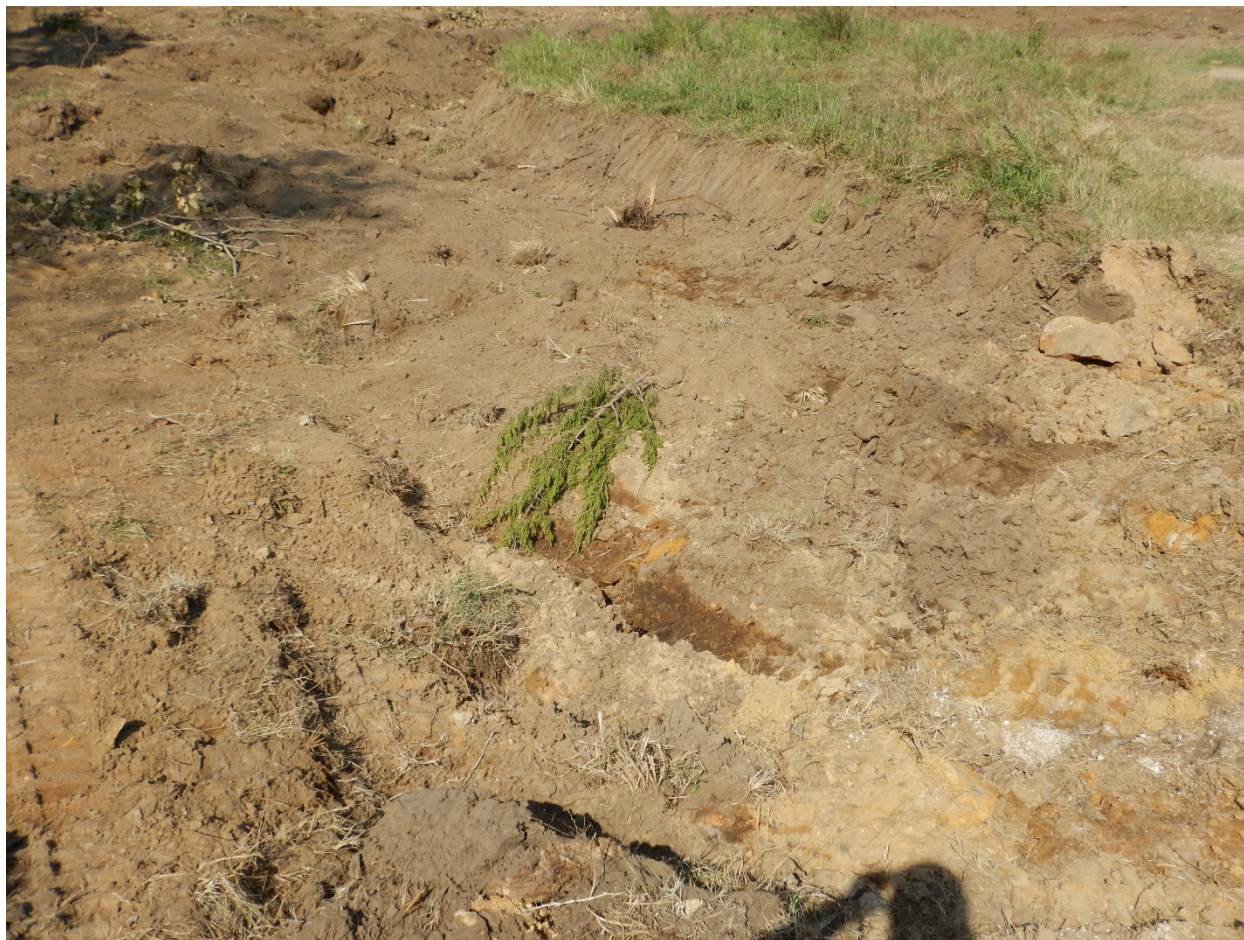
Photo No. 3

I observed significant soil and rock fill into the main channel of the impacted tributary this soil fill was a result of the banks being pulled into the main channel of the tributary. I also observed oil-stained soil and rocks present in the “fill” material (photo’s No. 3, 4, 6, 7, 8, 9, 11, 17, 18).

**Description:** This was the point of entry (POE) into the impacted tributary. The main channel had been filled with soil.

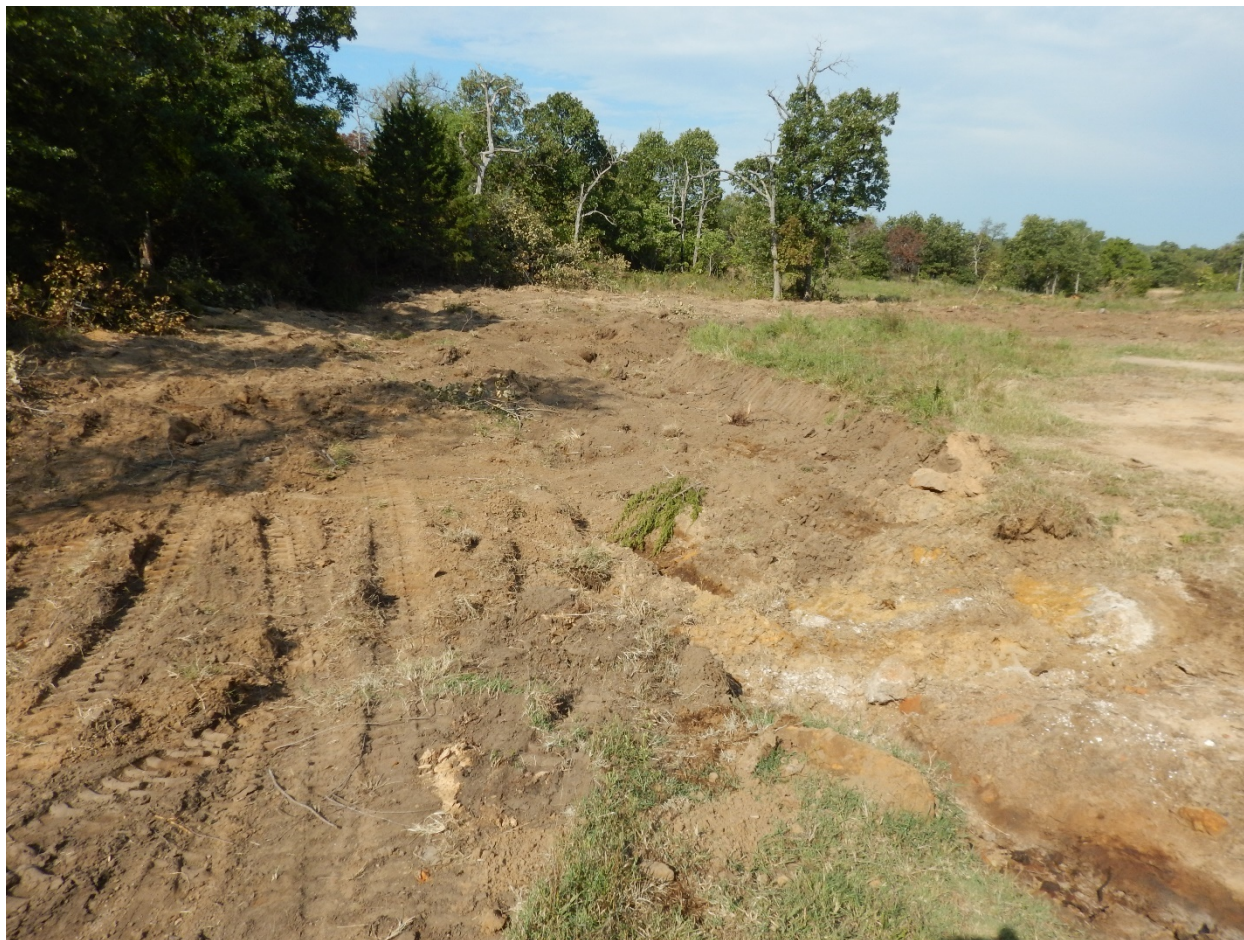
Photo No. 4

**Description:** This was a view looking across the POE with a downstream view, the main channel had been filled with soil and the banks had been reshaped with heavy equipment.

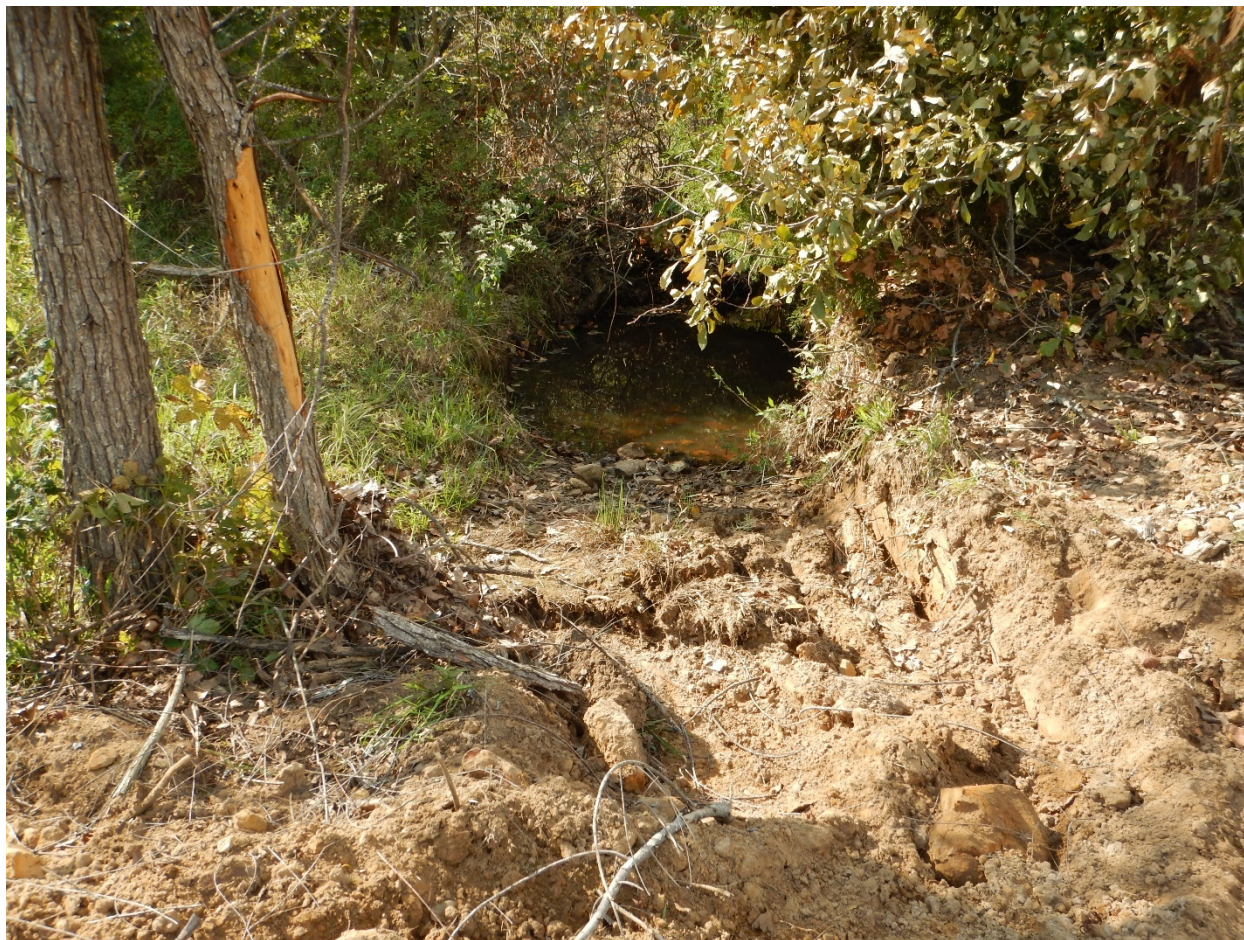
Photo No. 5

**Description:** This was a view from the POE looking upstream to an area not impacted by the spill.

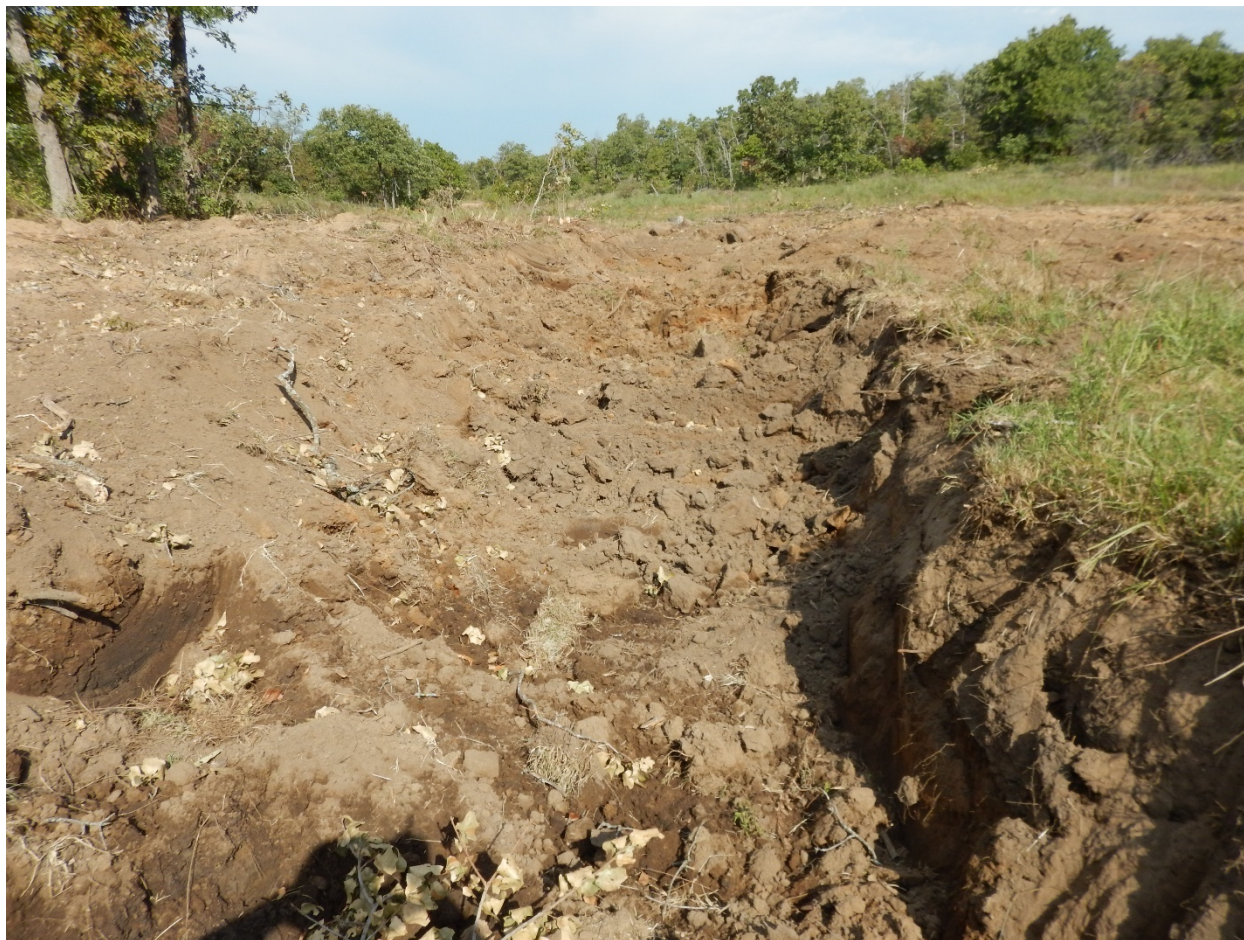
Photo No. 6

**Description:** This was a view of the altered and filled channel of the impacted tributary, approximately 150 feet downstream from the POE.

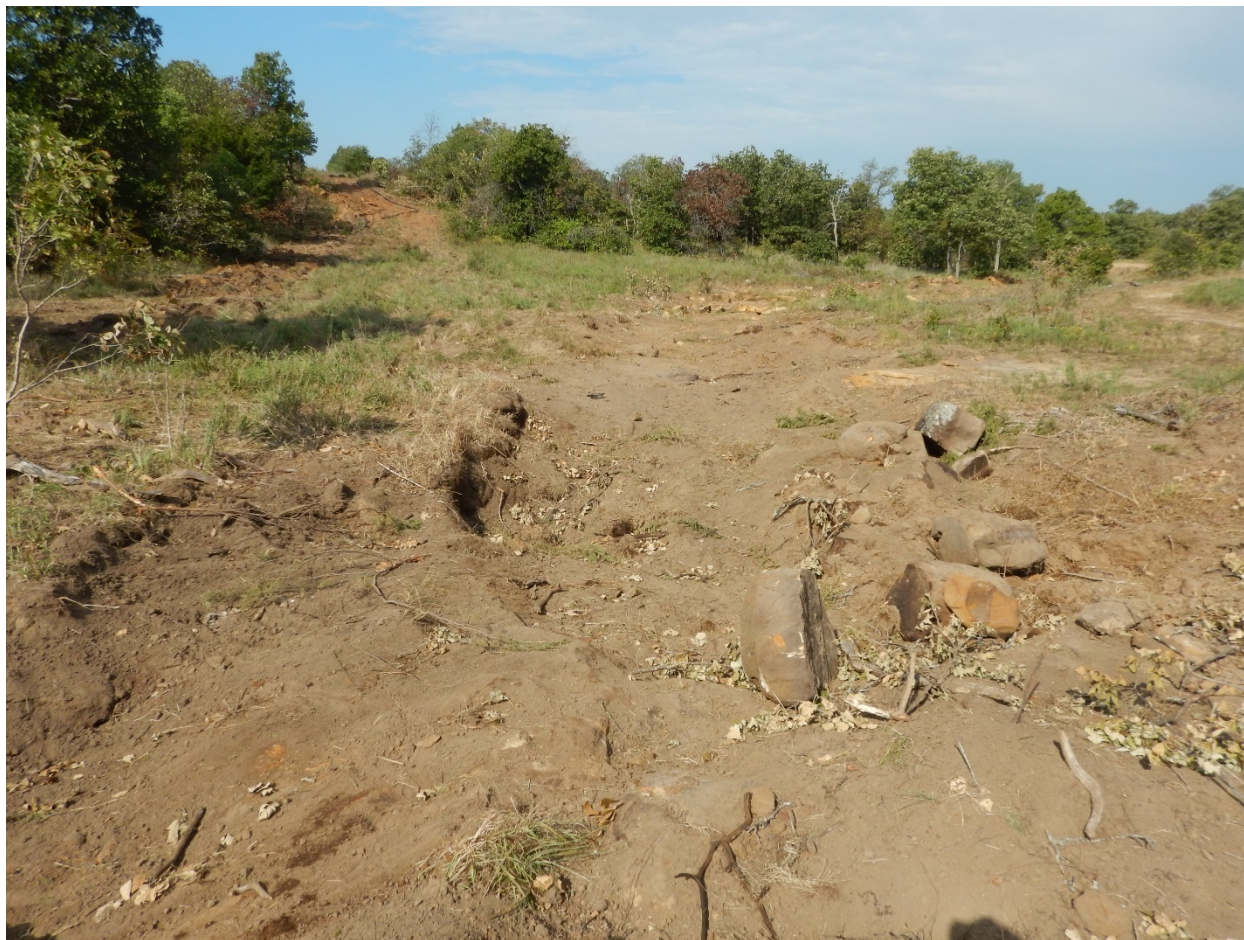
Photo No. 7

**Description:** This was the impacted tributary showing soil and rock fill in the main channel of the tributary. Oil-stained rocks were still present in the tributary.

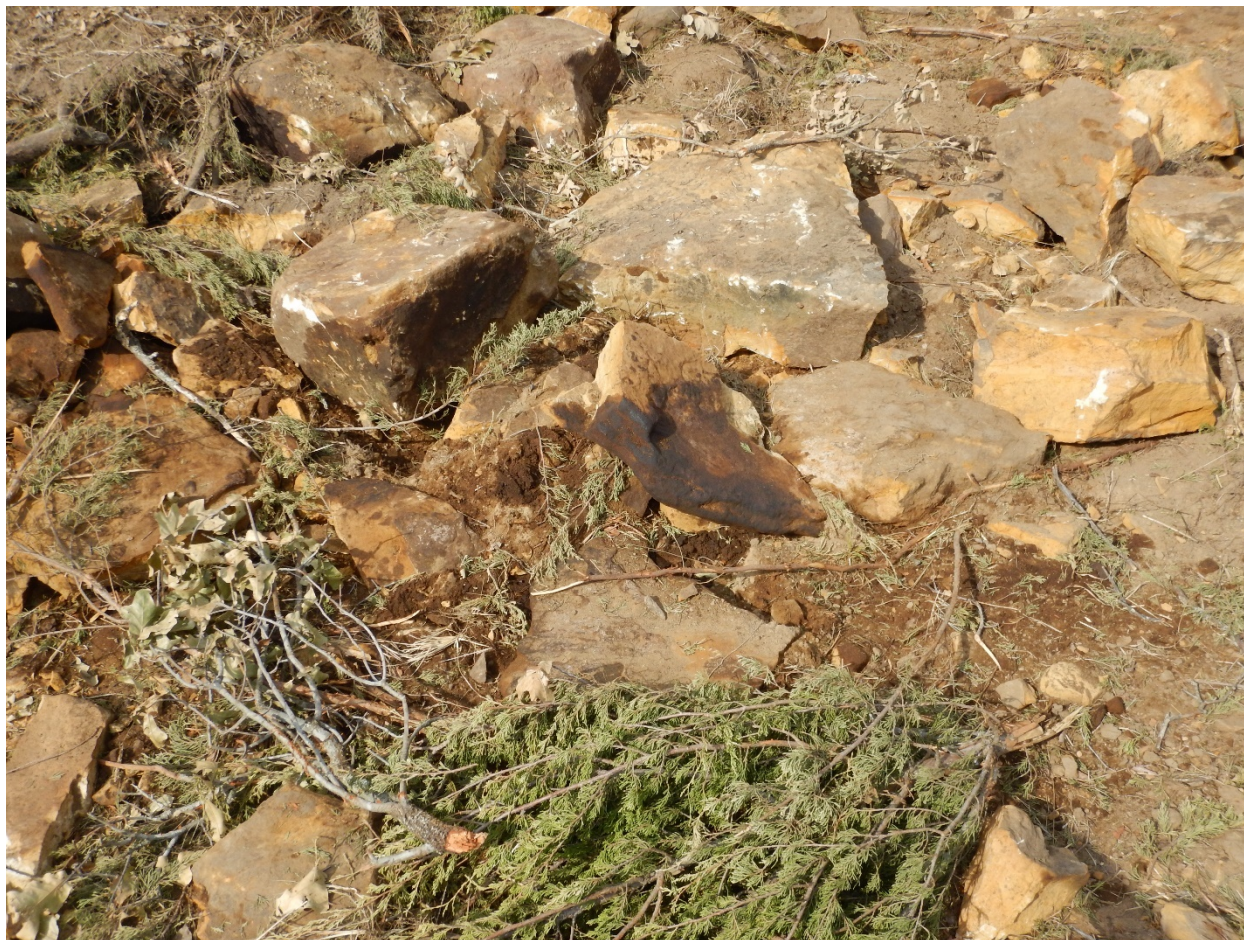
Photo No. 8

**Description:** This was a photo of oil-stained rocks and soil in the main channel of the impacted tributary.

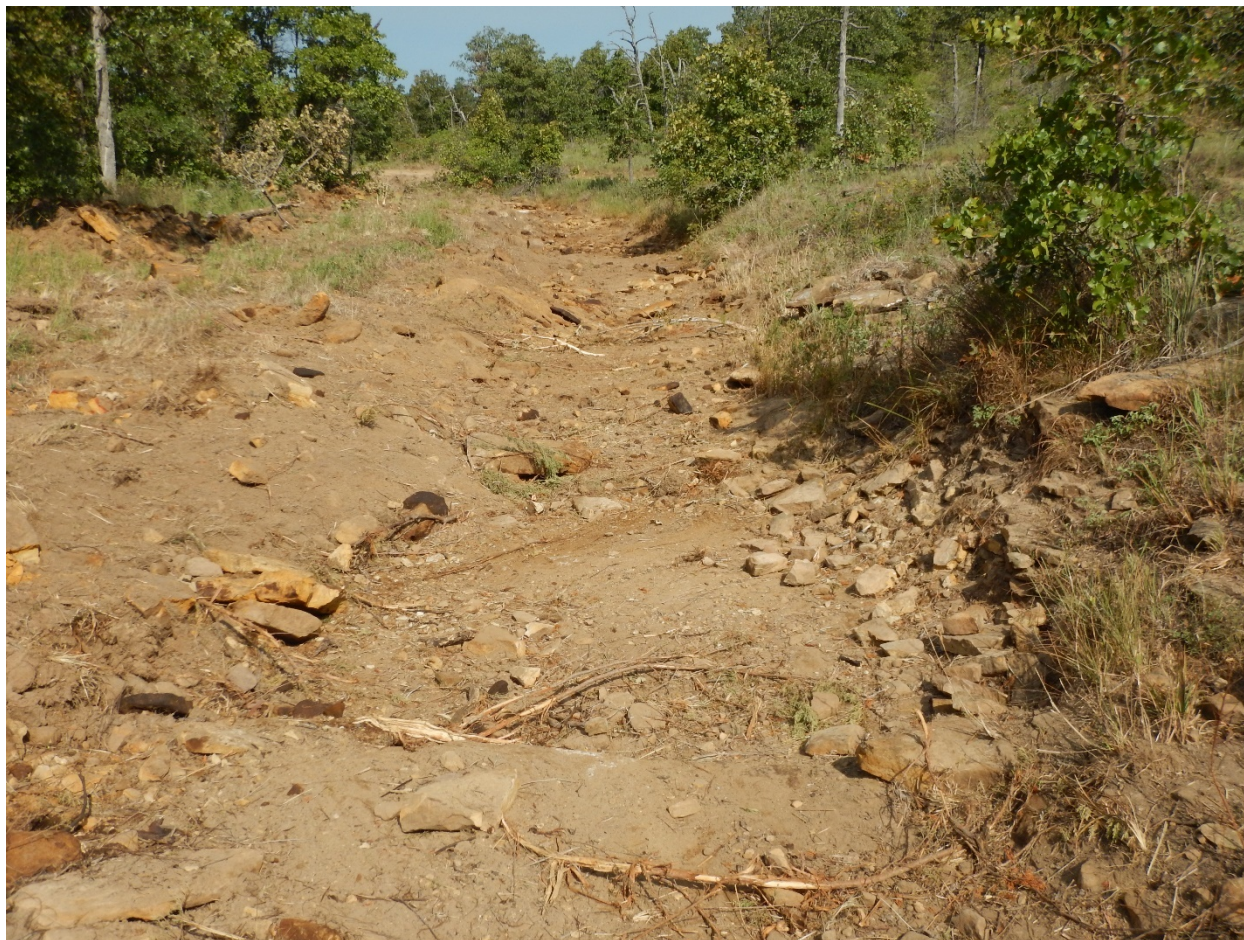
Photo No. 9

**Description:** This was a photo along a section of the impacted tributary showing soil and rock fill in the main channel.

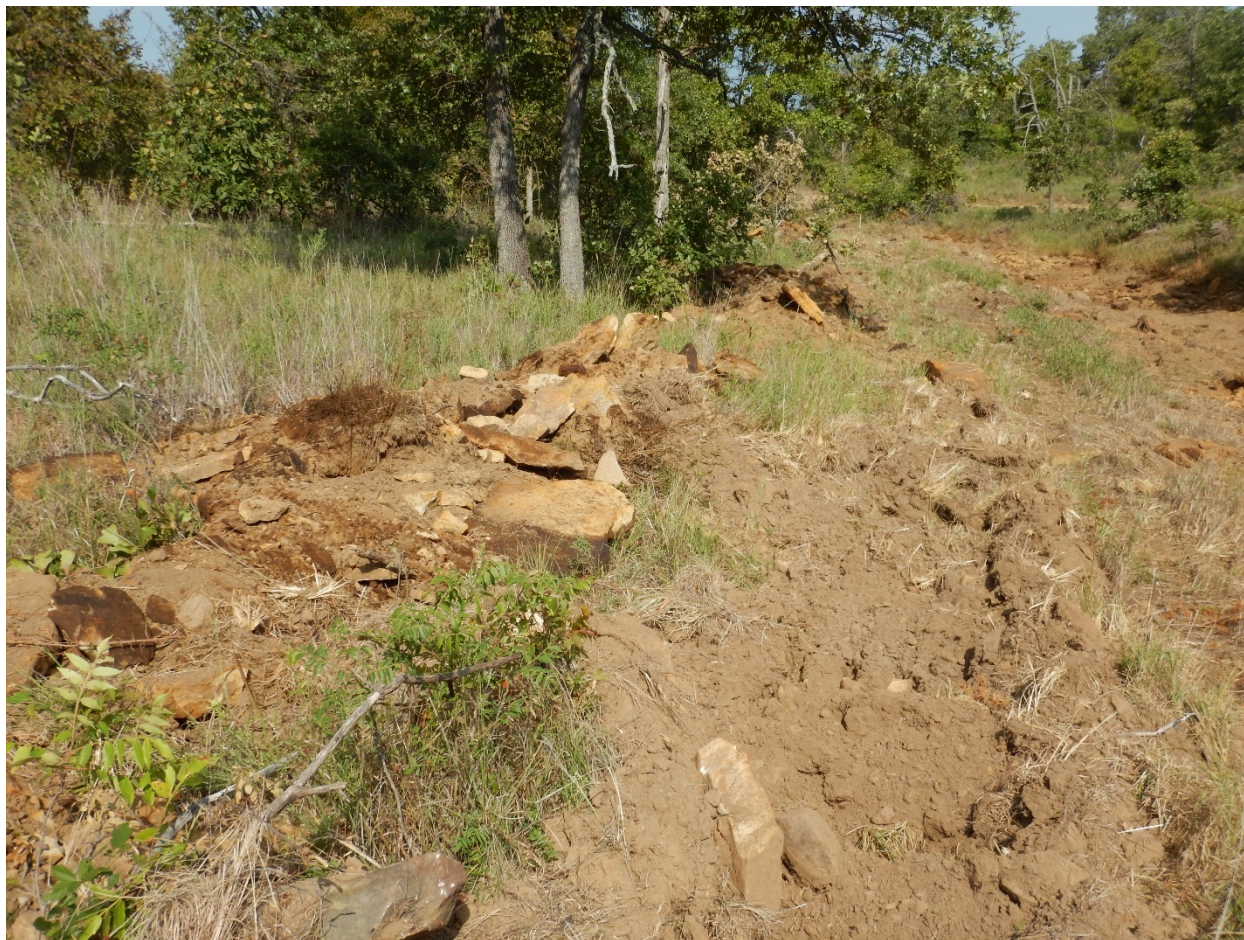
Photo No. 10

I observed a row of oil-stained rocks and soil which had been removed from the tributary and piled approximately 15 feet south of tributary. (See photo No. 10).

**Description:** This was a photo showing impacted soil and rocks which had been removed from the channel and banks of the impacted tributary. The soil and rocks were in a row approximately 15 feet south of the tributary.

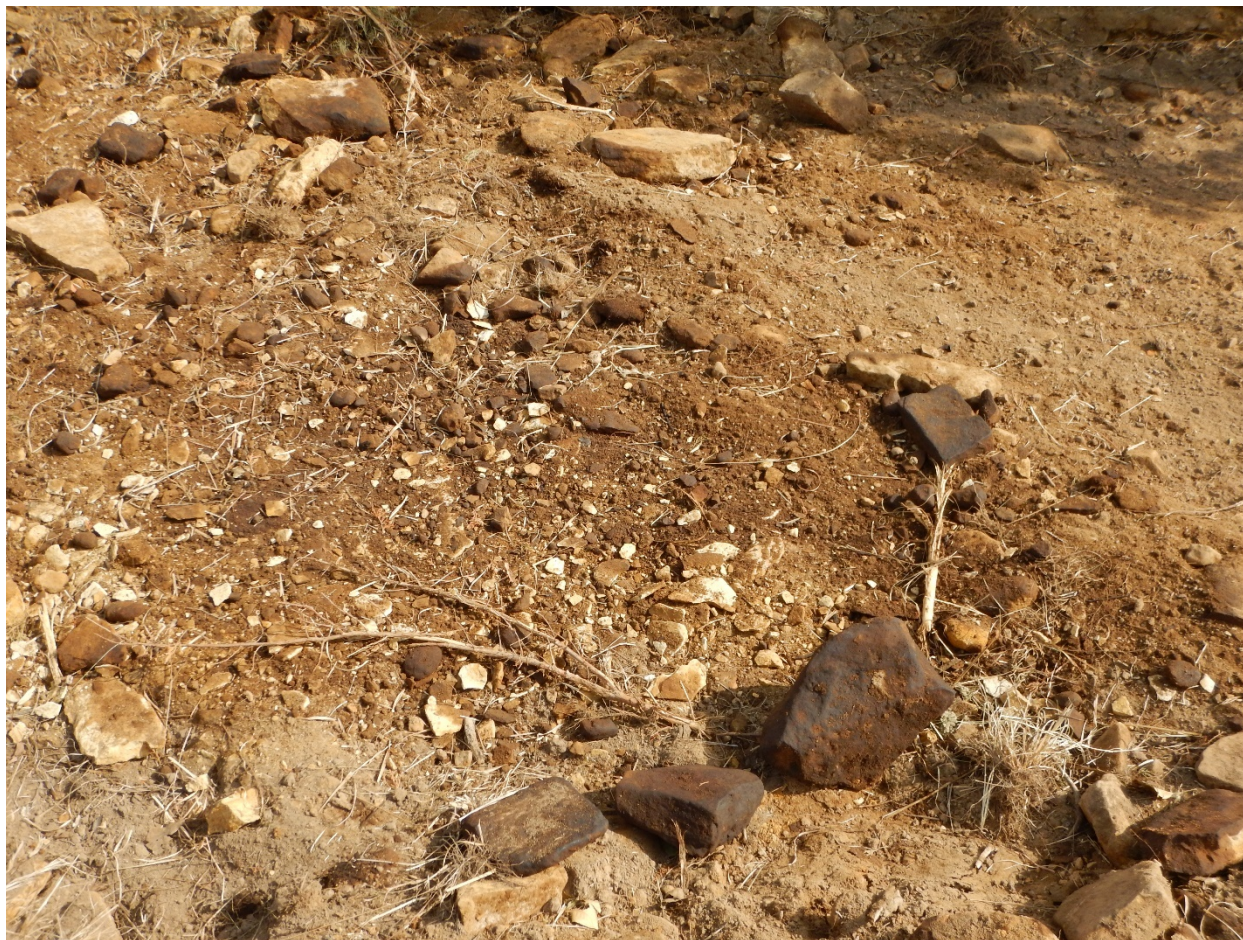
Photo No. 11

**Description:** This was a photo of oil impacted soil and rock in the main channel of the tributary.

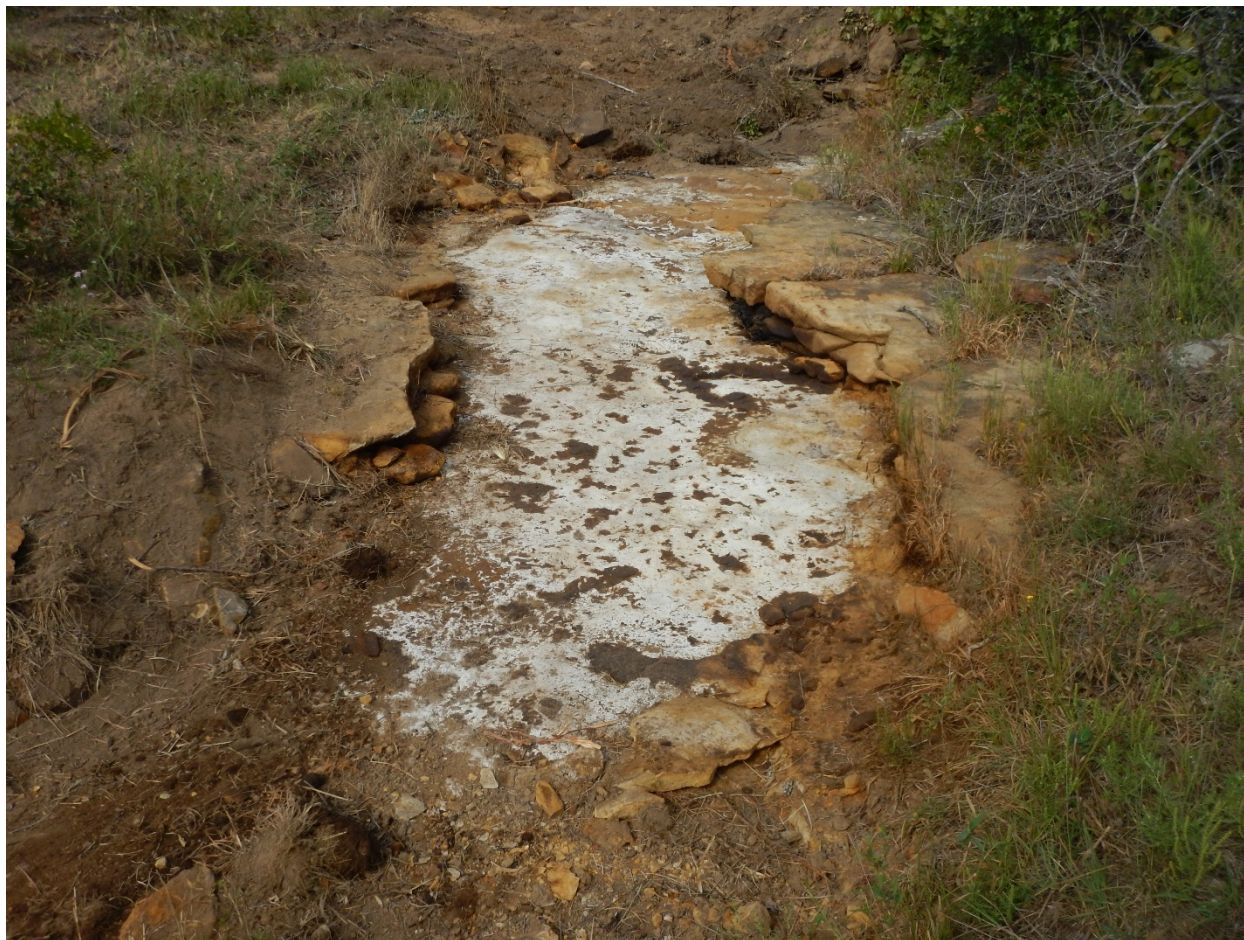
Photo No. 12

I observed a small section of the impacted tributary where oil staining and residual salt were present, evidence that flushing activities had not been conducted, or inadequate flushing had occurred. (Photos No. 12, 13, 15)

**Description:** This was an area of the impacted tributary which had not been impacted by the soil fill. This section of the tributary had not been flushed to remove residual brine and oil stains were still present along the channel.

There were multiple areas along the impacted tributary where oil staining and salt crystals present in the main channel indicated inadequate flushing operations to remove contamination from the impacted tributary. Additional clean up should occur to remove the residual salt and oil staining.

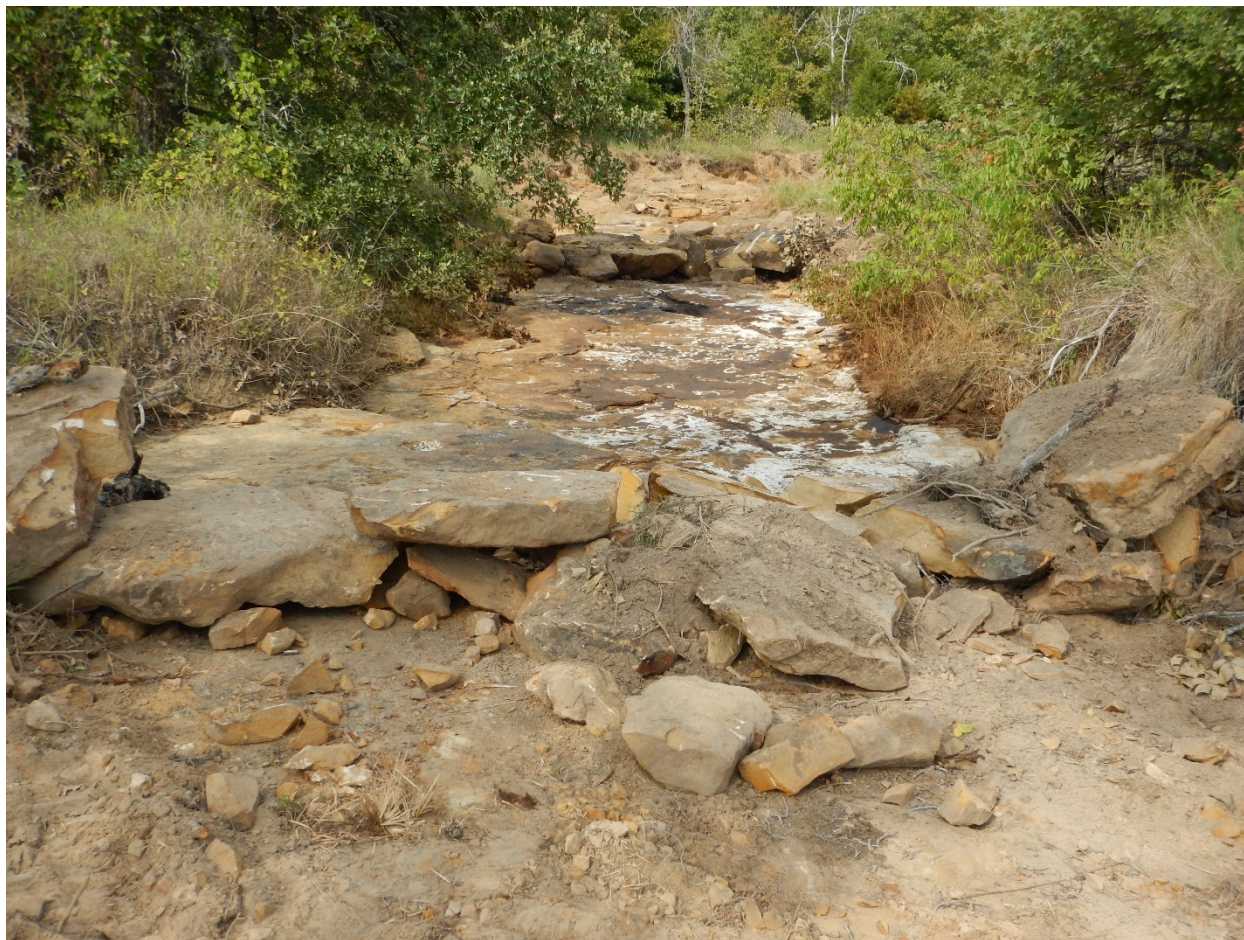
Photo No. 13

**Description:** This was a photo of 2 rows of rocks placed in/across the main channel of the impacted tributary. Oil stains and residual brine impacts were captured in the photo along the area between the two rows of rocks.

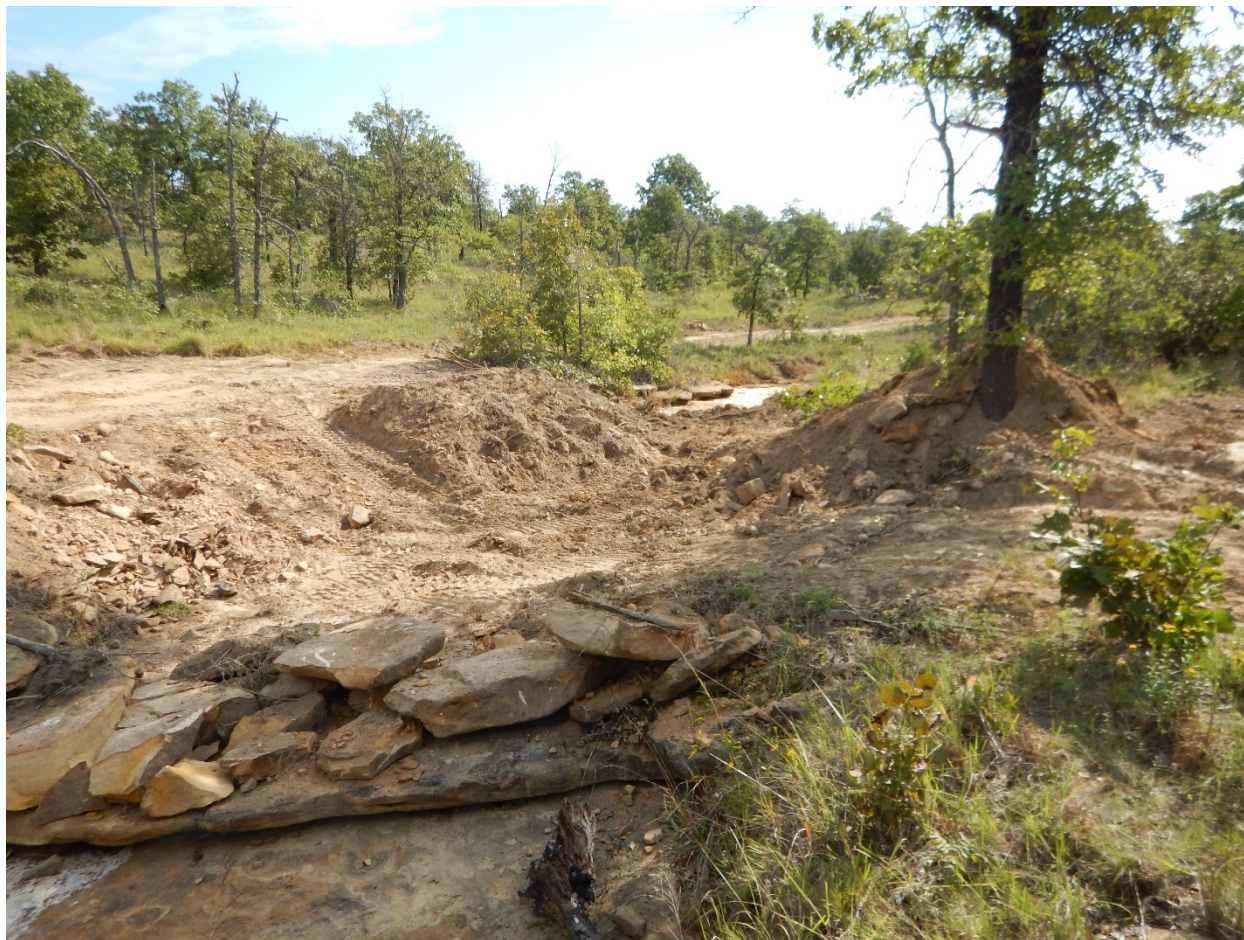
Photo No. 14

I observed the location of the most upstream temporary containment dam. At the time of the inspection, the dam had been partially removed, see photo No 14.

**Description:** This was the location of the most upstream temporary containment dam. The dam had been partially removed at the time of the inspection.

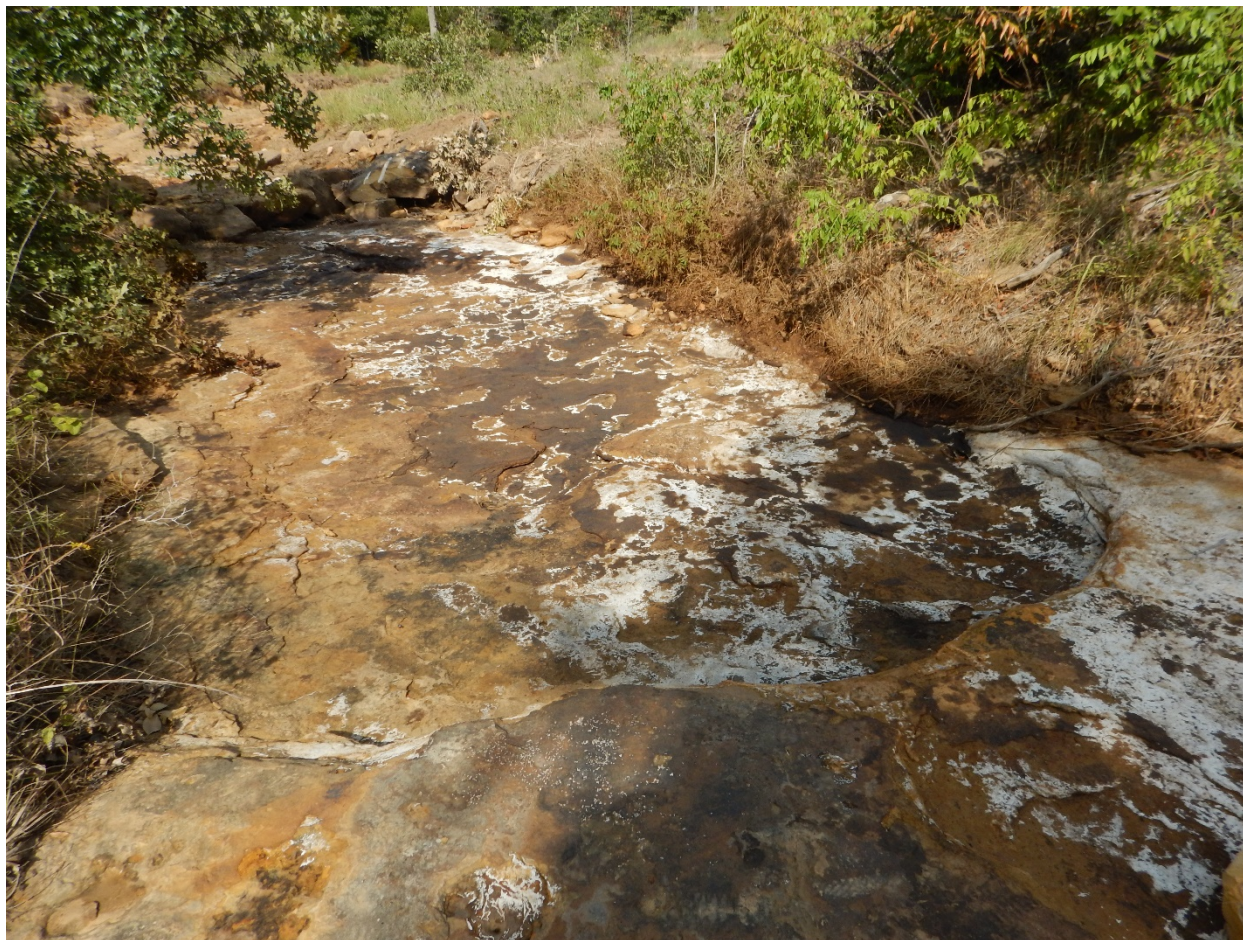
Photo No. 15

**Description:** This was a closeup view of the oil stains and residual brine impacts from photo No. 13.

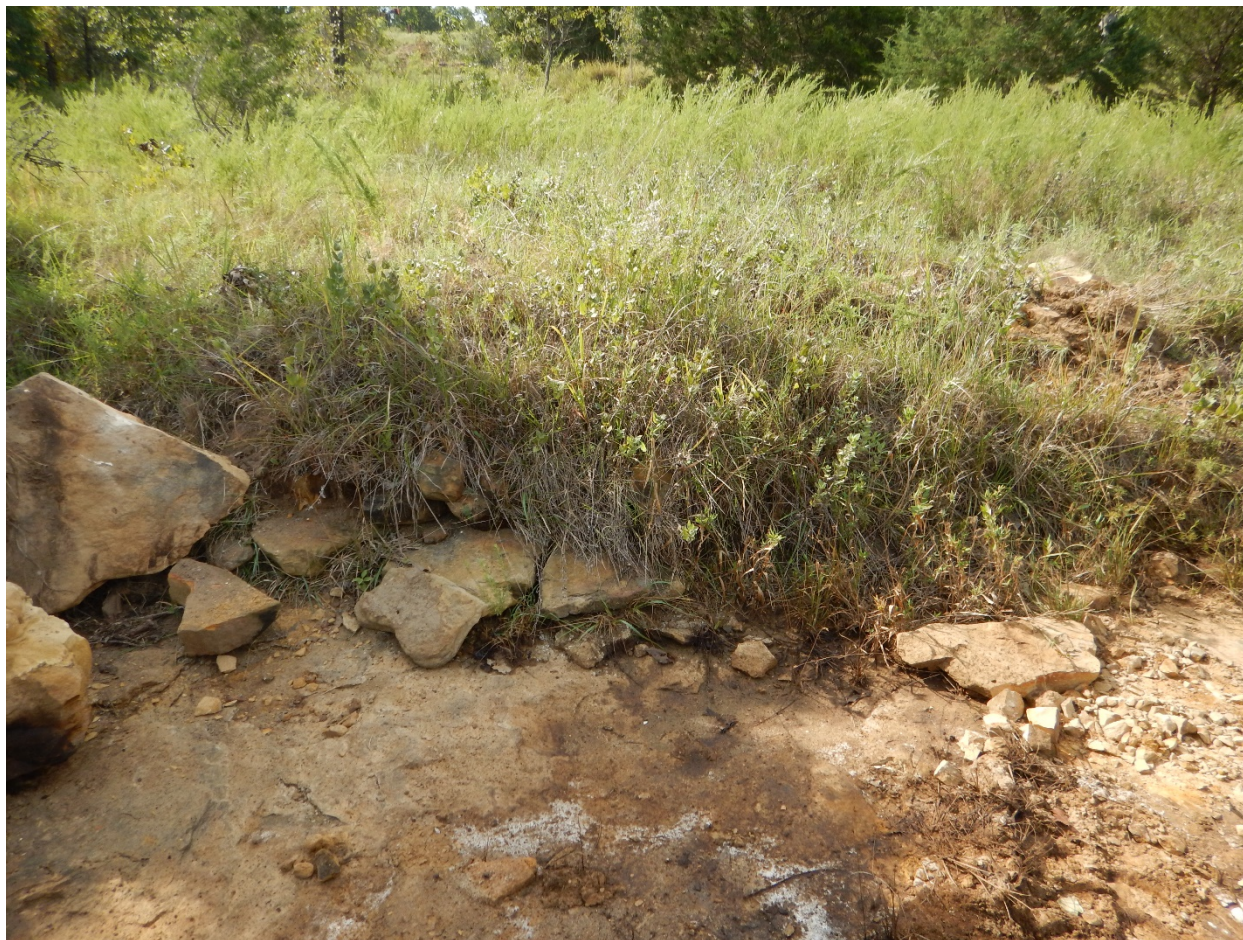
Photo No. 16

**Description:** This was an area along the impacted tributary where the banks had not been altered during cleanup activities.

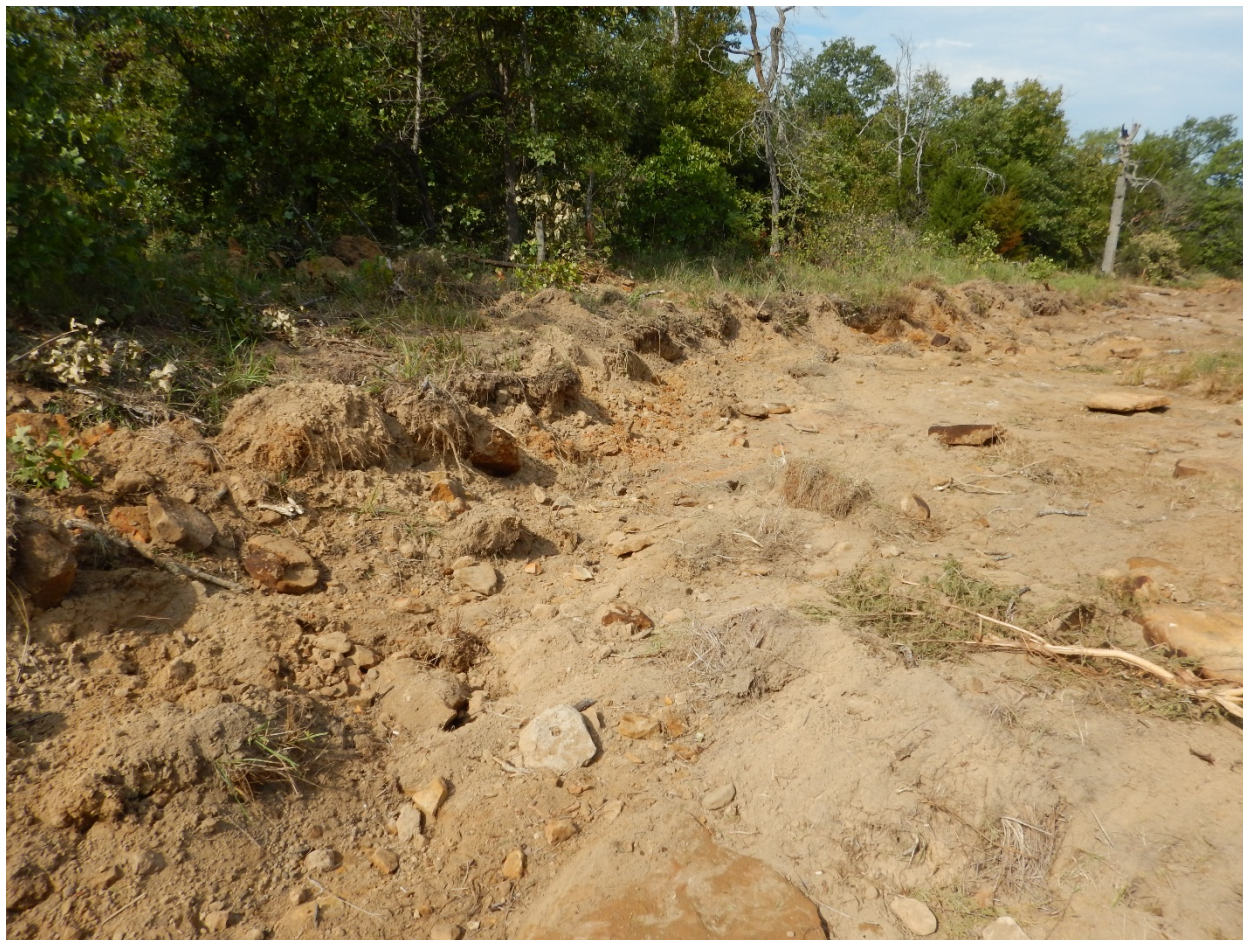
Photo No. 17

As the inspection continued downstream, I observed additional areas where the banks of the tributary were pulled into the main channel resulting in contaminated soil and rocks partially filling the channel. (Photos No. 17 and 18).

**Description:** This was an area where the banks of the tributary had been pulled into the main channel.

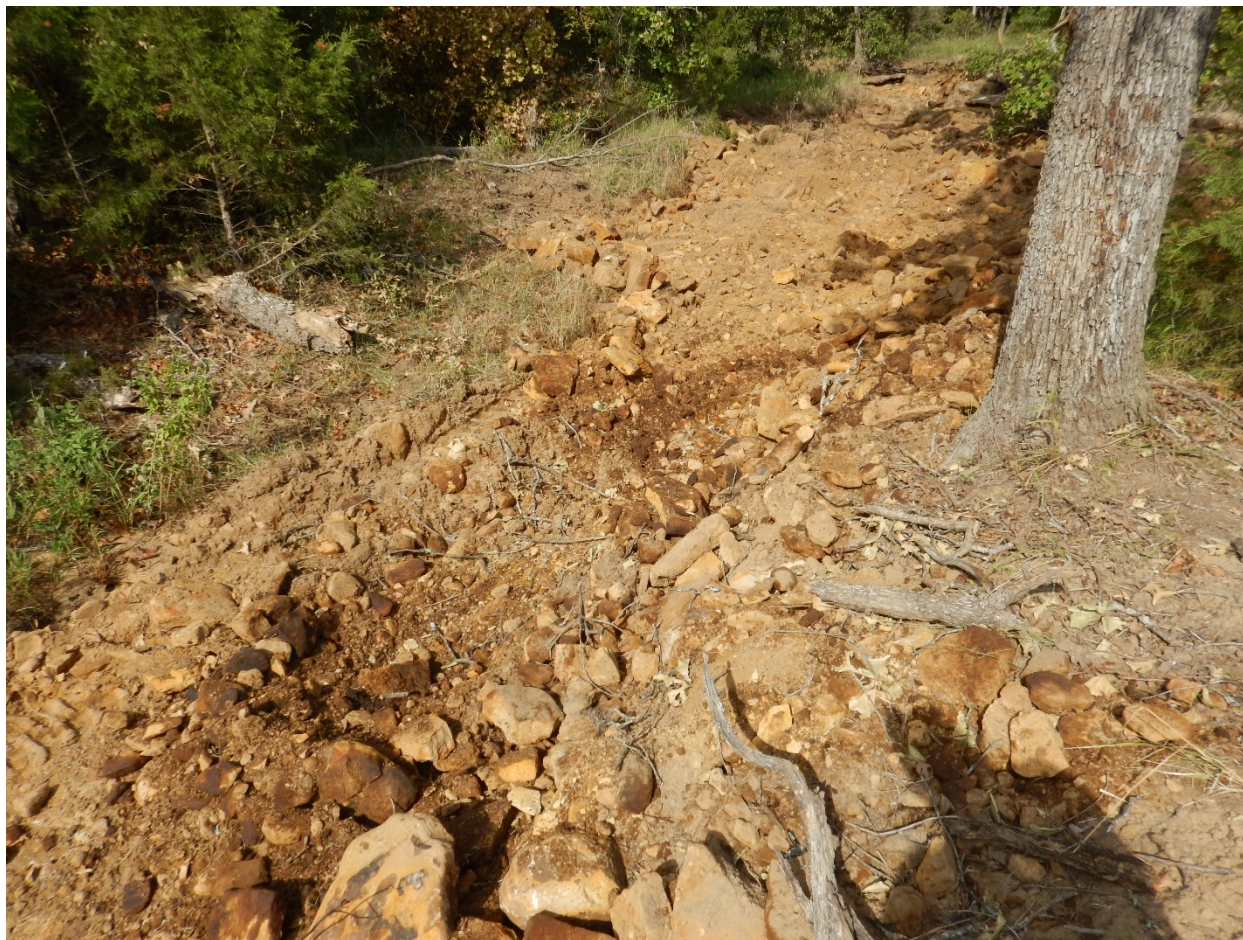
Photo No. 18

**Description:** This was a photo of oil-stained rocks and soil filling the bed of the impacted tributary.
