## Region 6 - Enforcement & Compliance Assurance Division

### INSPECTION REPORT

| Company Name: | Northcote Cleveland LLC | |
| Facility Name: | Osage B Lease | |

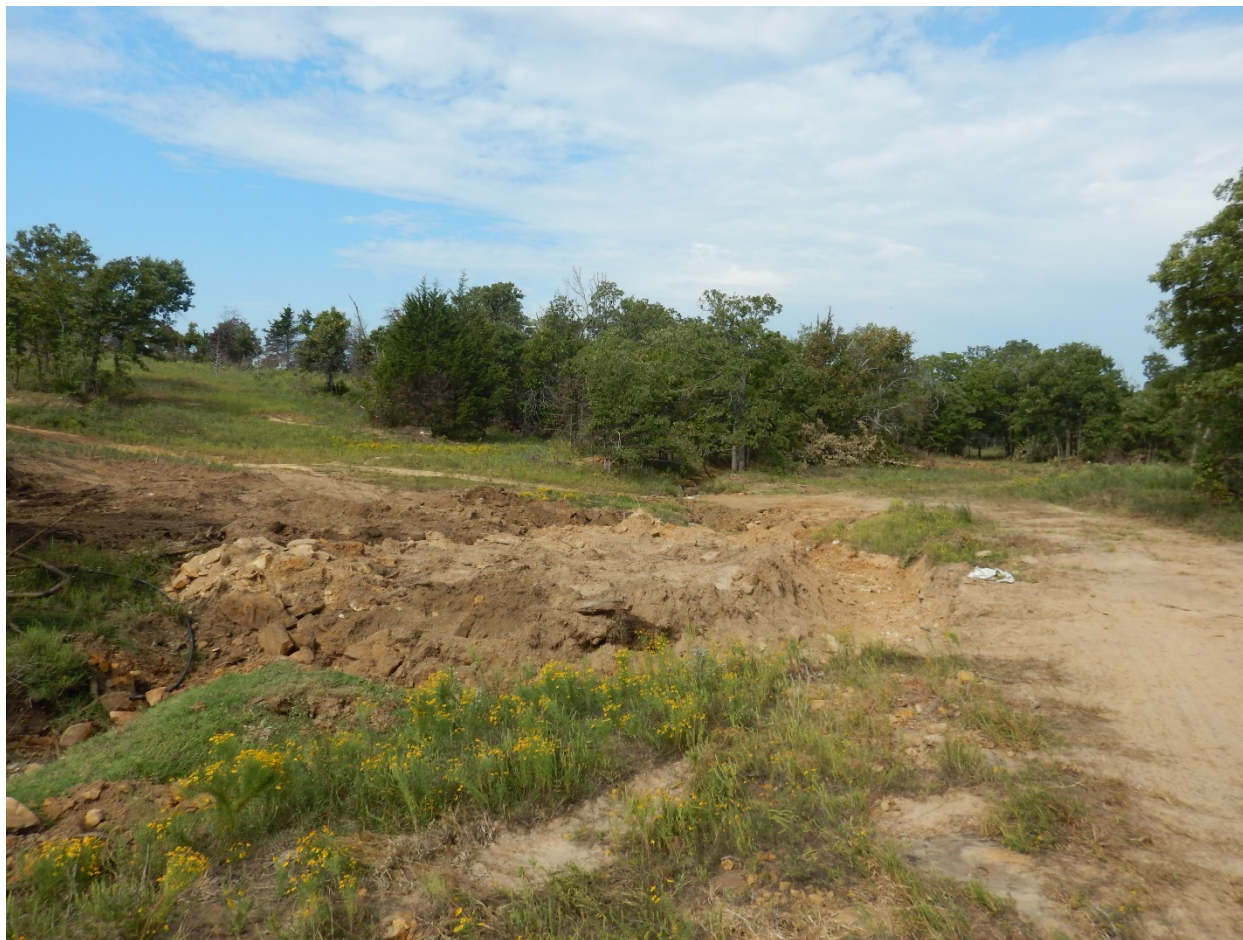
Photo No. 19

I observed two areas where the original main channel of the tributary had been filled in and a new channel had been dug. See photos No. 19 and No. 20 for additional description and location information.

**Description:** This was an area where the stream had been filled with dirt and a new channel was dug along the north edge of the fill. The main channel was moved to the north by the operator to provide better access to a nearby oil well location.

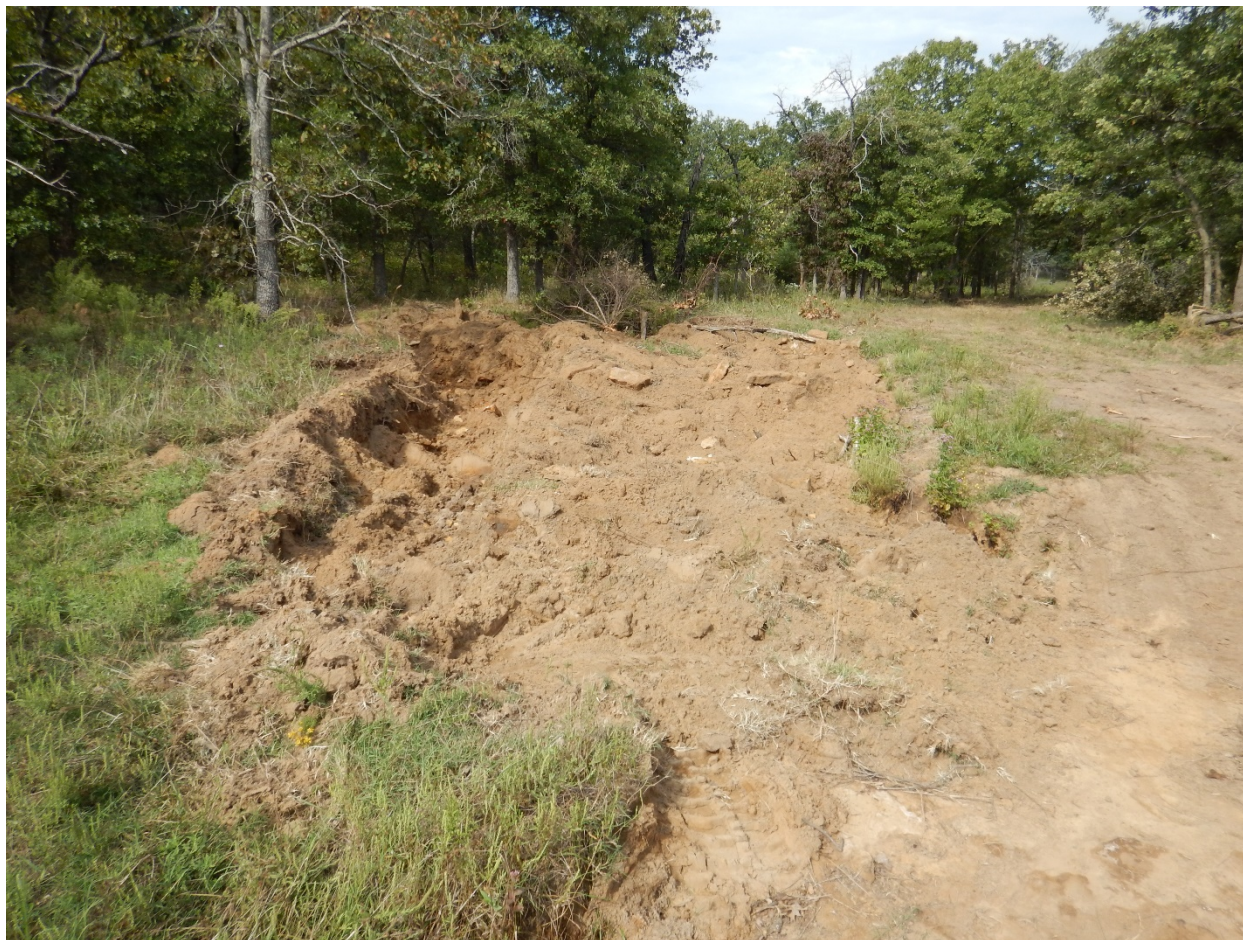
Photo No. 20

**Description:** This was an area along a sharp bend in the tributary where the original oil and brine impacted channel was buried and a new channel was dug approximately 10 feet from the original channel.

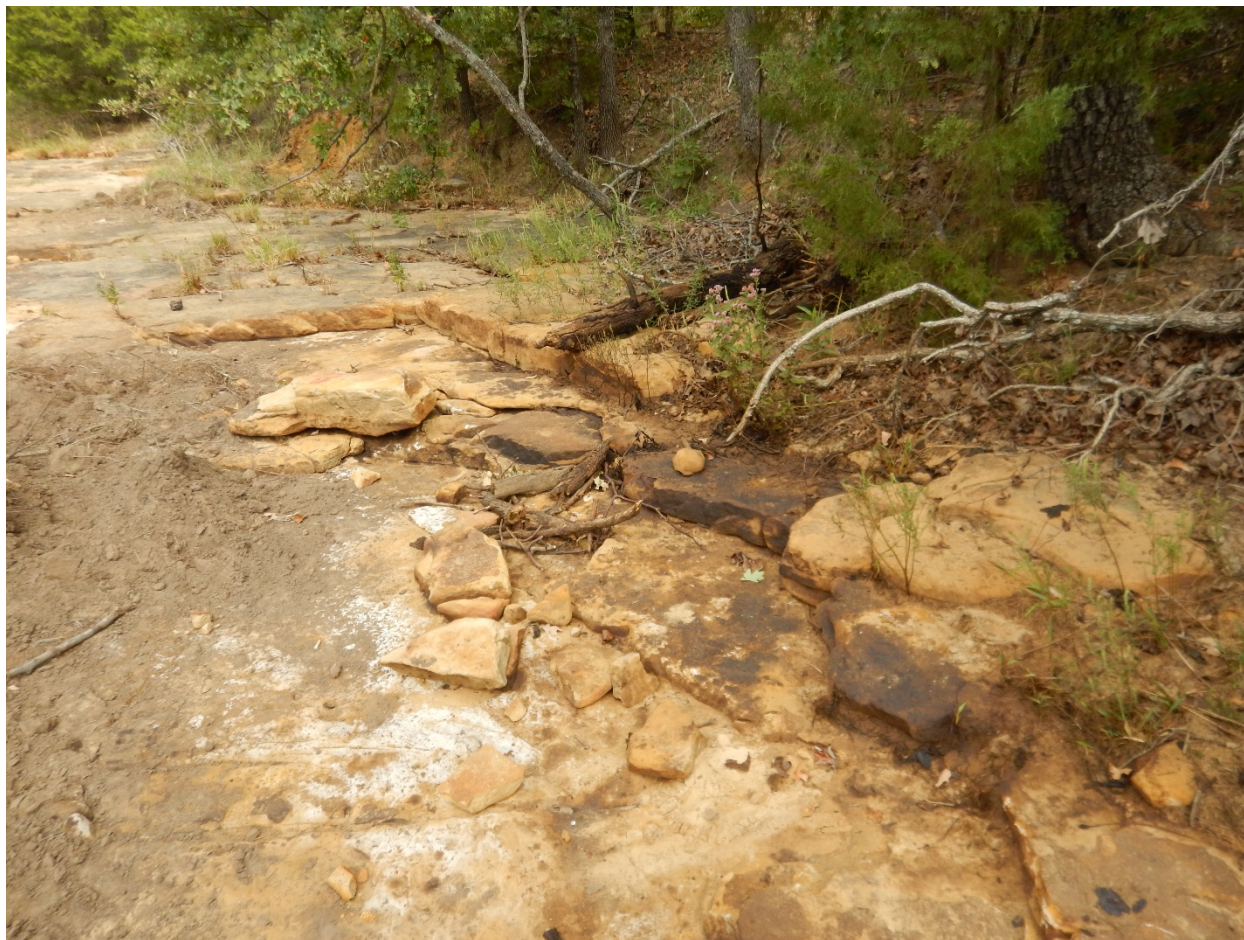
Photo No. 21

I observed multiple locations where soil was dug from the banks of the tributary and placed in the bed of the tributary to cover oil-stained areas. Evidence of these observations can be seen in photos No. 21, 22, 23, 24, 25, 26, and 27.

**Description:** This was an area where oil-stained rocks were still present in the channel. Dirt had been removed from the south bank of the tributary and placed in the channel to cover additional oil staining on the rock bed of the tributary.

Much of the tributary was “filled” with soil and rocks which was pulled in from the banks. Some of this fill material itself was contaminated with oil and brine. The fill material is covering areas where residual salt and oil are still present in the main channel of the tributary. The fill material should be removed from the main channel, and the residual salt and oil stains should be removed from the impacted tributary.

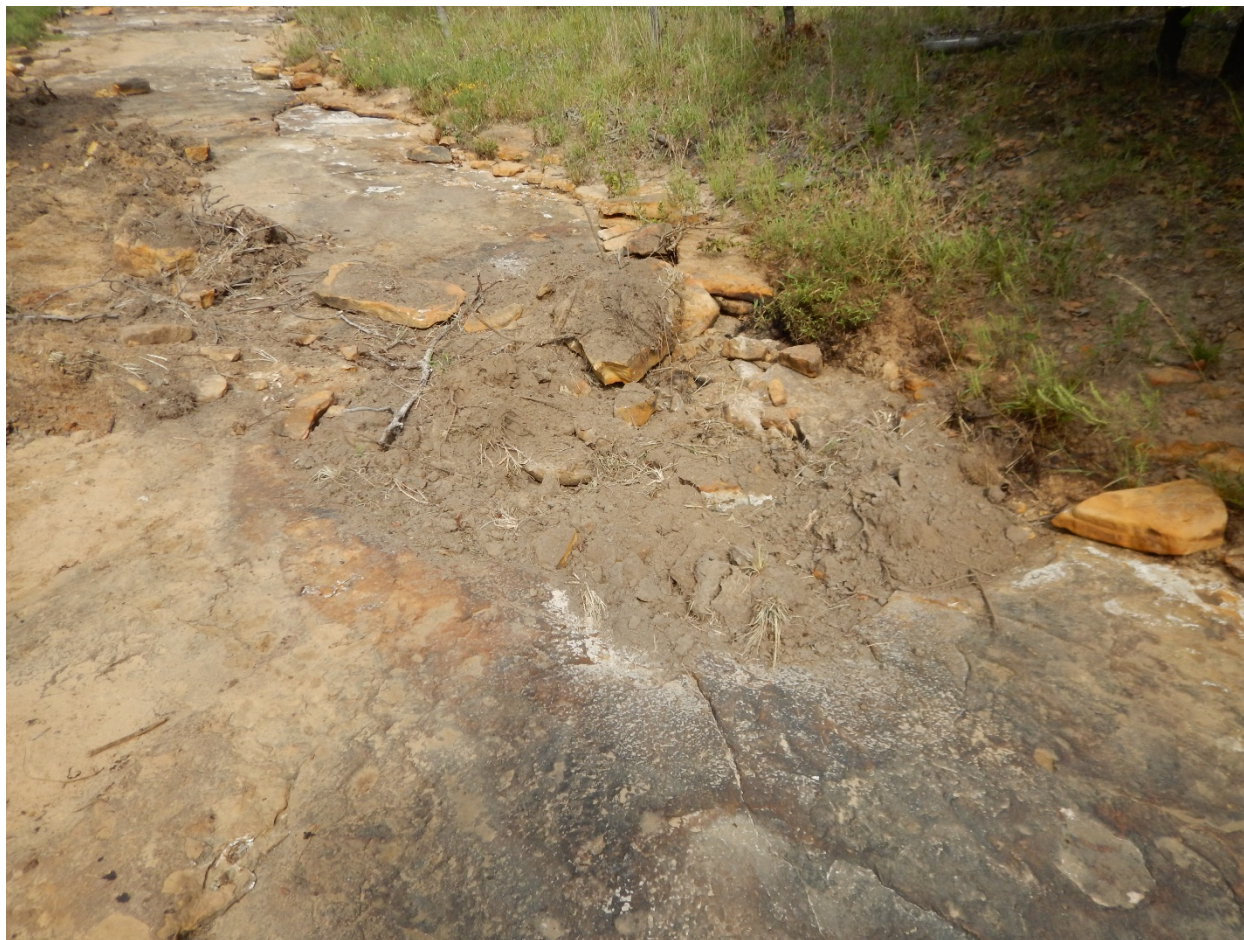
Photo No. 22

**Description:** This was an area where dirt was removed from the bank of the tributary and placed in the bed of the tributary to cover oil-stained rock.

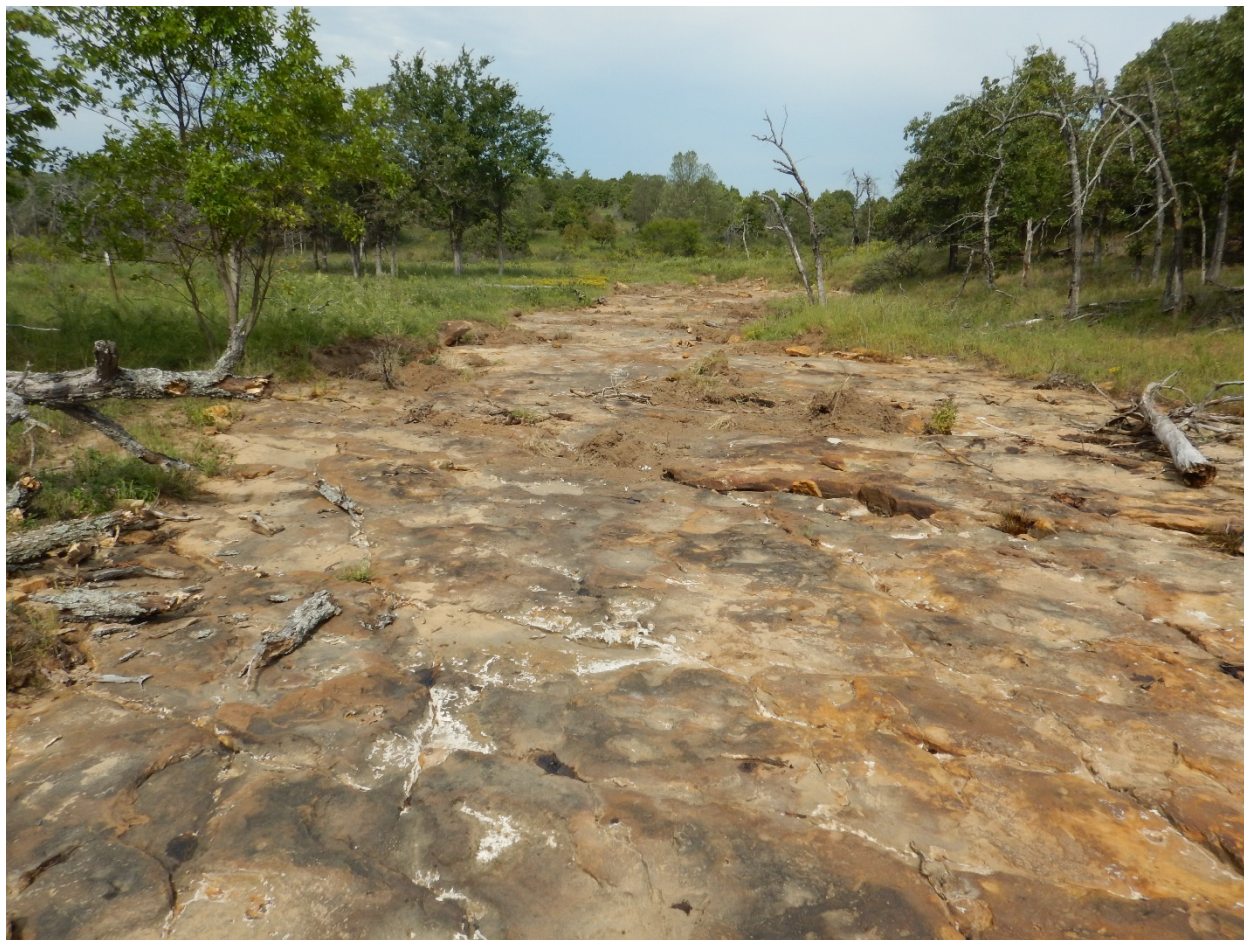
Photo No. 23

**Description:** This was an overview of an area where dirt was removed from the banks and placed in the bed to cover oil stains.

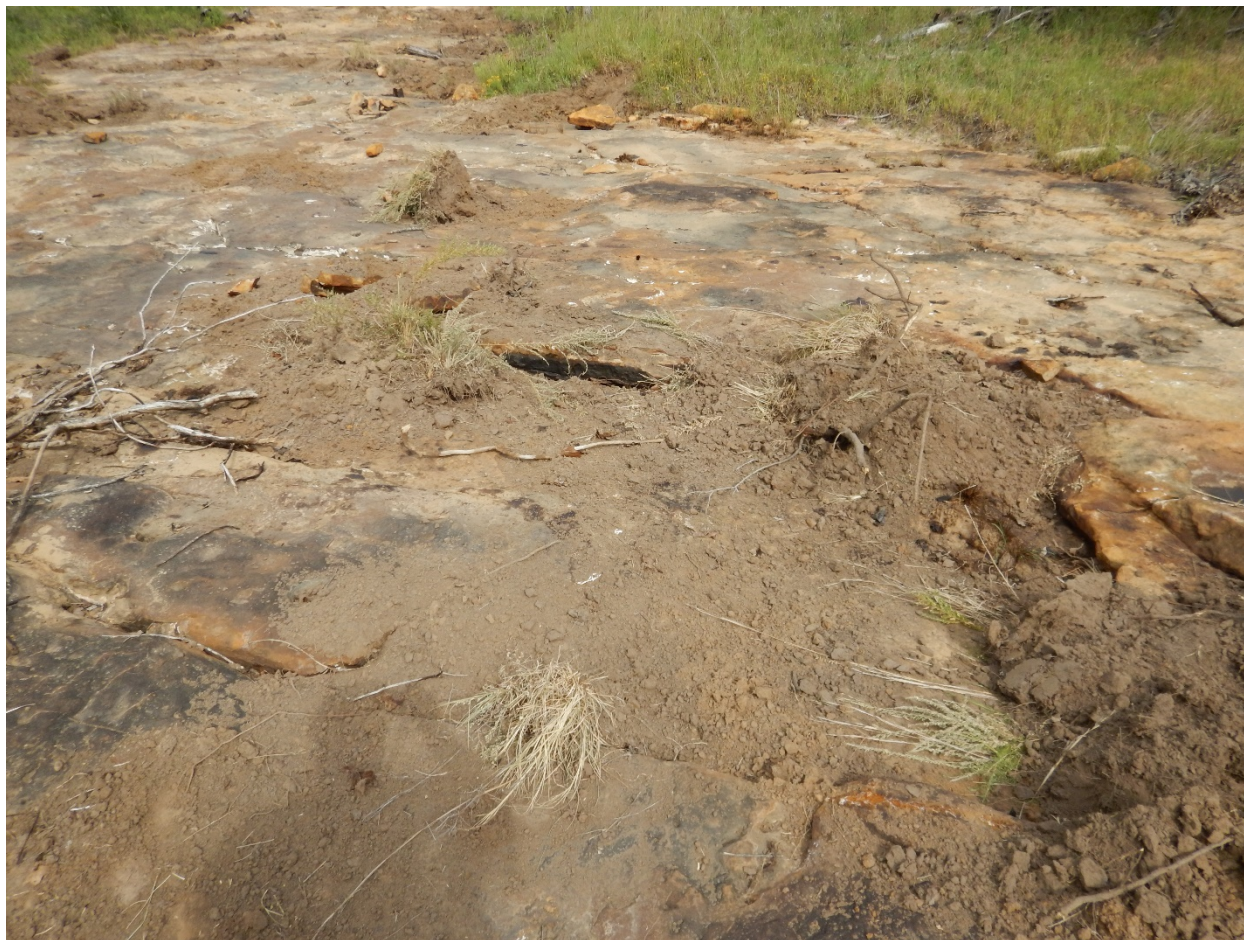
Photo No. 24

**Description:** This was a closeup view of the dirt covering oil stains along the bed of the tributary.

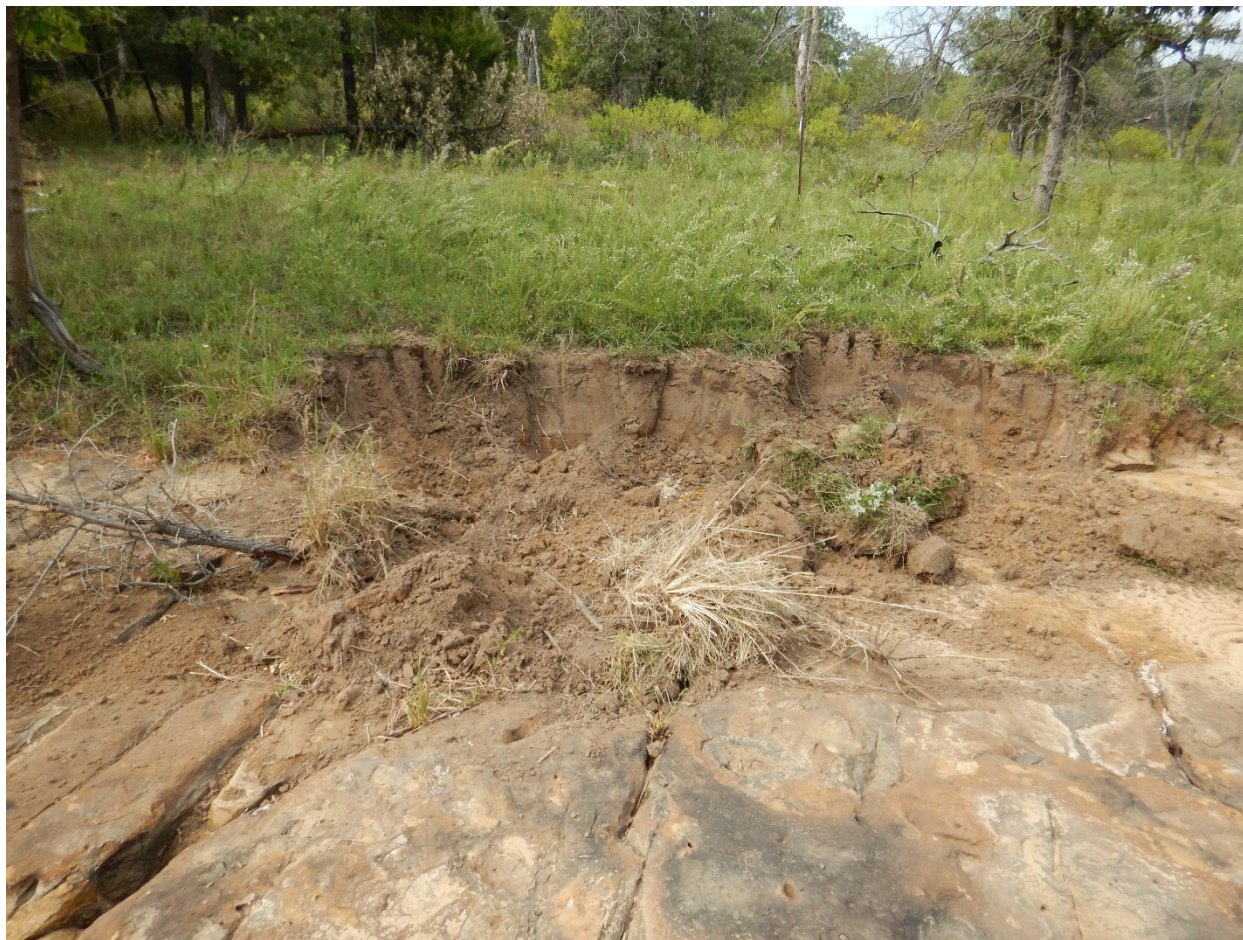
**Description:** This is a portion of the bank where dirt was removed, then placed into the tributary bed to cover the remaining oil stains.

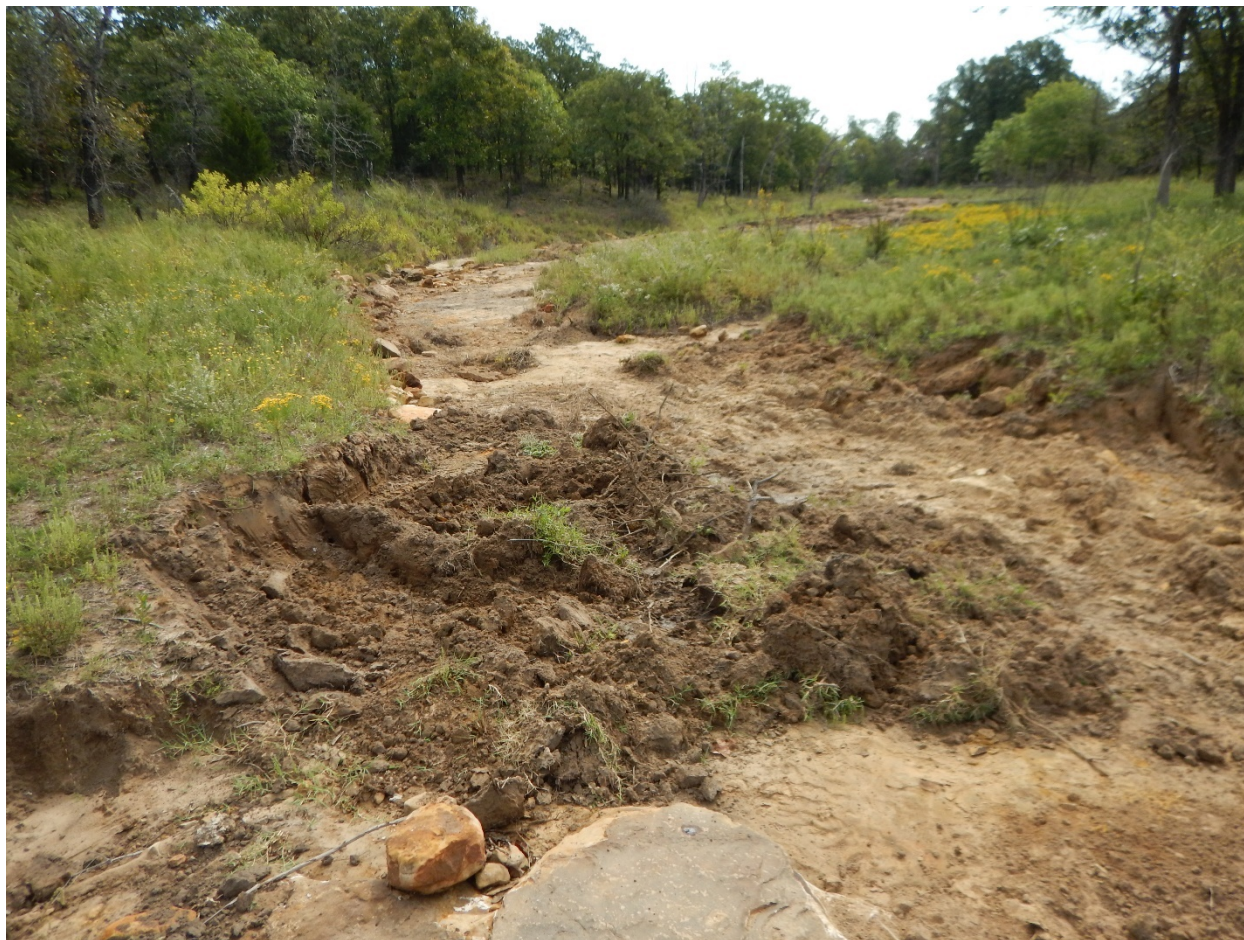
**Description:** This was an area where dirt was pulled from the banks and placed in the bed to cover the oil-stained bed of the tributary.

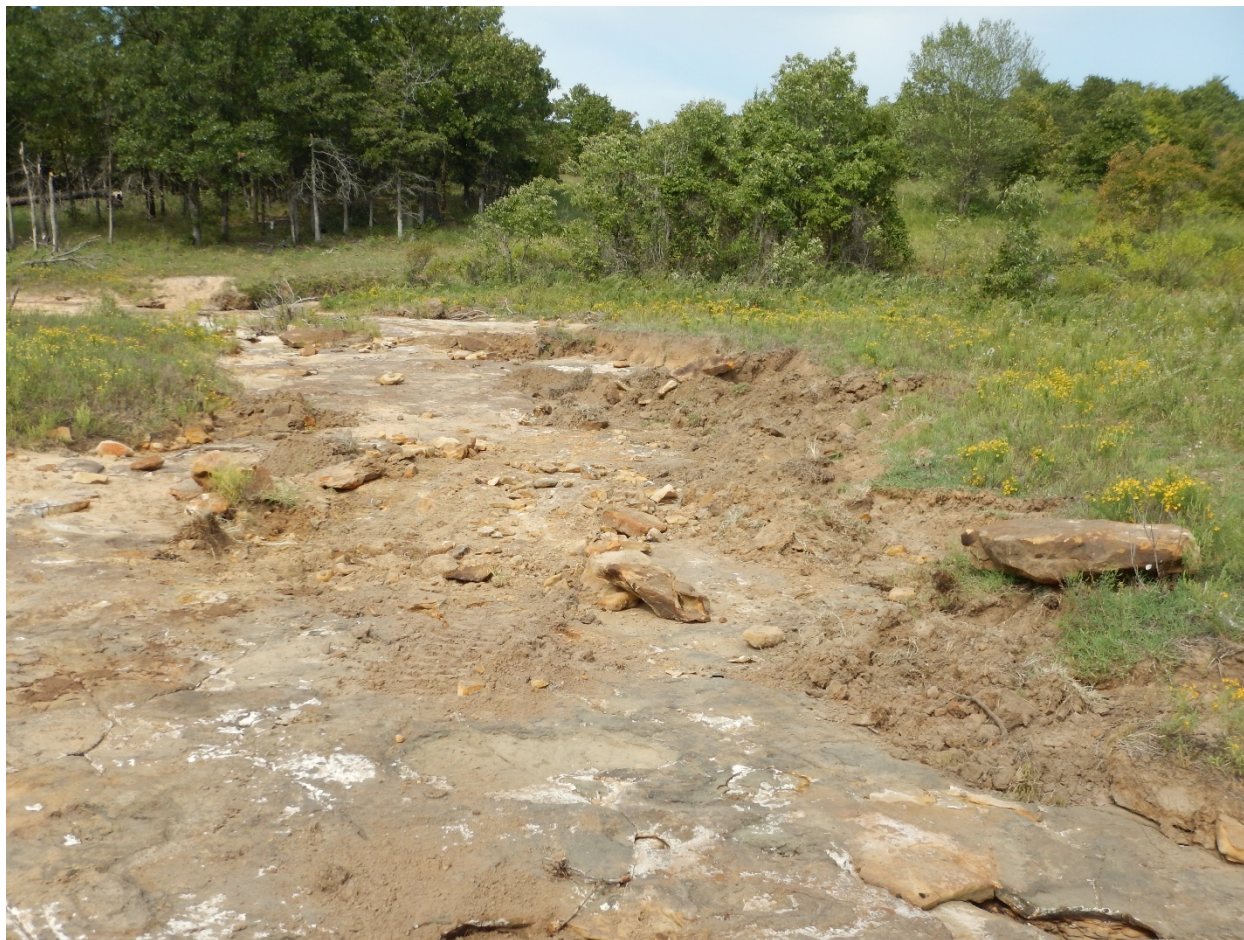
**Description:** This was a photo where soil was removed from the banks and placed in the bed to cover oil staining.

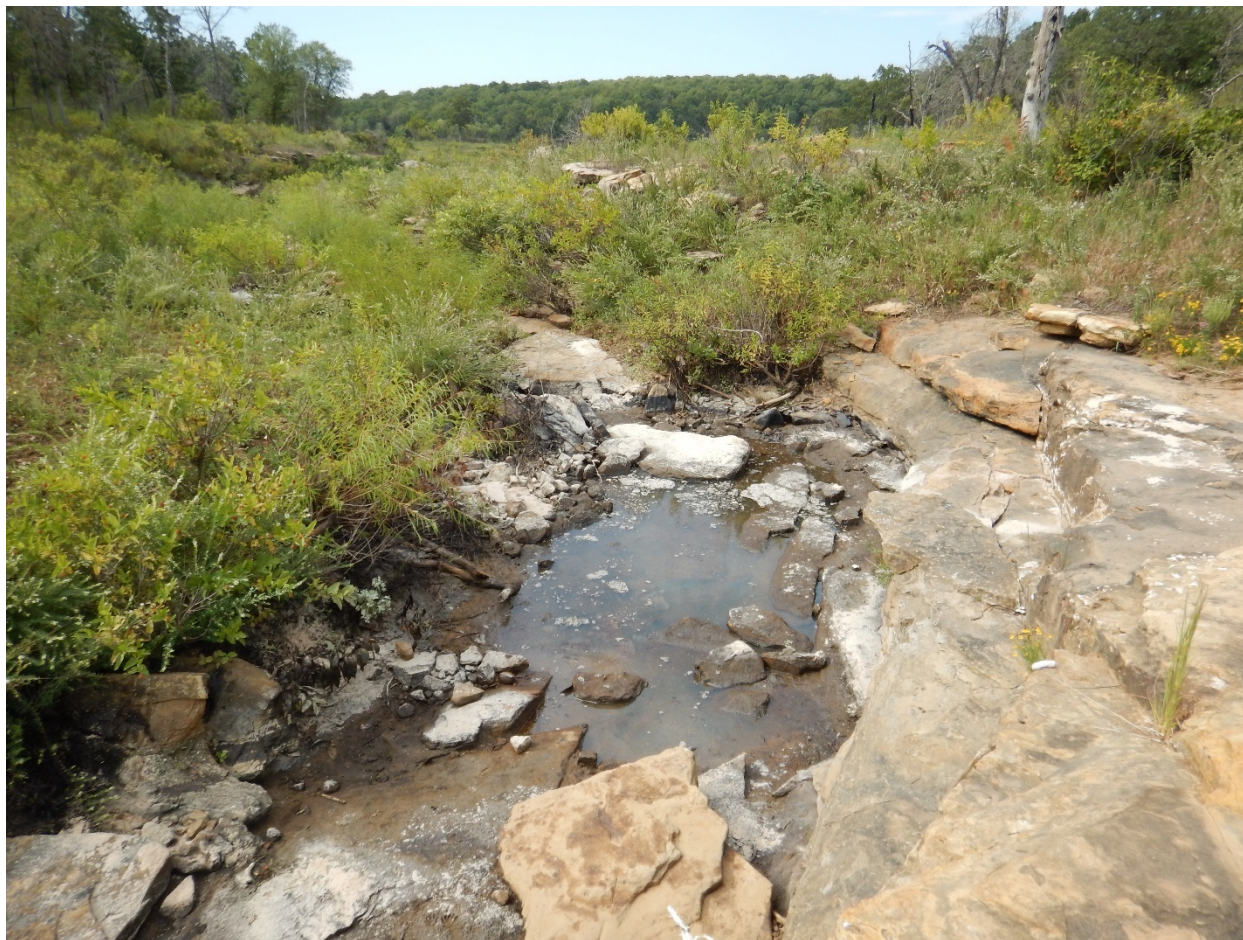
I observed a final area along the impacted tributary where “clean B” industrial absorbent had been applied to oil and oil stains at the final pool of water along the tributary. See photo No. 28.

**Description:** This was an area along the impacted tributary where "clean B" industrial absorbent had been applied to oil and oil stains.

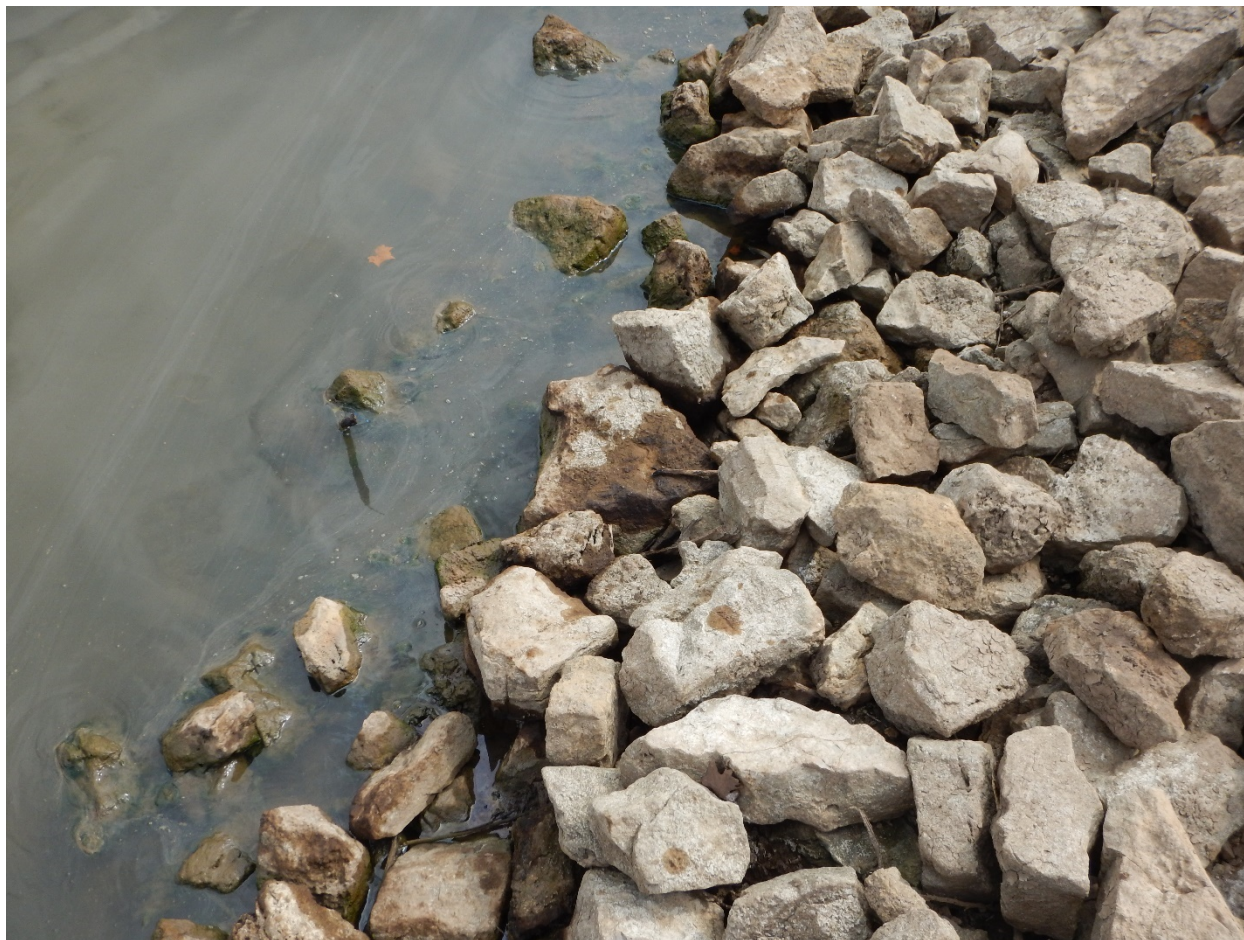
I observed oil-stained rocks along the base of New Prue Road as the road crossed Mud Creek/Keystone Lake. There was much less staining present than during the previous two inspections. I did observe a film on the water, but it was not oil sheen. See photo’s No. 29, 30, and 31.

**Description:** This was the "rip rap" along New Prue Road, there was some oil staining present on the rocks but much less staining than during the two previous inspections. The film on the water was not oil sheen, when disturbed, the film remained fractured, evidence that it was not oil.

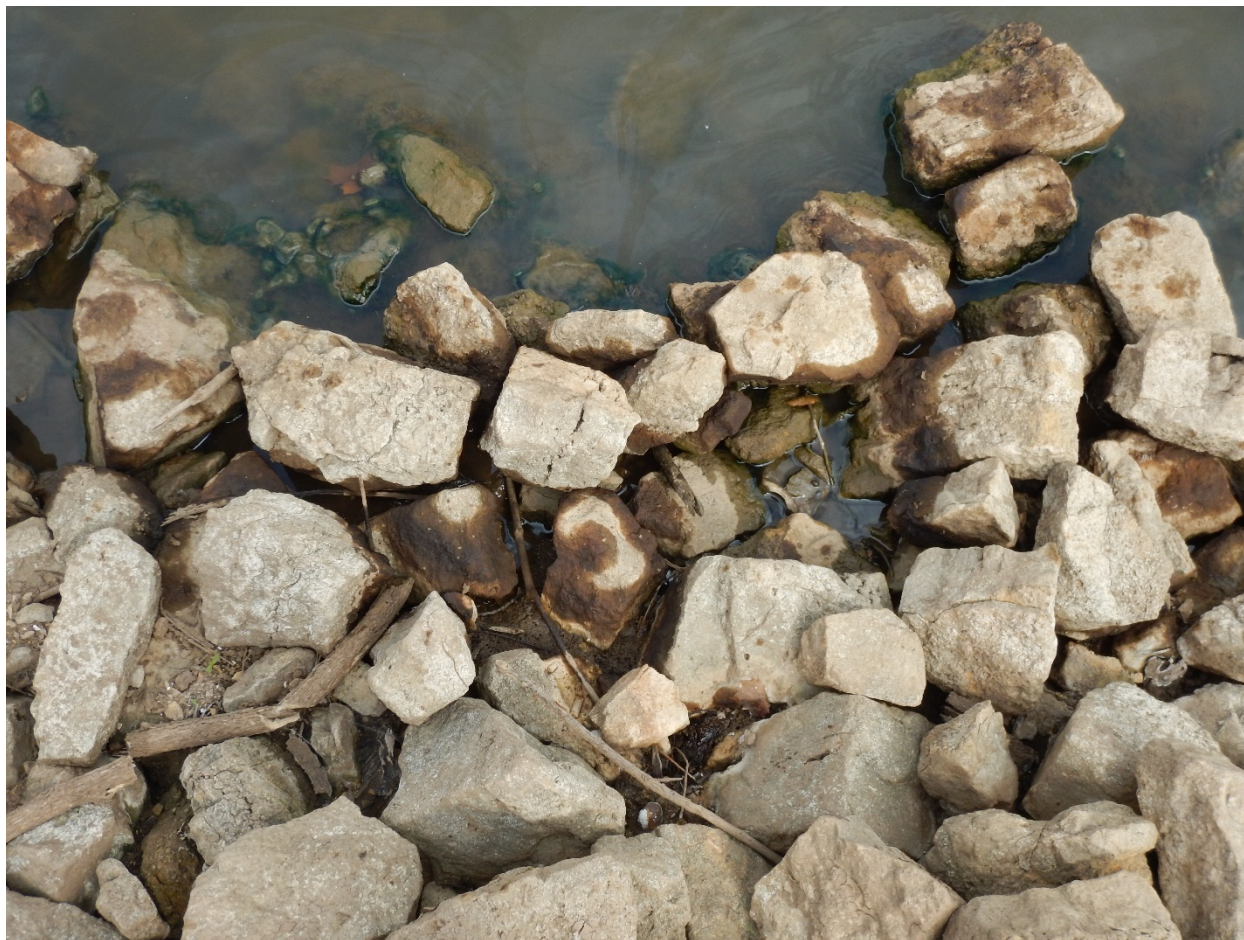
**Description:** This was oil-stained rip rap along New Prue Road.

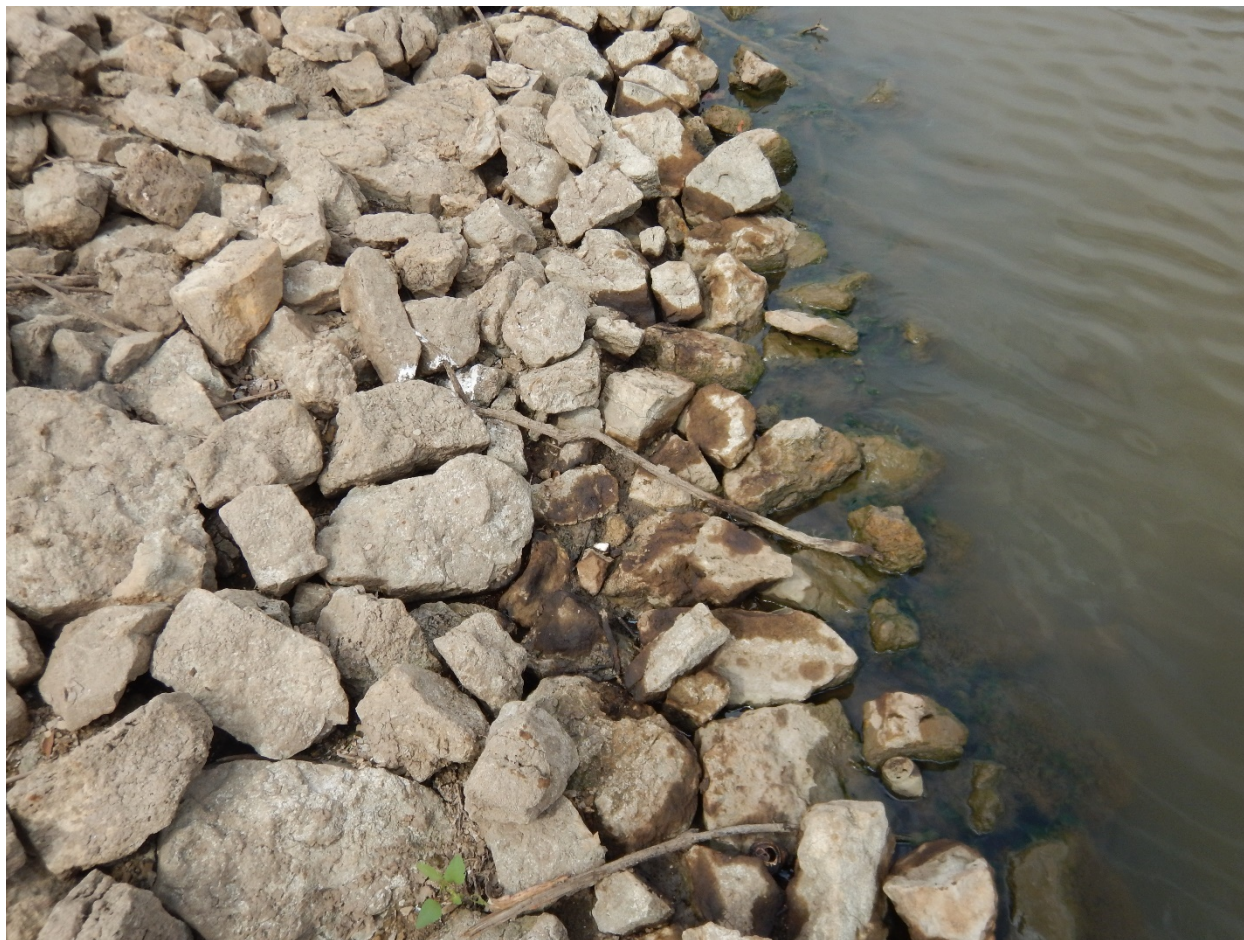
**Description:** This was oil-stained rocks along the base of New Prue Road.

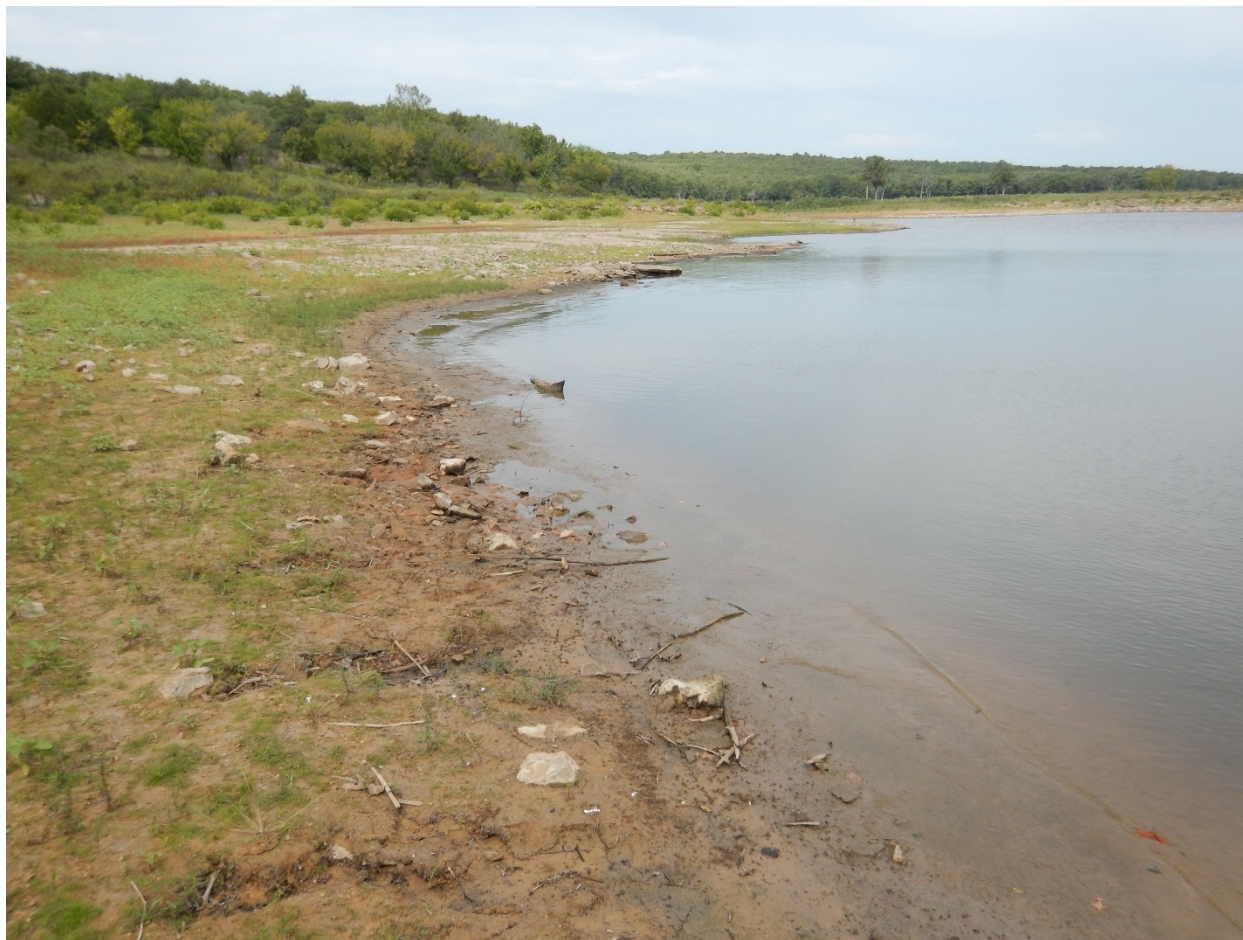
I observed a large section of shoreline along Mud Creek/Keystone Lake which had previously been impacted with oil and oil-staining. At the time of the inspection, the area was clean with no evidence of oil or oil stains. See photo No. 32.

**Description:** This was an area of shoreline which had obvious oil and oil staining during previous inspections. At the time of this inspection, the area was clean and free of oil and oil stains.
