**Region 6 Compliance Assurance and Enforcement Division**  
**INSPECTION REPORT**

| Media: | Water | | |
| Regulatory Program(s) | NPDES | | |
| Identification/Permit Number: | LAU000476 | | |

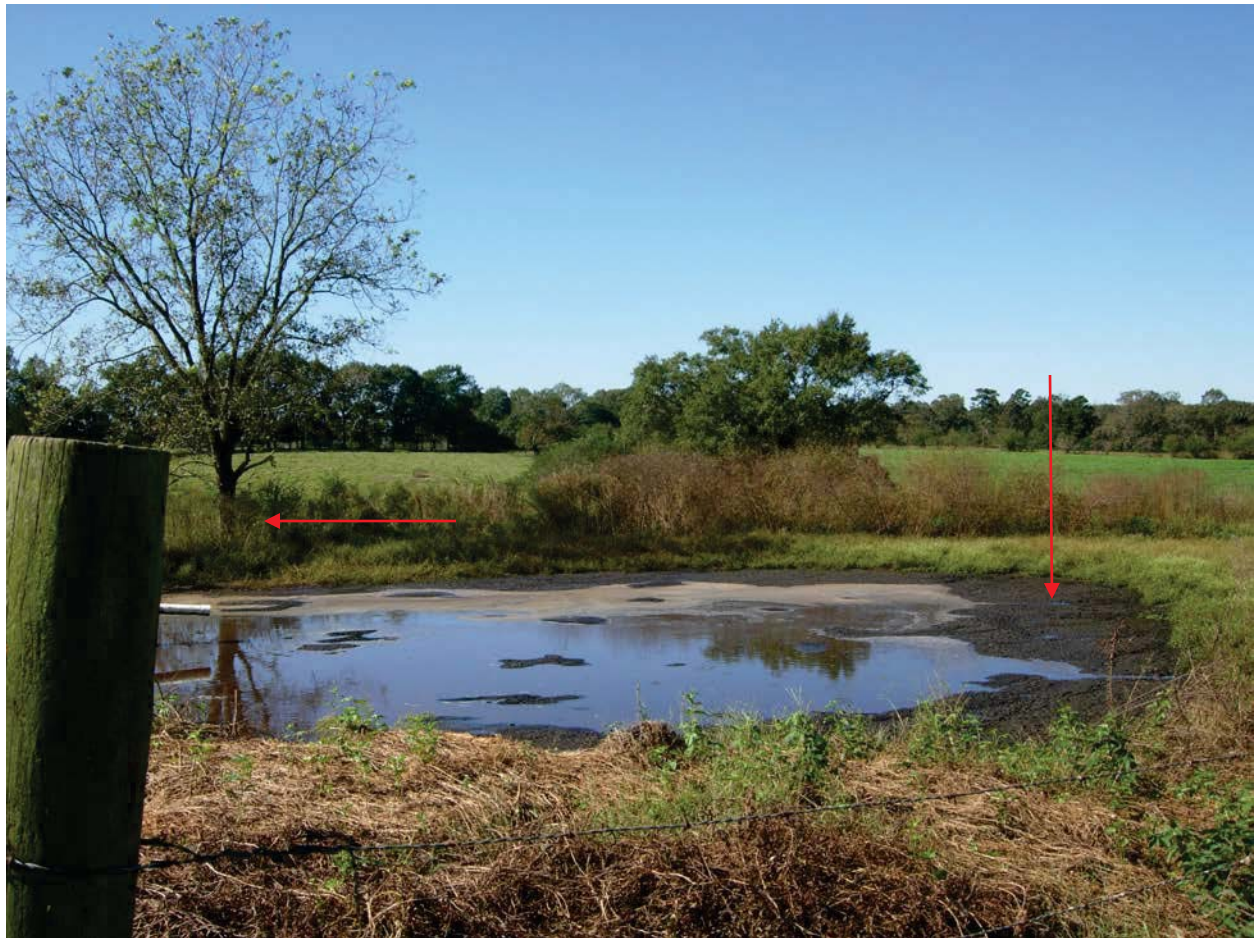
Photo No. 1

At the time of the inspection, [REDACTED] had one Retention Control Structure (RCS). We observed that this RCS had a substantial buildup of solids, trees rooted within the embankment, and nutria holes within the berms.

- The RCS had a substantial buildup of solids, trees rooted within the embankment, and nutria holes within the berms. At the time of the inspection, we observed no seepage or overflow from the lagoon, however, the above factors often contribute to the development of a lagoon seep and/or overflow.

Description: Photo taken facing south-southwest across the RCS. Note the buildup of solids and tree rooted within the RCS berm.

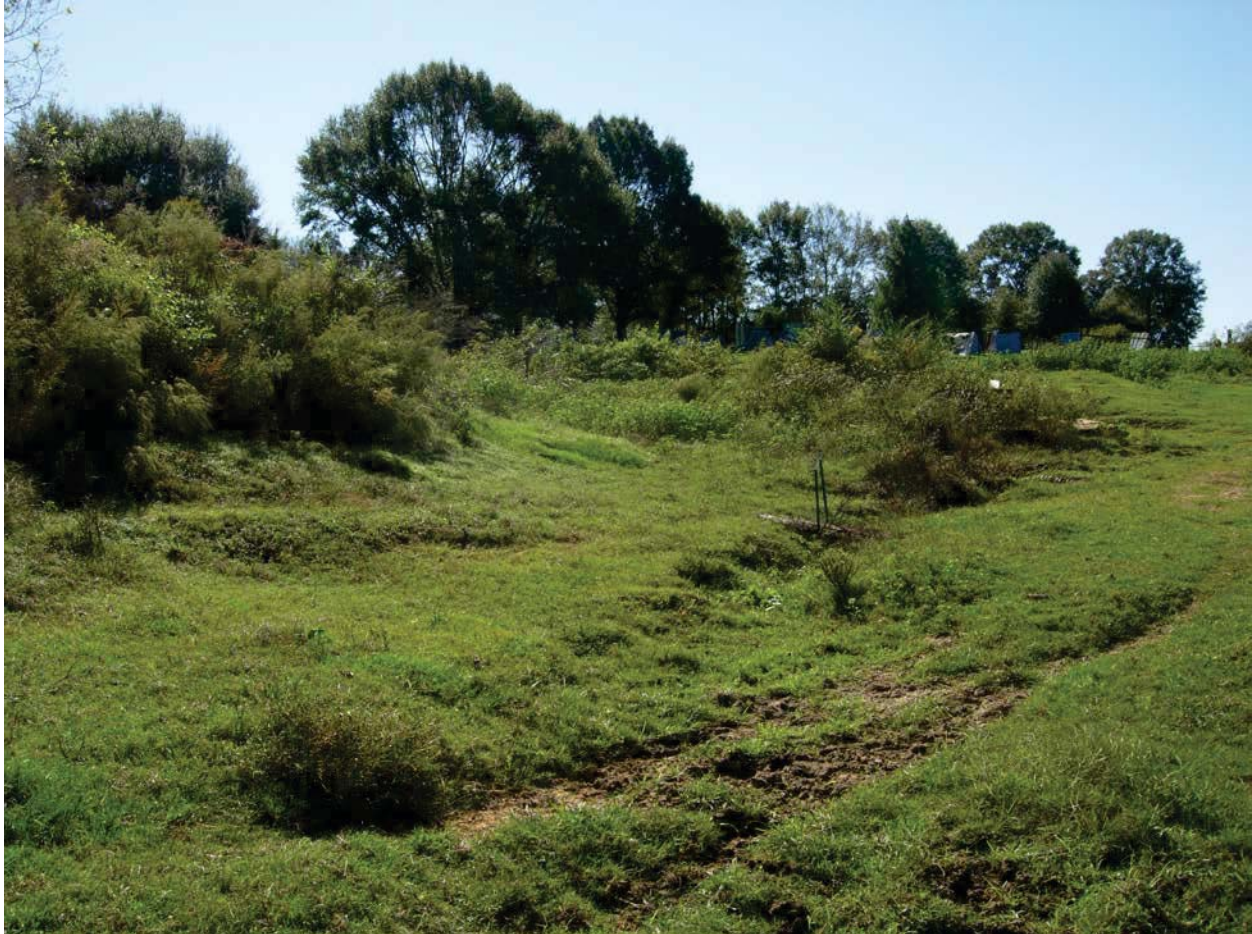
Photo No. 2

Description: Photo taken facing south toward northern berm of the RCS. Note the drainageway which would likely receive wastewater in the event of a lagoon overflow.
