**INSPECTION REPORT**

<b>Inspection Date:</b>	3/22/22	Inspection Announced: No
<b>Time:</b>	Entry: 8:50 AM (EST)	Exit: 11:55 AM (EST)
<b>Media:</b>	Water	
<b>Statute (s)/Program(s):</b>	Clean Water Act, National Pollutant Discharge Elimination System (NPDES), Industrial	
<b>Type of inspection:</b>	CEI - Compliance Evaluation Inspection	
<b>Access:</b>	Granted	
<b>Permittee Name:</b> Louisville Wastewater Treatment Plant (WWTP)		
<b>Facility or Site Name:</b> Louisville WWTP		
<b>Facility/Site Physical Address:</b> 2301 Ravenna Avenue NE		
<b>(city, state, zip code)</b> Louisville, Ohio 44641		
<b>County/Parish:</b> Stark		
<b>Permit Number:</b> OH0026182		
<b>SIC or NAICS:</b> SIC 4952

**Louisville WWTP****Inspection Date(s):****3/22/2022**

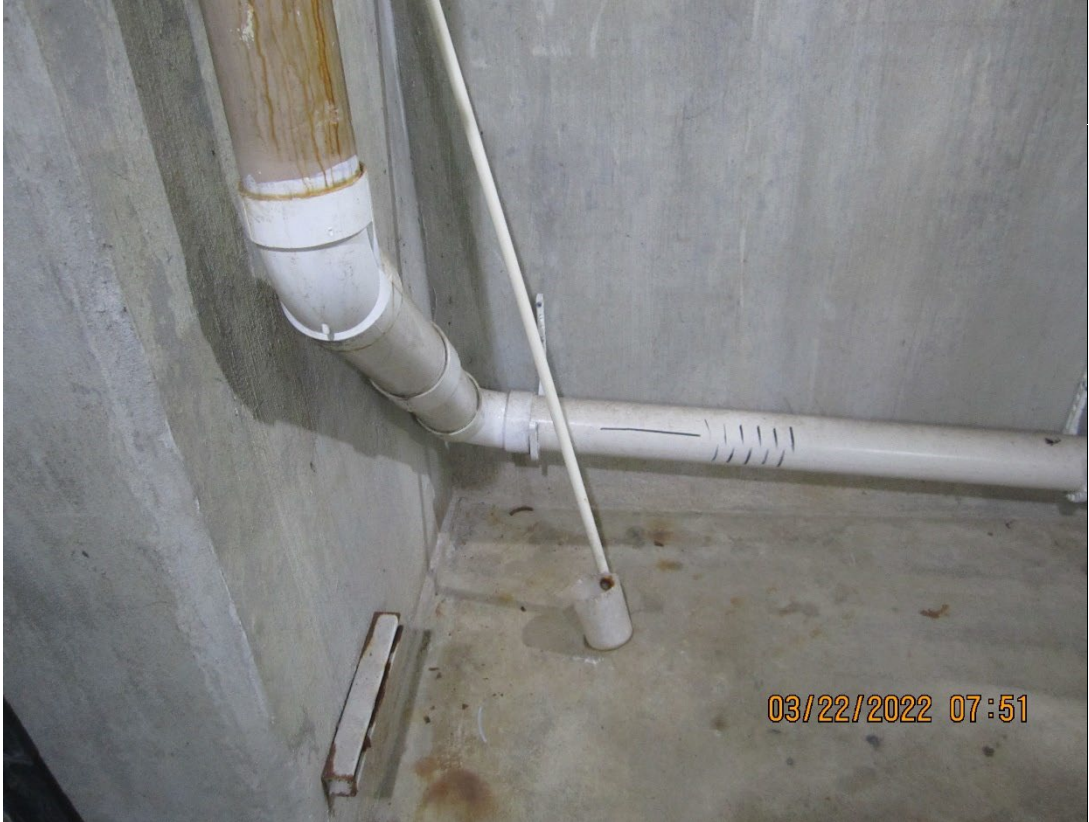
<b>Photo No.:</b> 1	<b>Time:</b> 9:51 AM		
<b>Direction Photo Taken:</b>			
<b>Photo Description:</b> Sampling pole used to collect samples at outfall 001.			
		<b>File:</b> Louisville IMG_0001.JPG

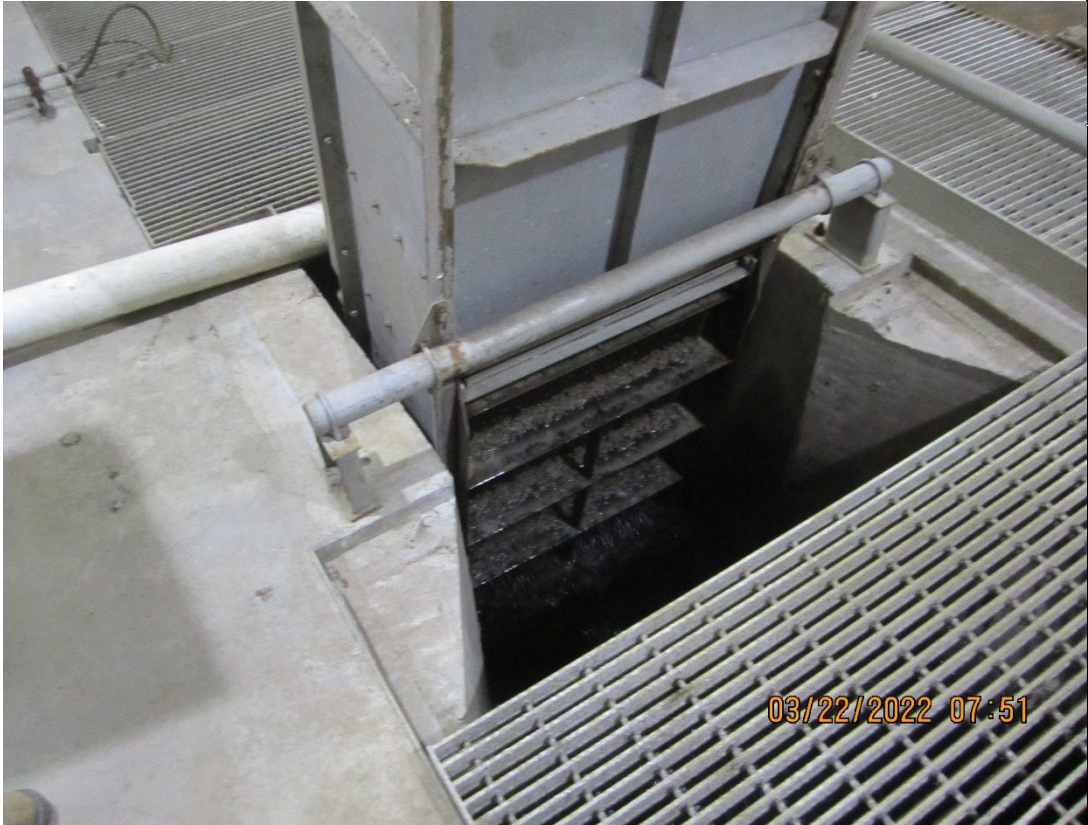
<b>Photo No.:</b> 2	<b>Time:</b> 9:51 AM		
<b>Direction Photo Taken:</b> Down			
<b>Photo Description:</b> Sample location 001			
		File: Louisville IMG_0002.JPG

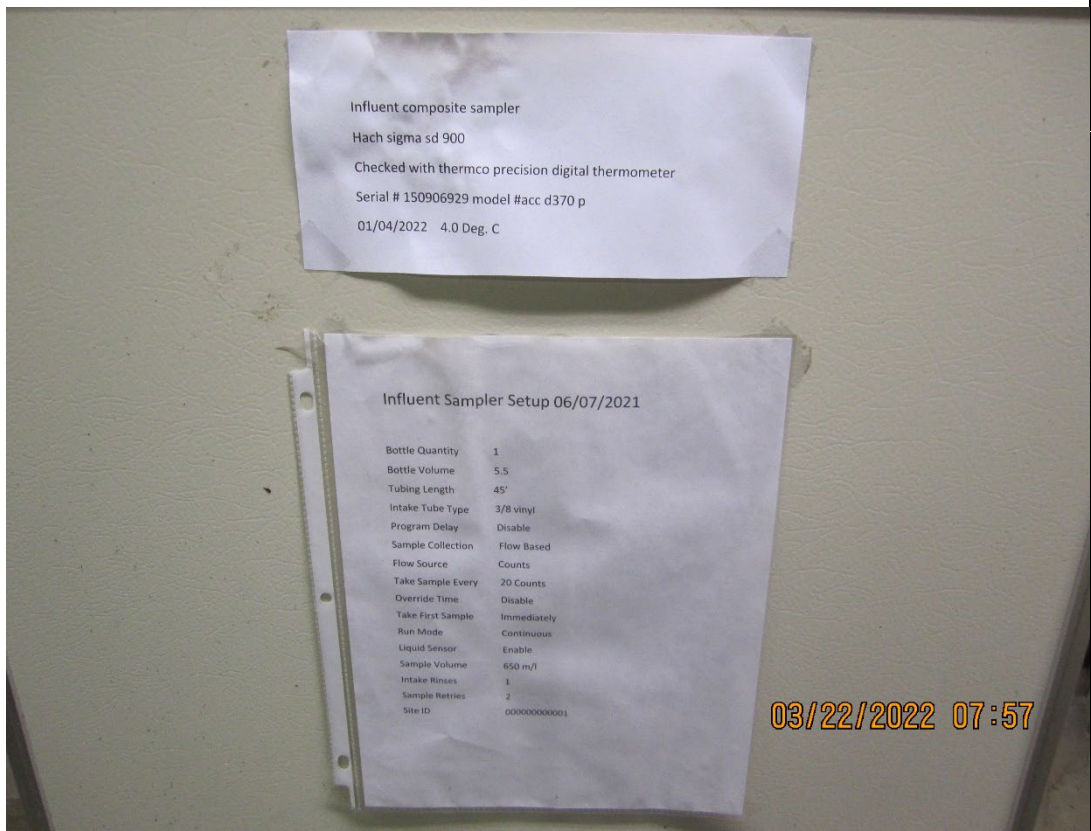
**Photo No.:** 5

**Photo Description:**  
**Instructions for taking a sample and using Hach Sigma 900 at outfall 601.**

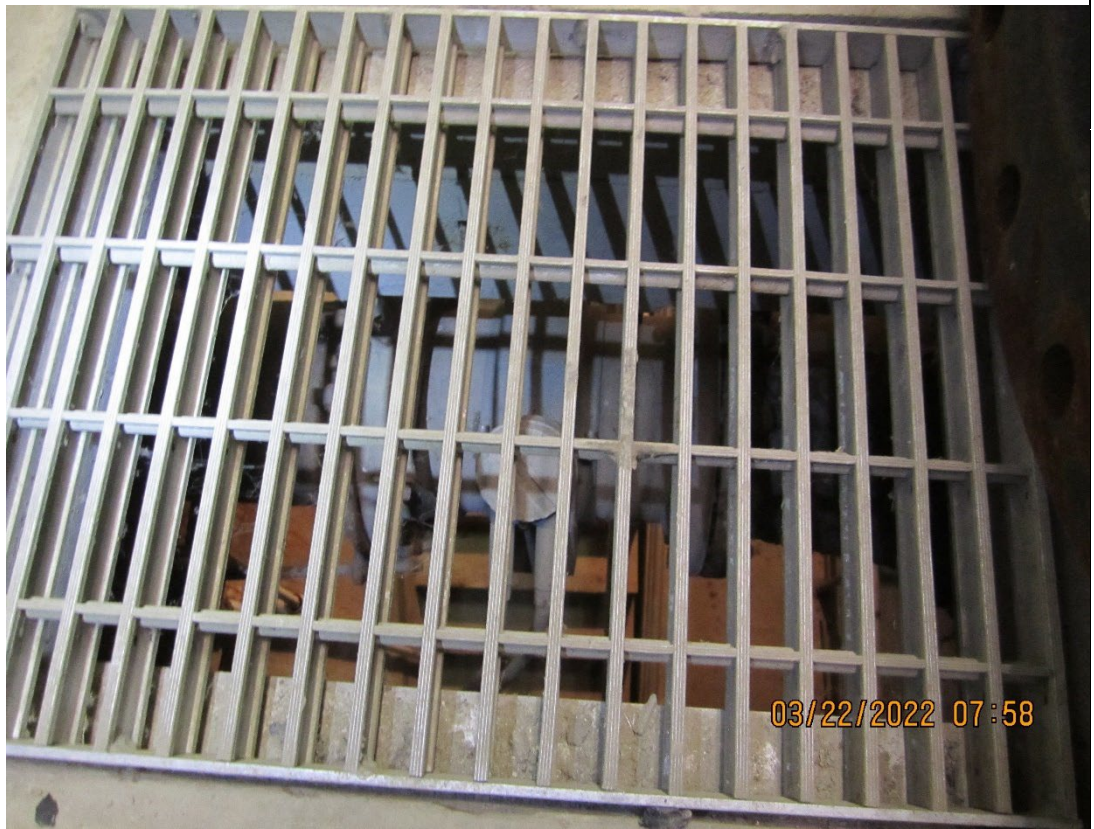
<b>Photo No.: 6</b>	<b>Time:</b> 9:58 AM
-------------------------	-------------------------

**Photo Description:**  
Influent Magmeter

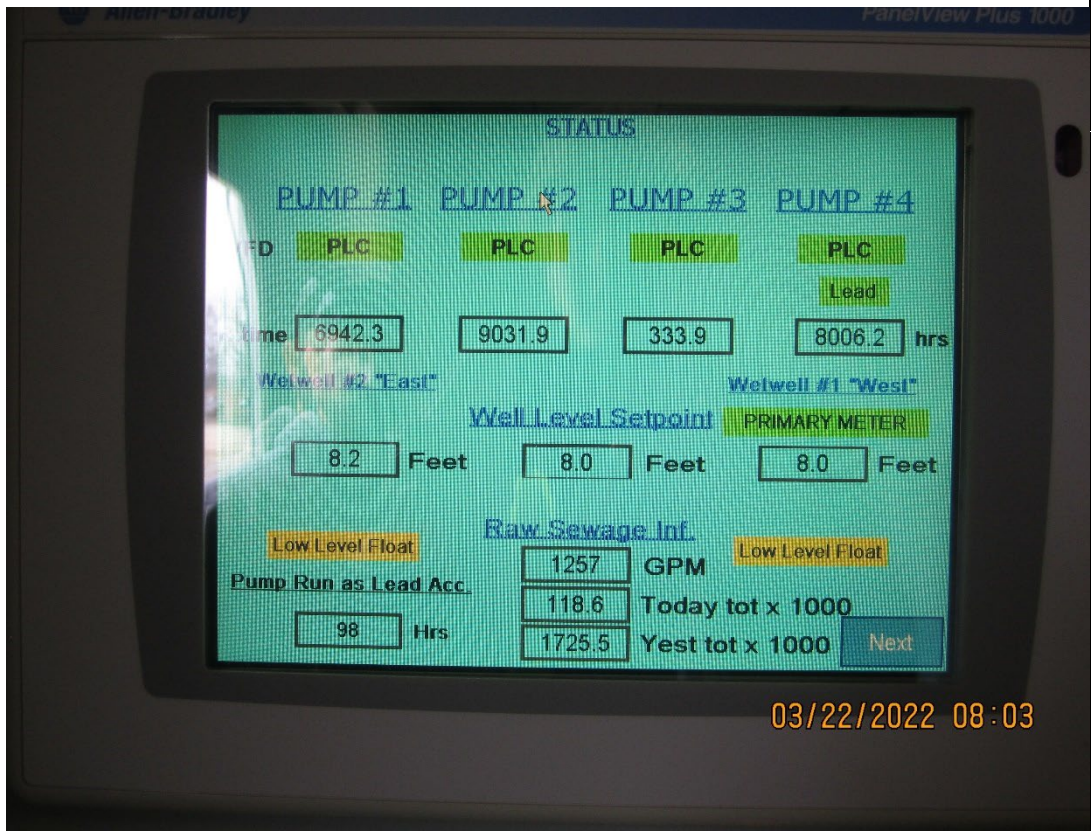
<b>Photo No.:</b> 7	<b>Time:</b> 10:03 AM
---------------------	--------------------------

**Photo Description:**  
 Influent pump readings with raw sewage rate and totalized flow.

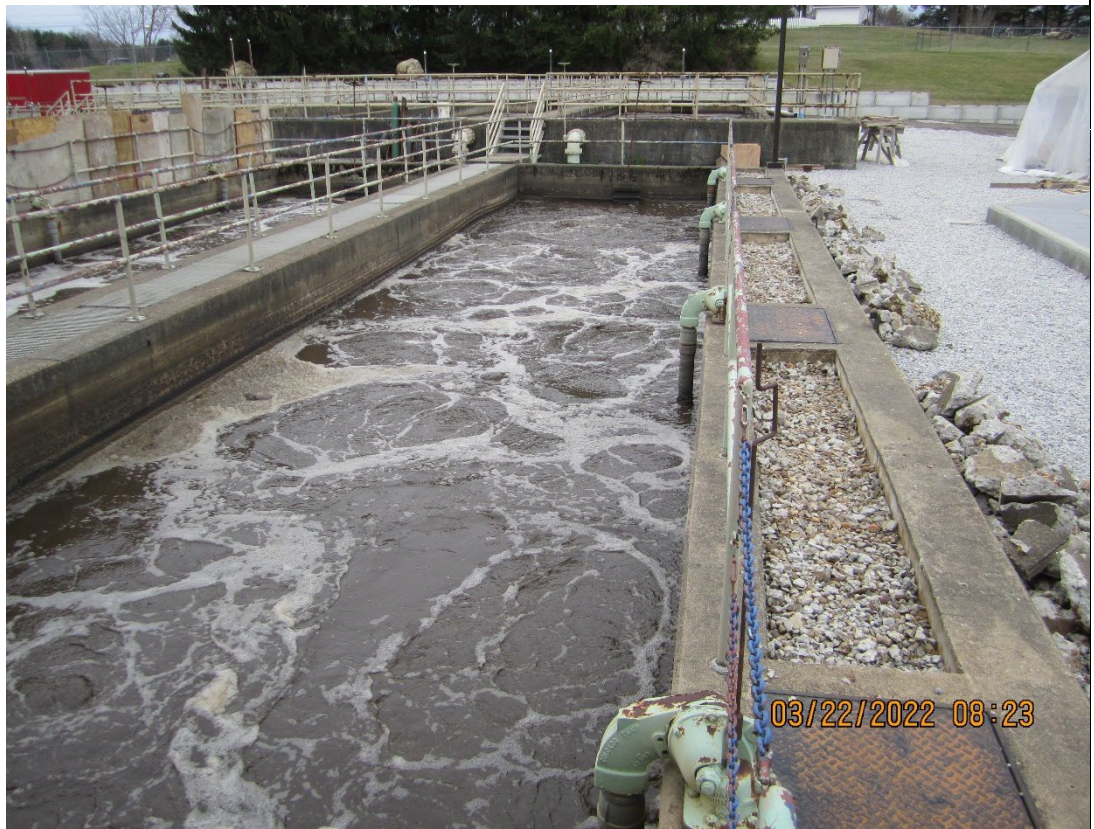
<b>Photo No.: 9</b>	<b>Time:</b> 10:23 AM
-------------------------	--------------------------

**Photo Description:**  
Aeration Tank.

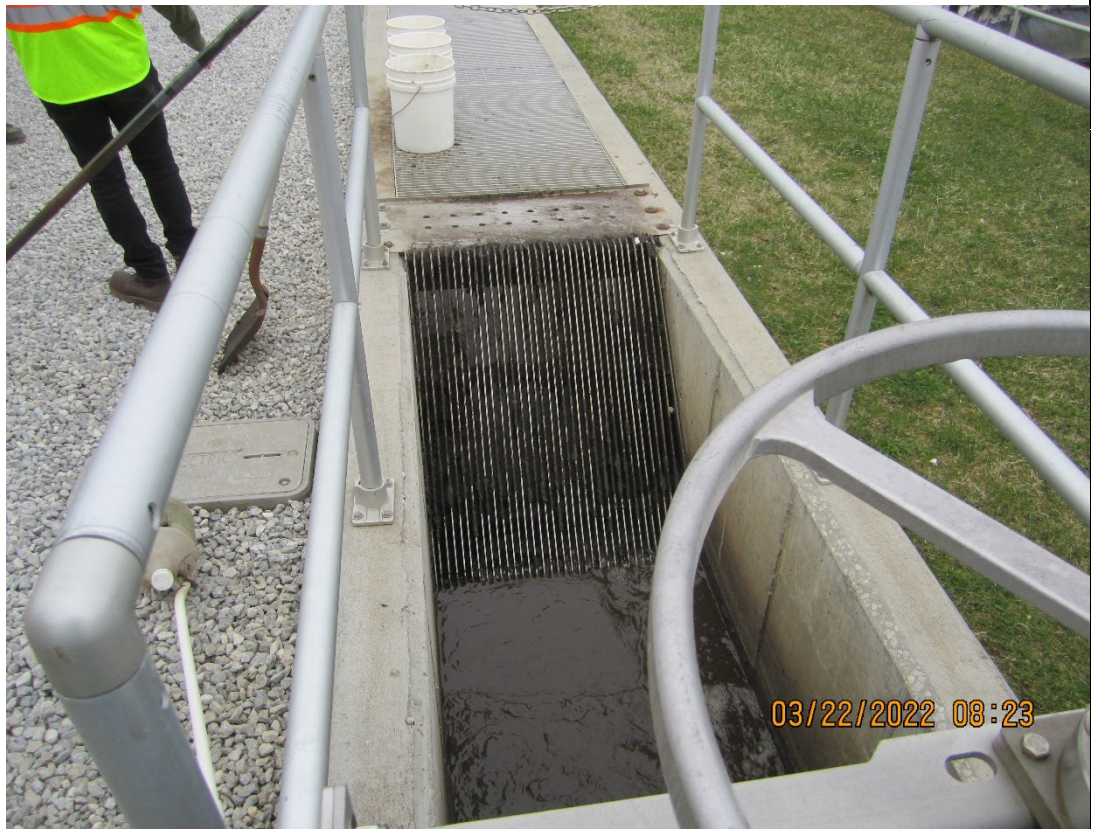
<b>Photo No.:</b> 10	<b>Time:</b> 10:23 AM
----------------------	-----------------------

**Photo Description:**  
Screen after aeration tank.

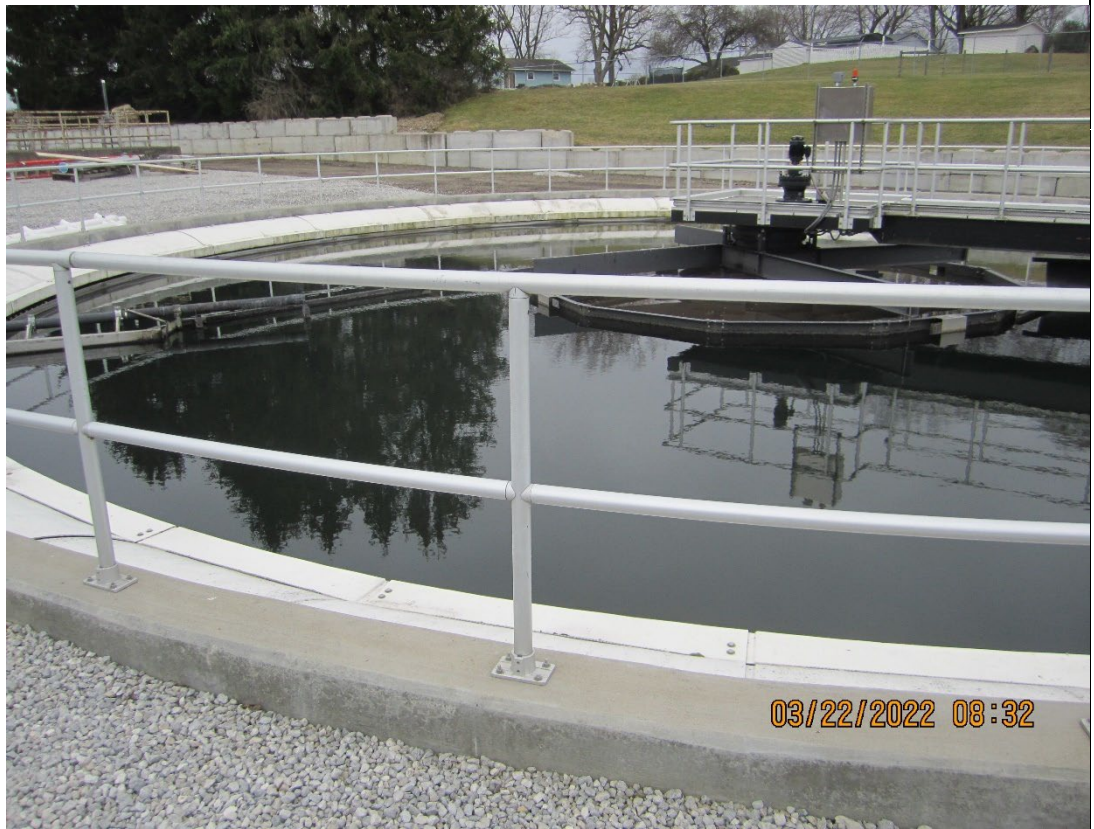
<b>Photo No.: 11</b>	<b>Time:</b> 10:32 AM
--------------------------	--------------------------

**Photo Description:**  
Clarifier #1

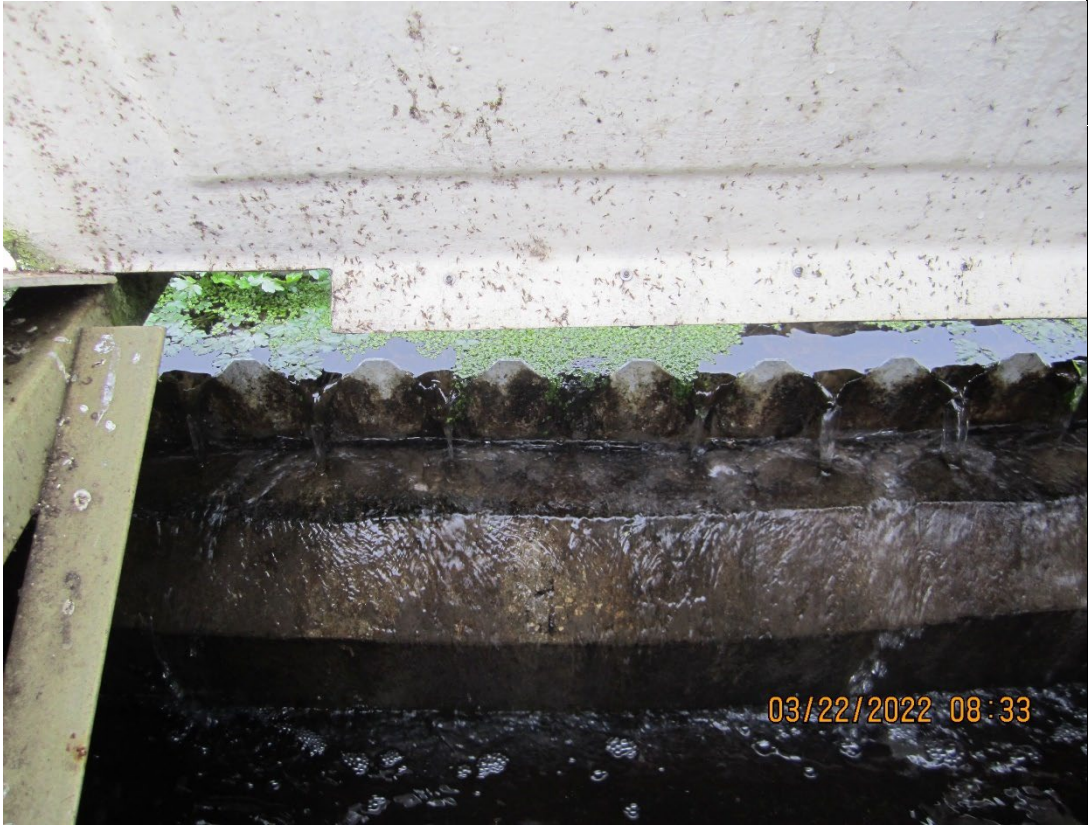
<b>Photo No.:</b> 12	<b>Time:</b> 10:33 AM		
<b>Direction Photo Taken:</b> down/south			
<b>Photo Description:</b> Clarifier #1 weirs.			
		File: Louisville IMG_00012.JPG

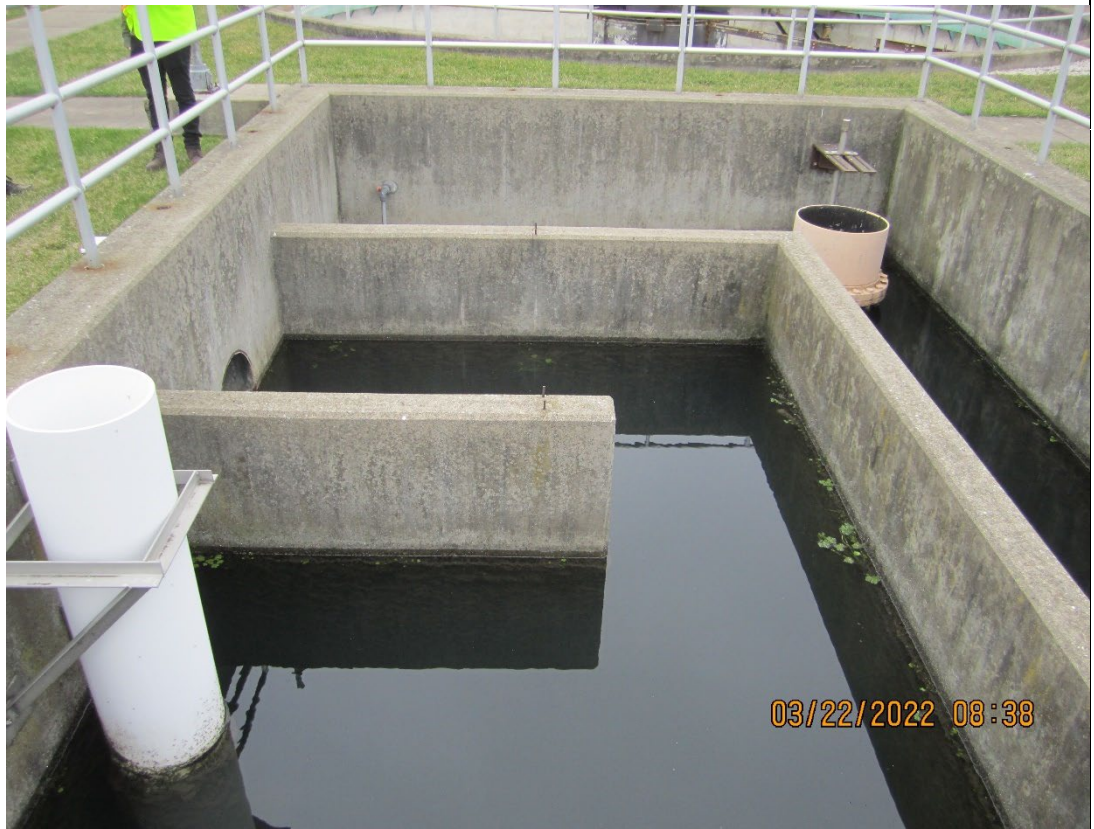
<b>Photo No.: 13</b>	<b>Time:</b> 10:38 AM
--------------------------	--------------------------

**Photo Description:**  
Chlorine contact  
basin.

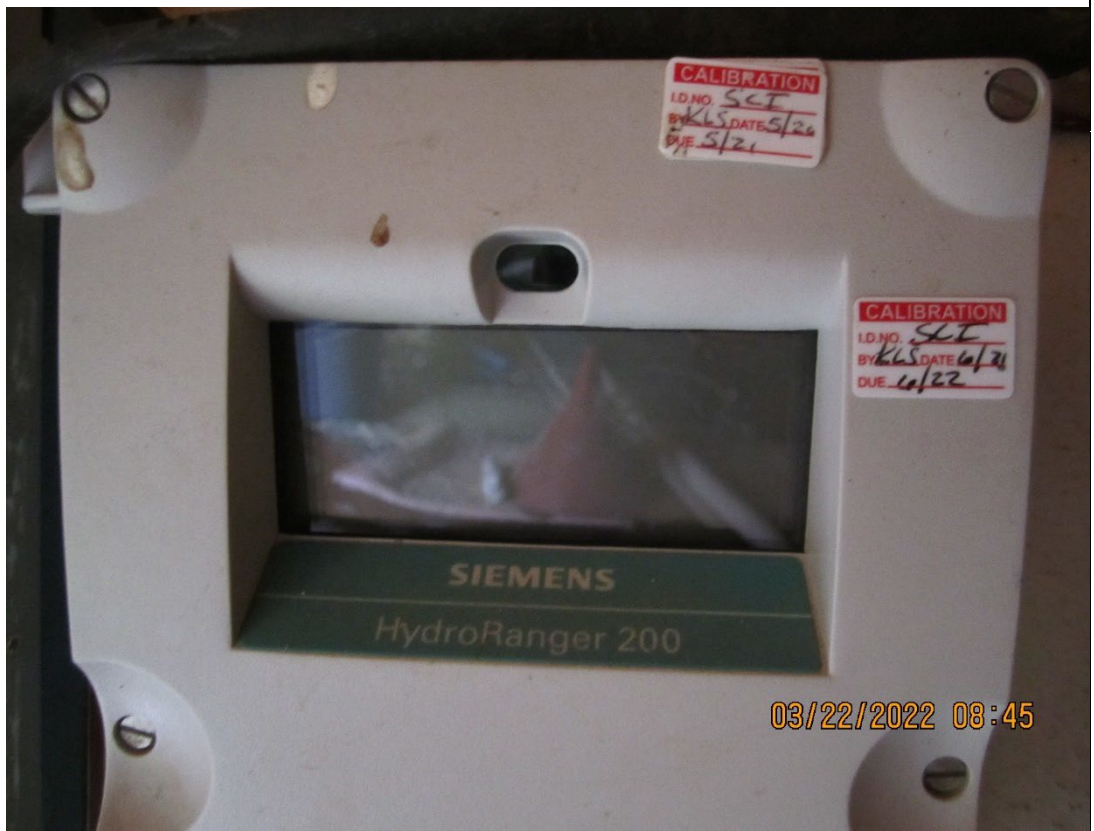
<b>Photo No.:</b> 14	<b>Time:</b> 10:45 AM
----------------------	-----------------------

**Photo Description:**  
Siemens  
HydroRanger 200  
ultrasonic level  
monitor for outfall  
001. Last calibrated  
06/21.

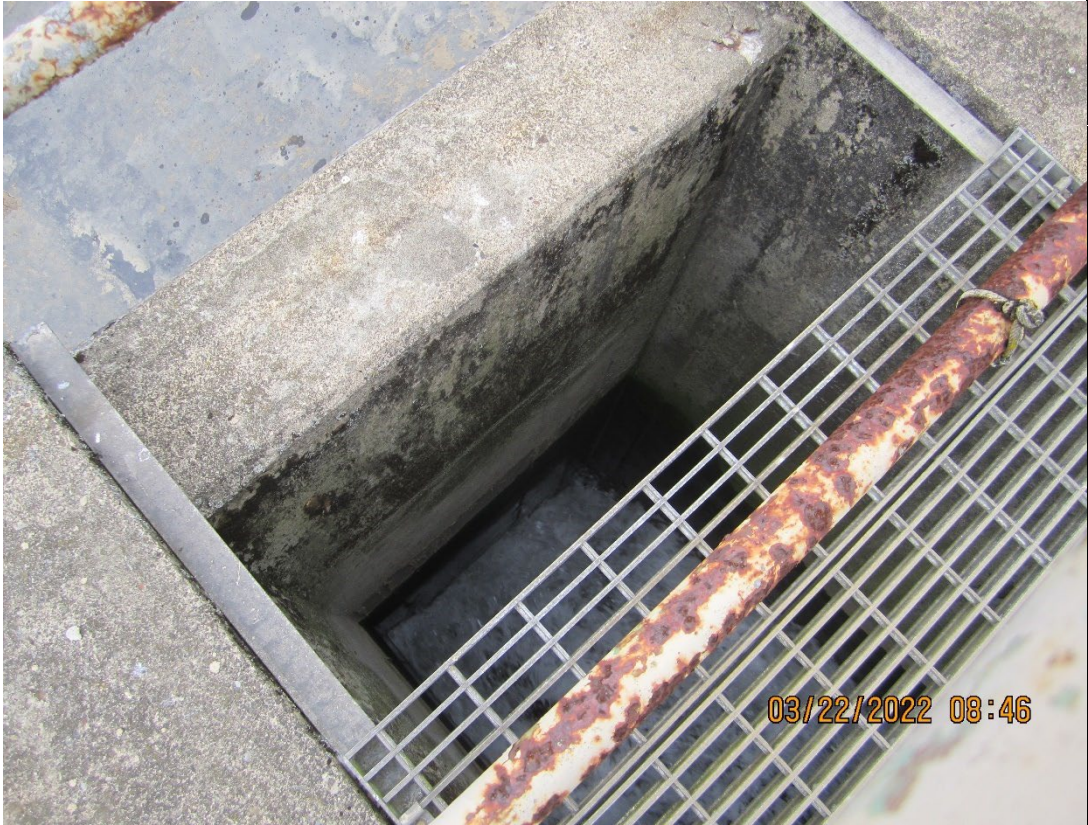
<b>Photo No.:</b> 15	<b>Time:</b> 10:46 AM		
<b>Direction Photo Taken:</b> down			
<b>Photo Description:</b> 001 Grab Sampling Location.			
		<b>File:</b> Louisville IMG_0015.JPG

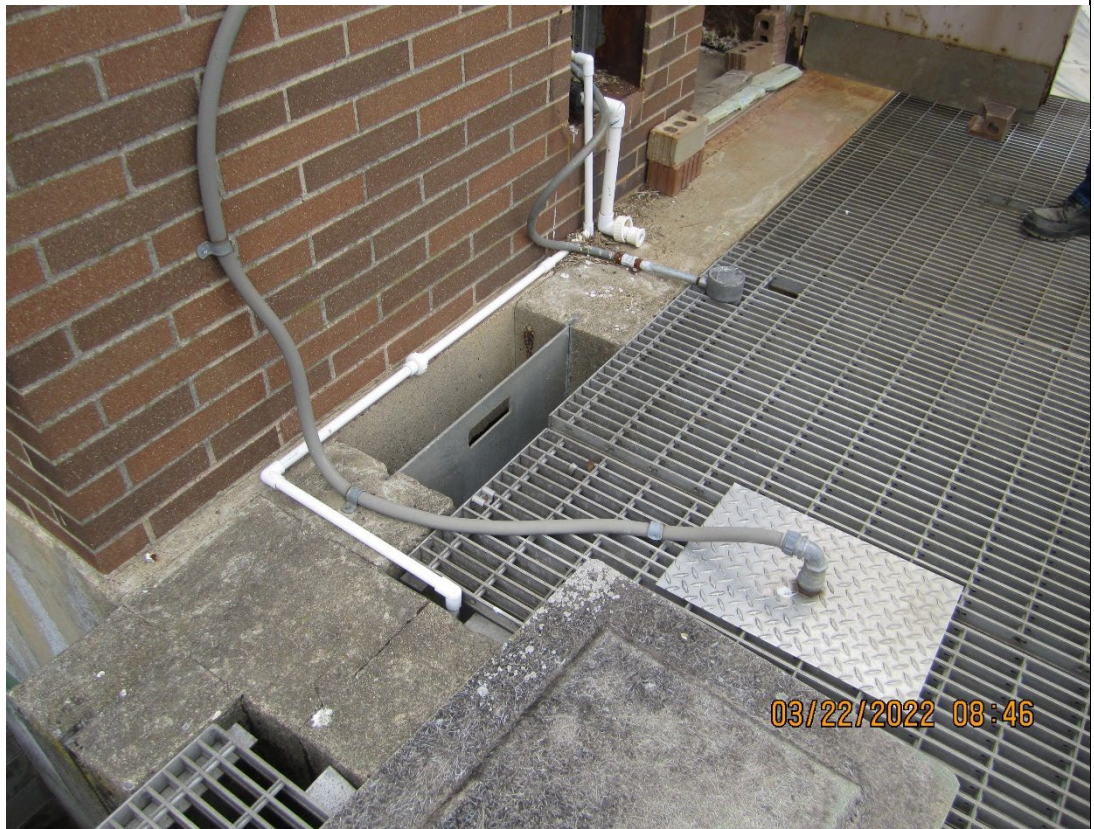
<b>Photo No.:</b> 16	<b>Time:</b> 10:46 AM
----------------------	-----------------------

**Photo Description:**  
Transducer for head measurements at 001 (center) and chemical feed for chlorination (white plastic pipe)

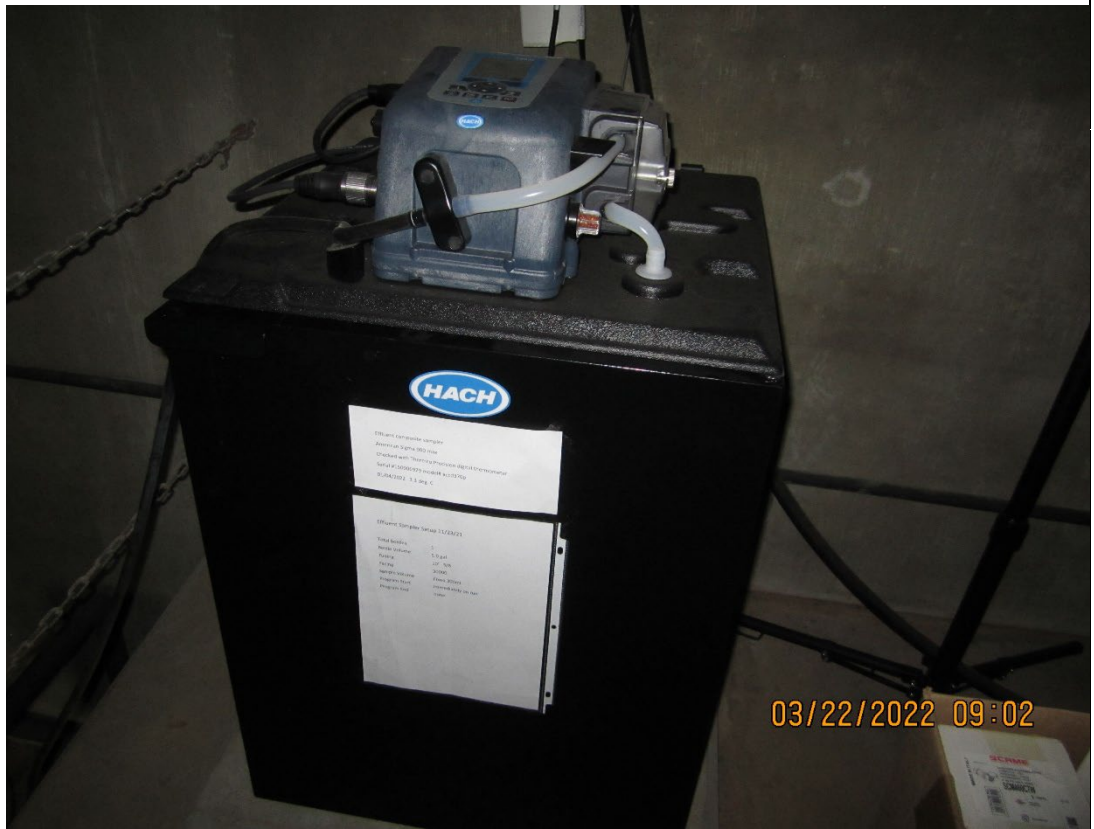
<b>Photo No.:</b> 20	<b>Time:</b> 11:02 AM
----------------------	-----------------------

**Photo Description:**  
Outfall 001 Hach auto sampler.

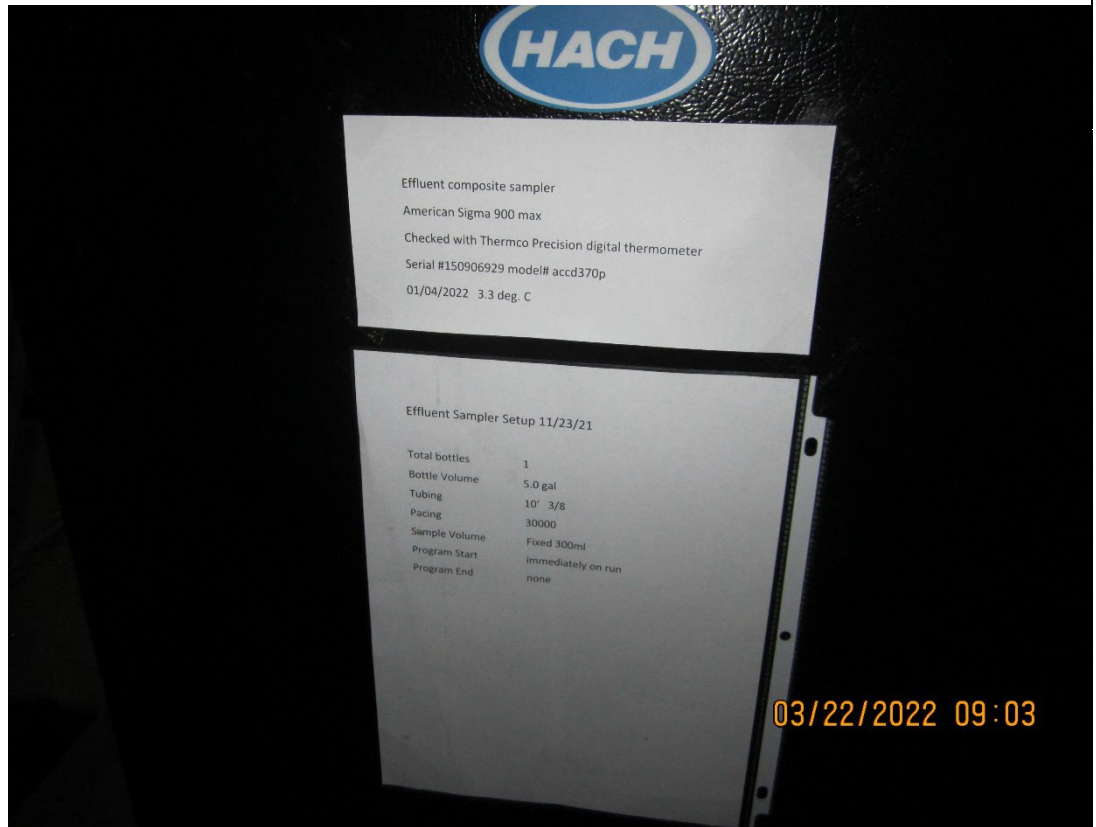
<b>Photo No.:</b> 21	<b>Time:</b> 11:02 AM
----------------------	--------------------------

**Photo Description:**  
Outfall 001 auto sampler precision check and setup date.

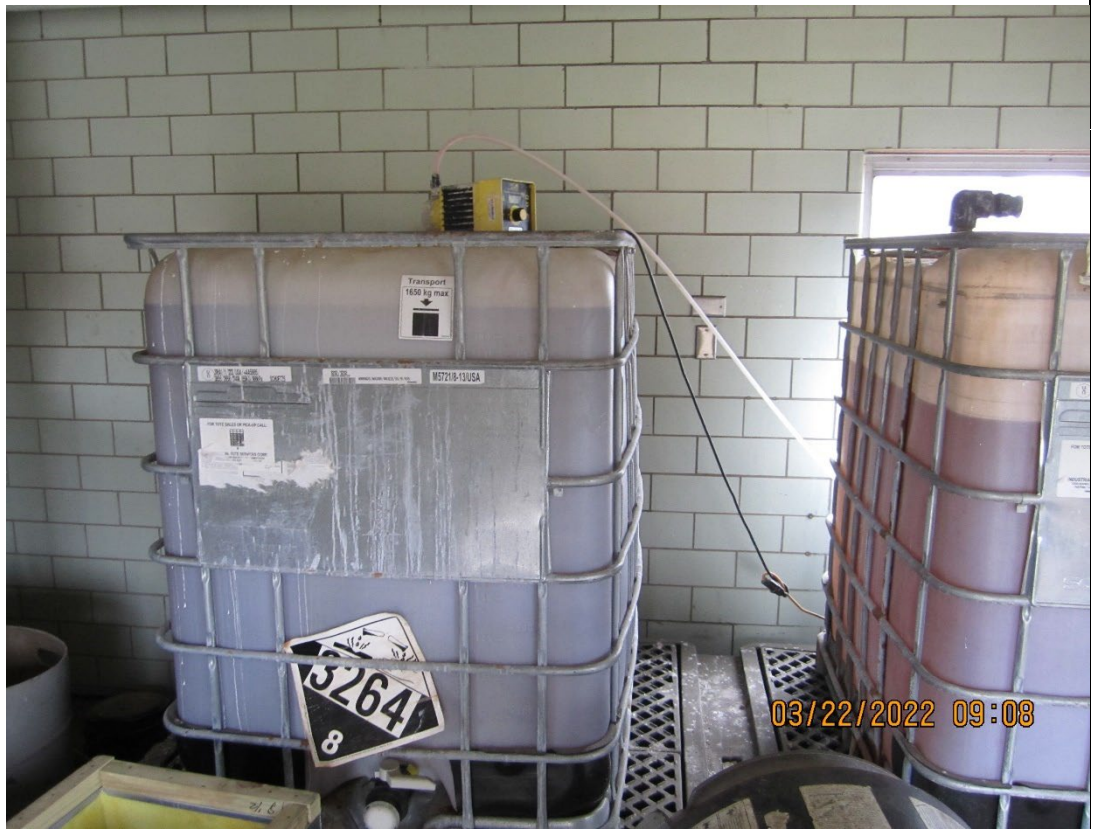
<b>Photo No.:</b> 22	<b>Time:</b> 11:08 AM
----------------------	-----------------------

**Photo Description:**  
Totes of aluminum sulfate solution for phosphorous removal and metering pump. Added to channel before screen ahead of clarifiers.

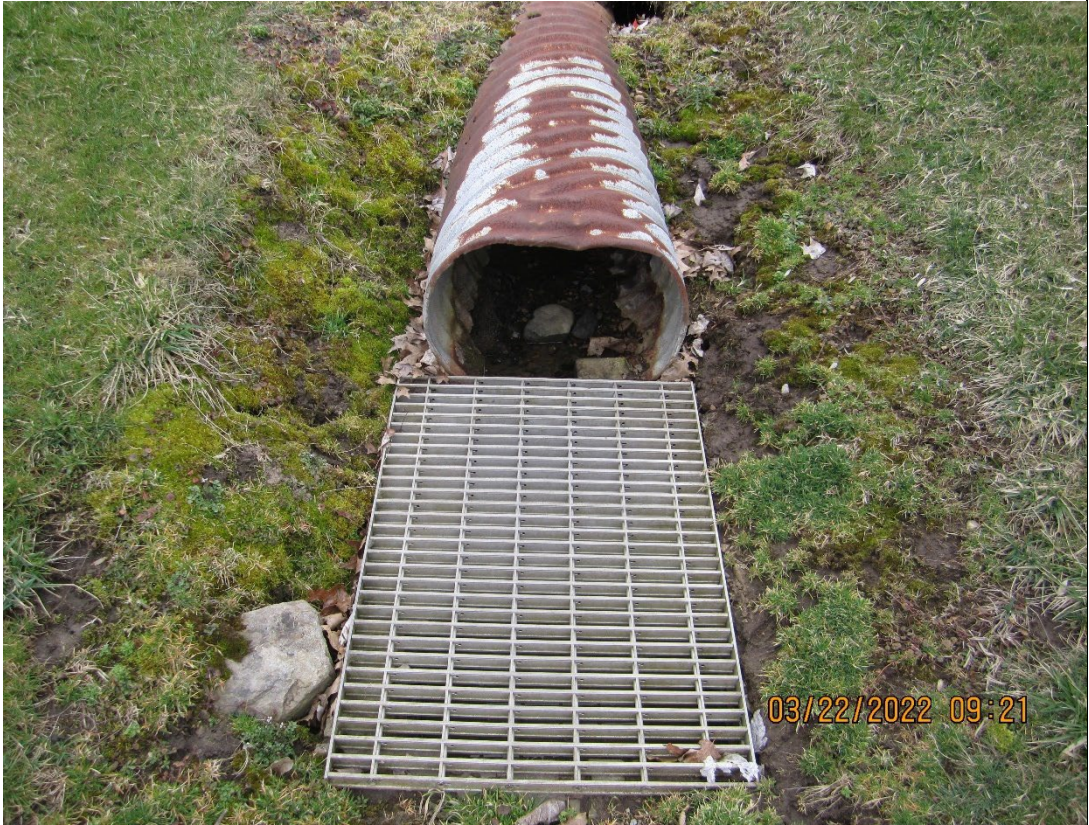
<b>Photo No.:</b> 24	<b>Time:</b> 11:21 AM		
<b>Direction Photo Taken:</b> South			
<b>Photo Description:</b> Stormwater outfall catch basin for outfall furthest east			
<b>File:</b> Louisville IMG_0024.JPG

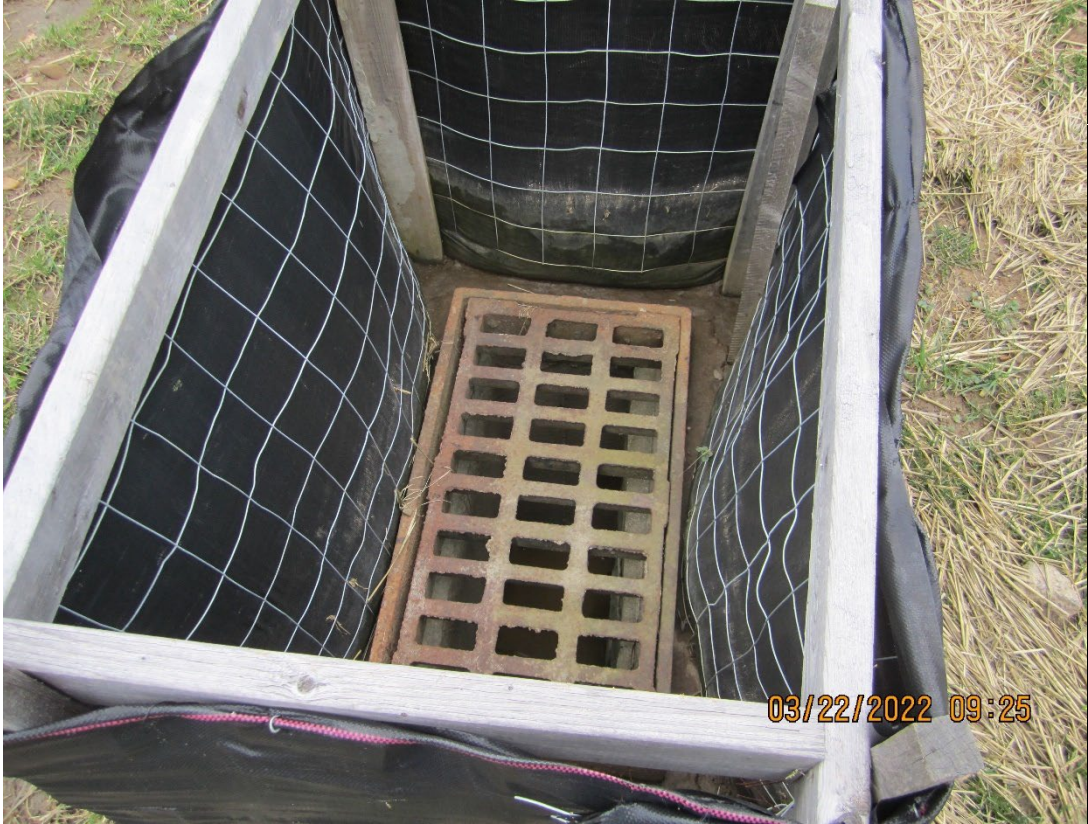
<b>Photo No.:</b> 26	<b>Time:</b> 11:25 AM		
<b>Direction Photo Taken:</b> Northwest			
<b>Photo Description:</b> Catch basin for collapsed stormwater outfall depicted in photo 25.			
		File: Louisville IMG_0026.JPG
