**UNITED STATES ENVIRONMENTAL PROTECTION AGENCY**  
**REGION 1, ECAD-WCB**  
**5 Post Office Square - Suite 100, Boston, MA 02109-3912**

**Clean Water Act (CWA) Inspection Report**

| <b>Permittee Name:</b> Presby Recycling LLC | <b>NPDES/ICIS No.:</b> (Unpermitted at time of inspection) | |
| <b>Facility Inspected:</b> Presby Recycling, 664 Eaton Road, Franconia, NH 05380 | <b>Lat, Long:</b> 44.209200°, -71.751783°<br><b>NAICS / SIC Code:</b> Not known by the On-site Facility Representative | |

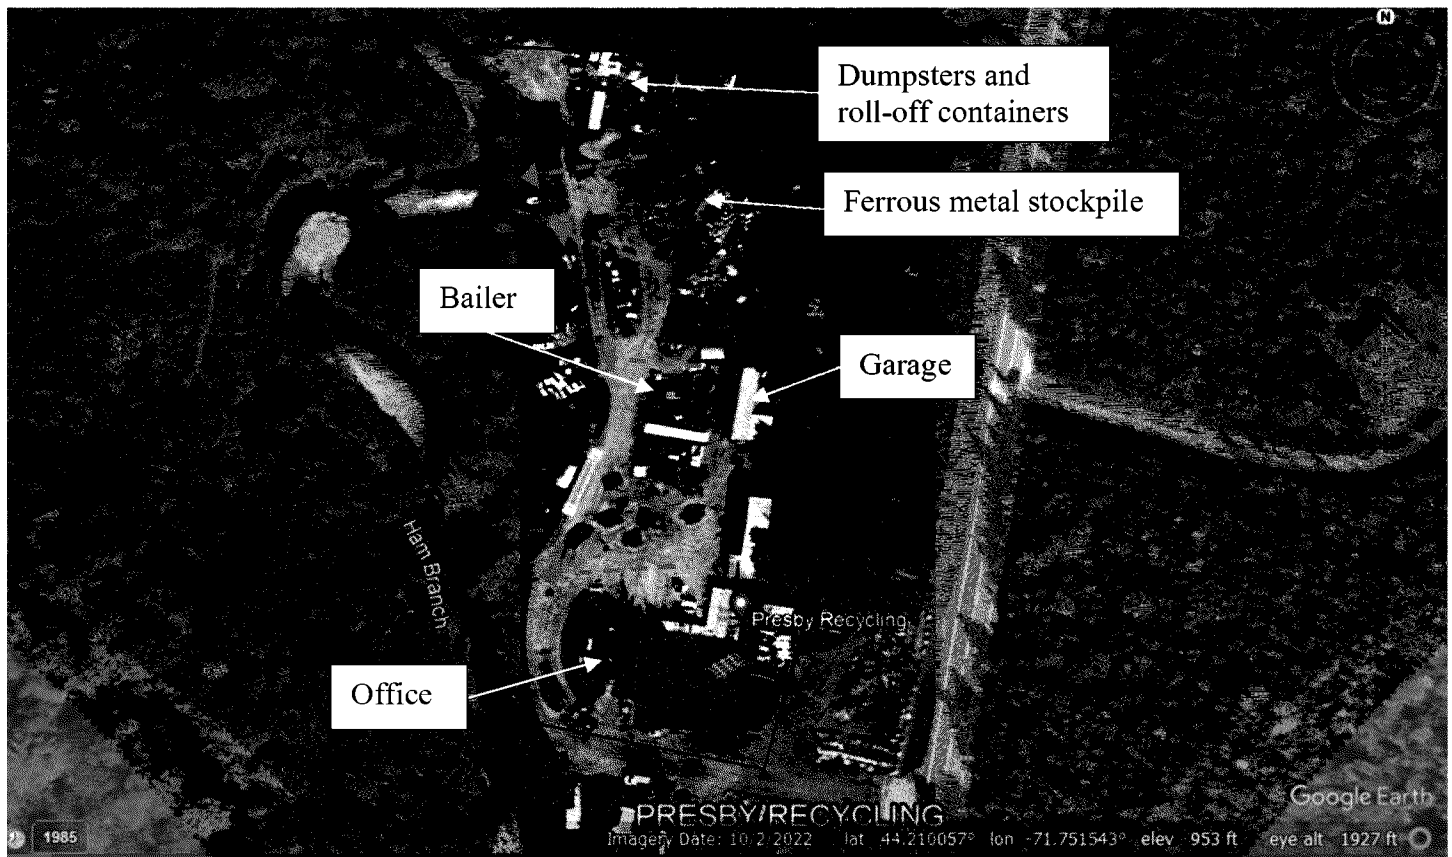
Figure 1. Google Earth aerial view of the Facility dated 10/2/2022. The blue arrows depict observed flow pattern, the red lines and Ham Branch are the approximate Facility boundaries.

The EPA Inspector observed that stormwater would flow east to west across the Facility. A vegetated buffer ranging in width from 20 feet to more than 100 feet, estimated with Google Earth, separated areas of the Facility used for industrial activity from Ham Branch (refer to [Appendix A, Photographs 2, 3, 17, 18, and 19](#)), except for the northwestern end of the Facility. In the northwestern part of the Facility the active area of the Facility extended to the edge of Ham Branch (refer to [Appendix A, Photographs 20 and 21](#)).

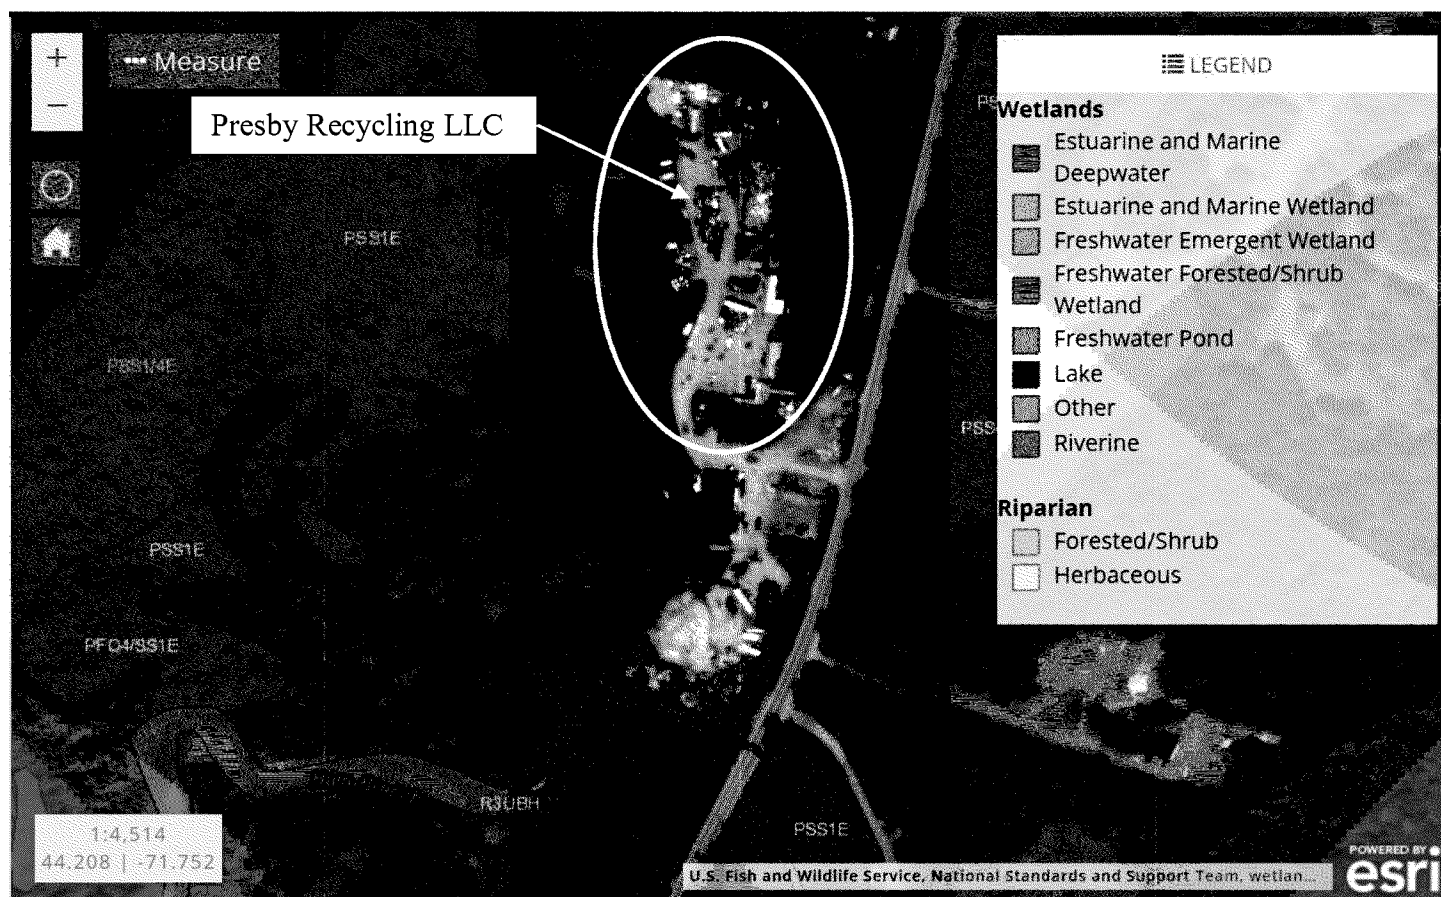
The Facility is surrounded by Ham Branch to the west, private property to the north, Eaton Road to the east, and private property to the south (Figure 2). Bailed tires were used to construct a barrier between the Facility and the property to the north (refer to [Appendix A, Photographs 22 and 23](#)).

Figure 2. NWI Map of the area surrounding Presby Recycling

The Facility grounds were surfaced with compacted earth. Ham Branch of the Gale River flows in a northerly direction along the Facility's western boundary (Figure 2 and refer to [Appendix A, Photographs 2, 3, 20, and 21](#)).
