## EPA Region 10 Enforcement Division

### INSPECTION REPORT

| <b>Type of Inspection</b> | CEI - Compliance Evaluation Inspection | |
| <b>Company Name</b> | Qorvo | |

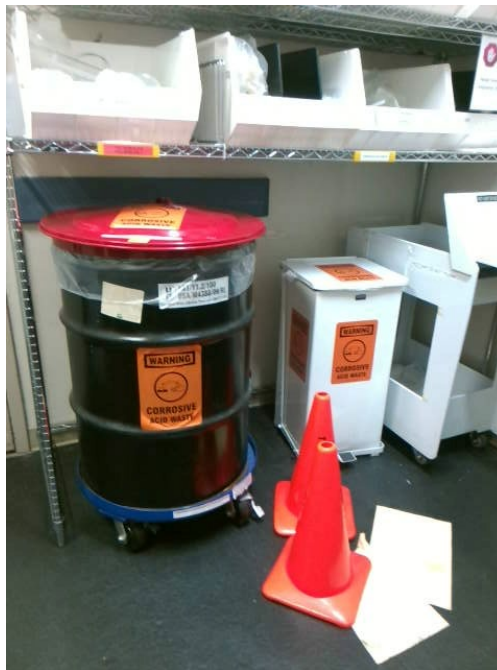
| SAA | IMG-202208230941234123196533.jpg | |

Corrosive acid waste two containers. Both empty.

| Corrosive acid waste 2 containers;<br>Both empty. | <b>Citations:</b> 40 CFR | <b>Sections:</b> 262.34(c)(1) |

I observed some follow up at the time of the inspection. The extra container in the SAA was removed, the universal waste lamps were placed inside the closed containers, and labels placed to include the words hazardous waste and the hazard indicator.

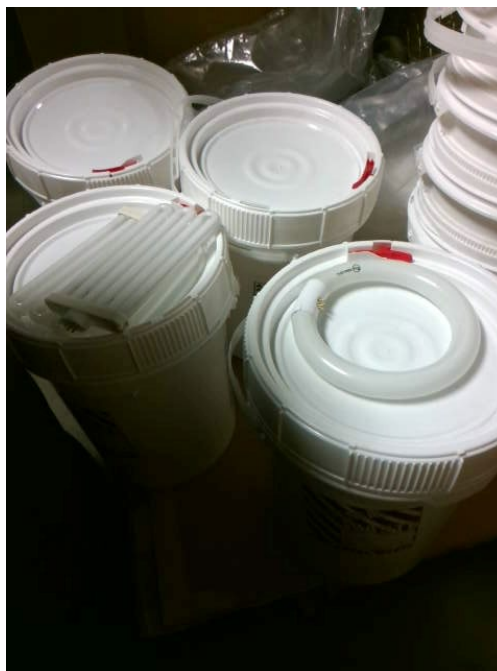
| Universal Waste Lamps on Containers | IMG-202208231128372837128416.jpg | |

3 universal waste lamps on top of containers.

| 3 UW lamps on top of containers | <b>Citations:</b> 40 CFR | <b>Sections:</b> 273.13(d)(1) |

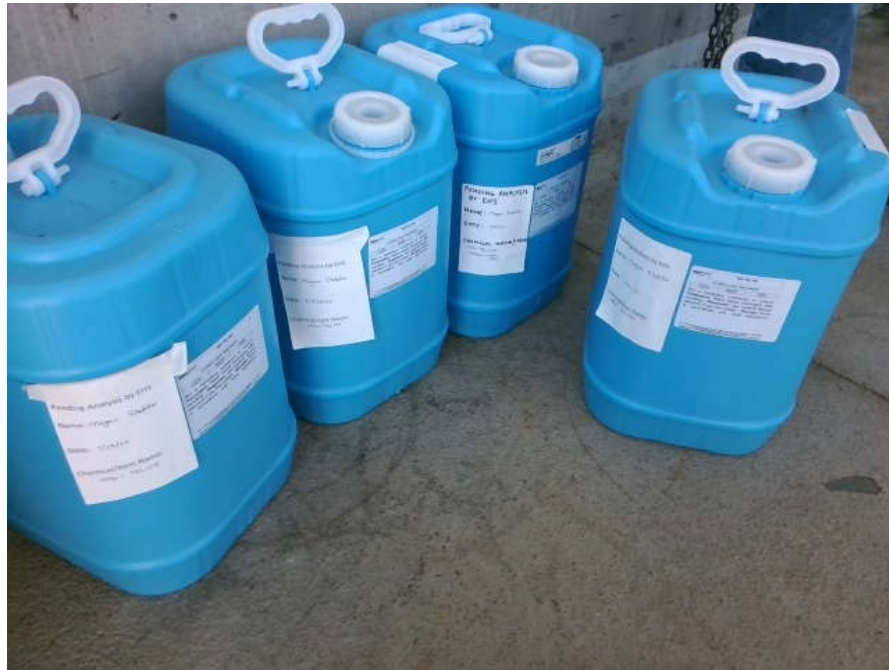
| Outdoor CAA Bin 101 | | No CBI | No PII |

| Bin 101 label issue waste pending analysis didn't have "hazardous waste" or hazard indicator. | | | |

| Bin 101 label issue waste pending<br>analysis didn't have "hazardous<br>waste" or hazard indicator | <b>Citations:</b> 40 CFR | <b>Sections:</b> 262.34(a)(3) |

| "Waste Pending Analysis" not labeled hazardous nor a hazard indicator | | IMG-202208230952155215211871.jpg | |

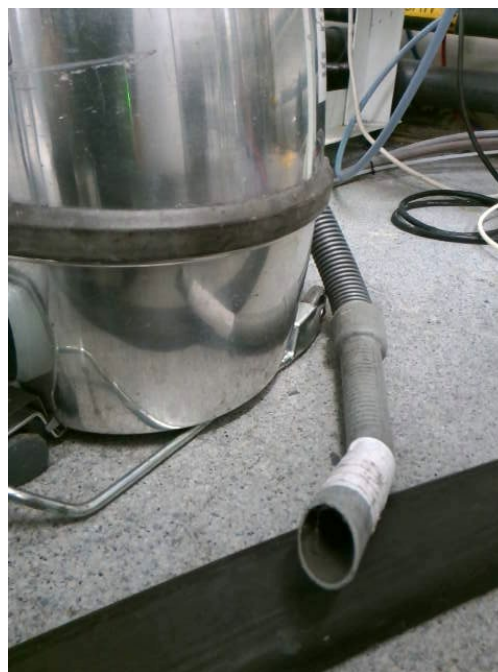
| Fab/Finish fab | | No CBI | No PII |

Finish fab vacuum open end.

| Finish fab vacuum open end | <b>Citations:</b> 40 CFR | <b>Sections:</b> 262.34(a)(1)(i) |

| Hazardous waste vacuum with open end | | IMG-20220823110154154169187.jpg | |
