## MULTI-SECTOR GENERAL PERMIT NON-FILER INSPECTION CHECKLIST

| <b>Inspection Date(s):</b> | 2/7/2023 | |
| <b>Operator Name:</b> | Lebarron's Auto Salvage | |

**Appendix A. Aerial Map**  
**Clean Water Act Inspection**  
**Lebarrons Auto Salvage**

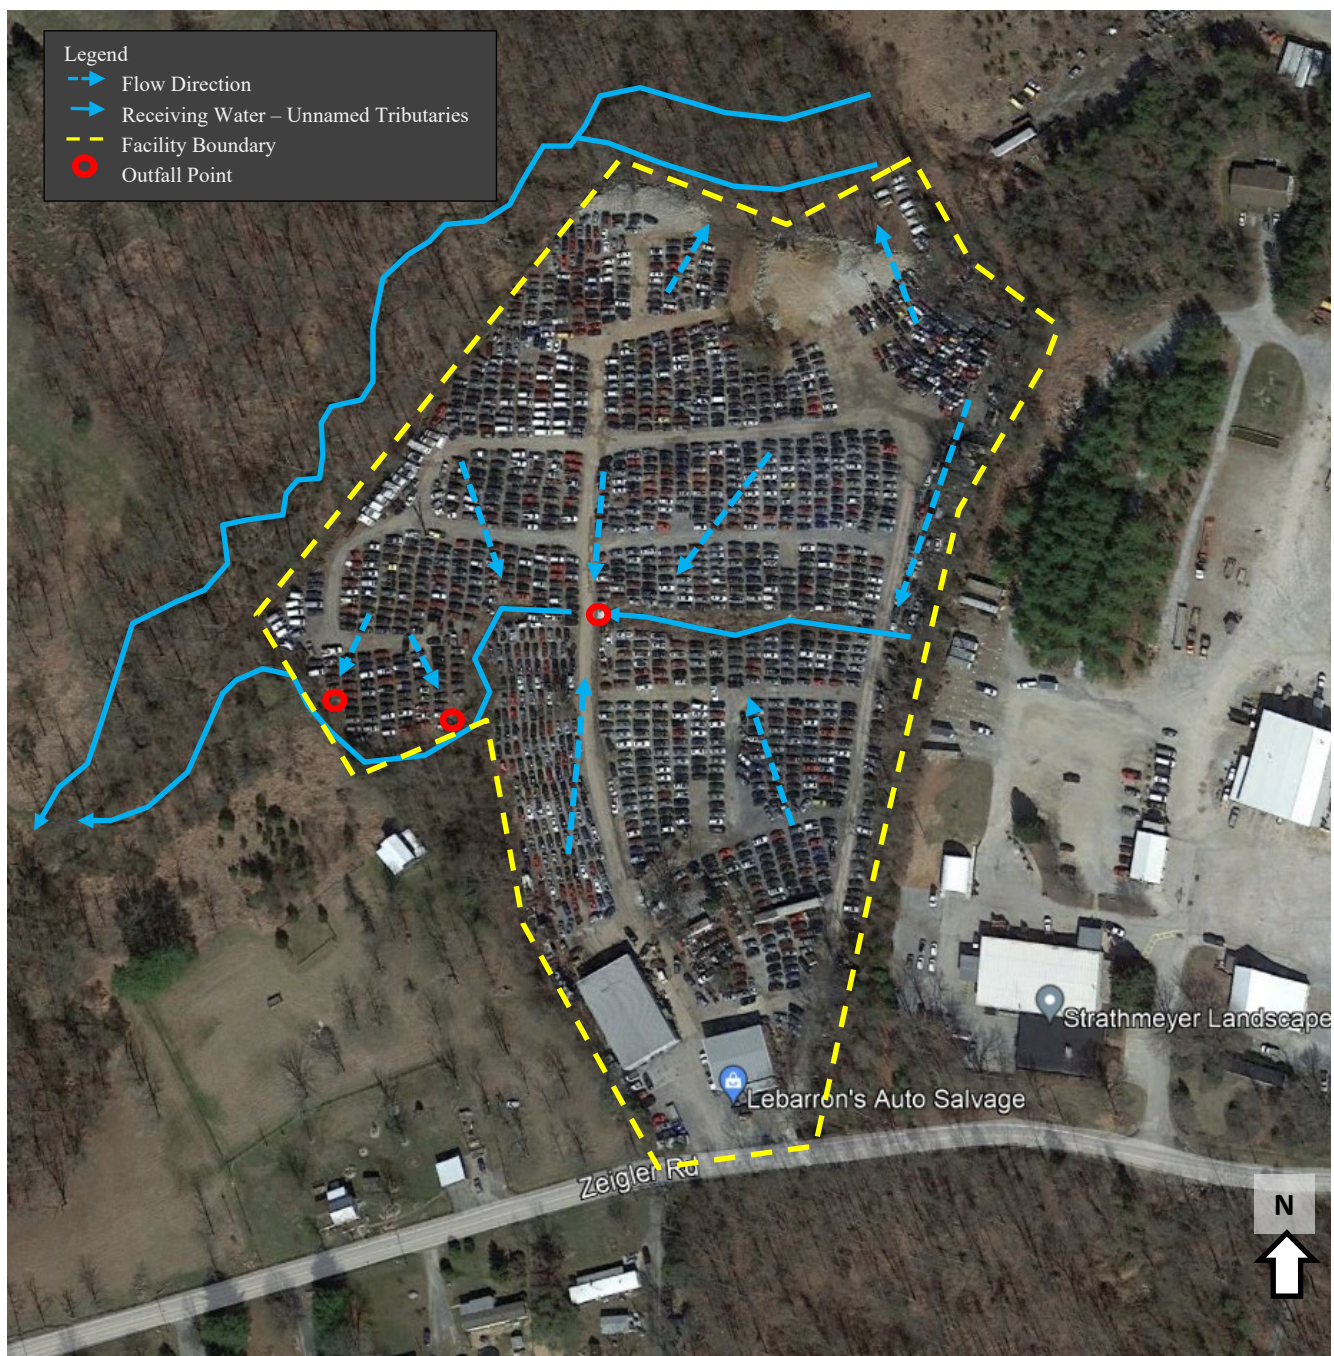
**Figure 1.** Aerial image of Lebarron's Auto Salvage from Google Earth (imagery dated 3/8/2020). An unnamed tributary to Conewago Creek runs east to west through the Facility. Another unnamed tributary to Conewago Creek runs northeast to southwest along the Facility's western boundary. The red circles identify stormwater discharge locations around the facility.

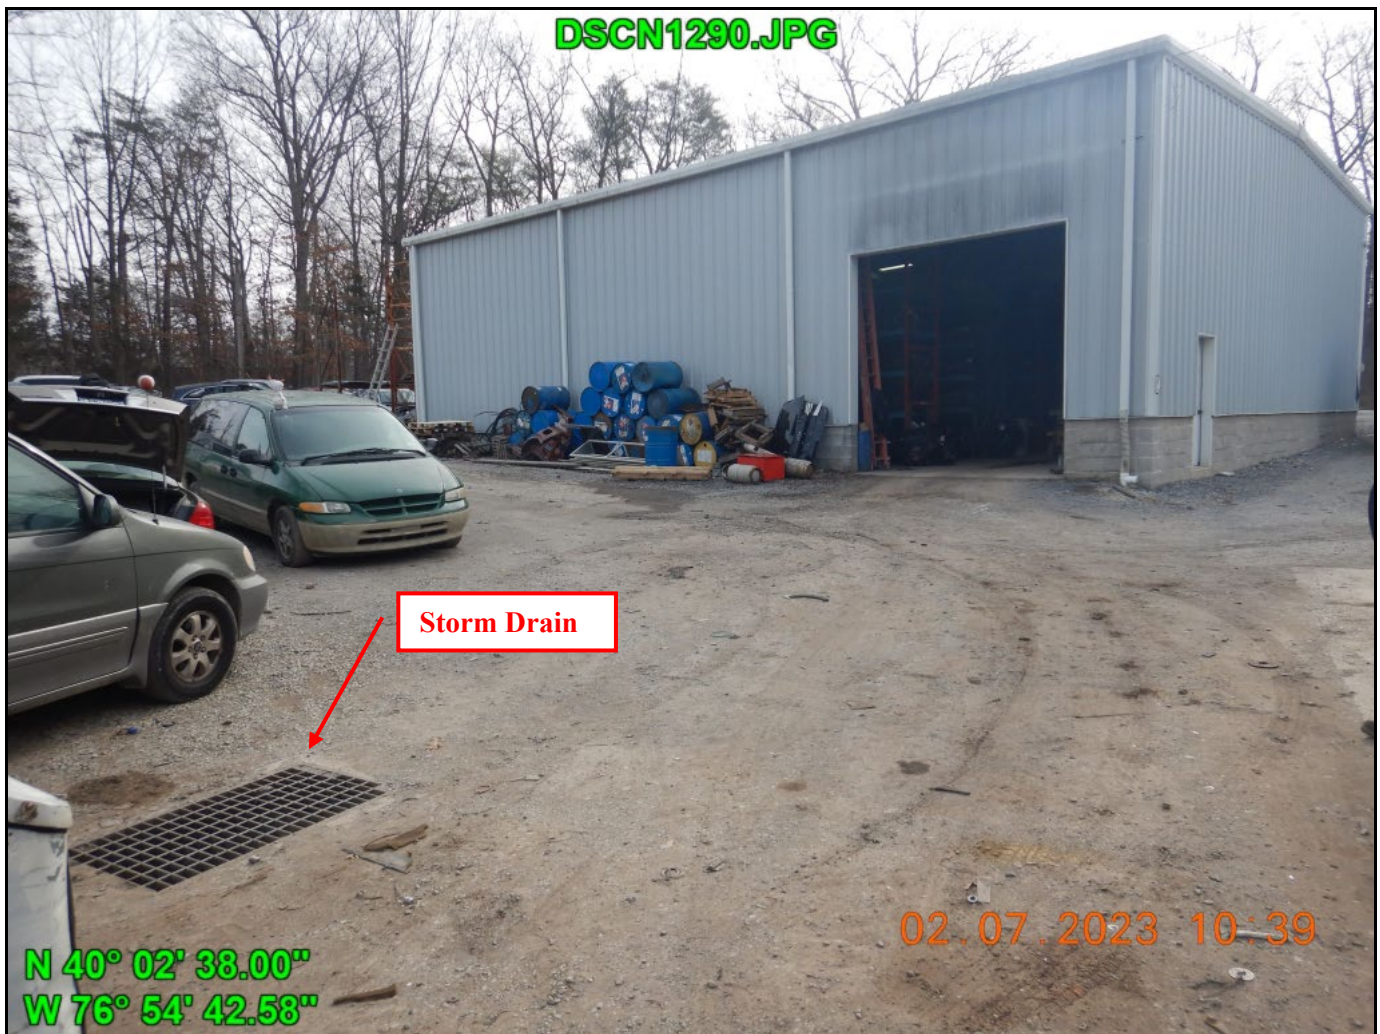
DSCN1290, DSCN1293, & DSCN1296). At the time of the inspection, a few drums behind the main office building were observed to have liquid inside them. It was unclear and EPA did not infer what type of liquid was inside. The rest of the drums were empty. All drums were unmarked and without cover or containment.

| Description | View of the Facility's indoor work area, storm drain, and approximately thirty (30) 55-gallon drums (empty and unmarked). Note the lack of inlet protection on the storm drain, as well as the salvage vehicles, debris, and petroleum product staining on the upgradient impervious surface. |

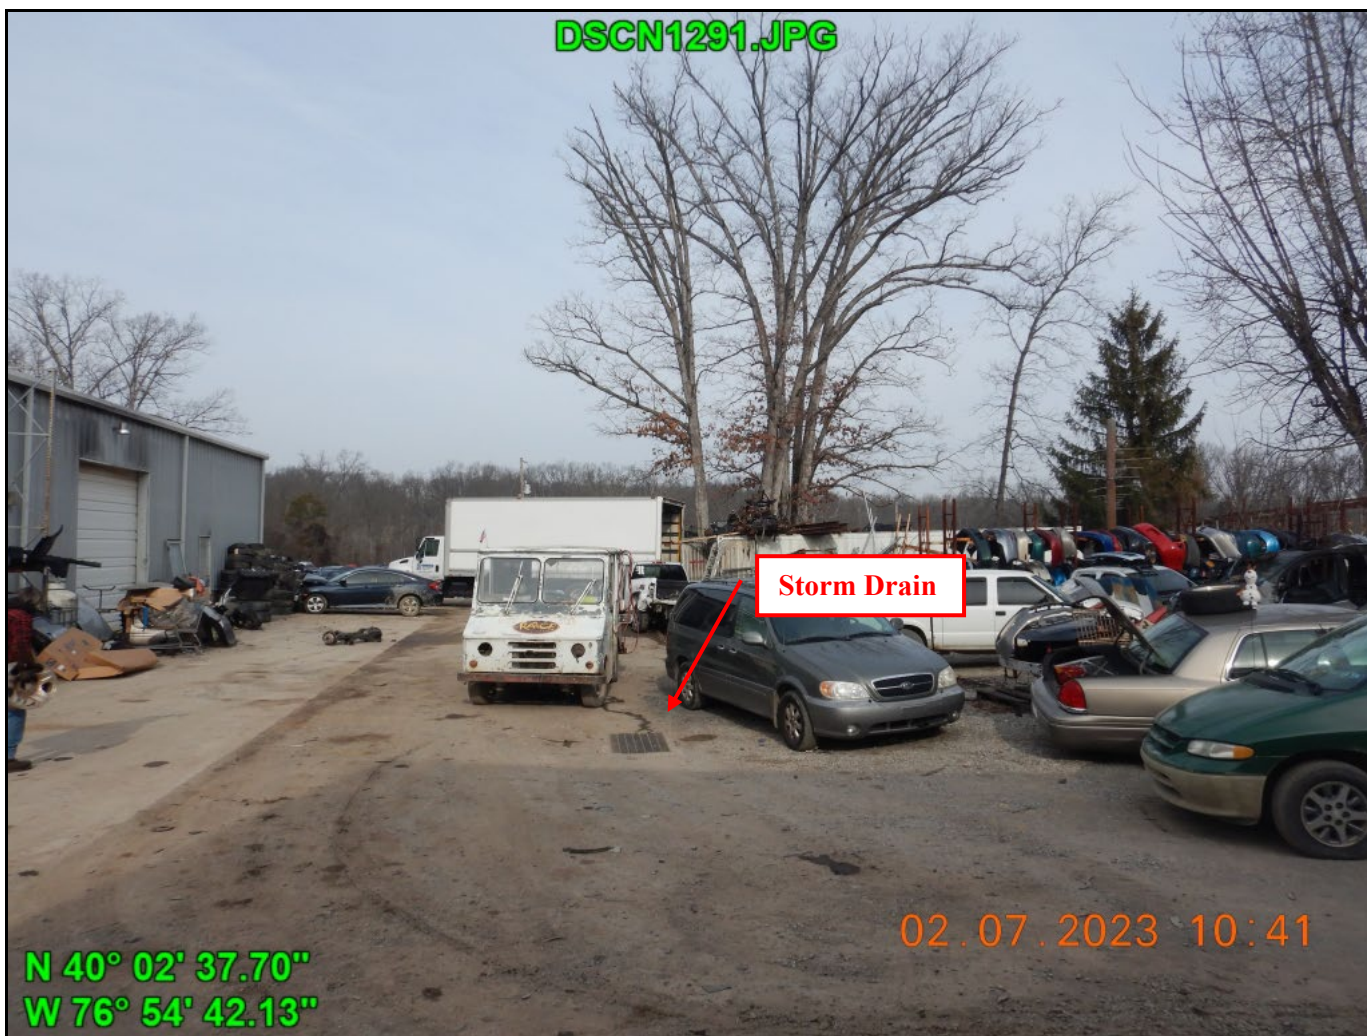
| Description | View of the storm drain adjacent to the indoor work area. Note the lack of inlet protection, as well as the salvage vehicles, debris, and petroleum product staining on the upgradient impervious surface. |

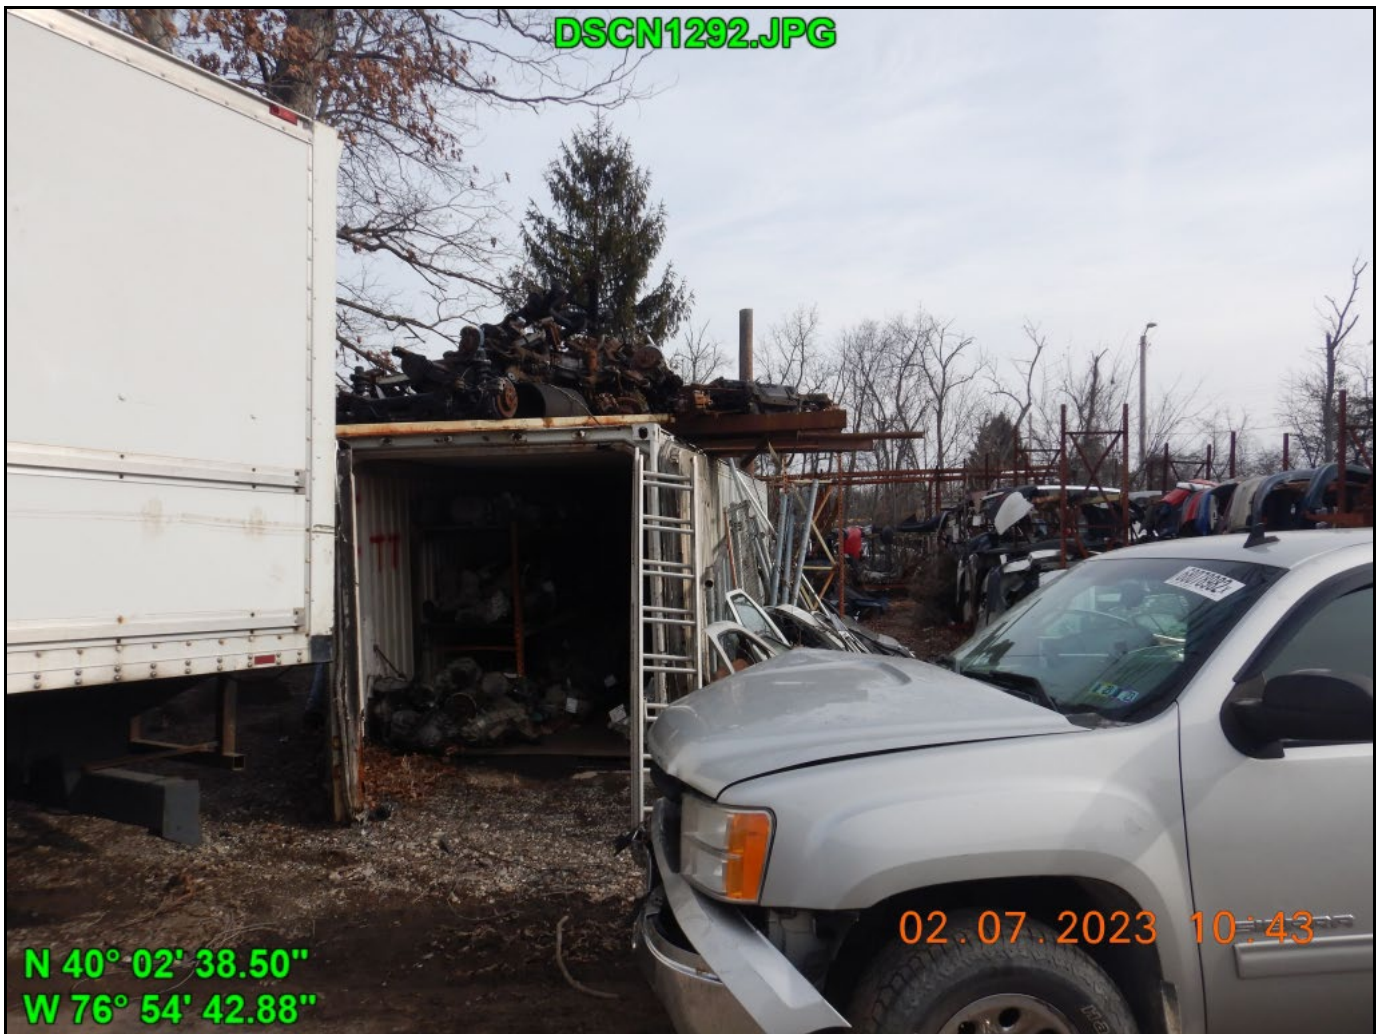
| Description | View of shipping containers used to store salvaged vehicle parts in the central area of the Facility. |

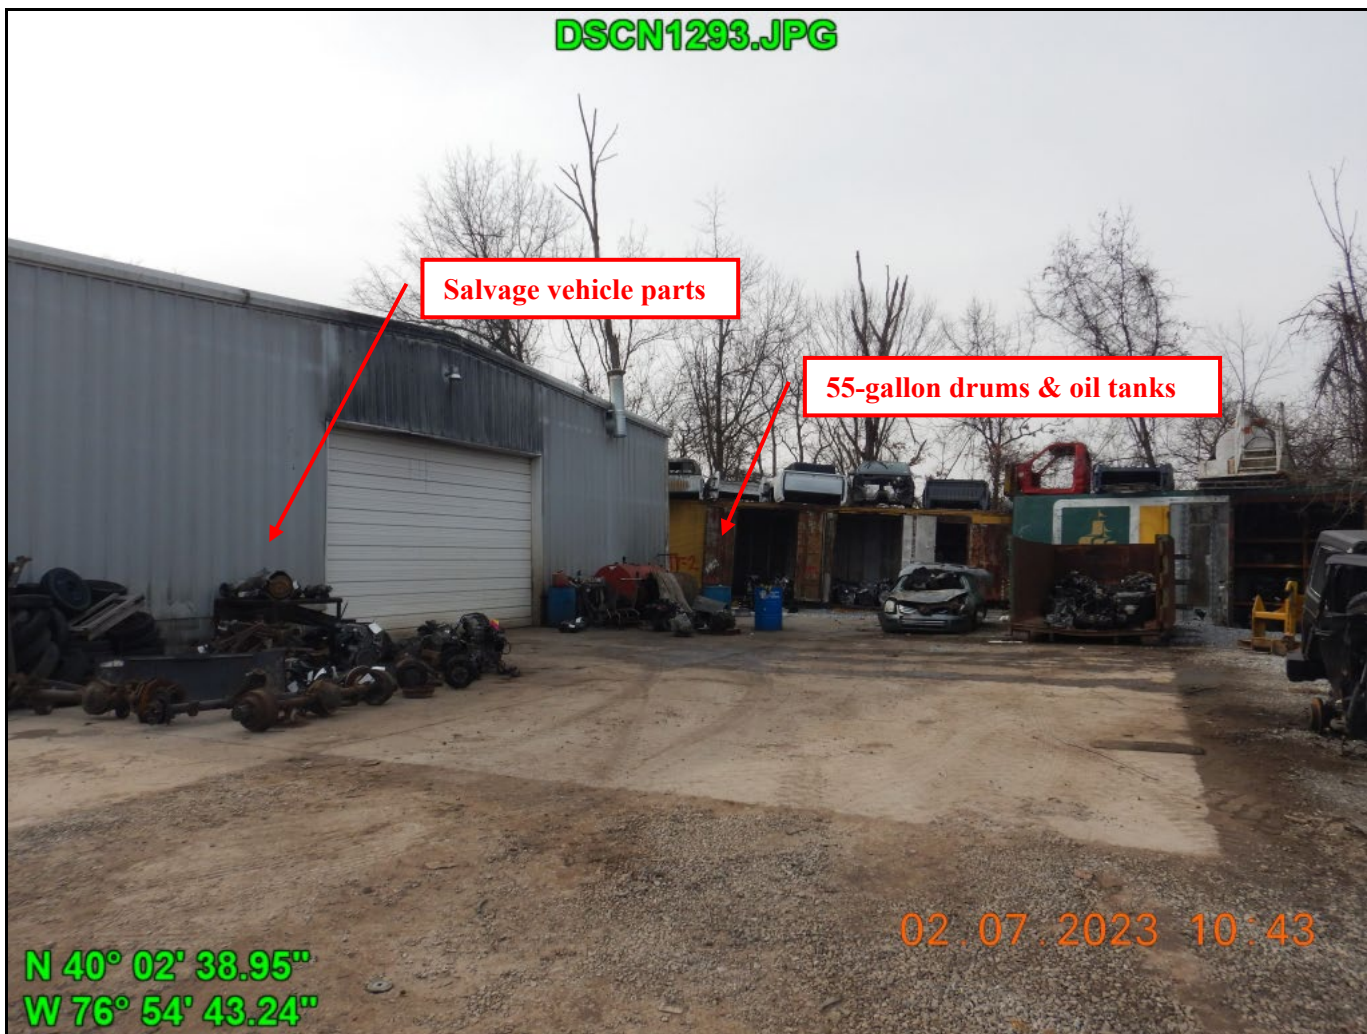
| Description | View of the back of the main office where 55-gallon drums, oil tanks, and salvage vehicle parts were stored directly on the ground without containment or overhead cover. |

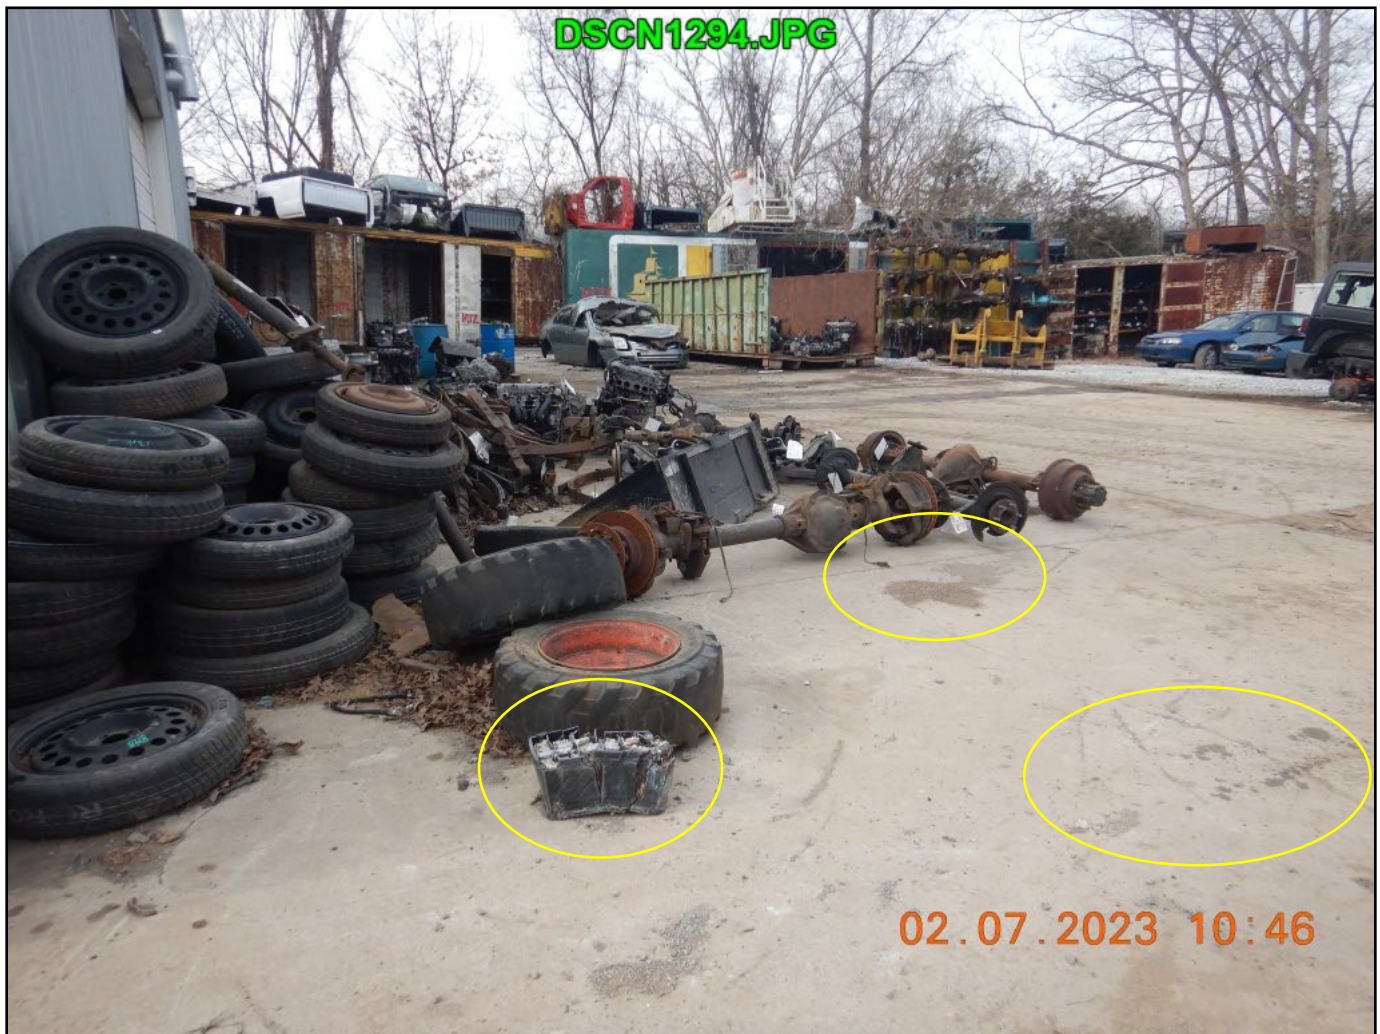
| Description | View of salvage vehicle parts and tires north of the Facility's main office. Note the petroleum product staining on the impervious surface and a crushed car battery. |

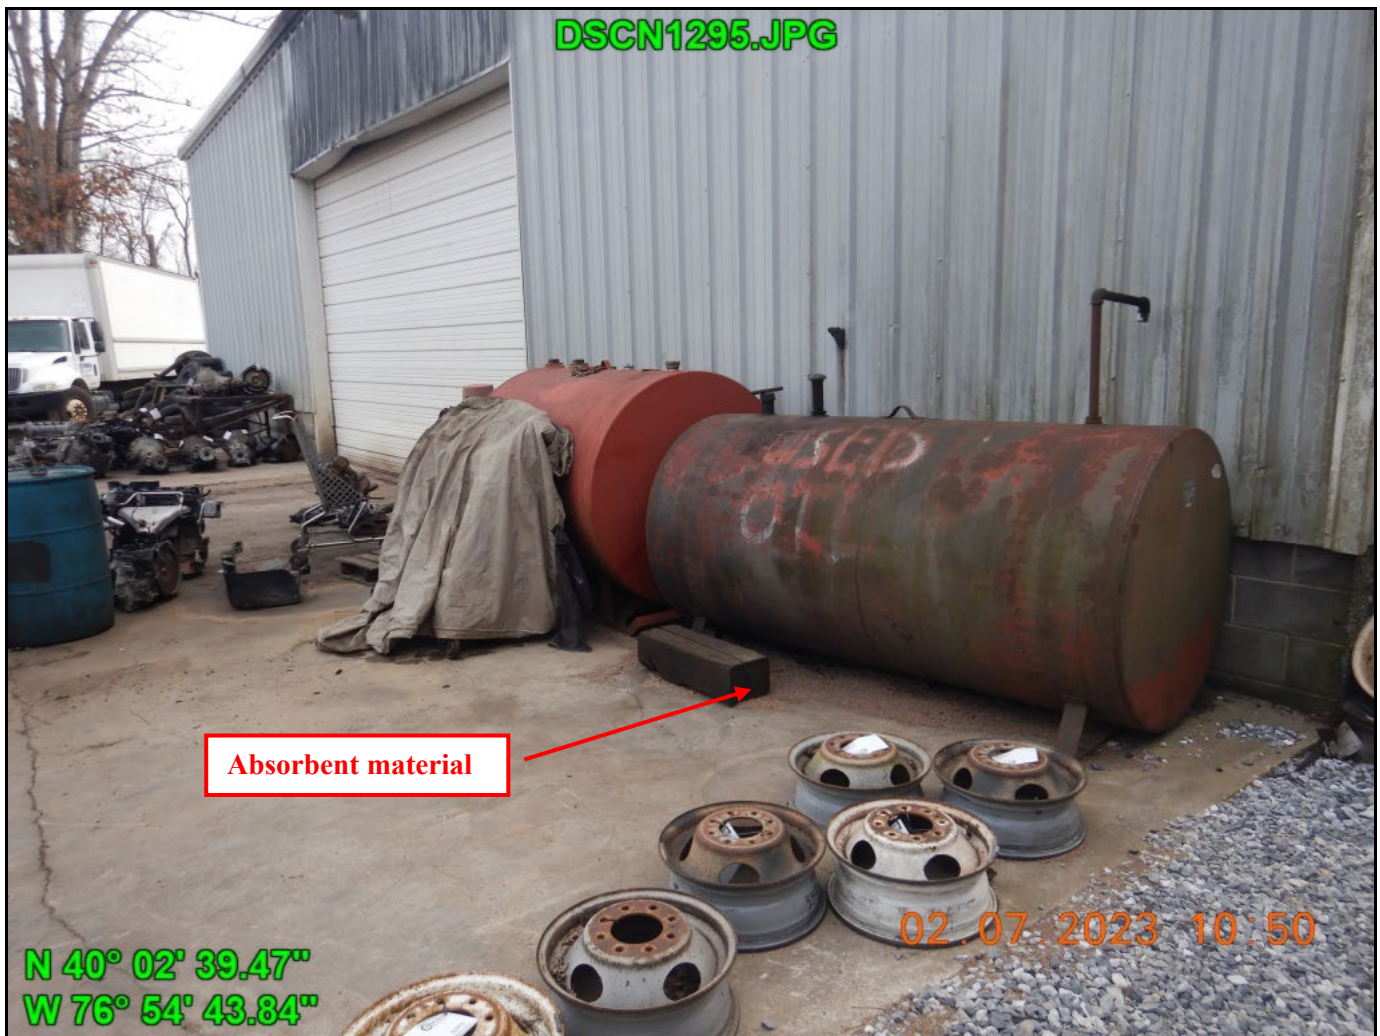
| SITE EVALUATION | |
|---|---|
| <b>Spills/Leaks Handling</b> | The EPA Inspection Team observed absorbent material scattered on top of spilled oil underneath the used oil tank at the Facility's main office building (refer to <u>Appendix B, Photograph DSCN1295</u> ).<br>The EPA Inspection Team observed petroleum product staining around the main office building (refer to <u>Appendix B, Photographs DSCN1294 &amp; DSCN1290</u> ). |

| Description | View of oil tanks at back of Facility's main office without secondary containment. Both contained liquid, one marked used oil. Note the absorbent underneath the used oil tank. |

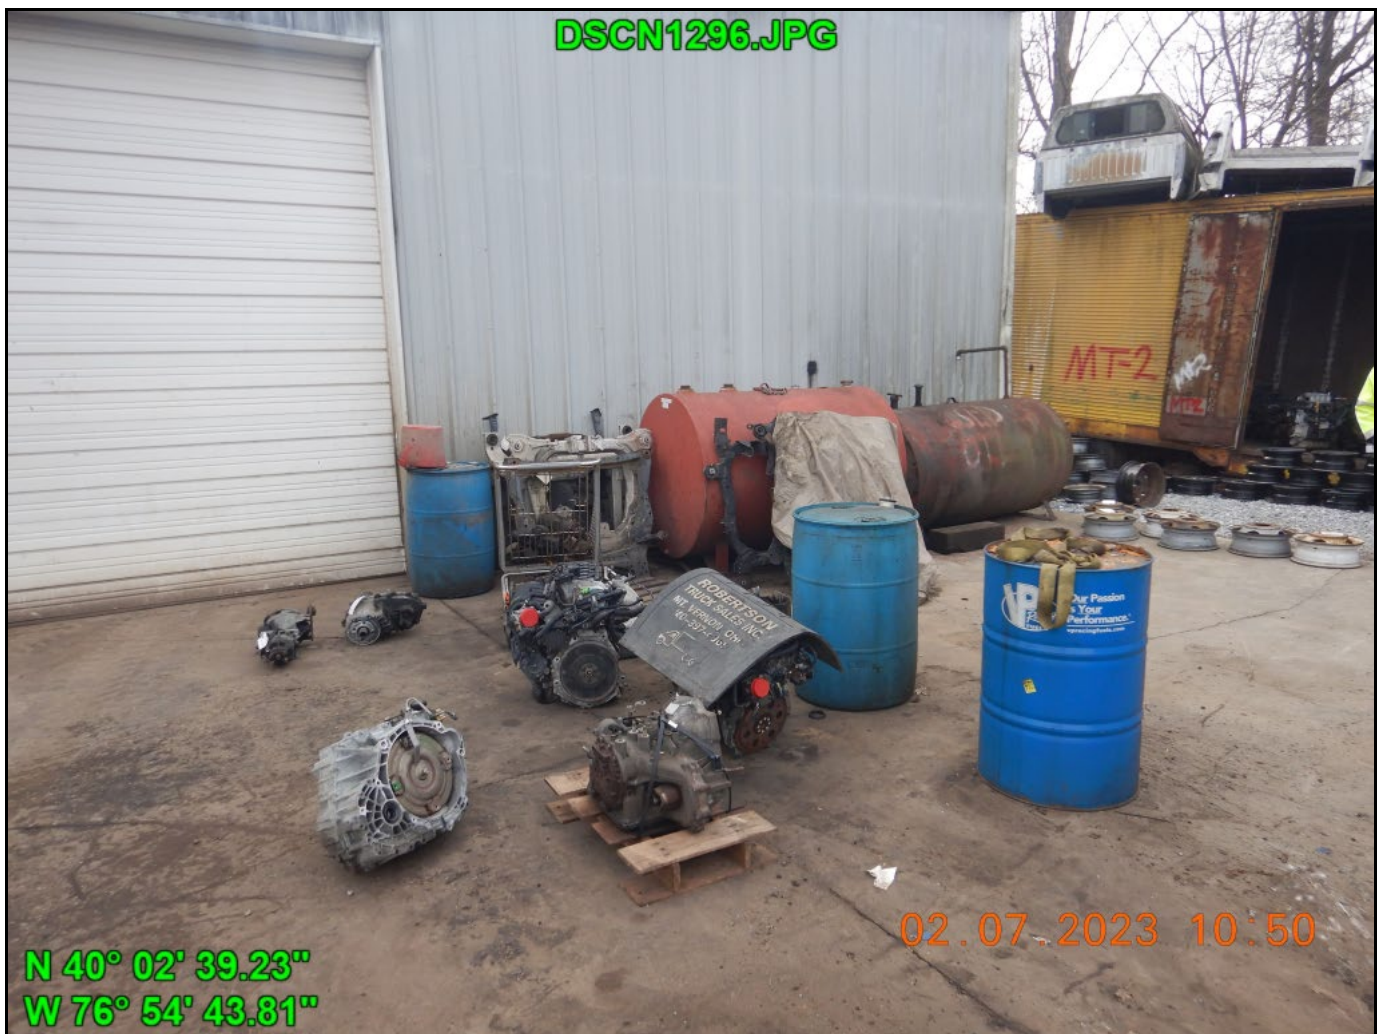
| Description | View of the back of the main office building with salvage vehicle parts, three (3) 55-gallon drums (empty and unmarked), and oil tanks (containing liquid, one marked used oil). Extensive staining throughout this area. |

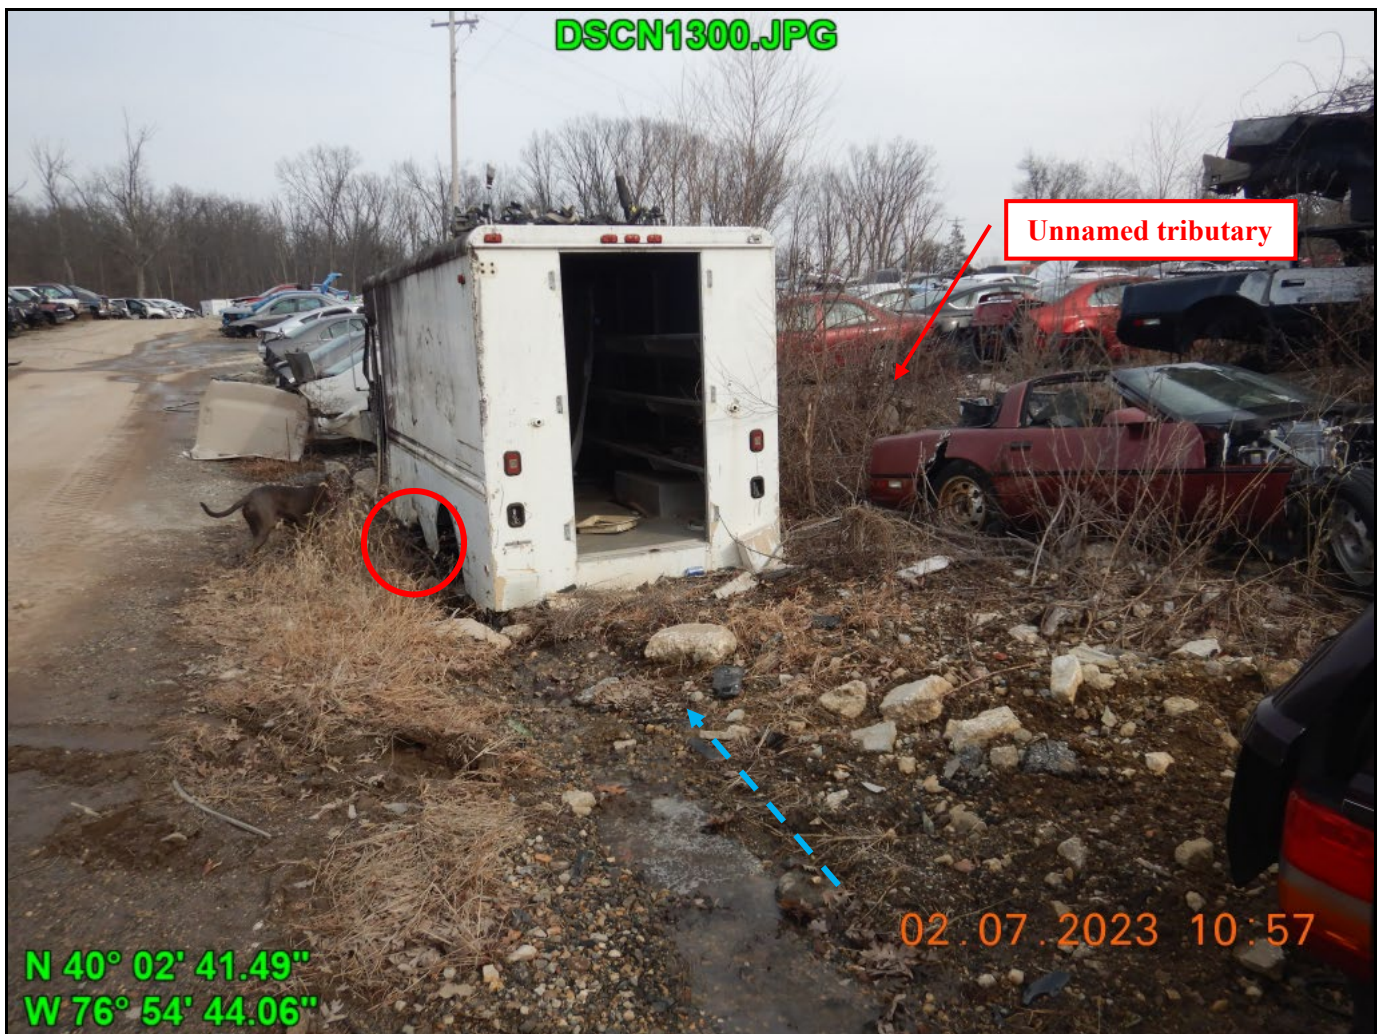
| Description | View of a discharge point to the unnamed tributary to Conewago Creek. View of salvage vehicles stored adjacent to the unnamed tributary to Conewago Creek. The white box truck spans across the unnamed tributary to Conewago Creek. |

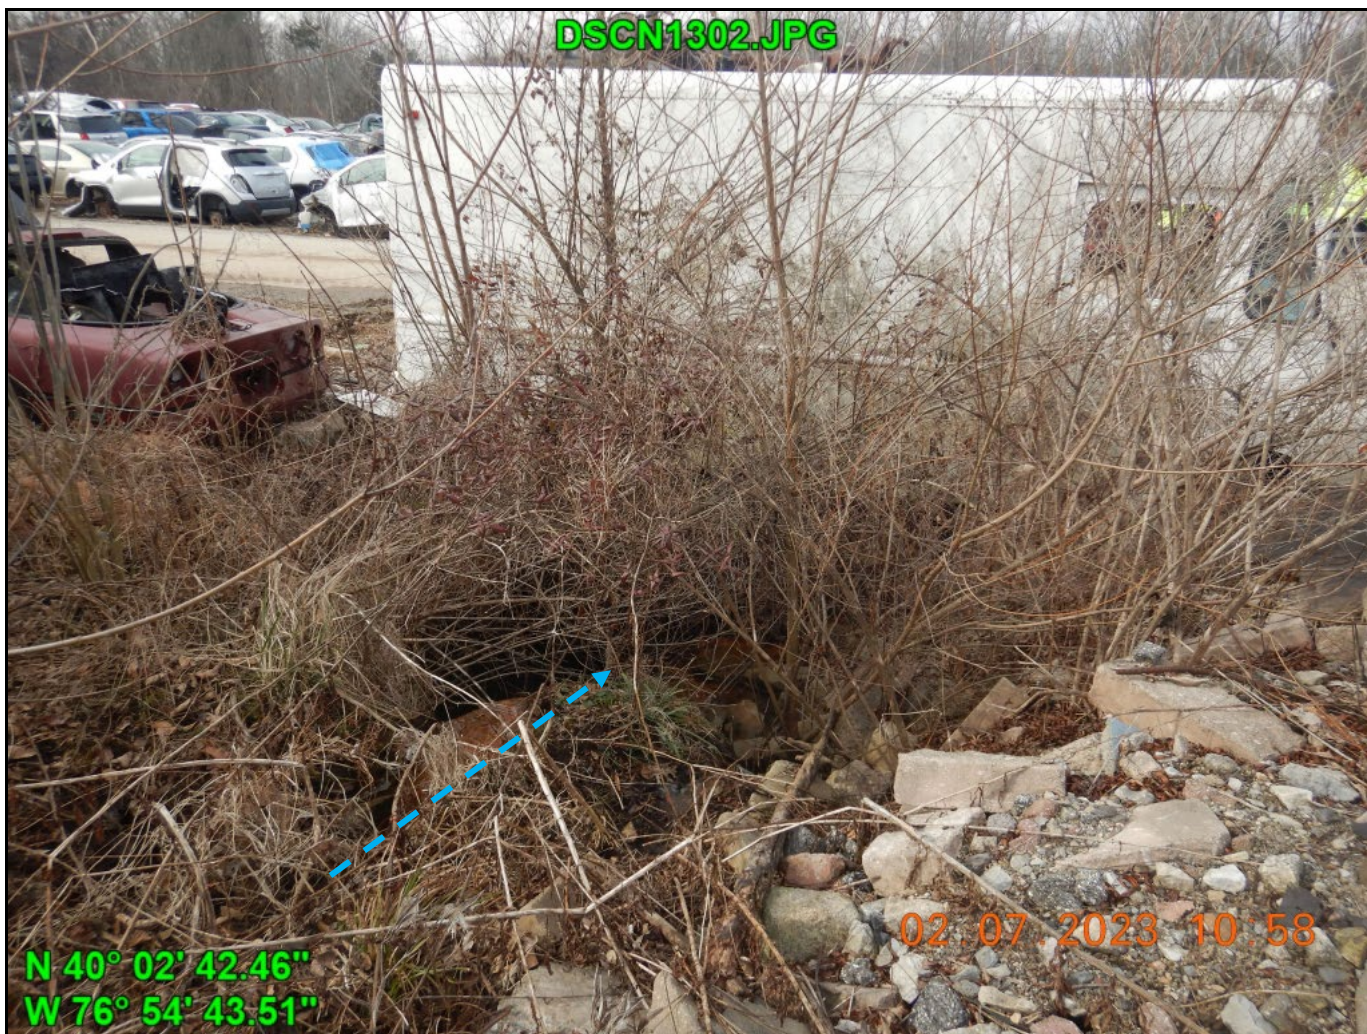
| Description | Additional view of discharge point to the unnamed tributary to Conewago Creek, running underneath a salvage vehicle into a culvert underneath the driveway. The unnamed tributary to Conewago Creek runs from east to west. |

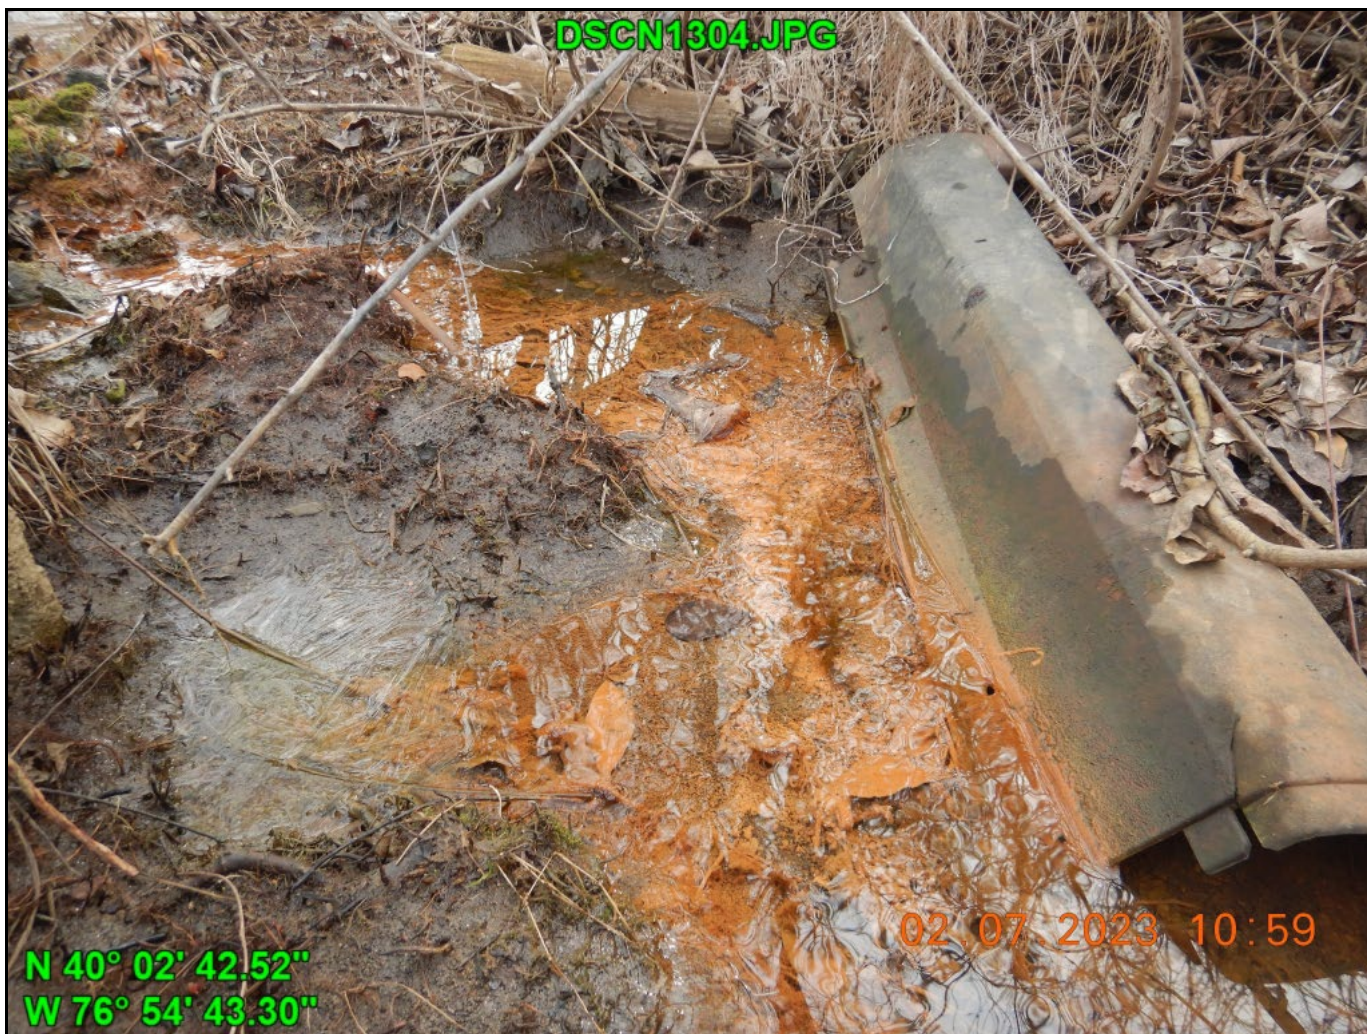
| Description | View of orange-colored ponded water south of the unnamed tributary to Conewago Creek with metal scrap from salvaged vehicles. The coloration was consistent with evidence of iron oxidizing bacteria. |

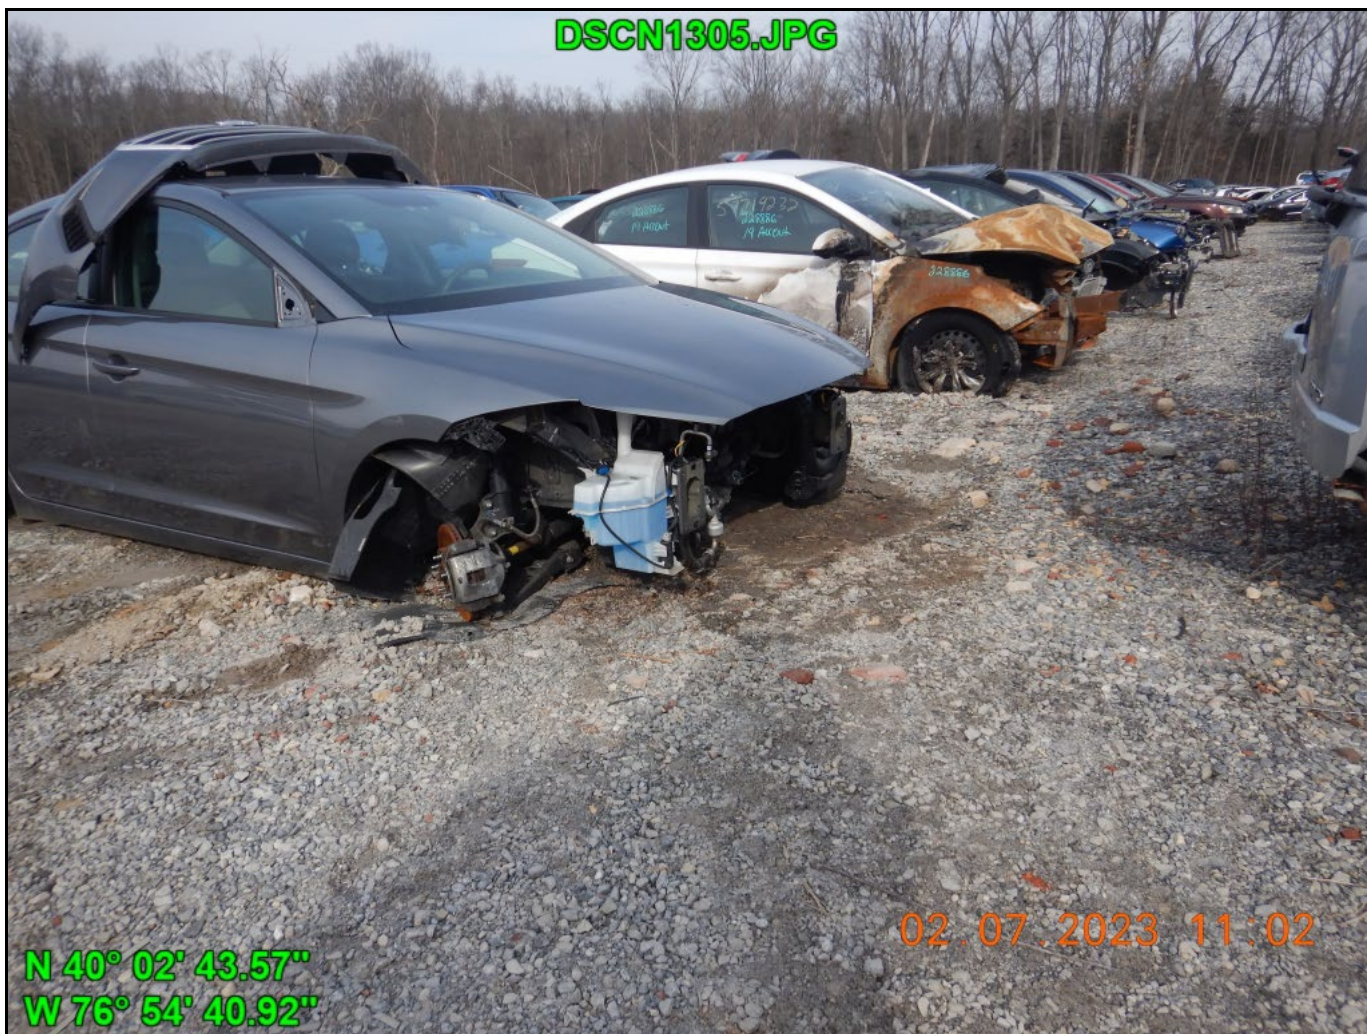
- c. The Facility did not have coverage under a Permit at the time of the inspection.
- 2) The EPA Inspection Team observed salvage vehicles still containing windshield washer fluid in the outdoor salvage vehicle storage area (refer to Appendix B, Photograph DSCN1305).

| Description | View of a salvage vehicle on the pervious surface in the north area of the Facility containing windshield wiper fluid. |

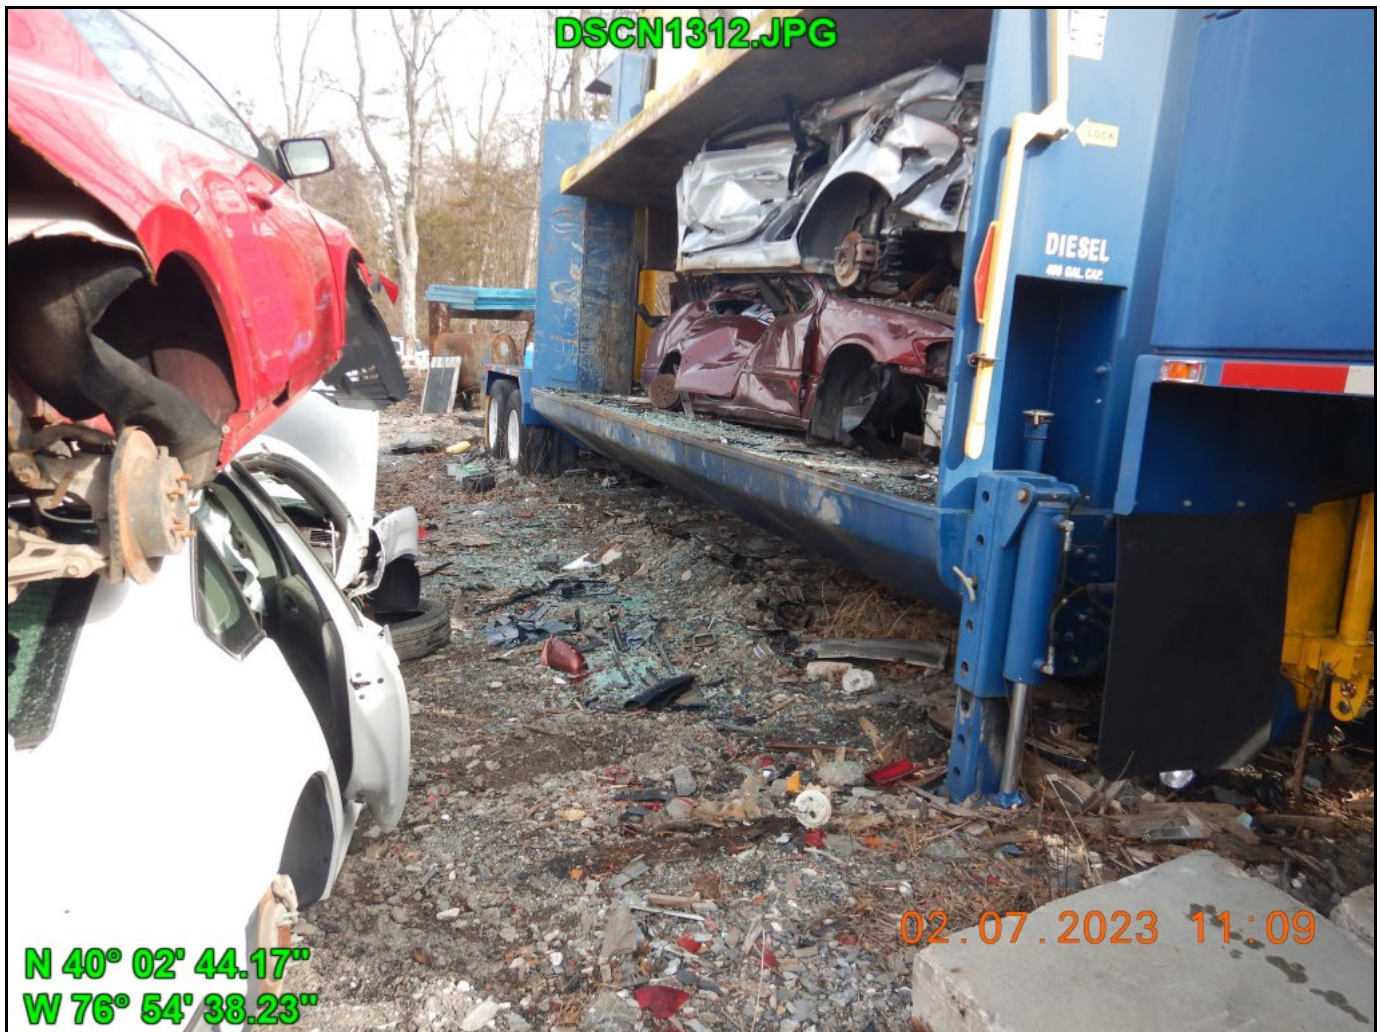
| Description | Additional view of salvage vehicle crusher with substantial debris surrounding the operation. |

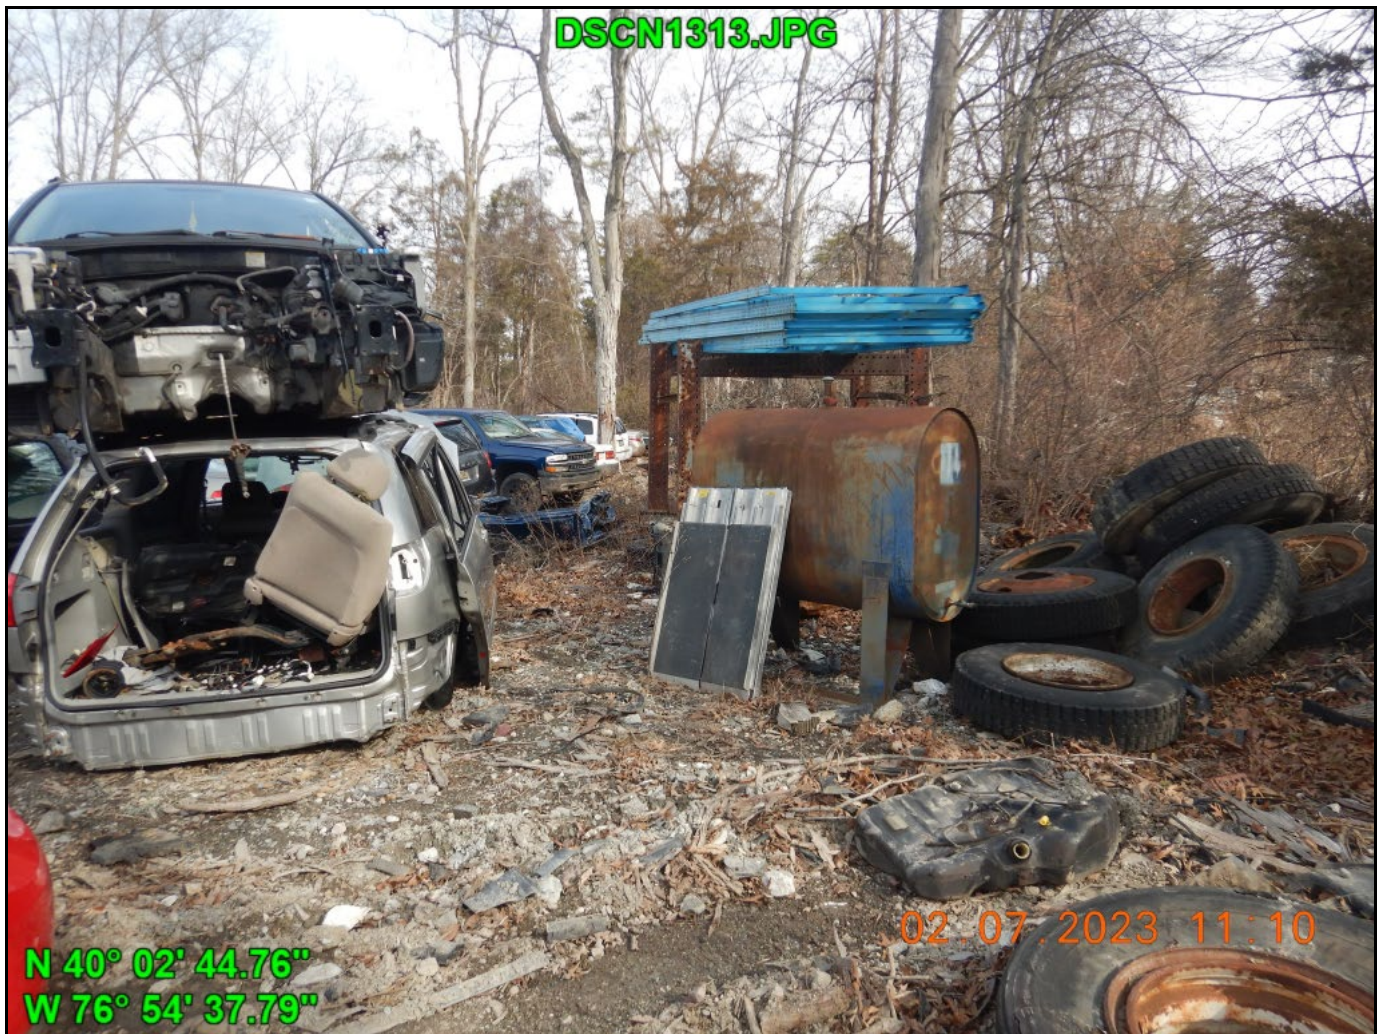
- 4) The EPA Inspection Team observed three (3) oil tanks at the Facility. One by the salvage vehicle crusher (refer to Appendix B, Photograph DSCN1313), which was empty, unmarked, and without containment nor under cover. The two oil tanks by the main office building (refer to Appendix B, Photographs DSCN1293, DSCN1295, & DSCN1296), both contained liquids, one of which was labeled as used oil, and neither of the oil tanks were in containment nor under cover.
- 5) The EPA Inspection Team observed orange-colored ponded water south of the unnamed tributary to Conewago Creek running through the Facility property (refer to Appendix B, Photograph DSCN1304). The coloration was consistent with that of typical iron-oxidizing bacteria.

| Description | View of an oil tank adjacent to the salvage vehicle crusher. The tank was empty, unmarked, and without containment or cover at the time of inspection. Empty fuel tank in the foreground. |

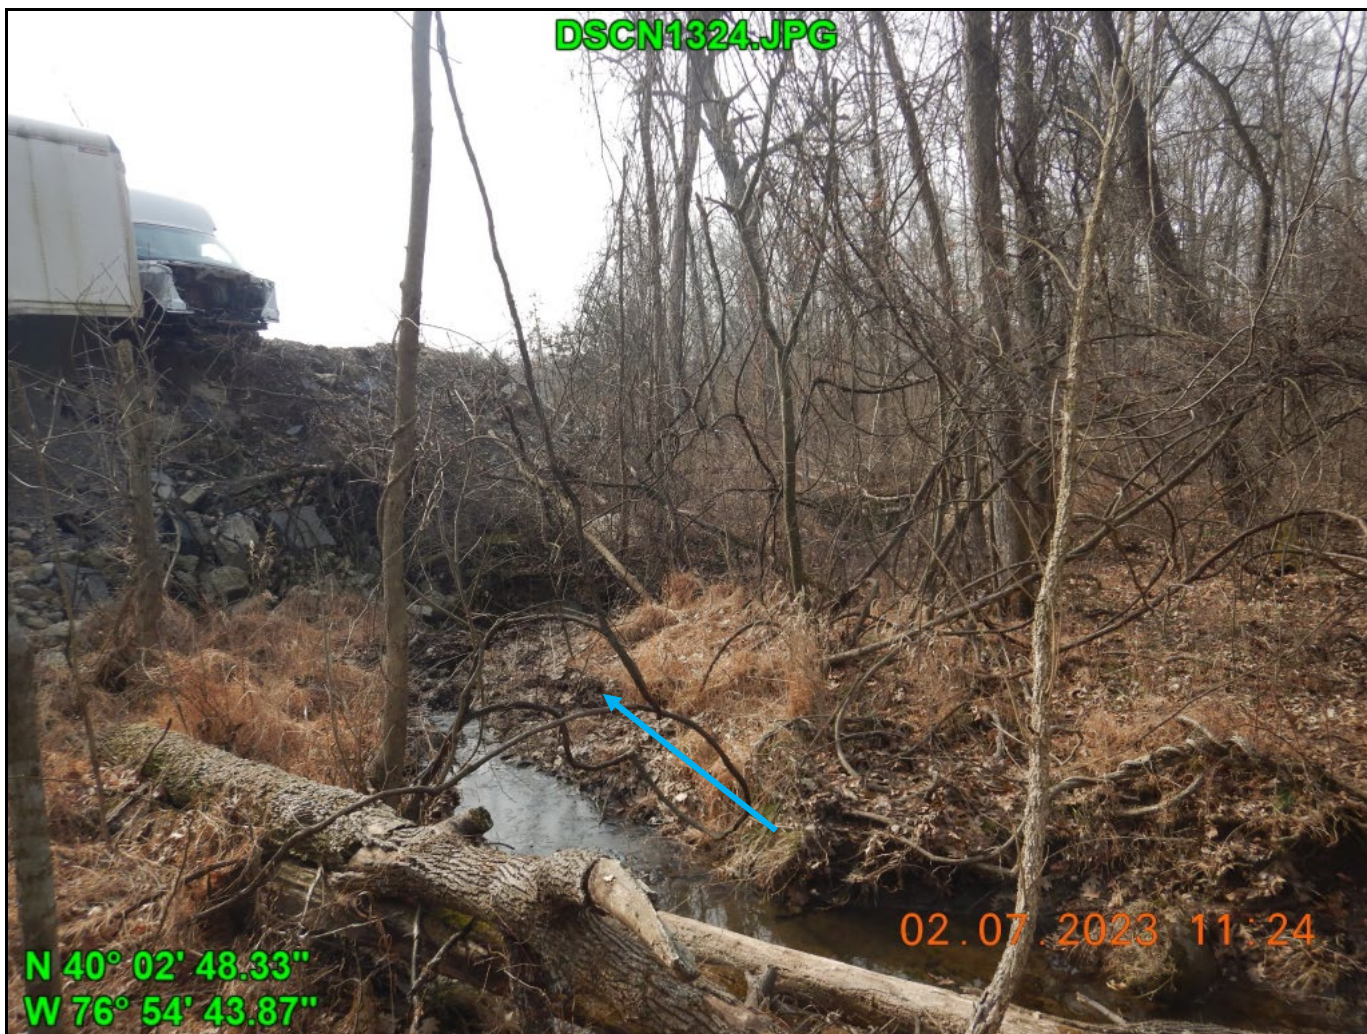
| Description | View of the unnamed tributary to Conewago Creek running along the Facility's western boundary. Note the salvage vehicles stored adjacent to the unnamed tributary. |
