## MULTI-SECTOR GENERAL PERMIT NON-FILER INSPECTION CHECKLIST

| <b>Inspection Date(s):</b> | 2/7/2023 | |
| <b>Operator Name:</b> | Lebarron's Auto Salvage | |

**Appendix A. Aerial Map**  
**Clean Water Act Inspection**  
**Lebarrons Auto Salvage**

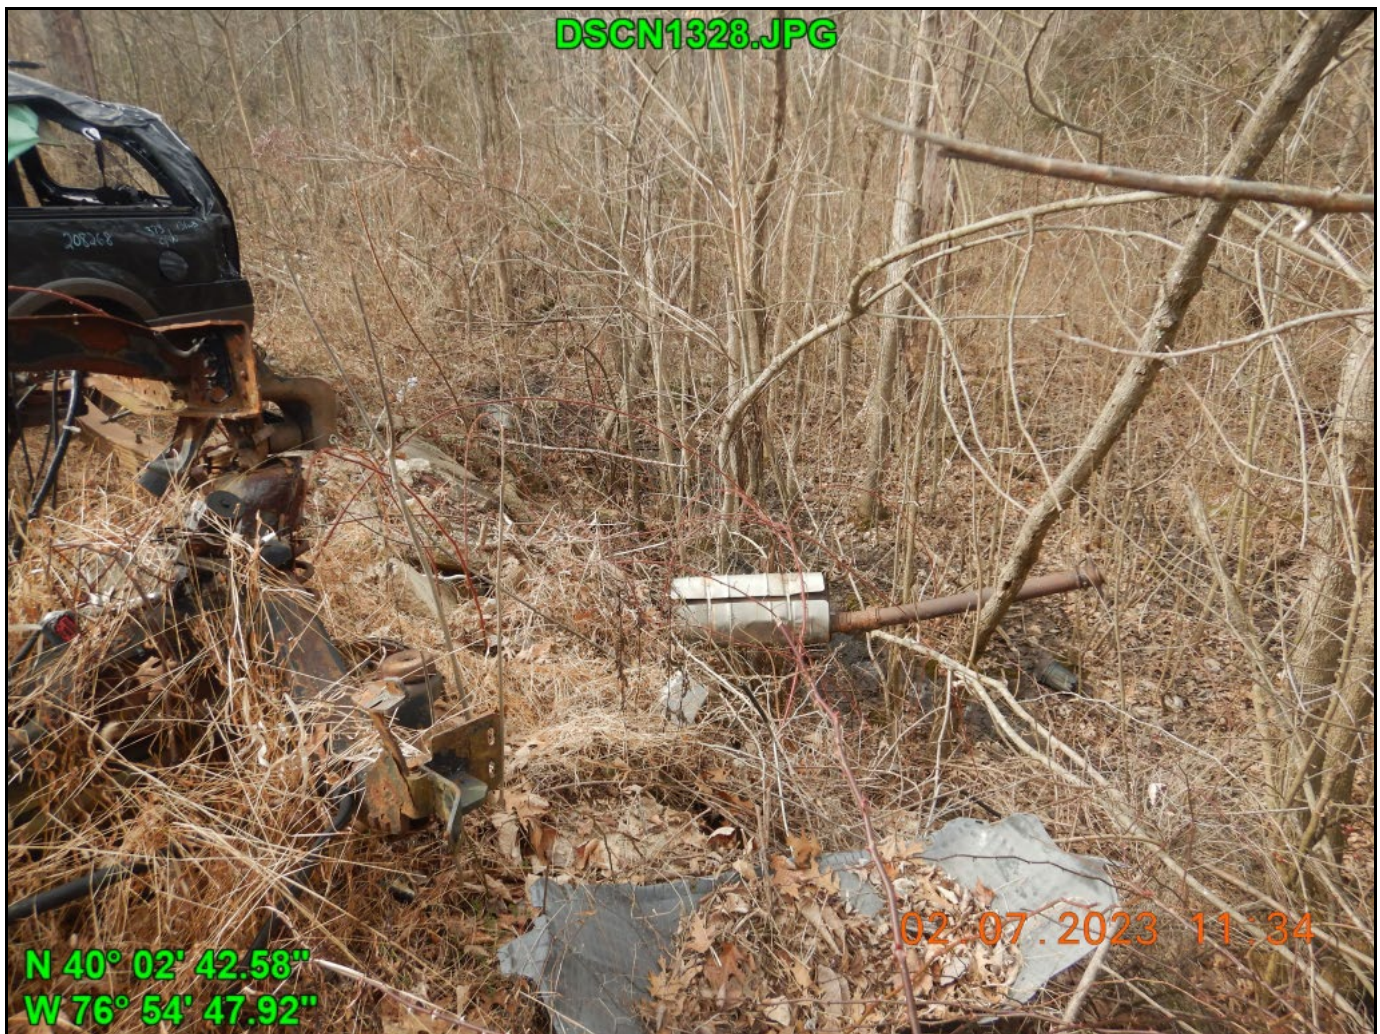
| Description | View of salvage vehicle scrap parts adjacent to the unnamed tributary to Conewago Creek running along the Facility's western boundary. |

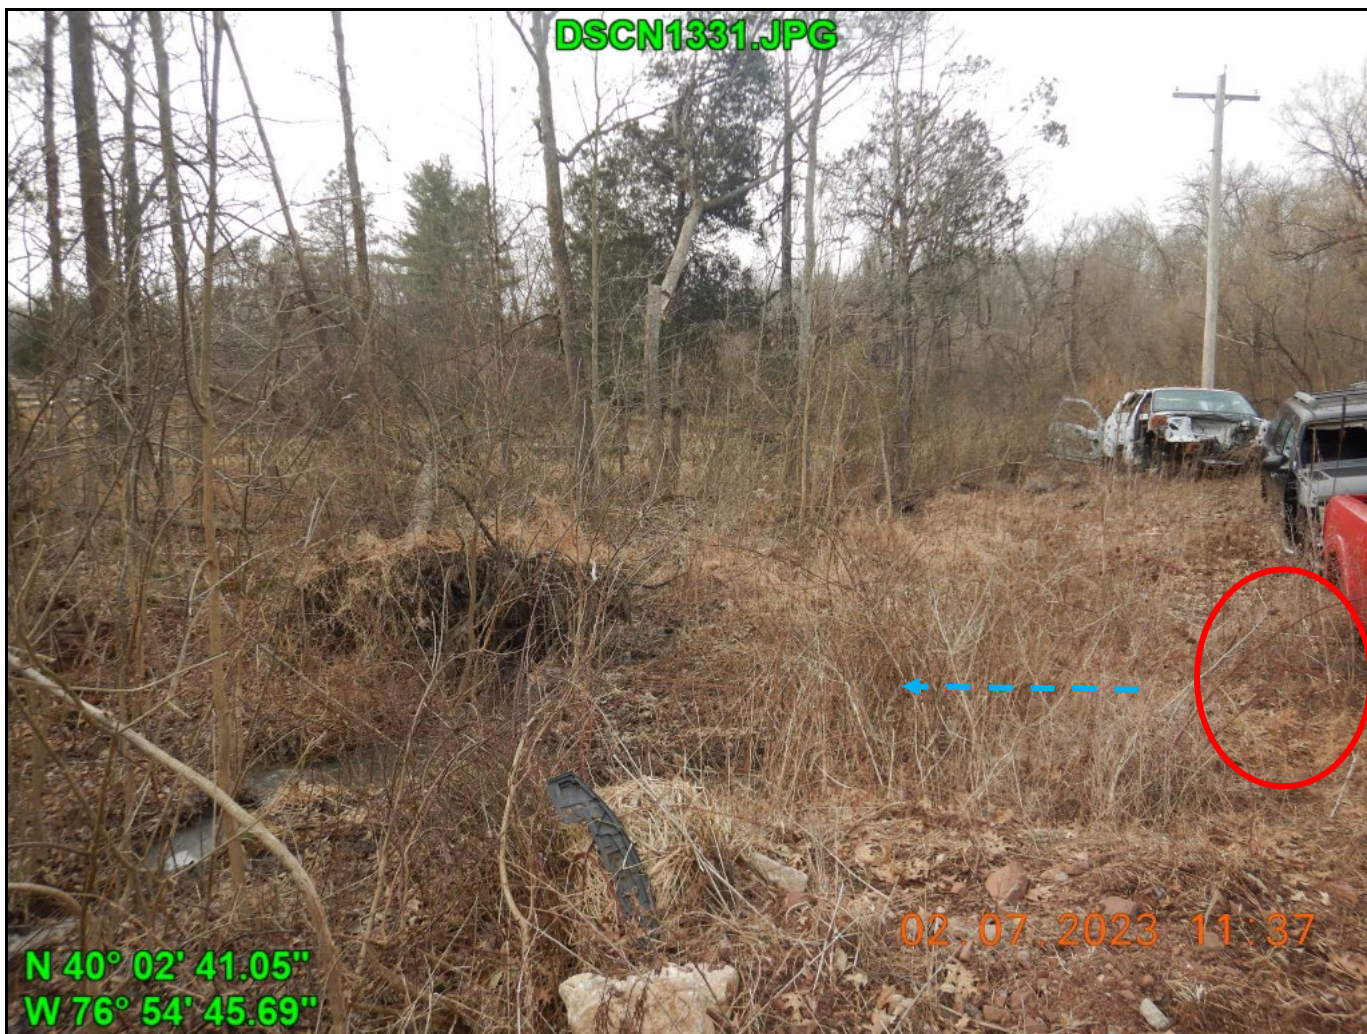
| Description | Point of concentrated discharge (red circle) to the unnamed tributary to Conewago Creek running along the southwest corner of the Facility. |

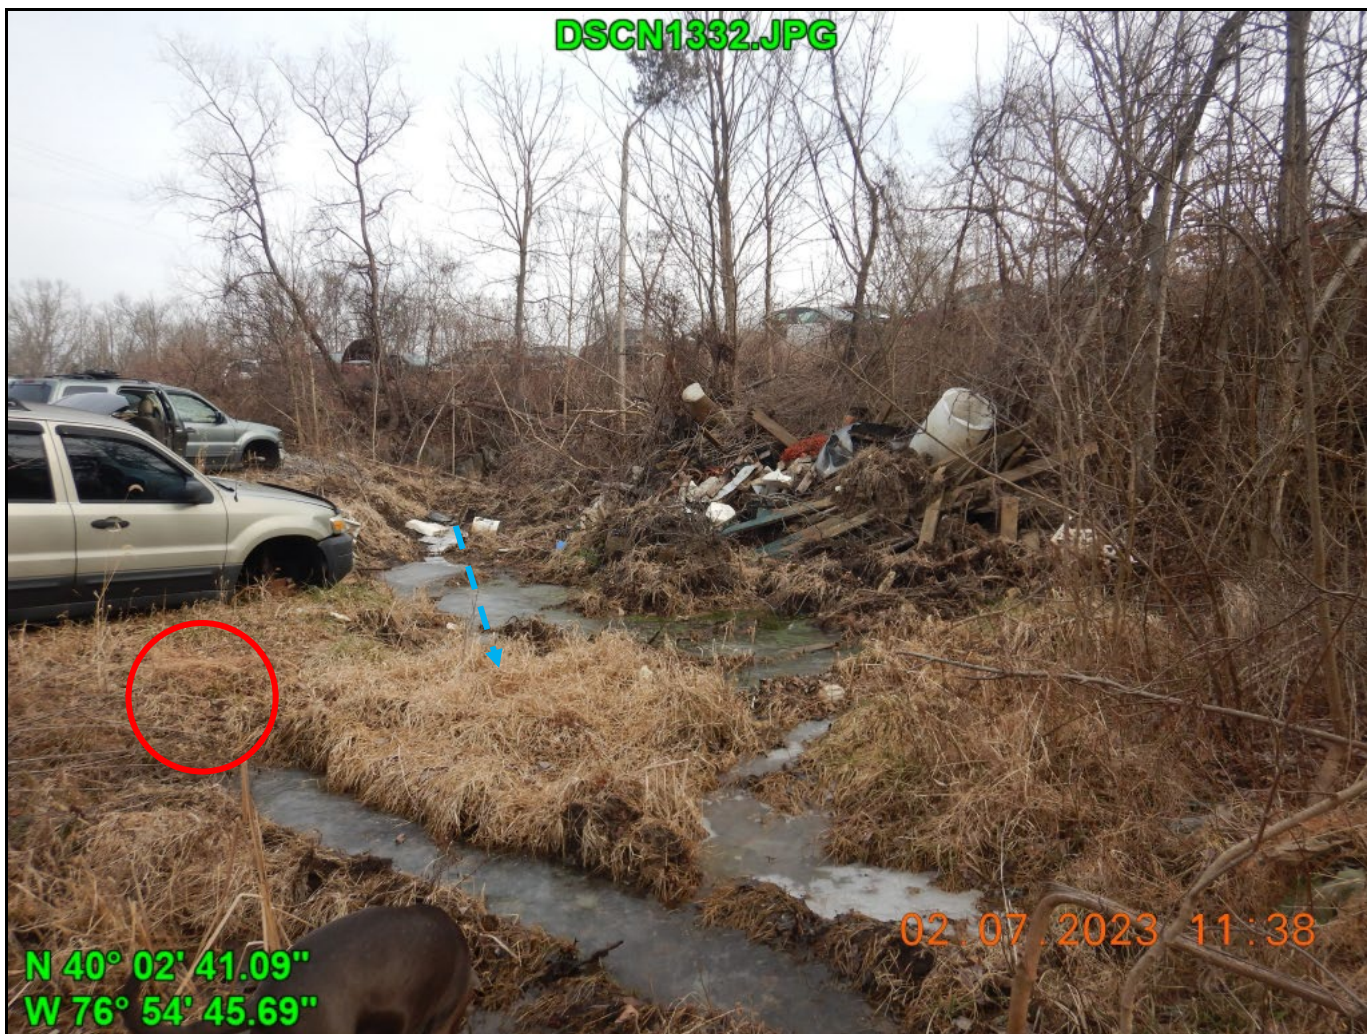
| Description | Point of concentrated discharge (red circle) to the unnamed tributary to Conewago Creek running through the Facility with a substantial collection of trash and debris along the bank. Salvage vehicles stored adjacent to unnamed tributary. |

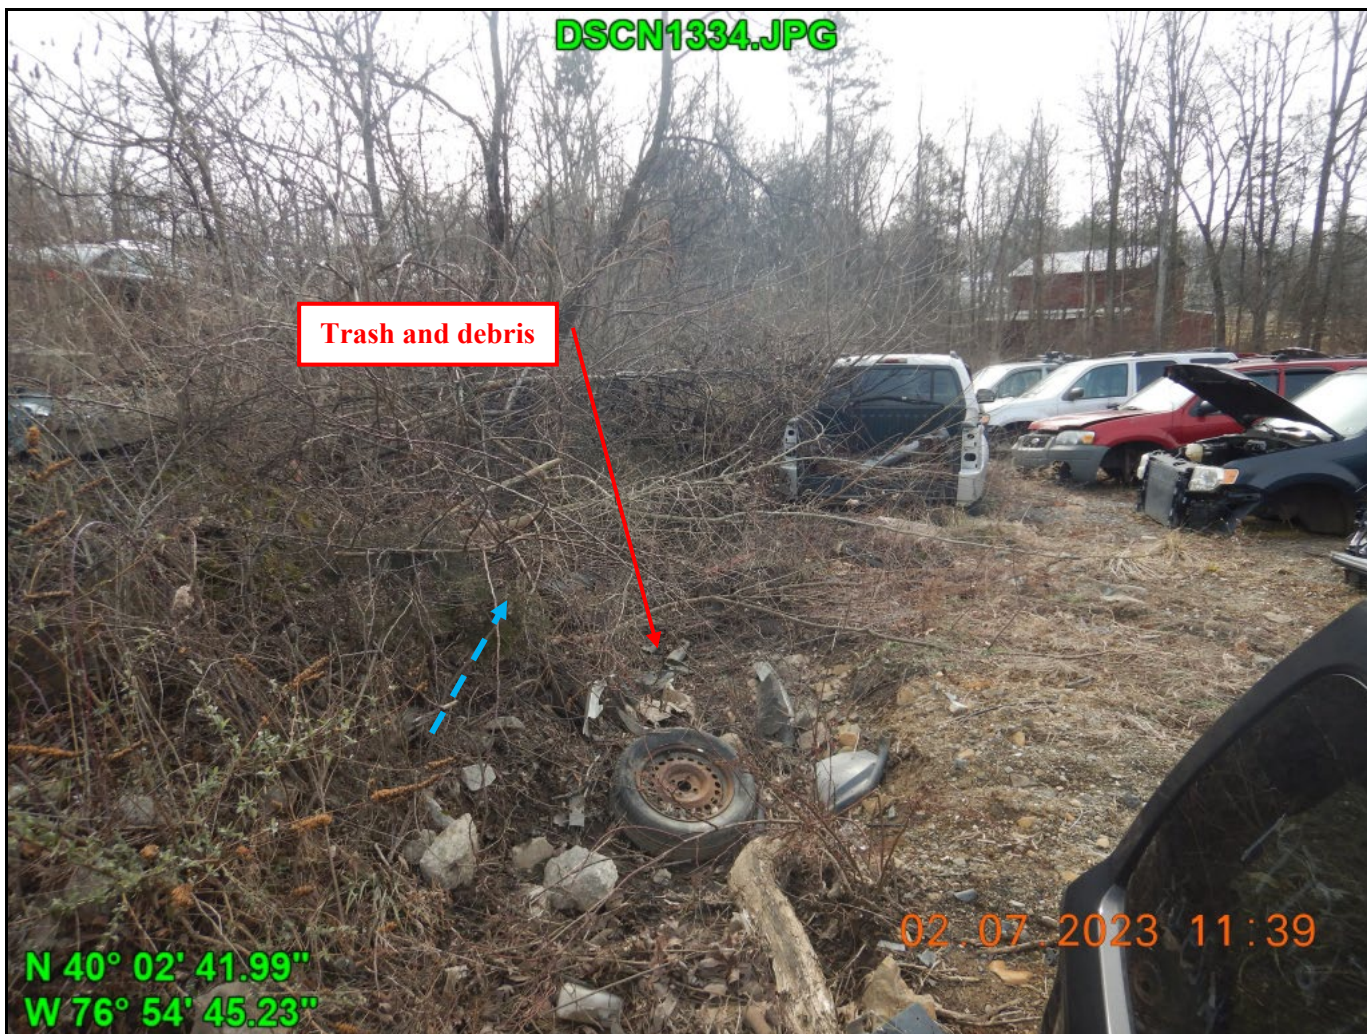
| Description | View of the unnamed tributary to Conewago Creek running through the Facility. Note the trash and debris in and around the tributary. Also note the salvage vehicles stored adjacent to the unnamed tributary. |
