## Region 6 - Enforcement & Compliance Assurance Division

### INSPECTION REPORT

| Company Name: | <b>L.A. Look Auto Inc.</b> | |
| Facility Name: | <b>Alpha Auto Parts</b> | |

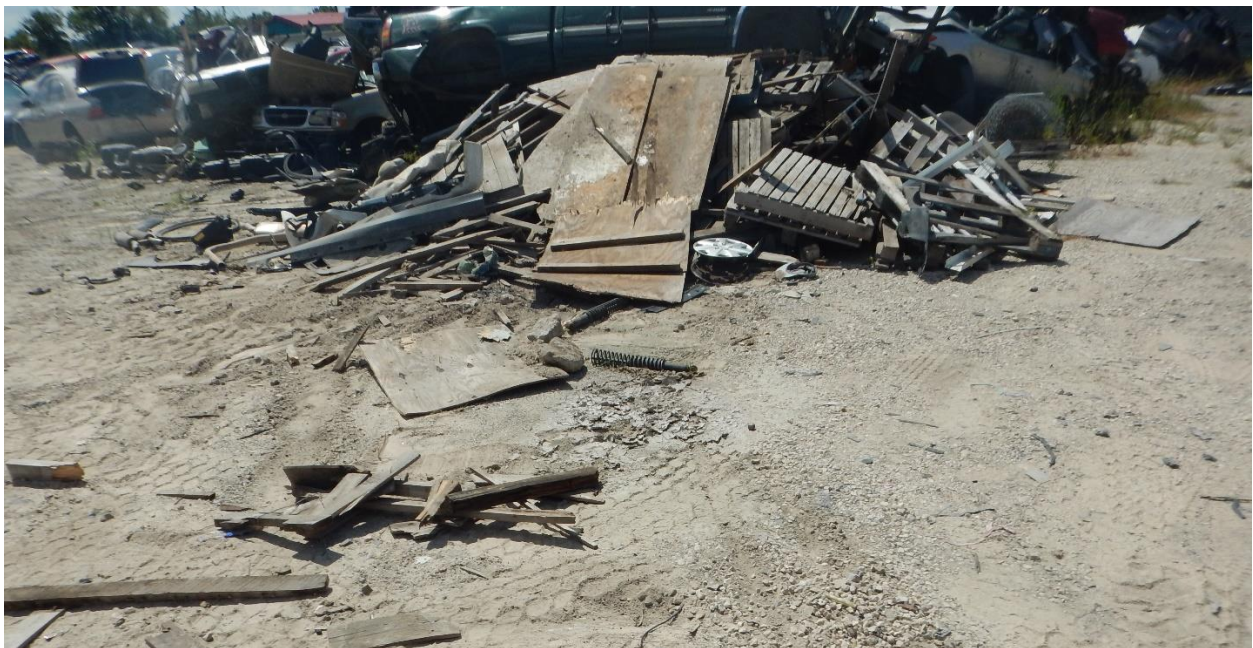
Photo No. 2

5. Pollution Prevention Measures and Controls (See Appendix 1, Photograph Log, Photo Nos. 2-18):
  - a. In accordance with **TPDES General Permit TXR050000, Part III, Section A(4)a) and A(4)(b)**, the salvage yard was not maintained in an effective operating condition (i.e., poor housekeeping).

- i. Trash and other automotive debris and equipment were improperly stored;
    - ii. The permittee was unable to provide a process and/or confirmation that all scrap metal material/equipment was properly drained, prior to discarding in the roll off boxes; and

Description: View, of Alpha Auto Parts' salvage yard, not maintained in an effective operating condition (e.g., poor housekeeping; trash and other automotive debris and equipment improperly stored).

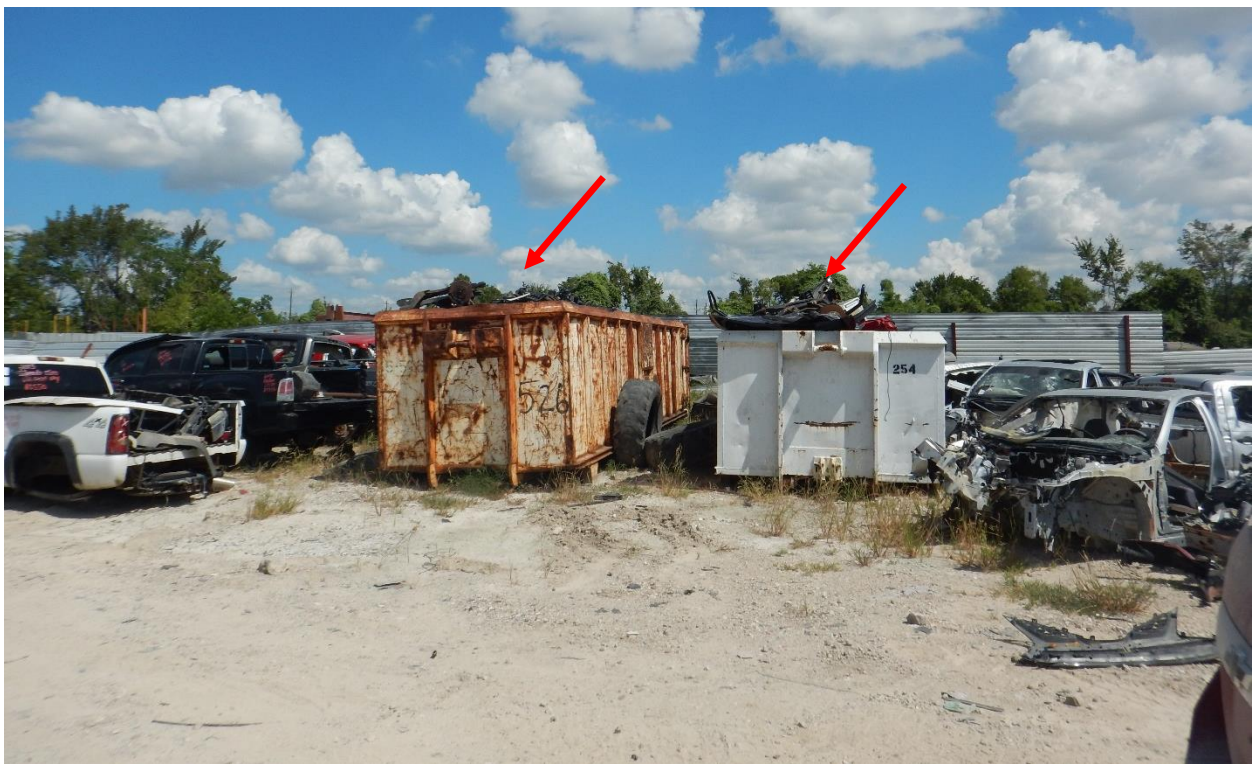
Photo No. 3

- iii. Oily, discarded automotive equipment was stored in open-top containers exposed to the elements, etc. (See Appendix 1, Photograph Log, Photo Nos. 1-4).

Description: View, of full roll off boxes containing scrap metal and other discarded auto parts. Note: The containers were full, uncovered and exposed to the elements, including rainwater that is received at the facility. The permittee was unable to provide a process and/or confirmation that all equipment was properly drained, prior to discarding in the roll off boxes. Closer views provided in following photos #4 and #5.

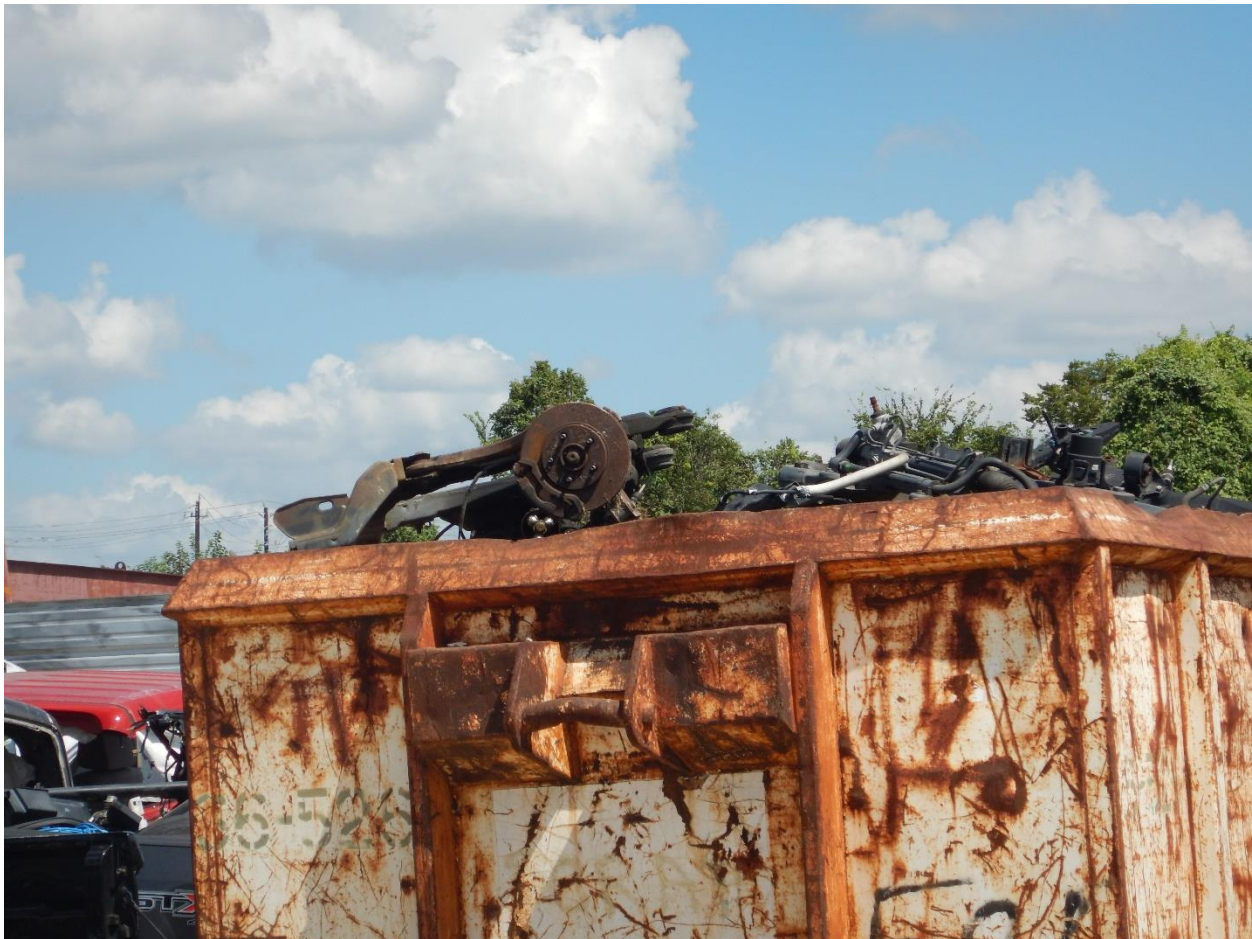
Photo No. 4

Description: Closer view, of full roll off boxes containing scrap metal and other discarded auto parts.

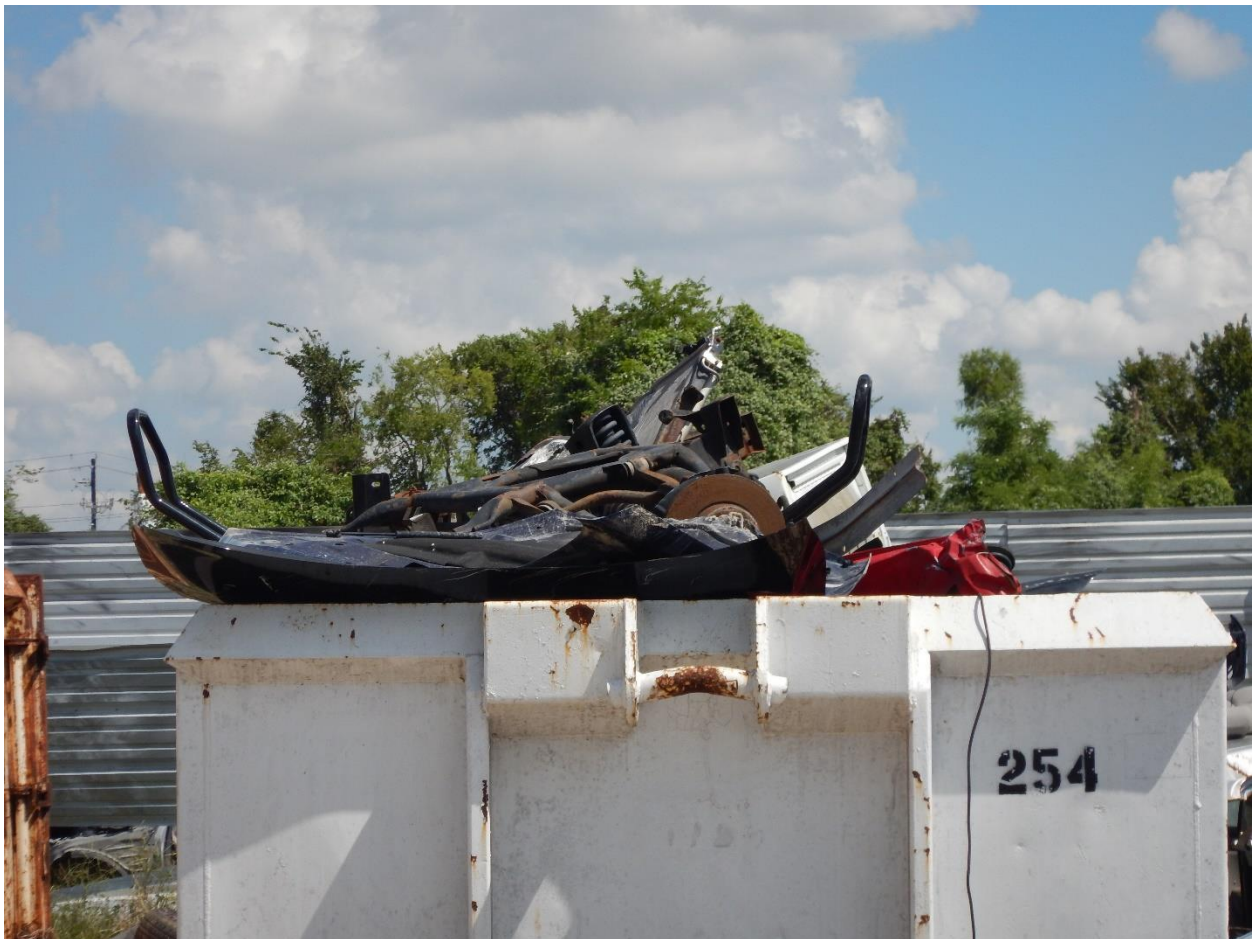
Photo No. 5

Description: Closer view, of full roll off boxes containing scrap metal and other discarded auto parts.

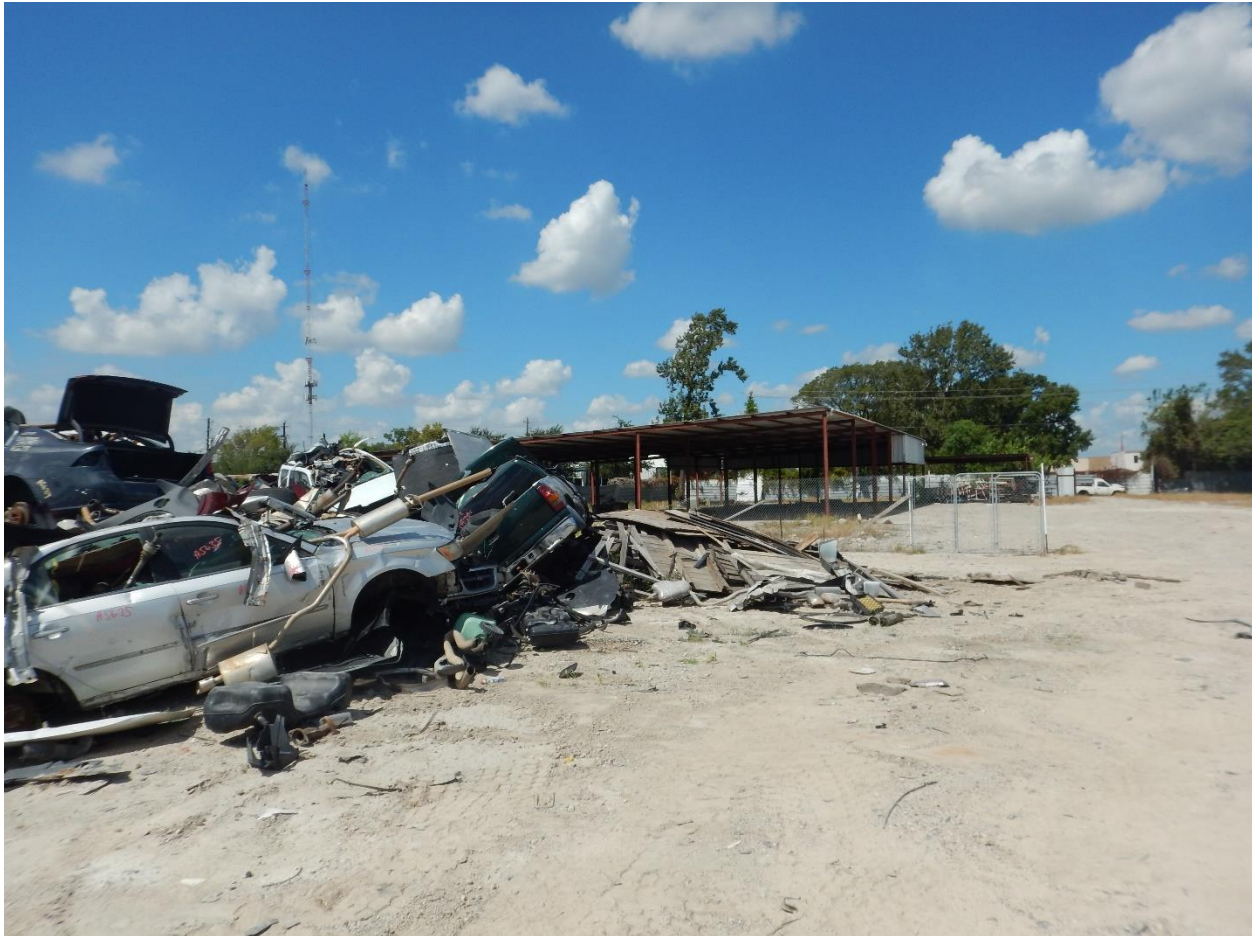
Photo No. 6

Description: View, of Alpha Auto Parts' salvage yard, not maintained in an effective operating condition (e.g., poor housekeeping; trash and other automotive debris and equipment improperly stored).

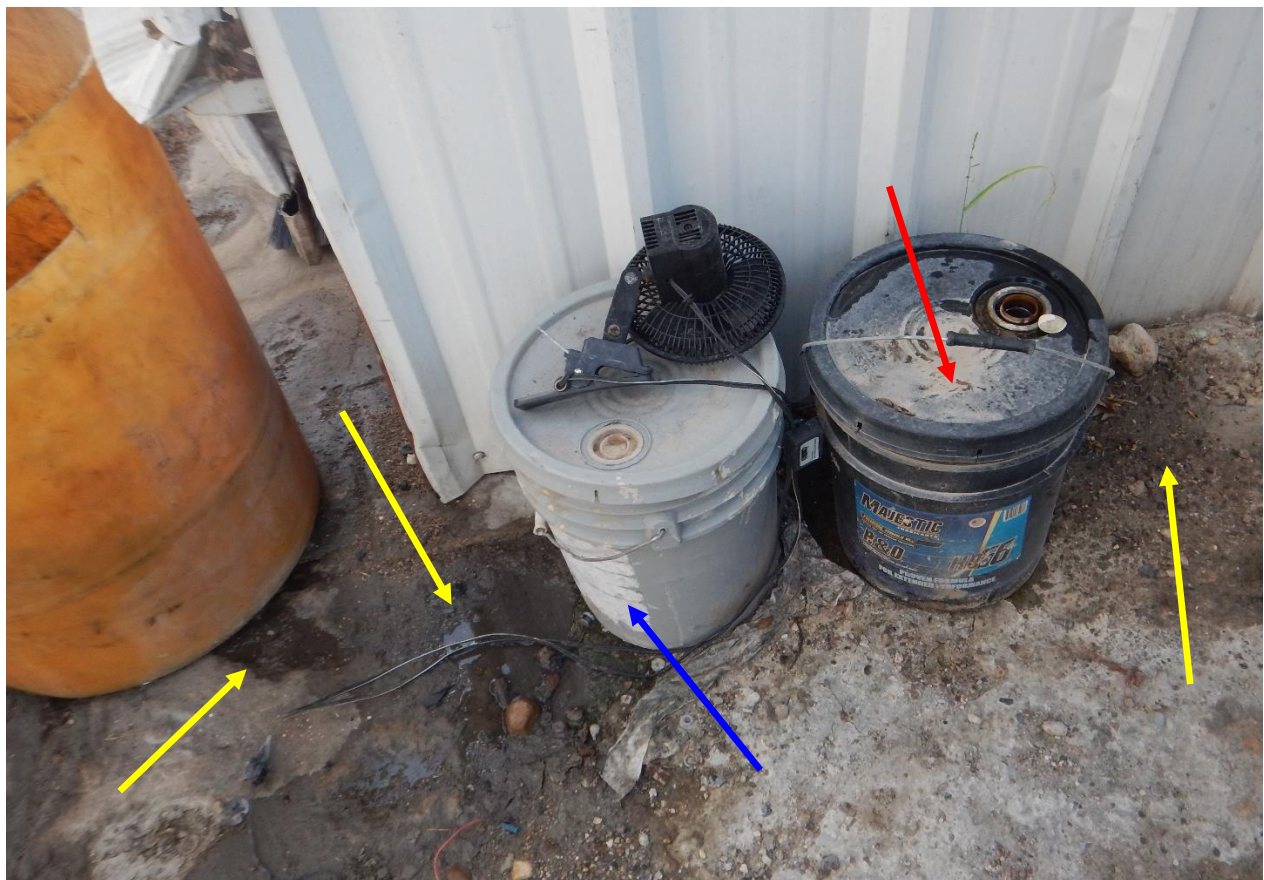
Photo No. 7

Description: View, of two (2) 5-gallon buckets and a 55-gallon drum/container, not maintained in an effective operating condition (e.g., poor housekeeping). The labeling on one bucket was not legible to confirm contents and the permittee was also unsure (see blue arrow). The other bucket contained hydraulic oil (see red arrow). Note: Oily residue was observed in the immediate vicinity of the two (2) buckets and 55-gallon drum. A closer view of the labeled bucket reflected by red arrow captured in photo #8 and #9. Photo #10 captures a closer view of the 55-gallon drum/container.

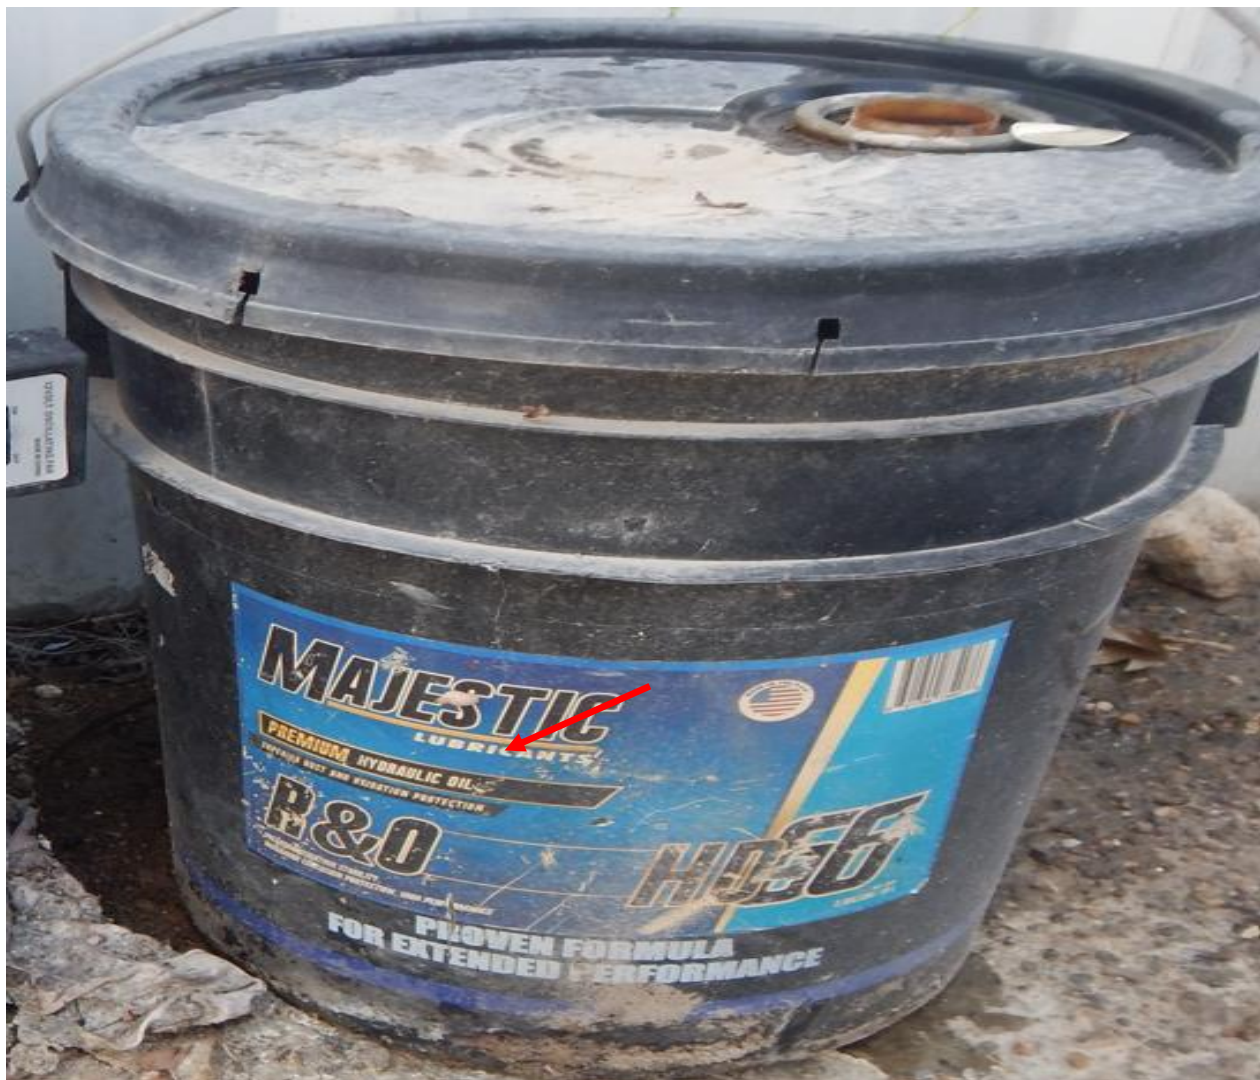
Photo No. 8

Description: Closer view, of 5-gallon bucket containing hydraulic oil (see red arrow).

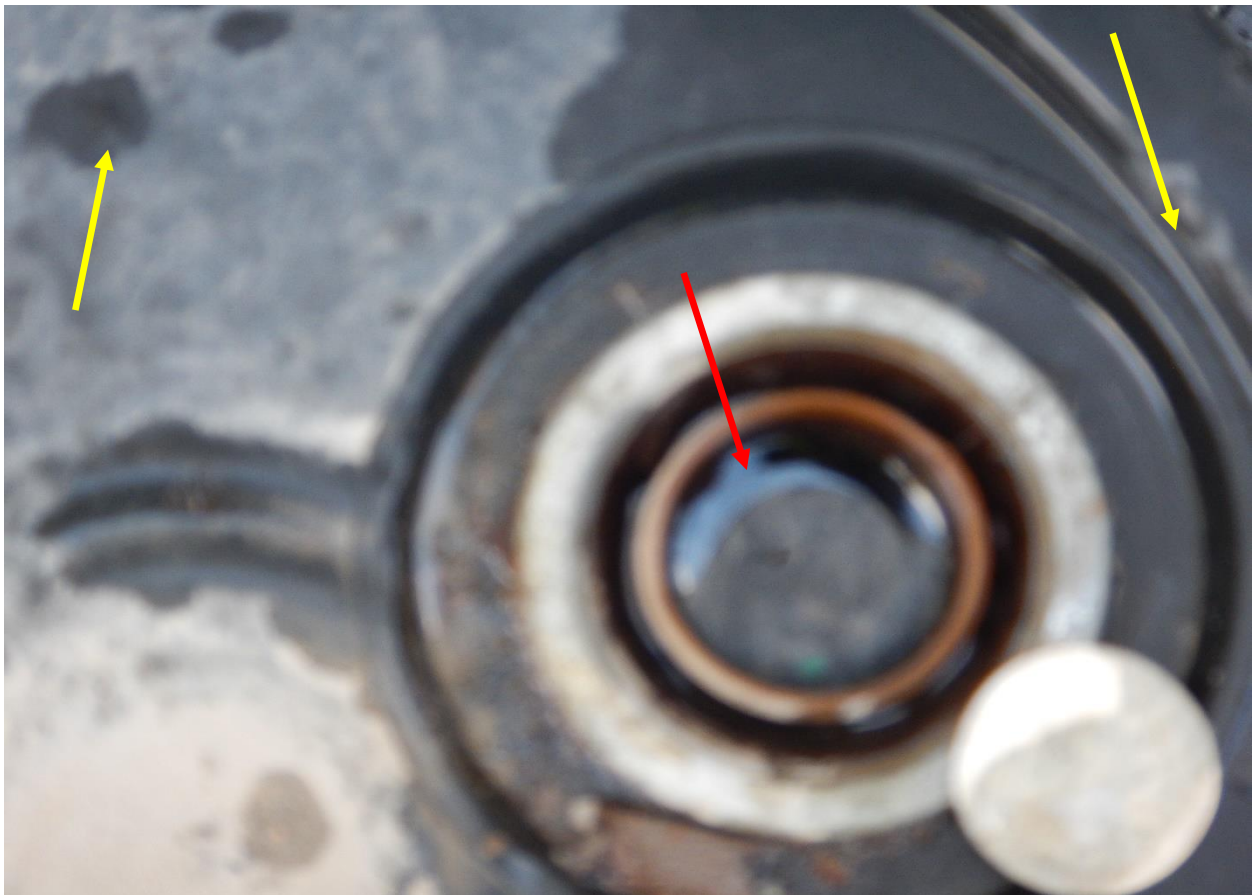
Photo No. 9

Description: Closer view, of the top of the 5-gallon bucket containing hydraulic oil. Note: Reflected by the red arrow, there was no plug on the bucket, thus exposing the oily material to the elements. In addition, around the uncapped section of the bucket, dampness and staining was observed (see yellow arrows). Oily residue and staining of the ground were also observed in the immediate vicinity of the bucket.

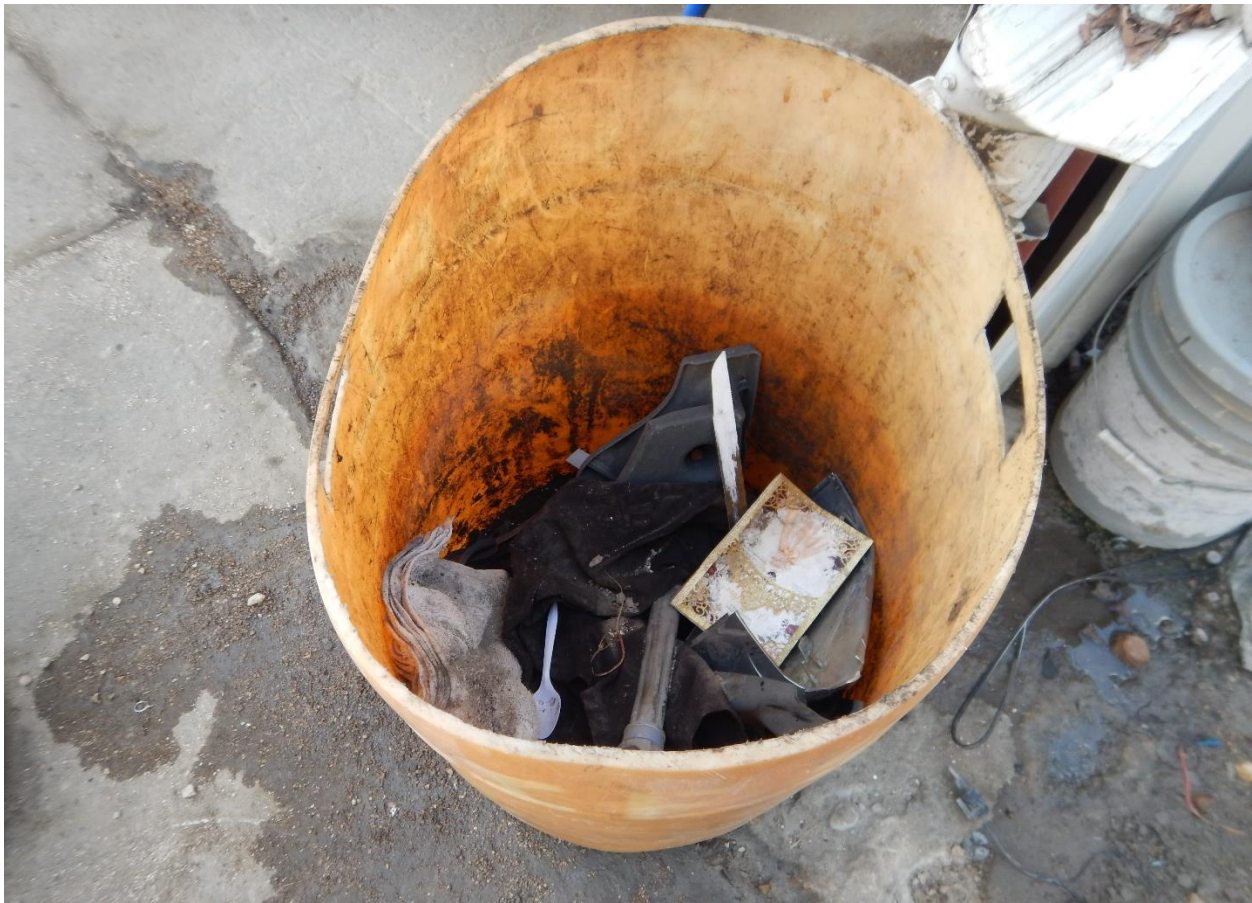
Photo No. 10

Description: Closer view, of 55-gallon drum/containers, not maintained in an effective operating condition (e.g., poor housekeeping). The permittee was utilizing the drum/containers as a trash can, which contained oily filters, soiled absorbent pads, and other automotive debris and trash. The drum/containers was exposed to the elements, and oily residue and staining to the ground/soil in the immediate vicinity of the drum/containers was observed.

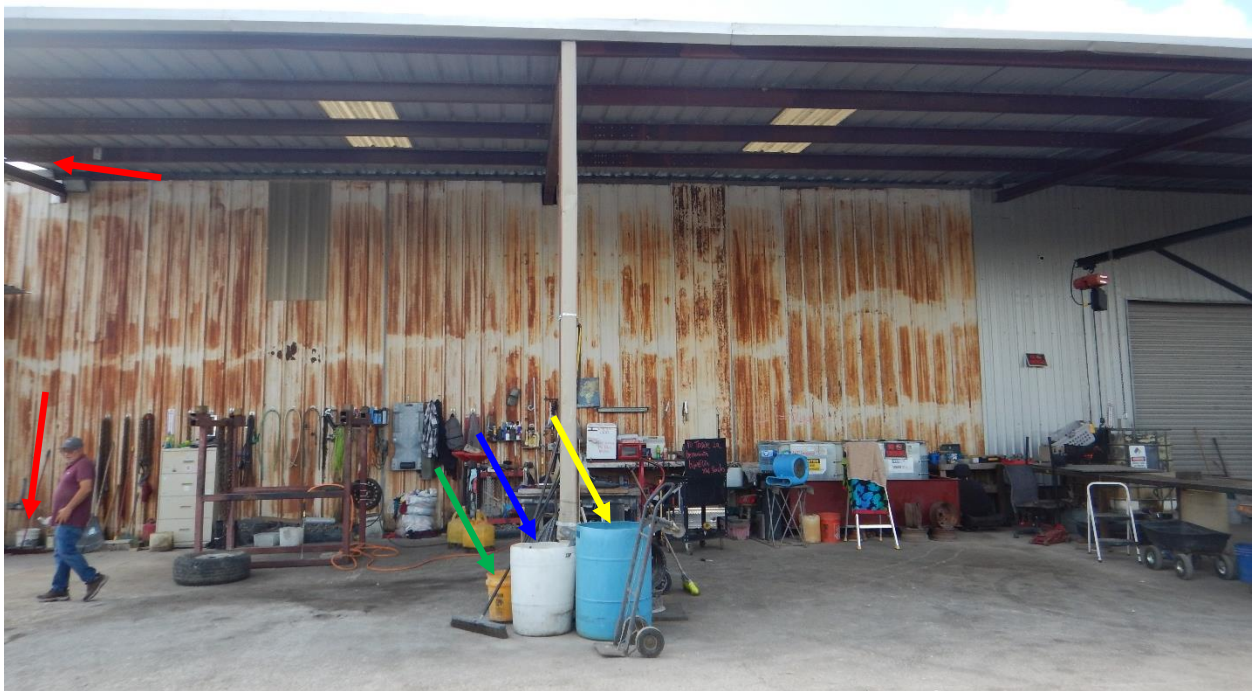
Photo No. 11

Description: View, of Alpha Auto Parts' Maintenance Shop, not maintained in an effective operating condition (e.g., poor housekeeping). The permittee was utilizing various-sizes drums/toes/buckets as trash cans, which all contained oily materials exposed to the elements. The location of these containers was outside of the covered area of the shop. Closer views of container contents captured in photos #12 (green arrow), #13 (blue arrow), and #14 (yellow arrow). Details regarding items reflected by red arrows are captured in photos #15 and #17.

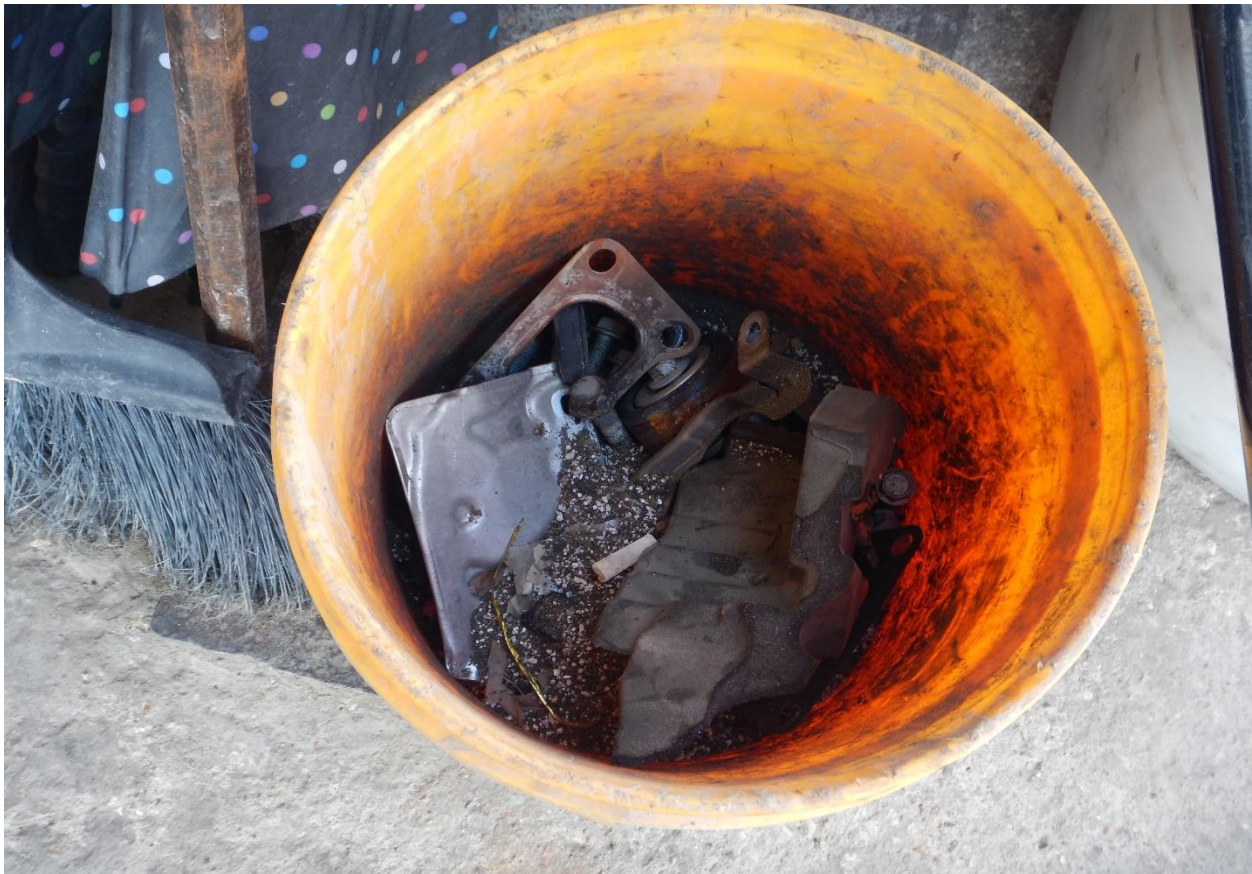
Photo No. 12

Description: Closer view, of yellow container being utilized as a trash can, which contained oily materials exposed to the elements. The location of this container was outside of the covered area of the shop, and contained oily discarded auto parts, absorbent material (kitty litter), and other debris.

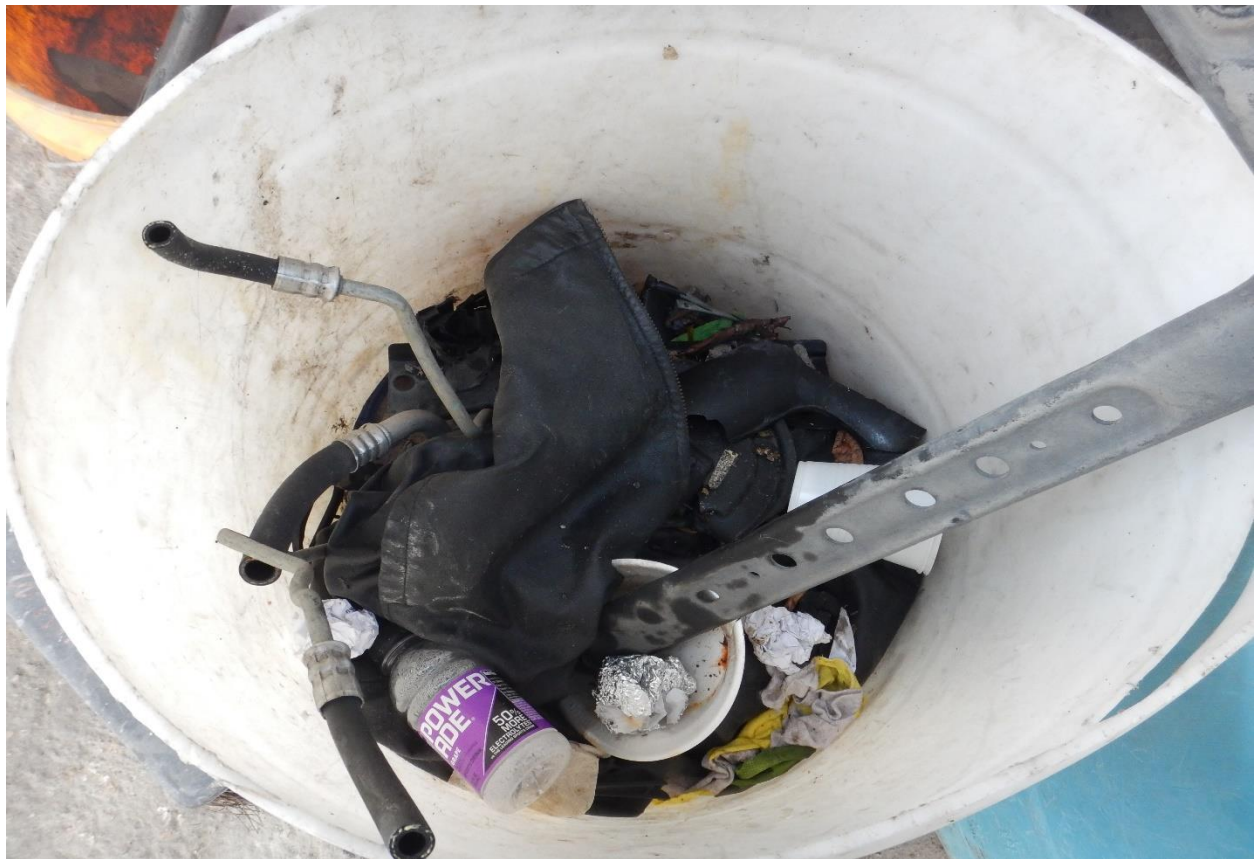
Photo No. 13

Description: Closer view, of white container being utilized as a trash can, which contained oily materials exposed to the elements. The location of this container was outside of the covered area of the shop, and contained oily discarded auto parts, trash, and other debris.

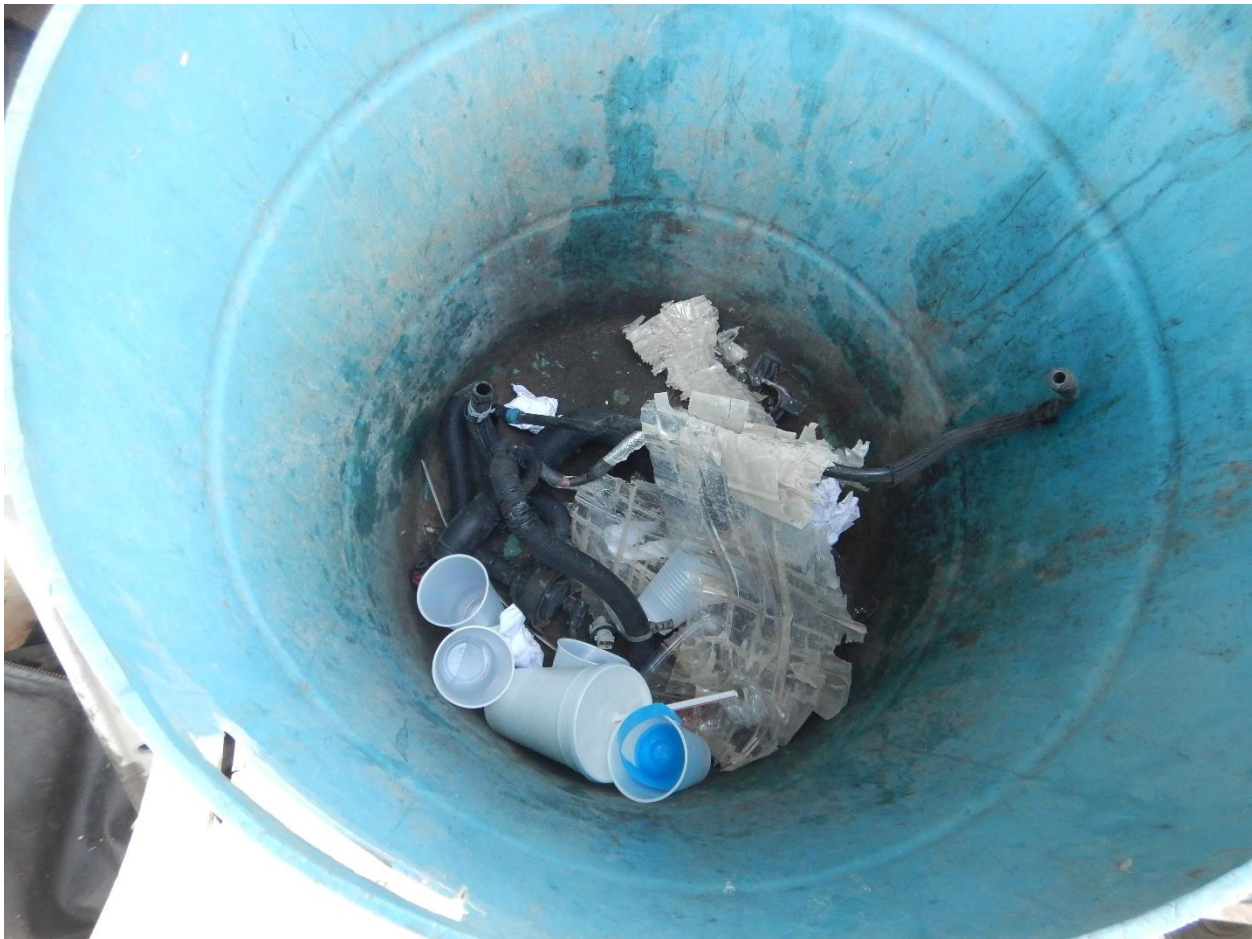
Photo No. 14

Description: Closer view, of blue container being utilized as a trash can, which contained oily materials exposed to the elements. The location of this container was outside of the covered area of the shop, and contained oily discarded auto parts (hoses), trash, and other debris.

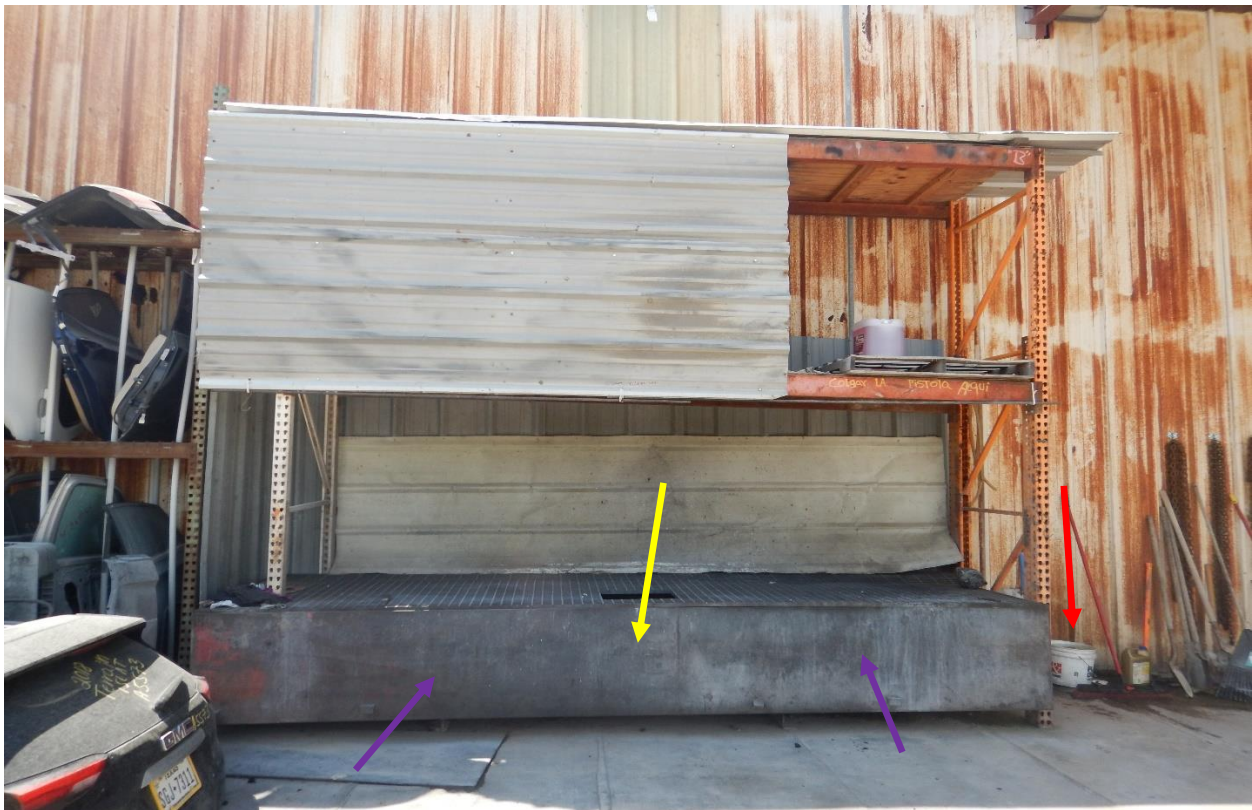
Photo No. 15

Description: View, of Alpha Auto Parts Oil Bay Area, not maintained in an effective operating condition (e.g., poor housekeeping). While this area is located under a covered shed, it should be noted that due to heavy, oily staining in the immediate area, the potential to impact stormwater runoff is possible. It was evident that the reservoir had experienced overflowing as indicated by the heavy, oily staining along the outer walls of the front of the reservoir (see purple arrows). Closer views of the oil reservoir (reflected by yellow arrow), and white, 5-gallon bucket (see red arrow) are further discussed and captured in photos #16 and #17, respectively.

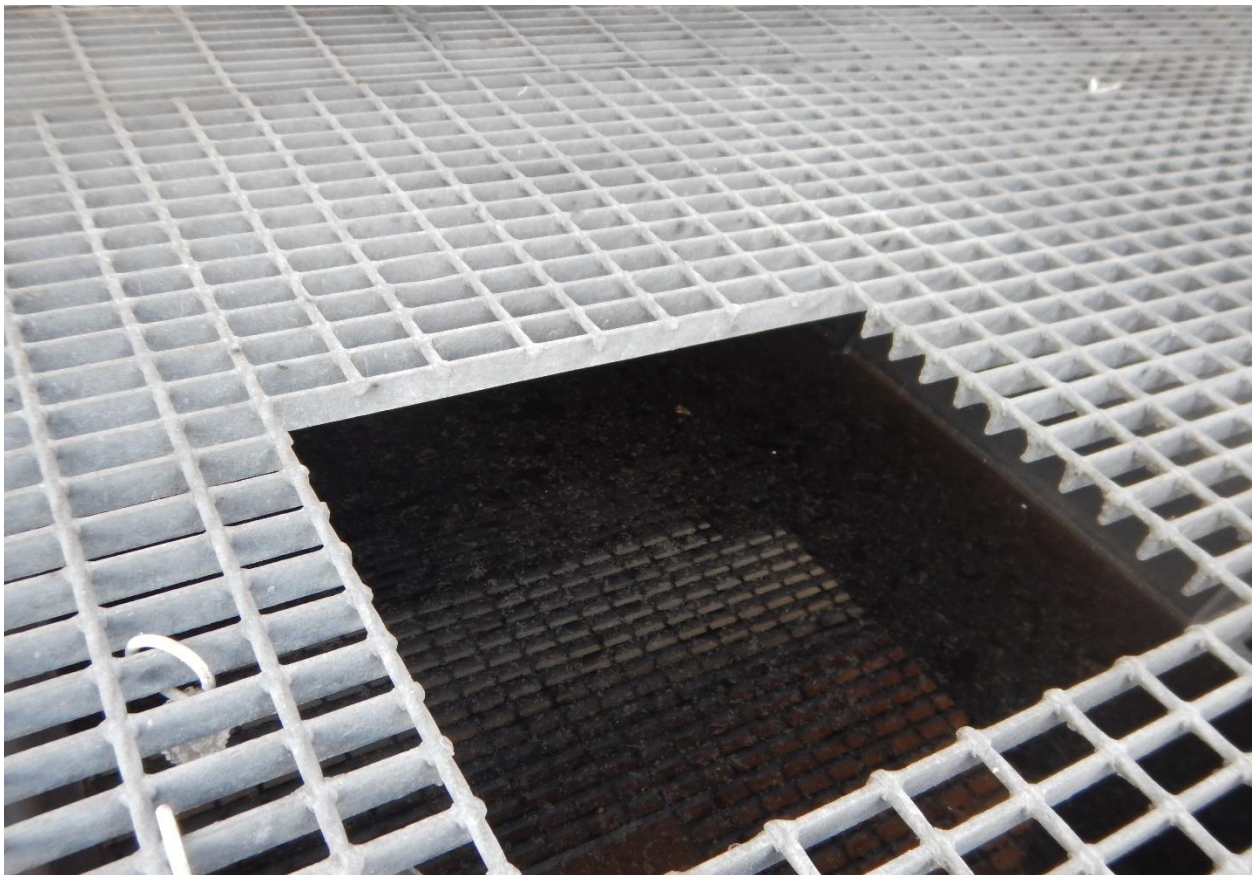
Photo No. 16

Description: Closer view, of Alpha Auto Parts Oil Bay Area, not maintained in an effective operating condition (e.g., poor housekeeping). The permittee did not have a formal, consistent, and reliable method for determining when to drain the oily reservoir. Specifically, the inspectors were informed that “they just know when it is time”; however, it was evident that the reservoir had experienced overflowing as indicated by the heavy, oily staining along the outer walls of the front of the reservoir (see photo #15 reflected by purple arrows).

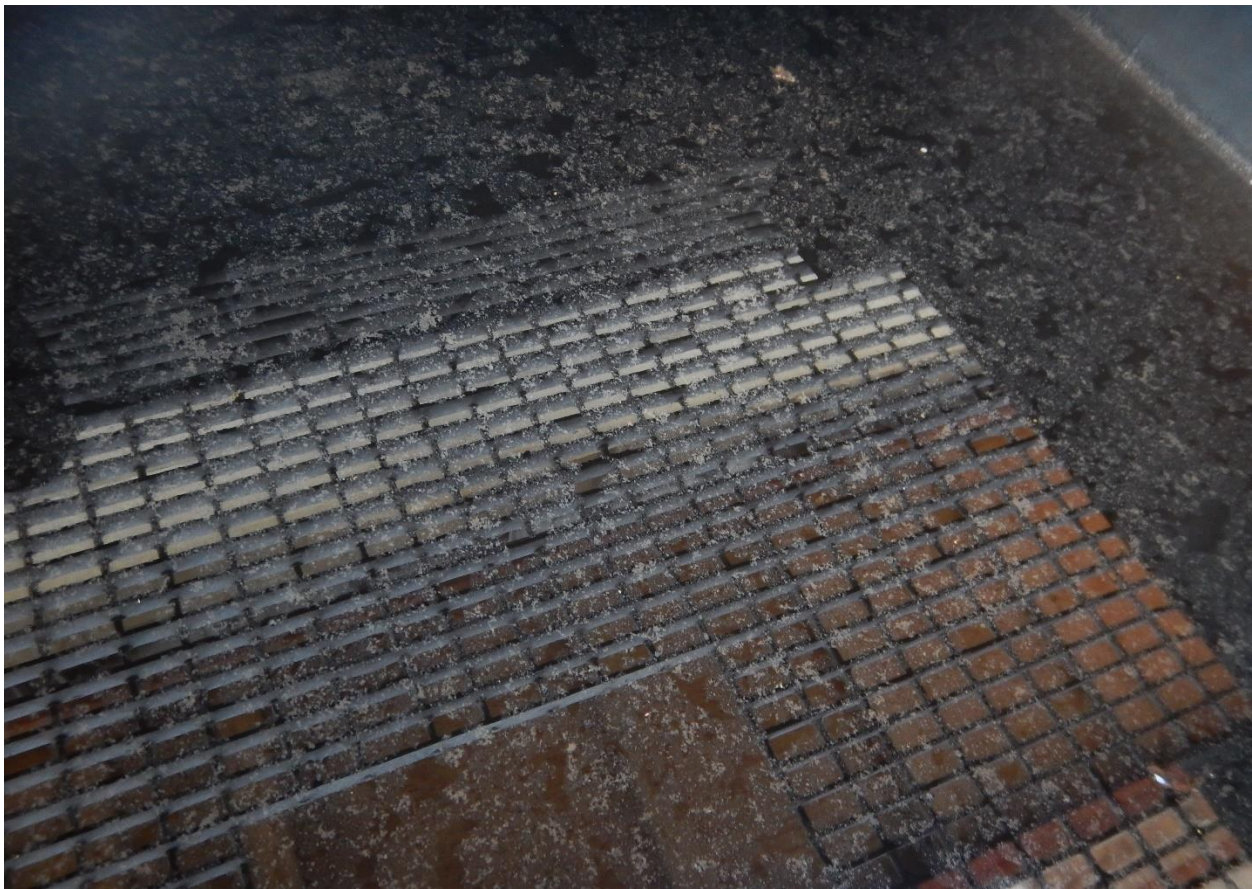
Photo No. 17

Description: Closer view, of Alpha Auto Parts Oil Bay Area, not maintained in an effective operating condition (e.g., poor housekeeping). The permittee did not have a formal, consistent, and reliable method for determining when to drain the oily reservoir. Specifically, the inspectors were informed that “they just know when it is time”; however, it was evident that the reservoir had experienced overflowing as indicated by the heavy, oily staining along the outer walls of the front of the reservoir (see photo #15 reflected by purple arrows).

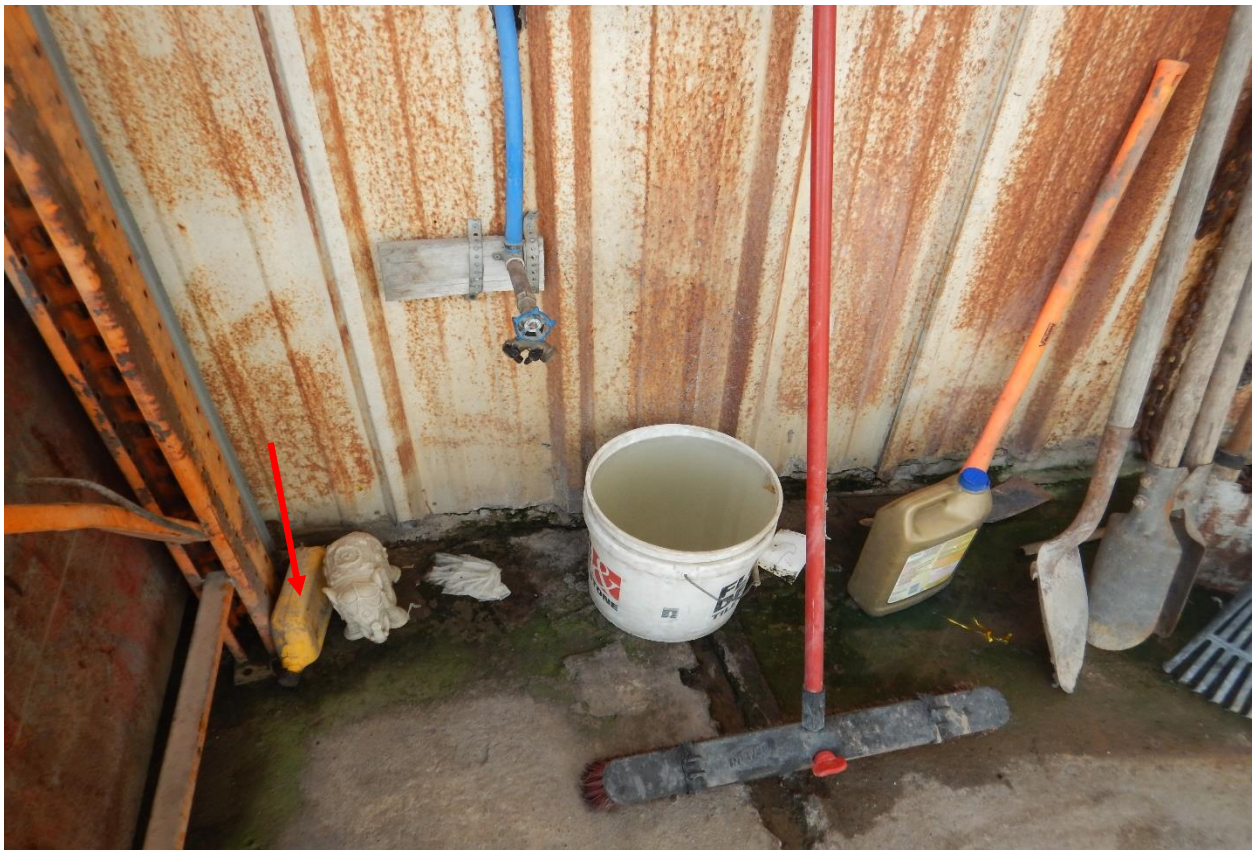
Photo No. 18

Description: View, of Alpha Auto Parts Oil Bay Area, not maintained in an effective operating condition (e.g., poor housekeeping). As reflected by the red arrows captured in photo #11, this section, which is located in between the Maintenance Shop and Oil Bay Area, is not covered, and thus exposed to the elements. As such, the while, 5-gallon bucket had the opportunity to fill up with rainwater. Note: The collected water was turbid. In addition, there was an uncapped quart bottle of auto fluid lying on its side. Staining was also noted at the mouth and immediate vicinity of the bottle.

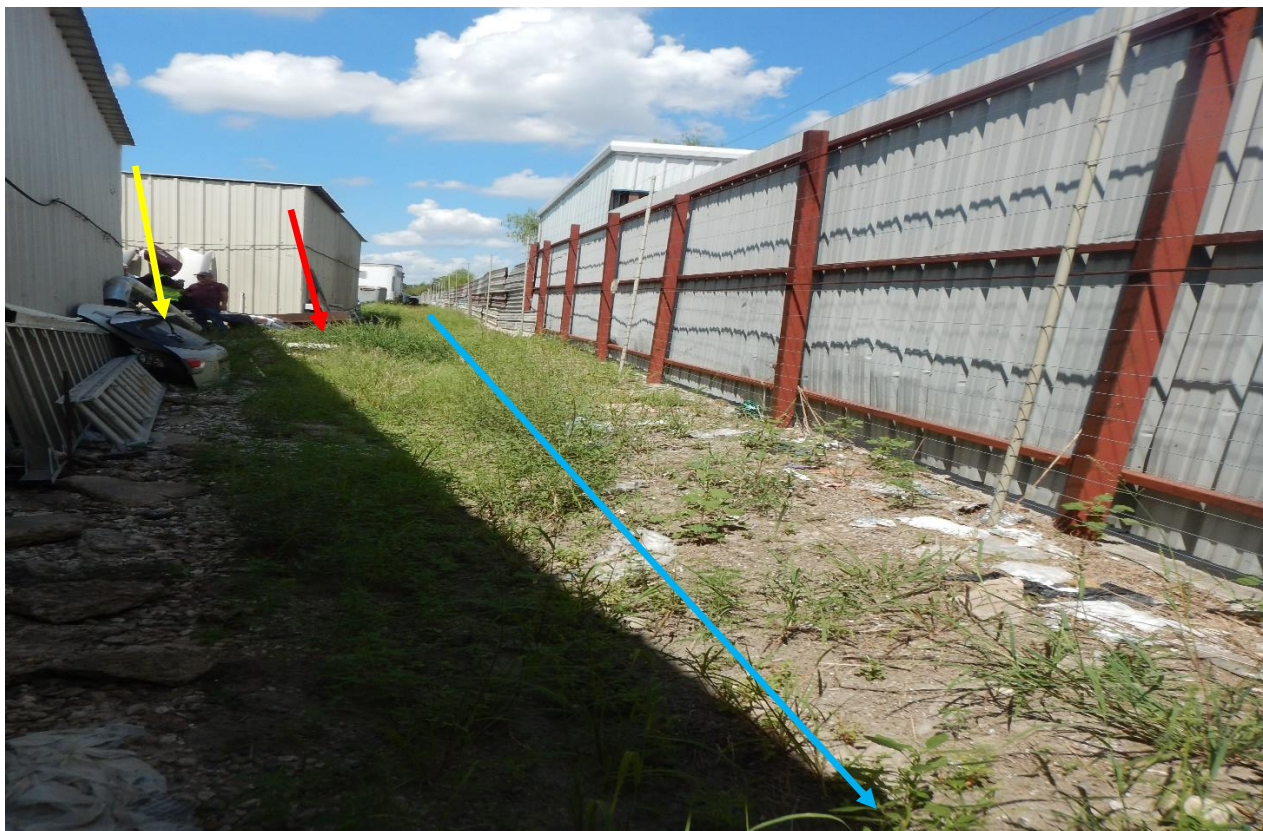
Photo No. 19

Description: View, on the side of the Parts Warehouse, location of sample point reflected by red arrow. The blue arrow depicts the flow direction of stormwater from the site, and the yellow arrow identifies material stored downstream of the sample collection point. Closer views reflected and additional details provided in the following photos.

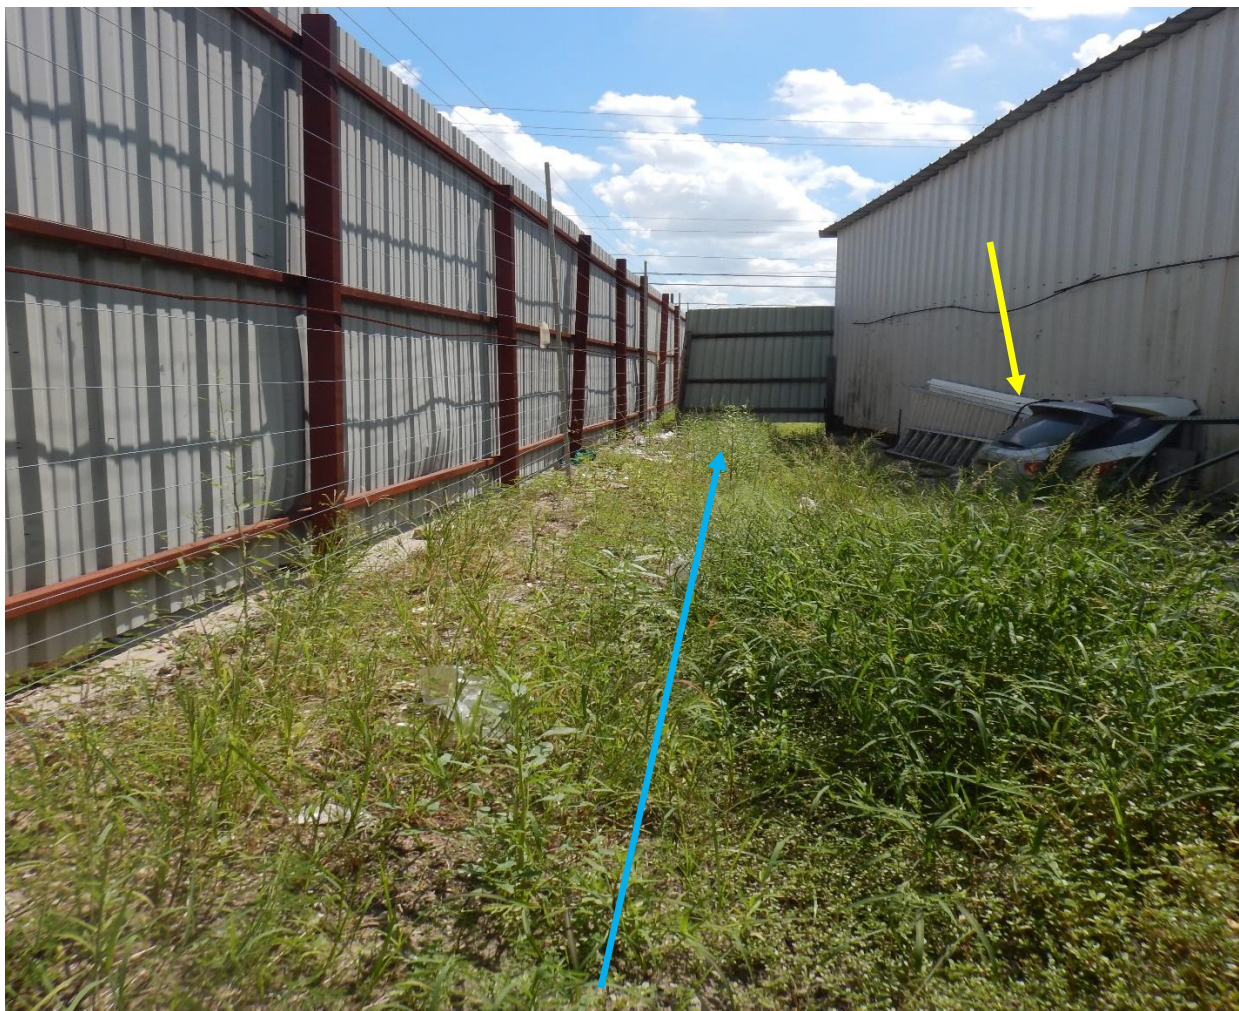
Photo No. 21

Description: Additional view, on the side of the Parts Warehouse, flow direction of stormwater, just north of sample point, and material stored downstream of the sample collection point (yellow arrow).
