## Region 6 - Enforcement & Compliance Assurance Division

### INSPECTION REPORT

| Company Name: | <b>L.A. Look Auto Inc.</b> | |
| Facility Name: | <b>Alpha Auto Parts</b> | |

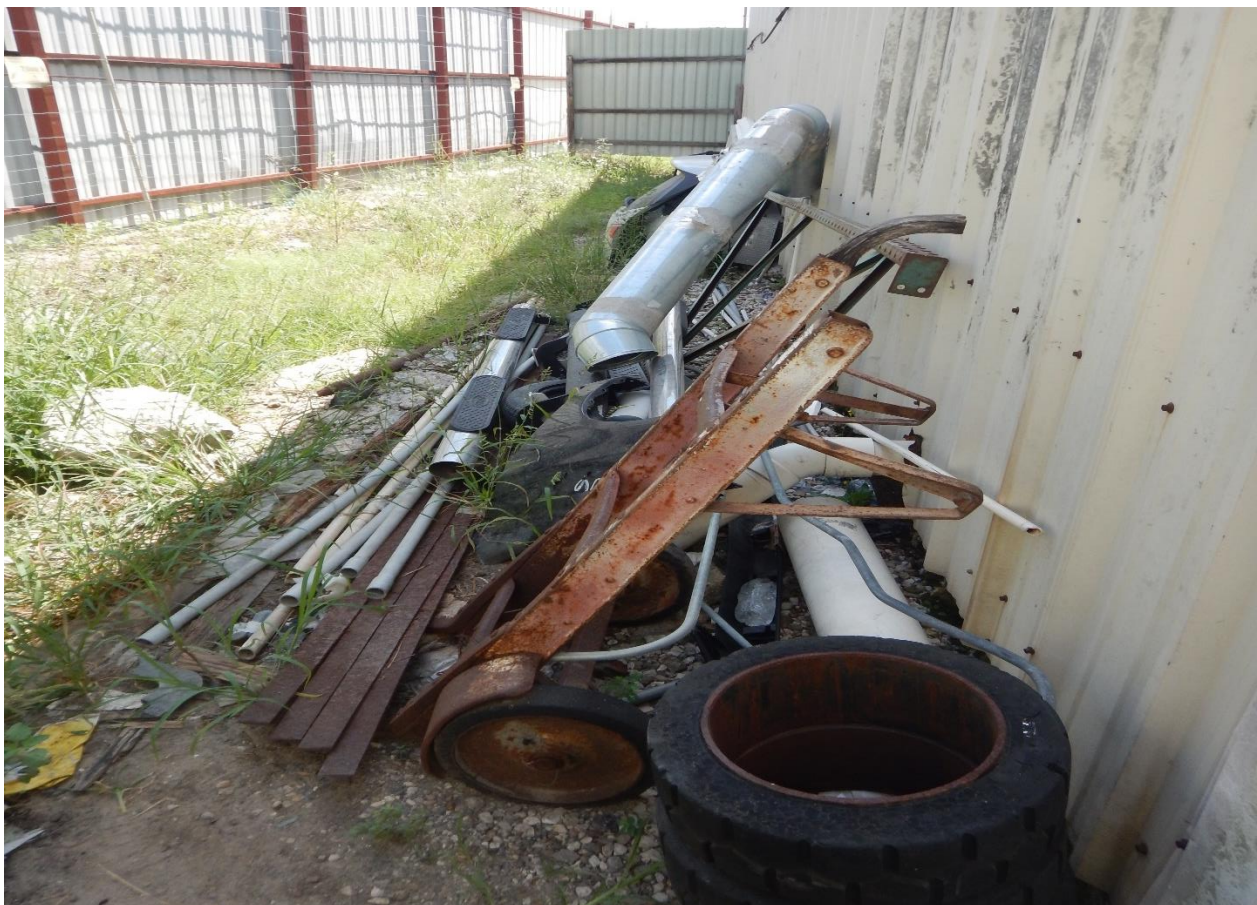
Photo No. 22

Description: Closer view, on the side of the Parts Warehouse, of material stored downstream of the sample collection point. Items included, but was not limited to, various discarded auto parts, tires, piping, air conditioning ventilation hoses, and a rusted dolly. Note: The location of these items has the potential to contaminate and impact the stormwater discharges and would not be captured via compliance sampling event, particularly since these items are located downstream and of all sampling events.
