**CLEAN WATER ACT COMPLIANCE EVALUATION INSPECTION REPORT  
U.S. ENVIRONMENTAL PROTECTION AGENCY  
REGION 5**

**Purpose:** Compliance Evaluation and Stormwater Inspection

**Facility:** CountryMark Refining and Logistics, LLC (CountryMark)  
1200 Refinery Road  
Mt. Vernon, Indiana 47620

**Date of Inspection:** August 29, 2023

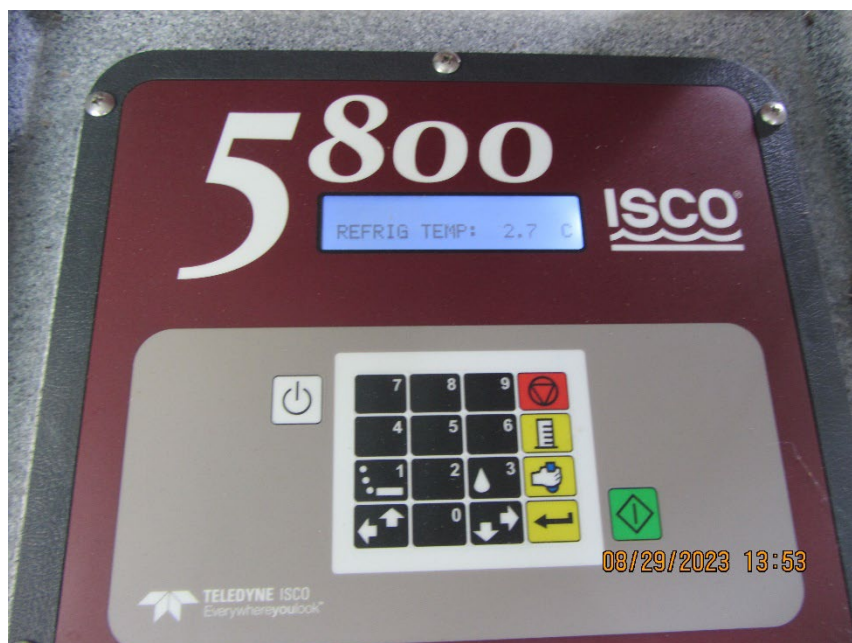
3: IMG\_0323

After the laboratory, we went to a small building which houses the composite sampler for Outfall 001 (Photo 3). Microbac obtains the collected samples from here to take back to its laboratory. Inside the building is a digital display that shows continuous readings from an automatic pH sampling probe. CountryMark does not use these readings for required monitoring and reporting purposes; it takes a grab sample from this location and performs the Permit-required pH compliance analysis in the on-site laboratory.

Description: ISCO composite sampler for Outfall 001 showing 2.7 °C refrigeration temperature

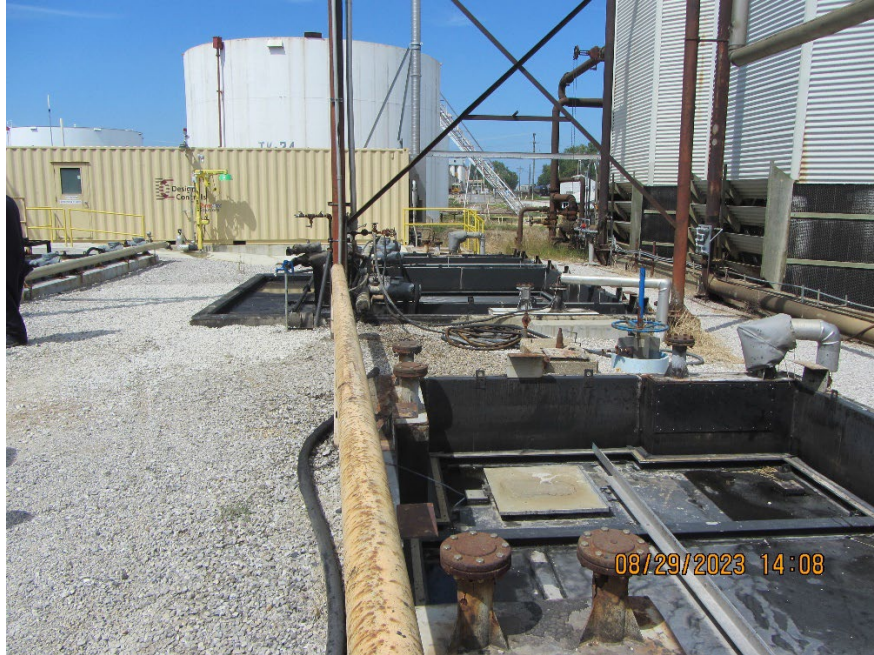
4: IMG\_0324

Next, we toured part of the WWTP, starting at the grit chamber and the upper API separators (Photo 4). We saw where the cooling tower backwash enters the system and where CountryMark adds usually phosphoric acid between the upper and lower APIs, although at the time of the inspection it had been adding sulfuric acid instead (Photo 6). In this area were totes of cooling tower additives, including sodium hypochlorite and sulfuric acid, and another tank that was unlabeled (Photo 7).

Description: Grit chamber in foreground, upper APIs in background

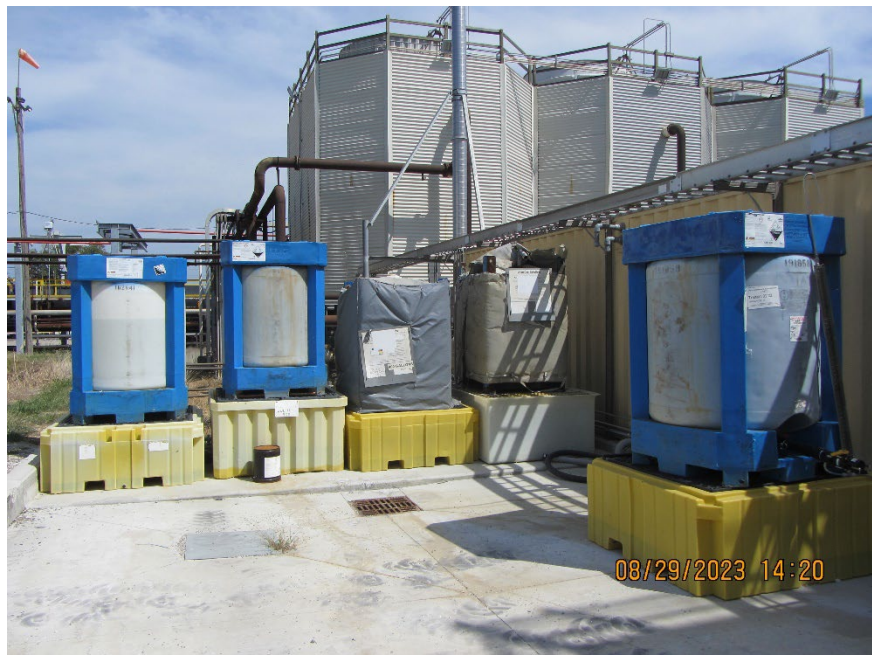
7: IMG\_0327

1. CountryMark explained that BOD<sub>5</sub> exceedances were caused partly by cold weather hindering biological treatment and by hydraulic loading issues. EPA is concerned that these exceedances may occur again.
2. There was an unlabeled tank in the cooling tower additives area. When notified of this, CountryMark stated that it would mark the tank later that day.

Description: Totes of cooling water additives and phosphoric and sulfuric acid

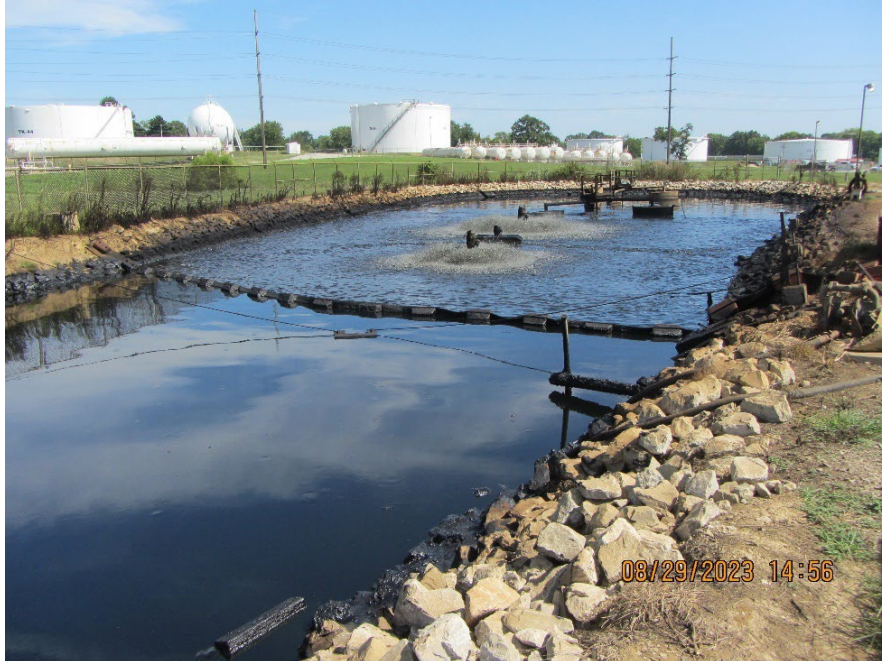
12: IMG\_0332

Description: EQ basin with hydrocarbons trapped in foreground

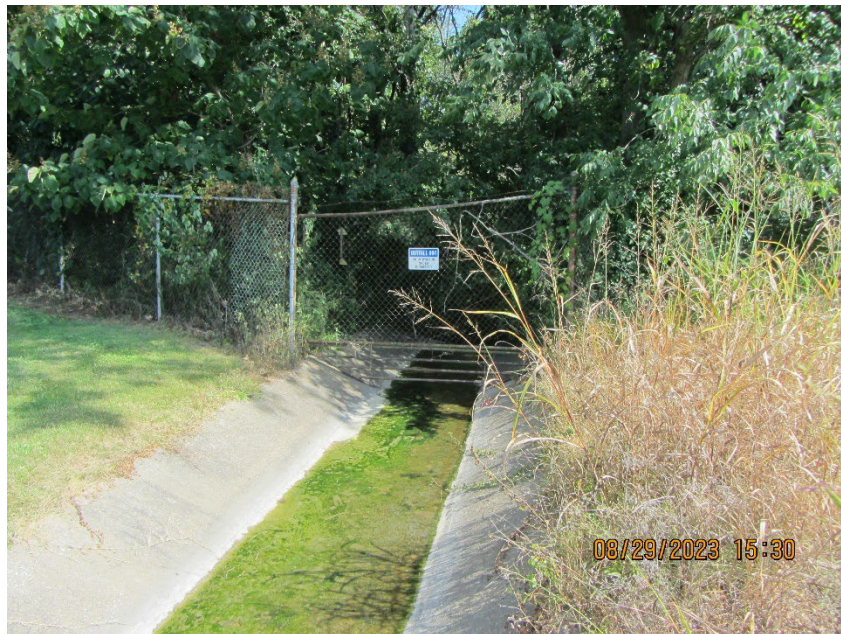
23: IMG\_0343

We next observed the stormwater outfalls, starting at Outfall 004, which is adjacent to Outfall 002 and which is for the unnamed tributary that runs through the Facility. The trench to this outfall contained algae (Photos 23 and 24). We then proceeded to Outfalls 003, 006, 005, and 007, in that order (Photos 25-29). Outfalls 005 and 006 were dry. With regard to stormwater, the berms, dikes, and secondary containment throughout the site appeared to be well maintained, and we noted good housekeeping being employed.

3. During the inspection, algae was present in the trench leading to Outfall 004.

Description: Outfall 004, with algae in trench

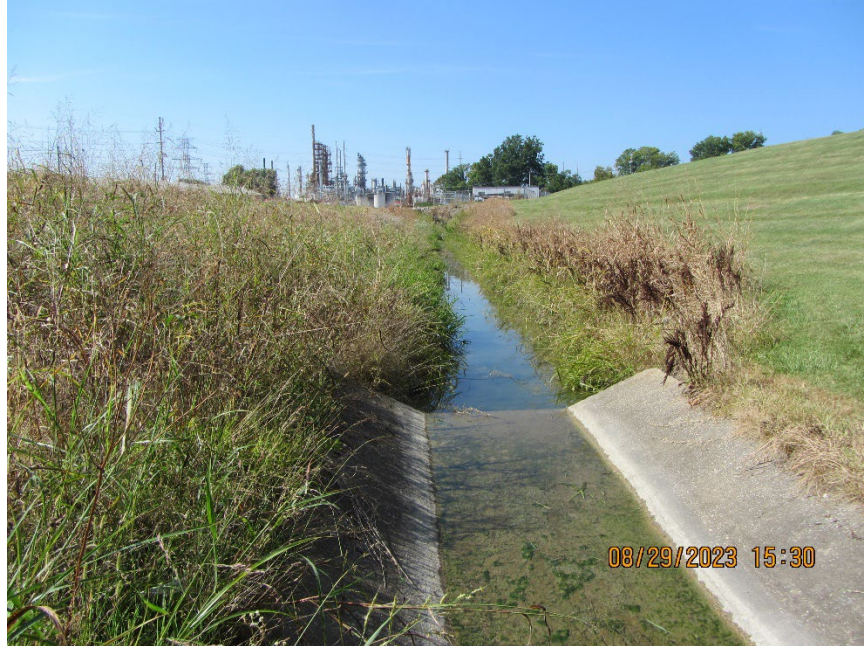
24: IMG\_0344

Description: Trench to Outfall 004
