**UNITED STATES ENVIRONMENTAL PROTECTION AGENCY  
REGION 8  
RESOURCE CONSERVATION AND RECOVERY ACT**

**Facility Name:** Evaporation Pit Systems,  
a.k.a. Barquin Pit

**Date of Inspection:** August 19, 2021

**Type and Purpose of Inspection:** Compliance Evaluation Inspection

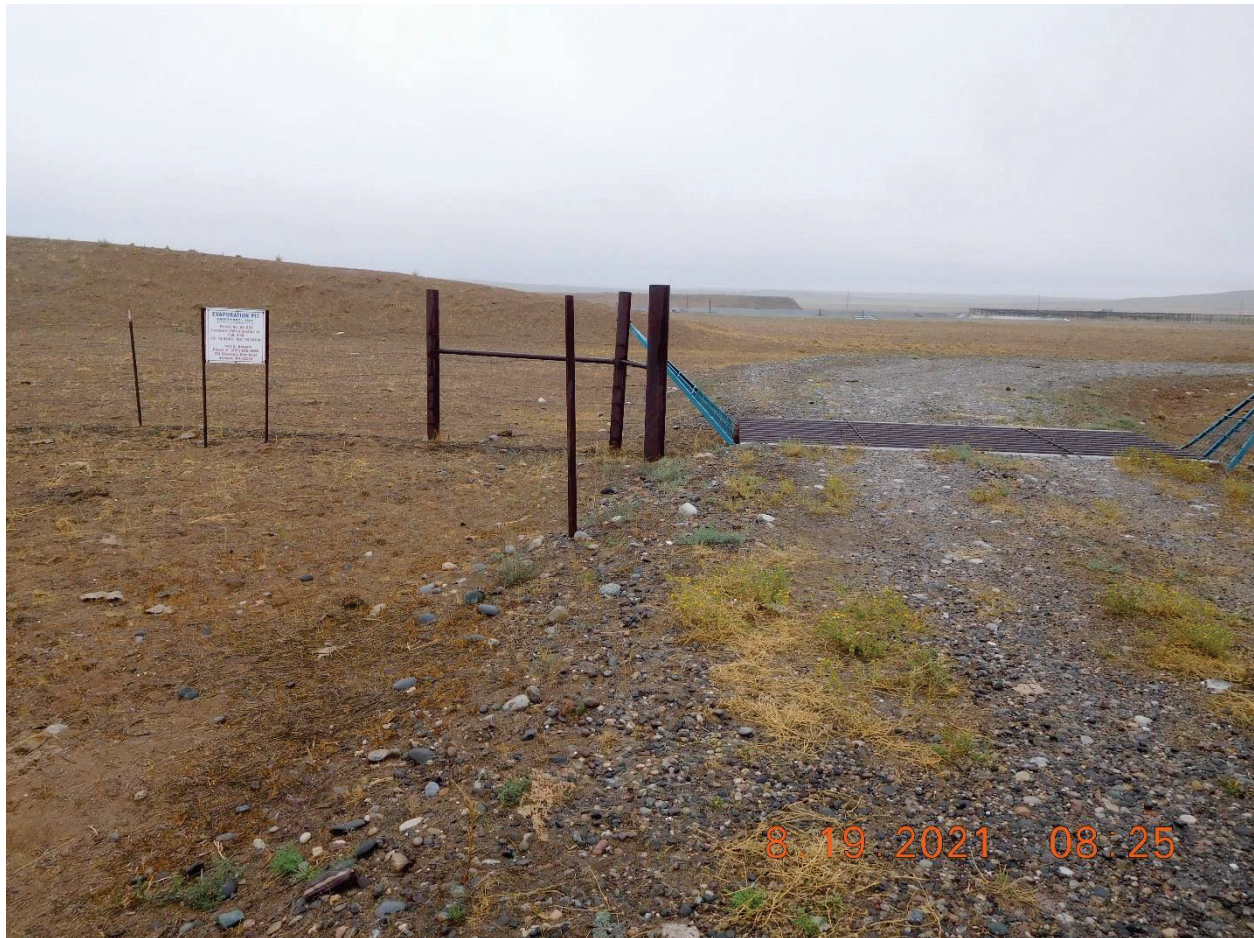
Upon arrival at the site, the gate to the Facility was open, but no site representatives were present.

Photo 1547: DSCN1457.jpg – photo of open gate at entrance to Facility.

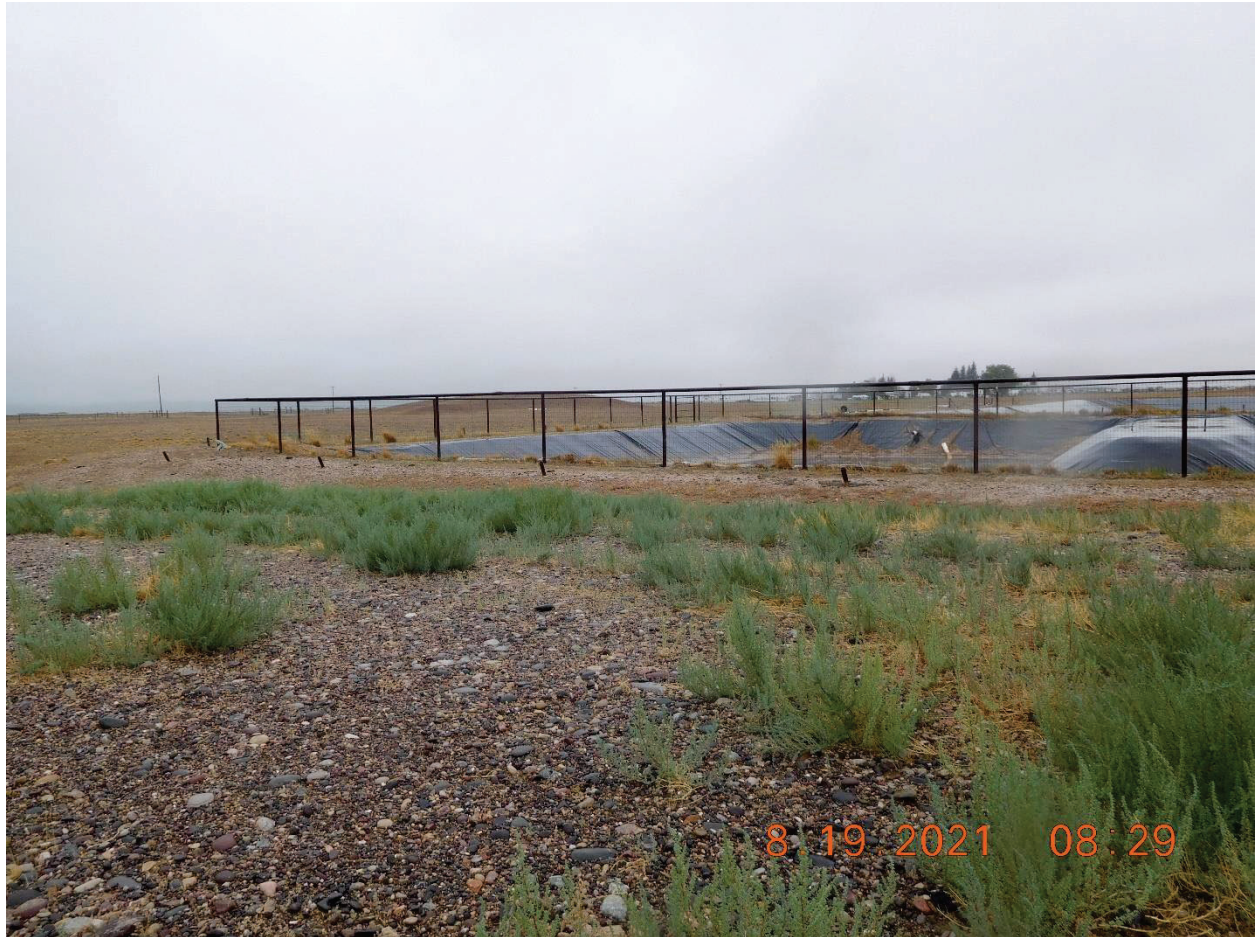
Photo 1550: DSCN1550.jpg – photo of un-netted settling pond.

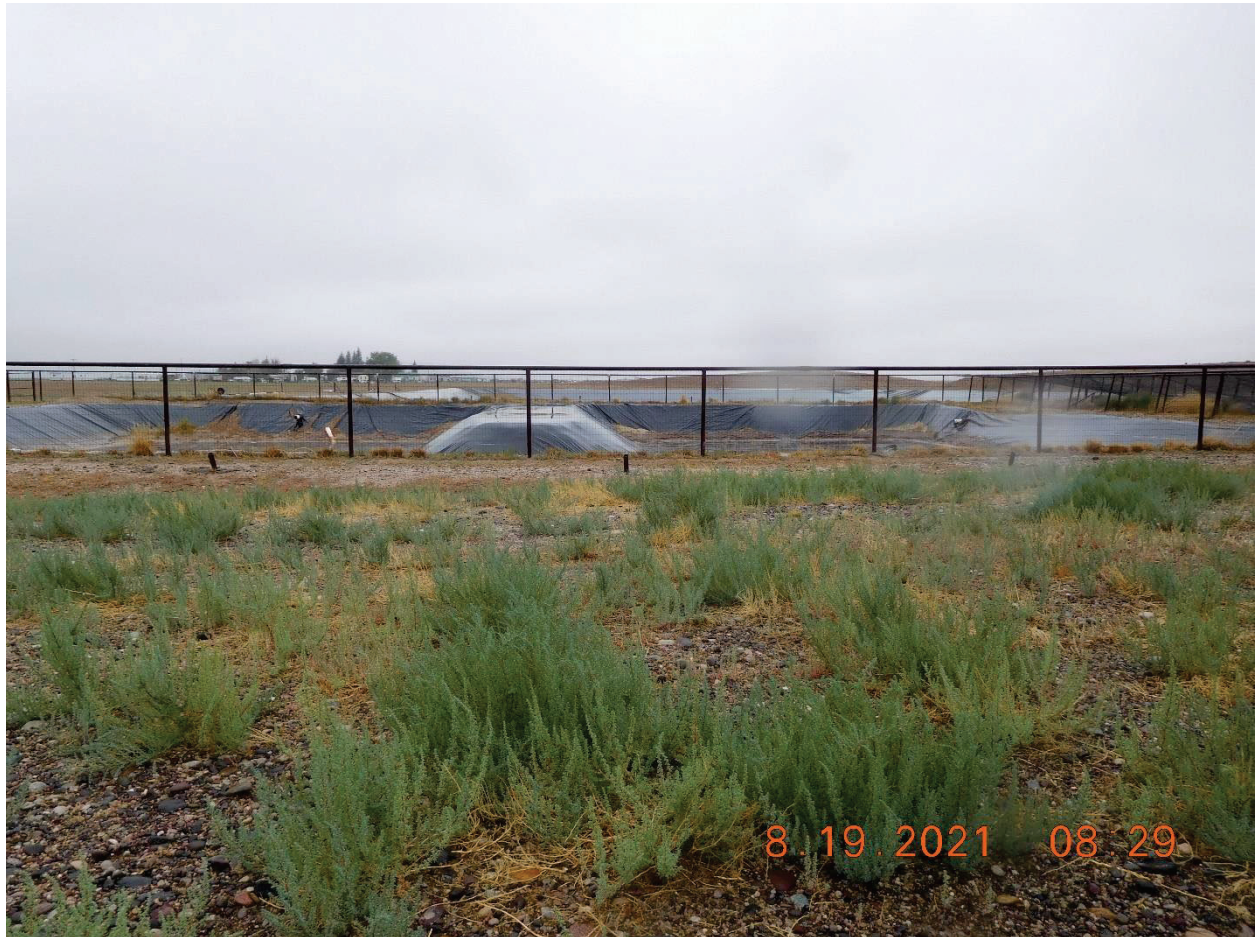
Photo 1551: DSCN1551.jpg – photo of un-netted separation pond, facing west/northwest, and panned right from photo 1550.

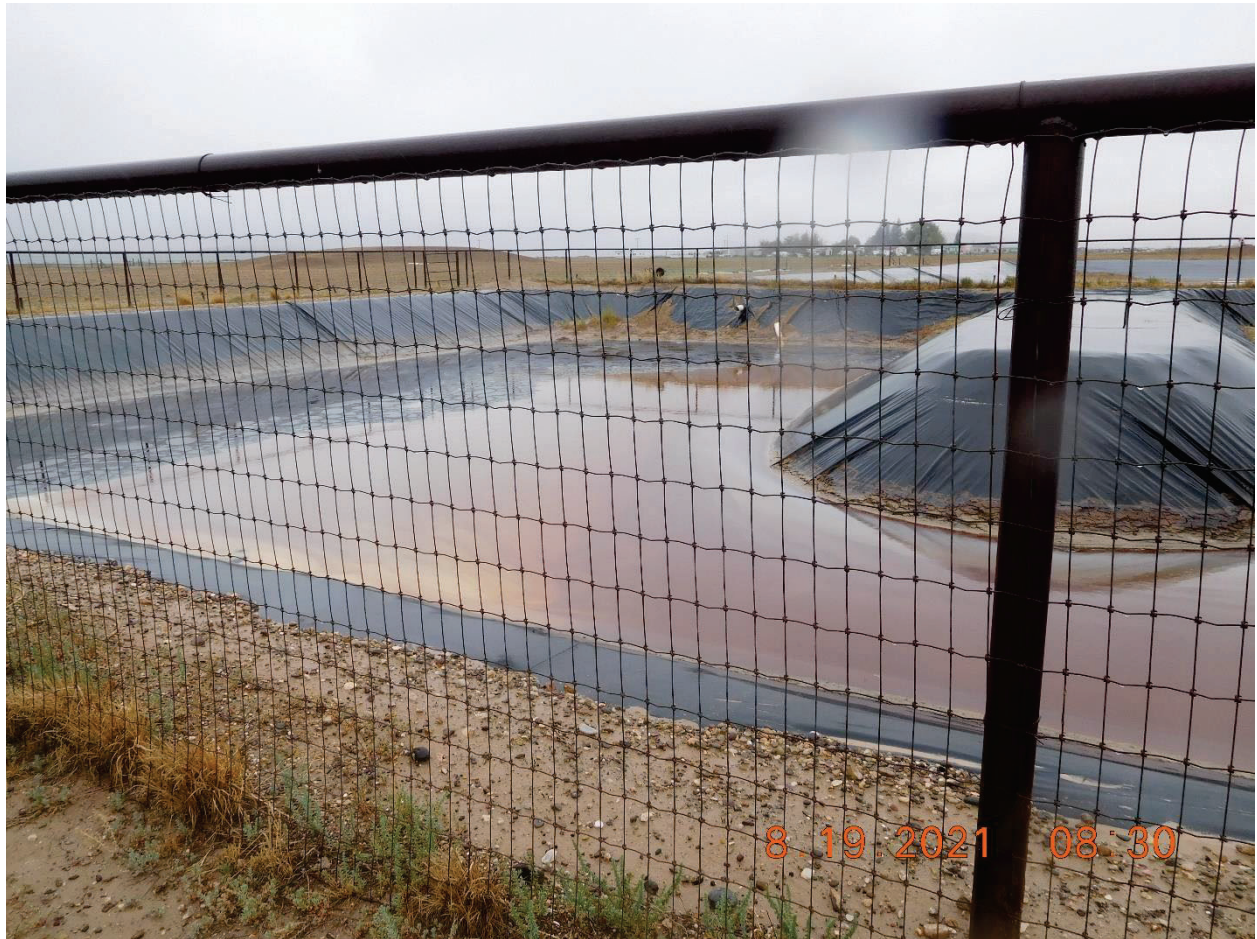
At the un-netted separation pond, I observed that oily waste was floating on the surface of water. The pond was surrounded by intact, durable fencing, but it was not covered across the top and so it was accessible to birds.

Oily waste that is not physically restricted from access by birds and other wildlife is a concern because of the potential for injury or mortality. Specifically, the large amount of oil on the un-netted settling pond and the poor condition of the netting over the netted settling pond pose a potentially serious threat to birds and other wildlife.

Photo 1554: DSCN1554.jpg – photo of southern section of un-netted separation pond taken facing west. Photo shows oil floating on the surface of the pond on the left side. Fencing appeared durable and in good condition.

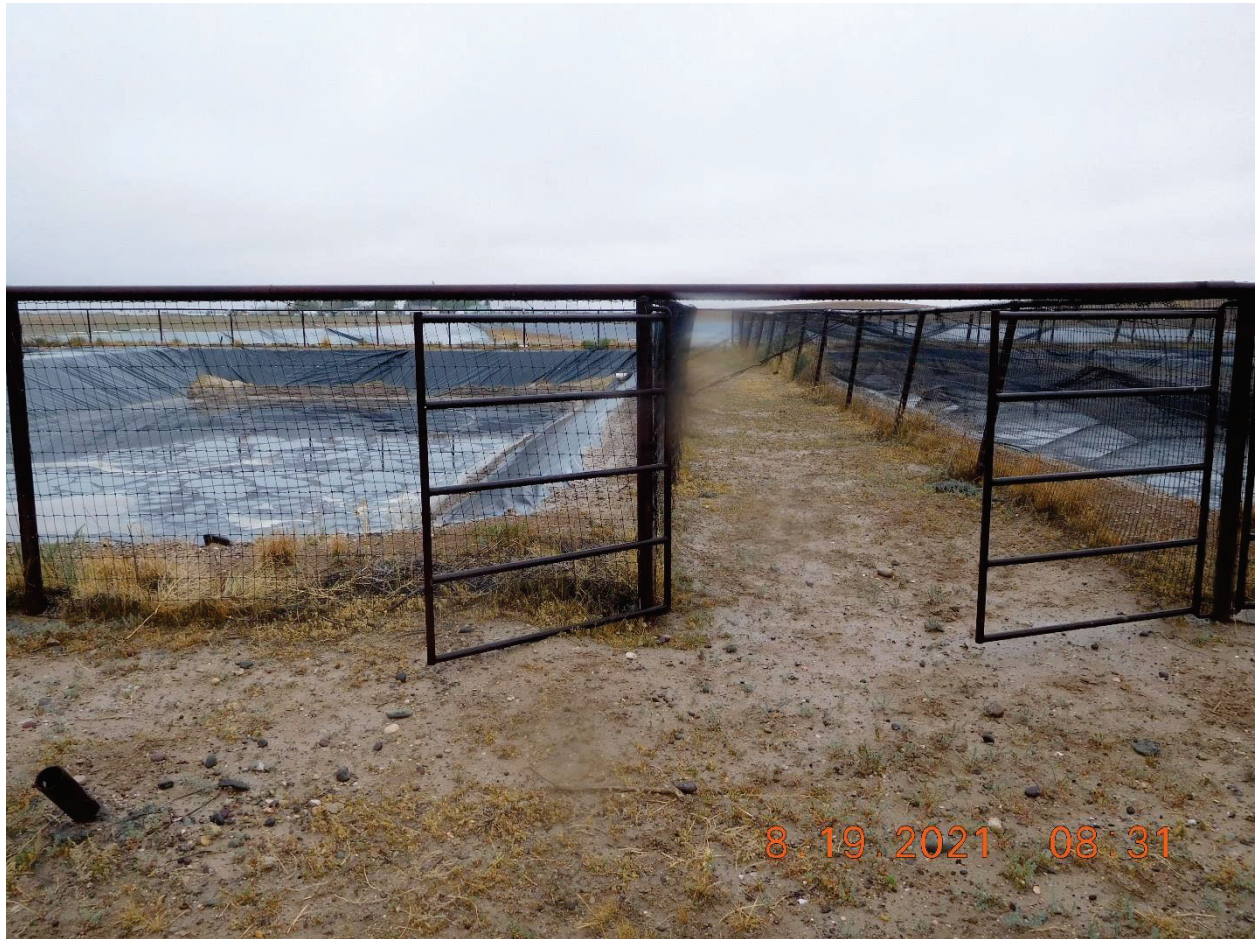
Photo 1557: DSCN1557.jpg – photo of the gated area between the un-netted separation pond (to left) and the netted separation pond (to right). The gate to the area between the two separation ponds was open, but both ponds were fully fenced.

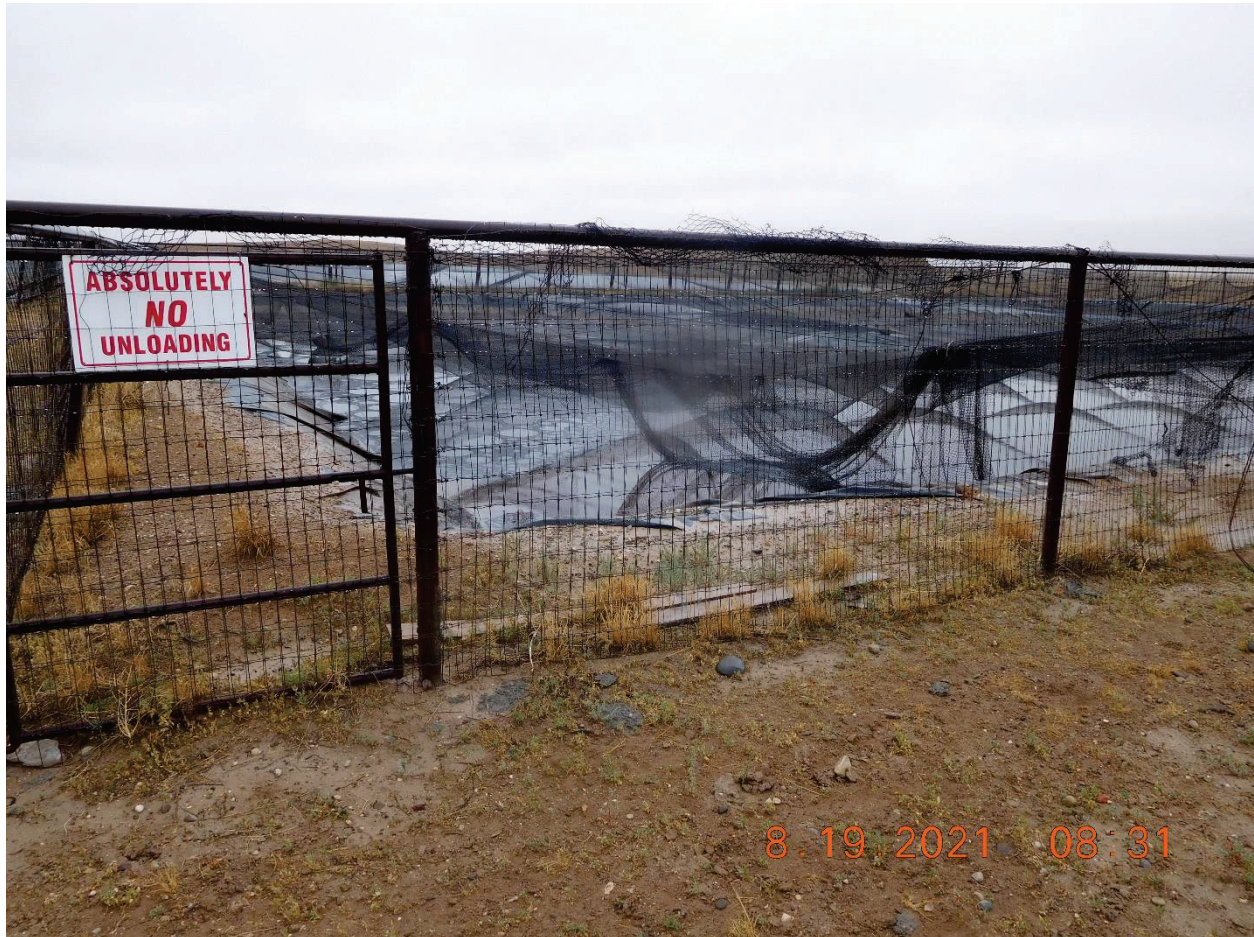
At the netted separation pond, I observed that the netting was in very poor condition with large holes and large sections of the netting dipping into oily waste floating on the pond surface. This pond was also surrounded on all sides by intact, durable fencing.

Photo 1558: DSCN1558.jpg – photo of netted separation pond taken facing west/northwest from the southeastern portion of the pond. Photo shows netting in poor condition with large holes in the netting and netting dipping into oil floating on the surface of the pond.

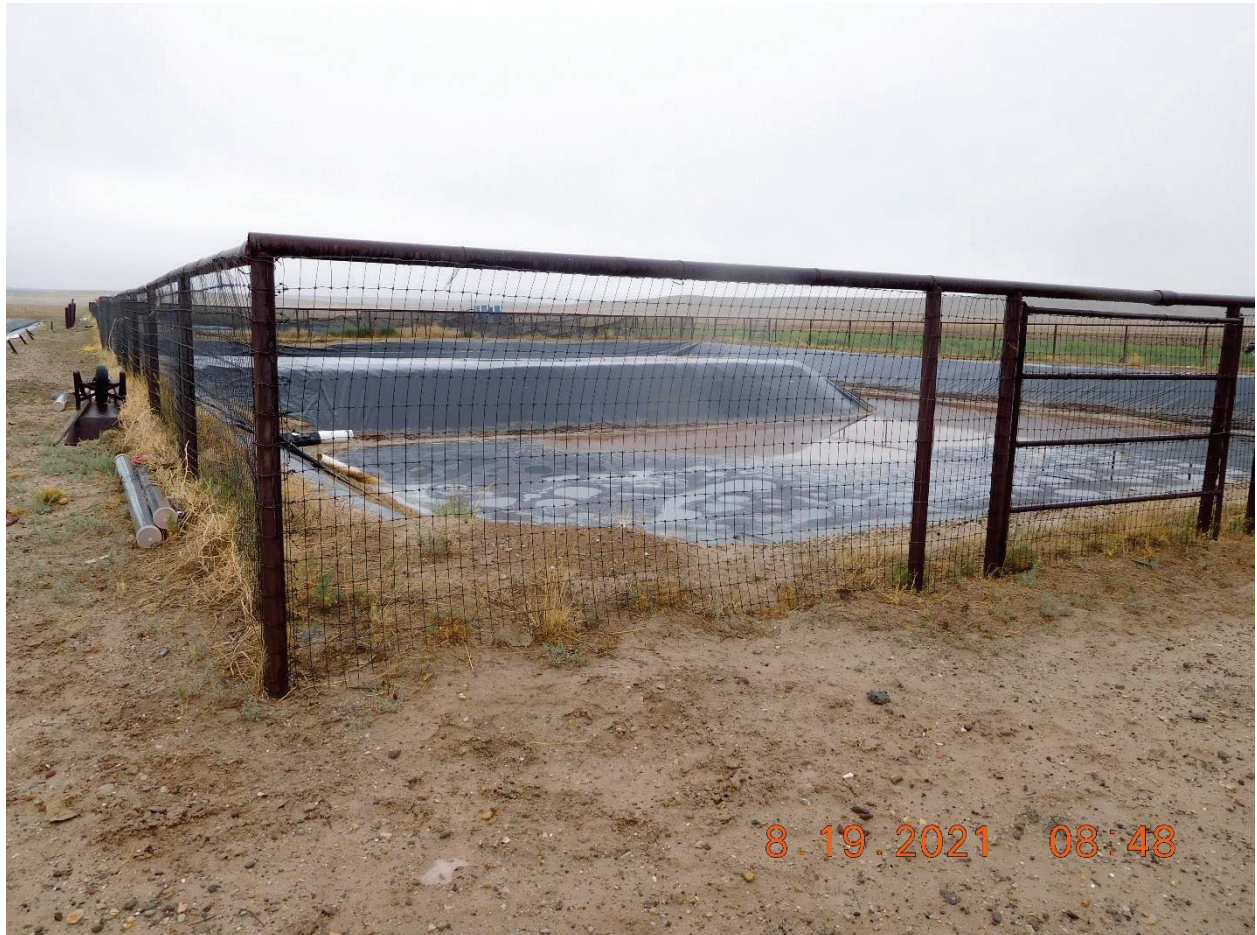
Photo 1576: DSCN1576.jpg – photo of un-netted separation pond taken from southwest corner of pond facing east.

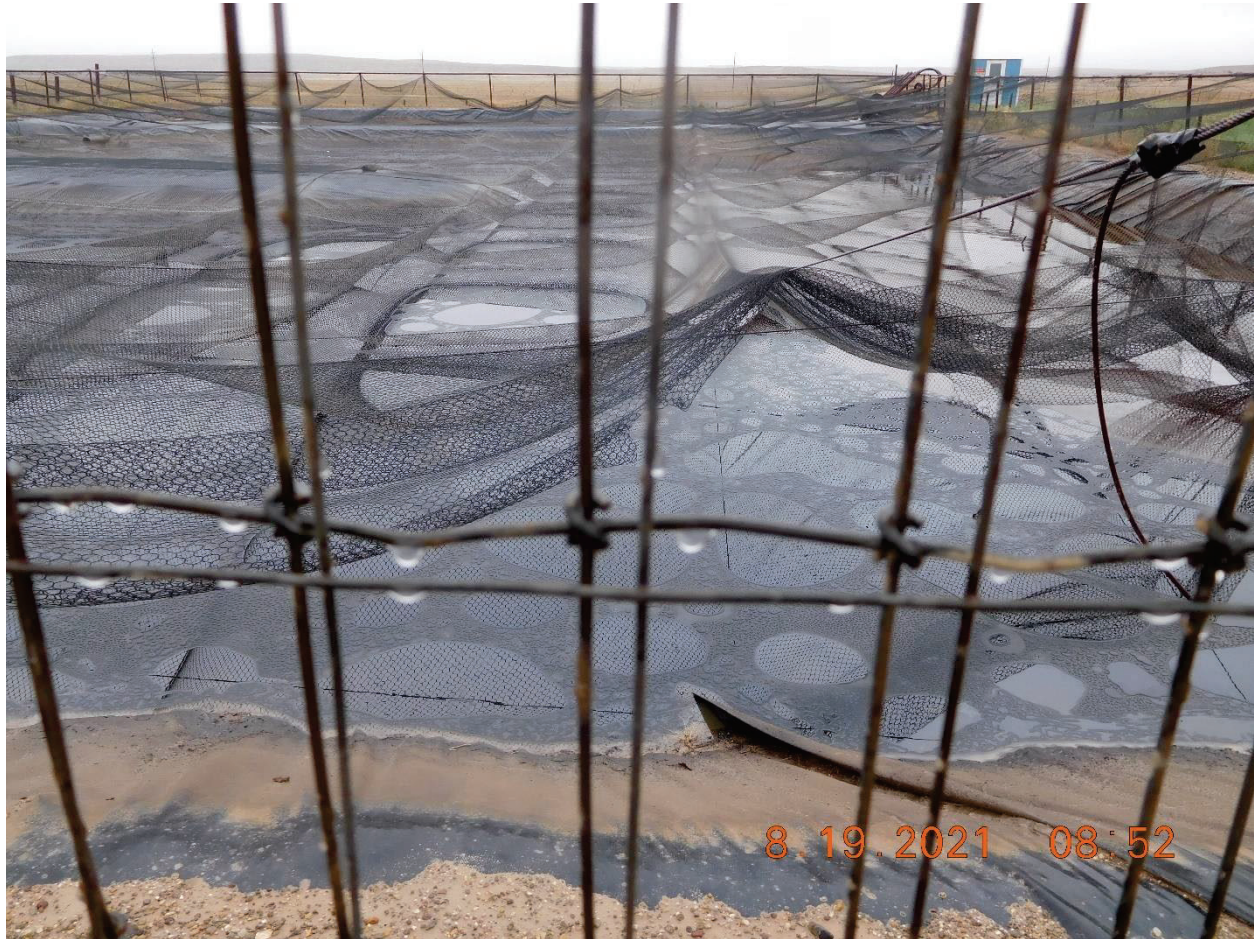
Photo 1578: DSCN1578.jpg – photo of netted separation pond showing poor condition of netting including holes in the netting; netting dipping into the pond; and oil floating on the surface of the pond.

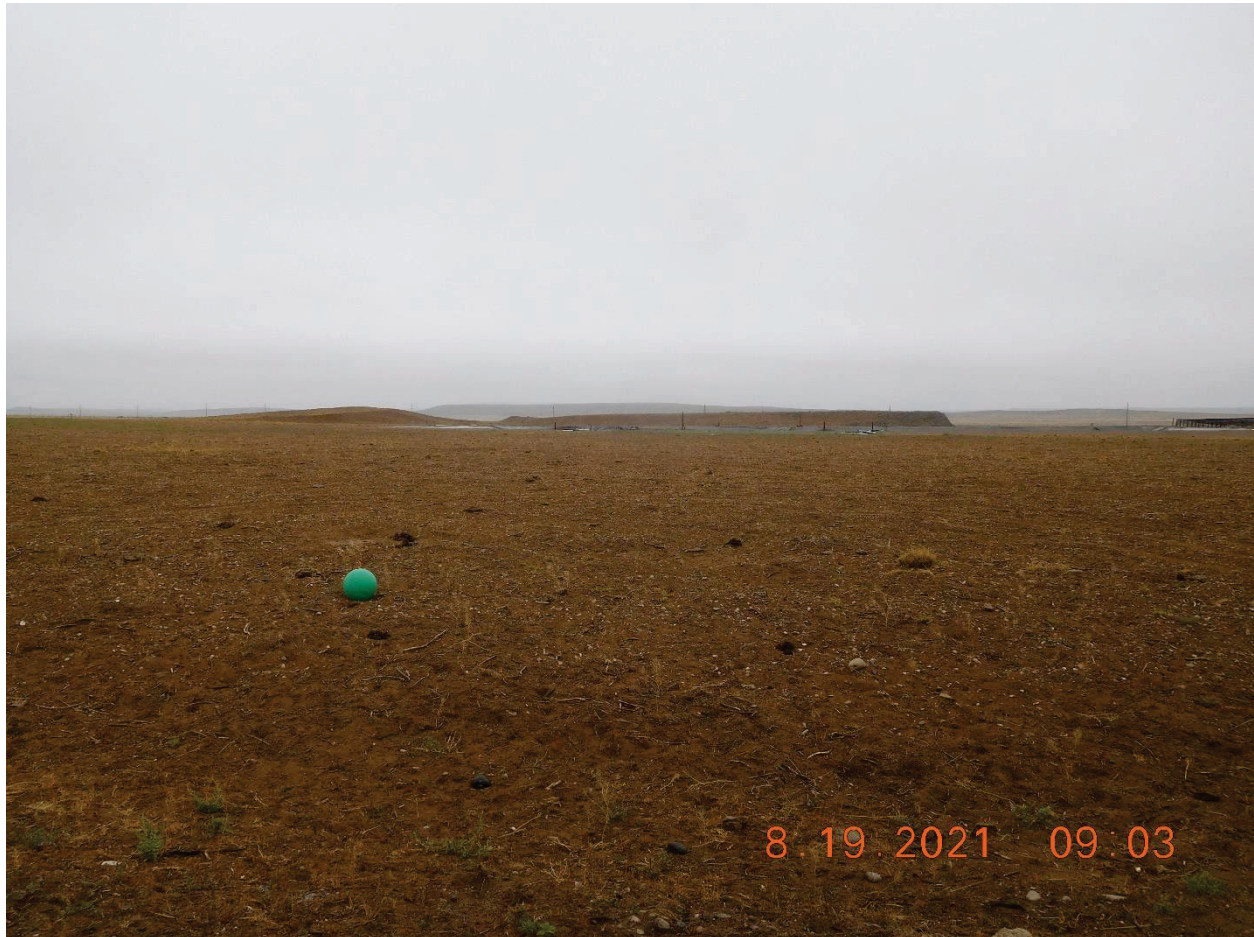
Photo 1579: DSCN1579.jpg – photo of what appears to be a child's ball located near the front gate of the Facility. The evaporation pond is visible in the photo in the background with settling ponds to the right.
