REPORT OF COMPLIANCE EVALUATION INSPECTION  
(INDUSTRIAL STORMWATER)

**BMaKK Corporation**

1440 Red Street  
Omaha, Nebraska 68112

October 5, 2023

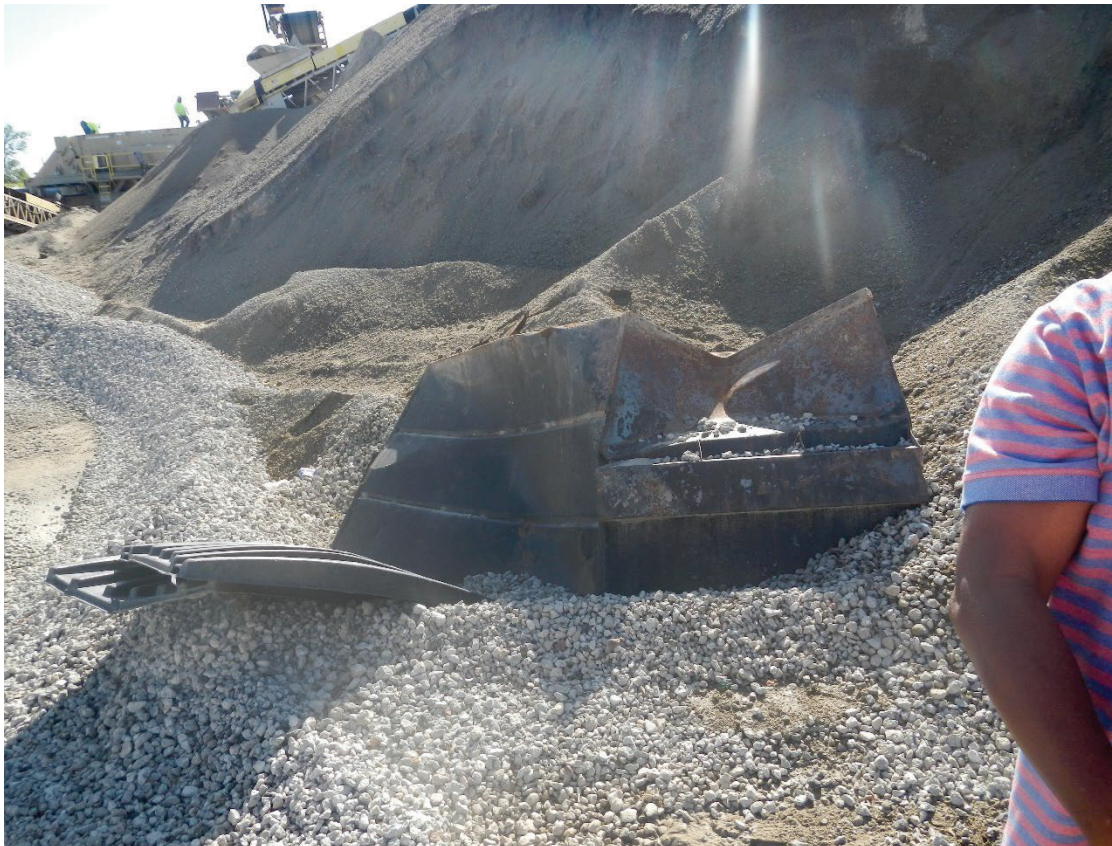
5. During our visual inspection of the outfalls, I noticed the following:
  - a. Outfall 04 is located in the final product storage piles area. The outfall was buried under the storage piles and facility personnel had placed a dumpster (upside-down) on top of it as a BMP to prevent sediment and stored material from entering the outfall as demonstrated in Photo 2 below.

**Photo 2, the Facility placed a dumpster on top of the outfall as BMP.**

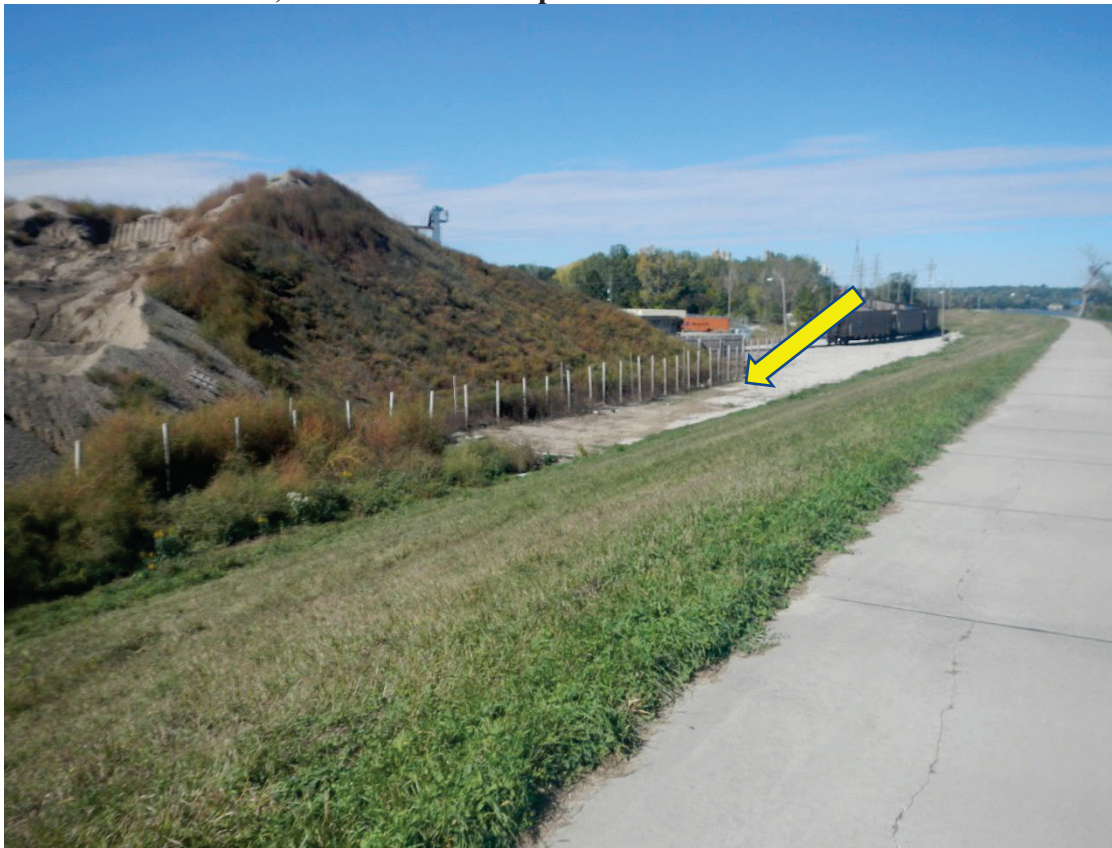
- c. Structural and nonstructural controls did not exist on site. But, overall, I did not observe significant number of debris or floatables.
6. While walking the Missouri River Levee after the inspection, we noticed that the Facility has a significant amount of material stored against the north fence line. The piles eroded and caused material to spill outside the fence into the levee ditch as demonstrated in Photo 8 below.

**Photo 8, Process material spilled outside the north fence line.**
