**Region 10 Enforcement and Compliance Assurance Division**  
**1200 6th Avenue**  
**Seattle, WA 98101**  
**INSPECTION REPORT**

| <b>Inspection Date:</b> | 02/23/2021 | |
| <b>Regulatory Program:</b> | CWA NPDES/Construction Stormwater | |
| <b>Site Name:</b> | The Oaks North | |

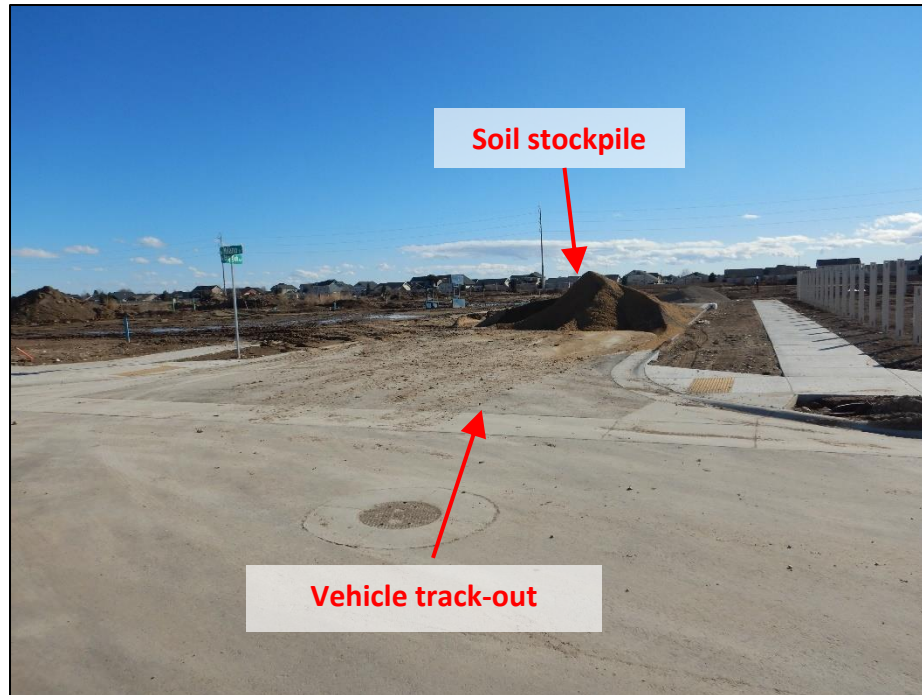
- Approximate slopes before and after major grading activities (Permit Part 7.2.4.b.ii)
- Locations where sediment, soil, or other construction materials will be stockpiled (Permit Part 7.2.4.b.ii) - We observed one soil stockpile on North Sunfield Road adjacent to a Site access point on West Millano Drive in Phase 4 (refer to Attachment A, Photograph 1).

We observed an unstabilized soil stockpile on North Sunfield Road adjacent to the Site access point on West Millano Drive in Phase 4. The stockpile was positioned adjacent to an unstabilized Site entrance in Phase 4 and appeared to be contributing to sediment track-out occurring in the area. We observed that the stockpile did not have any sediment barriers along the downgradient perimeter area on the roadway (refer to [Attachment A, Photograph 1](#)).

**Photograph 1.** View, facing south, of an unprotected stockpile on North Sunfield Road. Note the vehicle track-out in the foreground.

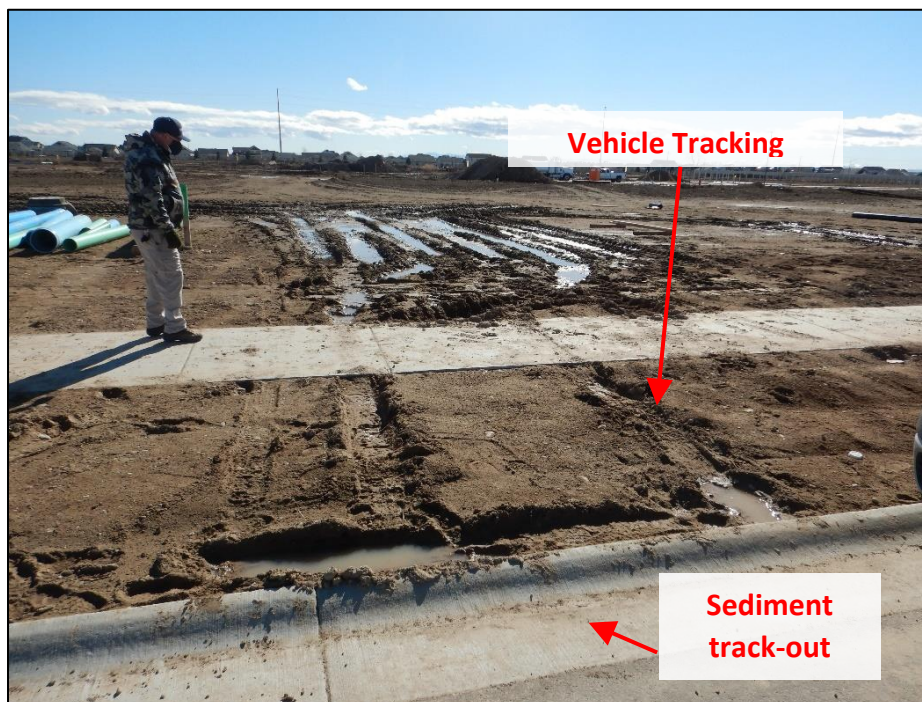
We observed that construction vehicle access had not been restricted to properly designated exit points in Phase 4. We observed three locations along the northern perimeter of Phase 4 on West Avilla Drive and one area on North Sunfield Road where the Site had been accessed by vehicles or construction equipment at non-designated exits. In all instances, stabilization techniques had not been installed at points where vehicle traffic entered on to paved roadways (refer to Attachment A, Photographs 1 through 6).

**Photograph 2.** View, facing south, of unrestricted vehicle access along the northern perimeter of Phase 4. Note no stabilization techniques had been implemented to prevent sediment track-out.

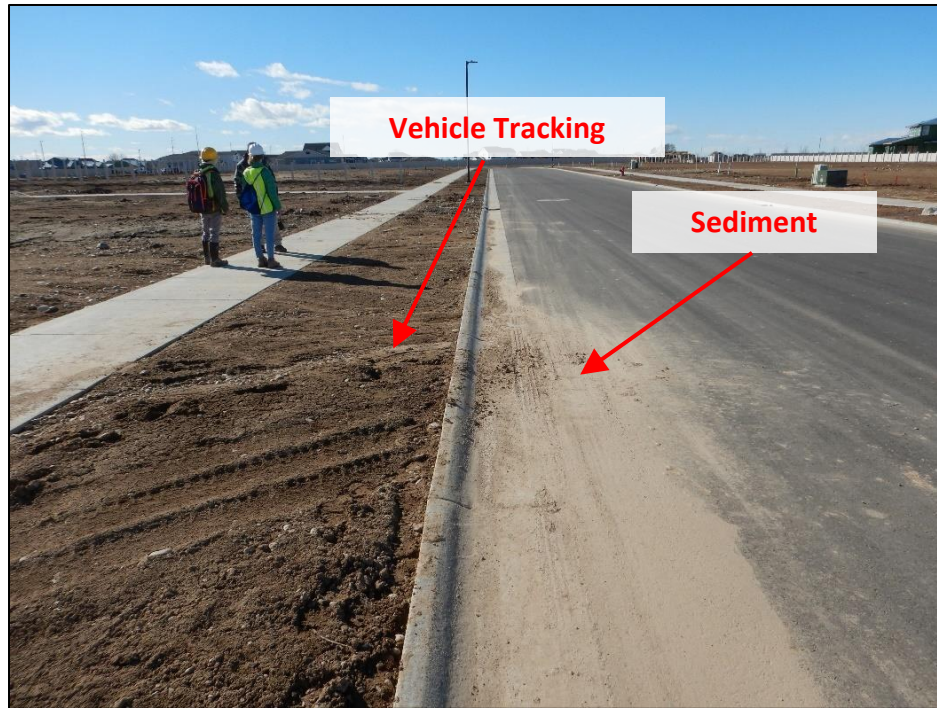
**Photograph 3.** View, facing west, of unrestricted vehicle access along the northern perimeter of Phase 4. Note no stabilization techniques had been implemented to prevent sediment track-out.

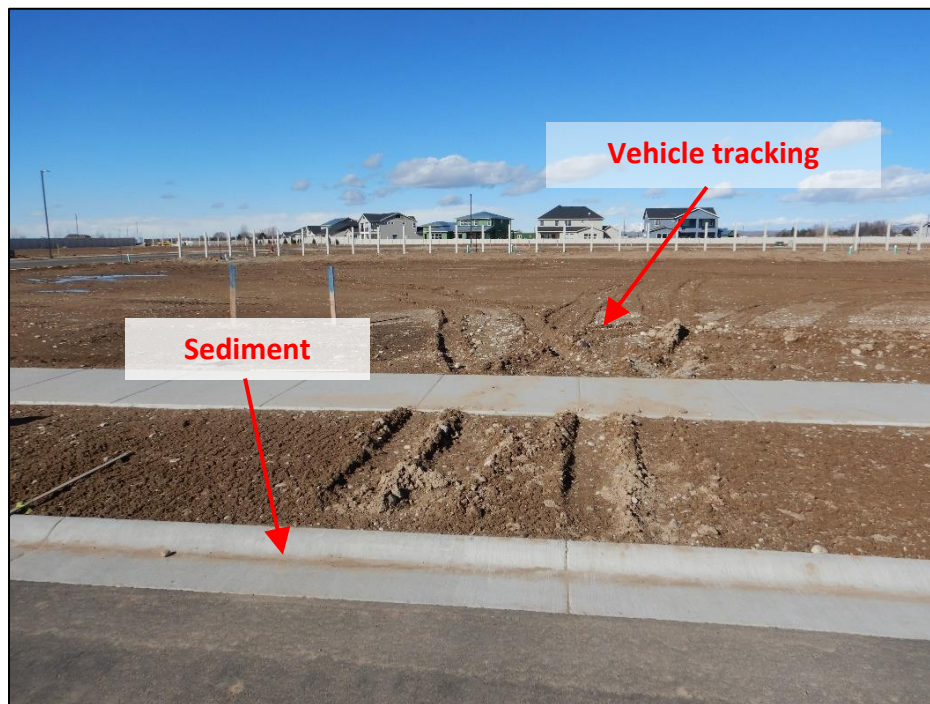
**Photograph 4.** View, facing north, of unrestricted vehicle access along the northern perimeter of Phase 4. Note no stabilization techniques had been implemented to prevent sediment track-out.

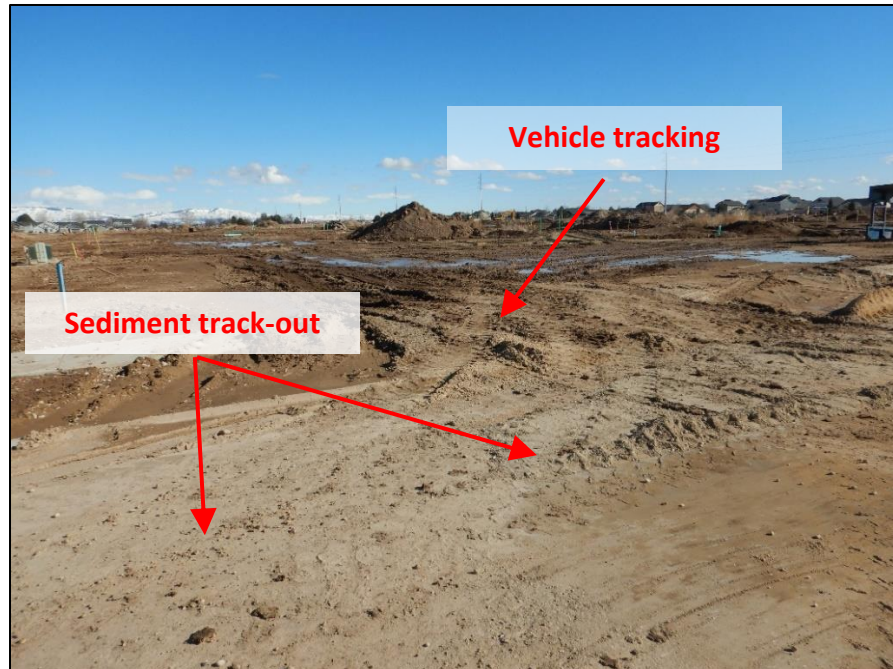
**Photograph 5.** View, facing east, of unrestricted vehicle access and construction vehicle track-out at North Sunfield Road in Phase 4. Note that no stabilization techniques had been implemented to prevent track-out.

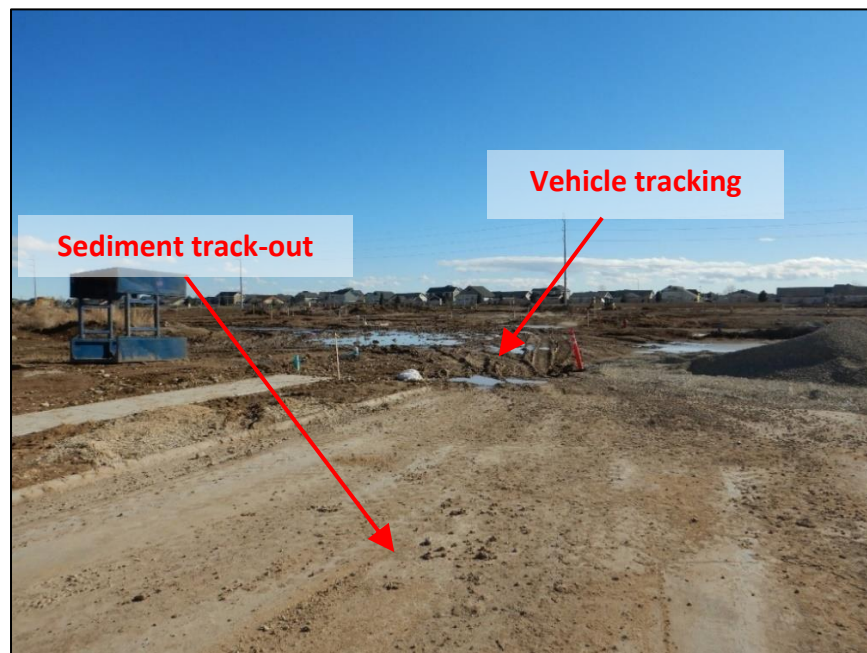
**Photograph 6.** Additional view, facing south, of unrestricted vehicle access and construction vehicle track-out on North Sunfield Road in Phase 4 as shown in [Photograph 5](#). Note no stabilization techniques had been implemented to prevent sediment track-out.

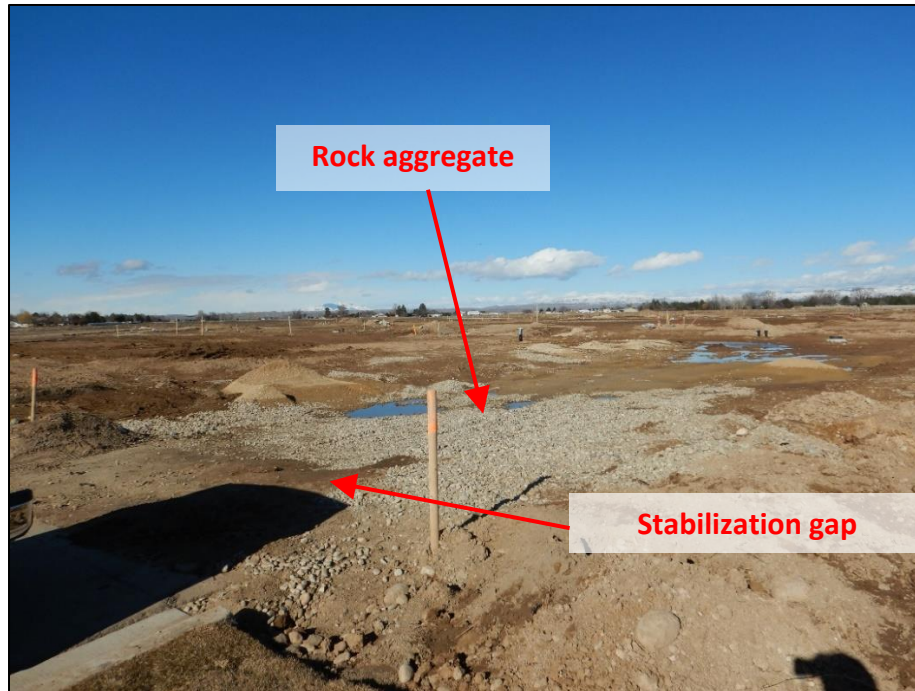
Additionally, we observed an improperly installed aggregate rock track-out control at the Phase 6 construction access point. The aggregate rock installed for the tracking control did not extend all the way to the pavement. As a result, an area of exposed soil was left between the pavement and the rock tracking pad (refer to Attachment A, Photograph 7).

**Photograph 7.** View, facing northeast, of the vehicle access point for Phase 6. Note rock aggregate placed to prevent sediment track-out does not extend to the paved area.

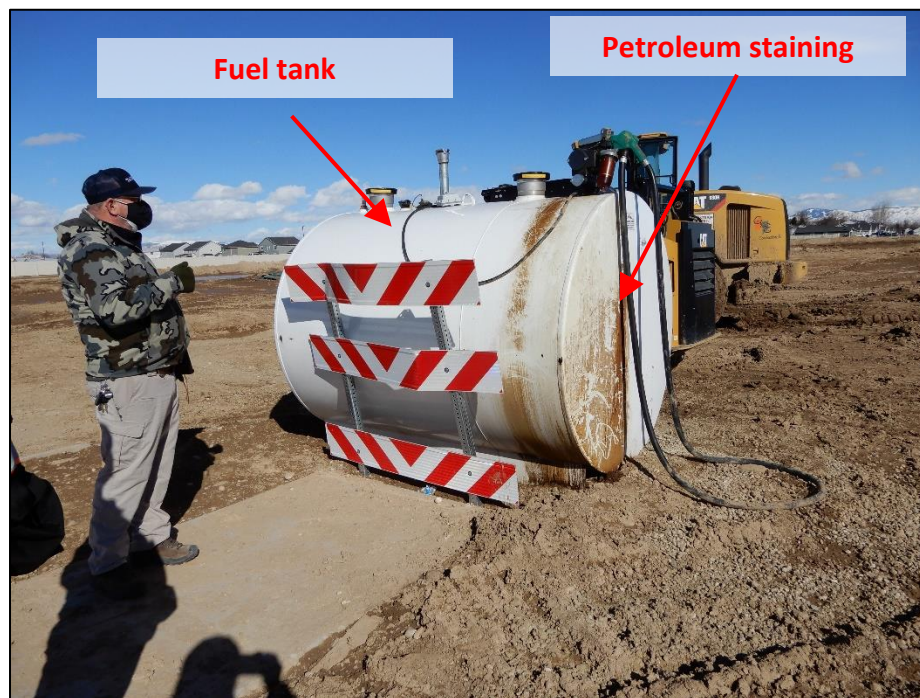
We observed a 500-gallon fuel tank adjacent to the access point on the eastern end of West Avilla Drive in Phase 4 that was not under a cover and did not have secondary containment. No spill kit was observed in the area to respond to any spills or leaks that occurred. Additionally, the fuel tank was observed to have petroleum residue on the outside of the tank (refer to Attachment A, Photograph 8).

**Photograph 8.** View, facing east, of a 500-gallon fuel tank at the eastern end of West Avilla Drive that was not covered or in secondary containment. Petroleum staining was visible on the outside of the tank.

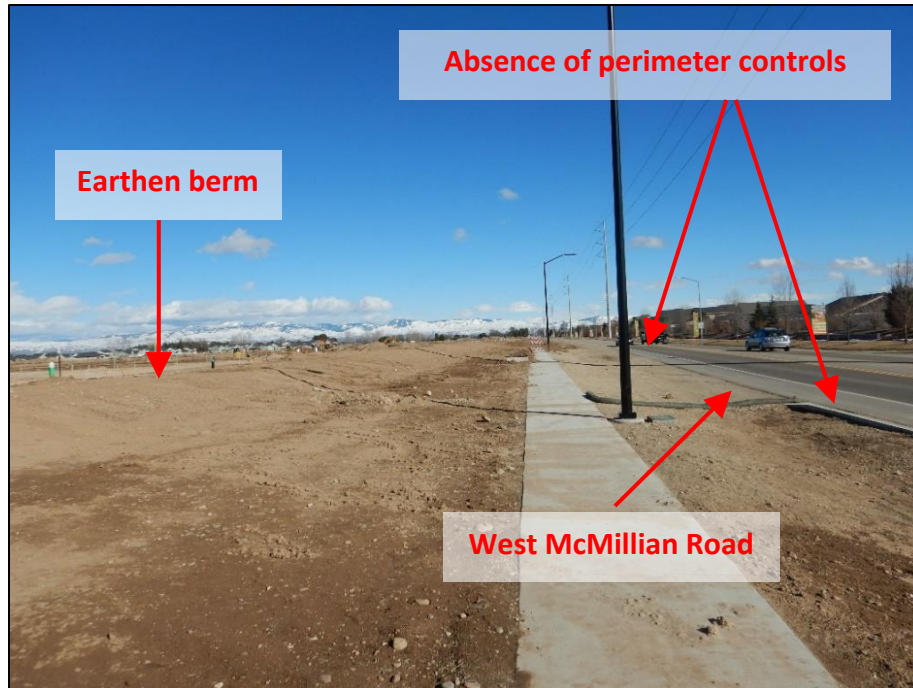
We observed a lack of effective sediment controls along the southern perimeter of the Site adjacent to West McMillian Road. We observed that the disturbed area along Phases 5 and 7 were adjacent to West McMillian Road and received runoff from the Site. No perimeter controls had been installed to prevent sediment from leaving the Site (refer to Attachment A, Photograph 9).

**Photograph 9.** View, facing east, of the southern perimeter in Phase 7. Note the absence of perimeter controls adjacent to West McMillian Road.

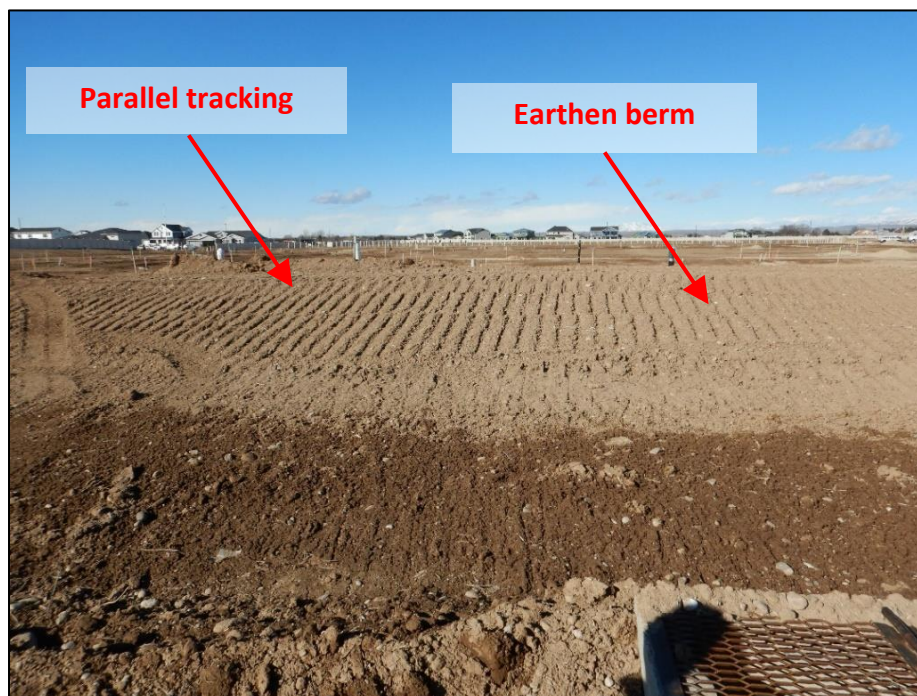
Additionally, along the Site’s southern perimeter, an earthen berm had been constructed as a part of the permanent landscaping plan. We observed that the berm had been compacted and tracked. However, the tracking was parallel to the slope instead of perpendicular, creating the potential for increased erosion (refer to Attachment A, Photograph 10).

**Photograph 10.** View, facing north, of a permanent earthen berm awaiting final stabilization. The berm is installed along the southern perimeter of Phase 5. Note that the tracking used to stabilize the berm was conducted parallel to the slope instead of perpendicular, creating an increased potential for erosion.

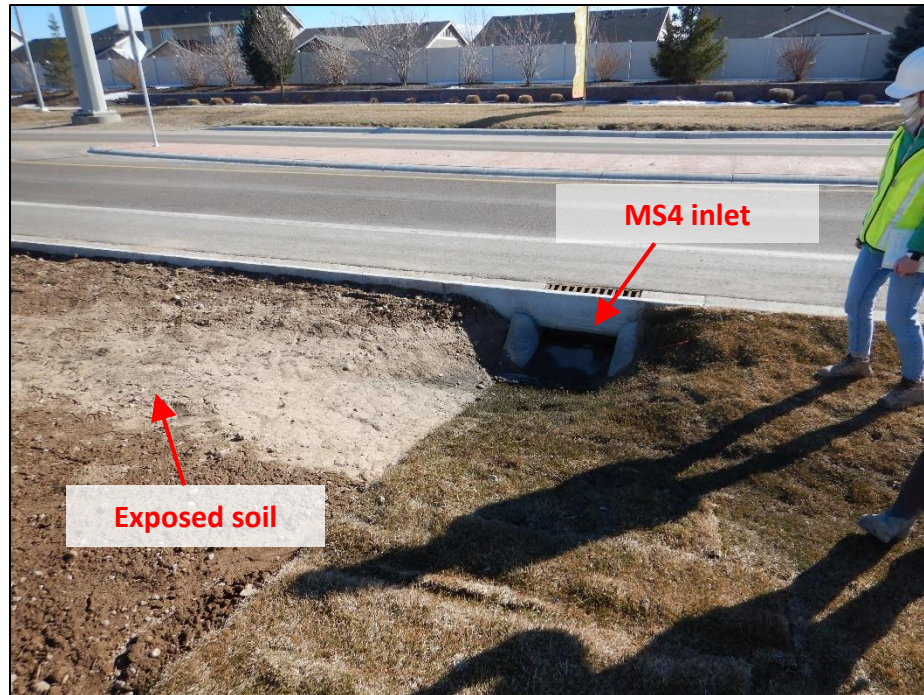
In the southwestern corner of Phase 5 we observed an unstabilized earthen swale that led to an unprotected MS4 inlet (refer to Attachment A, Photographs 11 and 12). During the post-inspection document review it was noted that the unprotected inlet was not identified as a discharge point on the Site’s SWPPP map (refer to Attachment D).

**Photograph 11.** View, facing south, of the southern perimeter of the Oaks North Subdivision Phase 5. An inlet to the Meridian MS4 was observed to not have inlet protection and had the potential to receive runoff from exposed soil on the Site.

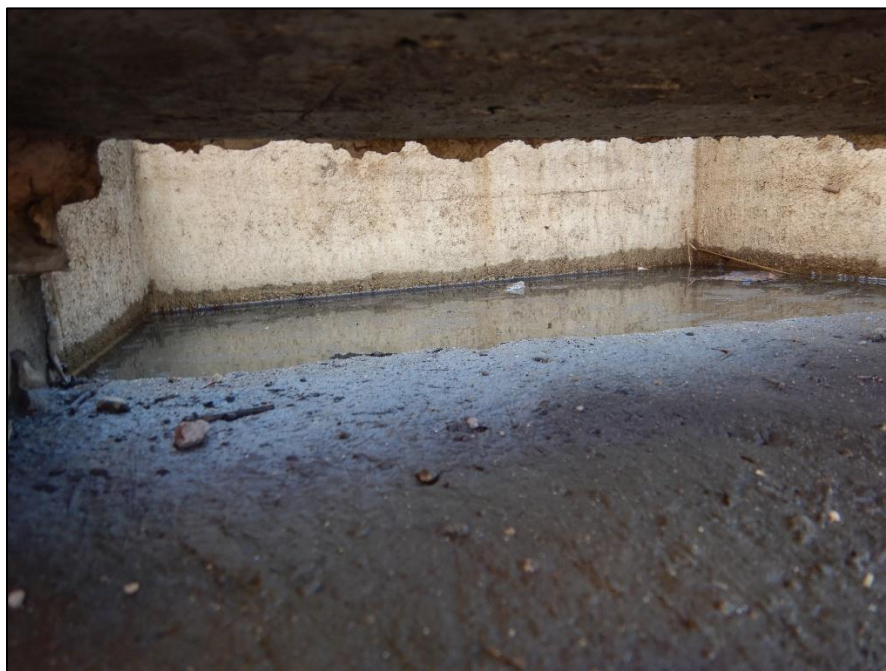
**Photograph 12.** View inside the inlet to the Meridian MS4 shown in [Photograph 11](#). Note the lack of inlet protection.

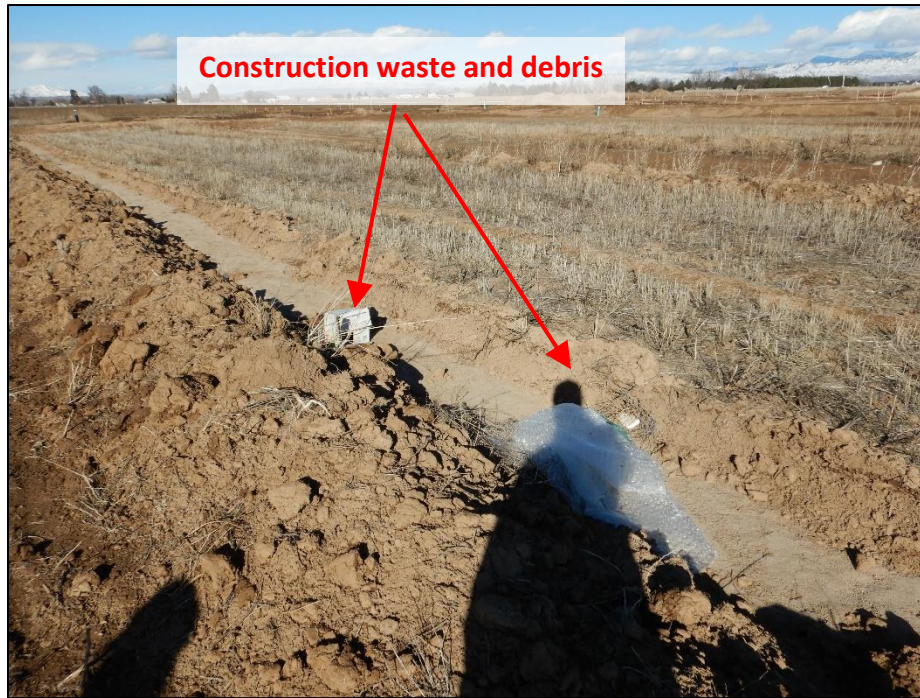
We observed uncontained construction waste and debris along the western perimeter of Phase 6. Mr. Calhoun stated that it had been windy in the previous week and that the waste had likely been blown into Phase 6 from other areas of the Site (refer to Attachment A, Photograph 13).

**Photograph 13.** View, facing northeast, of uncontained construction waste and debris observed along the western perimeter of Phase 6.

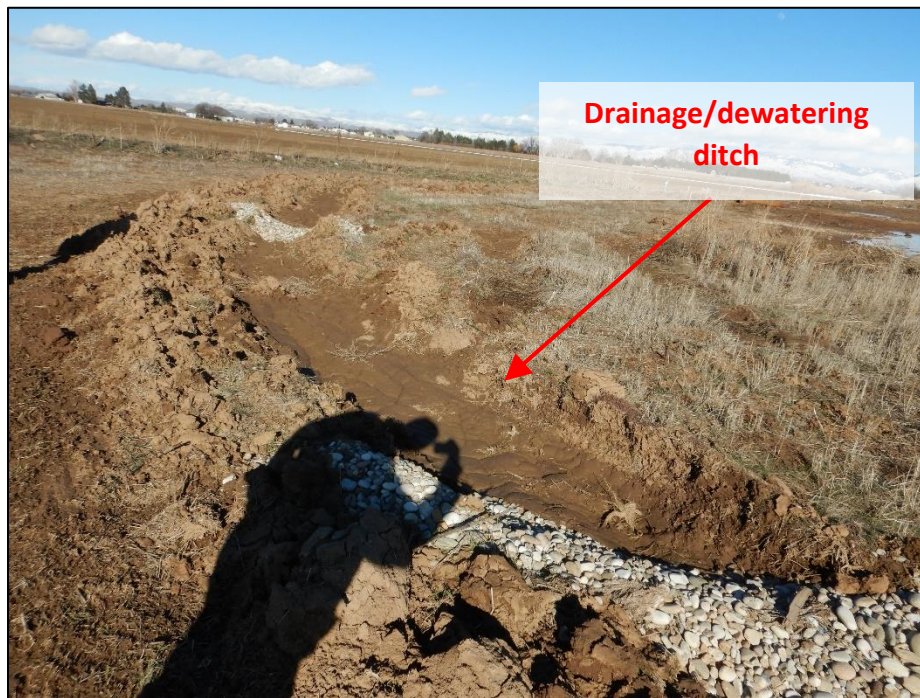
We observed a drainage/dewatering ditch along the western perimeter of Phase 6 that had been installed within the Site. At the time of the inspection, the ditch did not have flow in it. We observed that rock check dams had been installed along the length of the ditch. Mr. Calhoun stated that these had been installed to help reduce erosion and sediment discharges. The ditch met with the South Slough Canal at the northern perimeter of Phase 6. At the confluence of the drainage ditch and South Slough Canal, we observed an erosional cut and sediment deposited within South Slough Canal. At the time of the inspection, there was no water flowing in South Slough Canal (refer to Attachment A, Photographs 14 through 16).

**Photograph 14.** View, facing northeast, of a drainage/dewatering ditch observed in Phase 6. Rock check dams had been installed along the length of the ditch.

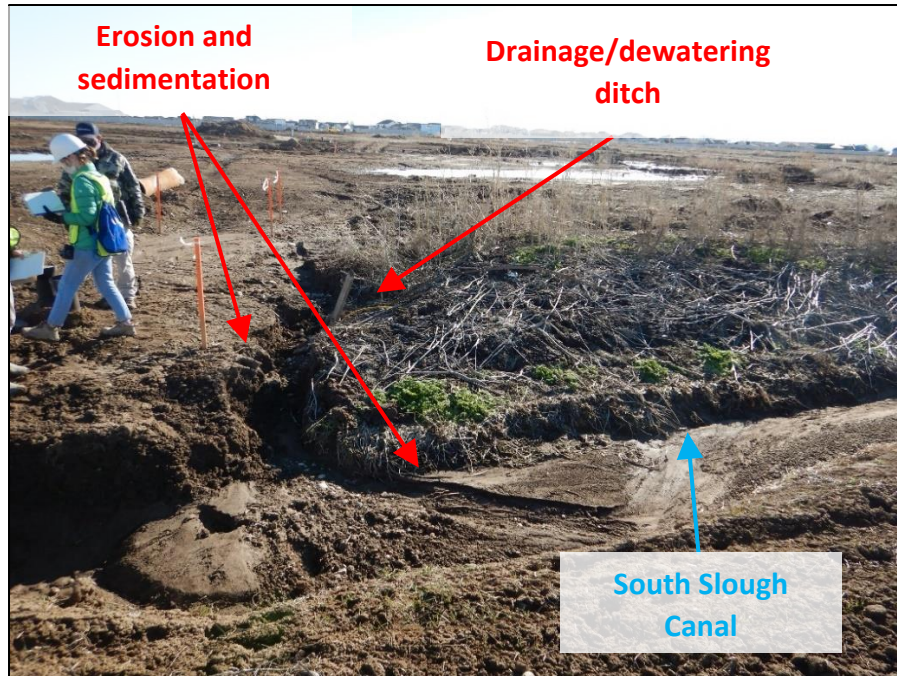
**Photograph 15.** View, facing south, of the confluence of the drainage/dewatering ditch and the South Slough Canal at the northern Site perimeter in Phase 6. Erosion in the drainage ditch and sedimentation in South Slough Canal was observed.

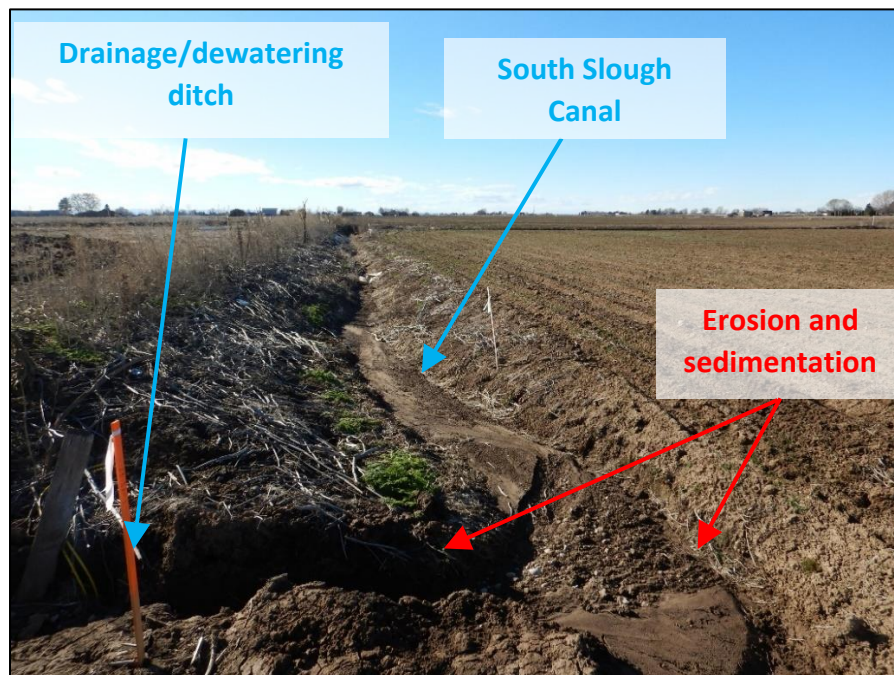
**Photograph 16.** View, facing west, of the confluence of the drainage/dewatering ditch and the South Slough Canal at the Site's northern perimeter (in Phase 6). Note the erosion in the drainage ditch and the sedimentation in South Slough Canal.

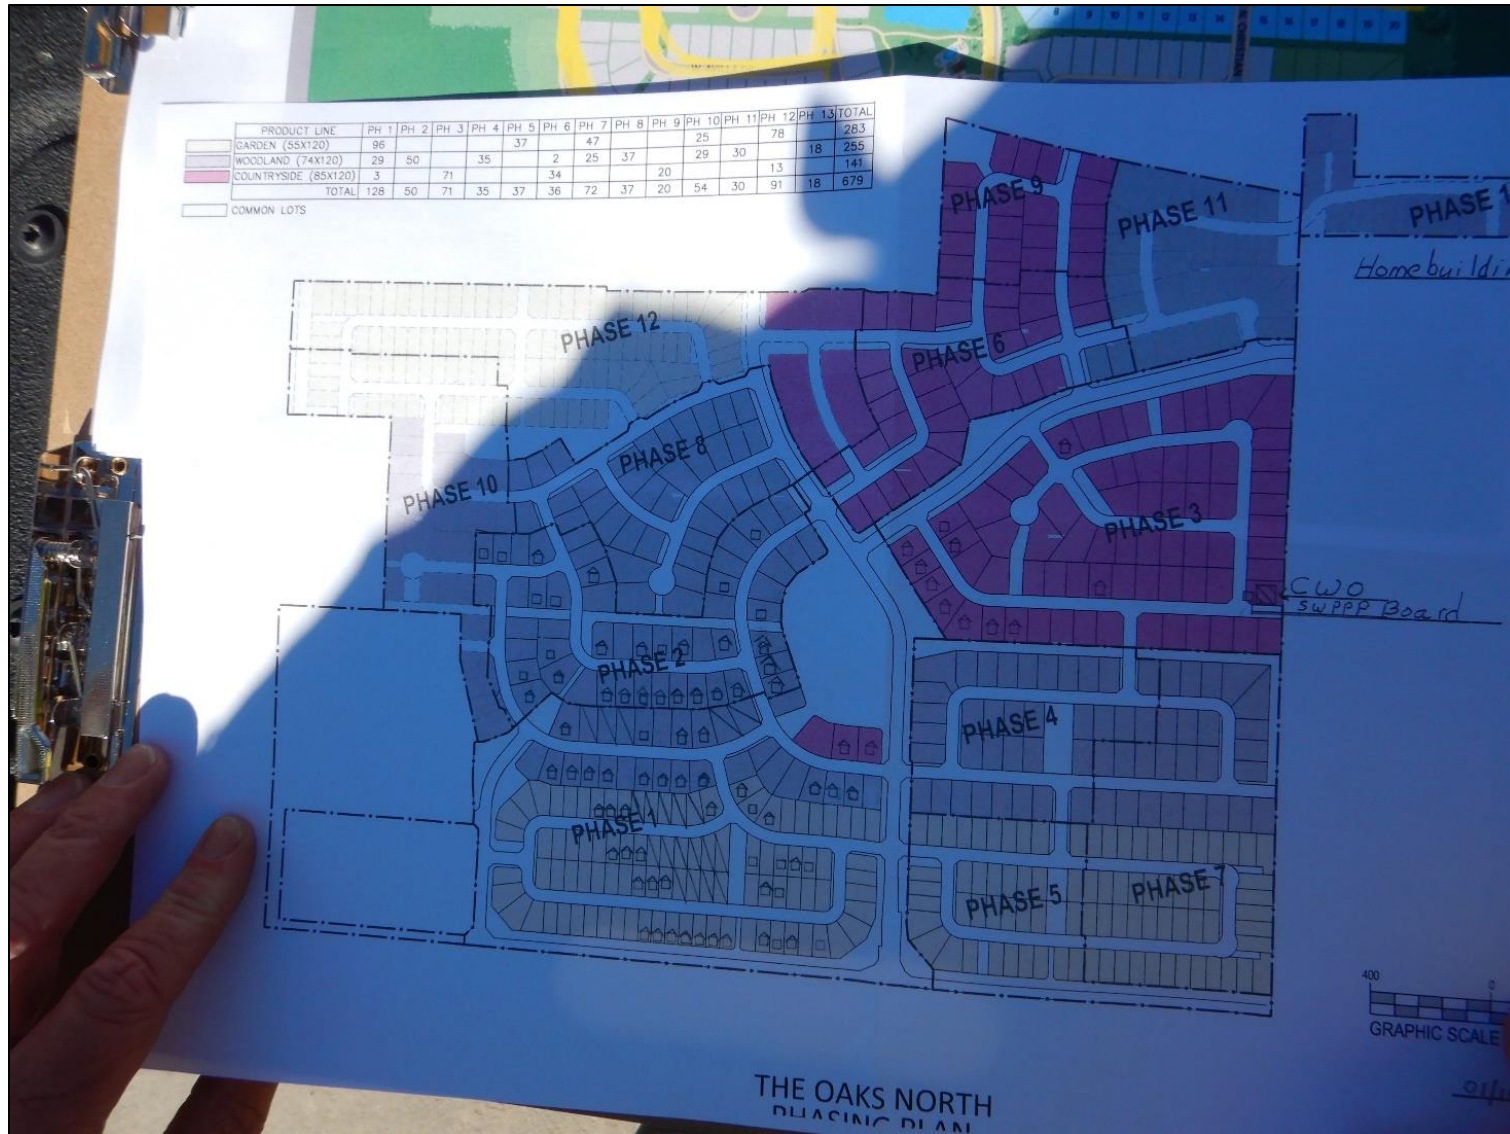
During the initial onsite records review, we observed that the SWPPP Site map and additional Site maps were not included in the SWPPP did not include all minimum information as required by Part 7.2.4 of the Permit. Specifically, the Site map did not identify the elements required by Part 7.2.4.b through 7.2.4.j of the Permit. Mr. Calhoun stated that additional Site maps existed that depicted the required elements, but at the time of the inspection, they could not be located (refer to Attachment B, Exhibits 2 and 3).

**Exhibit 2.** Image of the Site map provided on Site of the Oaks North. Note that the Site map does not identify the elements required by Part 7.2.4.b through 7.2.4.j of the Permit.

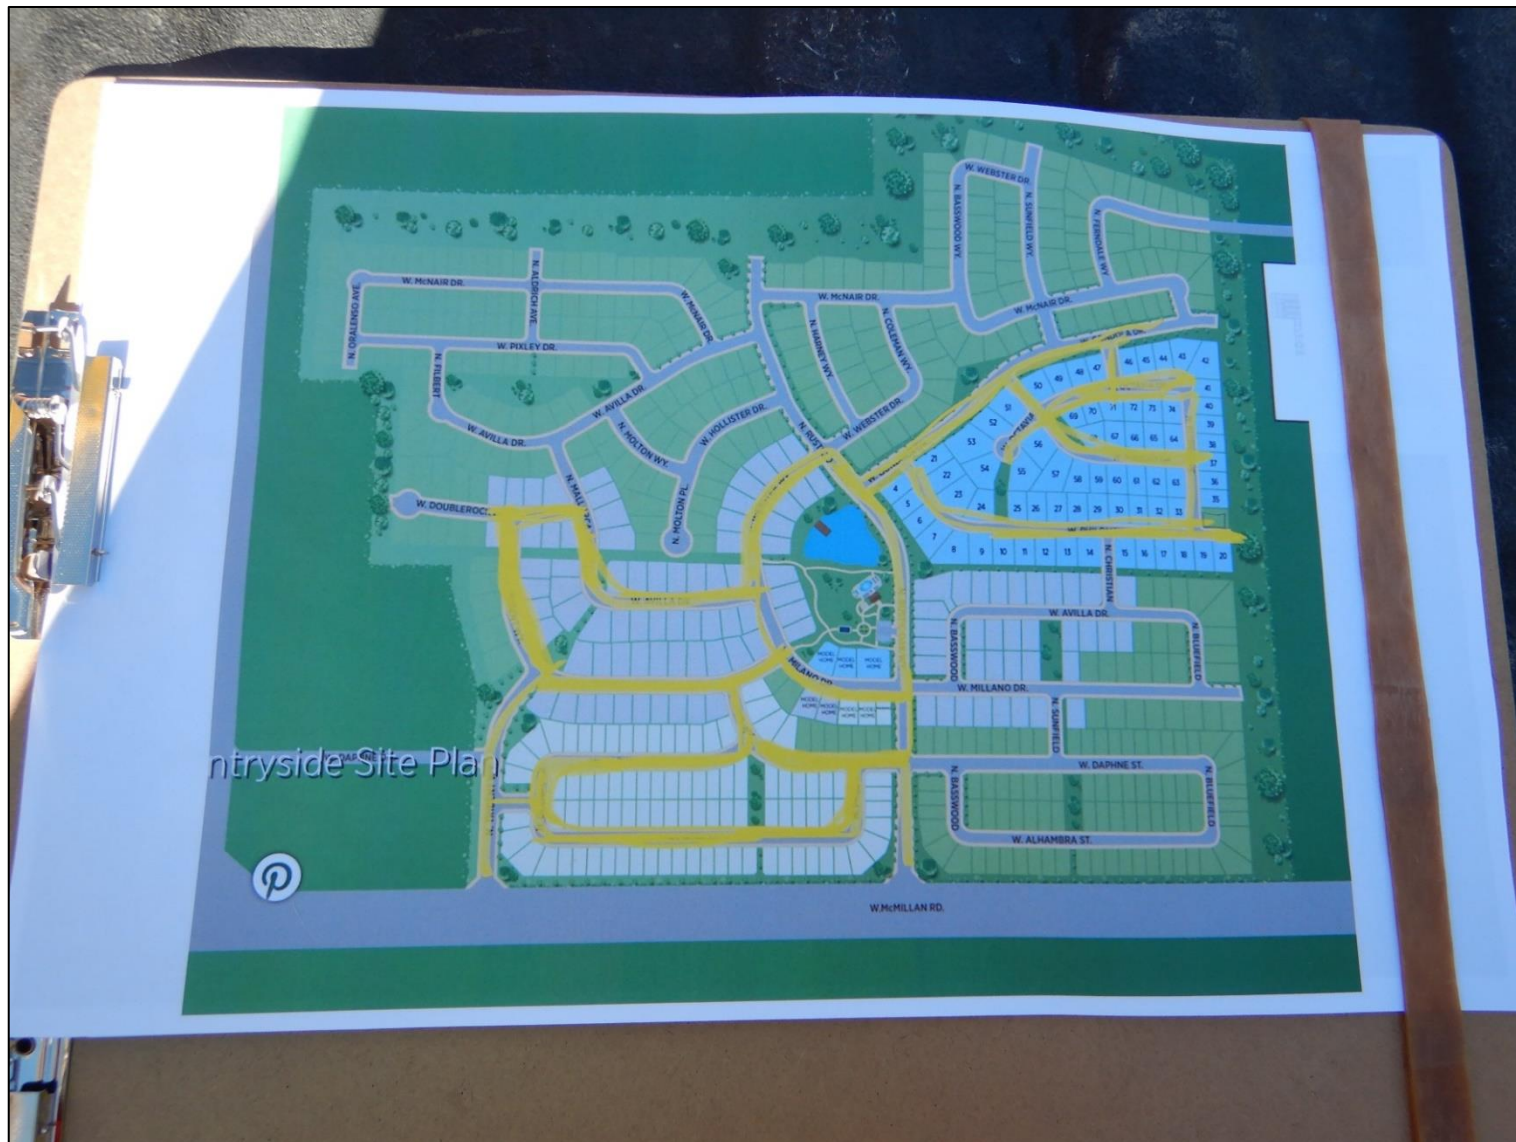
**Exhibit 3.** Image of another Site map provided on Site of the Oaks North that demonstrates street sweeping paths. Exhibit is not reproduced in the SWPPP.
