**Employers Insurance of Wausau**

Safety and Health Consultant's Report

5333 Strawberry Lane  
Louisville, Kentucky

M. S. Freshwater, environmental health engineer; and  
J. Warble, senior safety consultant; on December 11, 1975

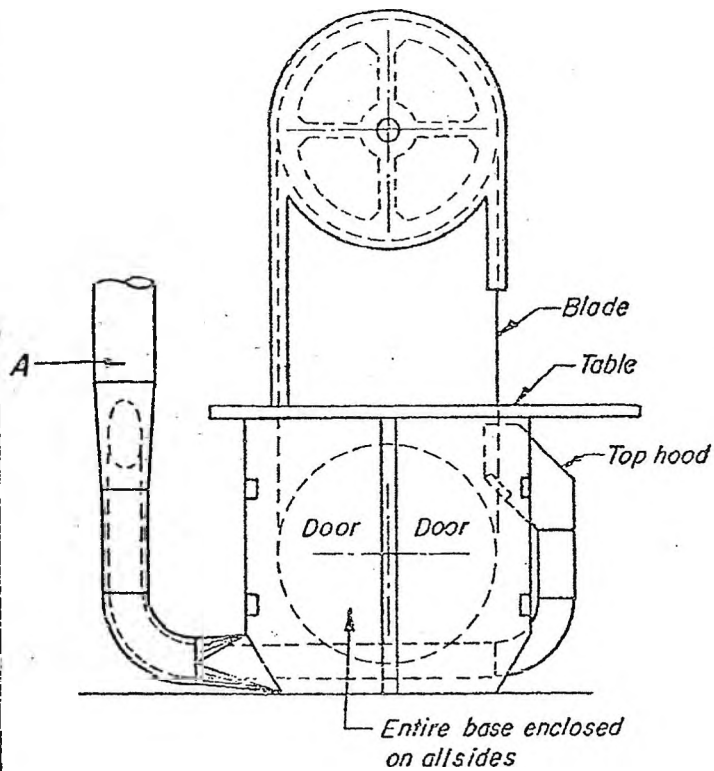
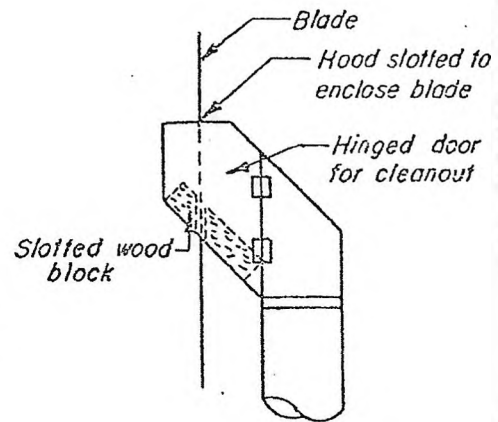
2. In the pipe shop, fabrication department, local exhaust ventilation is needed on the band saw during asbestos cutting. The enclosed print VS-706 illustrates basic ventilation design criteria (Industrial Ventilation, Committee on Industrial Ventilation, Post Office Box 452, Lansing, Michigan 48902).

4. The asbestos cutting operation on the LM895 band saw was not being performed during the survey. However, some improvements can be made to increase the ventilation effectiveness.

The open space underneath the table between the table and the slot should be enclosed. By doing so, the hood will be positioned closer to the dust source.

Dust duct velocities of 2,000 to 2,700 feet per minute (fpm) were measured compared to the usual design value of 3,500 fpm. Other design specifications can be found in the enclosed print VS-706 from 'Industrial Ventilation.'

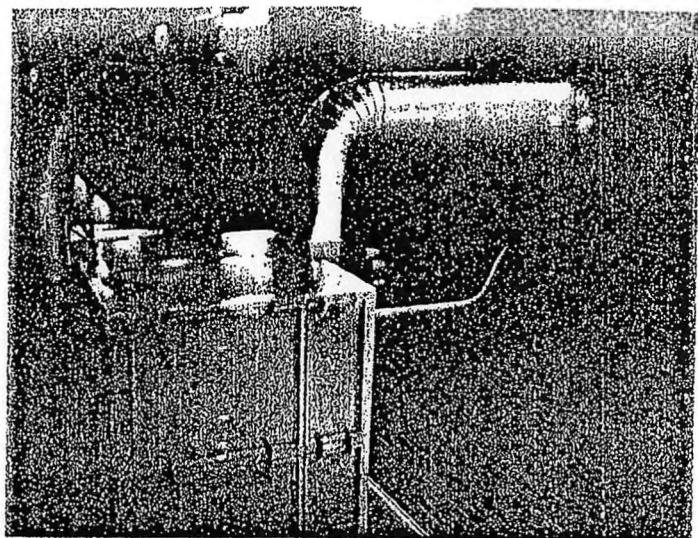
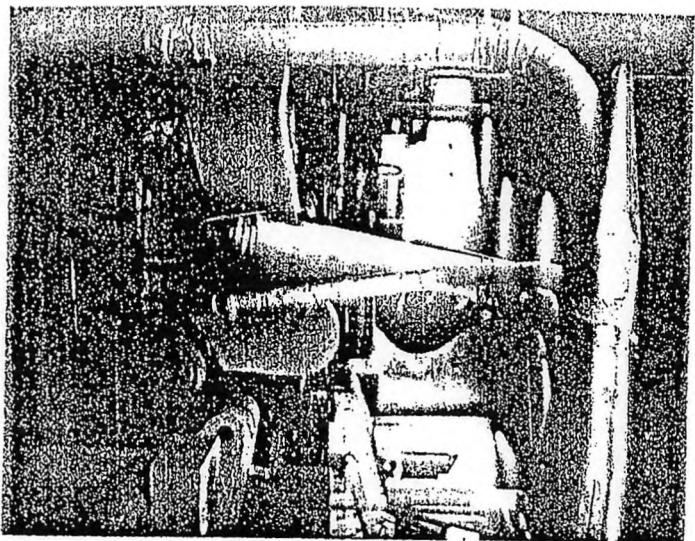
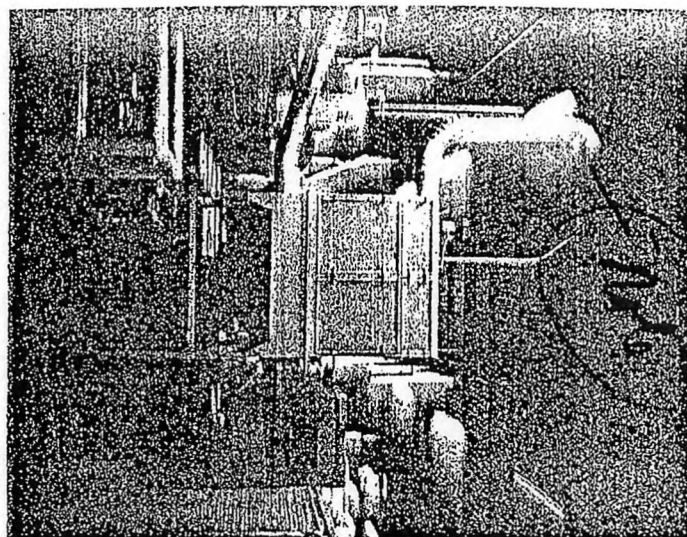
On M-67 Machine

- A. The Honeycomb Machine Saws are now on an American Air Filter "Bag" Unit discharging to the outside air.
- B. The M-67 Machine Saws are now on an "Unknown" brand filter unit discharging into the same room.
- C. Contact AAF in Louisville and have them send out a qualified Sales - Eng to look over the above and recommend how we should proceed to.
  1. Is the M-67 Machine Filter adequate?
  2. Should it be discharged outside the building?
  3. Could both the M-67 & Honeycomb Machine dusts be handled by the present AAF Unit?
  4. Is the present AAF Unit adequate for Asbestos to meet current regulation?
  5. If we add Saws to the SDNA line could we also tie it into this present AAF Unit?
  6. If Not these complete analysis & recommendations with pricing.
