## Clean Water Act Section 404: Site Visit/Case Development

| Inspector Name(s) | Chelsey Sherwood | Time In | 11:30 AM | Start Date | October 23, 2024 |
| Site Name | James Woodson | | | | |

| Inspection Purpose | Initial site visit | | |

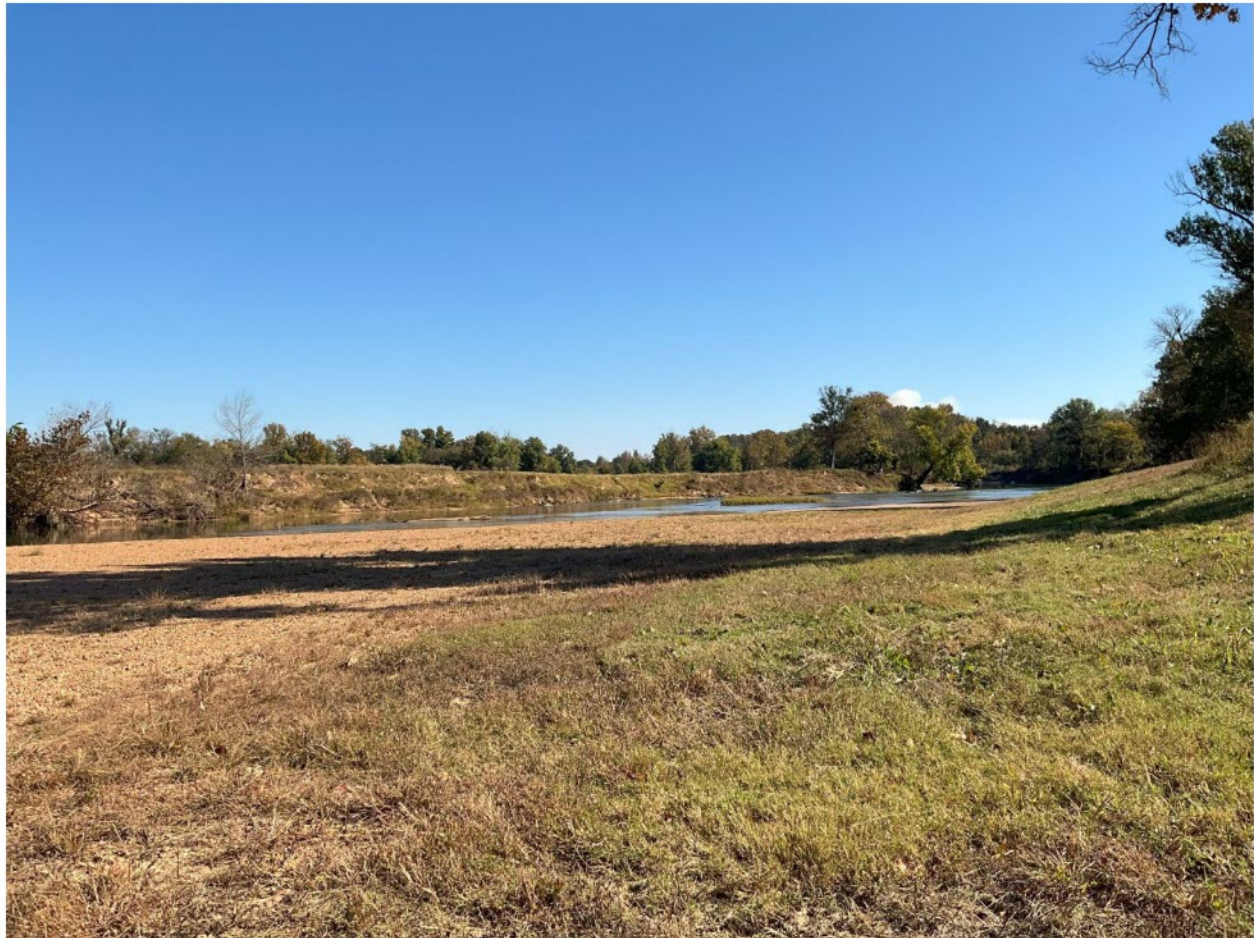
Photo No. 1

| Photo File Name | Date and Time of Photo | Photographer | Description |
|---|---|---|---|
| IMG_0097.HEIC | 10/23/2024, 11:47 AM | Chelsey Sherwood | Showing overview of project area where the stream bank was graded and fill material pushed into the stream channel. Picture taken facing east, downstream. |

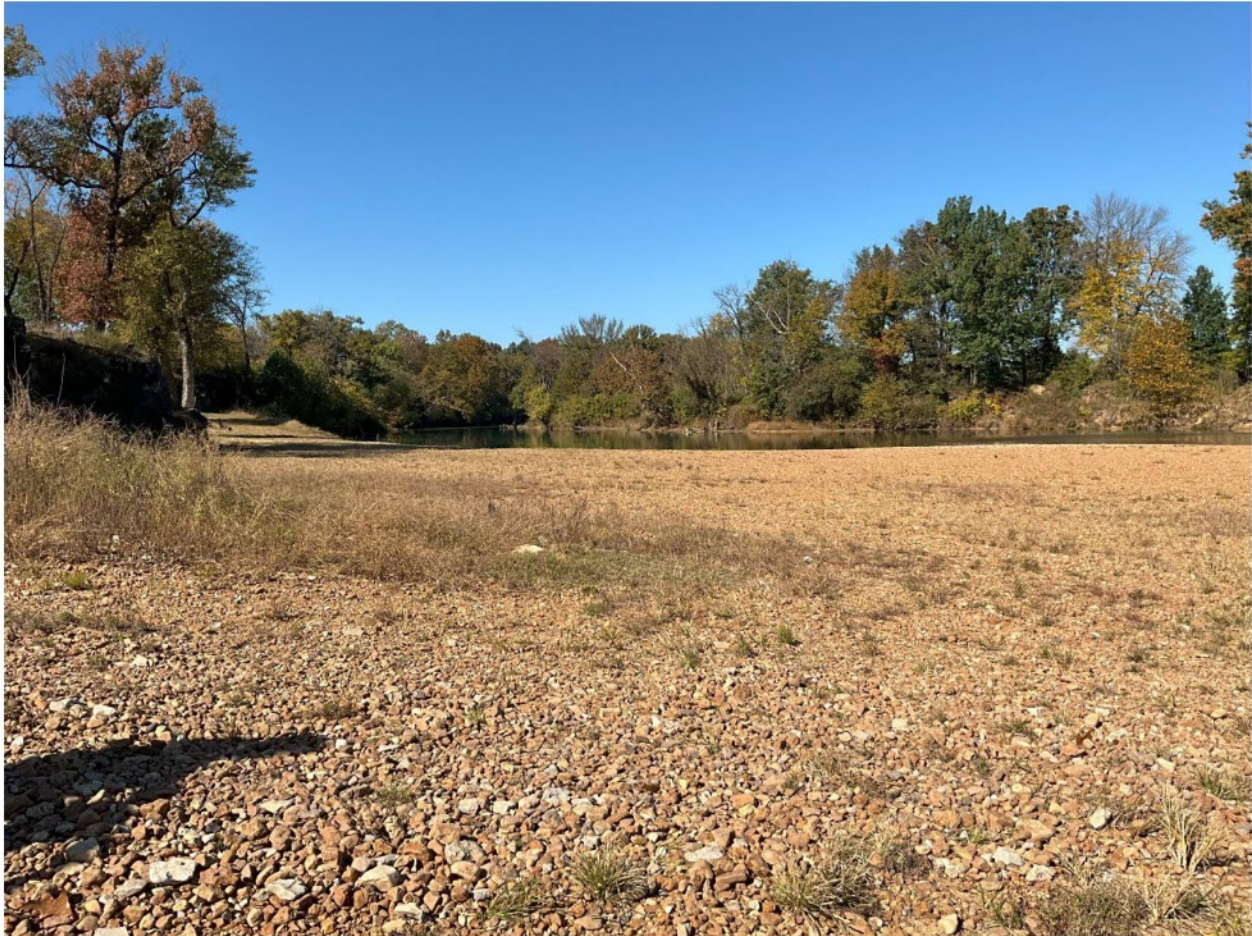
Photo No. 2

| Photo File Name | Date and Time of Photo | Photographer | Description |
|---|---|---|---|
| IMG_0098.HEIC | 10/23/2024, 11:47 AM | Chelsey Sherwood | Showing overview of project area where the stream bank was graded and fill material pushed into the stream channel. Picture taken facing west, upstream. |

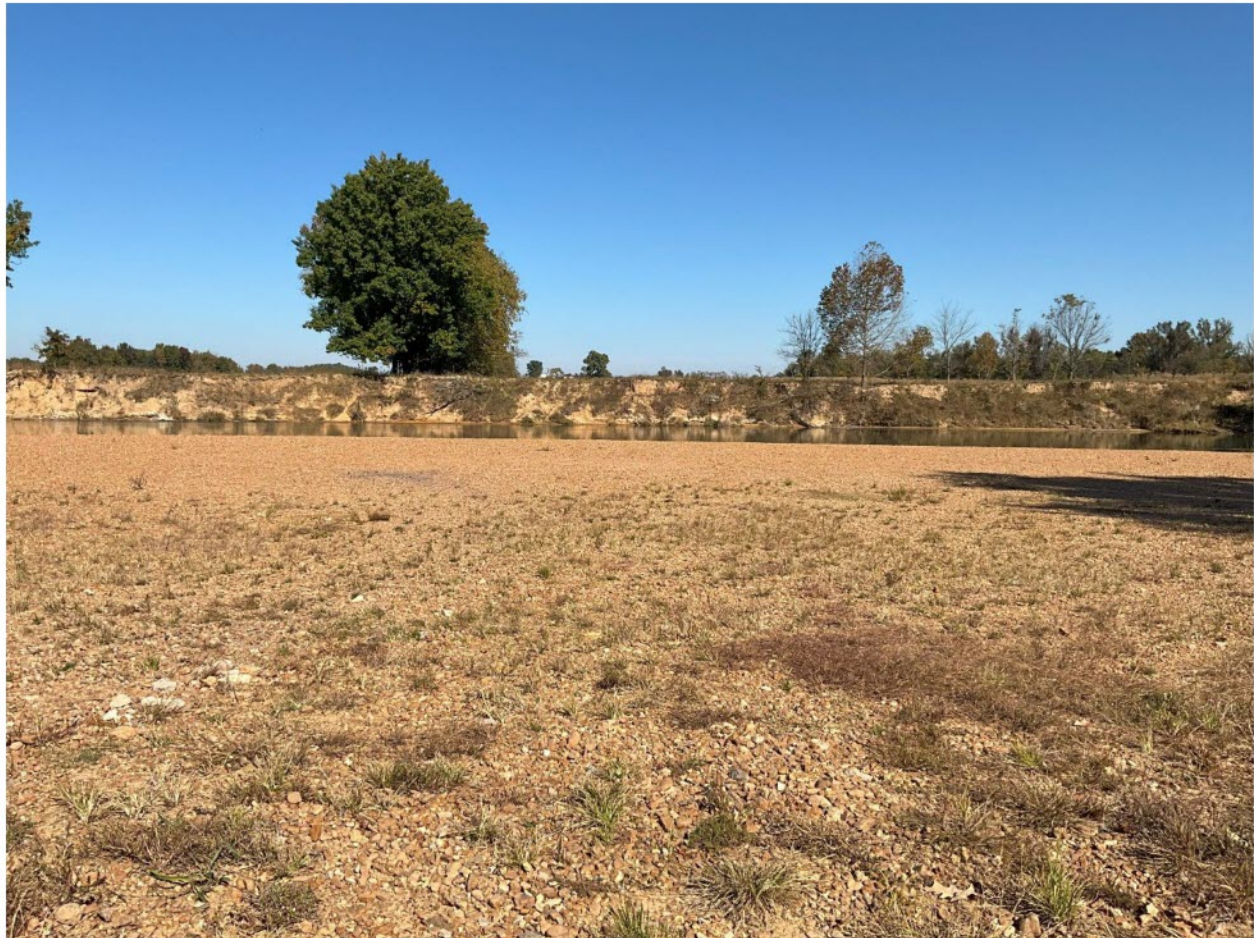
Photo No. 3

| We let the site owner know the concerns and issues of them changing the stream morphology when they graded the channel and created a large gravel bar. We let them know the potential issues of erosion on the river left bank because of changes in directional flow towards that bank due to the unauthorized discharges. | | | |

| Photo File Name | Date and Time of Photo | Photographer | Description |
|---|---|---|---|
| IMG_0099.HEIC | 10/23/2024, 11:47 AM | Chelsey Sherwood | Showing the erosion along the river left bank across from the graded stream bank. Picture taken facing north. |

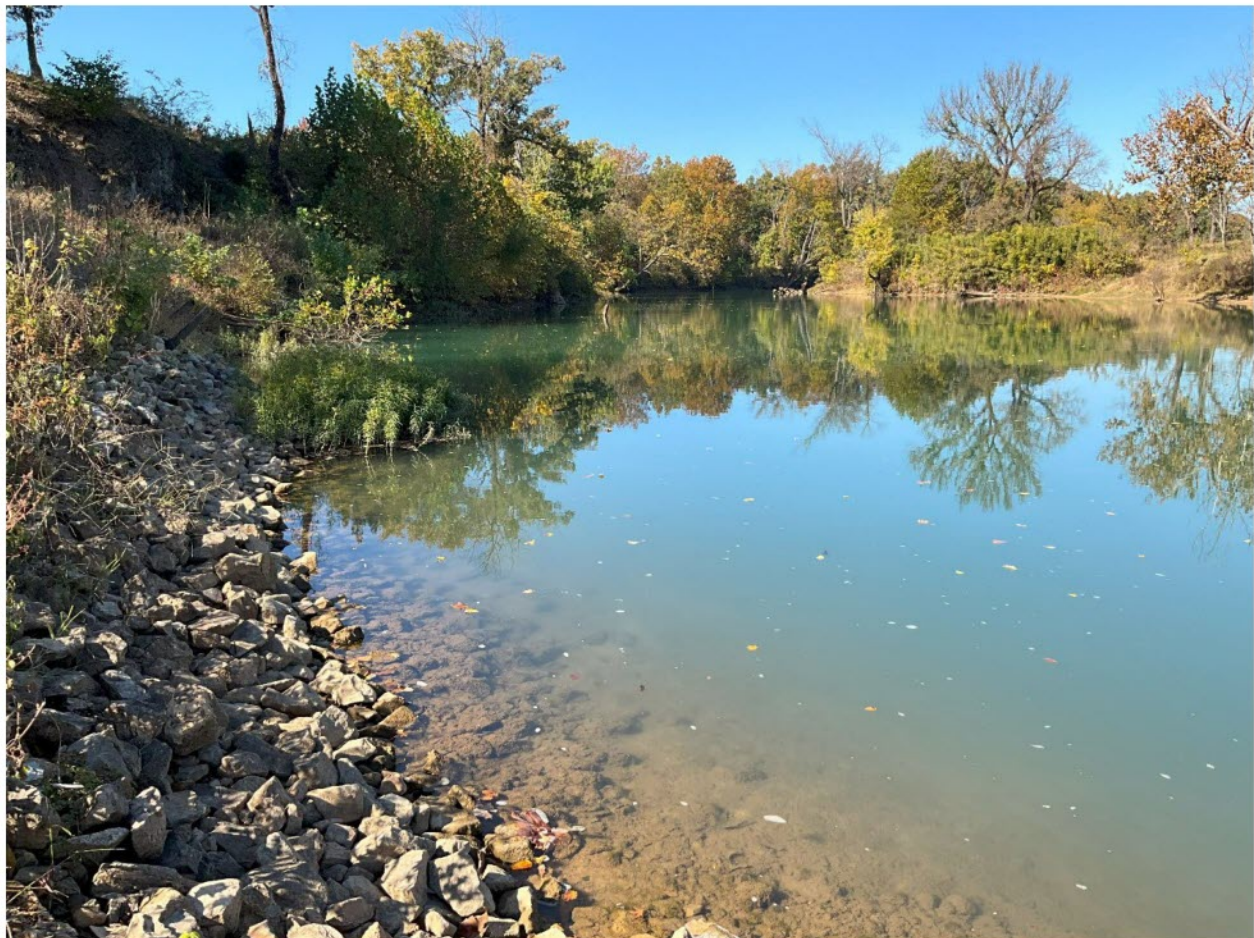
Photo No. 4

| Photo File Name | Date and Time of Photo | Photographer | Description |
|---|---|---|---|
| IMG_0100.HEIC | 10/23/2024, 11:55 AM | Chelsey Sherwood | Showing fill material below Ordinary High Water Mark along the stream bank. Picture taken facing west, upstream. |

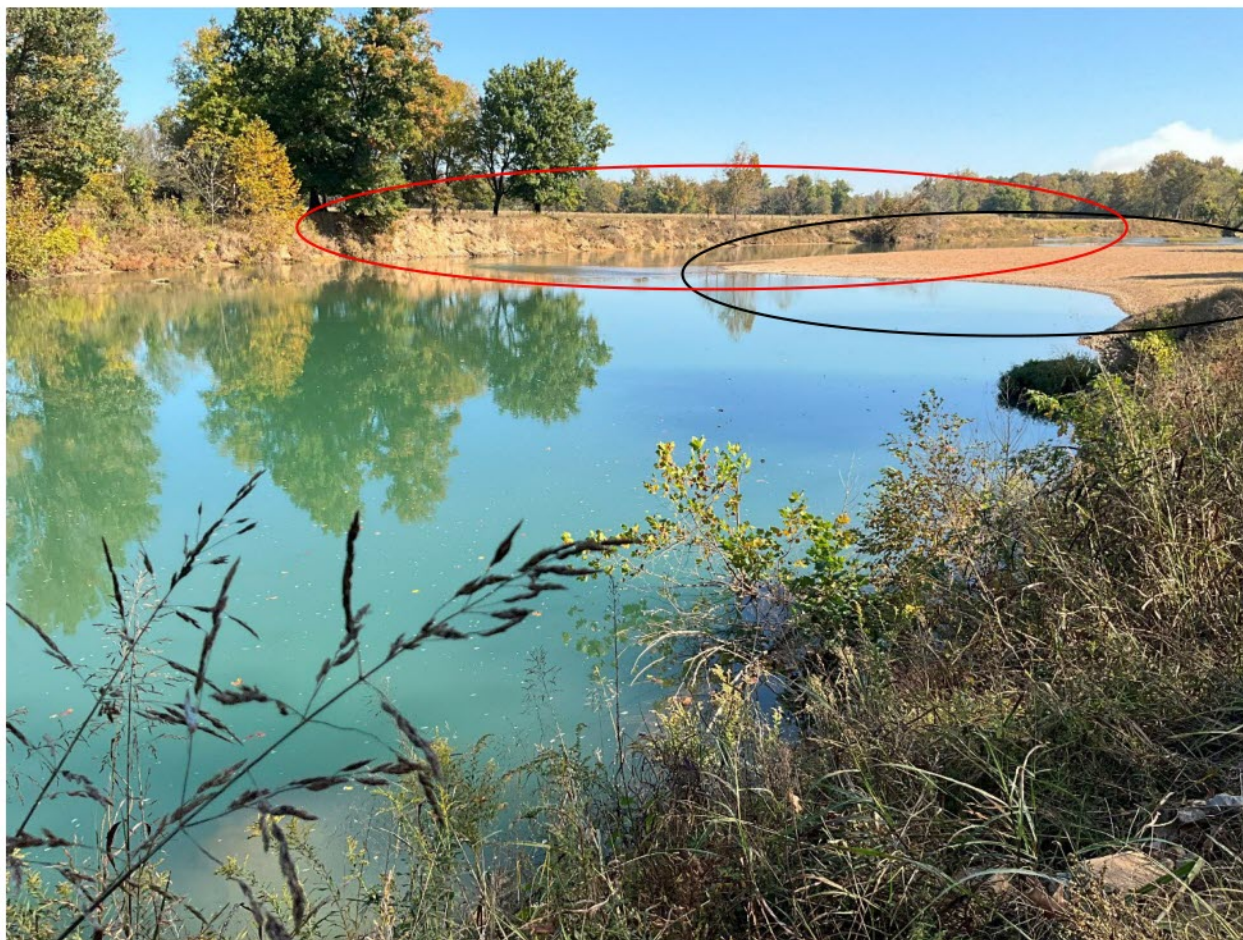
Photo No. 5

| Photo File Name | Date and Time of Photo | Photographer | Description |
|---|---|---|---|
| IMG_0101.HEIC | 10/23/2024, 11:57 AM | Chelsey Sherwood | Showing the erosion along river left bank (circled in red) directly across from where the stream bank was graded and fill material pushed out into the river channel (circled in black). Picture taken facing east, downstream. |

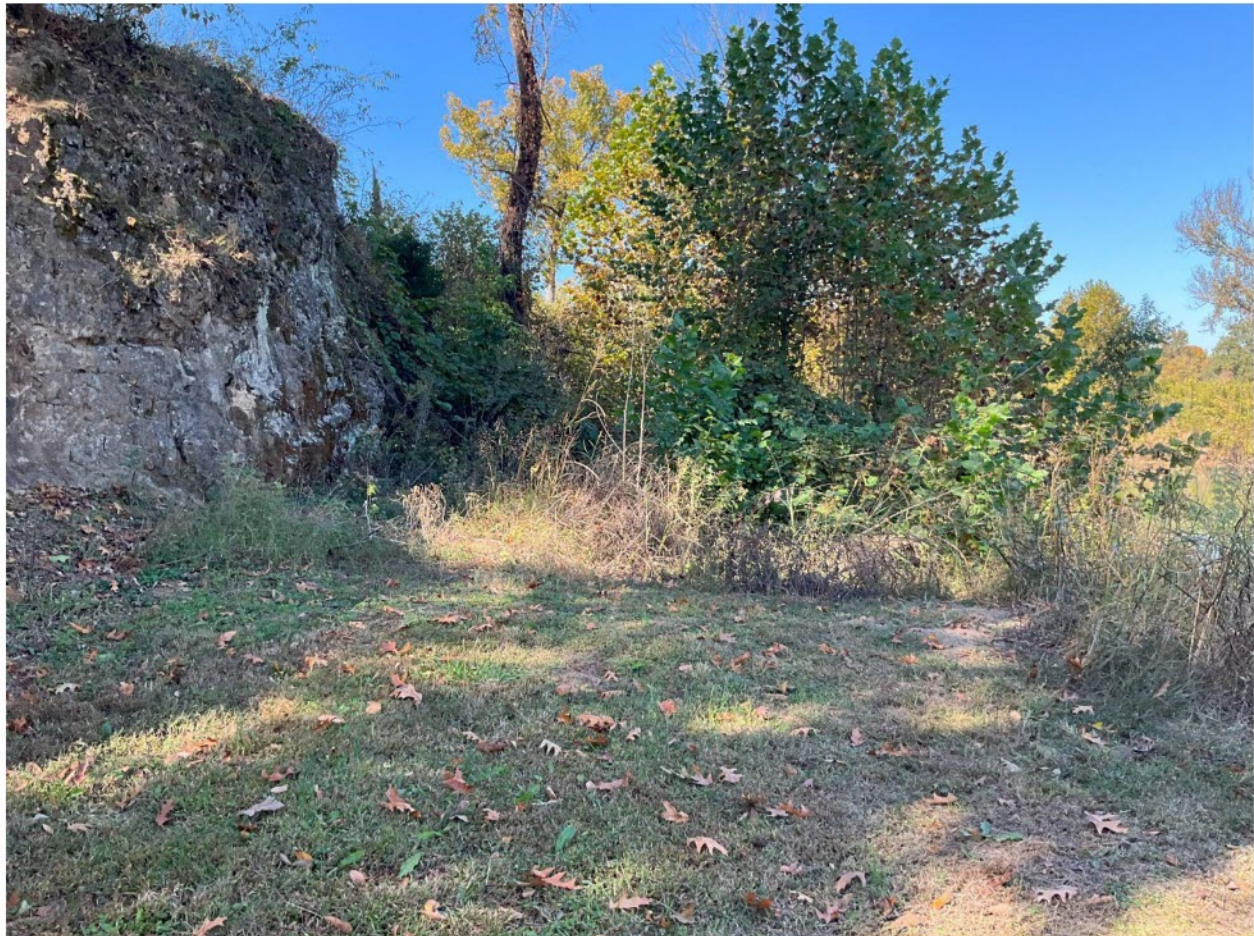
Photo No. 6

| Photo File Name | Date and Time of Photo | Photographer | Description |
|---|---|---|---|
| IMG_0102.HEIC | 10/23/2024, 11:59 AM | Chelsey Sherwood | Showing riparian area just above the site. Picture taken facing west, upstream. |

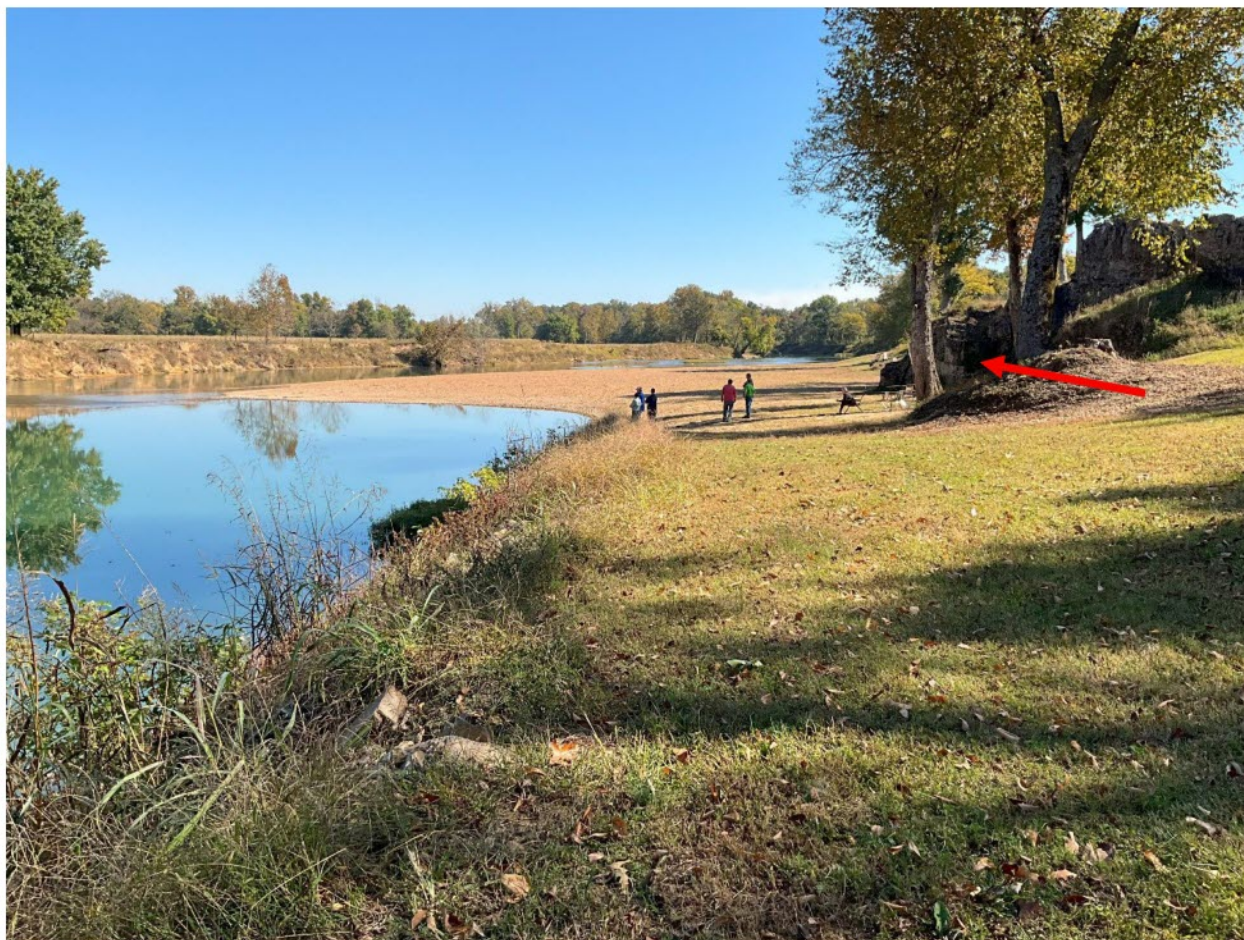
Photo No. 7

| Photo File Name | Date and Time of Photo | Photographer | Description |
|---|---|---|---|
| IMG_0104.HEIC | 10/23/2024, 12:08 PM | Chelsey Sherwood | Showing the project area from upstream end and the approximate location of the Ordinary High Water Mark, depicted by the red arrow. Picture taken facing east, downstream. |

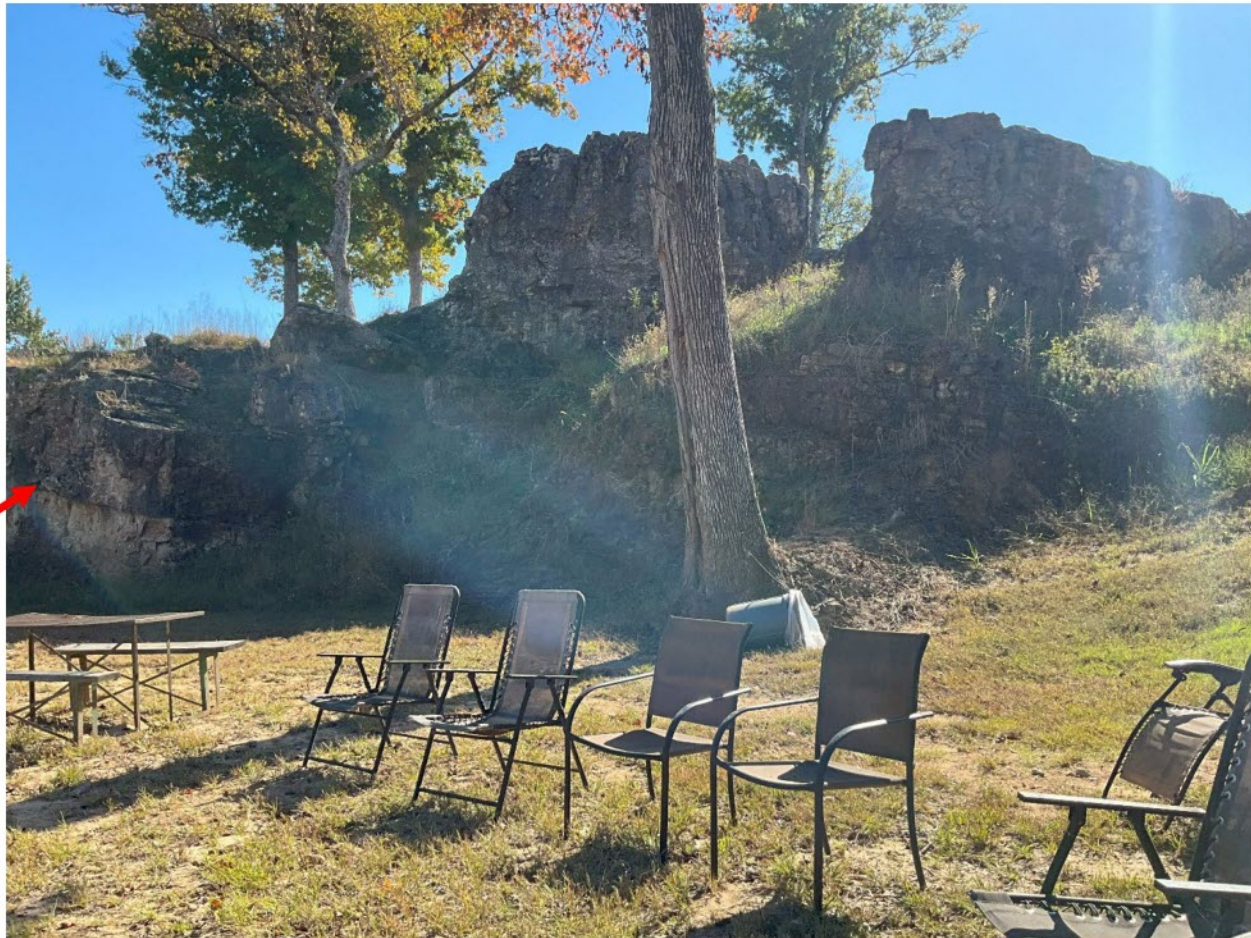
Photo No. 8

| Photo File Name | Date and Time of Photo | Photographer | Description |
|---|---|---|---|
| IMG_0105.HEIC | 10/23/2024, 12:12 PM | Chelsey Sherwood | Arrow pointing to Ordinary High Water Mark. Note: this photo is a close up from photo 8. Picture taken facing south. |

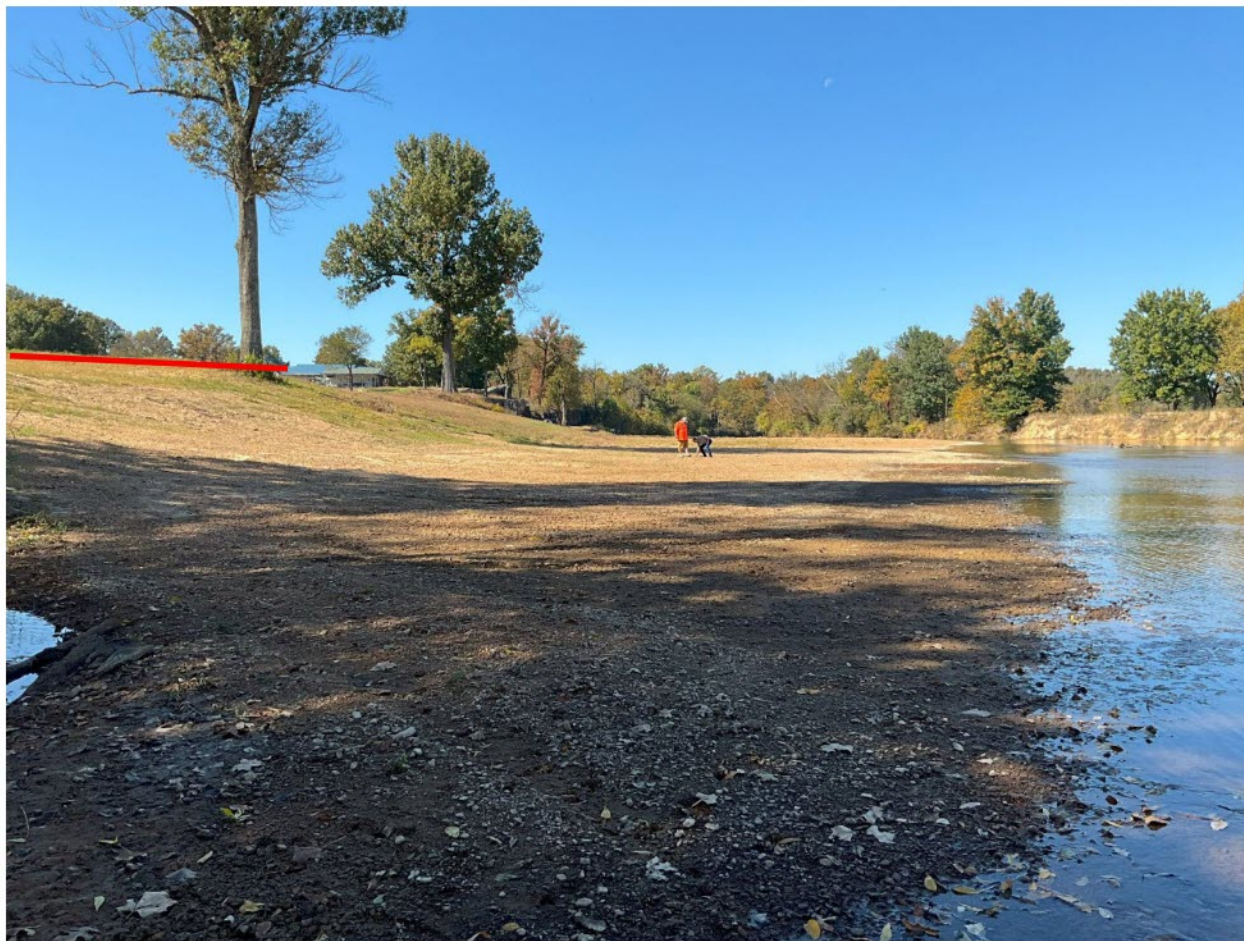
Photo No. 9

| Photo File Name | Date and Time of Photo | Photographer | Description |
|---|---|---|---|
| IMG_0106.HEIC | 10/23/2024, 12:19 PM | Chelsey Sherwood | Showing the graded stream bank and fill material pushed out into the stream channel. Note: Ordinary High Water Mark is approximately the top of the river bank (depicted by red line). Picture taken facing west, upstream. |

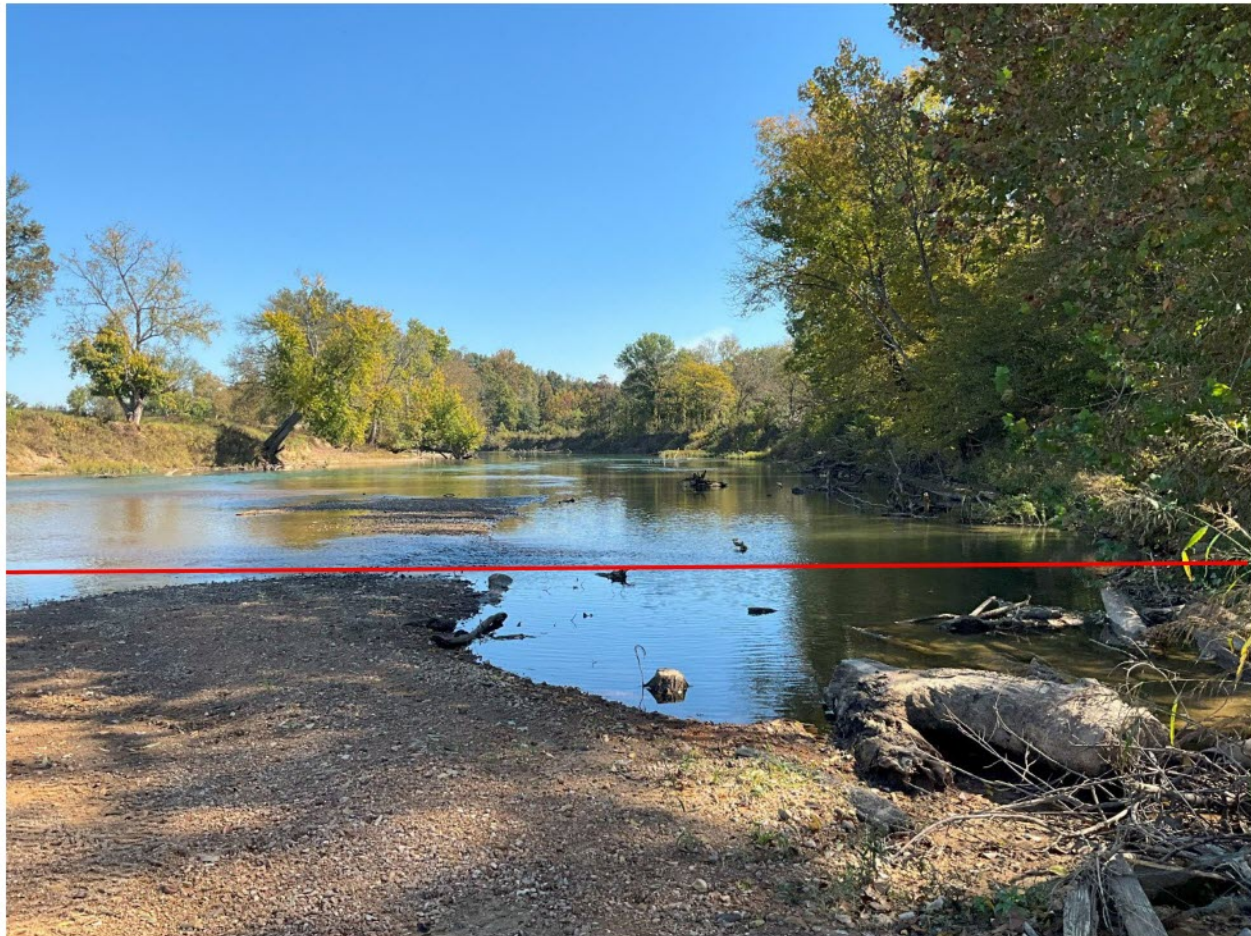
Photo No. 10

| Photo File Name | Date and Time of Photo | Photographer | Description |
|---|---|---|---|
| IMG_0107.HEIC | 10/23/2024, 12:22 PM | Chelsey Sherwood | Showing the stream channel just below the project area (depicted by the red line). Note: the shallow, lateral riffle. Picture taken facing east, downstream. |

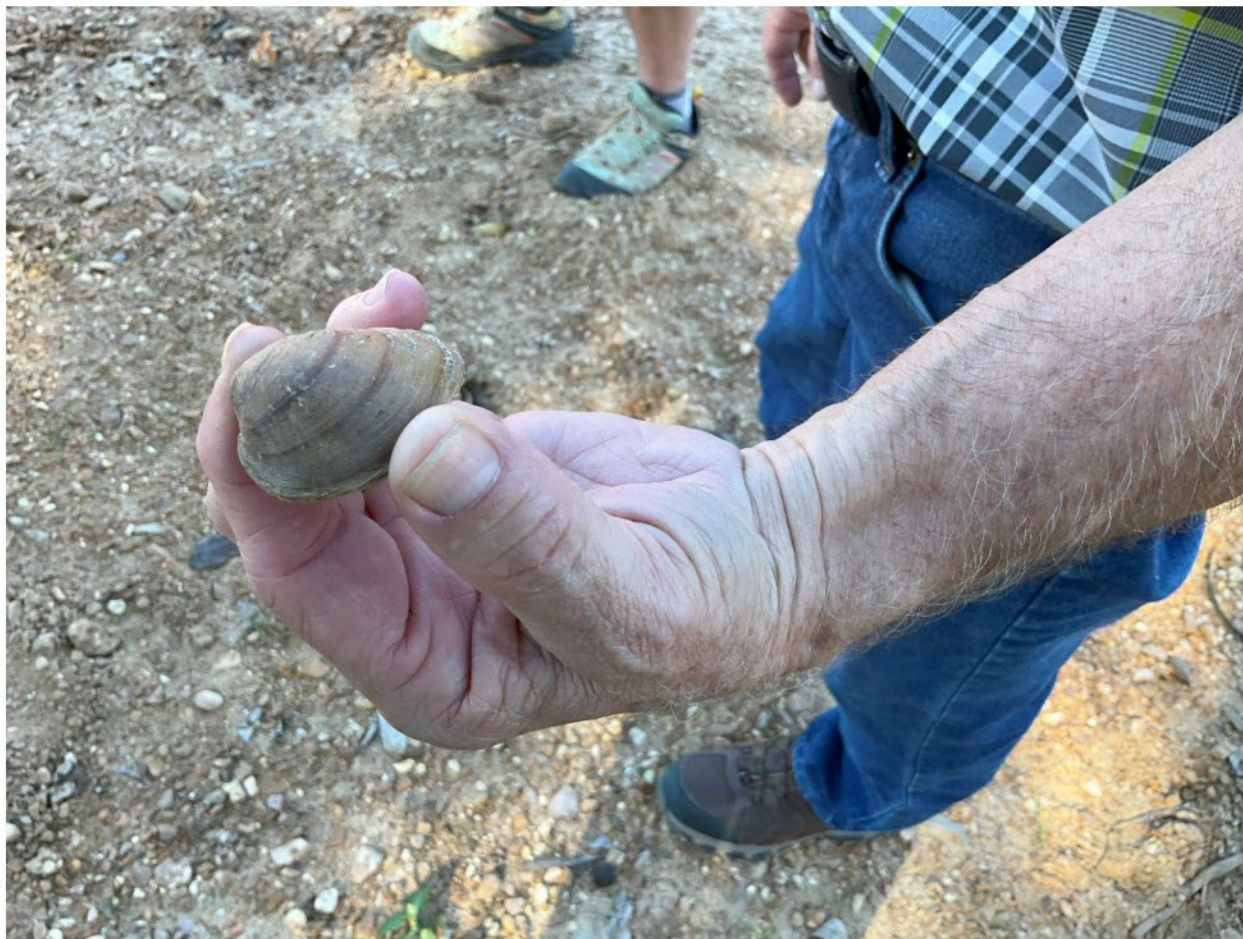
Photo No. 11

| Photo File Name | Date and Time of Photo | Photographer | Description |
|---|---|---|---|
| IMG_0108.HEIC | 10/23/2024, 12:27 PM | Chelsey Sherwood | Showing a mussel found on the gravel bar. |

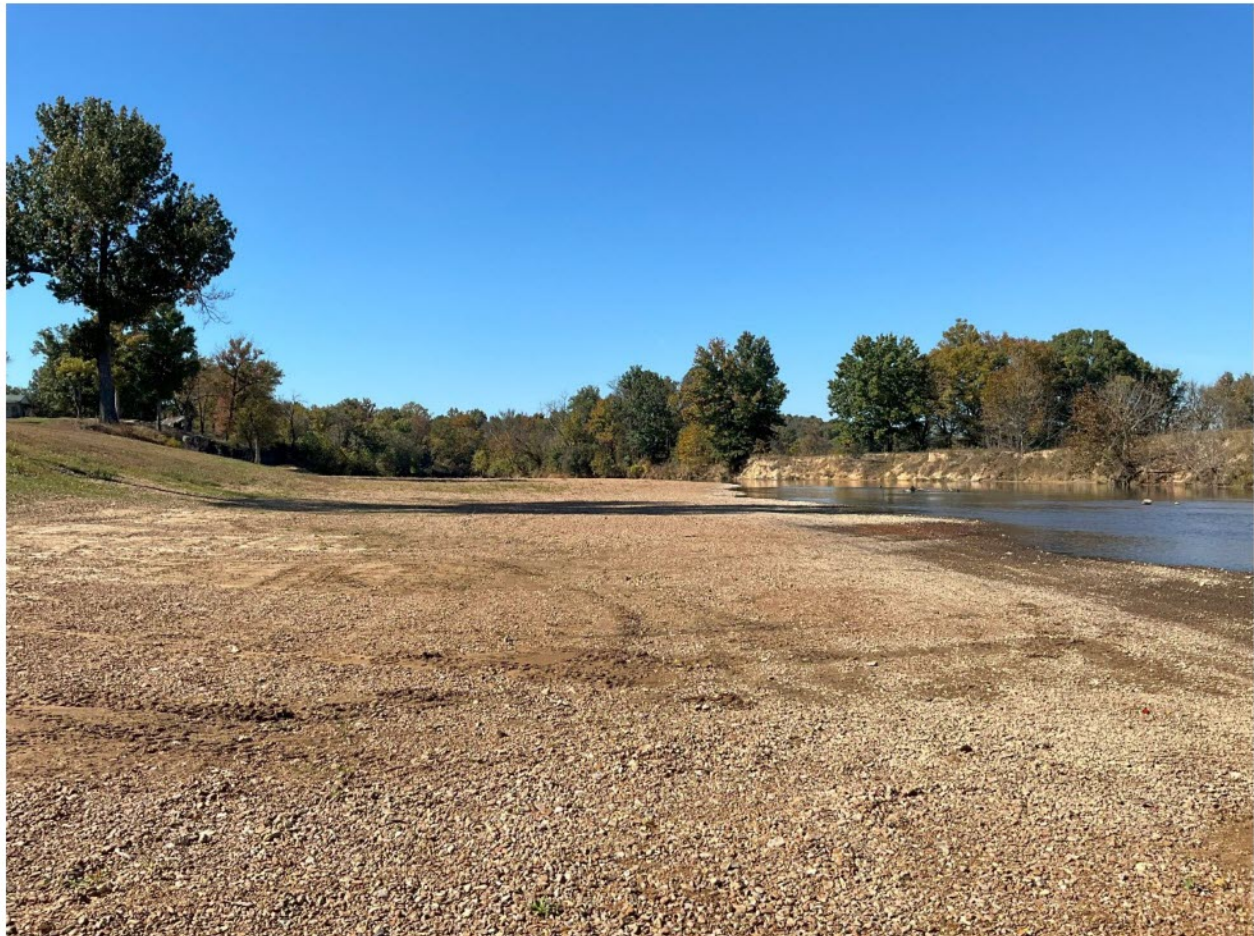
Photo No. 12

| Photo File Name | Date and Time of Photo | Photographer | Description |
|---|---|---|---|
| IMG_0109.HEIC | 10/23/2024, 1:20 PM | Chelsey Sherwood | Showing the large gravel bar that was created in the stream channel. Picture taken facing west, upstream. |

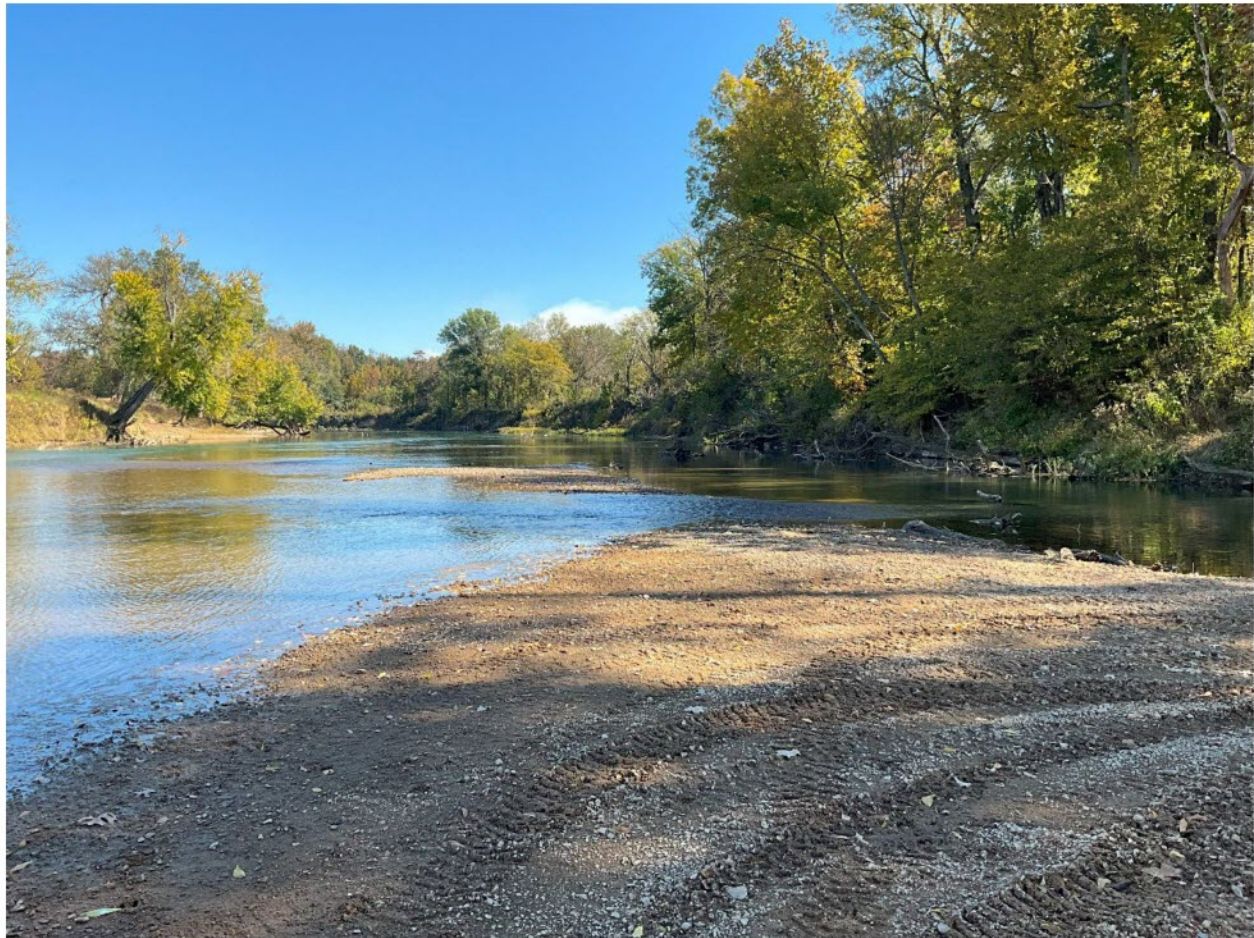
Photo No. 13

| Photo File Name | Date and Time of Photo | Photographer | Description |
|---|---|---|---|
| IMG_0110.HEIC | 10/23/2024, 1:20 PM | Chelsey Sherwood | Showing tire tracks in the stream channel. Picture taken facing east, downstream. |
