## Region 6 Compliance Assurance and Enforcement Division

### INSPECTION REPORT

| Company Name: | <b>John Sinclair Production LLC</b> | | |
| Facility Name: | <b>T.D. Murphy #3-B</b> | | |

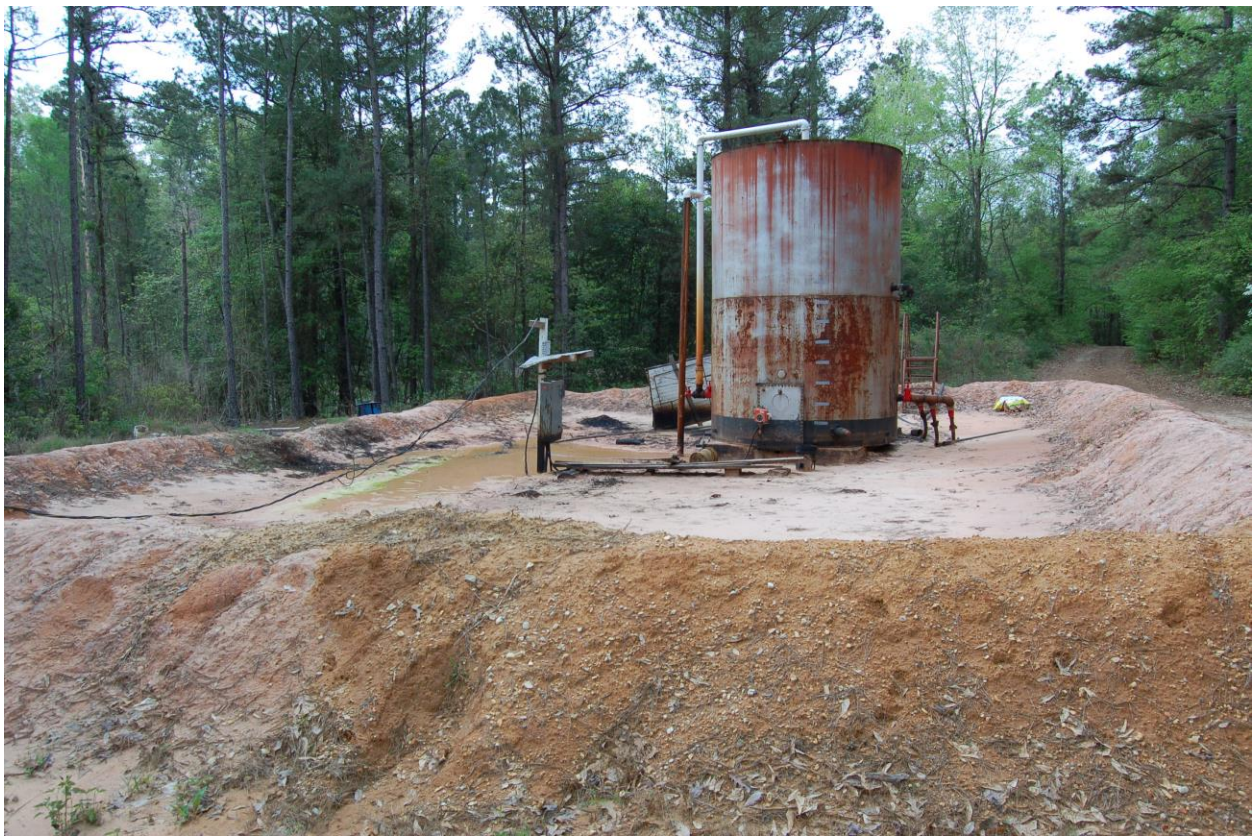
Photo Name: Photo 1 taken south.

Description: Shows the brine facility with berm.

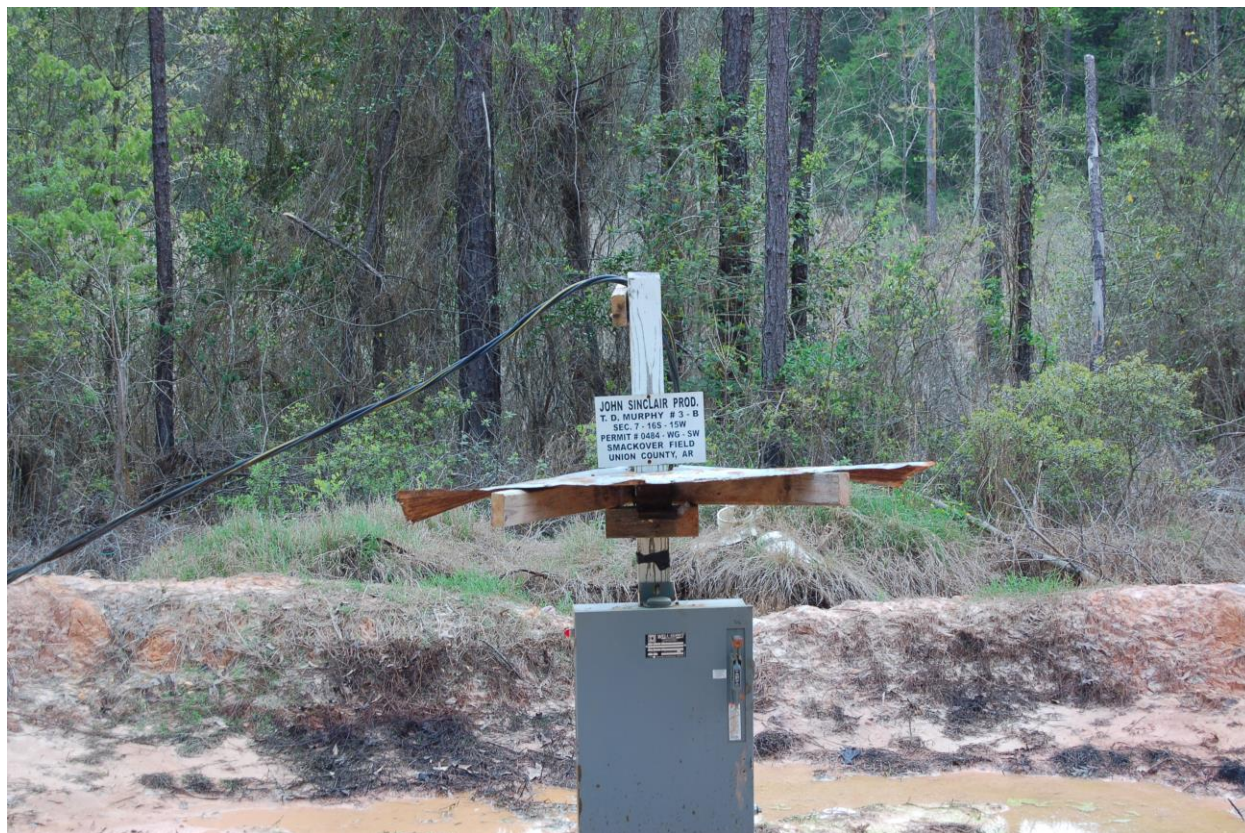
Photo Name: Photo 2 taken east.

Description: Shows the sign posted at the brine facility and the source of the discharge.

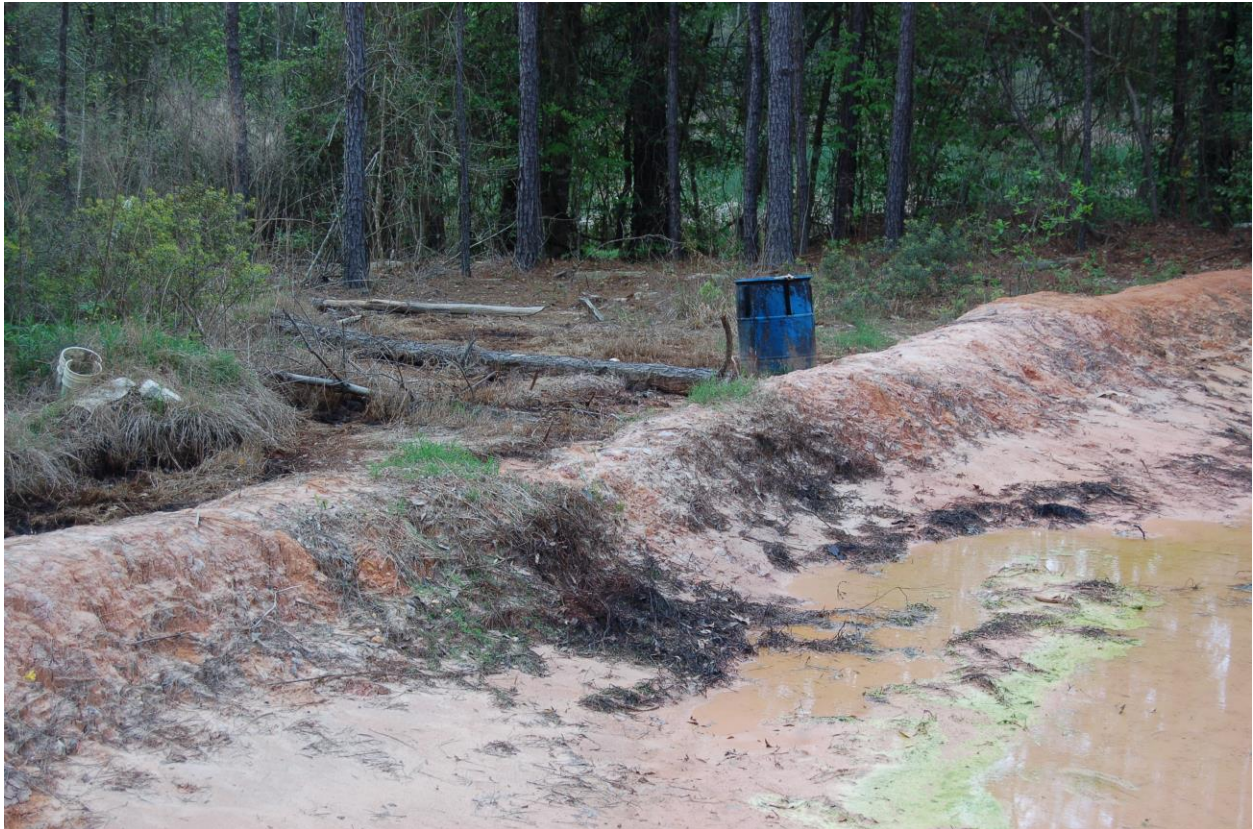
Name of Photo: Photo 3 taken southeast.

Description: Shows where the containment area ran over the berm and flowed eastward into the marsh.

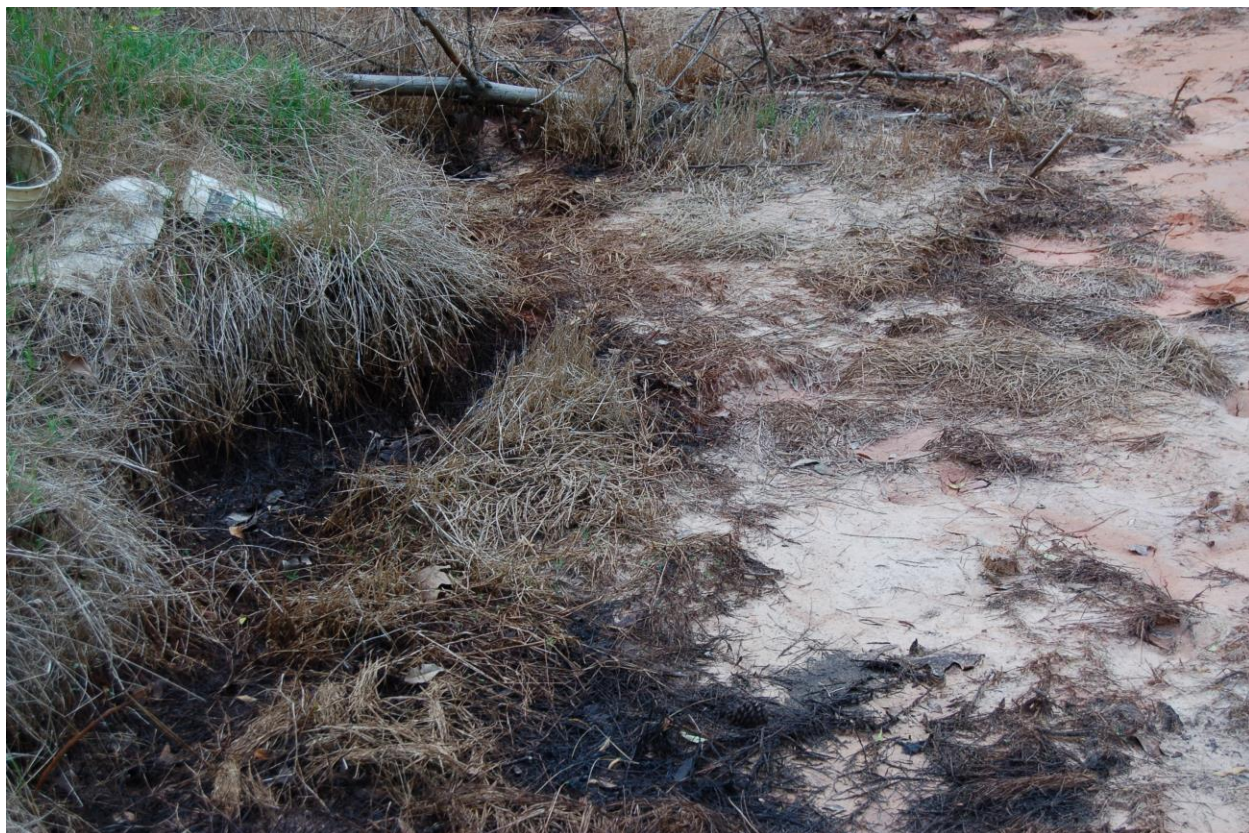
Name of Photo: Photo 4 taken east.

Description: Shows that the brine discharge overflow carried some oil with it to the marsh and into the tributary.

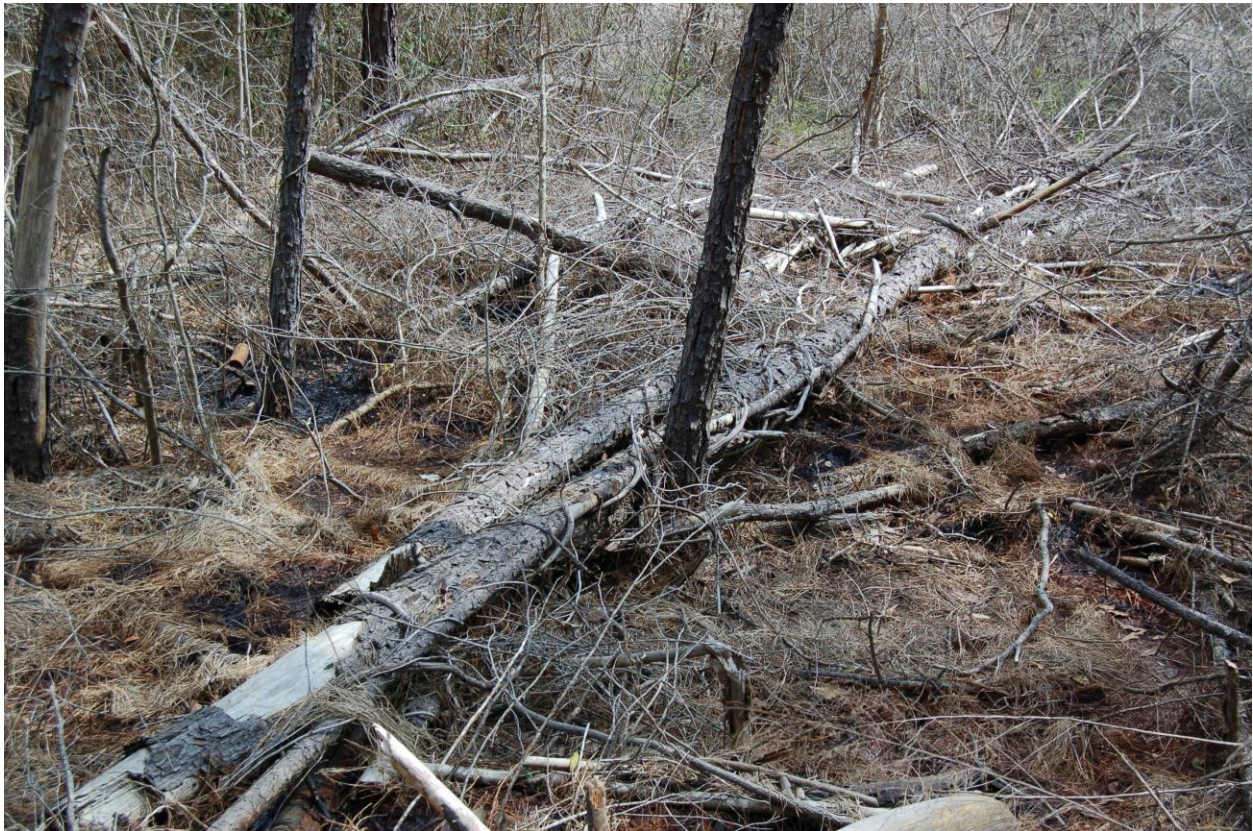
Name of Photo: Photo 5 taken east

Description: Dead vegetation and oil and brine staining is seen between the facility and the tributary.

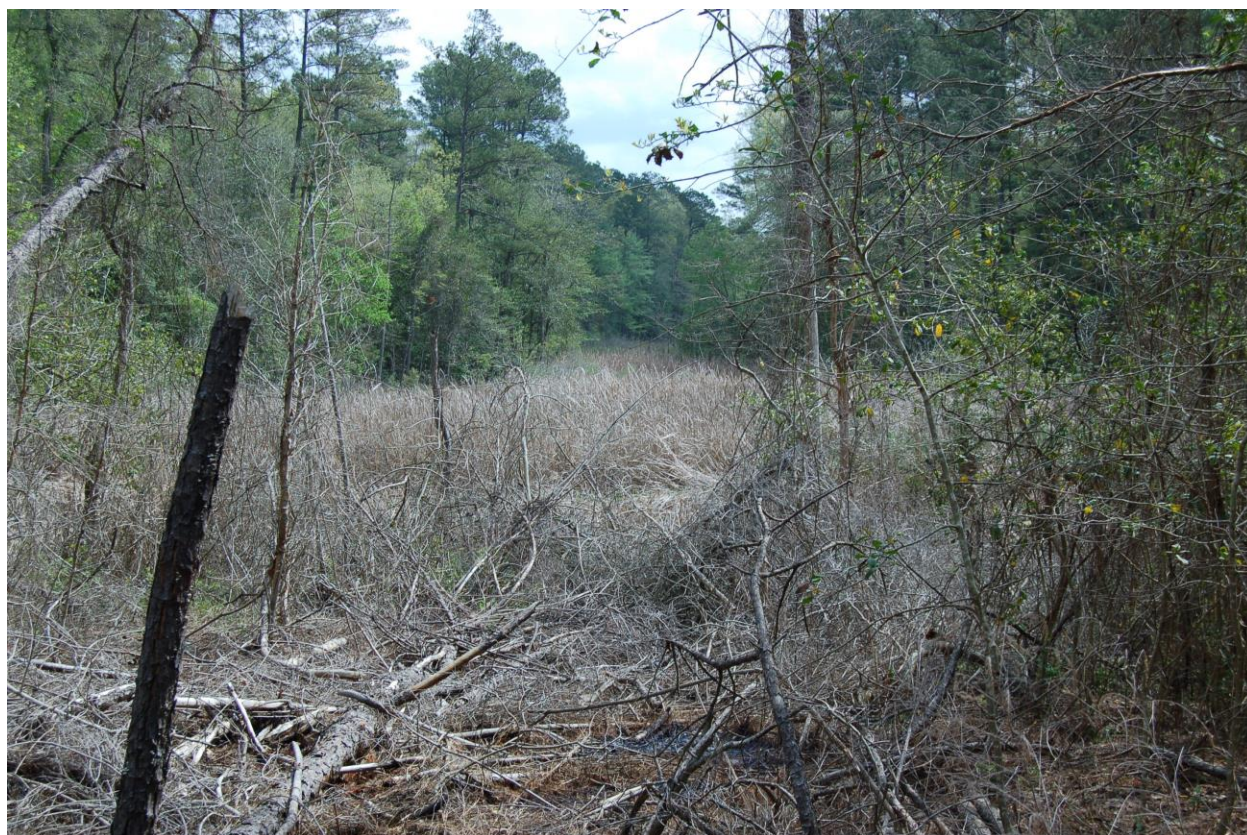
Name of Photo: Photo 6 taken east

Description: Shows the point of entry into the tributary which flows eastward.

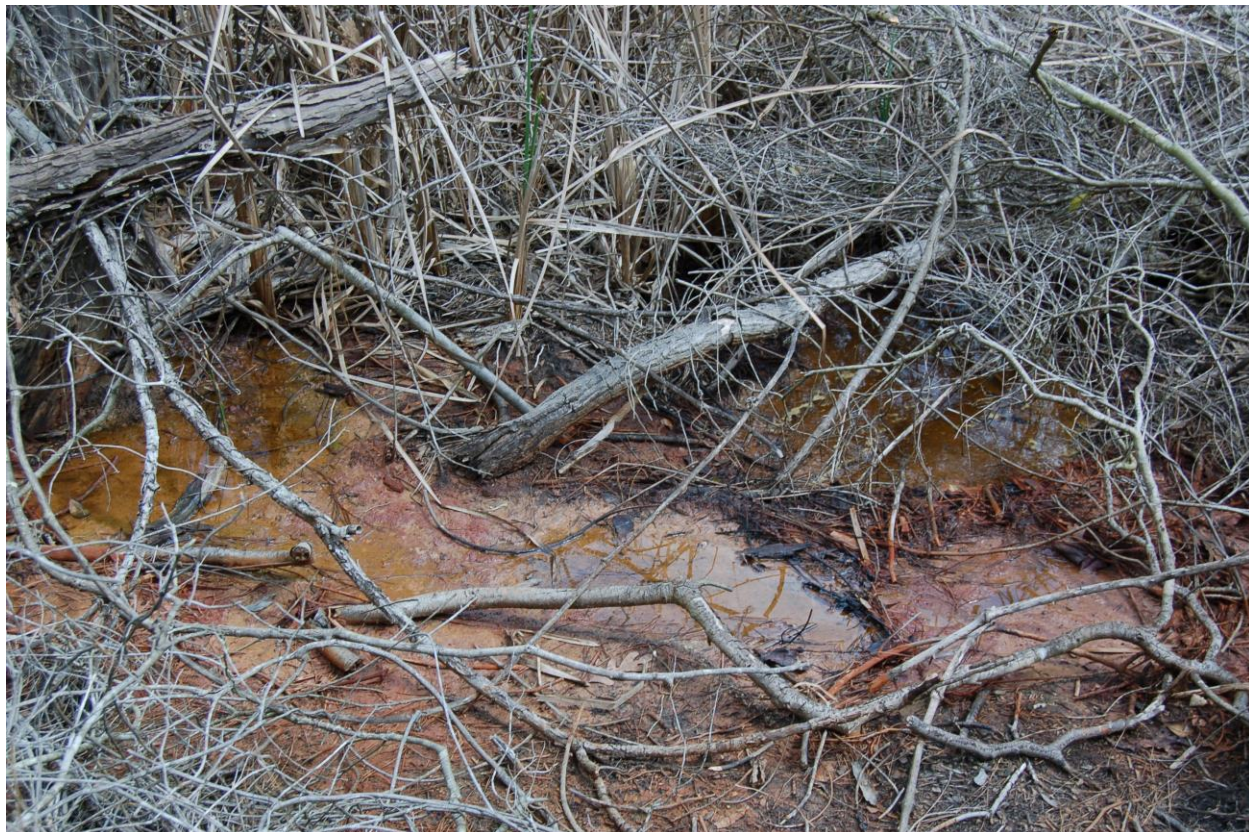
Name of Photo: Photo 7 taken east.

Description: Shows a small amount of oil and brine which entered the tributary.

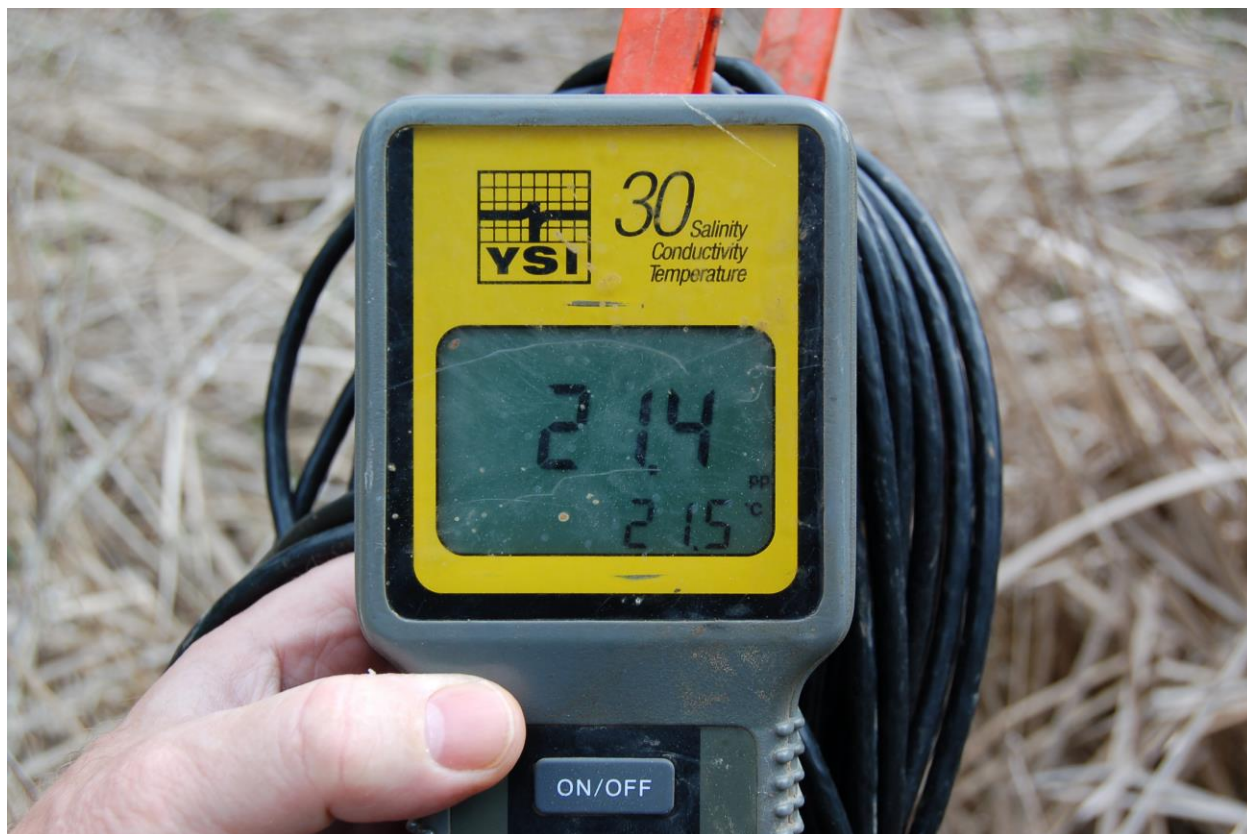
Name of Photo: Photo 8 taken southeast

Description: Shows a YSI meter reading of 21,400 ppm TSS at the point of entry into the tributary.

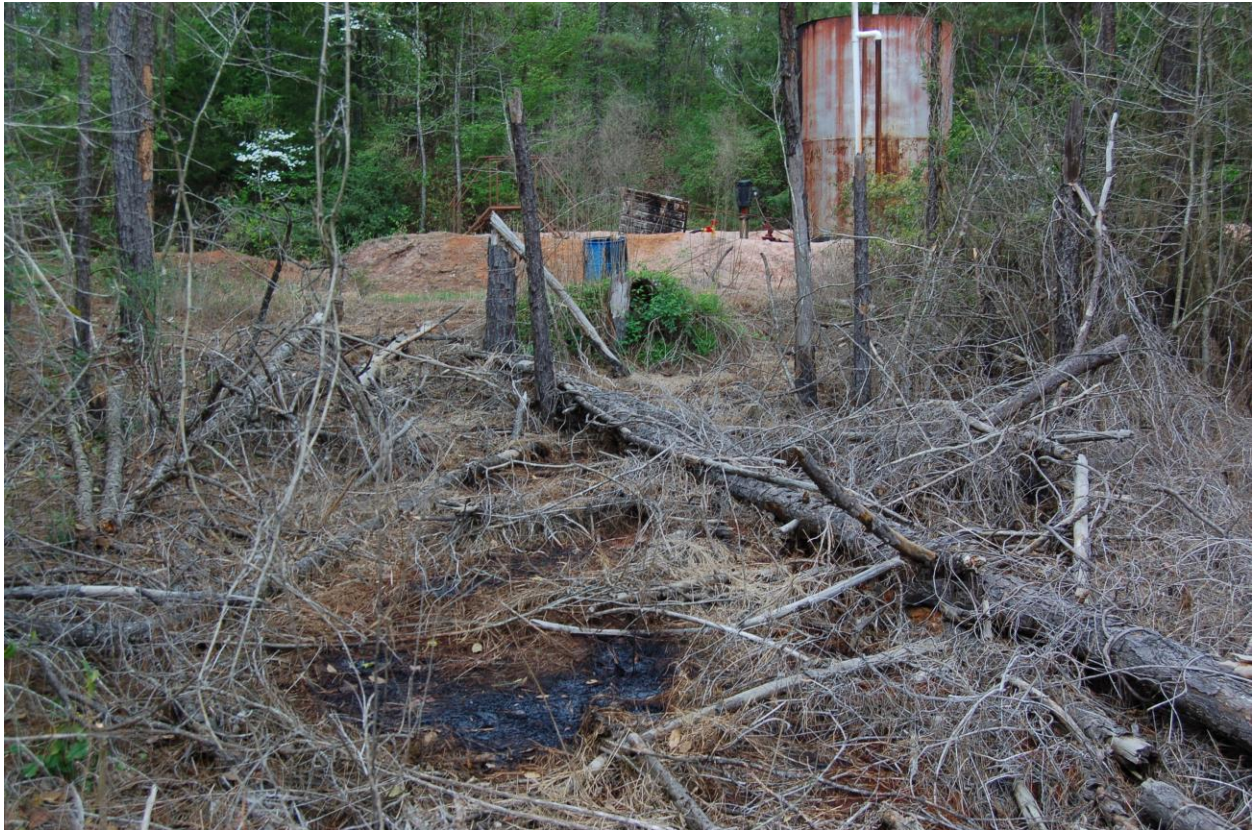
Name of Photo: Photo 9 taken west.

Description: Shown is a view from the point of entry back to the facility. Notice the oil staining in the tributary.

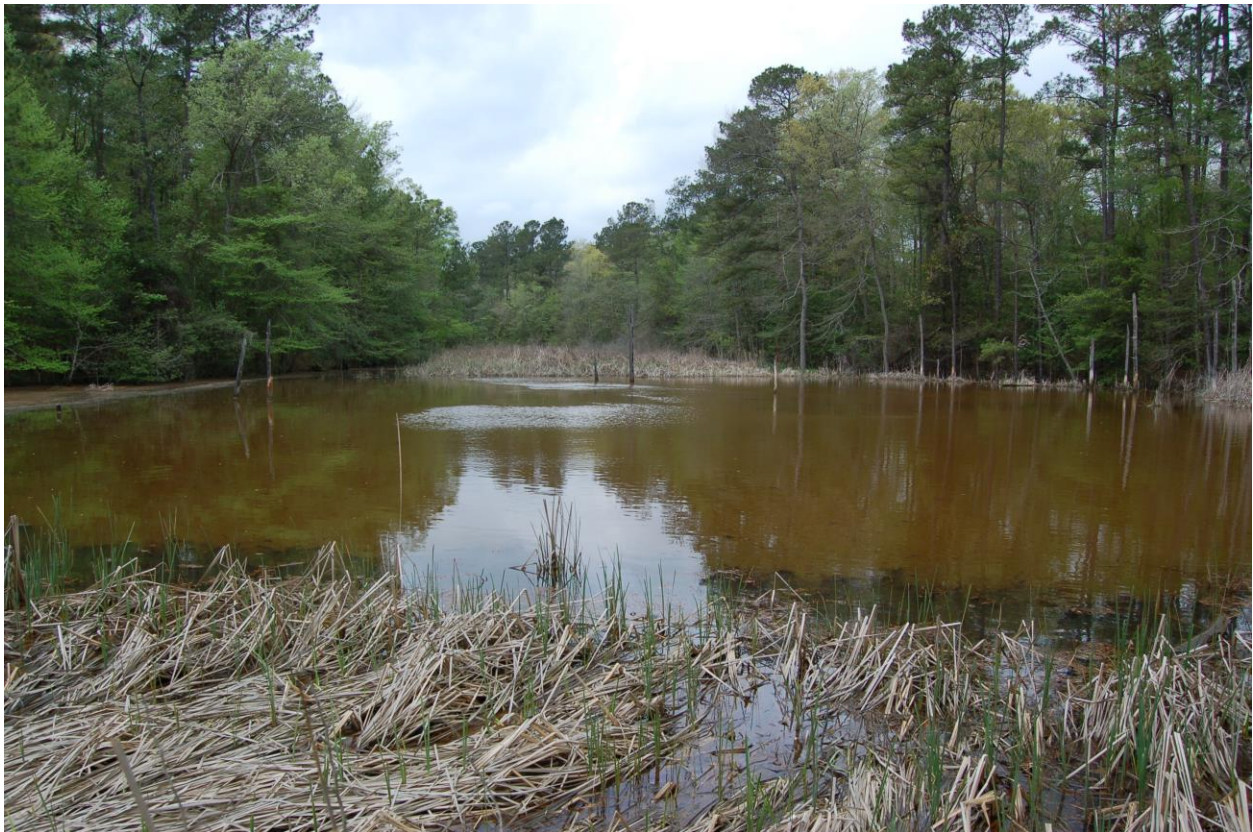
Name of Photo: Photo 10 taken west.

Description: Shows the same marshy tributary east of the entry point. The water is rust colored and does not contain any aquatic life. Flow is eastward into another marshy area downstream.

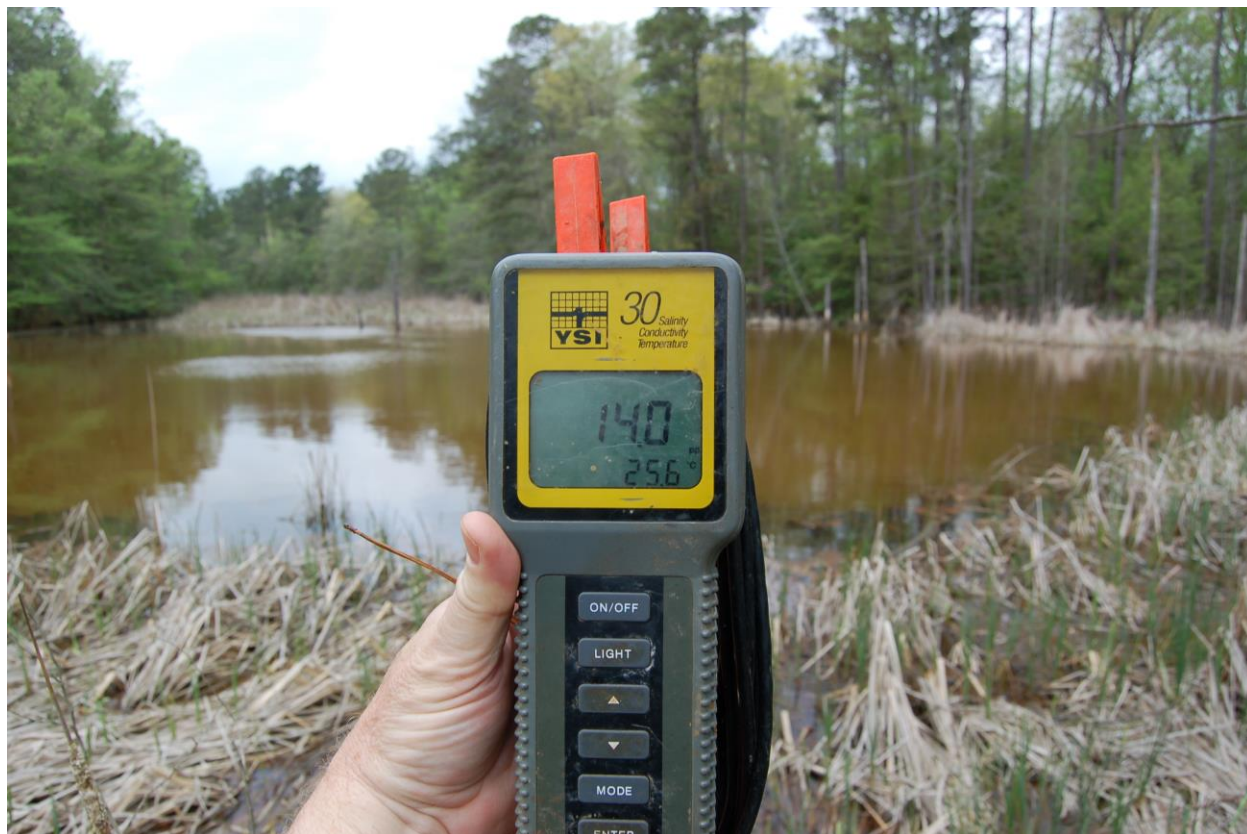
Name of Photo: Photo 11 taken west

Description: Shows a YSI meter reading of 14,000 ppm TSS in the area shown in Photo 10.

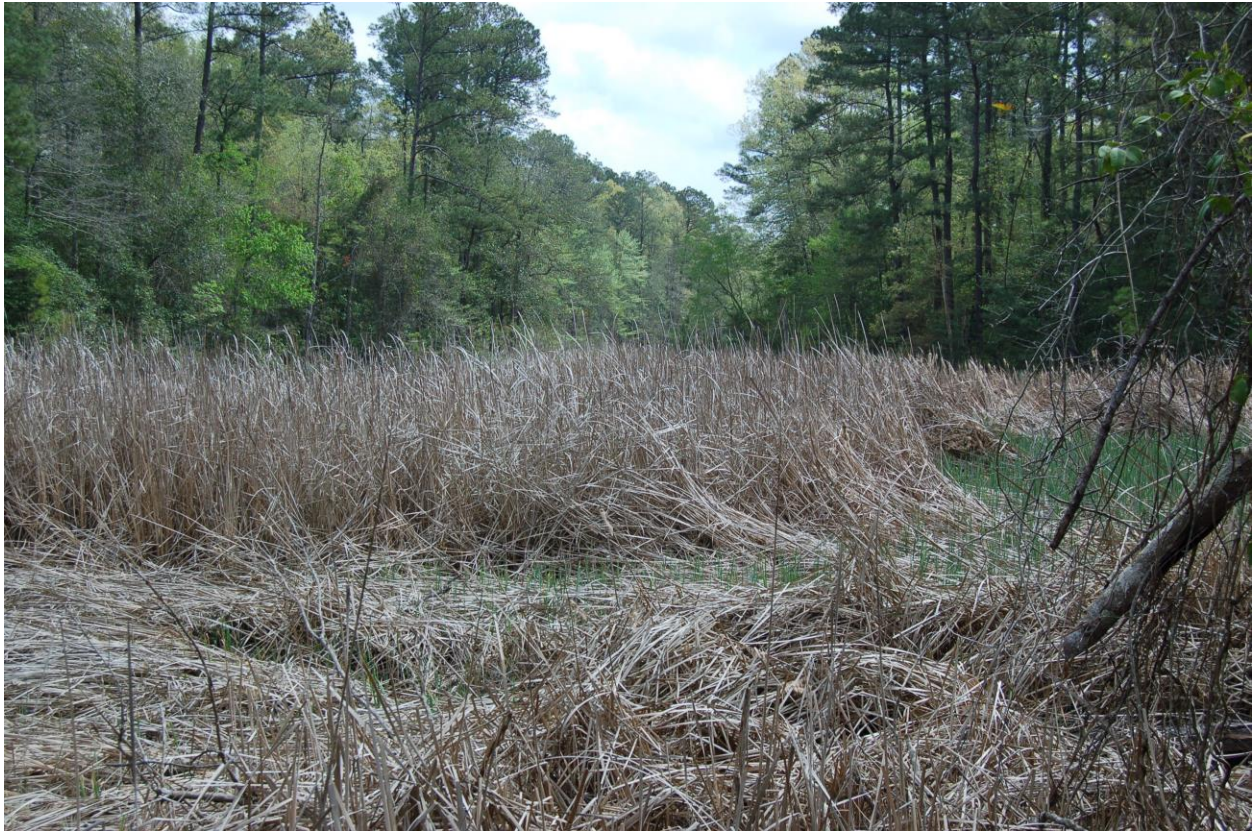
Name of Photo: Photo 12 taken east.

Description: Shows a marshy area east of Photo 10 near the junction of a small creek.

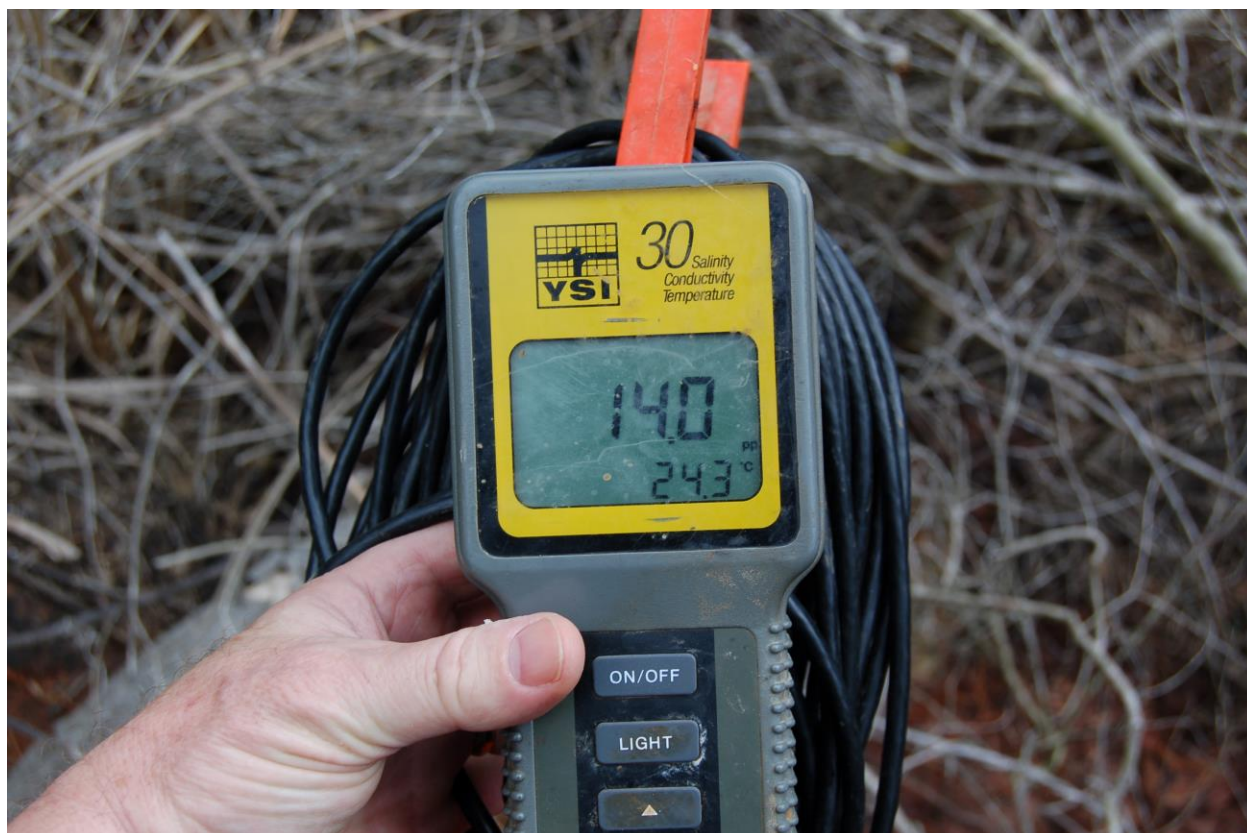
Name of Photo: Photo 13 taken south.

Description: Shows a YSI meter reading of 14,000 ppm TSS of the marsh in Photo 12.

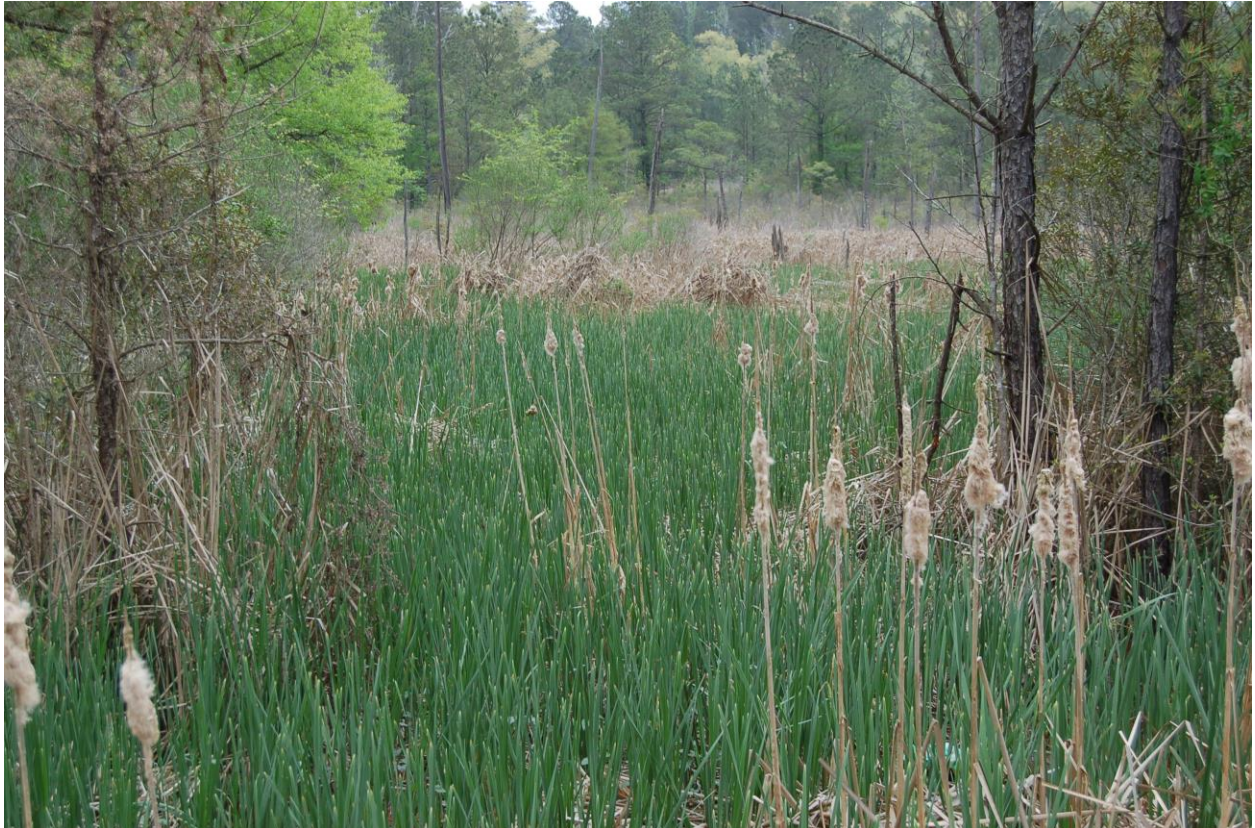
Name of Photo: Photo 14 taken south.

Description: Shows a view of the unaffected part of the marshy tributary system that is upstream of the discharge entry point.

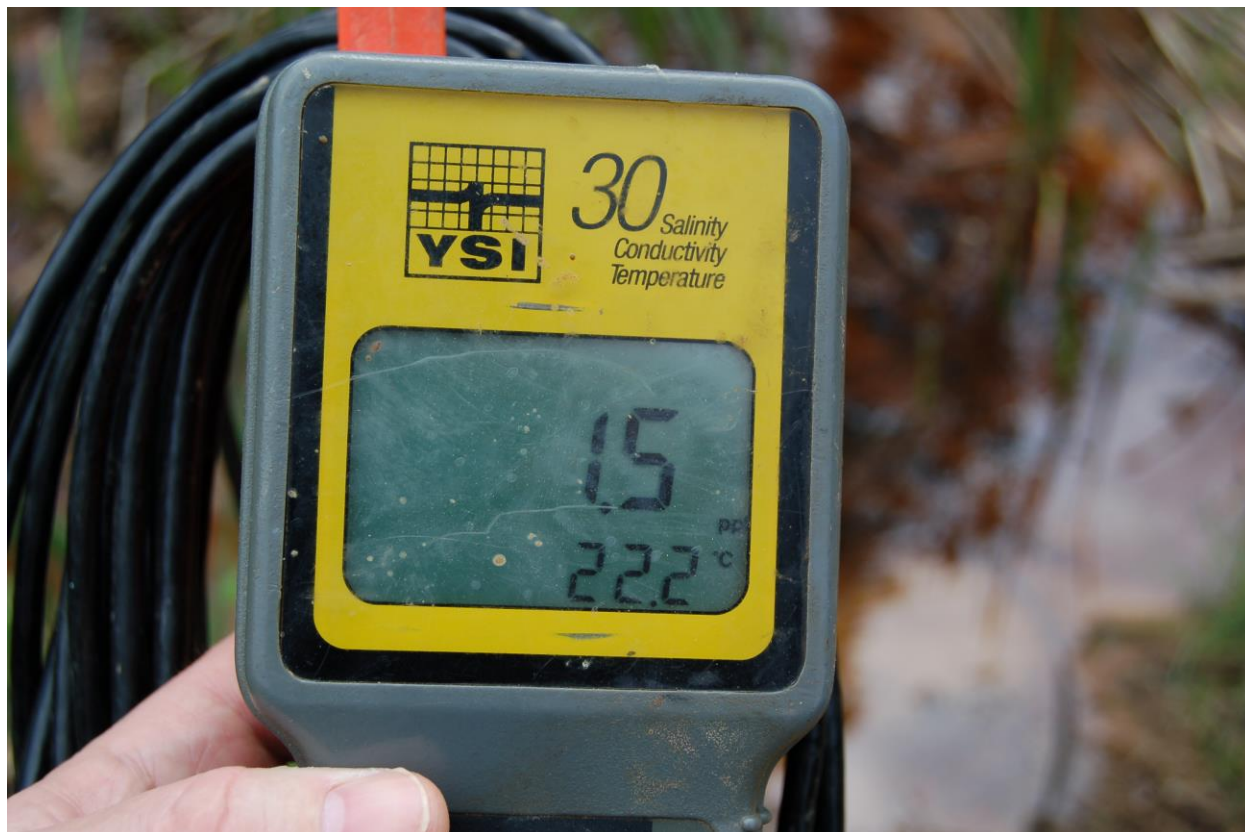
Name of Photo: Photo 15 taken south.

Description: Shows the YSI meter reading of 1500 ppm TSS in the unaffected portion of the marsh.
