Re: Inspection Report for Blackfeet Boarding Dormitories Wastewater Treatment Facility, NPDES Permit #MTU000695

## NPDES Wastewater Lagoon Inspection Report – No Discharge

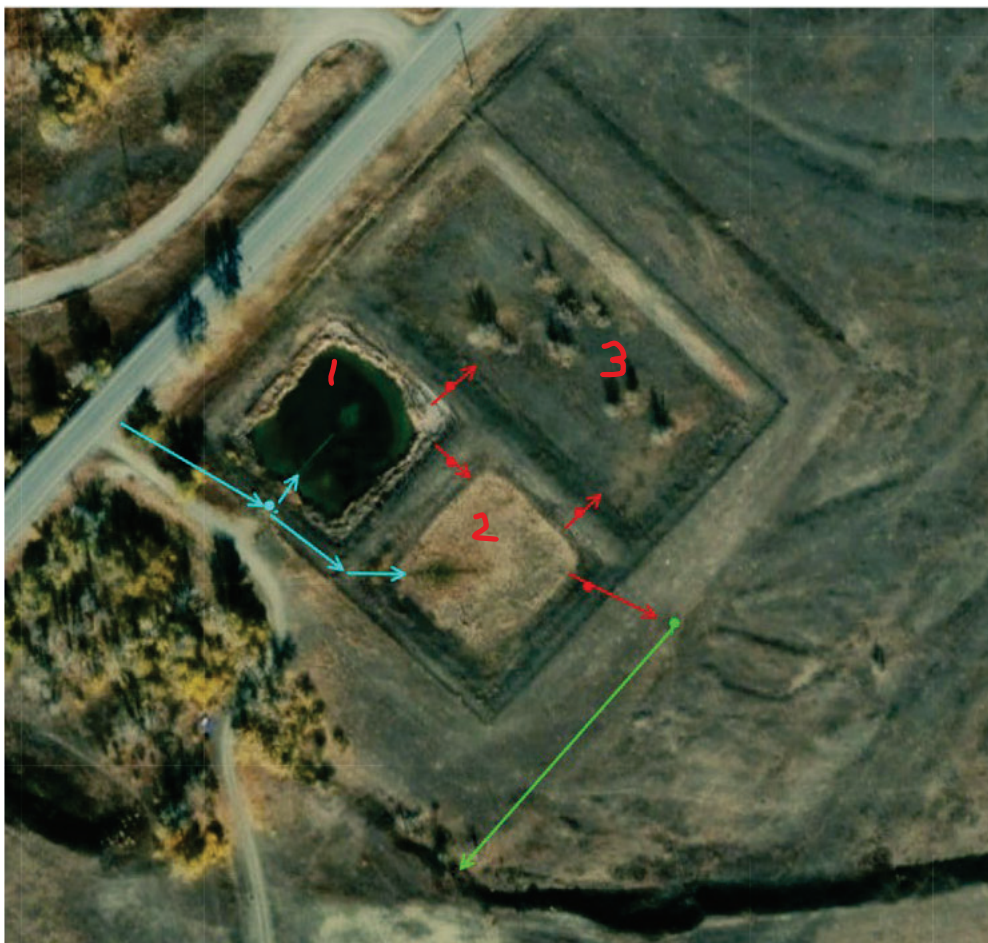
The Blackfeet Boarding Dormitories' wastewater treatment lagoons (facility) is a three-celled, facultative lagoon system. The facility has an intact locked fence with proper legible signage. All influent flows through a splitter box to control wastewater entering either cell 1 or cell 2. The facility is typically run in series. The splitter box was deteriorated and had moss and vegetative growth inside which is starting to inhibit proper flow (photo 681). At the time of the inspection wastewater was flowing to both cell 1 and 2. Wastewater enters cell 1 directly north of the splitter box through a pipe and into the center of cell 1 (see diagram below). The valve at the splitter box for cell 2 leads to a pipe and flows southeast to the corner of cell 2 and enters cell 2 in the northwest corner of the cell, discharging into the center of cell 2 (see diagram below). I observed cell 1 to have vegetative growth on the dike walls as well as entering the lagoon cells to include cattails and sedges (photo 676). Cell 2 was partially full with vegetative growth within the cell as well as on the dike walls (photo 677). Wastewater from cell 1 flows to cell 2 through a valved pipe located in the northern portion of the southeast dike wall (see diagram below). There is also a valved pipe from cell 1 to cell 3 located in the center of the northeastern dike wall (see diagram below). Cell 2 also has a valved pipe leading to cell 3 located in the center of the northeastern dike wall (see diagram below and photo 678). Cell 3 is a long linear cell covering the width of both cells 1 and 2 and located northeast of the cells. Cell 3 was observed to have vegetative growth as grasses and a few shrub trees (photos 682-684). Cell 3 does not have a discharge pipe; however, there is a valved pipe in the northeastern corner of cell 2 (photo 678) which leads to an outfall pipe southeast of the facility (photo 679) to a swale (photo 680) which would flow southwest approximately 300 feet to an intermittent stream which connects to Cut Bank Creek approximately 0.35 miles downstream. Mr. Spotted Eagle stated pipe was most likely an emergency discharge pipe, but that the valve is closed, and he has not known it to ever discharge. As we walked around the lagoon cells, it was noted there was small rodent damage by means of holes within the dike walls.
