REPORT OF COMPLIANCE EVALUATION INSPECTION  
(INDUSTRIAL STORMWATER)

**Iowa Specialties, Inc.**  
824 and 809 27<sup>th</sup> Ave. SW  
Cedar Rapids, Iowa 52404  
Authorization Number: **IA-0208-0135**

BY  
U.S. ENVIRONMENTAL PROTECTION AGENCY  
REGION 7  
ENFORCEMENT AND COMPLIANCE ASSURANCE DIVISION (ECAD)  
WATER BRANCH/DRINKING WATER & INSPECTIONS SECTION (WB/DWIS)

ON  
**February 7 and 8, 2024**

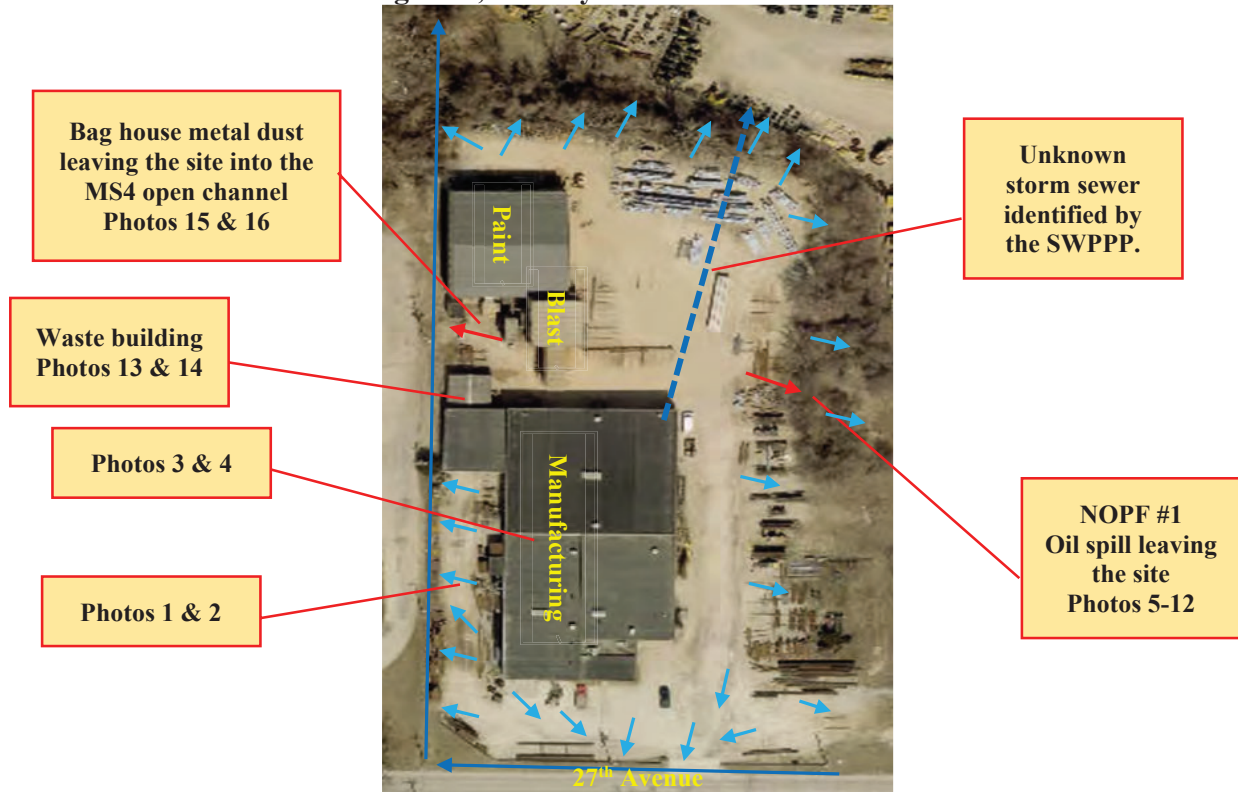
*North Drainage Area:* Stormwater runoff from the storage yard located on the north side of 27<sup>th</sup> Ave. SW. would flow to all directions. Surface runoff would flow to the north and east onto the steep cliff into the neighboring properties, south into the 27<sup>th</sup> Avenue ditch, and west into the Cedar Rapids MS4 open ditch. Stormwater in the 27<sup>th</sup> avenue ditch would flow west into the open channel. The flow in the open channel would flow north for at least 1400 feet into the unnamed tributary to Prairie Creek. The tributary would flow south approximately one mile into Prairie Creek. Prairie Creek flows northeast approximately 1.5 miles into Cedar River.

**Figure 2, North yard area Surface runoff**

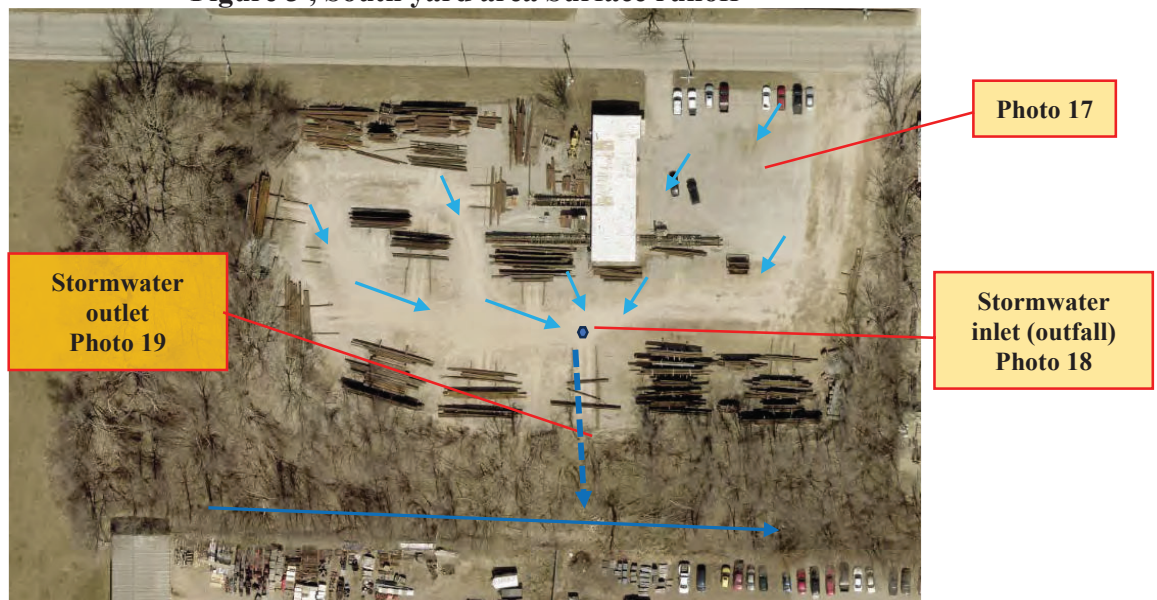
*South Drainage Area:* Stormwater runoff from the storage yard located on the south side of 27<sup>th</sup> Ave. is directed to flow toward a stormwater inlet located in the yard. The inlet is piped south on the 50-foot steep cliff into the Cedar Rapids MS4.

**Figure 3 , South yard area Surface runoff**

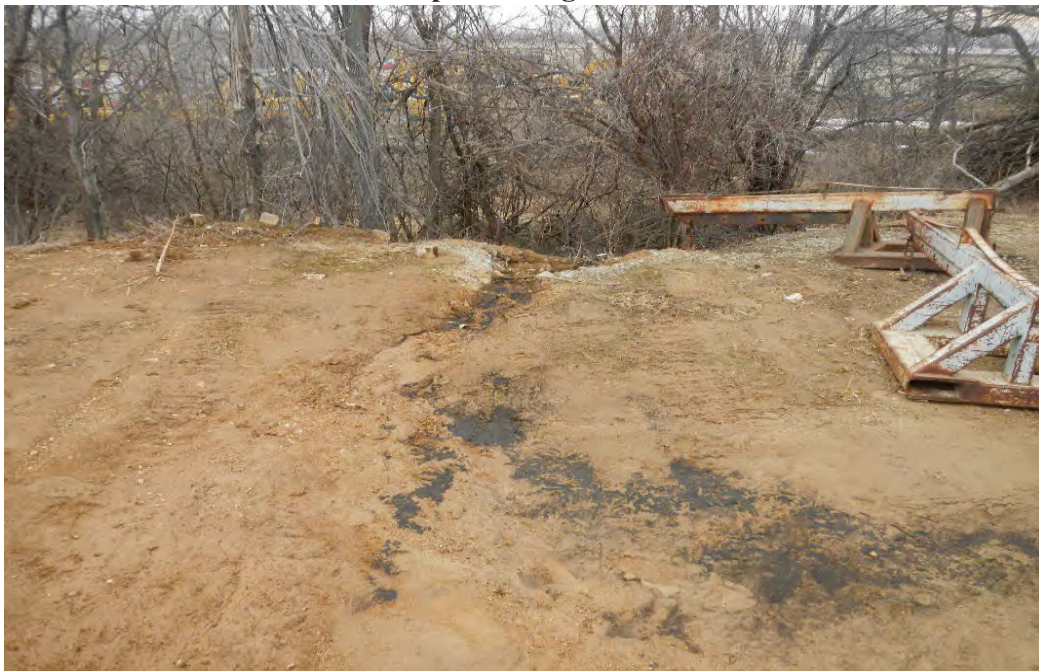
3. During our inspection of the north storage yard, we noticed an area of significant ground discoloration. The discoloration was an oil spill (photos 5-12). We pointed out our observation to Kevin Dixon, and he confirmed our observation. Kevin Dixon added that he doesn't know how or when this spill occurred, especially since no industrial activities take place outdoors. Therefore, we issued Notice of Preliminary Findings number 1 (NOPF #1) for evidence of oily substance discharged from the site into the neighboring property as shown in photo 5 below.

**Photo 5, Oil spill leaving the site onto the cliff**

4. Iowa Specialties should investigate the direction of the floor drains inside the manufacturing building and update the SWPPP map accordingly.
5. Section B.7 of the SWPPP discusses sediment and erosion of the south yard area. The SWPPP should also include the north yard area to prevent future spills from flowing directly down the cliff and discharging at the base of the cliff into neighboring property.

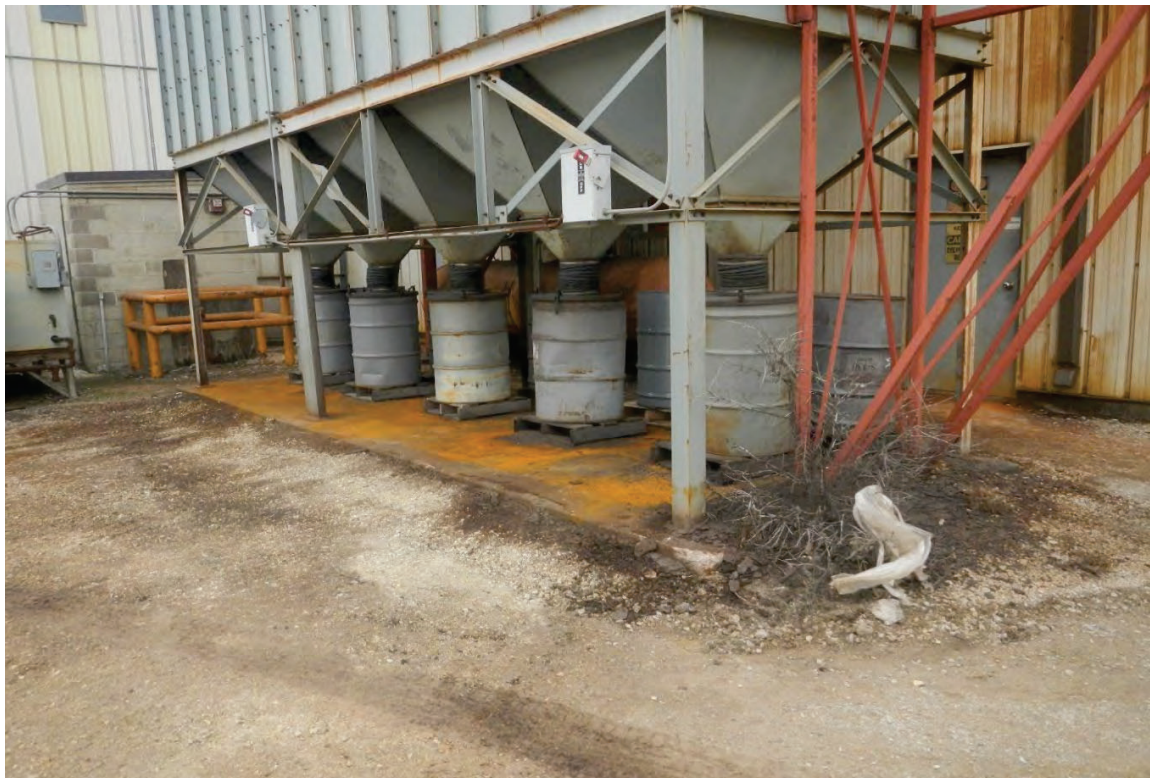
6. During our walkthrough inside the manufacturing building, we noticed the floor drainage system. Kevin Dixon was not aware where the system drains to. While reviewing the site map, I noticed that the map identified an underground stormwater pipe that runs from the northeast corner of the blast building to the north side of the site. We were unable to track the end of the pipe.
7. As mentioned above in 1.b., the facility did not identify the area surrounding the baghouse collection system located west of the blast building as a source of potential pollutants nor as a discharge point on the site map. The collection system area cliffs west, approximately 30 feet, toward the MS4 open ditch. We pointed out to Kevin Dixon the significant ground discoloration caused by fugitive dust from the collection system (photos 15 and 16 below).

**Photo 15, Ground discoloration from the collection system**

3. Kevin Dixon should include a signed certification statement in the SWPPP and include the Blast baghouse area as discharge point. Iowa Specialties should review the current SWPPP and updated as needed.

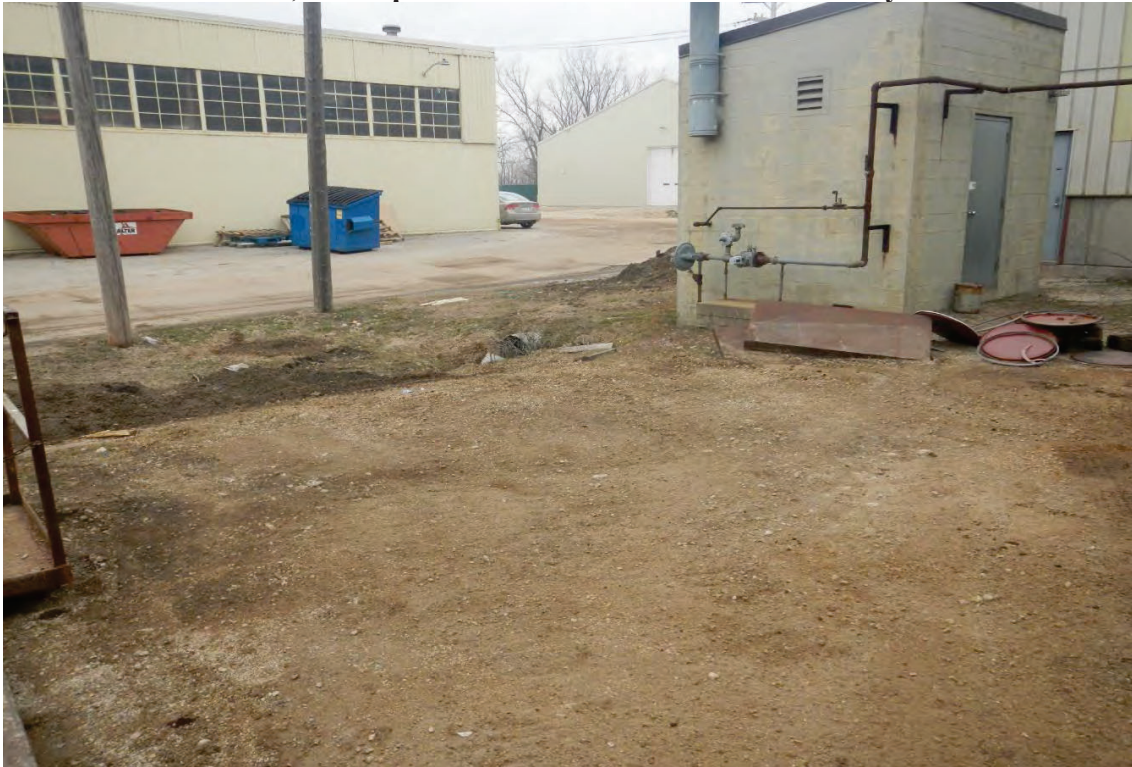
**Photo 16, MS4 open ditch 30 feet from the collection system**
