INSPECTION REPORT

| <b>Inspection Date:</b> | May 31, 2023 | Inspection Announced: No |
| <b>Type of inspection:</b> | CEI - Compliance Evaluation Inspection | |
| <b>Facility or Site Name:</b> | American Crystal Sugar – Moorhead | |

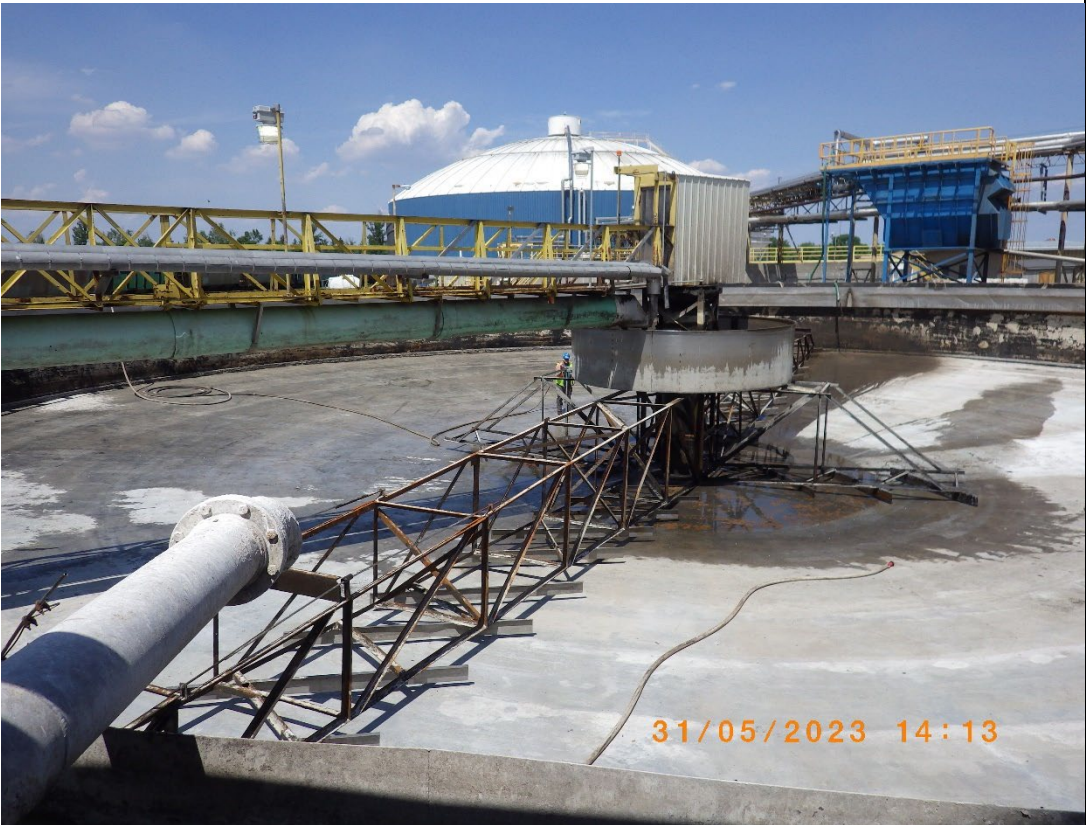
| <b>Photo No.:</b> 8 | <b>Time:</b><br>2:13 PM | | |

| <b>Photo Description:</b><br>Primary clarifier in the process of being cleaned. | | <b>File:</b> ACS_008.JPG | |

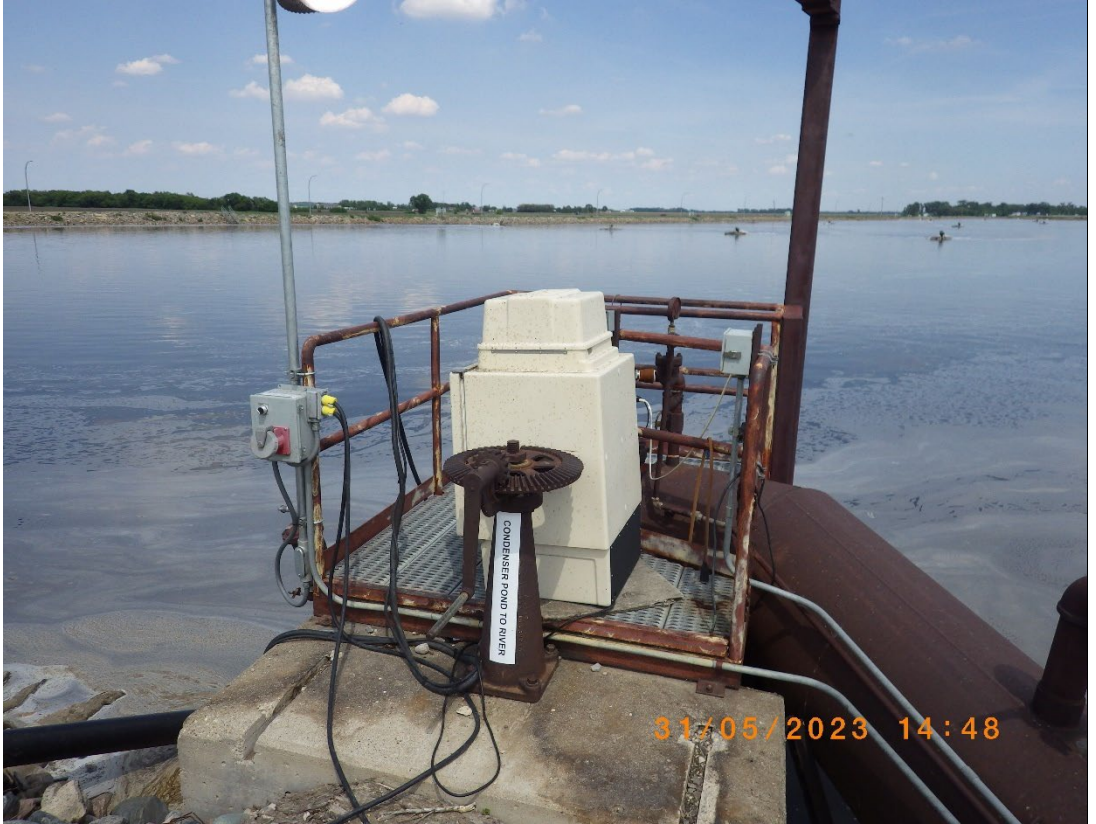
| <b>Photo No.: 15</b> | <b>Time:</b><br>2:48 PM | | |

| <b>Photo Description:</b><br>Condenser pond with autosampler (non-operational) and pipe that says to river. | | | |

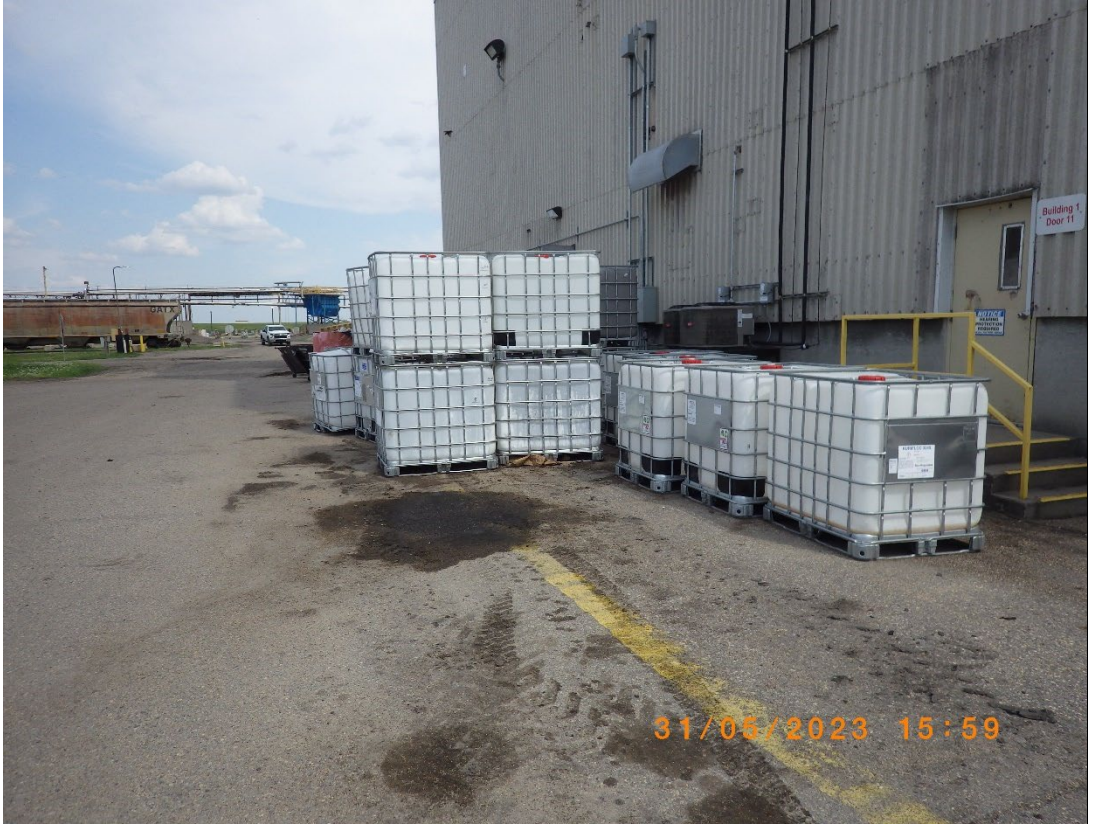
| <b>Photo No.: 22</b> | <b>Time:</b><br>3:59 PM | | |

| <b>Unique Identifying No.</b> | <b>Observation</b> | <b>Area of Concern?</b> |
|---|---|---|
| <b>MS-OB-001</b> | Facility had chemical totes stored on-site that were not being kept under cover or in secondary containment. (Photos #: 22 and 23) | Yes |

| <b>Photo Description:</b><br>Empty totes with no secondary containment or cover. | | | |

| No. | |
|---|---|
| <b>MS-OB-001</b> | <p>Facility had chemical totes stored on-site that were not being kept under cover or in secondary containment. (Photos #: 22 and 23)</p> <p>Chemicals and stored wastes should be kept under cover and in secondary containment to prevent any spills or leaks.</p> |

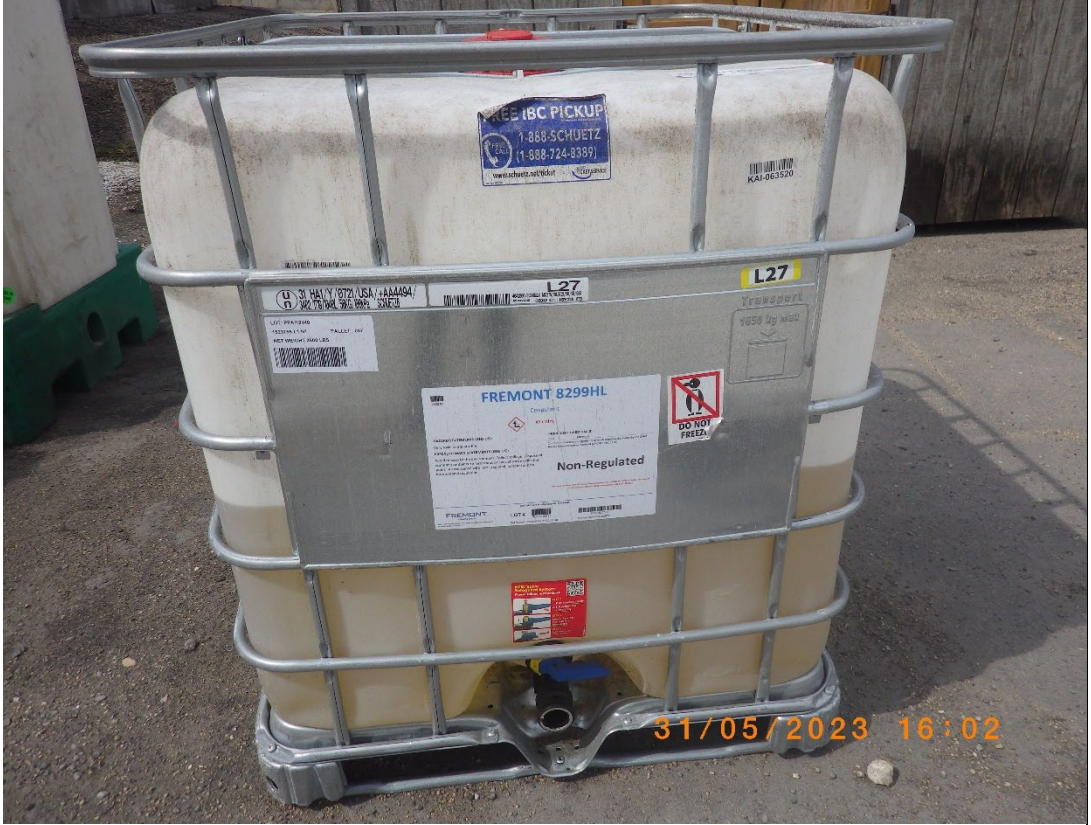
| <b>Photo No.:</b> 23 | <b>Time:</b><br>4:02 PM | | |

| <b>Photo Description:</b><br>Tote with label stating toxic to aquatic life. No secondary containment or cover. | | | |

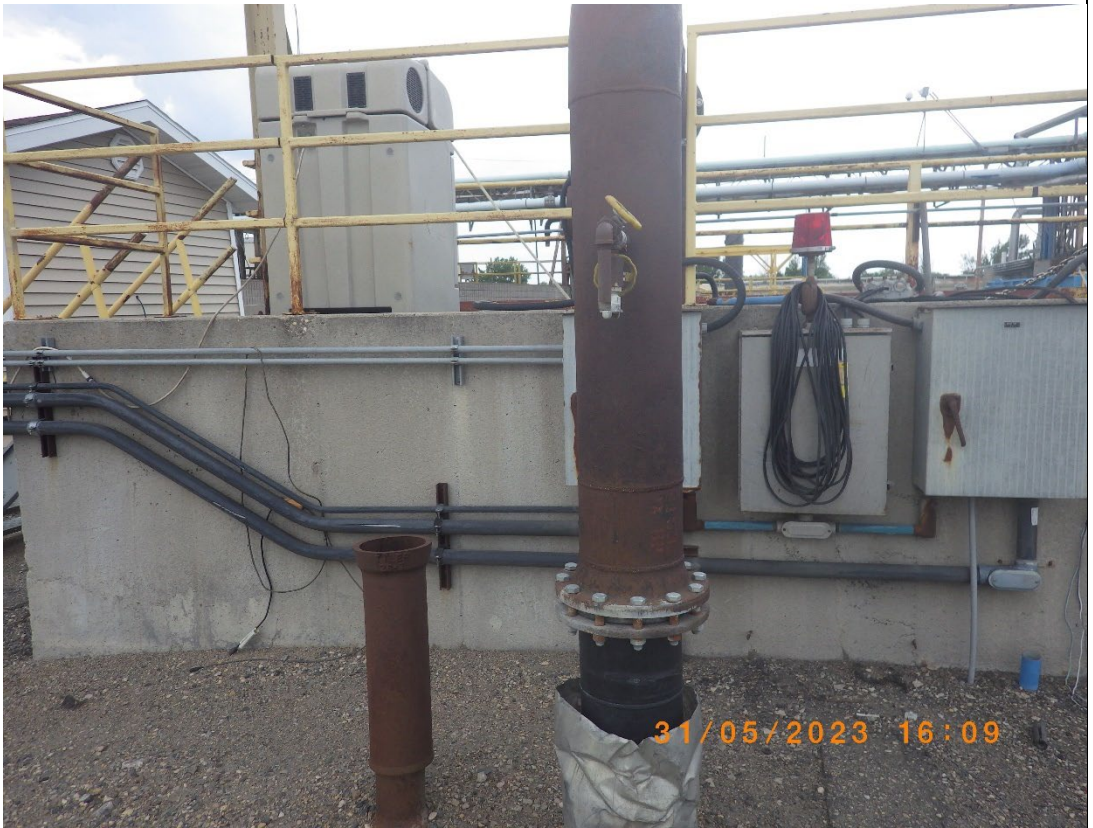
| <b>Photo No.:</b> 25 | <b>Time:</b><br>4:09 PM | | |

| <b>Photo Description:</b><br>Grab sample location for WS006 and composite sampler for SD002. | | | |
