INSPECTION REPORT

| Type of Inspection | Industrial Stormwater Inspection (ISI) | | |
| Permittee Name | Northeast Asphalt, Inc. (Hobart Quarry) | | |
| Facility/Site Physical Address | 451 County Highway EE | | |

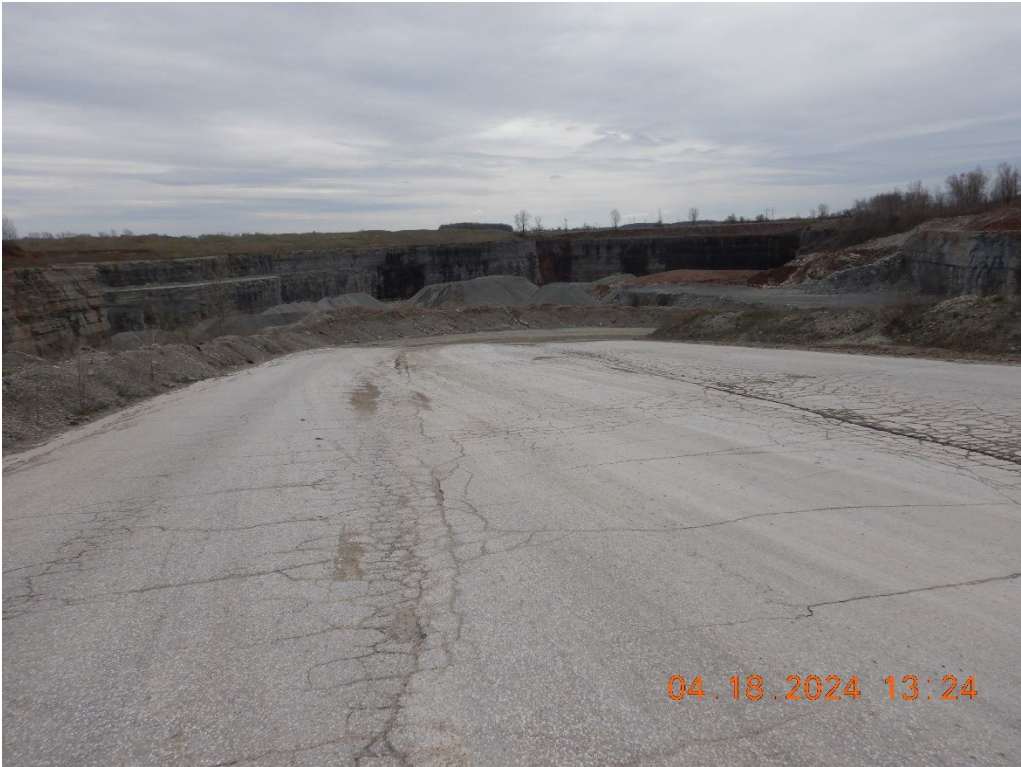
| Road Into Quarry | | | DSCN0642.JPG |

| Overview of Hobart Quarry from entrance | | | |

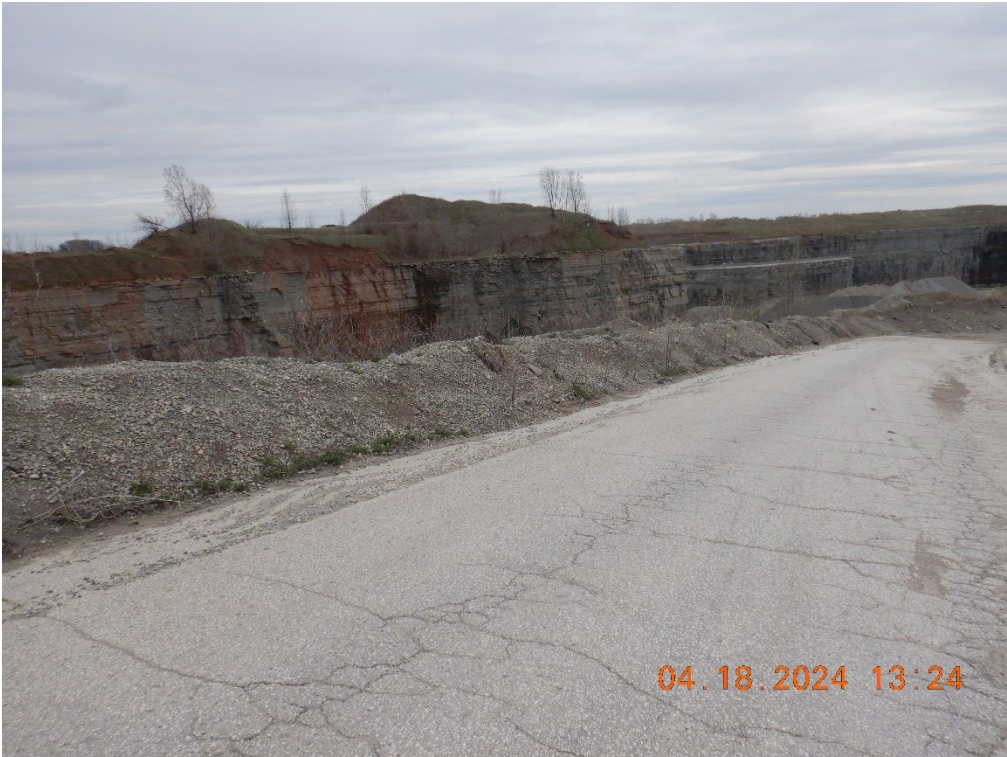
| Southeast side of Quarry | | | DSCN0643.JPG |

| Overview of southeast side of quarry | | | |

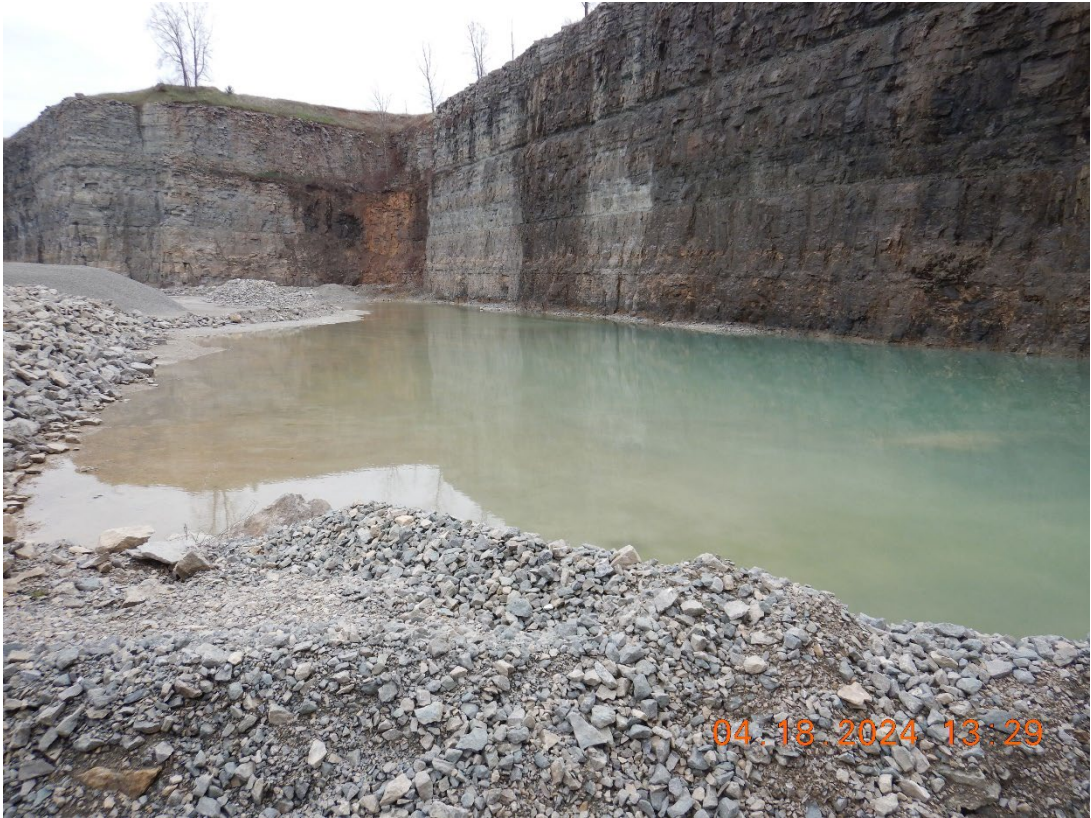
| Stormwater Sump Hole (Main) | | | DSCN0644.JPG |

| Stormwater main sump hole southwest corner | | | |

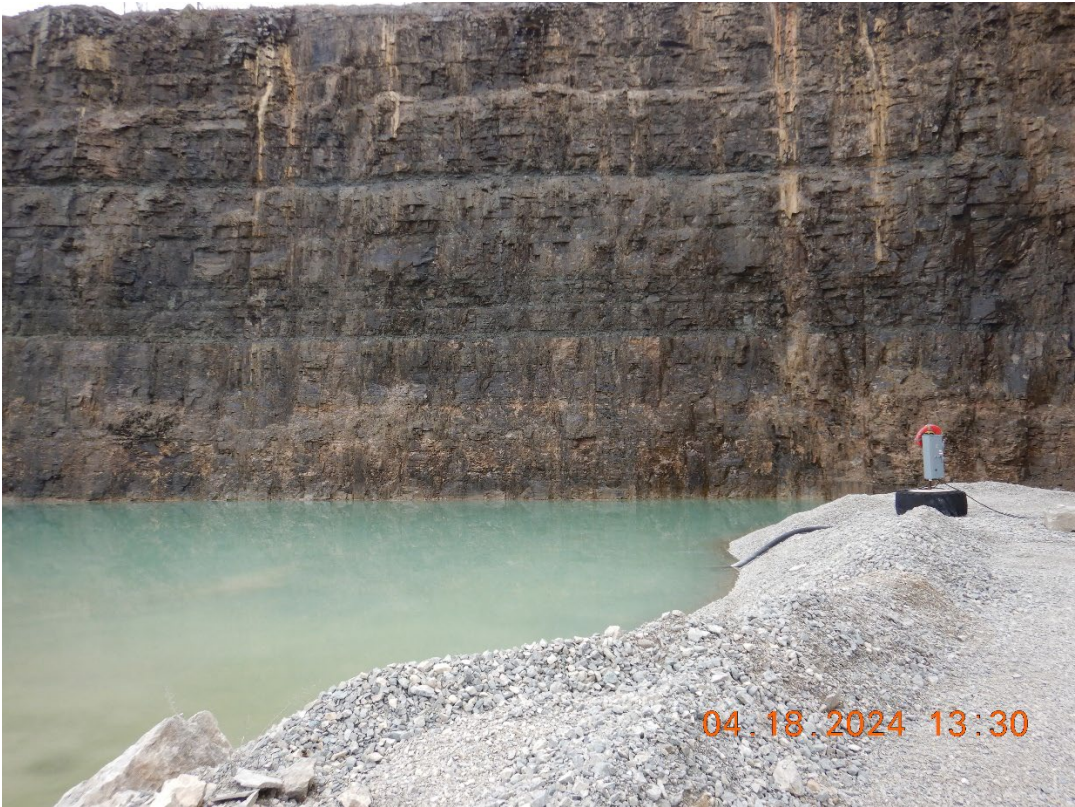
| Stormwater Sump Hole Pump Power Station | | | DSCN0645.JPG |

| Pump power for dewatering operations from main sump hole | | | |

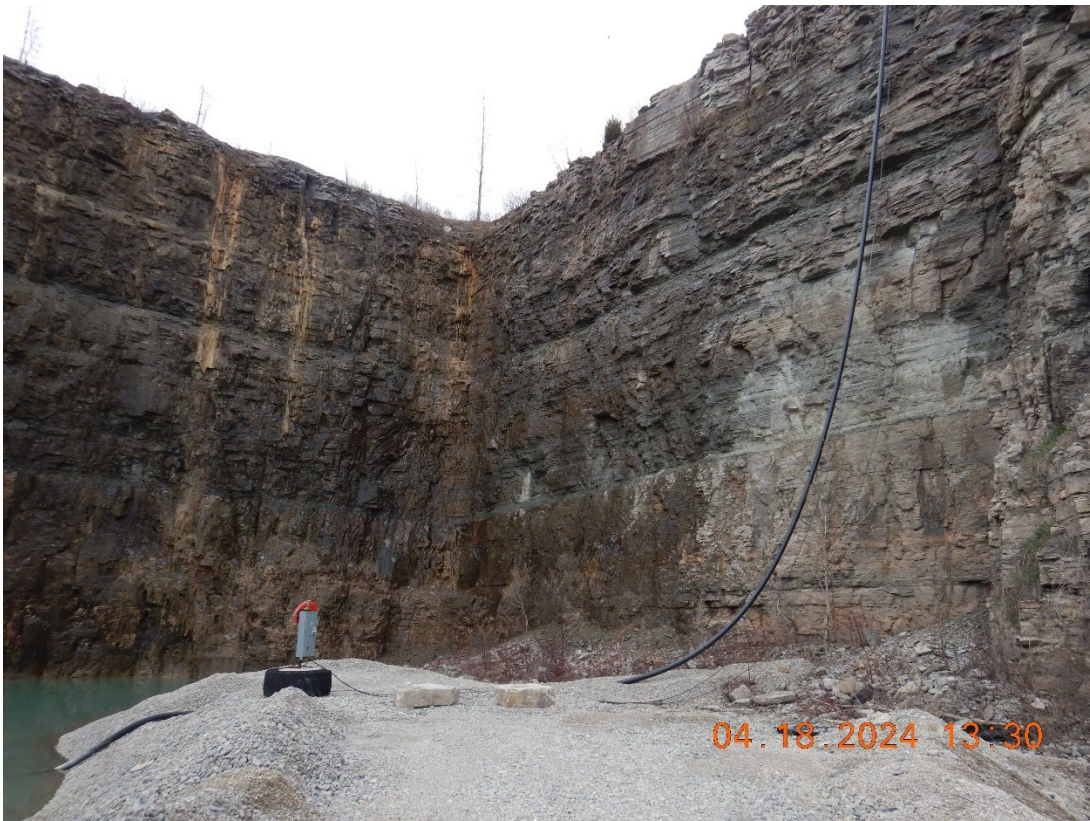
| Dewatering Hose | | | DSCN0646.JPG |

| Dewatering hose from main sump hole to top of quarry | | | |

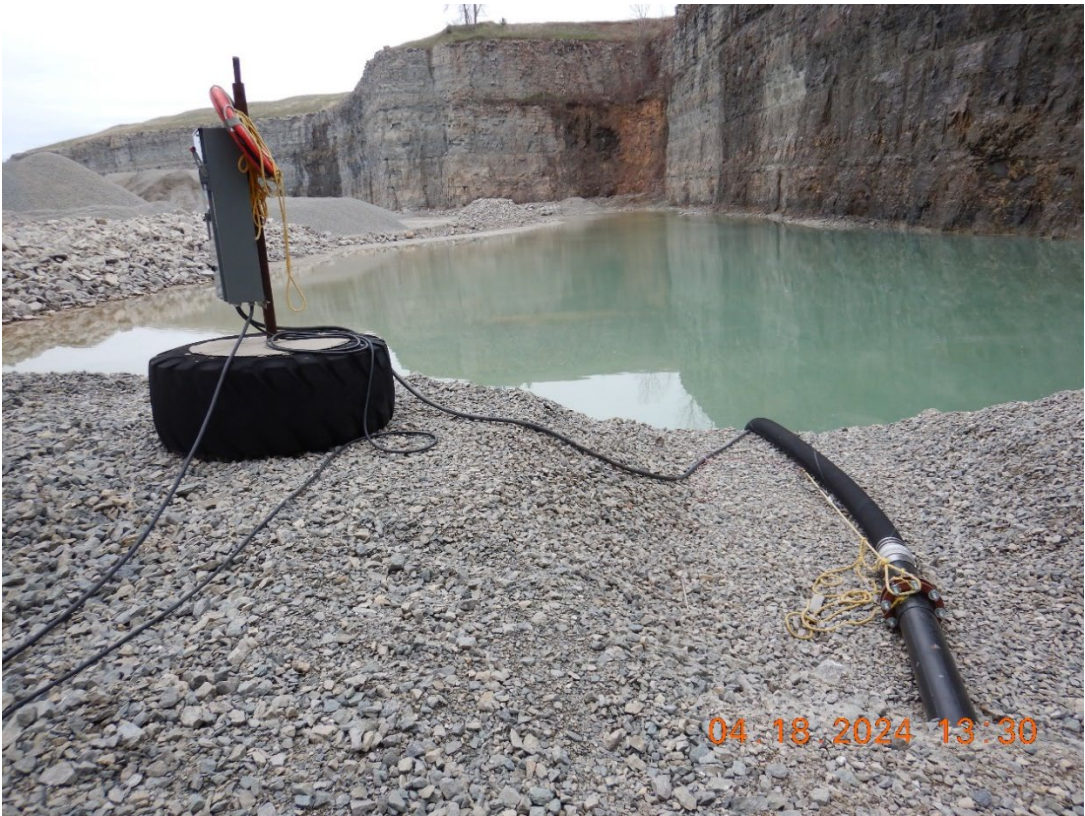
| Main Sump Hole | | | DSCN0647.JPG |

| Main sump hole southwest corner | | | |

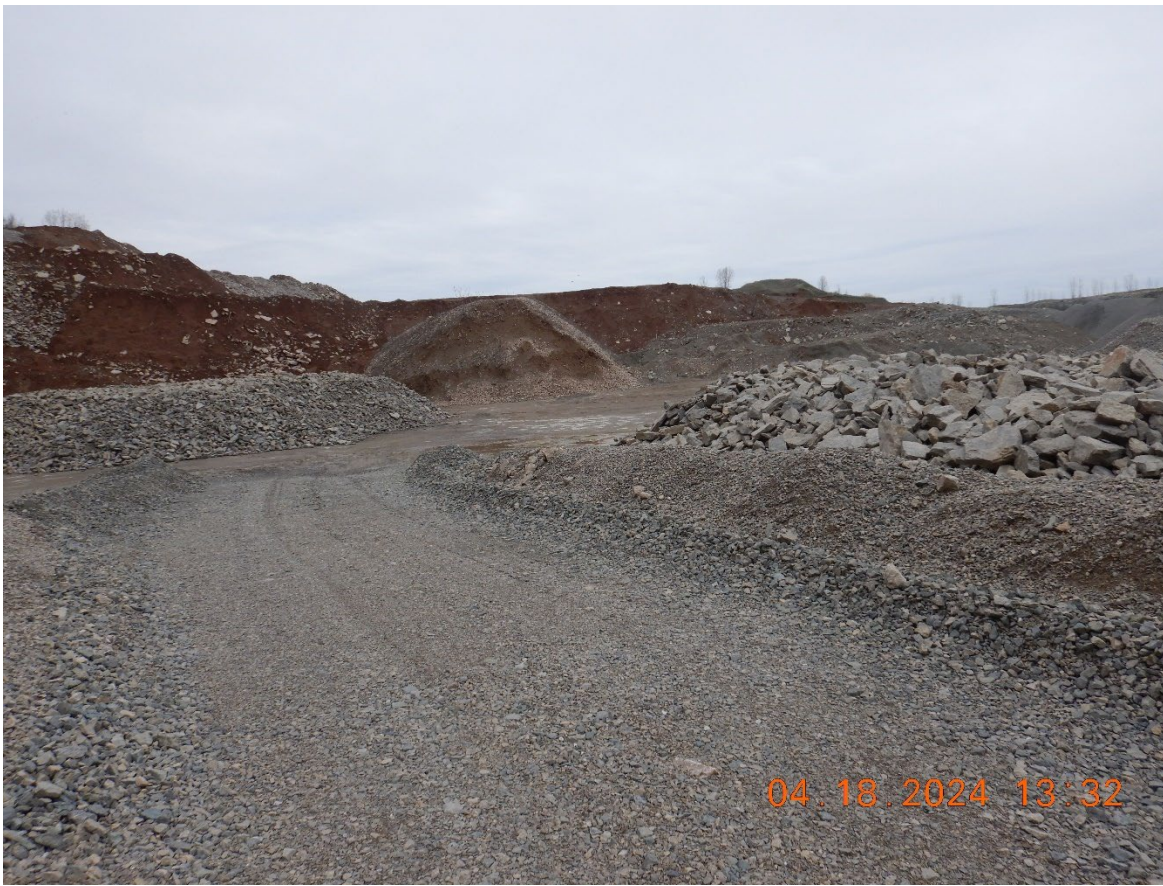
| Westside of Quarry | | | DSCN0648.JPG |

| Overview of westside of quarry | | | |

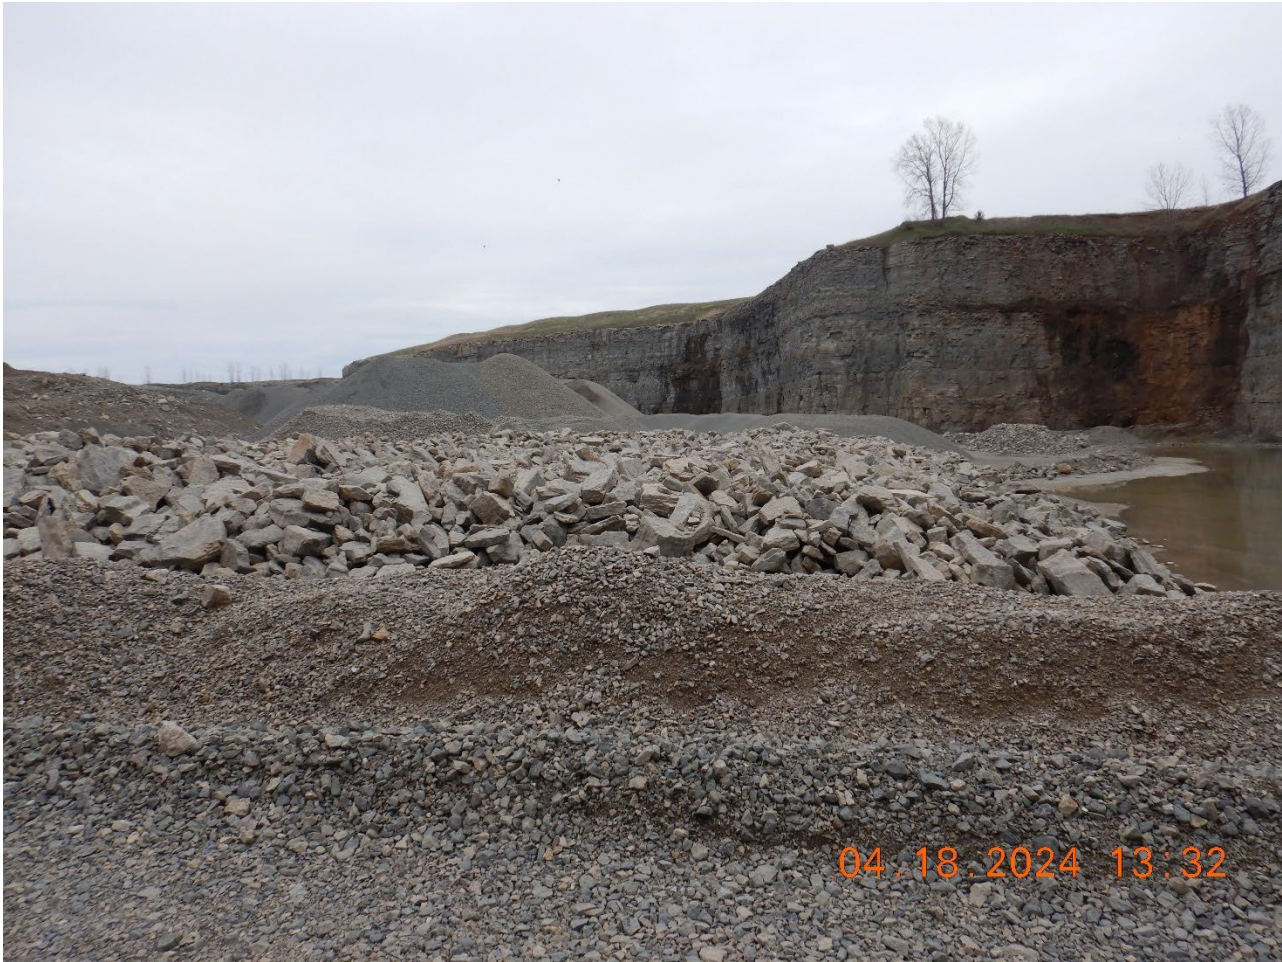
| Southeast Side of Quarry | | | DSCN0649.JPG |

| Overview of southeast side of quarry with secondary sump hole | | | |

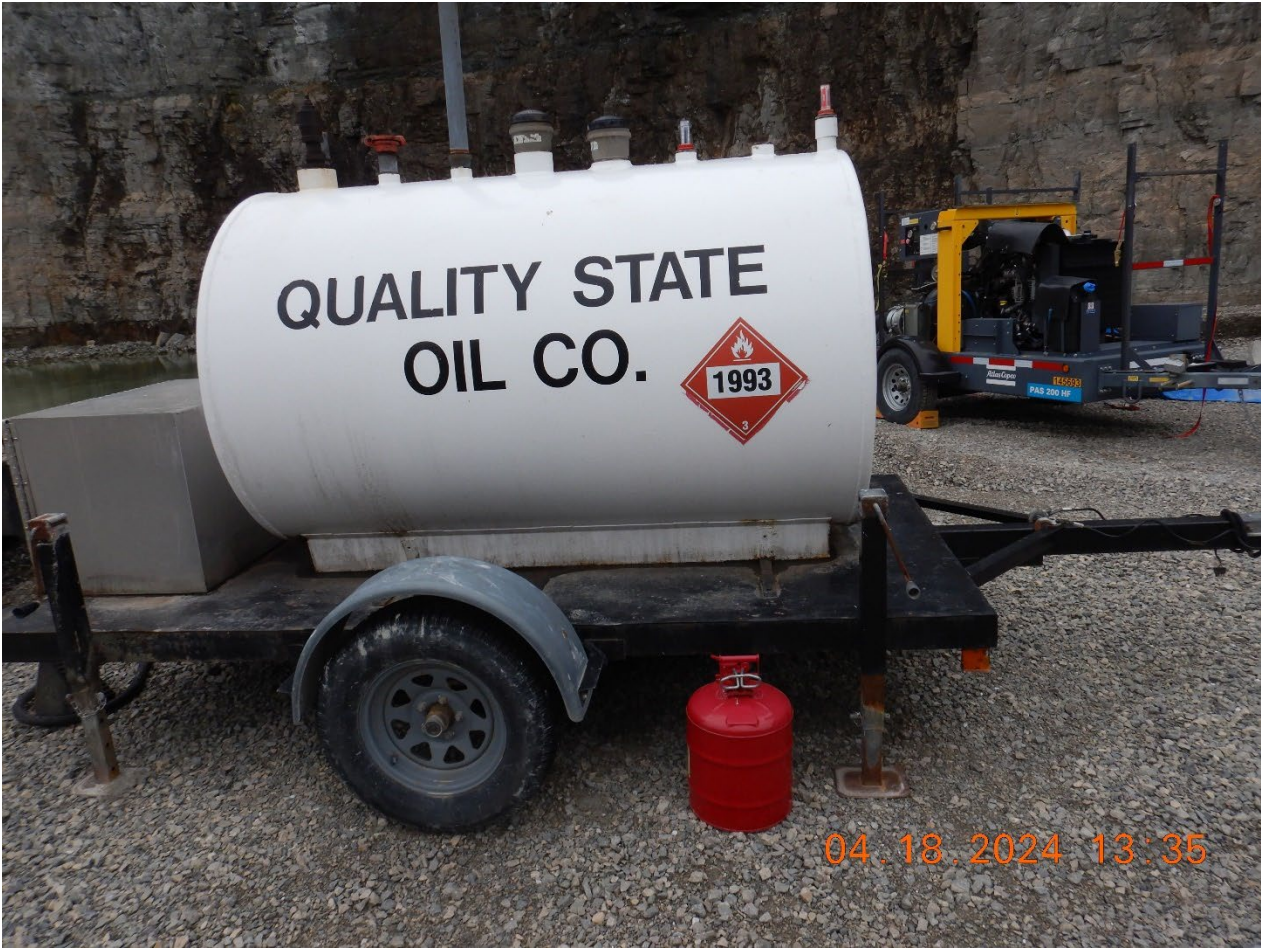
| Portable Fuel Tank | | | DSCN0650.JPG |

| <p>EPA observed the following, during the walkthrough of the outdoor area:</p> <ul style="list-style-type: none"><li>• At the secondary sump hole on the southeast side of the quarry, Mr. Nguyen noticed a portable fuel storage tank on a trailer near the collection hole. The fuel tank did not have secondary containment in case of leaks or spills.</li><li>• Mr. Leitner stated that grab samples are not taken from the ditch from the wetlands that merges into Duchman Creek.</li><li>• A permit coverage sign was posted at the entrance of the facility but had previous owner contact and coverage information and not the current owner contact information.</li></ul> | | |

| Portable fuel tank for pump generator power | | | |

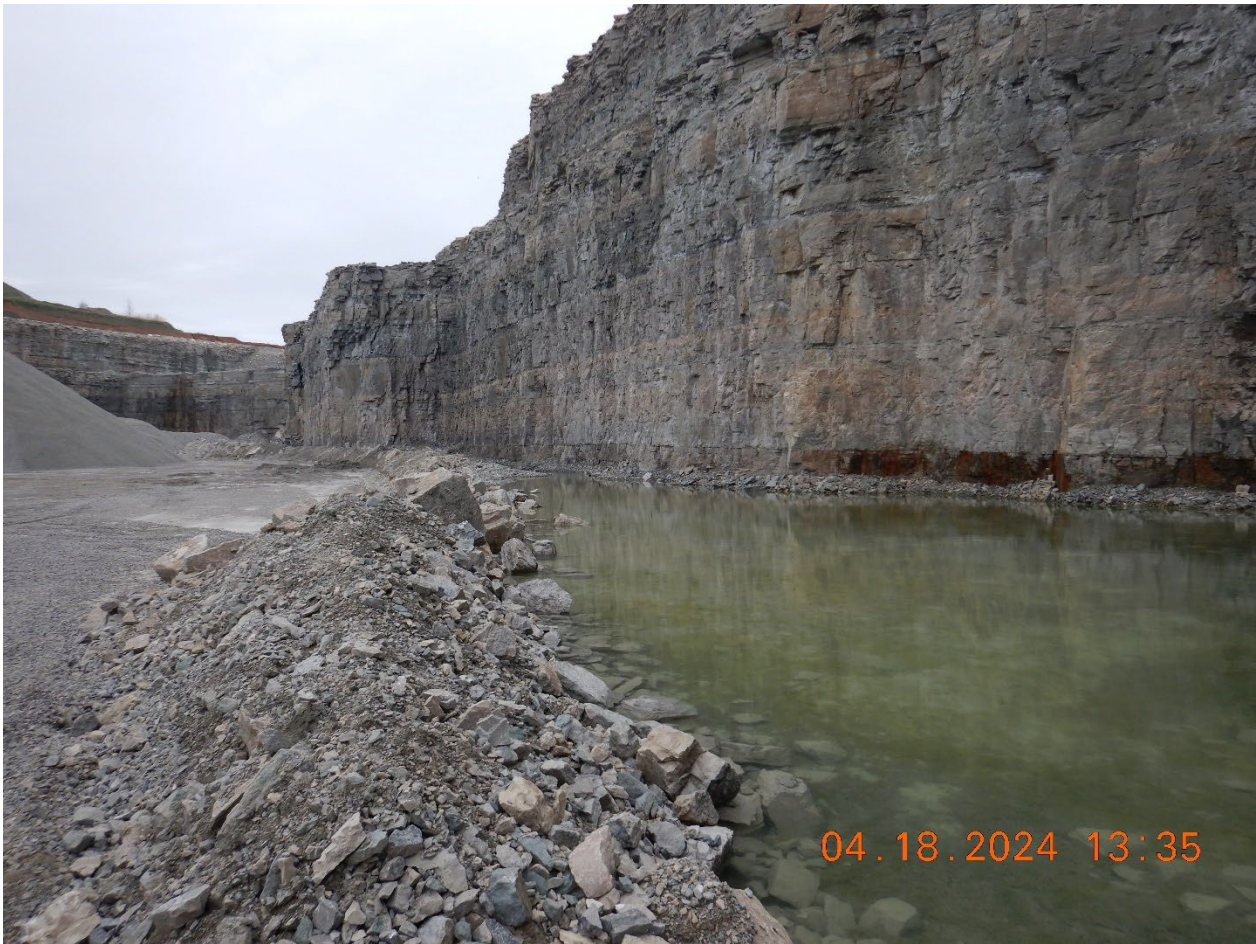
| Secondary Stormwater Sump Hole | | | DSCN0651.JPG |

| Overview of secondary sump hole stormwater collection (southeast corner of quarry) | | | |

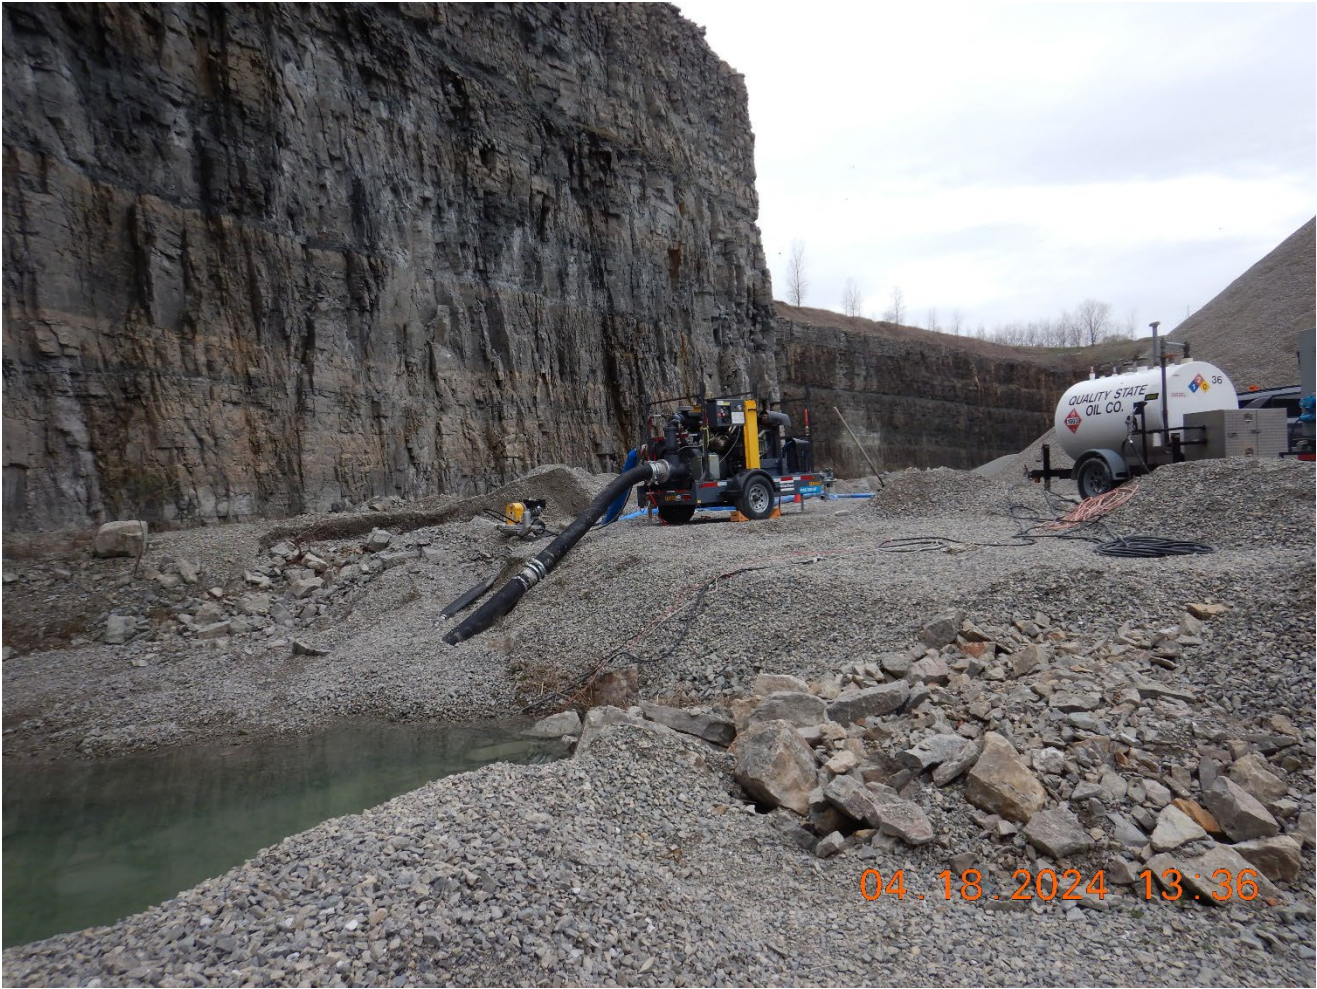
| Pump Generator | | | DSCN0653.JPG |

| Secondary sump hole pump generator for transfer of stormwater to main sump hole (southwest corner) | | | |

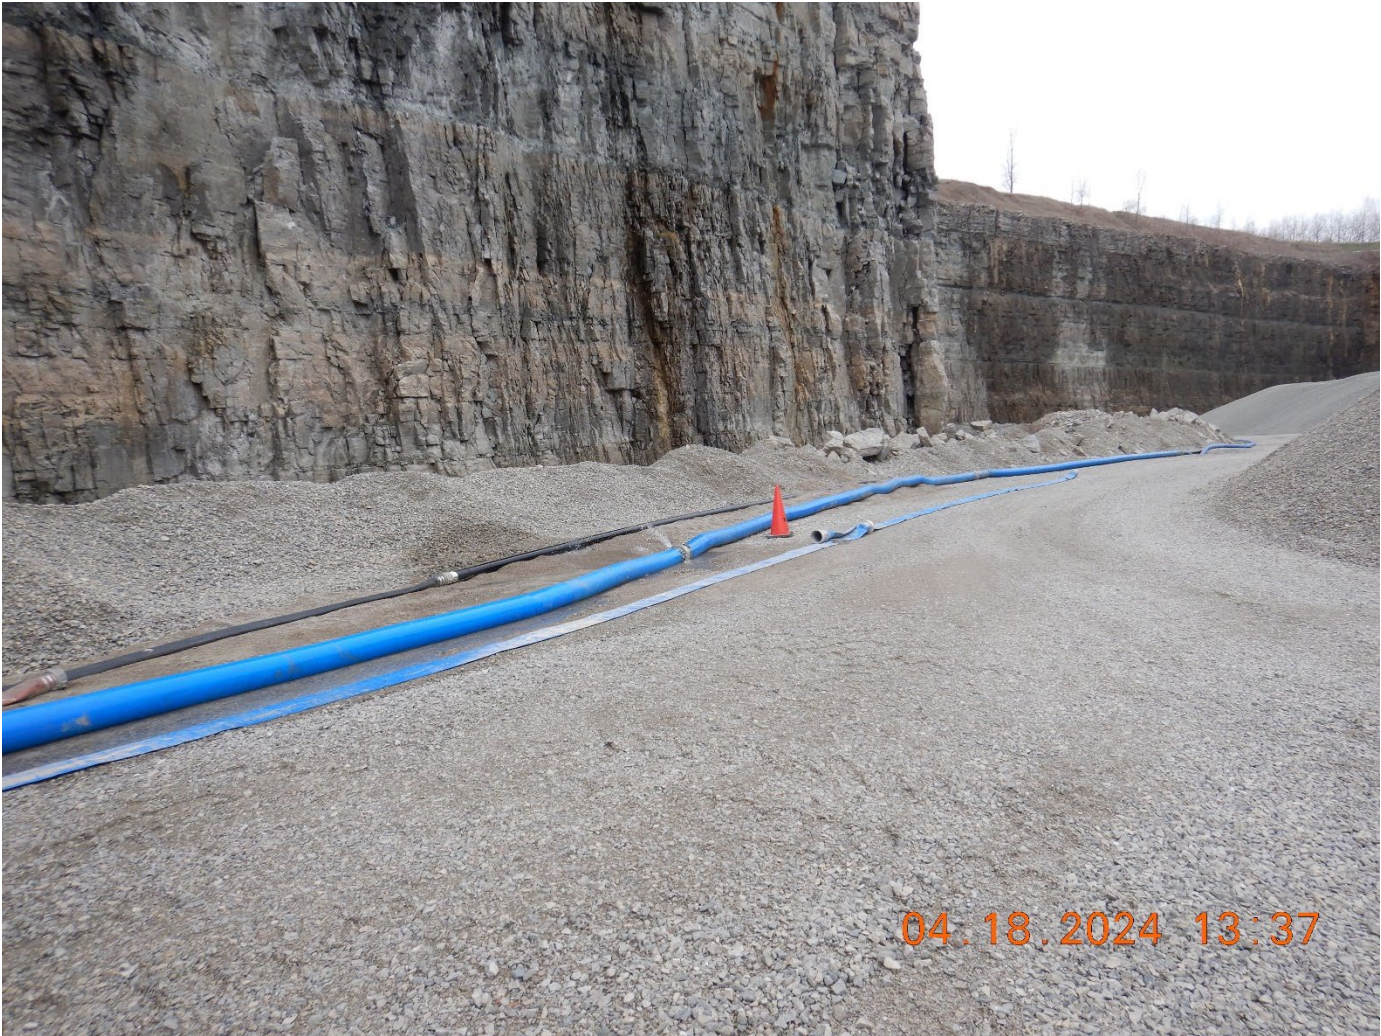
| Transfer Hose | | | DSCN0655.JPG |

| Stormwater transfer hose from secondary sump hole to main sump hole | | | |

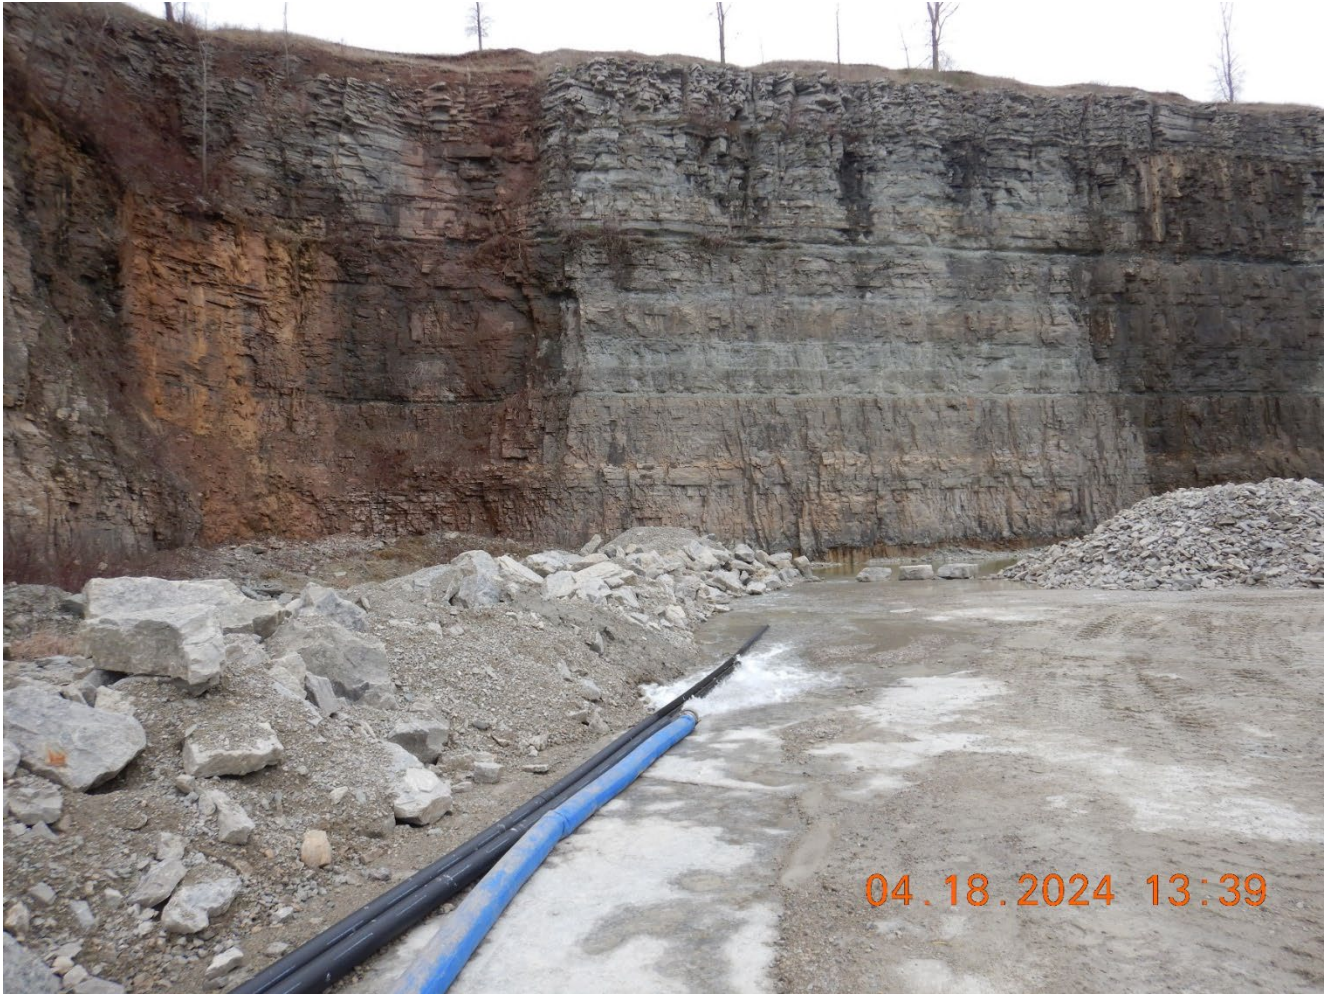
| Discharge to Main Sump Hole | | | DSCN0656.JPG |

| Stormwater transfer from secondary sump hole to main sump hole | | | |

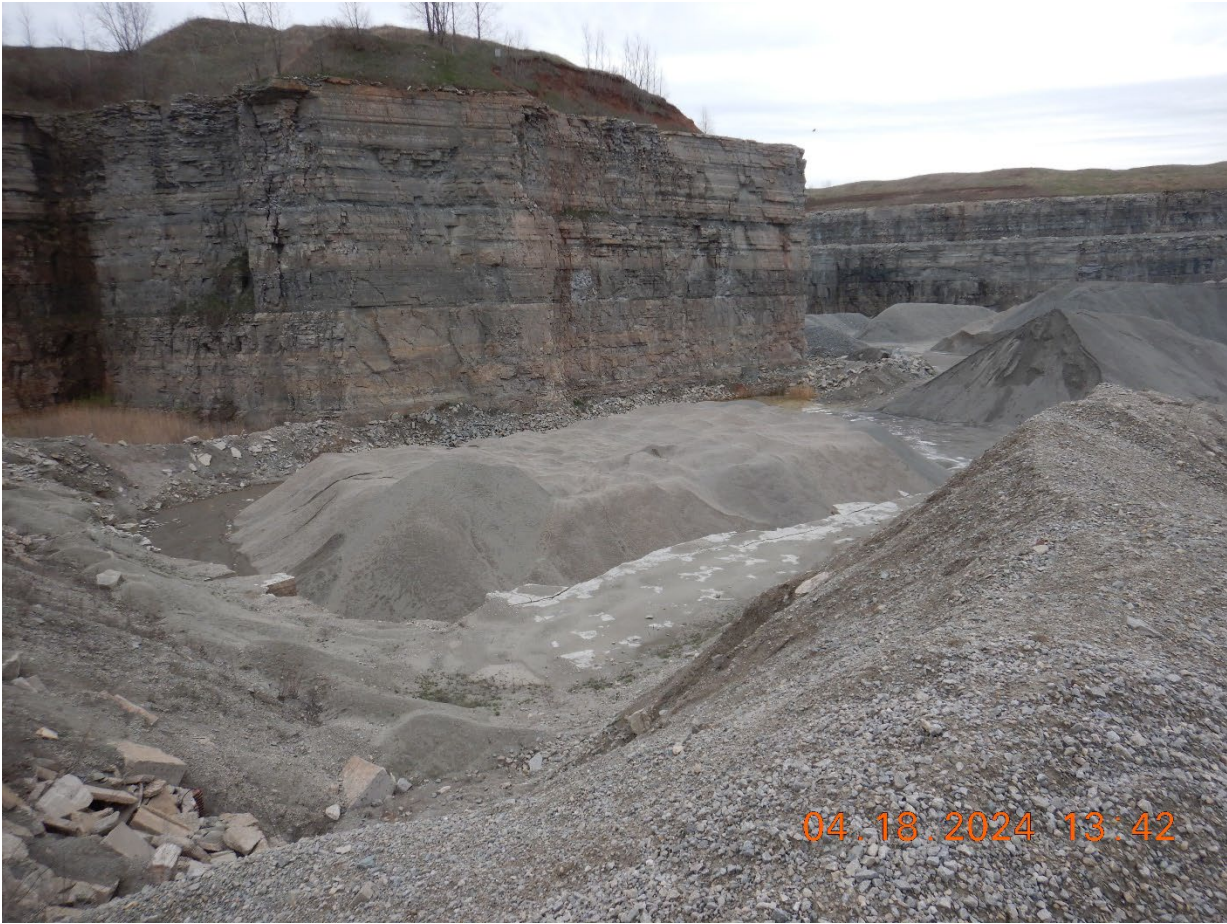
| East Side of Quarry | | | DSCN0658.JPG |

| Overview of southeast side in quarry | | | |

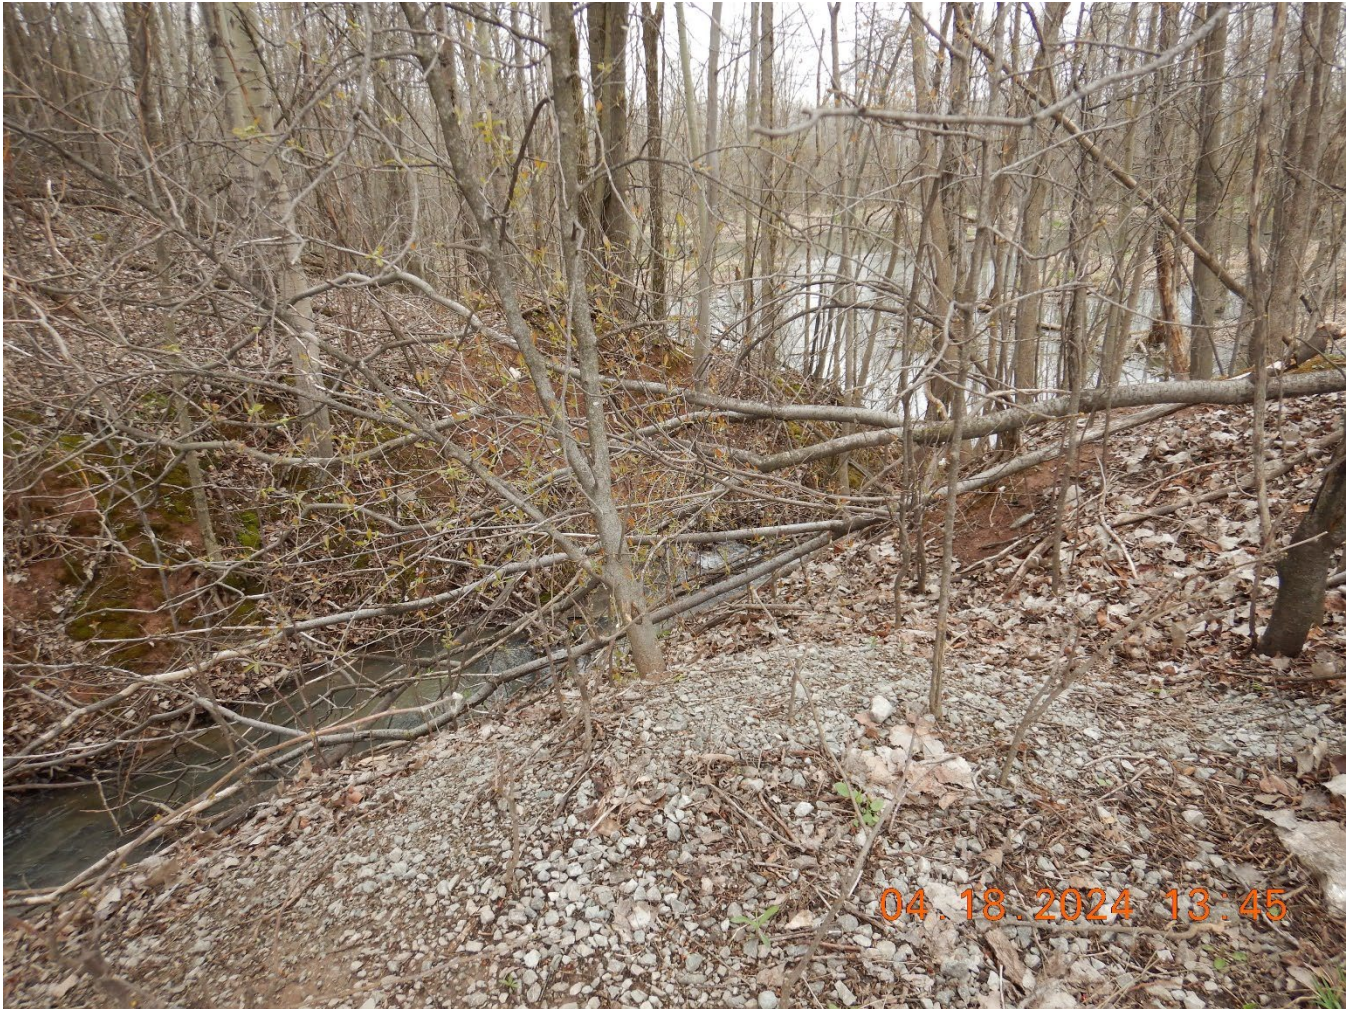
| Wetlands Area West Side | | | DSCN0661.JPG |

| Stormwater ditch flowing from south to north to wetlands area on the west side of NEA property outside of the quarry | | | |

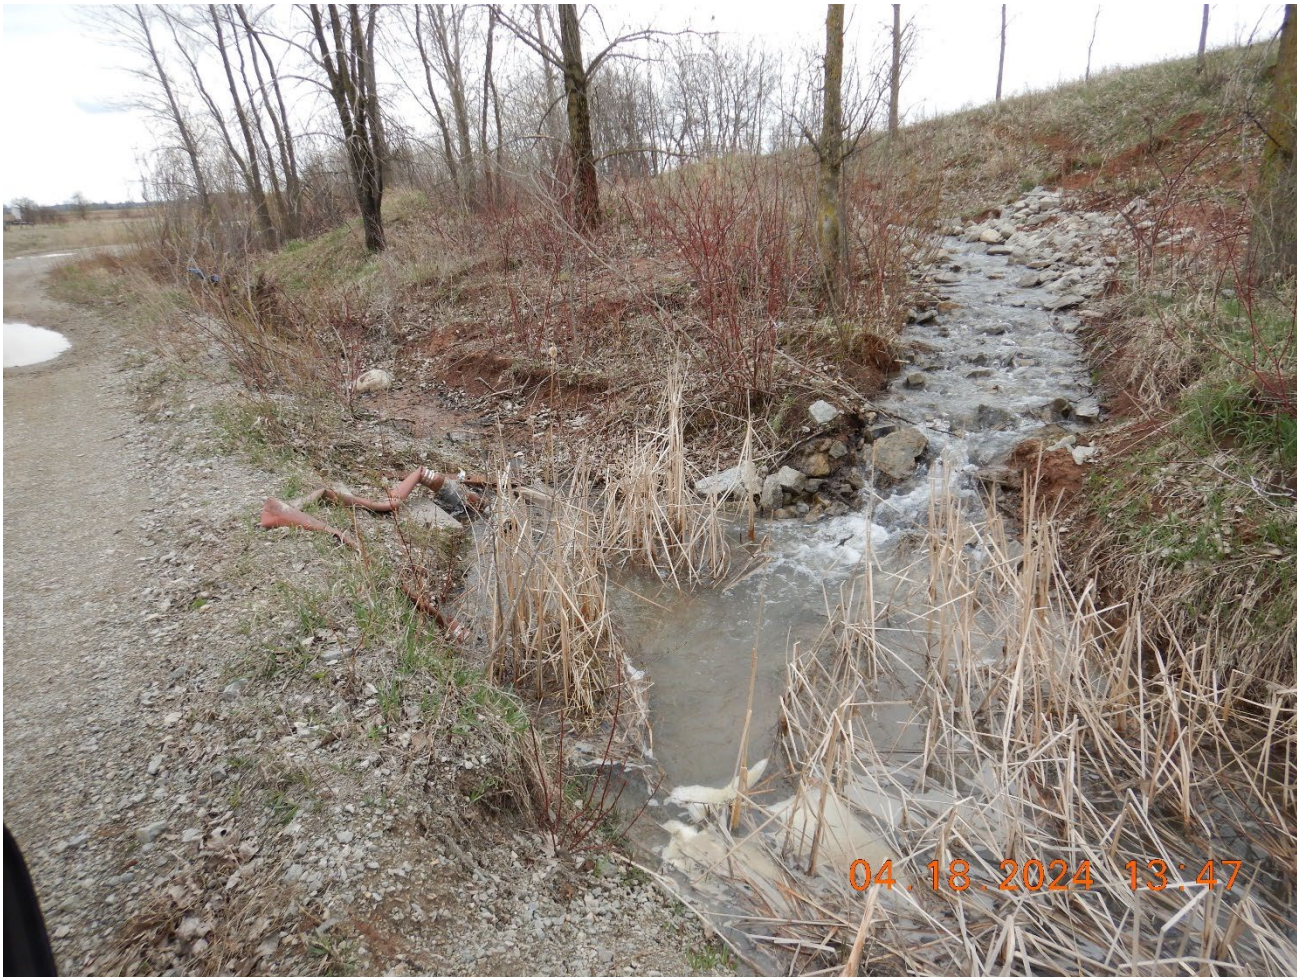
| Stormwater Waterfall from Discharge | | | DSCN0663.JPG |

| Discharge of stormwater from hose from main sump hole to south to north stormwater ditch that flows to wetlands on the west side of the property | | | |

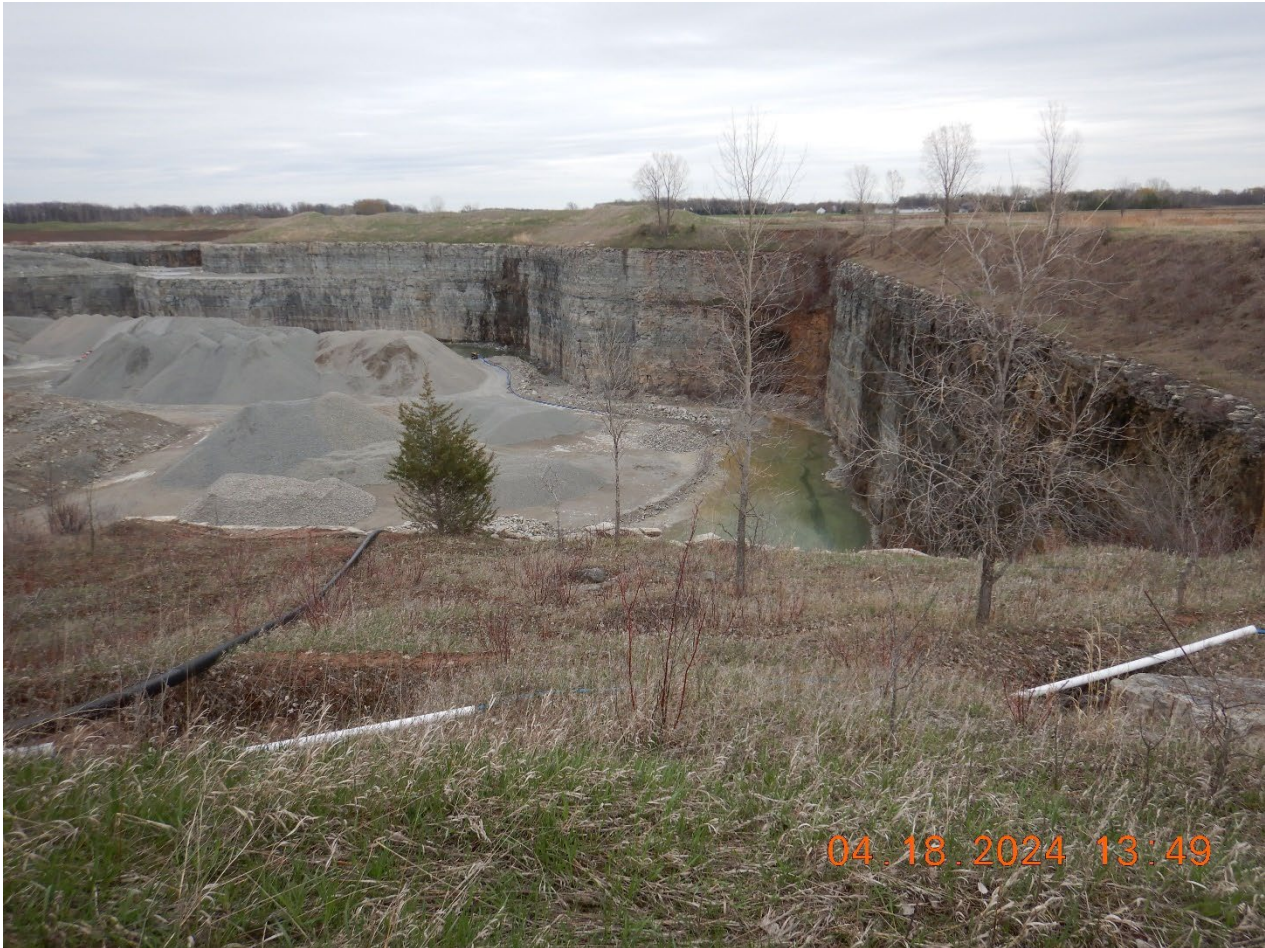
| Discharge Hose Top of Quarry | | | DSCN0667.JPG |

| Overview of top of quarry on the southwest side overlooking main sump hole with discharge hose | | | |

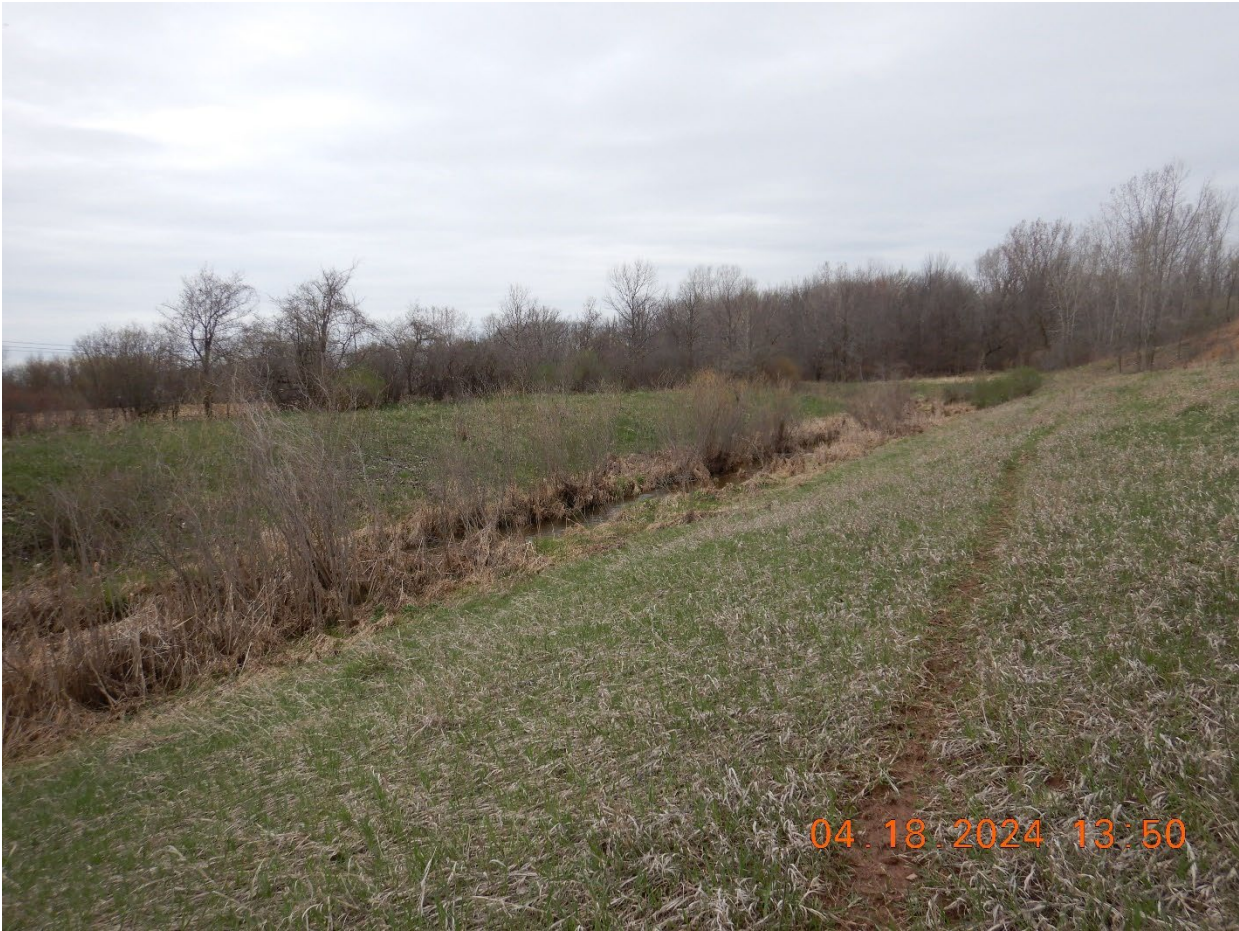
| Duchman Creek | | | DSCN0671.JPG |

| Duchman Creek on west side of property flowing north to south | | | |

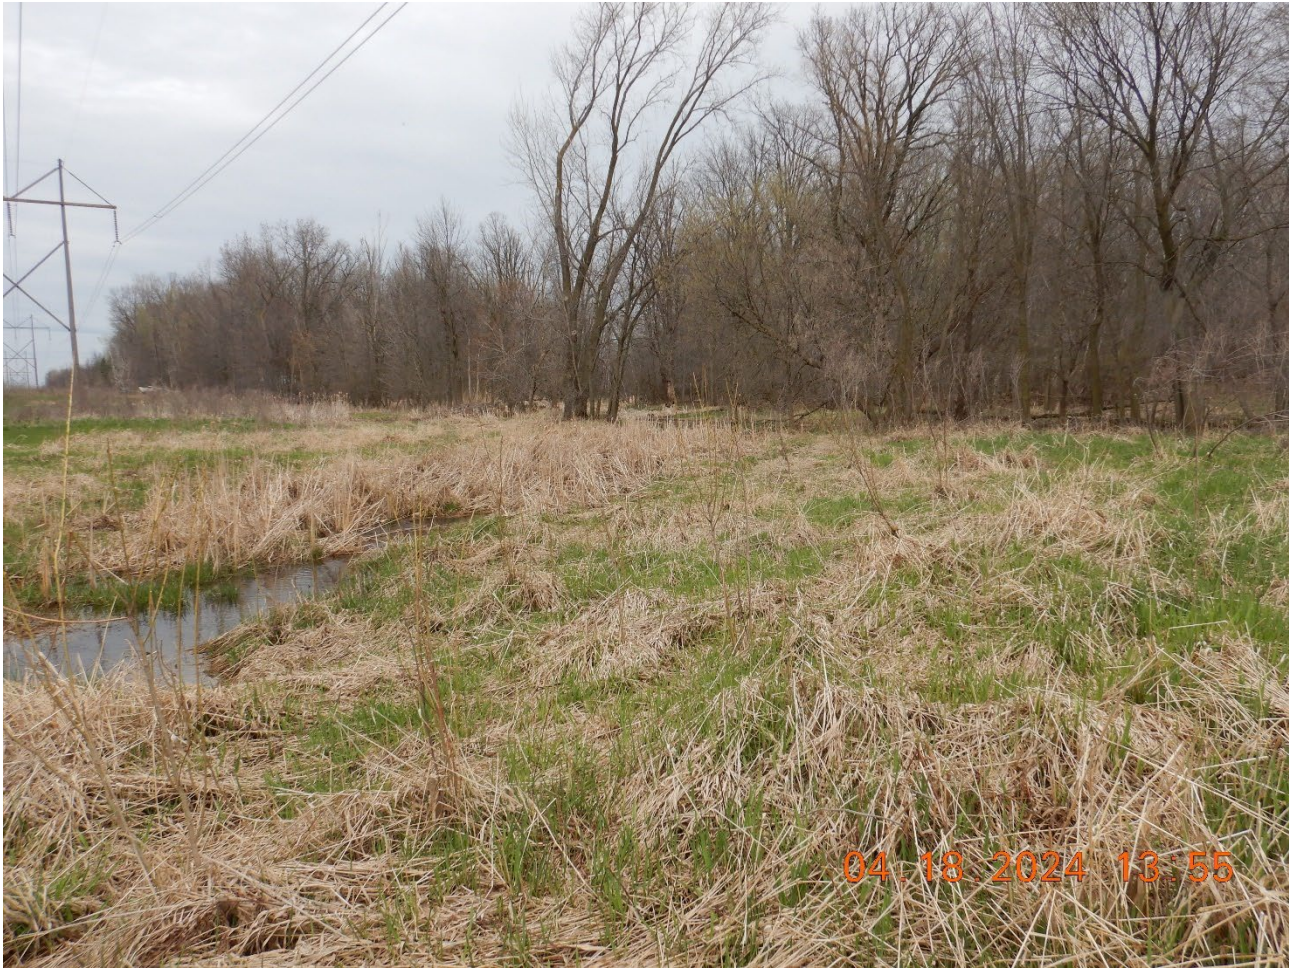
| Stormwater Ditch from Wetland Area | | | DSCN0678.JPG |

| Stormwater ditch from wetlands area on west side of property flowing from wetlands east to west towards merge with Duchman Creek | | | |

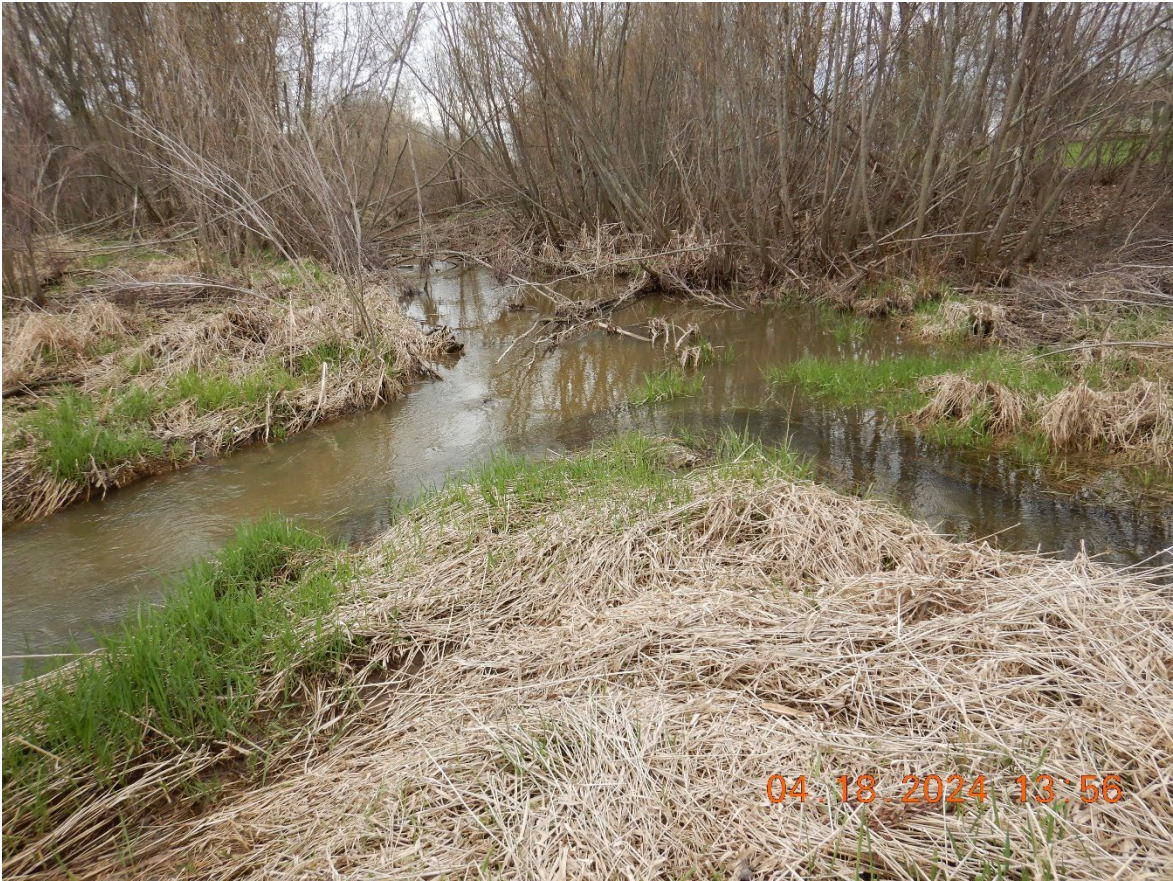
| Stormwater Merge with Duchman Creek | | | DSCN0681.JPG |

| Stormwater flowing from wetlands ditch (bottom right to top left) and merging with Duchman Creek flowing north to south (Top right to bottom left) | | | |
