INSPECTION REPORT

| Type of Inspection | Industrial Stormwater Inspection (ISI) | | |
| Permittee Name | Northeast Asphalt, Inc. (Hobart Quarry) | | |
| Facility/Site Physical Address | 451 County Highway EE | | |

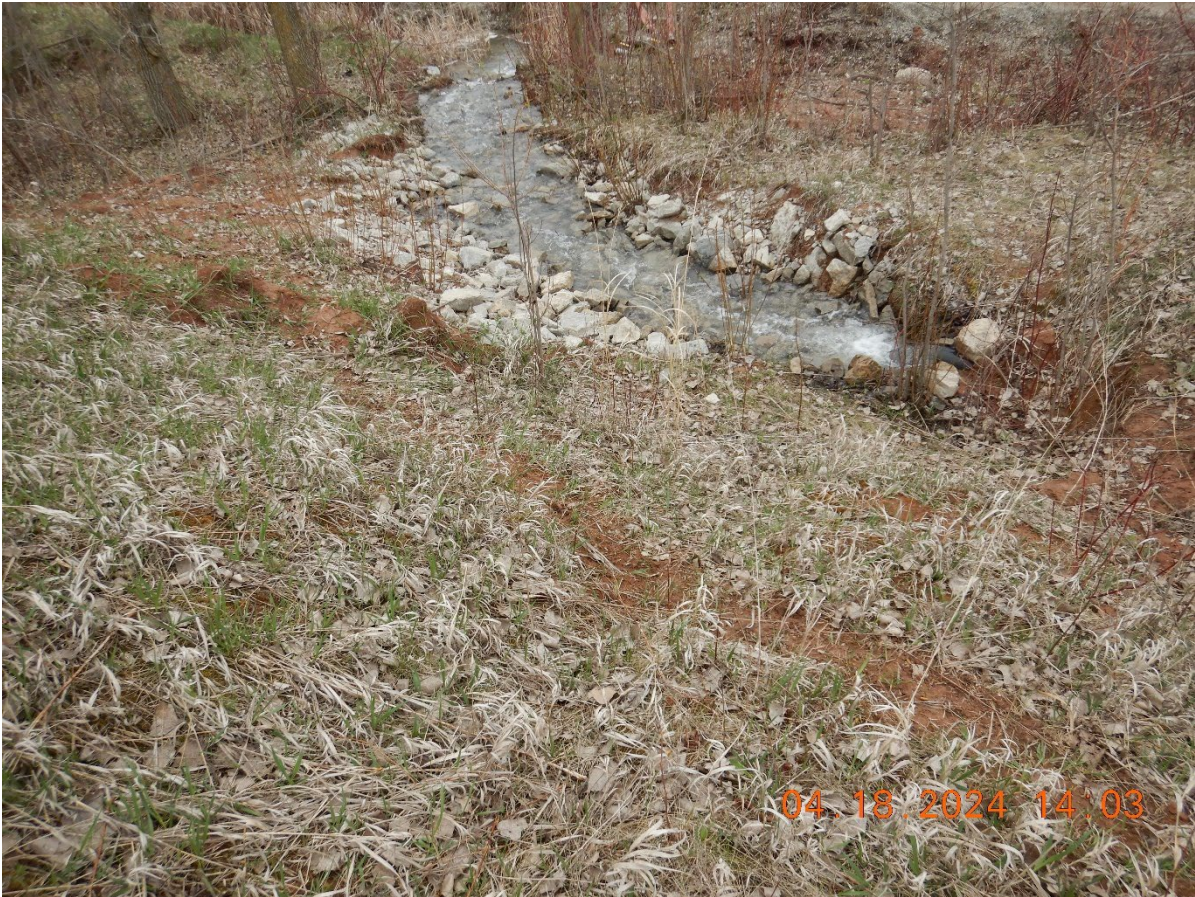
| Discharge from Main Sump Hole to Ditch | | | DSCN0682.JPG |

| Stormwater discharging from main sump hole in quarry via hose to waterfall ditch flowing south to north to wetlands area on west side of property | | | |

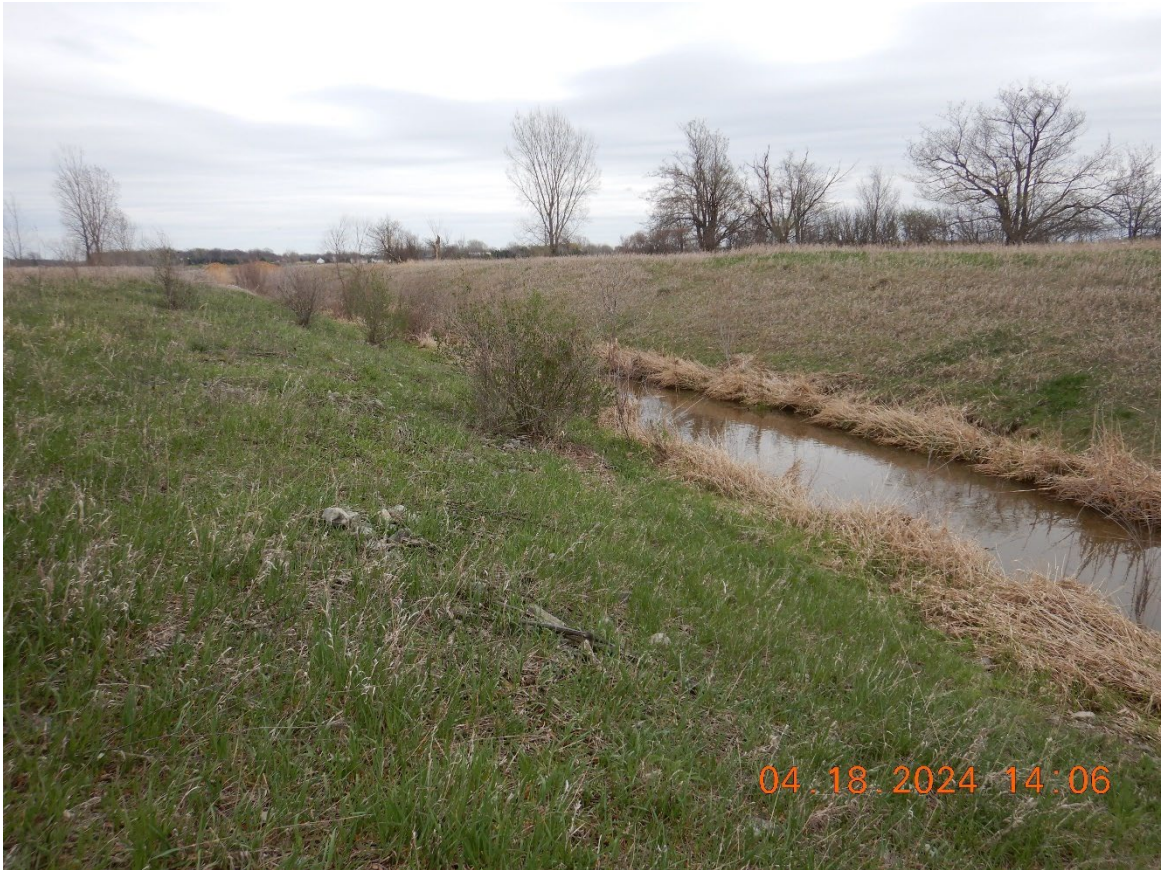
| Duchman Creek (South) | | | DSCN0684.JPG |

| Duchman Creek on south side of property above quarry flowing west to east | | | |

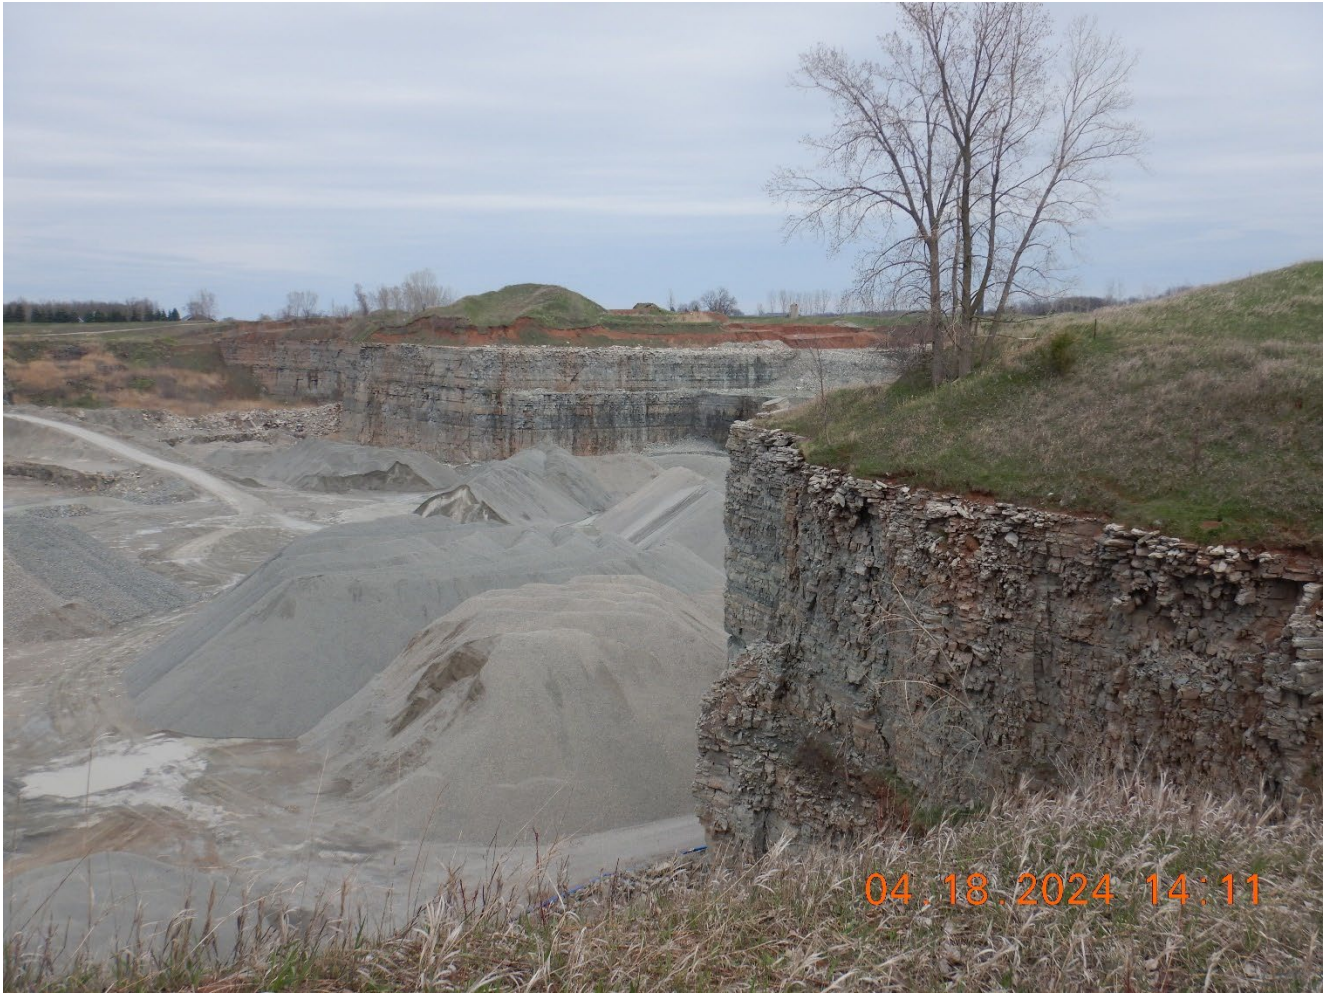
| Duchman Creek (South) | | | DSCN0689.JPG |

| Overview of east side of quarry/property from top | | | |

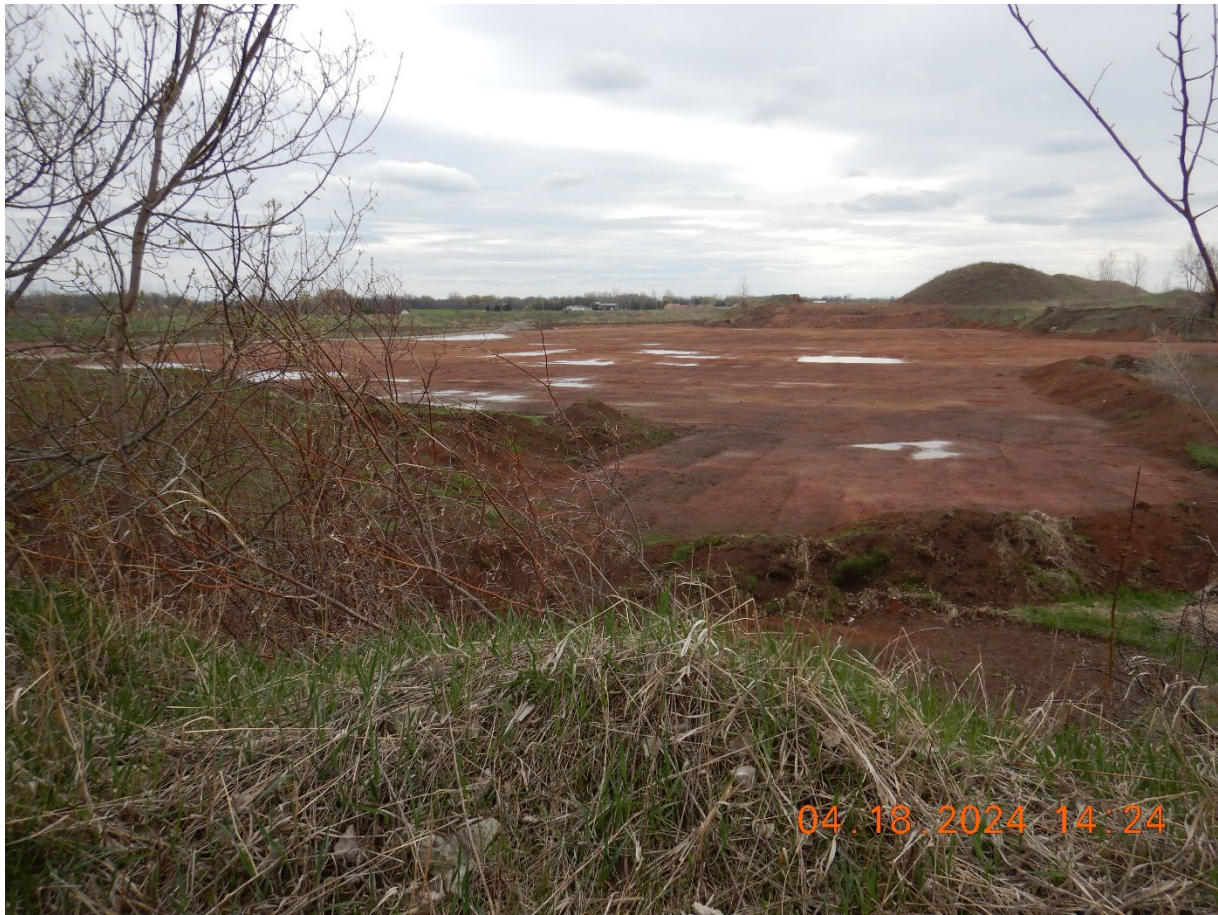
| East Side of Quarry | | | DSCN0693.JPG |

| East side of quarry for new excavation/blasting area. Area is surrounded by high berms. | | | |

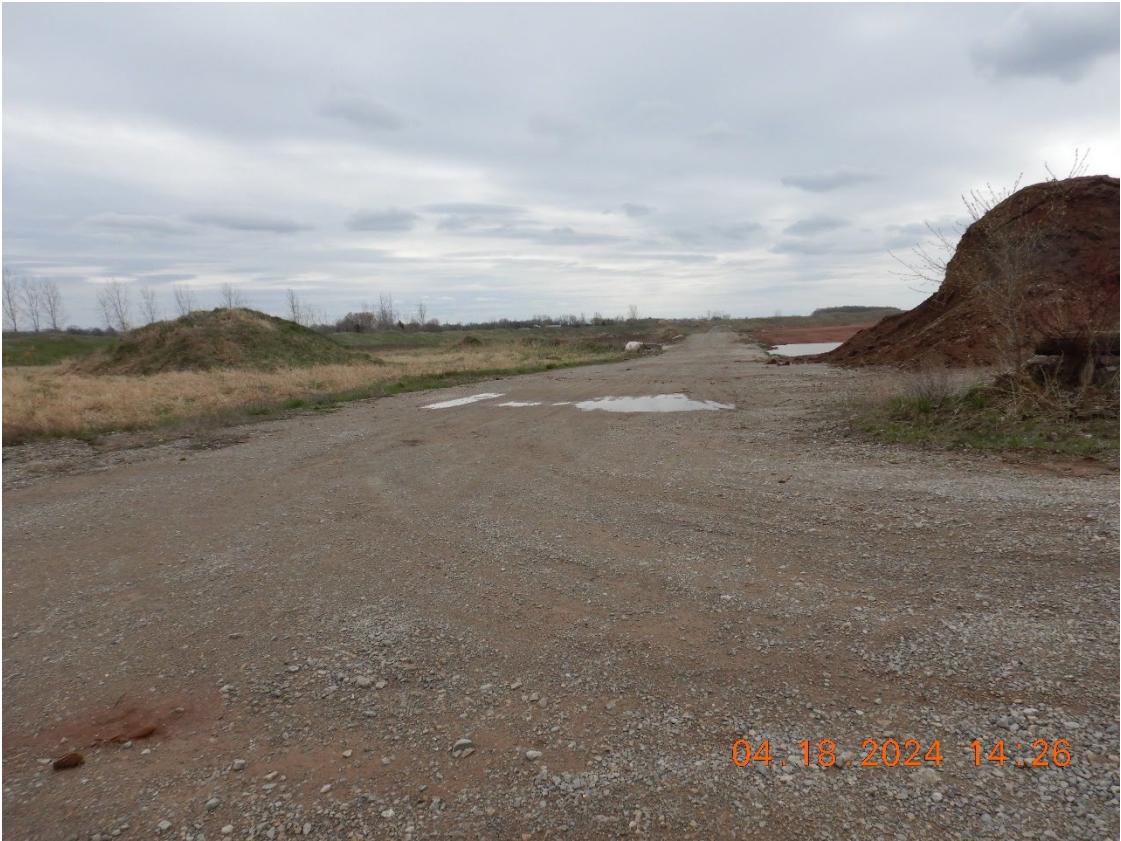
| Alternate Entrance Road East Side | | | DSCN0695.JPG |

| Alternate entrance road to east side of property | | | |

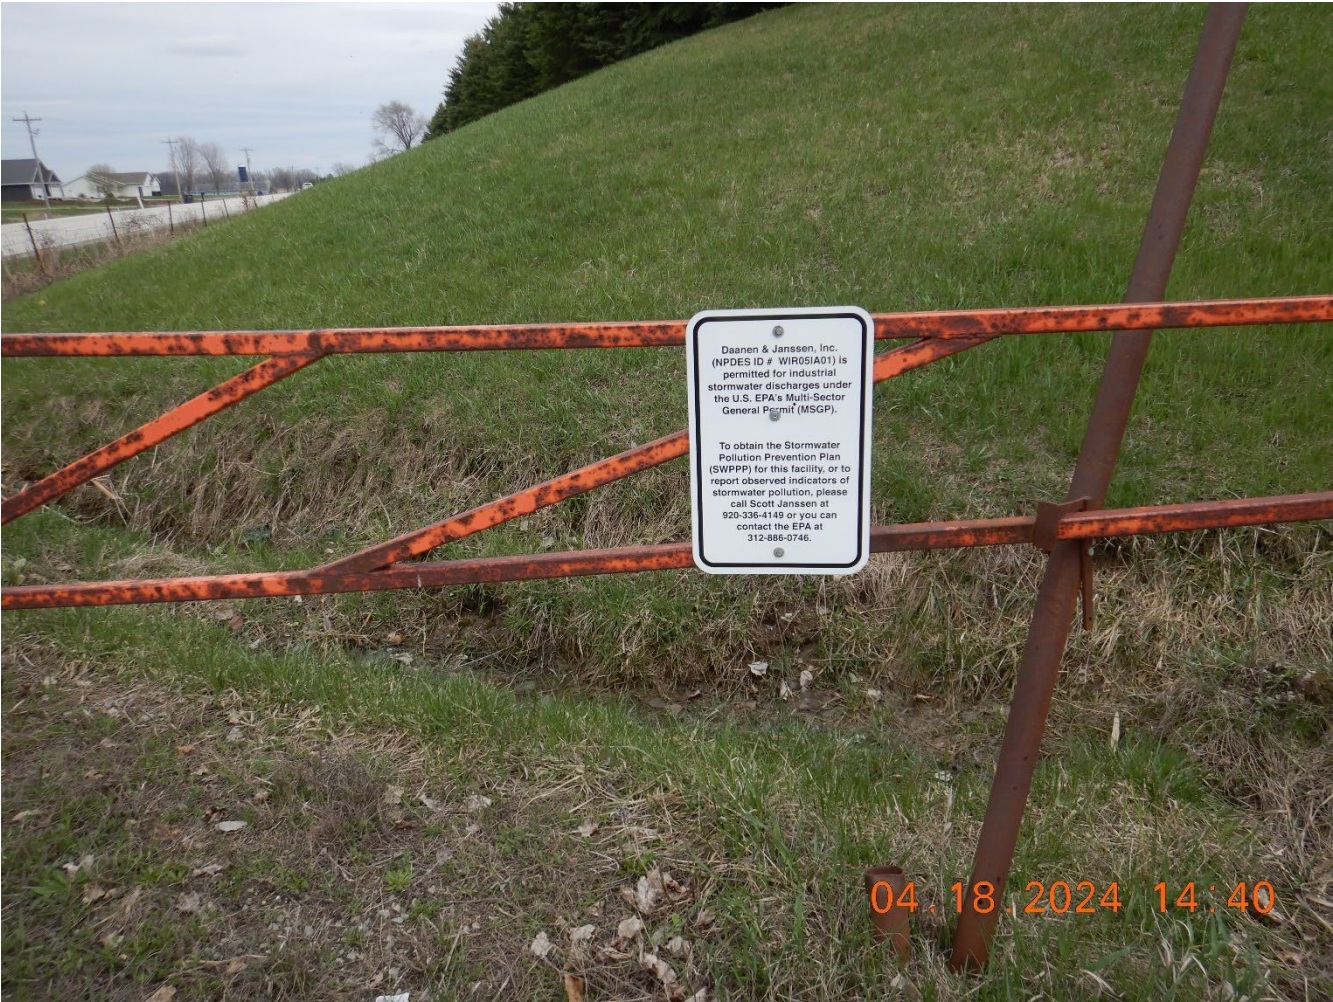
| Permit Coverage Sign (Previous Owner) | | | DSCN0699.JPG |

| <b>AOC:</b><br><br>The sign posted at site entrance is from the previous owner and had old coverage and contact information. | |

| Old stormwater permit coverage sign from previous owner posted at entrance of the quarry | | | |
