**Region 6 - Enforcement & Compliance Assurance Division**  
**INSPECTION REPORT**

| Regulatory Program(s) | NPDES CAFO | |
| Facility Name: | <b>Still Meadow Dairy (TXG920117)</b> | |
| Identification/Permit Number: | TXG920117 | |

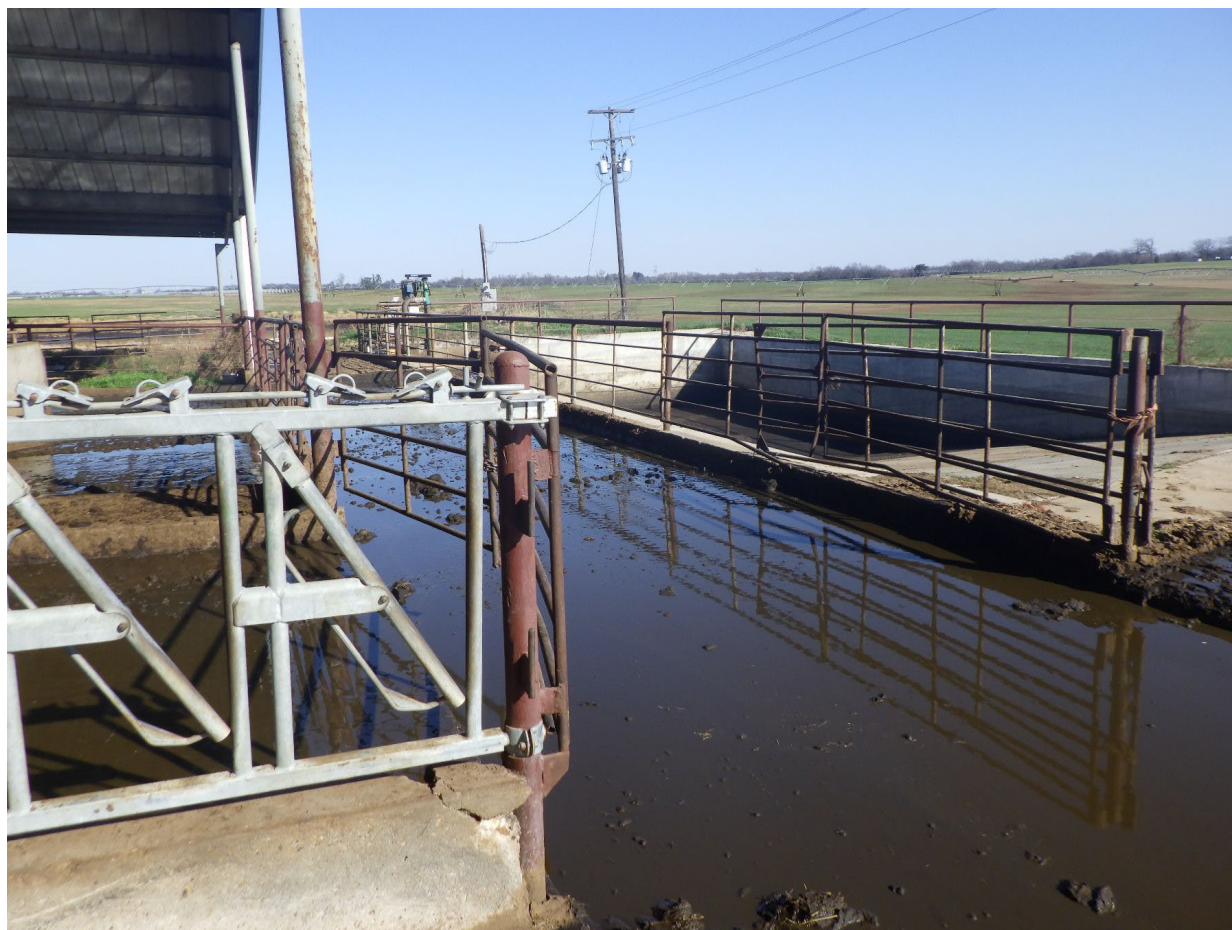
Photo No. 1

| Description: | View to the northeast. East end of the free stall lanes. Area where the flush enters the settling basin. | | |

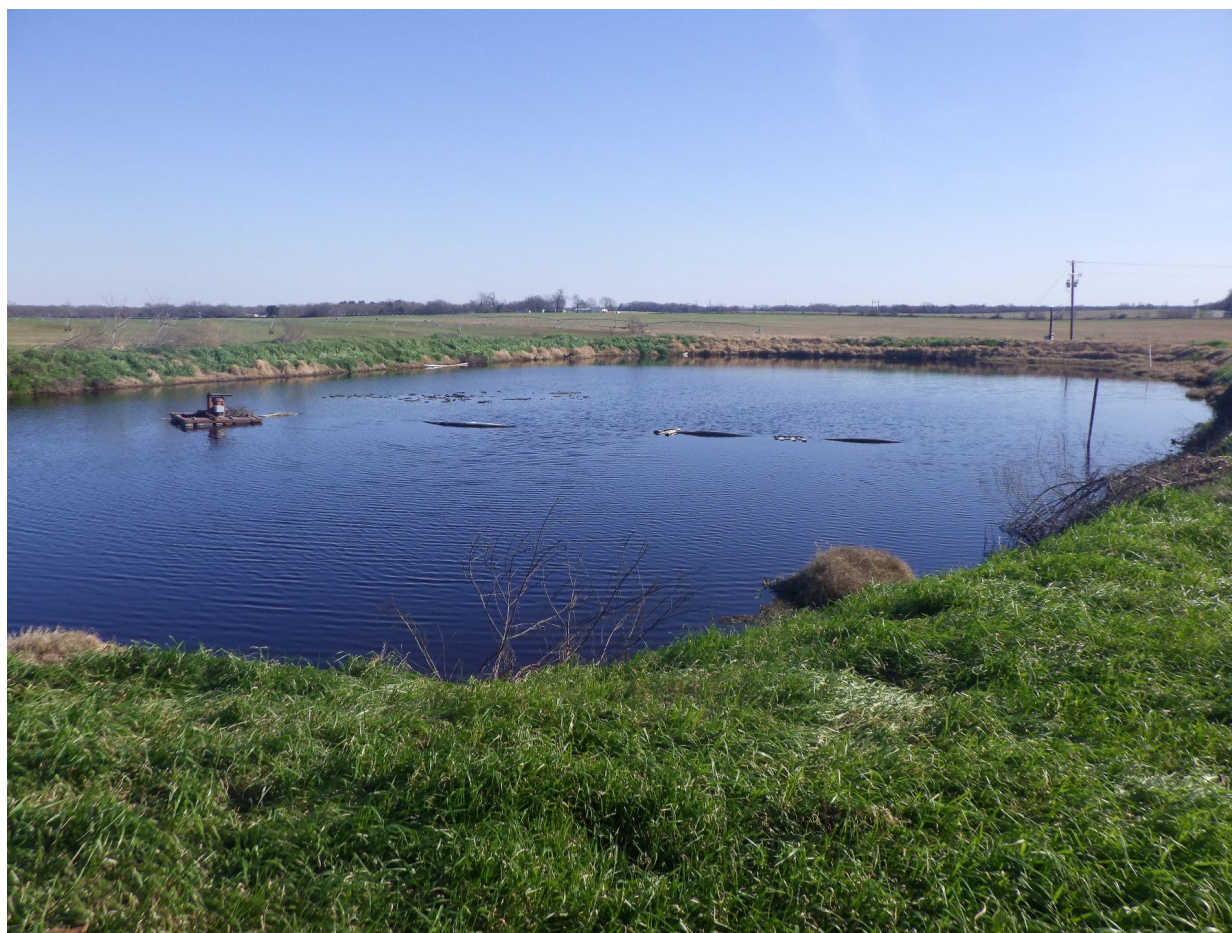
Photo No. 2

There are five wastewater lagoons located in the production area: RCS (Retention Control Structure) 1, RCS 2, RCS 3, Bain 1, and Bain 2. Bain 1 and Bain 2 are located at the dry cow facility east of the main dairy (Appendix 1, Photos 2-3). There is a concrete settling basin at the bottom of the freestalls which can pump to the RCS or directly to center pivots (Appendix 1, Photo 1). RCS 1, 2 and 3 are all in sequence with ability to pump back and forth as well as to the digester (Appendix 1, Photos 8-10). There are also concrete settling basins that separate solids and wastewater before it enters RCS 1 (Appendix 1, Photo 6). The facility has 31 LMUs (Land Management Unit): #1 - 35 acres, #2 - 45 acres, #3 - 25 acres, #4 - 85 acres, #5 - 60 acres, #6 - 135 acres, #7 - 40 acres, #8 - 35 acres, #9 - 70 acres, #10 - 35 acres, #11 - 85 acres, #12 - 45 acres, #13 - 35 acres, #14 - 50 acres, #15 - 40 acres, #16 - 40 acres, #17 - 45 acres, #18 - 325 acres, #19 - 197 acres, Hux #1 - 100 acres, Hux #2 - 40 acres, Bain #1 - 55 acres, Bain #2 - 45 acres, Bain #3 - 100 acres, Bain #4 - 100 acres, Bain #5 - 230 acres, Bain #6 - 155 acres, Wyr #1 - 35 acres, Lag #1 - 68 acres, Skid #2 - 108 acres, and Skid #3 - 53. Wastewater and manure can be applied to all LMUs using center pivots and honeywagon.

| Description: | View to the east. Bain RCS#1. | | |

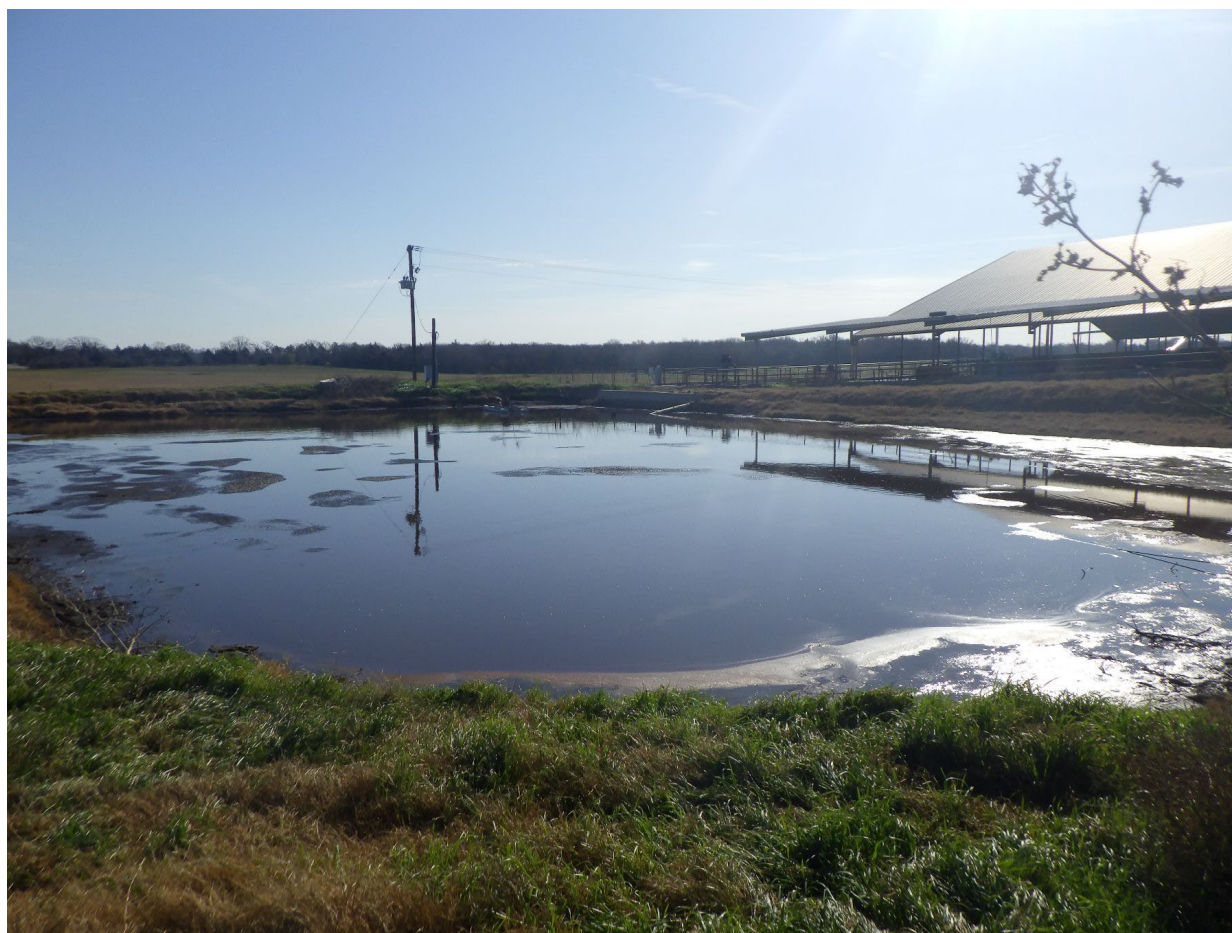
Photo No. 3

| Description: | View to the southeast. Bain RCS#2. | | |

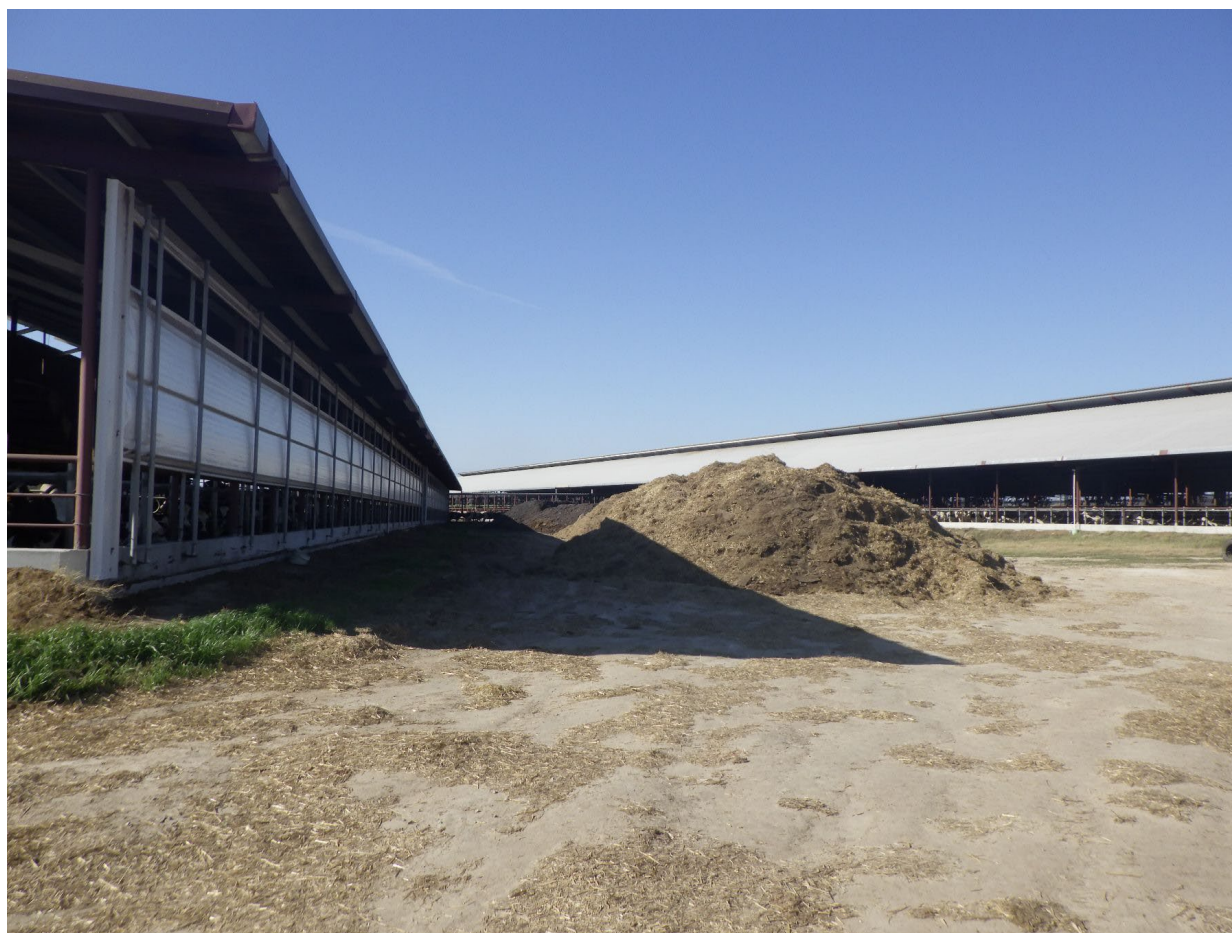
Photo No. 4

| Description: | View to the west. Bedding staging area in drainage of RCS. | | |

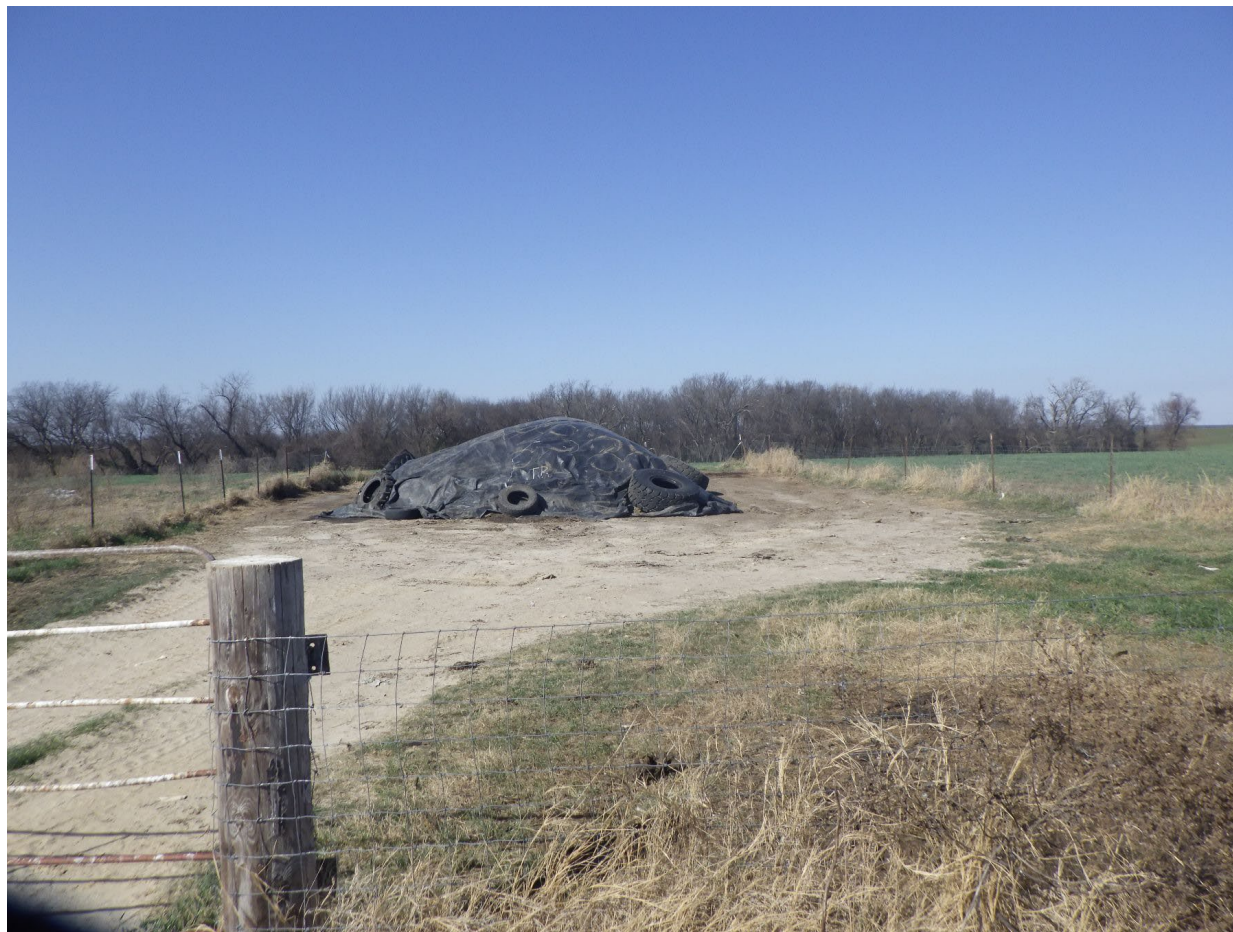
Photo No. 5

Mortalities are composted on site under covered barn. A mortality staging area exists on the north end of the facility before composting. The staging area was under tarp, and no exposed carcasses were observed (Appendix 1, Photo 5).

| Description: | View to the northwest. Mortality staging area under tarp. | | |

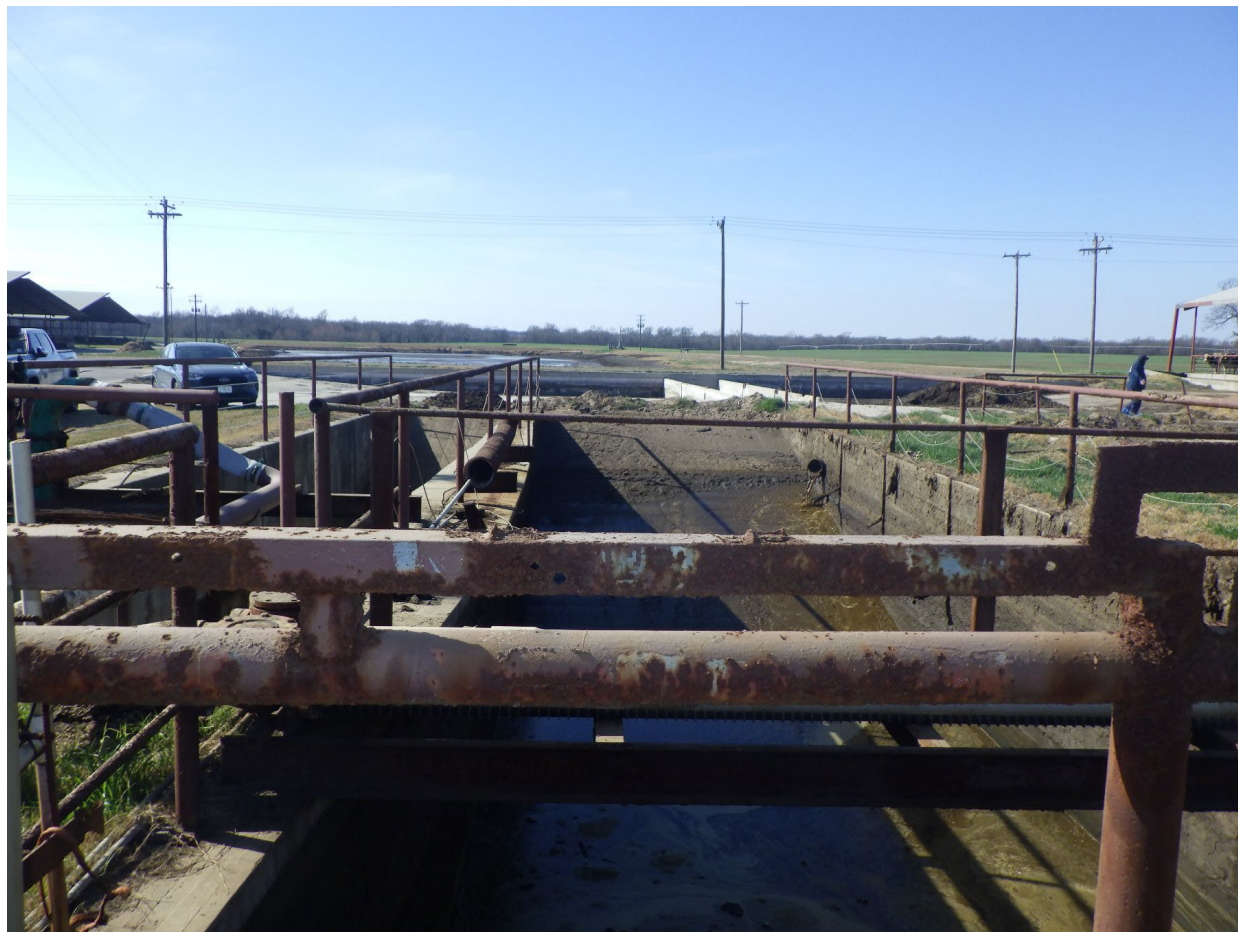
Photo No. 6

| Description: | View to the west. Settling basin for freestalls. | | |

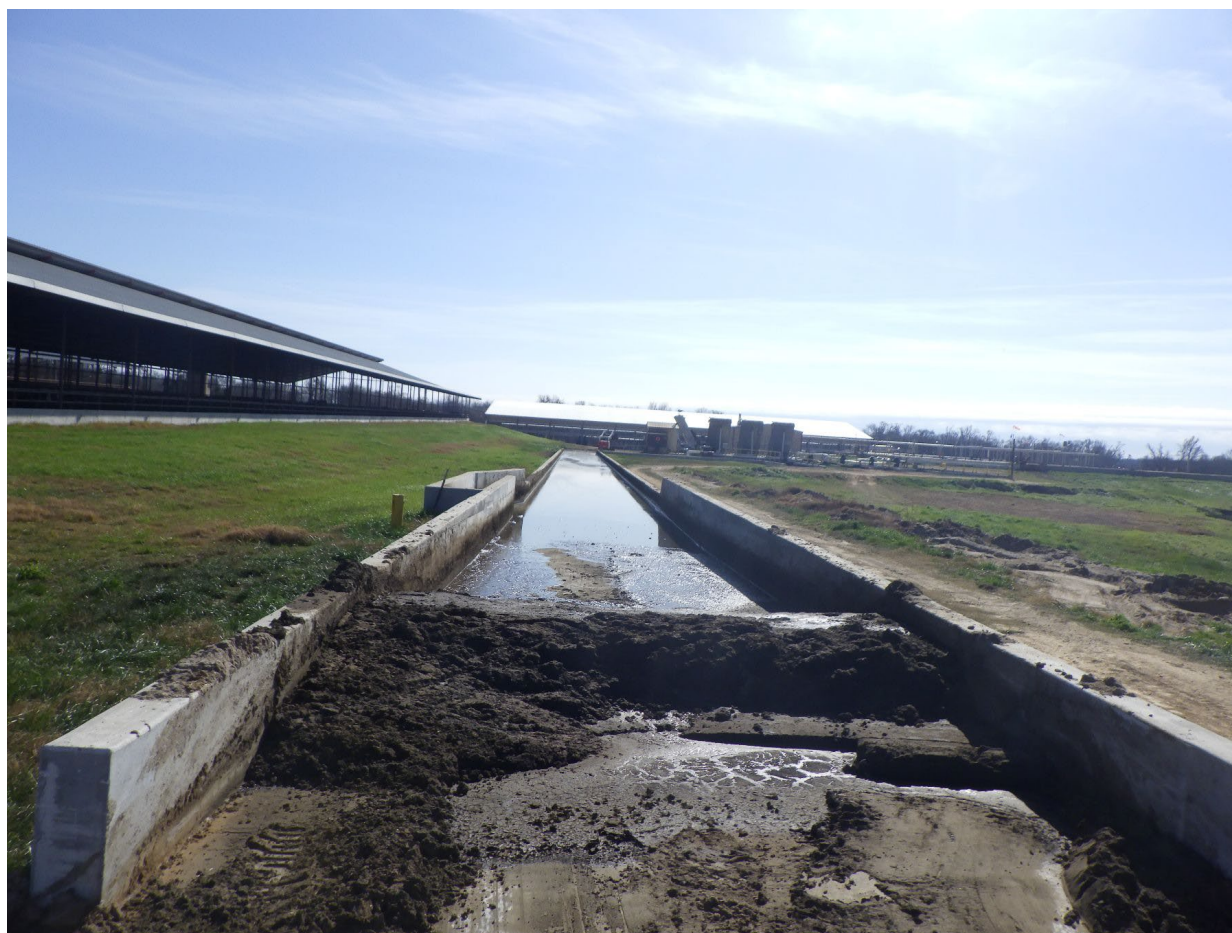
Photo No. 7

| Description: | View to the south. Thickening pit received from settling basin on route to digester. | | |

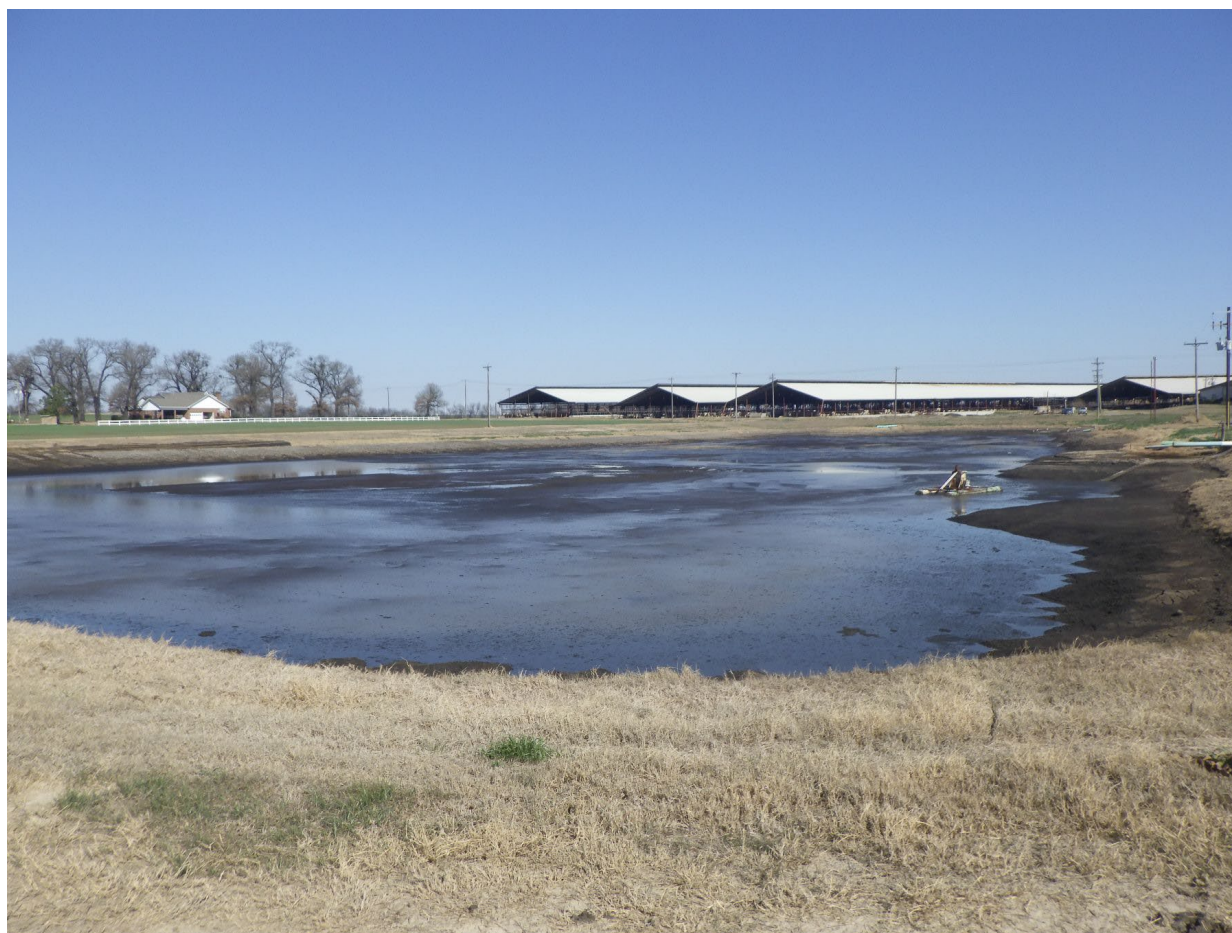
Photo No. 8

| Description: | View to the east. Lagoon 1 with freestalls in background. | | |

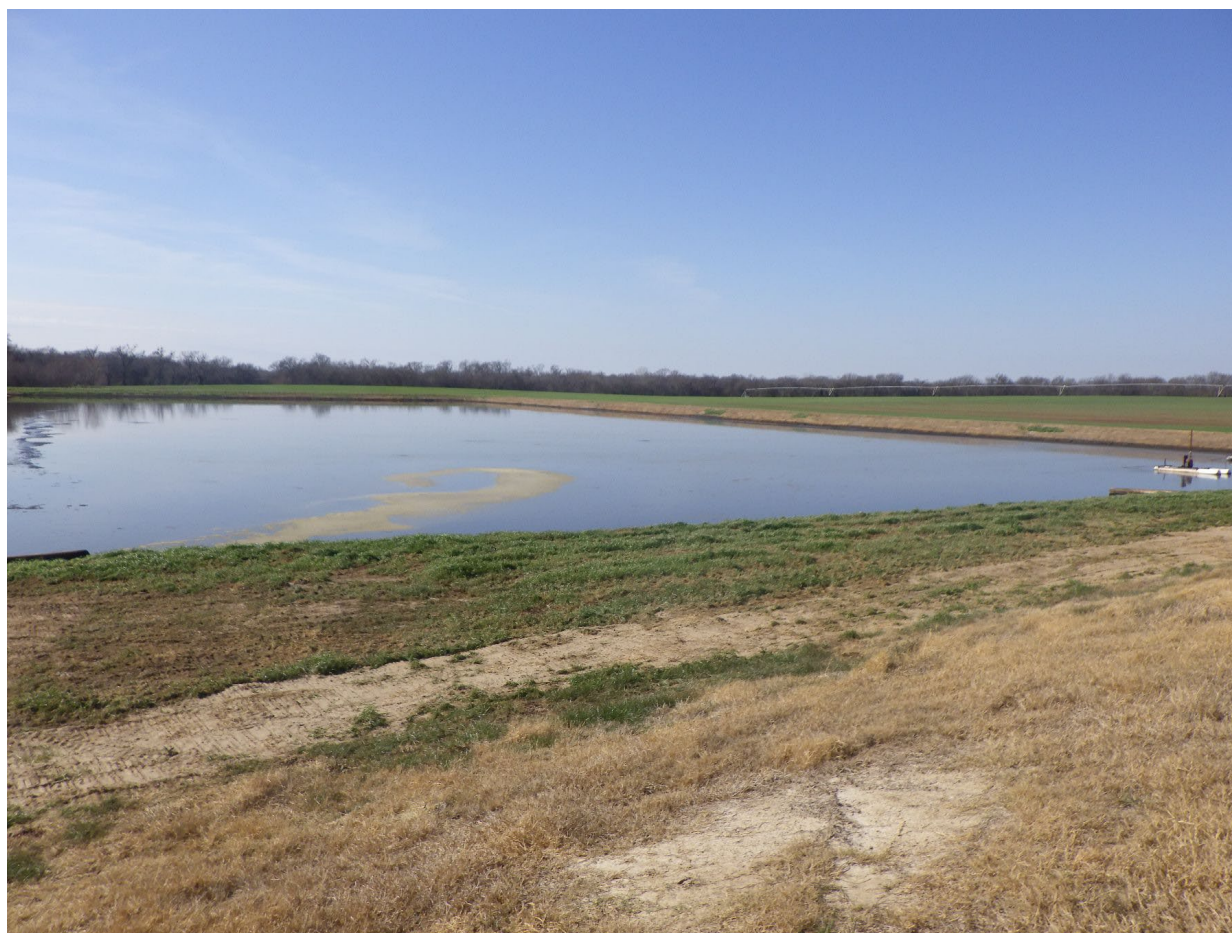
Photo No. 9

| Description: | View to the northwest. Lagoon 2. | | |

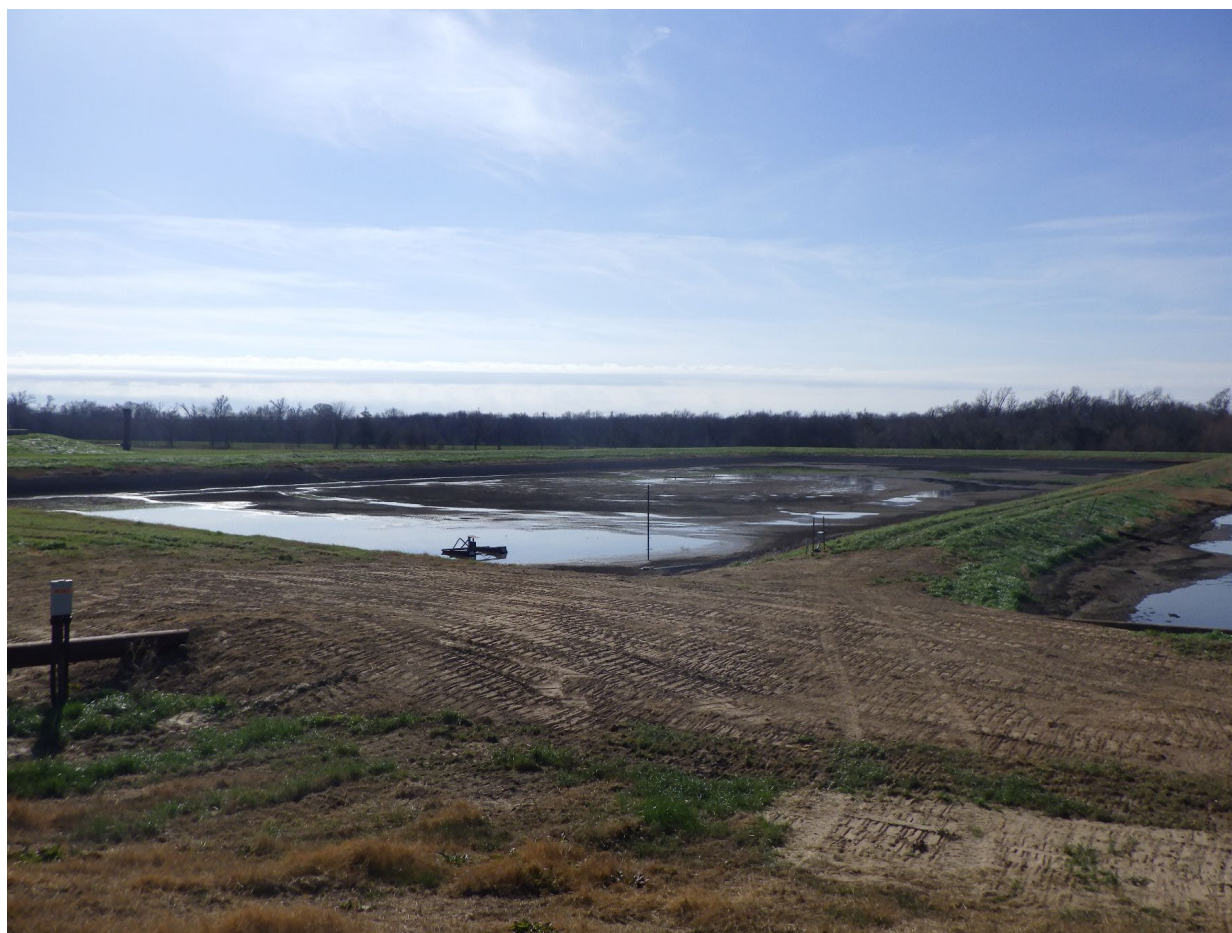
Photo No. 10

| Description: | View to the southwest. Lagoon 3. | | |
