**Purpose:** Metro East Sanitary District (MESD) – Recon Inspection Report

**Facility:** MESD's Harding Ditch Stormwater Outfalls, Centreville, Illinois

**Date of Inspection:** April 1, 2021

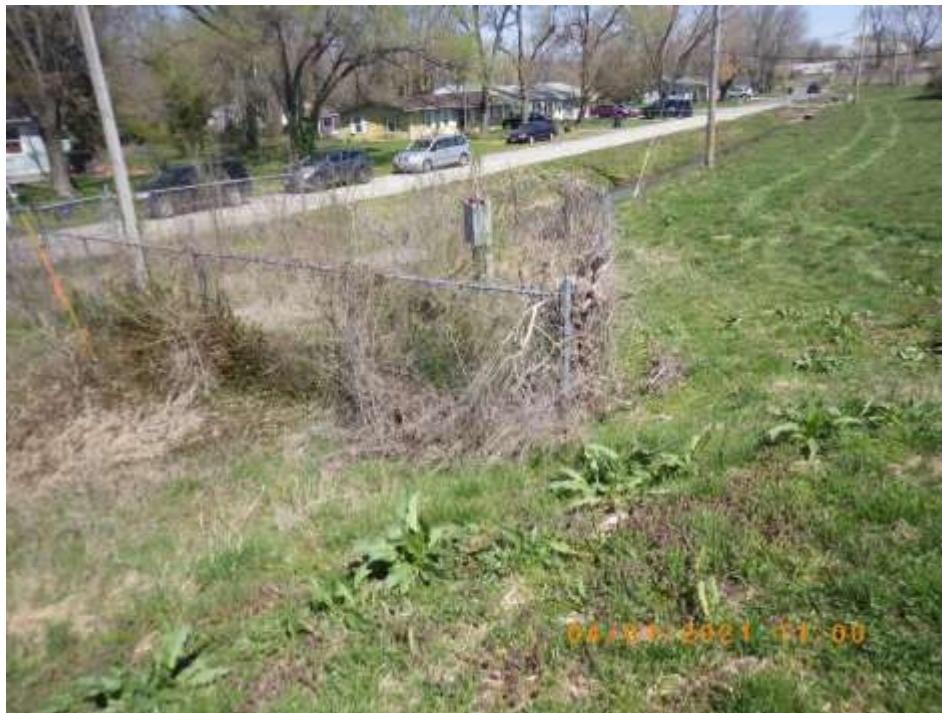
1: MESD0001

We walked to the berm along the north side of Harding Ditch and began the inspection at the stormwater outfall at Inspection Station 1 (see Attachment A for a map of the outfall inspection stations). First we observed the stormwater pump station at the end of Delano Drive. (Photograph 1; MESD0001.jpg). The pump station sends stormwater flow to an outfall to Harding Ditch (Photograph 2; MESD0002.jpg). The outfall appeared to be partially blocked by rocks and debris. The outfall was not visibly discharging but it appears that once stormwater discharges from the outfall it flows through a short gully to Harding Ditch (Photograph 3; MESD0003.jpg). At this point in the inspection, Joan Rogers and Ted Flatebo departed to attend another meeting. Mr. Hillman and I walked back to our vehicles on Delano Drive and drove along the berm on the north side of Harding Ditch to Inspection Station #2.

Description: stormwater pump station.

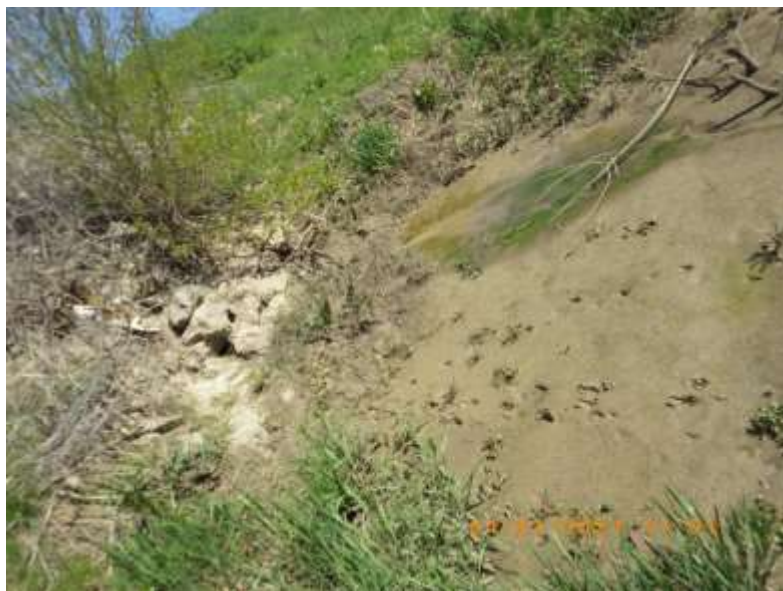
2: MESD0002

Description: outfall to Harding Ditch. The outfall appeared to be partially blocked by rocks and debris.

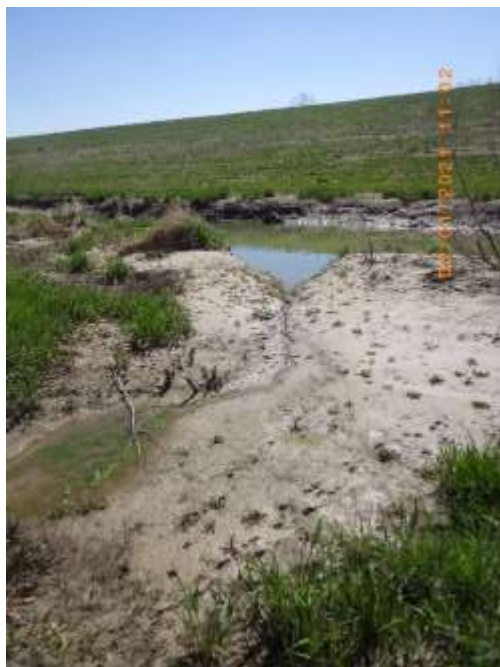
3: MESD0003

Description: short gully from outfall to Harding Creek.

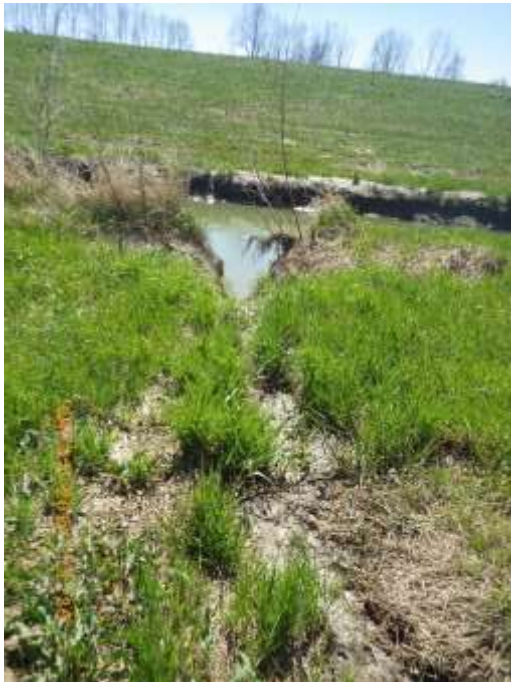
4: MESD0004

The outfall at this location discharges to a short gully to Harding Ditch (Photograph 4; MESD0004.jpg). The outfall itself appeared to be damaged and was not discharging (Photograph 5; MESD0005.jpg). The outfall pipe runs under the berm (Photograph 6; MESD0006.jpg) and conveys stormwater from a ditch and field north of the berm.

Description: outfall discharges to a short gully to Harding Ditch.

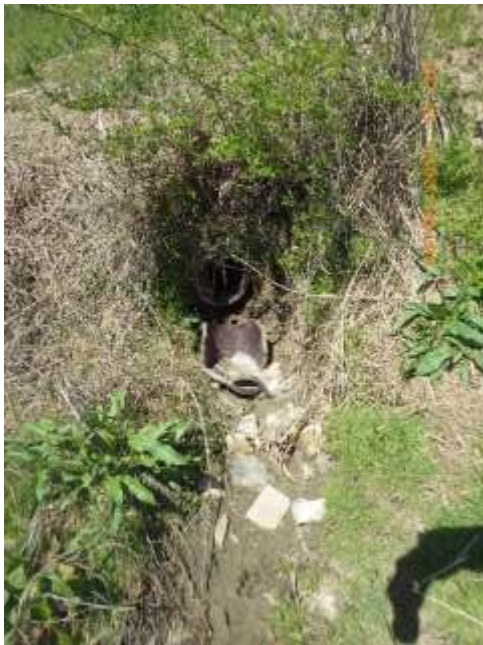
5: MESD0005

Description: outfall appeared to be damaged and was not flowing.

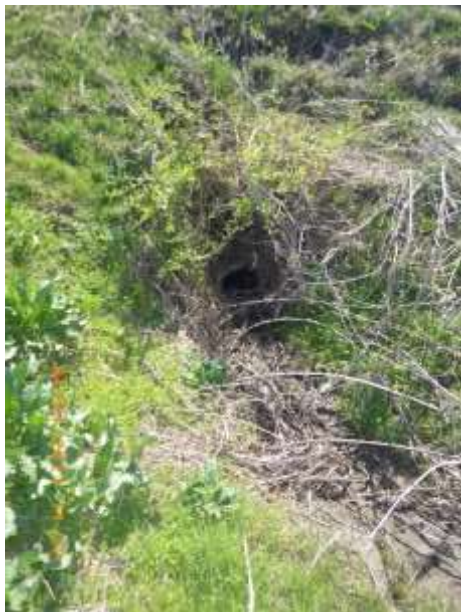
6: MESD0006

Description: outfall pipe inlet under the berm. Conveys stormwater from a ditch and field north of the berm to Harding Ditch.

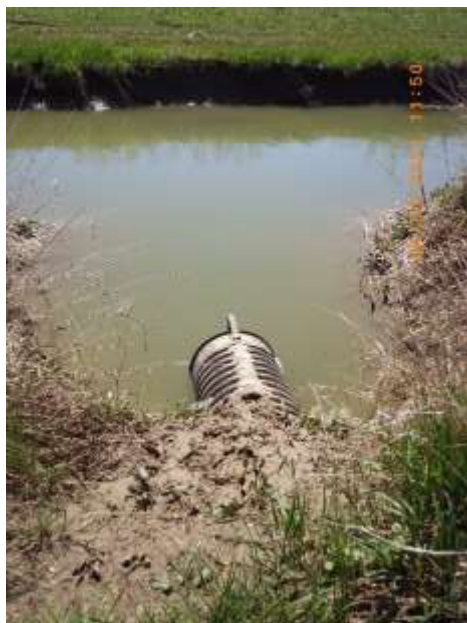
7: MESD0007

We continued along the berm to Inspection Station #3. The outfall at this station discharges directly to Harding Ditch and was partially submerged. The outfall pipe runs under the berm (Photograph 7; MESD0007.jpg) and conveys stormwater from a ditch north of the berm (Photograph 8; MESD0008.jpg). I observed flowing water in the ditch.

Description: The outfall at this station discharges directly to Harding Ditch and was partially submerged.

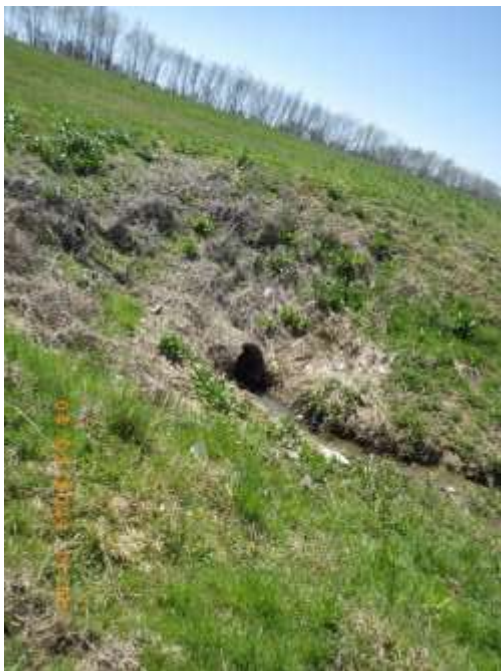
8: MESD0008

Description: outfall pipe inlet under the berm. Conveys stormwater from a ditch north of the berm to Harding Ditch.

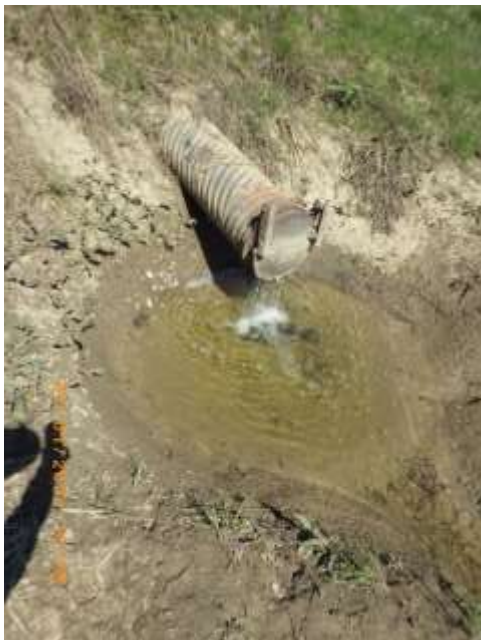
9: MESD0009

At Inspection Station #4, a corrugated metal outfall was discharging (Photograph 9; MESD0009.jpg) to a short gully to Harding Ditch (Photograph 10; MESD0010.jpg). The outfall pipe runs under the berm and conveys stormwater from a ditch north of the berm (Photograph 11; MESD0011.jpg). The corrugated pipe inlet appeared damaged and partially buried in sediment.

Description: corrugated metal outfall. Discharging to a short ditch to Harding Ditch.

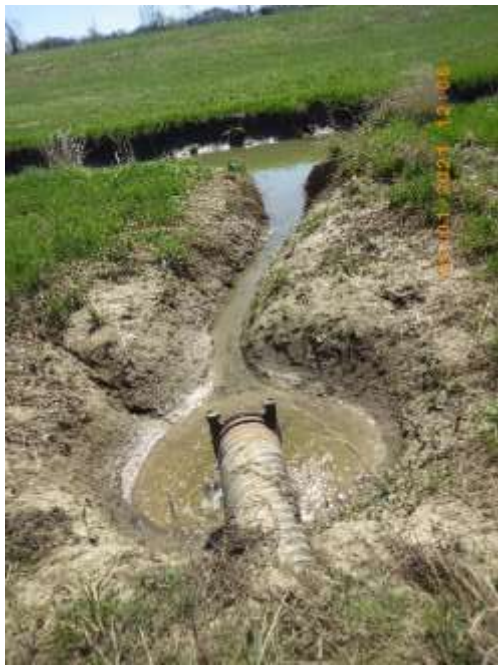
10: MESD0010

Description: Outfall discharging to a short ditch to Harding Ditch.

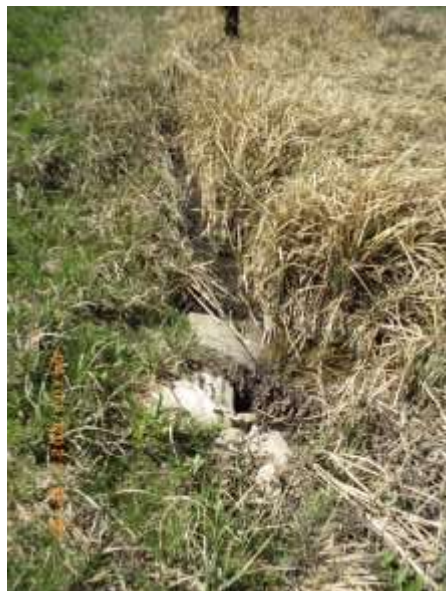
11: MESD0011

Description: inlet to outfall pipe running under the berm, conveying stormwater from a ditch north of the berm. The inlet appeared damaged and partially buried in sediment.

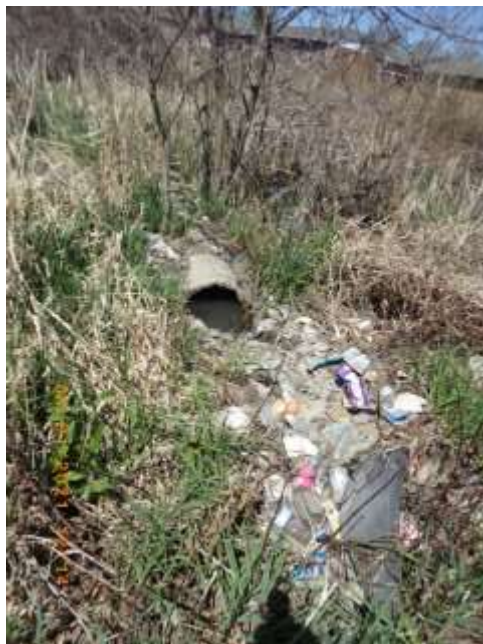
12: MESD0012

We continued to Inspection Station #5. An outfall was observed in a ditch along the base of the north side of berm and appeared to be coming from the upland area towards Camp Jackson Road (Photograph 12; MESD0012.jpg). The outfall was not discharging and I noted heavy litter and debris in the ditch. No outfall was observed on the south side of the berm along Harding Ditch at this inspection station.

Description: outfall observed in a ditch along the base of the north side of berm and appeared to be coming from the upland area towards Camp Jackson Road. Note heavy litter and debris.

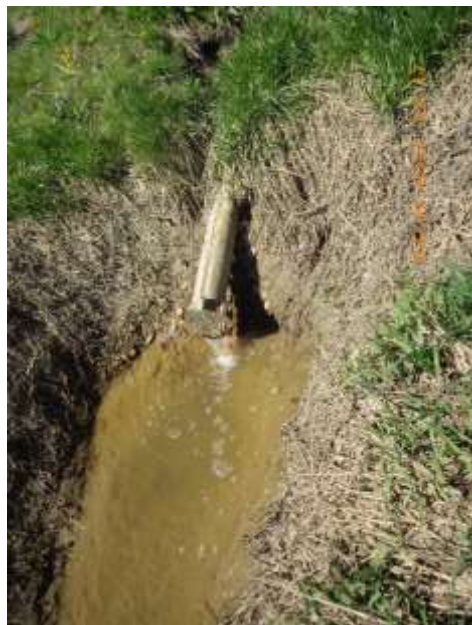
13: MESD0013

We continued along the berm to Inspection Station #6. An outfall was observed at this station and was discharging to a short ditch to Harding Ditch (Photograph 13; MESD0013.jpg). Mr. Hillman noted a sewage smell near the area of the discharge. I also noted the odor. The last section of the outfall pipe was separated from the pipe heading under the berm (Photograph 14; MESD0014.jpg). The outfall pipe runs under the berm and neither the other end of the pipe or an inlet was visible on the north side of the berm.

Description: outfall observed discharging at this station to a short ditch to Harding Ditch.

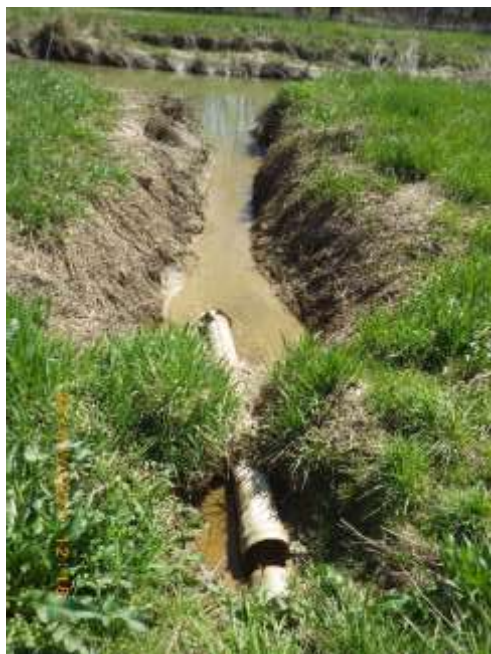
14: MESD0014

Description: outfall pipe was separated from the pipe heading under the berm.

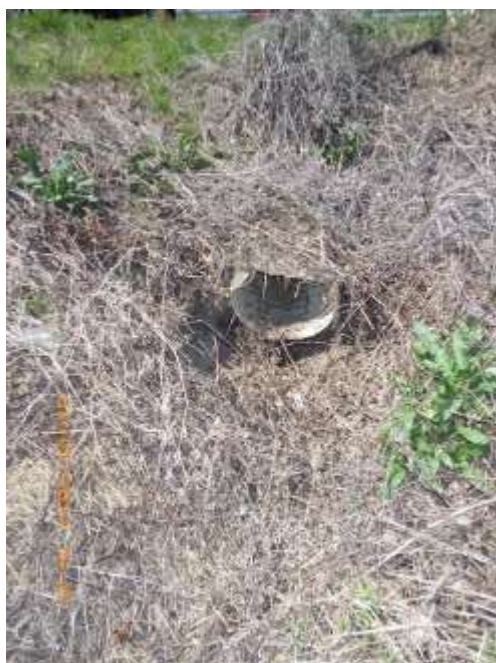
15: MESD0015

We continued along the berm to Inspection Station #7. In this area there is no drop off in elevation on the north side of the berm. I observed an outfall along the south side (Harding Ditch side) of the berm and it was not discharging (Photograph 15; MESD0015.jpg). The outfall pipe runs under the berm and neither the other end of the pipe or an inlet was visible on the north side of the berm.

Description: outfall along the south side (Harding Ditch side) of the berm.

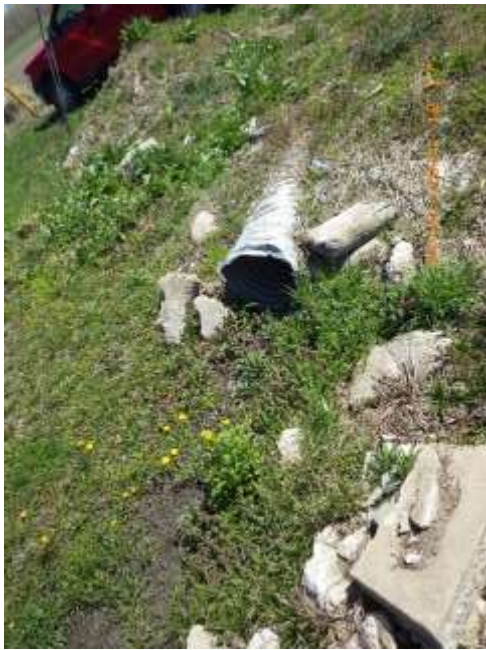
16: MESD0016

Description: inlet of metal pipe heading under the berm and to the outfall on Harding Ditch.

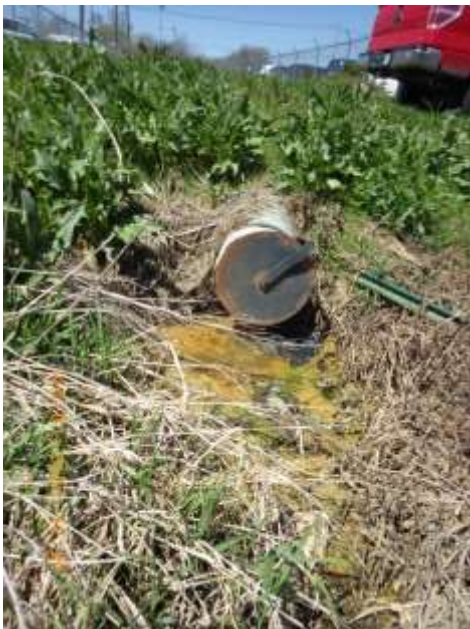
17: MESD0017

We continued to along the berm to the last station, Inspection Station #8. Similar to Inspection Station #7, there is only a small drop off in elevation on the north side of the berm. I observed a ditch between the two facilities and Camp Jackson Road to the north, and the inlet of a metal pipe (Photograph 16; MESD0016.jpg) that leads under the berm to the outfall on the south side (Harding Ditch side) of the berm. The outfall was not visibly discharging but a small pool of rust-colored water was observed under the outfall (Photograph 17; MESD0017.jpg). The outfall discharges to a short ditch that flows into Harding Ditch.

Description: outfall to Harding Ditch not visibly discharging but a small pool of rust-colored water was observed under the outfall.
