**Region 6 - Enforcement & Compliance Assurance Division**  
**INSPECTION REPORT**

| Inspection Date(s): | 04/15/2025 | |
| Company Name: | <b>Enerco Operating Corporation</b> | |
| Facility Name: | <b>Clark Tank Battery</b> | |

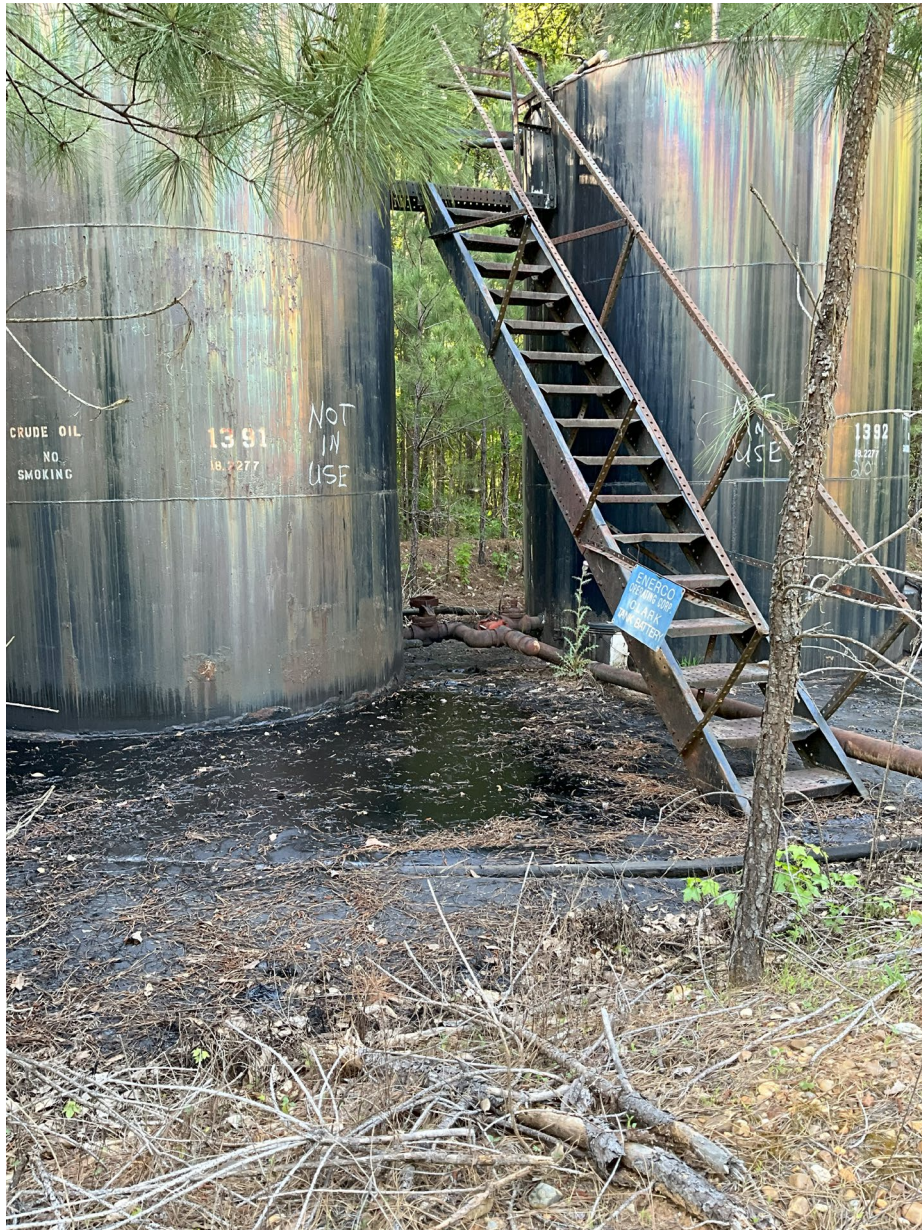
I observed woody vegetation on the secondary containment berm, see Photo No. 1 and No. 2. I observed loose oil inside secondary containment, see Photo No. 3. I also observed two (2) tanks labeled “not in use” but did not include the date that they were no longer in use, see Photo No. 3. The third tank at the facility was missing both a “not in use” label and a date, see Photo No. 2.

**Description:** Looking north, this photo shows the sign at the facility and loose oil inside secondary containment.

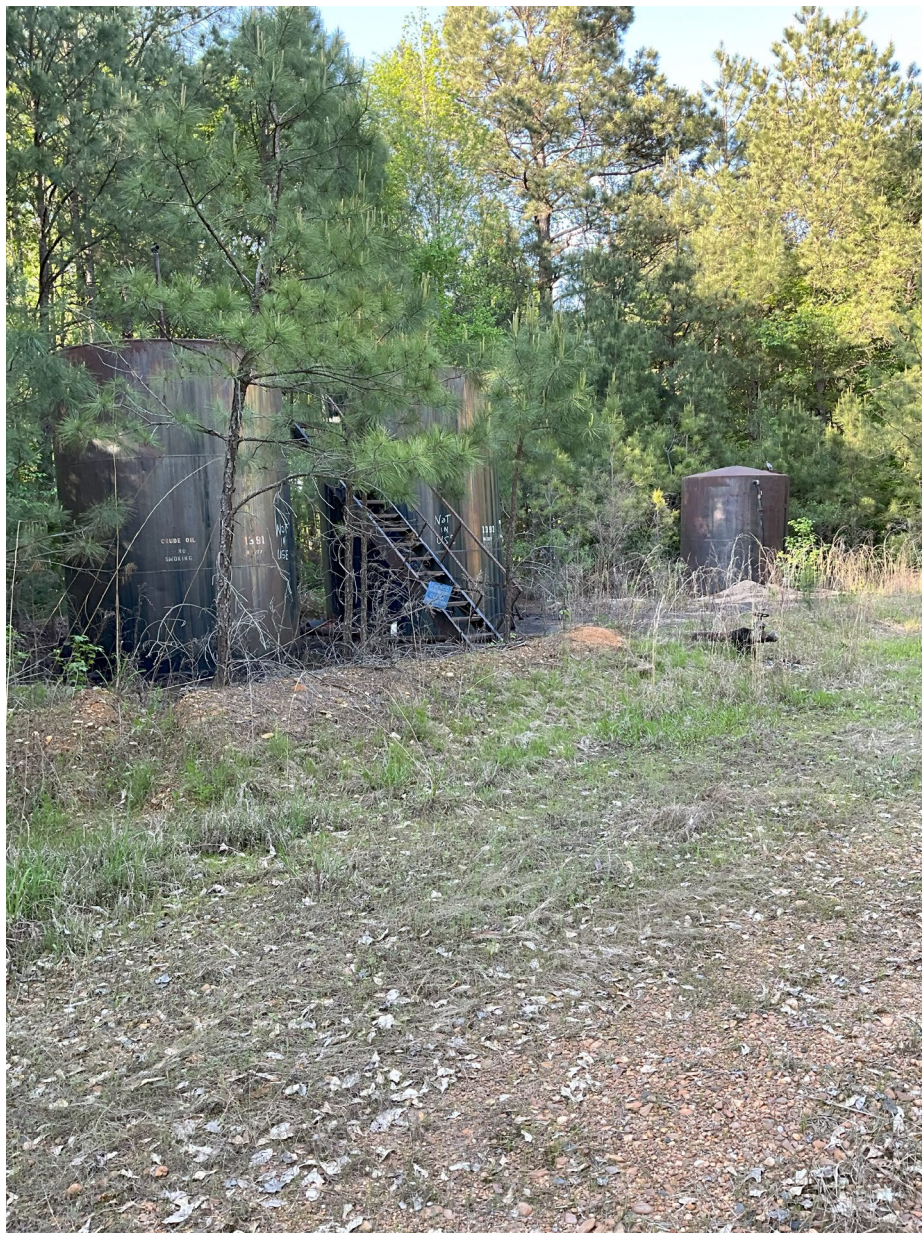
Photo No. 2

**Description:** Looking north, this photo shows an overview of the facility, with woody vegetation on the secondary containment berm. The tank on the far right of the photo is missing a "not in use" label and date.

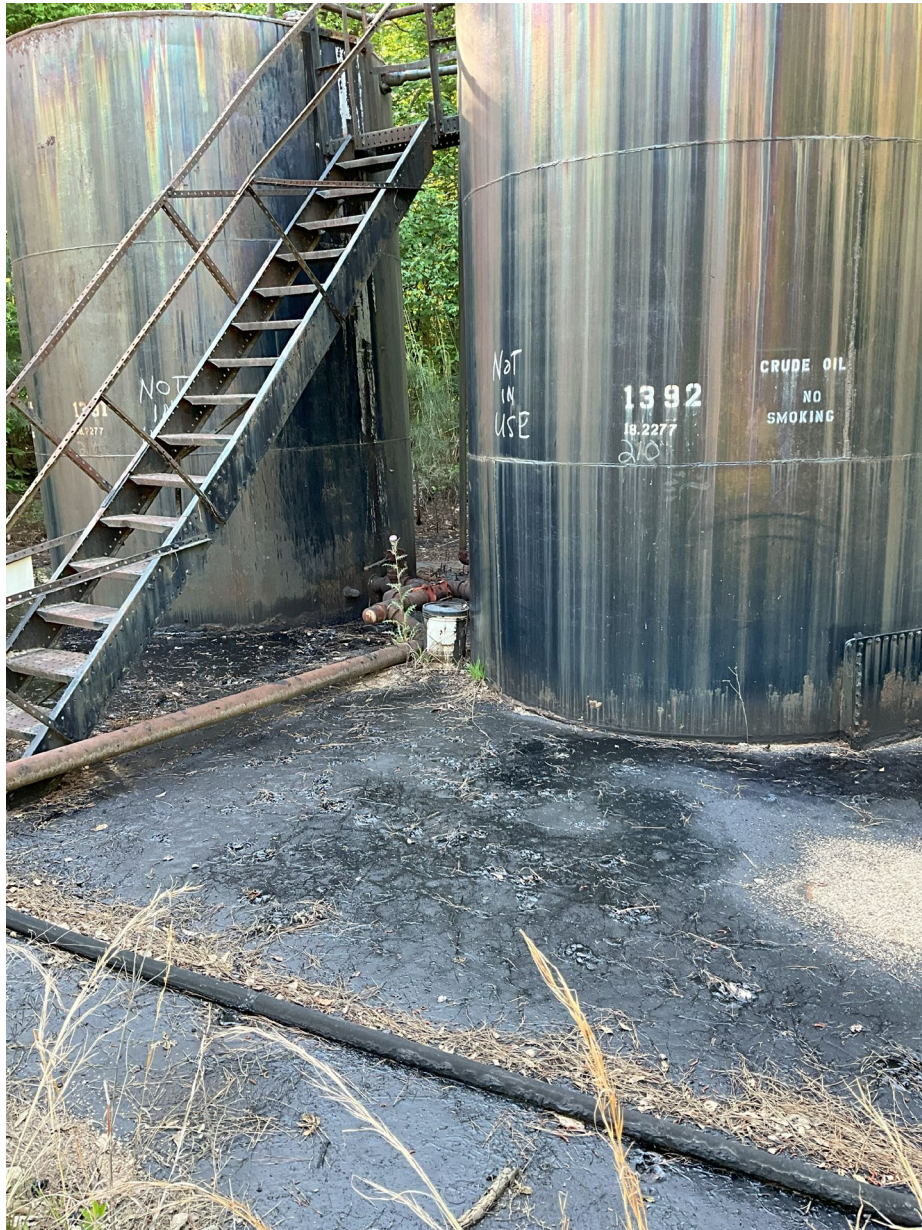
Photo No. 3

The “not-in-use” tanks are subject to the SPCC rule unless the facility meets the requirements for a permanently closed tank. According to §112.2, a container or facility is permanently closed if “(1) all liquid and sludge has been removed from each container and connecting line; and (2) all connecting lines and piping have been disconnected from the container and blanked off, all valves (except ventilation valves) have been closed and locked, and conspicuous signs have been posted on each container stating that it is a permanently closed container and noting the date of closure.”

**Description:** Looking northwest, this photo shows loose oil inside secondary containment. The two (2) tanks marked "not in use" are missing dates and proper close out of tanks according to §112.2.
