### REGION 3

**Report Title:** Clean Water Act, Section 404 Inspection Report for Terrace at Maplewood  
**Inspection Date(s):** 05/23/2025  
**Start Time:** 10:30 **End Time:** 12:45  
**Regulatory Program(s):** Inspections authorized pursuant to Clean Water Act, Sections 308 and 404 (33 U.S.C. §§ 1318 and 1344)  
**Site Name:** Terrace at Maplewood  
**Site Location:** Elmwood Drive  
Harrisburg, PA 17110  
**Latitude:** 40.3237 **Longitude:** -76.8505  
**County/Parish:** Dauphin County  
**Site Owner(s):** Terraces at Maplewood LLC  
**Mailing Address:** 1454 Baltimore St, Suite A  
Hanover, PA 17331  
**DSB-ID #:** ECAD-5477  
**Site Contact(s):** Philip Kauffman - Burkentine and Sons Builders, Inc.  
Phone: 717-633-5163 Email: pkauffman@burkentine.com

**Terraces at Maplewood  
Harrisburg, PA**

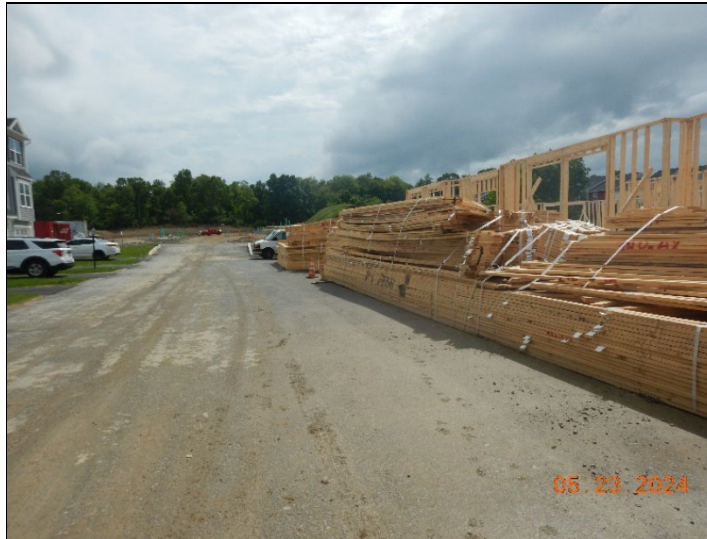
Terrace at Maplewood  
Date: 23 May 2024  
Photo ID: DSCN5367.JPG  
Photo taken by: Katelyn Almeter

Notes: East facing view of construction material staged on the site.

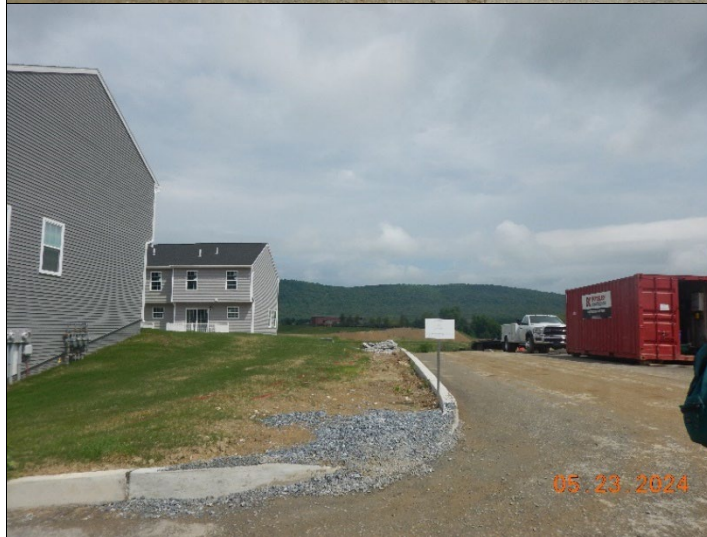
Terrace at Maplewood  
Date: 23 May 2024  
Photo ID: DSCN5368.JPG  
Photo taken by: Katelyn Almeter

Notes: North facing view along Hawthorne Dr.

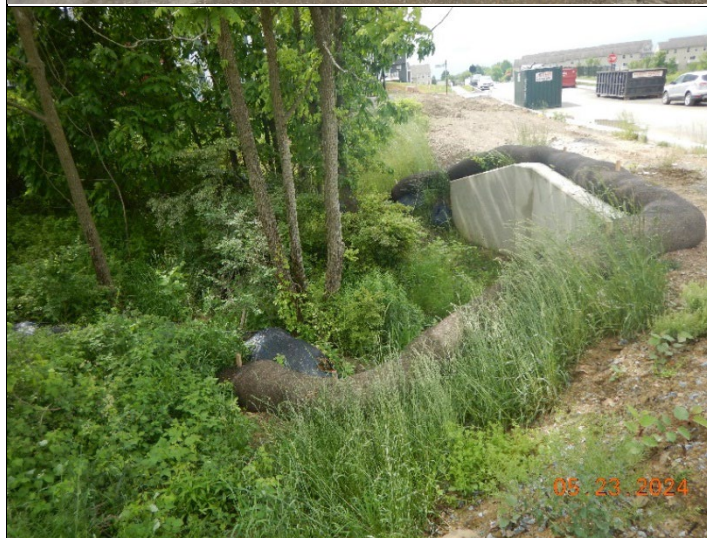
Terrace at Maplewood  
Date: 23 May 2024  
Photo ID: DSCN5369.JPG  
Photo taken by: Katelyn Almeter

Following opening conference, the inspection began at the northern end of the Site on Elmwood Drive near Hickorywood Lane. The inspectors observed a culvert under Elmwood Drive that had concentrated water flowing into it at the time of the inspection (DSCN5369 and DSCN5370). The slopes of the drainage area upstream of the culvert were densely vegetated and silt socks were present on each of the slopes (DSCN5371). Garbage was noted near the entrance of the culvert (DSCN5372 to DSCN5374). The inspectors observed that no water was flowing out of the culvert and the area immediately downstream of the culvert contained sediment and was sparsely vegetated (DSCN5375 and DSCN5376). Following the drainage path downstream, areas more densely vegetated with herbaceous vegetation followed by areas with woody vegetation were observed (DSCN5377 and DSCN5379). Surface hydrology was observed again in this location.

Notes: View of silt sock along a culvert and slope of drainage way flowing under Hawthorne Dr.

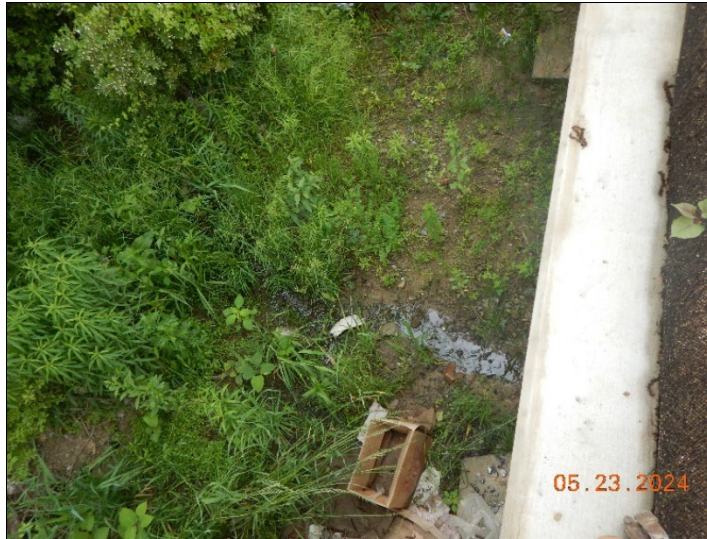
Terrace at Maplewood  
Date: 23 May 2024  
Photo ID: DSCN5370.JPG  
Photo taken by: Katelyn Almeter

Notes: View of water flowing into culvert.  
Note garbage present at the foot of the culvert.

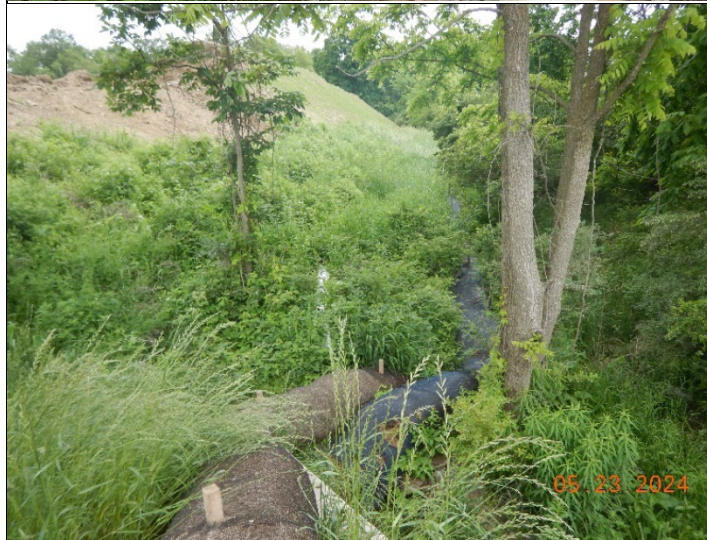
Terrace at Maplewood  
Date: 23 May 2024  
Photo ID: DSCN5371.JPG  
Photo taken by: Katelyn Almeter

Notes: View facing northeast of a silt sock  
placed at the toe of the slope leading to a  
drainage way.

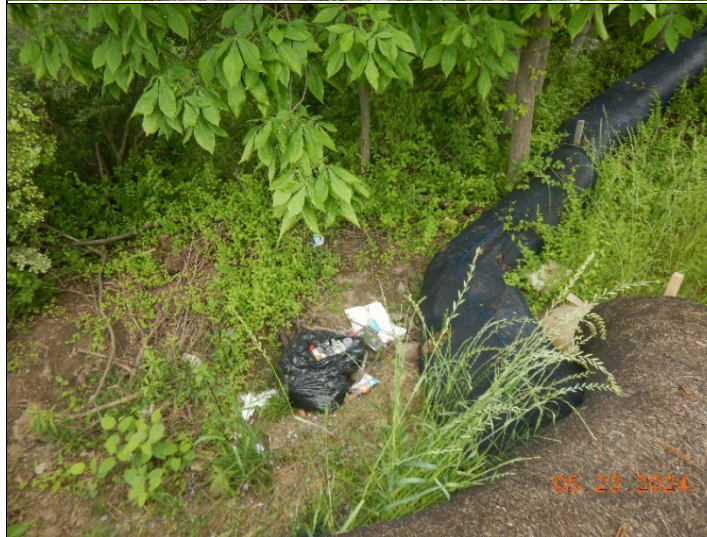
Terrace at Maplewood  
Date: 23 May 2024  
Photo ID: DSCN5372.JPG  
Photo taken by: Katelyn Almeter

Notes: Garbage on the downgradient side  
of the silt sock.

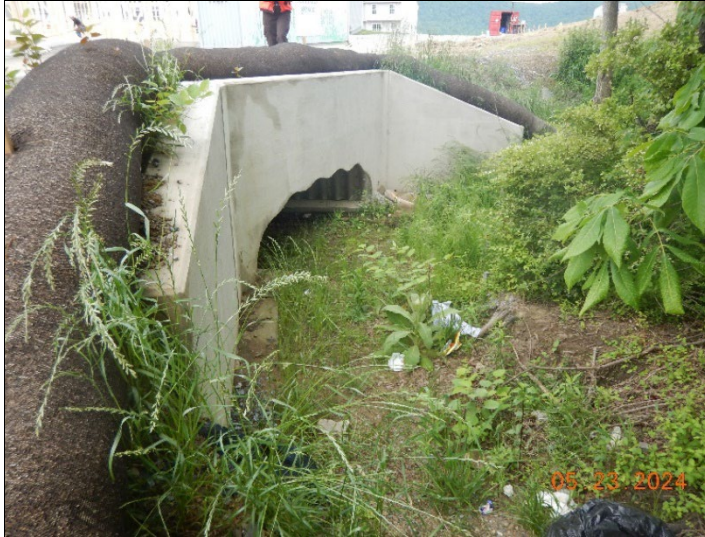
Terrace at Maplewood  
Date: 23 May 2024  
Photo ID: DSCN5373.JPG  
Photo taken by: Katelyn Almeter

Notes: View on upgradient side of culvert. Note the presence of garbage within the vegetation.

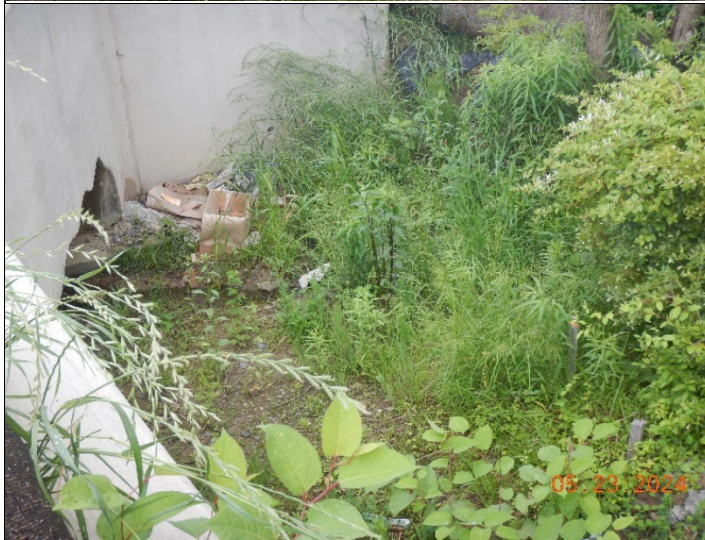
Terrace at Maplewood  
Date: 23 May 2024  
Photo ID: DSCN5374.JPG  
Photo taken by: Katelyn Almeter

Notes: Another view of the upgradient side of the culvert.

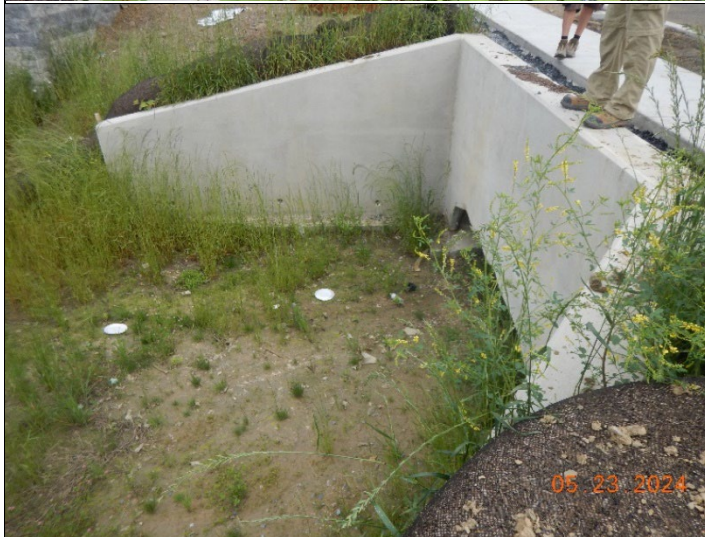
Terrace at Maplewood  
Date: 23 May 2024  
Photo ID: DSCN5375.JPG  
Photo taken by: Katelyn Almeter

Notes: View of the downgradient side of the culvert.

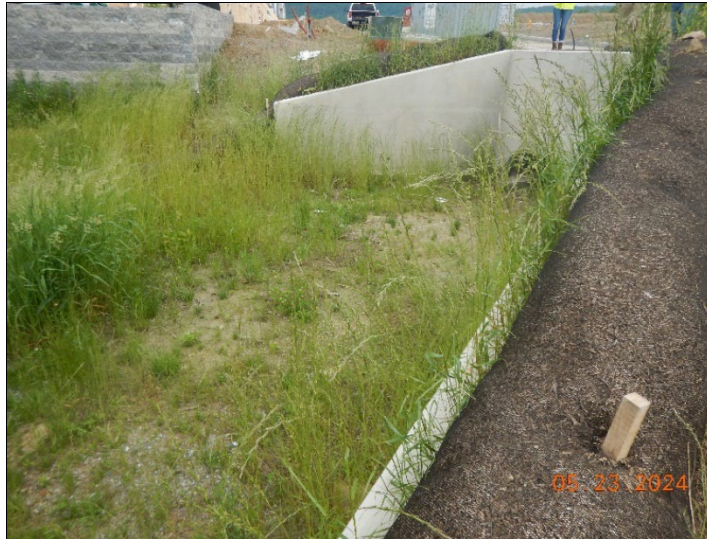
Terrace at Maplewood  
Date: 23 May 2024  
Photo ID: DSCN5376.JPG  
Photo taken by: Katelyn Almeter

Notes: View facing north of the downgradient side of the culvert.

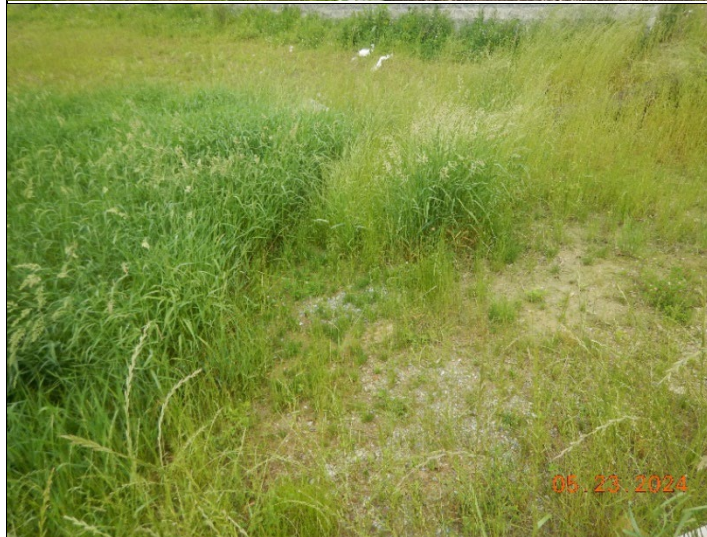
Terrace at Maplewood  
Date: 23 May 2024  
Photo ID: DSCN5377.JPG  
Photo taken by: Katelyn Almeter

Notes: View of vegetation present on the downgradient side of the culvert.

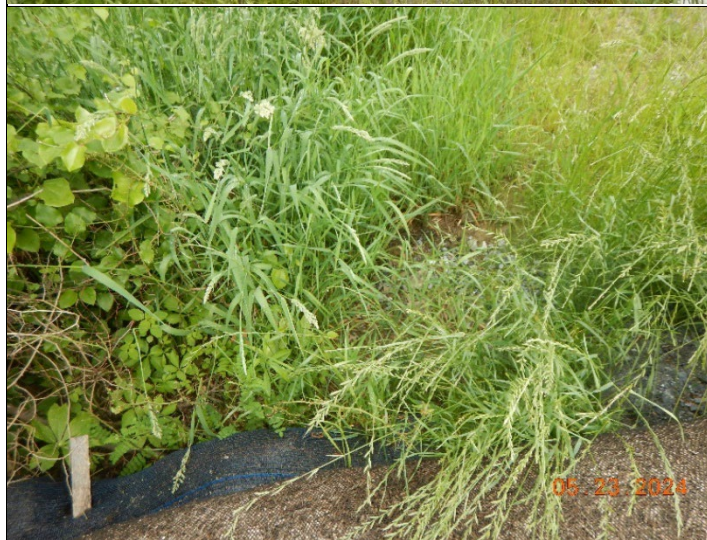
Terrace at Maplewood  
Date: 23 May 2024  
Photo ID: DSCN5378.JPG  
Photo taken by: Katelyn Almeter

Notes: Silt sock and vegetation present in the downgradient area west of the culvert.

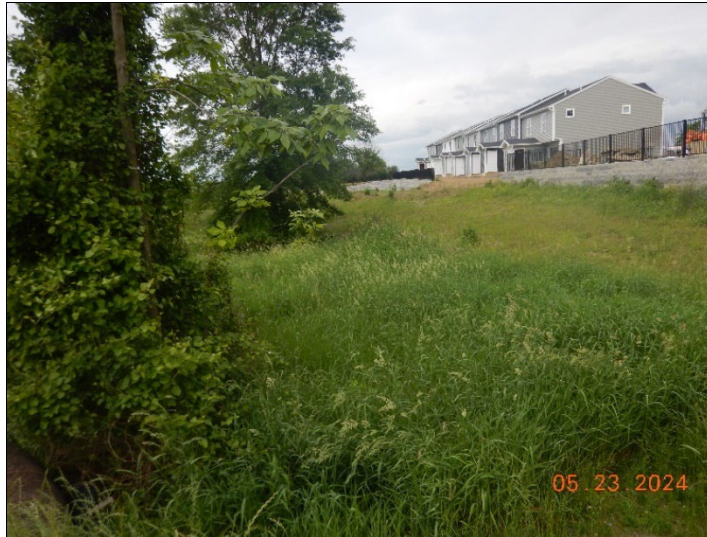
Terrace at Maplewood  
Date: 23 May 2024  
Photo ID: DSCN5379.JPG  
Photo taken by: Katelyn Almeter

Notes: West facing view of construction area to the north of vegetated area.

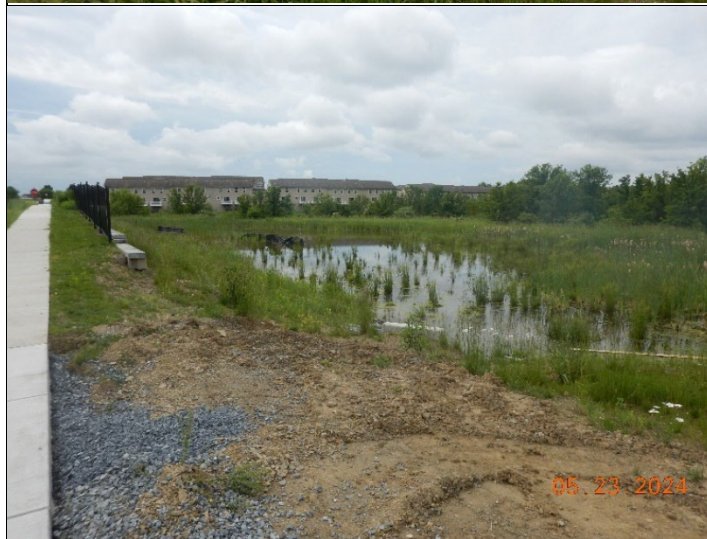
Terrace at Maplewood  
Date: 23 May 2024  
Photo ID: DSCN5380.JPG  
Photo taken by: Katelyn Almeter

The inspection continued south on Elmwood Drive. A stormwater retention pond was observed to the west of Elmwood Drive that appears to be capturing runoff from the road (DSCN5380 to DSCN5382). A silt fence and cattails (*Typha latifolia*) were observed in the stormwater retention pond. Continuing south on Elmwood Drive, the inspectors observed a low-lying, linear wetland area between two rows of townhouses (DSCN5383 and DSCN5385). Surface water was observed and the area was densely vegetated with herbaceous vegetation (DSCN5384).

Notes: View facing south of stormwater retention pond.

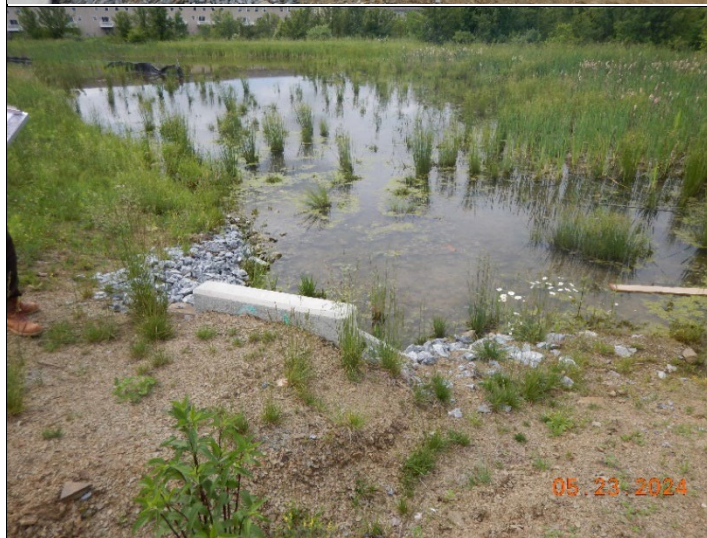
Terrace at Maplewood  
Date: 23 May 2024  
Photo ID: DSCN5381.JPG  
Photo taken by: Katelyn Almeter

Notes: Outfall to the stormwater retention pond.

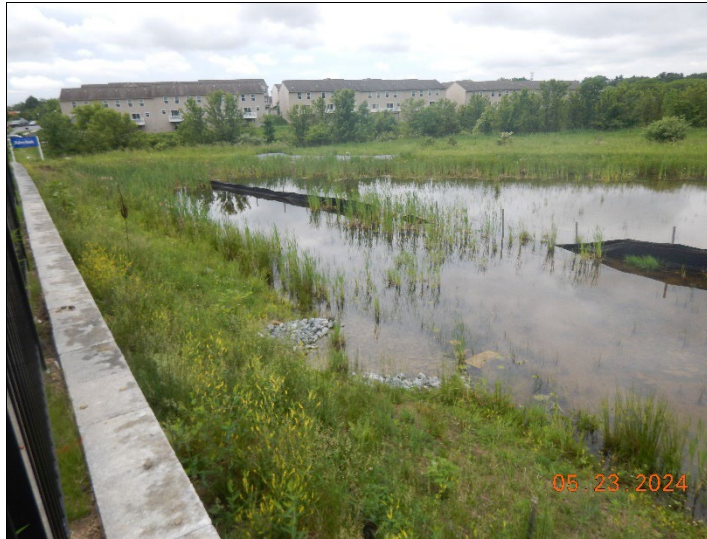
Terrace at Maplewood  
Date: 23 May 2024  
Photo ID: DSCN5382.JPG  
Photo taken by: Katelyn Almeter

Notes: View of silt fence along the center of the retention pond.

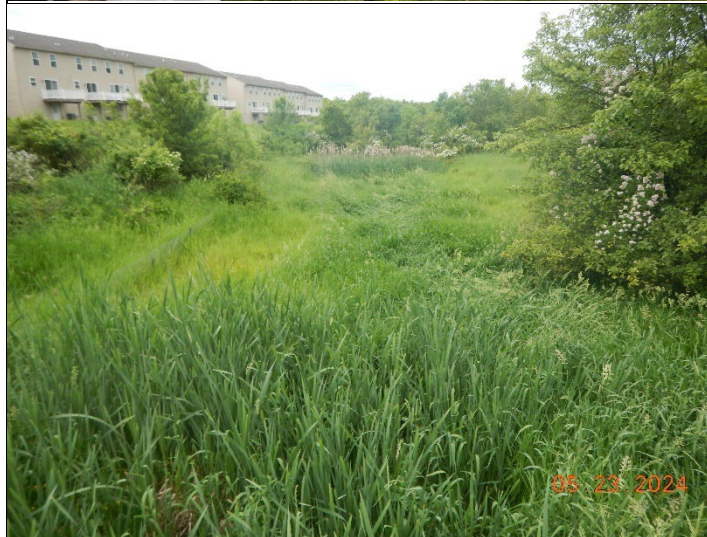
Terrace at Maplewood  
Date: 23 May 2024  
Photo ID: DSCN5383.JPG  
Photo taken by: Katelyn Almeter

Notes: Low-lying area adjacent to the south of the retention pond.

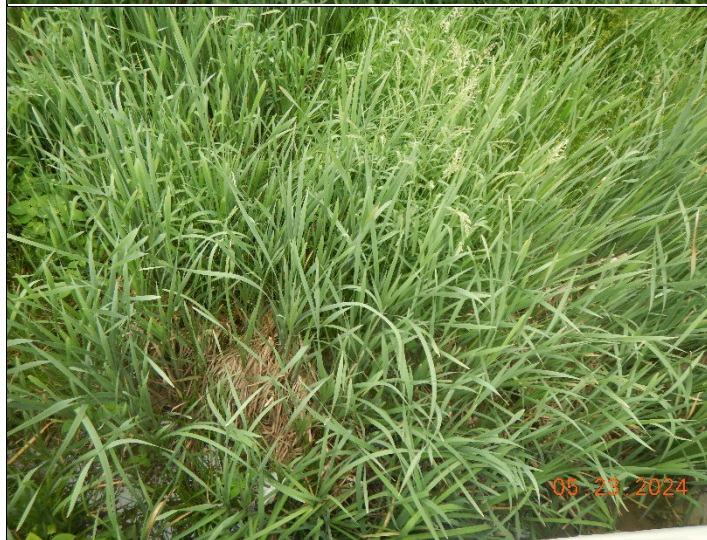
Terrace at Maplewood  
Date: 23 May 2024  
Photo ID: DSCN5384.JPG  
Photo taken by: Katelyn Almeter

Notes: surface water observed on the downgradient side of the culvert.

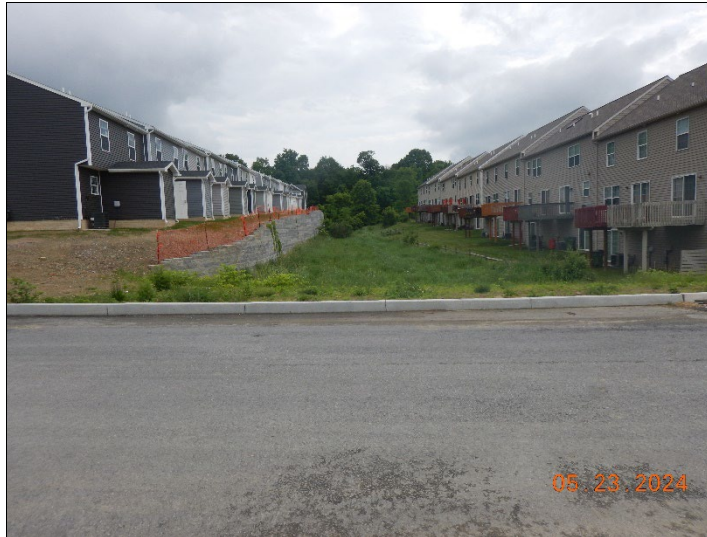
Terrace at Maplewood  
Date: 23 May 2024  
Photo ID: DSCN5385.JPG  
Photo taken by: Katelyn Almeter

Notes: East facing view of drainage area between two rows of townhouses.

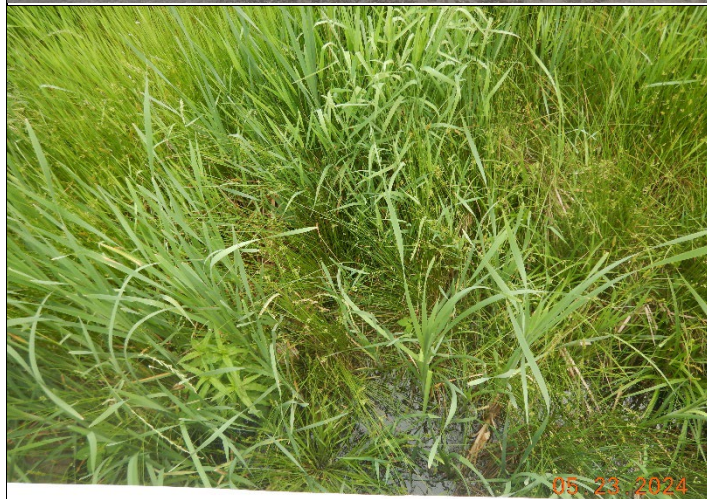
Terrace at Maplewood  
Date: 23 May 2024  
Photo ID: DSCN5386.JPG  
Photo taken by: Katelyn Almeter

Notes: surface water observed.

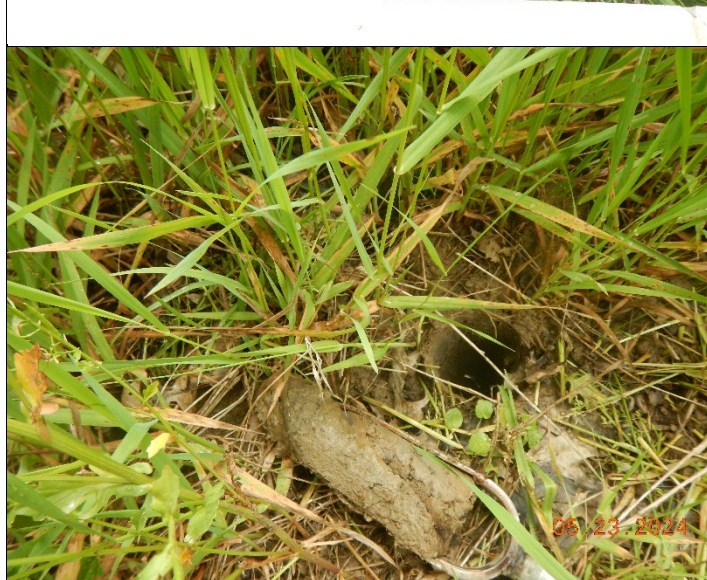
Terrace at Maplewood  
Date: 23 May 2024  
Photo ID: DSCN5387.JPG  
Photo taken by: Katelyn Almeter

Notes: Soil boring showing a saturated, undisturbed soil profile. Water table present in soil pit.

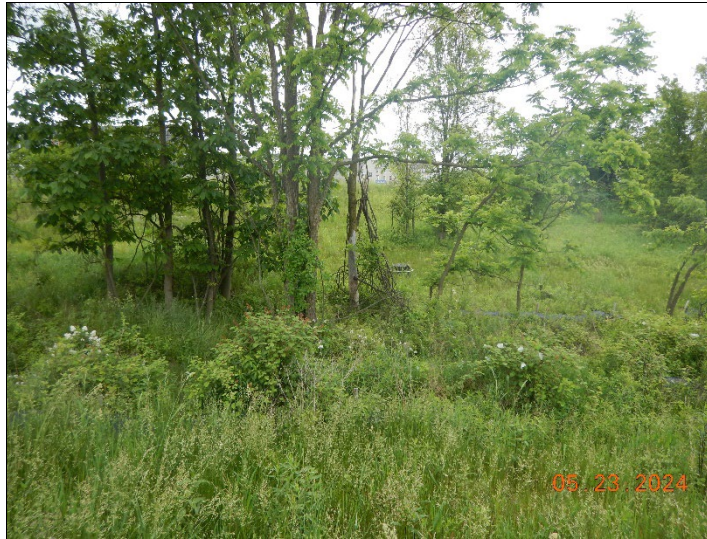
Terrace at Maplewood  
Date: 23 May 2024  
Photo ID: DSCN5388.JPG  
Photo taken by: Katelyn Almeter

The inspection moved back north along Elmwood Drive towards Hickorywood Lane and continued into the vegetated area west of Elmwood Drive across from Maplewood Circle moved to the west in the vegetated area to the south of the active construction area. A soil boring was conducted at approximately 40.32405, -76.85174, the soil was observed to be saturated and a high water table was present (DSCN5387). The soil profile had a depleted matrix and redoximorphic features were observed. The area was densely vegetated with herbaceous vegetation. Woody vegetation was also observed in the vicinity of the soil boring (DSCN5388).

Notes: View of the surrounding area where the soil boring was collected. Note the sanitary sewer manhole beyond the woody vegetation.

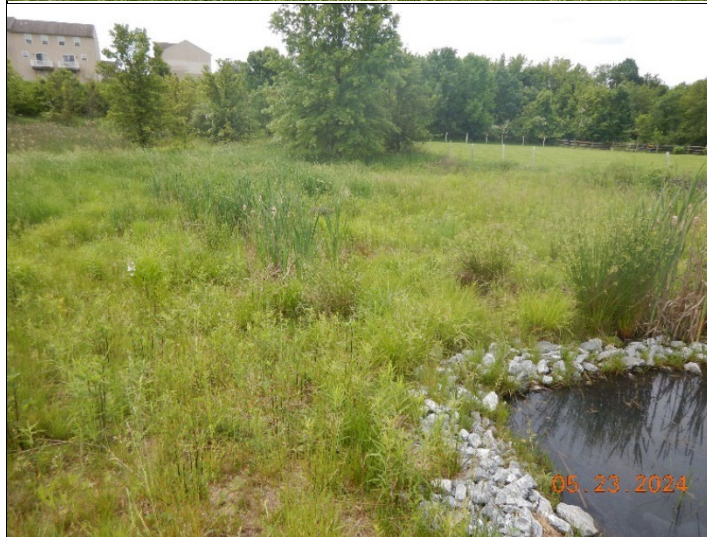
Terrace at Maplewood  
Date: 23 May 2024  
Photo ID: DSCN5389.JPG  
Photo taken by: Katelyn Almeter

The inspectors continued to the west and noted that the area was densely vegetated. A constructed stormwater pond and manhole were observed in the vicinity (DSCN5389 and DSCN5390). The inspectors observed areas with sparser vegetative coverage in areas of exposed earthen material and crushed rock. The inspectors conducted a second soil boring at 40.323235, -76.852487 and observed fill material from 0 to 6 inches above a matrix that was characterized as 7.5YR 4/2 with 15%

Notes: East facing view of the wetland area. Note the stormwater retention pond in the right foreground.

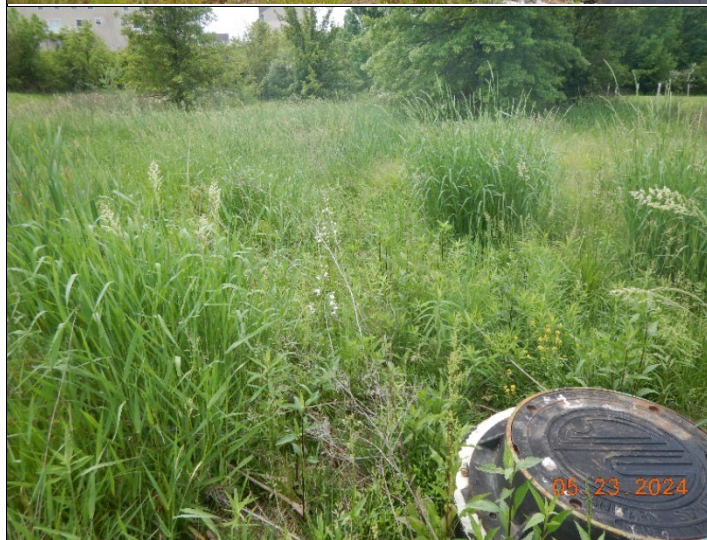
Terrace at Maplewood  
Date: 23 May 2024  
Photo ID: DSCN5390.JPG  
Photo taken by: Katelyn Almeter

Notes: View of the vegetated wetland area with a sanitary sewer manhole.

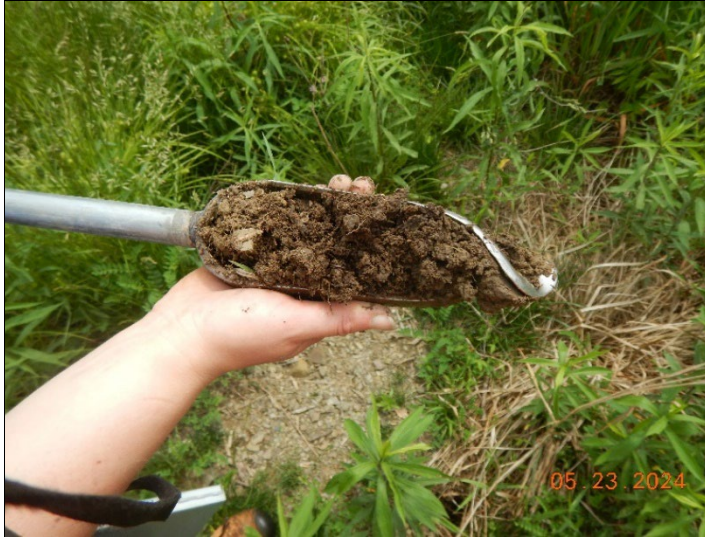
Terrace at Maplewood  
Date: 23 May 2024  
Photo ID: DSCN5391.JPG  
Photo taken by: Katelyn Almeter

5YR 4/6 redoximorphic features (DSCN5391 and DSCN5392). The soils met the hydric soil indicator of **F3: depleted matrix**. Soils were saturated with a high water table present. Herbaceous vegetation observed in this area included multiple species of sedges (*Carex sp.*), Rice Cutgrass (*Leersia oryzoides*), Switchgrass (*Panicum virgatum*), foxtail (*Alopecurus sp.*), and soft rush (*Juncus effusus*).

Notes: Soil boring with fill material.

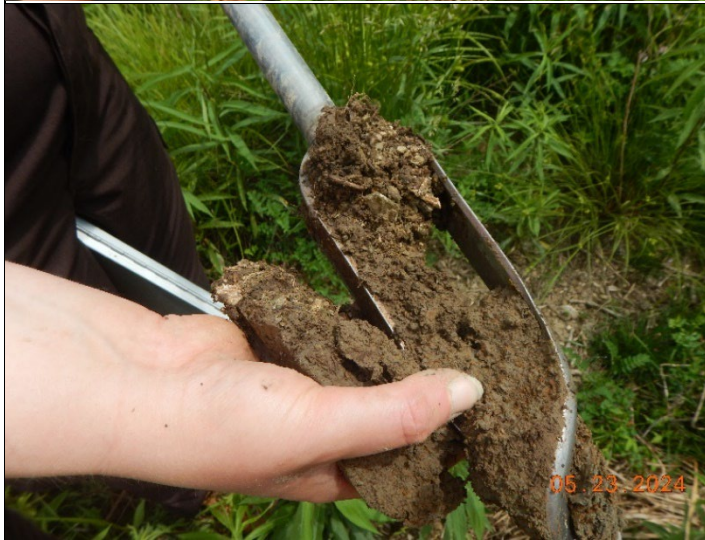
Terrace at Maplewood  
Date: 23 May 2024  
Photo ID: DSCN5392.JPG  
Photo taken by: Katelyn Almeter

Notes: Soil boring with redoximorphic features present.

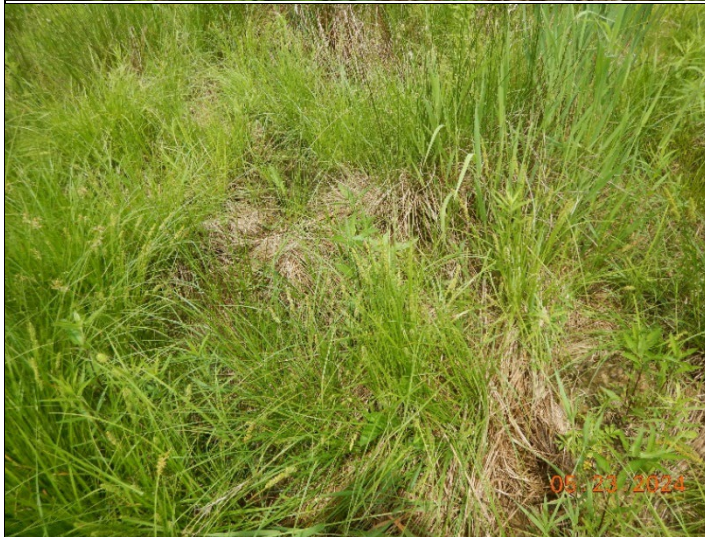
Terrace at Maplewood  
Date: 23 May 2024  
Photo ID: DSCN5393.JPG  
Photo taken by: Katelyn Almeter

Notes: surface water observed near area of the soil boring.

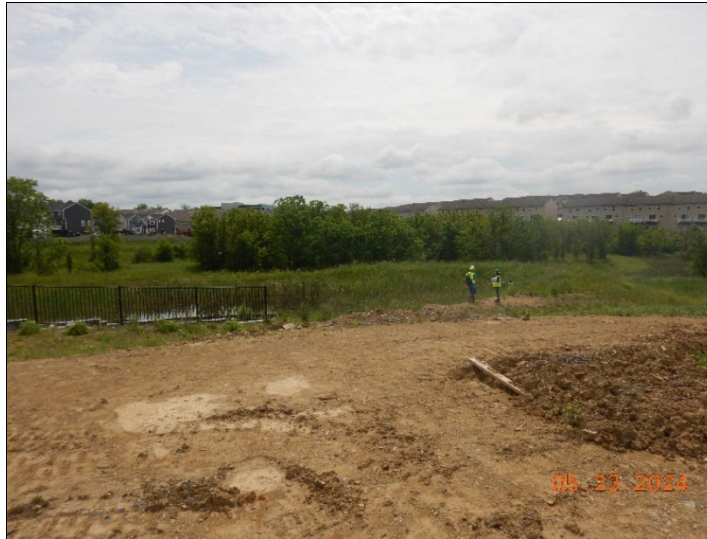
Terrace at Maplewood  
Date: 23 May 2024  
Photo ID: DSCN5394.JPG  
Photo taken by: Katelyn Almeter

Notes: Overview of construction area.

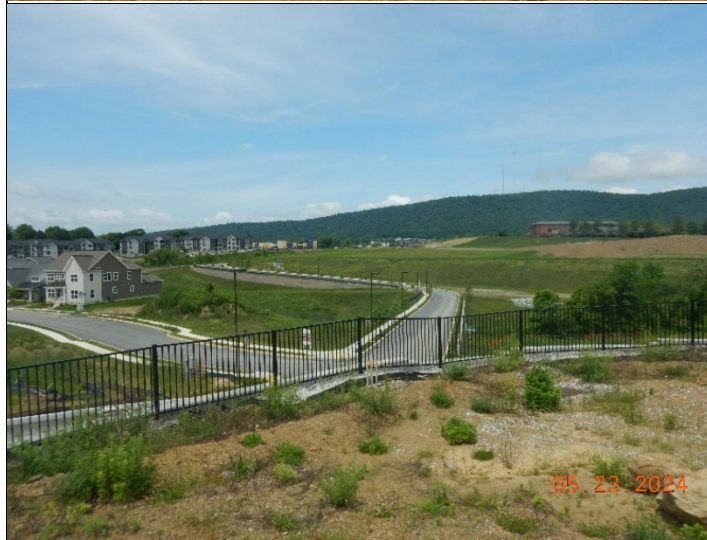
Terrace at Maplewood  
Date: 23 May 2024  
Photo ID: DSCN5395.JPG  
Photo taken by: Katelyn Almeter

Notes: View facing northwest at the boundary of the development with Black Run and another development in the background.
