**Region 6 - Enforcement & Compliance Assurance Division**  
**INSPECTION REPORT**

| Inspection Date(s): | 1/29/2025 | |
| Company Name: | <b>RT Production, LLC</b> | |
| Facility Name: | <b>Alex Jones Tank Battery</b> | |

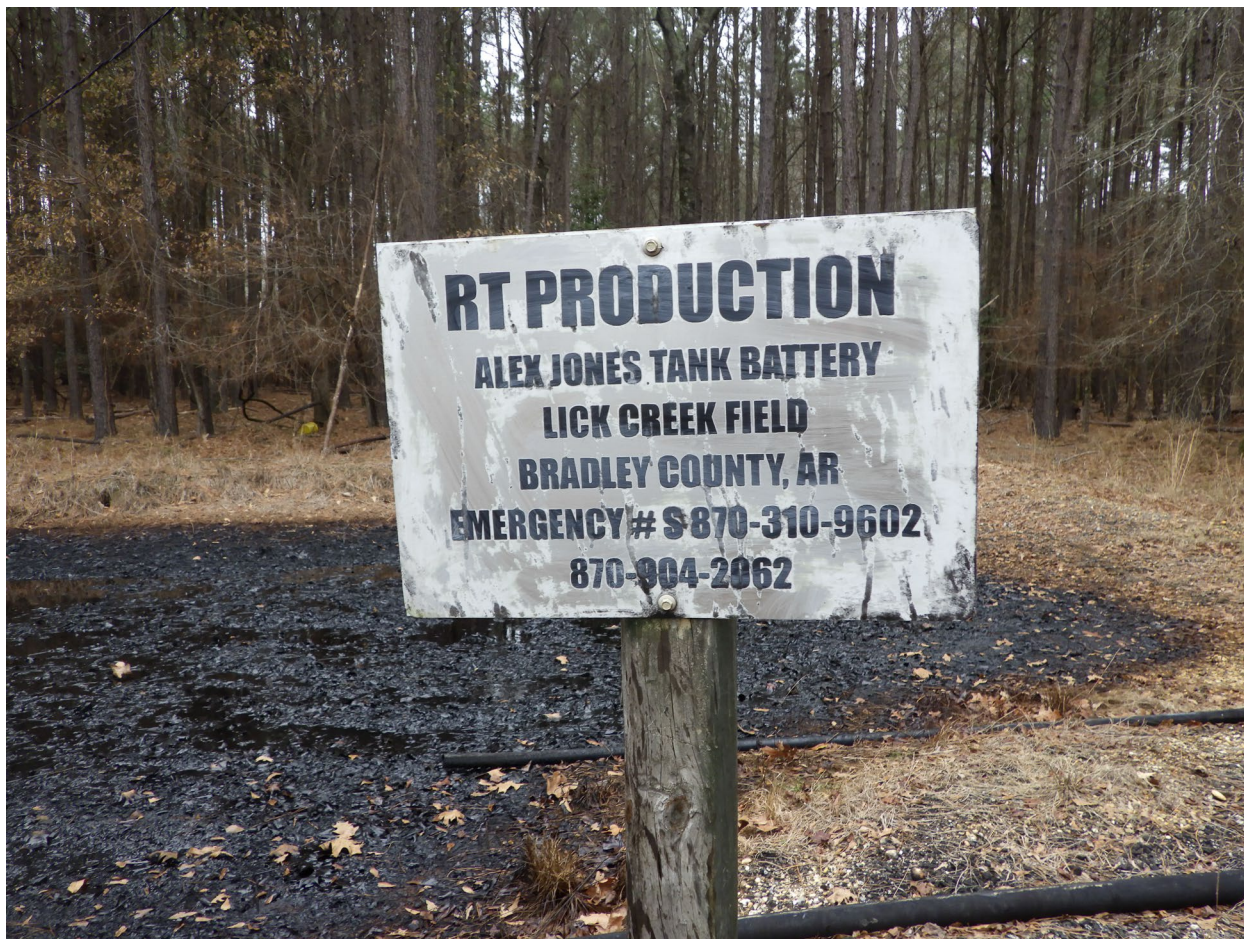
Photo No. 1

**Description:** This photo was taken looking northeast and shows the facility sign.

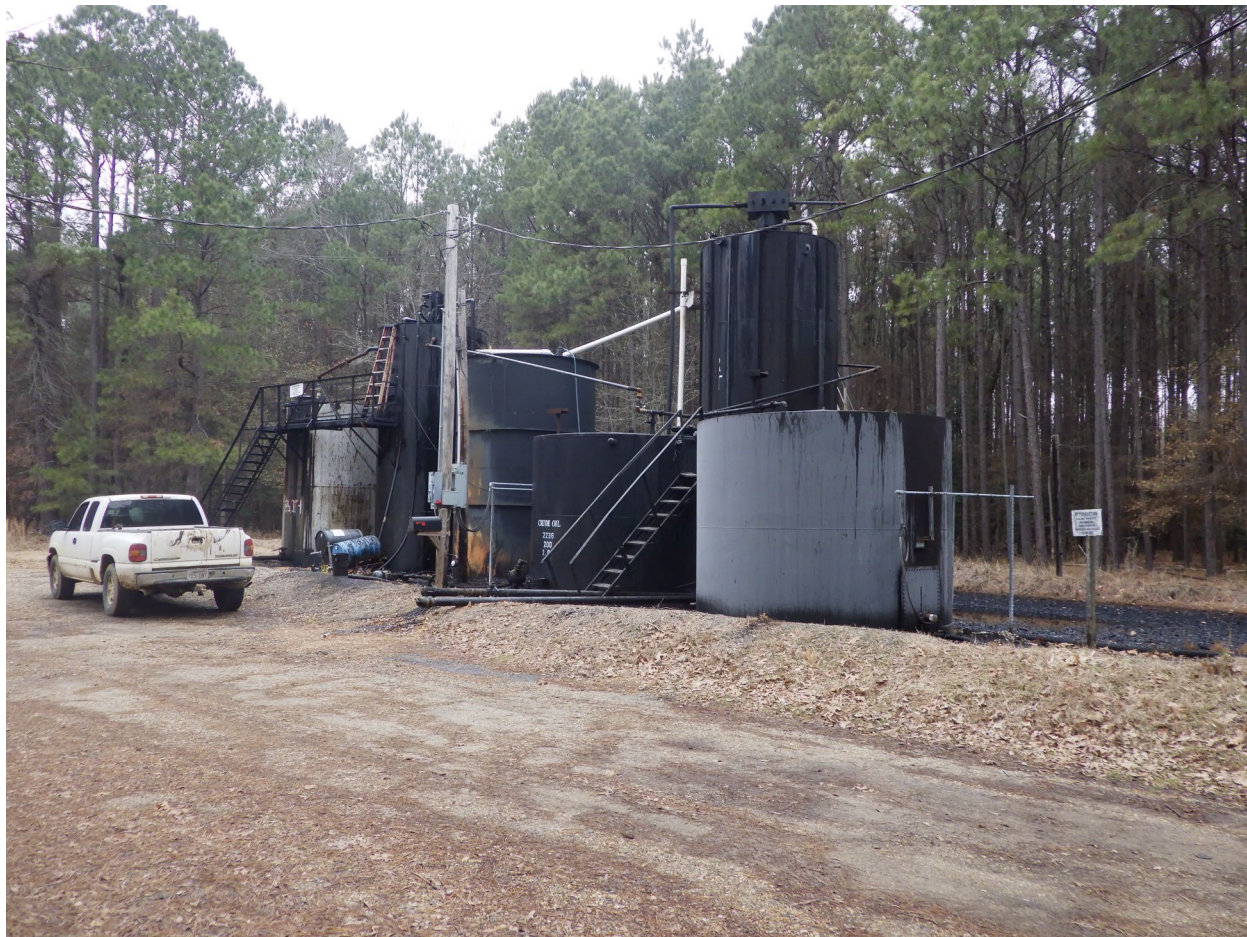
Photo No. 2

I observed missing catchment buckets on the load lines, see photo No. 2.

**Description:** This photo was taken looking north and shows an overview of the facility and missing catch buckets on the load lines.

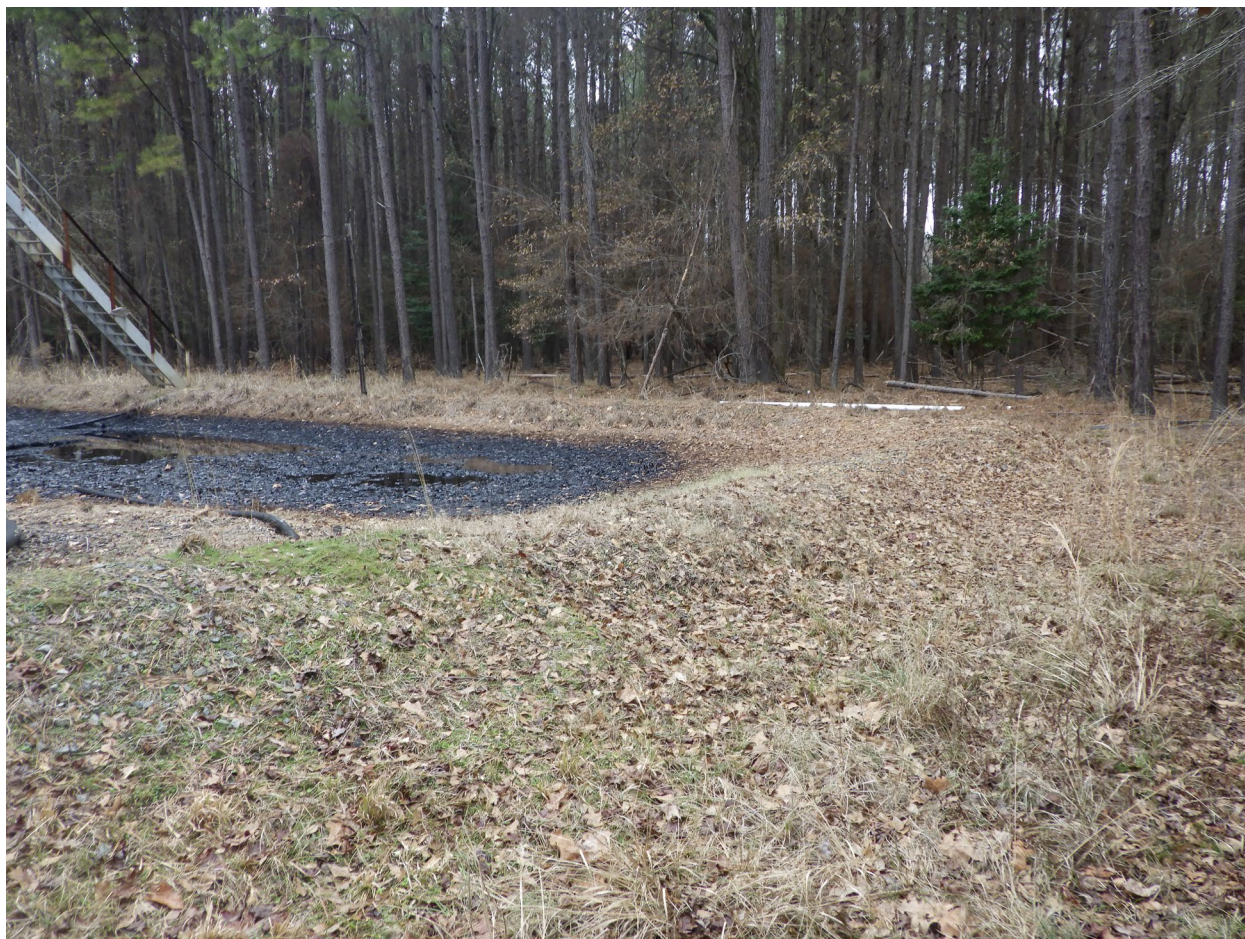
Photo No. 3

I observed a low spot in the secondary containment berm, see photo No. 3.

**Description:** This photo was taken looking north and shows a low spot in the secondary containment berm.

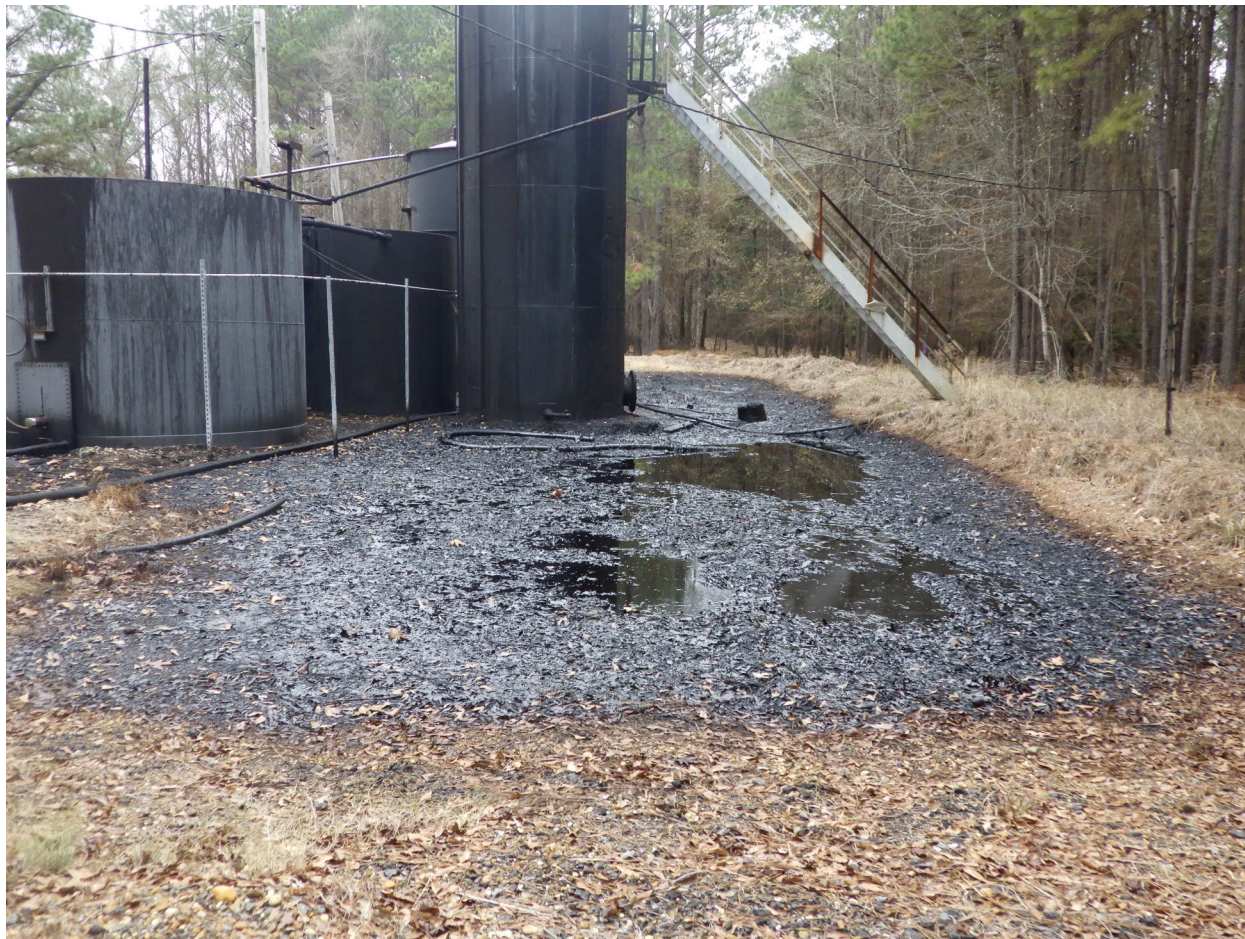
Photo No. 4

I observed loose oil inside of secondary containment, see photo No. 4.

**Description:** This photo was taken looking west and shows loose oil inside secondary containment.
