**Region 6 - Enforcement & Compliance Assurance Division**  
**INSPECTION REPORT**

| Inspection Date: | 01/12/2026 | |
| Company Name: | Cypress Operating, Inc. | |
| Facility Name: | Haydon #1-A SWD System | |

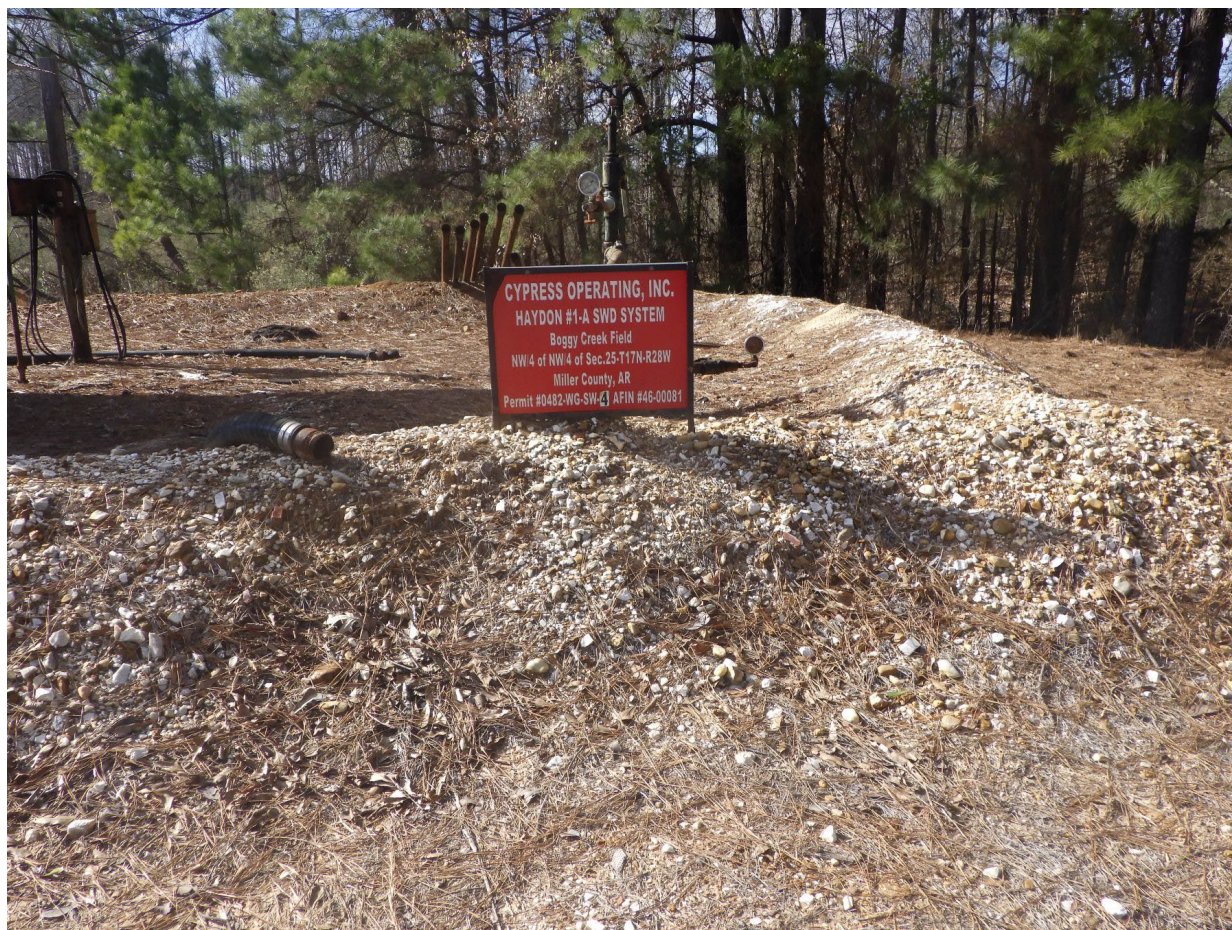
Photo No. 1

| Description: | This photo was taken facing northwest and shows the facility sign and SWD injection well. | | |

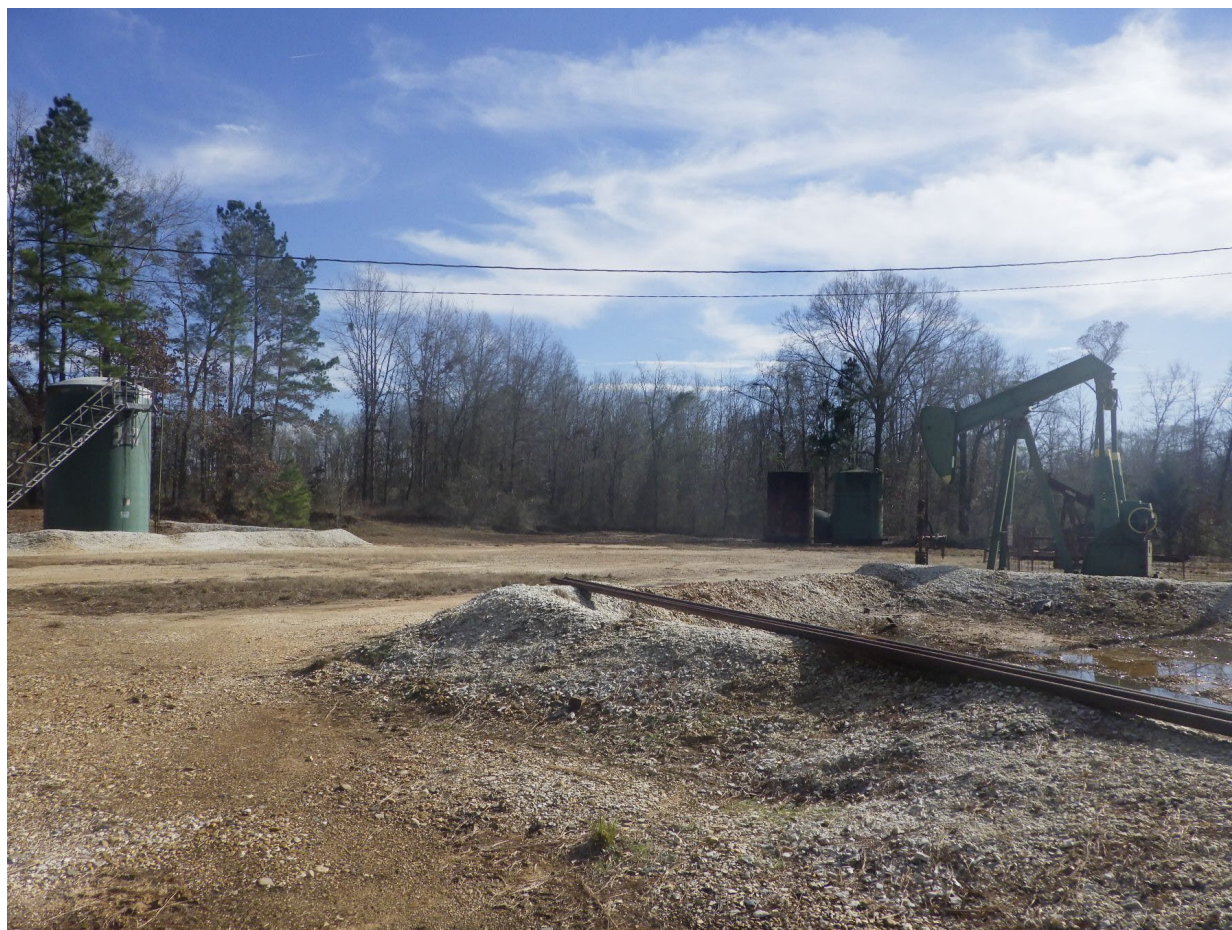
Photo No. 2

| Description: | This photo was taken facing south and shows an overview of the facility. | | |

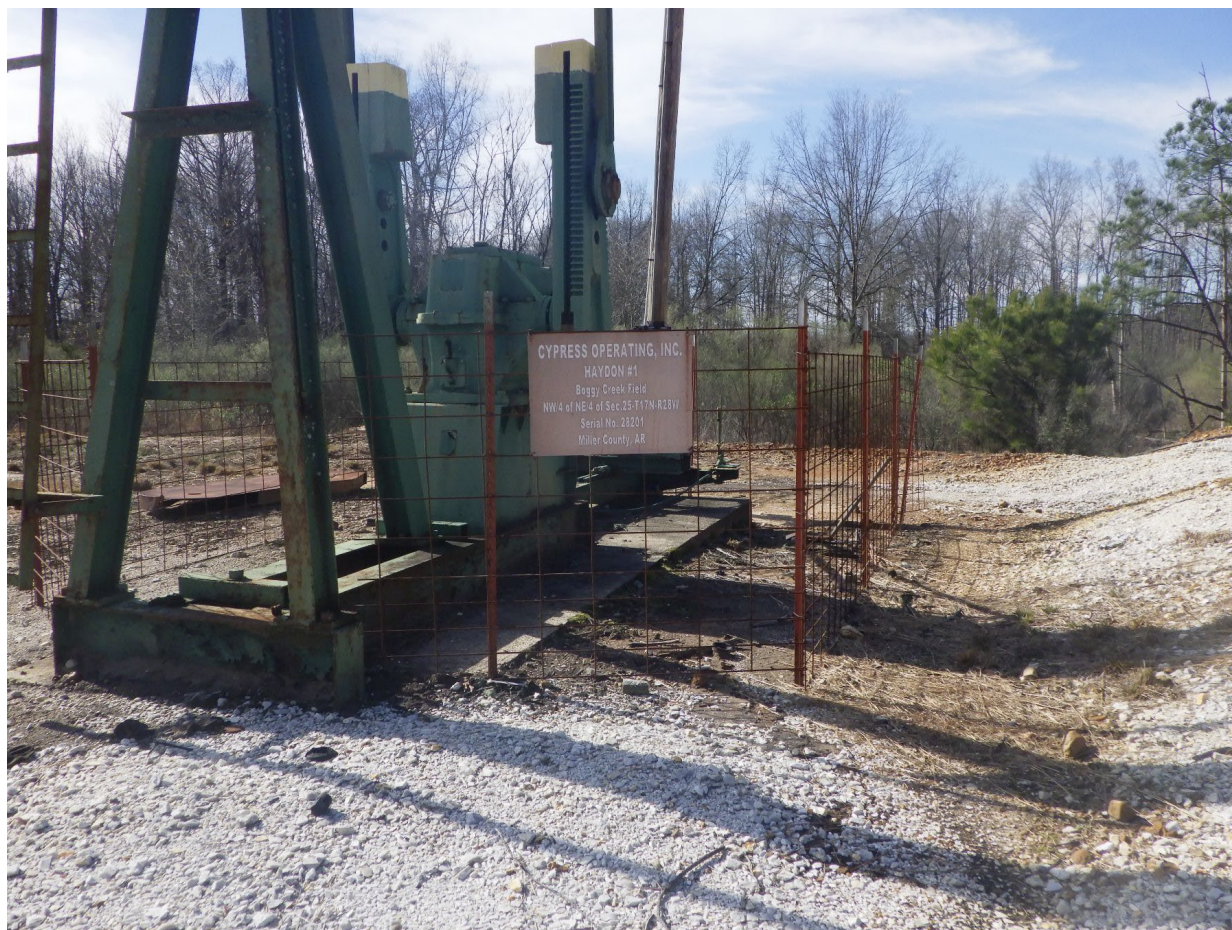
Photo No. 3

| Description: | This photo was taken facing northwest and shows that sign for a production well. | | |

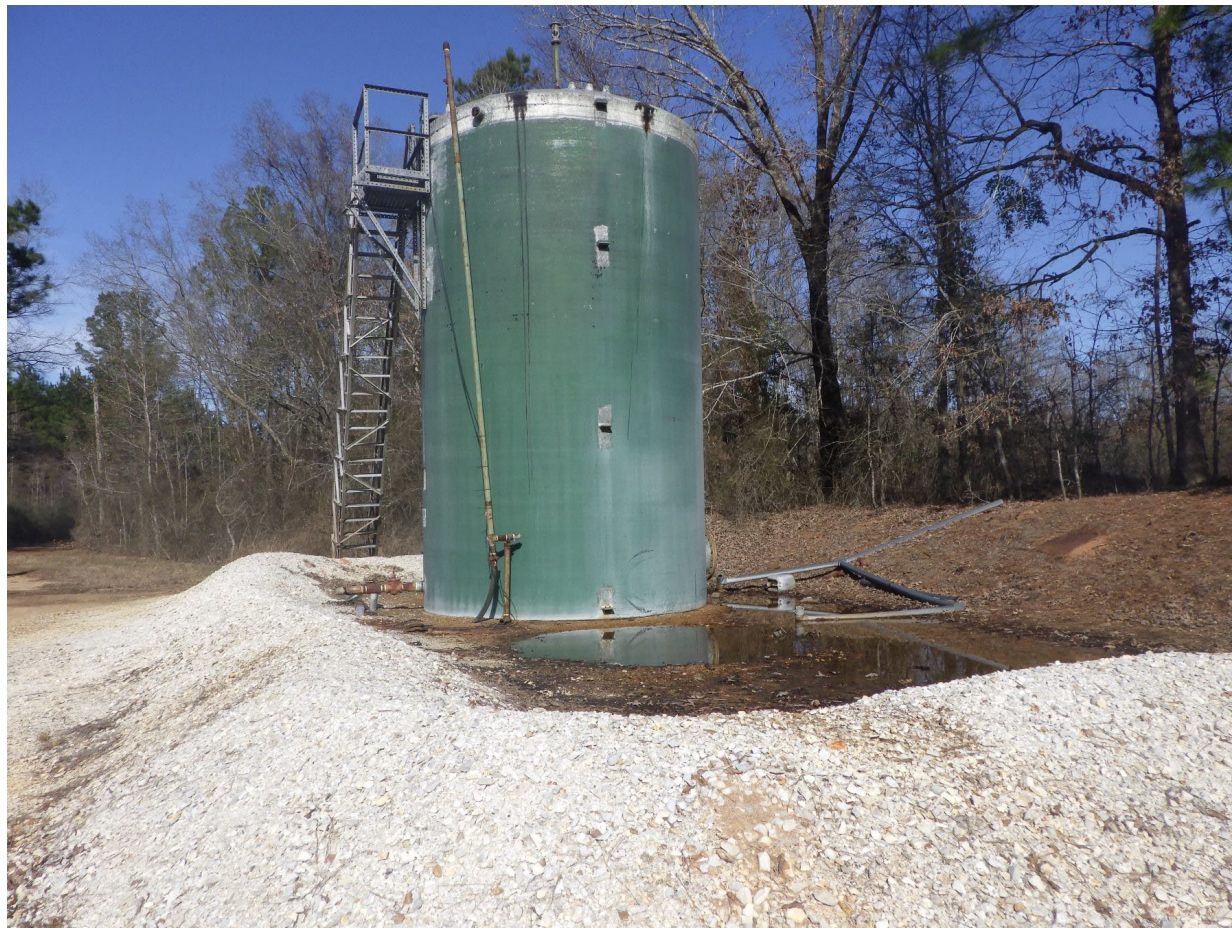
Photo No. 4

| Description: | This photo was taken facing north and shows the SWD storage tank at the facility. | | |

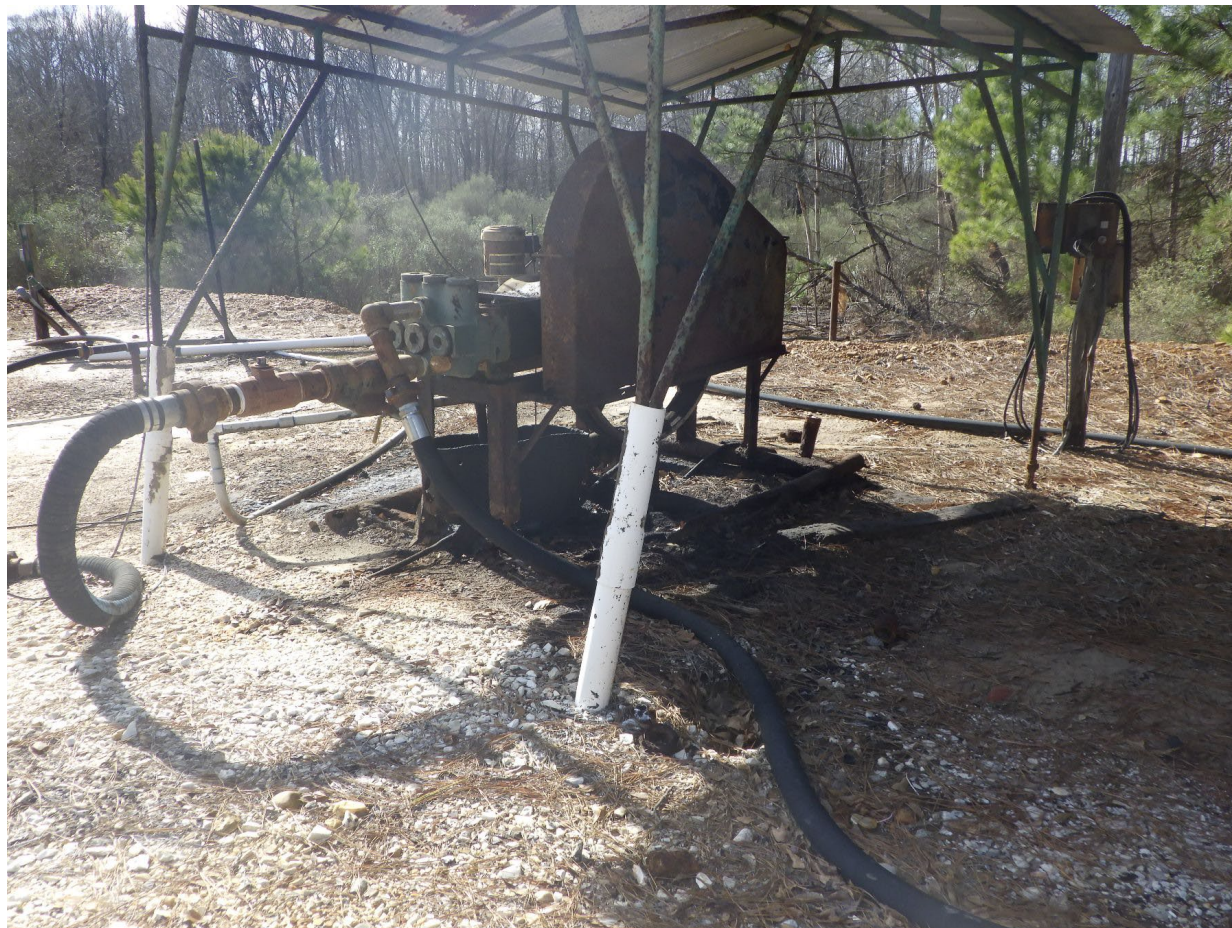
Photo No. 5

I observed loose oil around the injection pump, see Photo No. 5.

- Loose oil around the injection pump;
- Indicators of past saltwater discharge based on visible flow path from the facility.

| Description: | This photo was taken facing west-northwest and shows loose oil around the injection pump. | | |

Inspector will conduct follow-up phone calls with the company representatives over the coming weeks and months to ensure areas of concern are properly addressed.

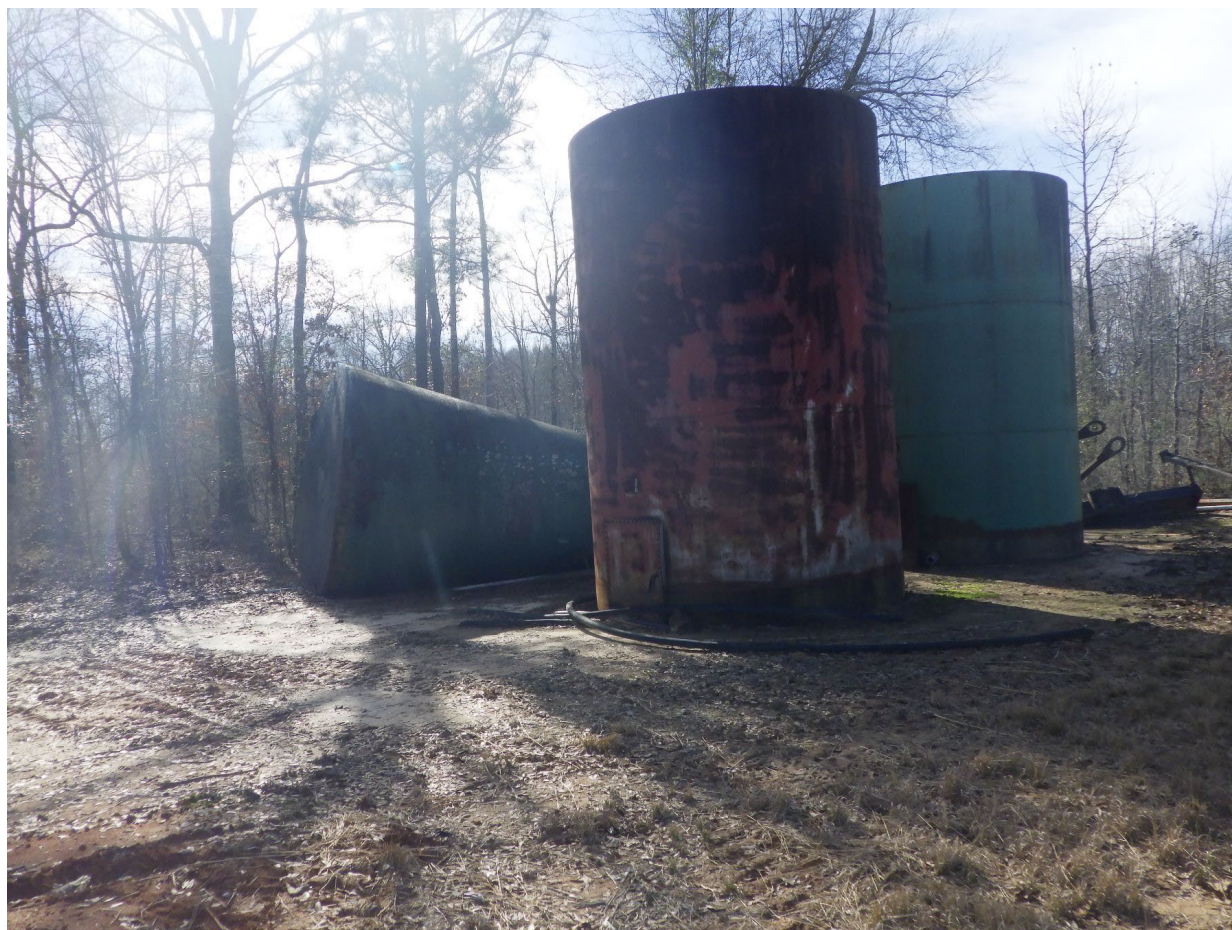
Photo No. 6

I observed three (3) storage tanks outside secondary containment that appeared to be “out of service” or “not in use” and did not have piping, see Photo No. 6.

| Description: | This photo was taken facing west and shows storage tanks that appear “out of service” or “not in use.” | | |

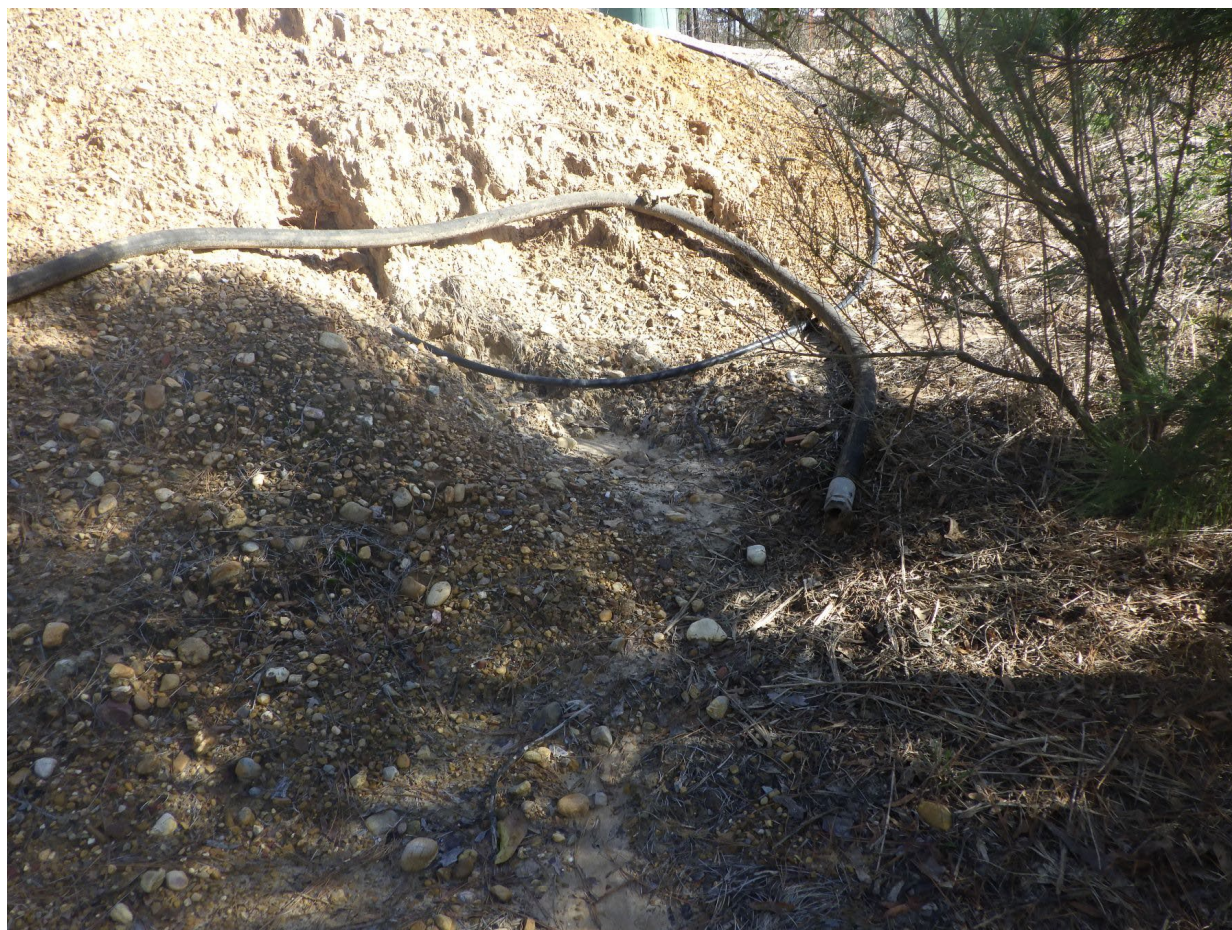
I observed indicators of past or historic saltwater discharge based on a flow path from the facility, presence of salt crystals, and dead vegetation, see Photo No. 7 through No. 9.

| Description: | This photo was taken facing north-northeast and shows indicators of a past saltwater discharge based on the flow path visible in this photo and salt crystals observed during the inspection. | | |

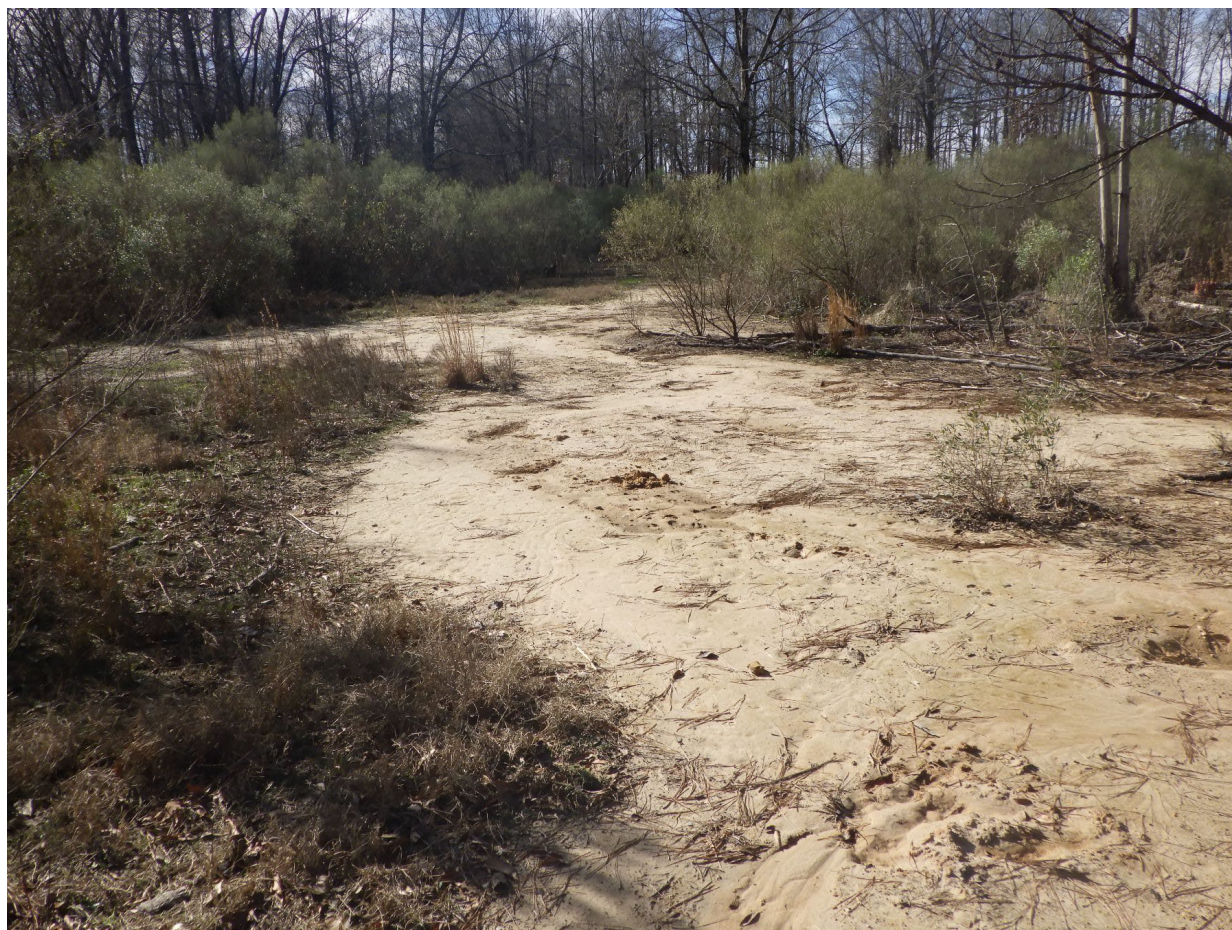
Photo No. 8

| Description: | This photo was taken facing west-northwest and shows additional indicators of a past saltwater discharge based on a continuation of the flow path in Photo No. 7 and dead vegetation. | | |

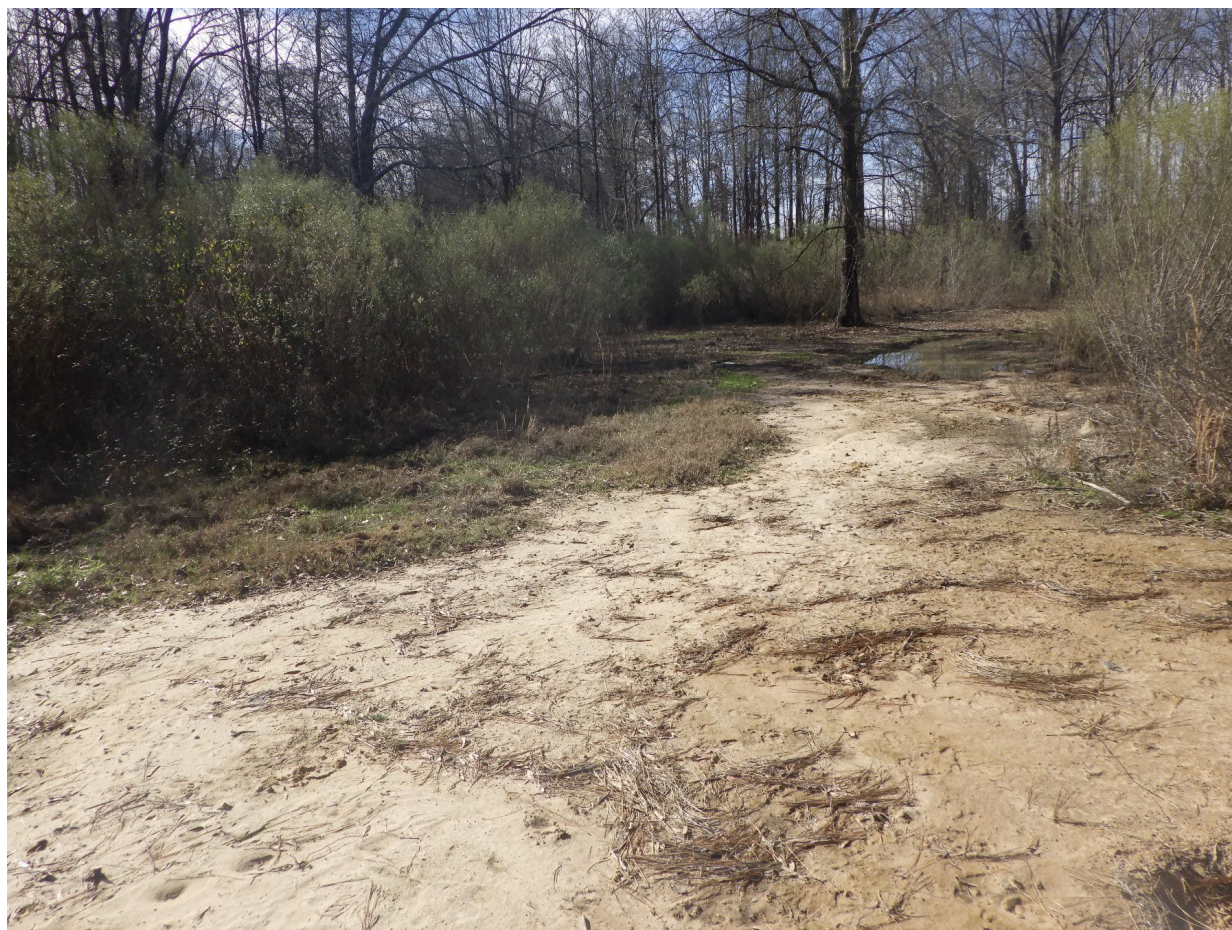
Photo No. 9

| Description: | This photo was taken facing west-northwest and shows additional indicators of a past saltwater discharge based on a continuation of the flow path in Photo No. 7 and dead vegetation. | | |
