**U.S. ENVIRONMENTAL PROTECTION AGENCY  
REGION VIII WATER BRANCH, ENFORCEMENT  
AND COMPLIANCE ASSURANCE DIVISION  
CLEAN WATER ACT  
COMPLIANCE INSPECTION REPORT**

**Name of Facility:** Suncor Energy (USA) Inc. Commerce City Refinery  
**Facility Address:** 5801 Brighton Blvd., Commerce City, CO 80022  
**Mailing Address:** 5801 Brighton Blvd., Commerce City, CO 80022

| <b>Type of Inspection:</b> | Industrial Stormwater CEI |

**Inspection Dates:** June 22, 23, and 24, 2021

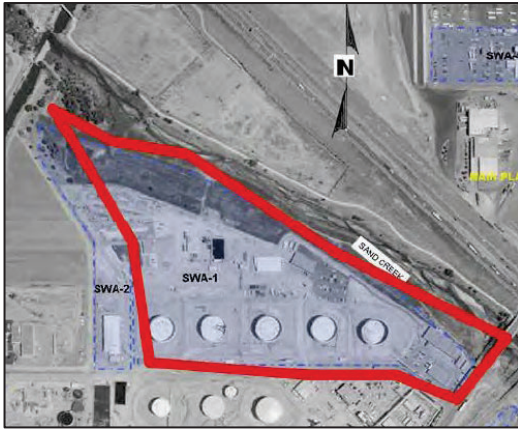
**Figure 1.** SWA Nos. 1 and 2.

Stormwater runoff from SWA Nos. 1 and 2 (areas within Plant 1 where stormwater runoff is not treated by the WWTP; see Figure 1) is collected in the stormwater detention area upgradient of Outfall 023A (refer to [Appendix A, Photographs 6 and 13](#)). This stormwater detention area also receives runoff from the contaminated groundwater swale (referred to as the Sand Creek Swale Pond, see Figure 2) located between Plant 1 and Sand Creek during significant storm events (refer to [Appendix A, Photograph 12](#)). Additionally, stormwater runoff from an unnamed stormwater detention area located immediately east of the groundwater treatment systems (GWTS) (refer to [Appendix A, Photograph 11](#)) also drains to the stormwater detention area at Outfall 023A. Stormwater runoff from SWA No. 2 first collects in a concrete conveyance channel that runs north and northwest along the boundary of Plant 1 and adjacent to Metro Wastewater Reclamation District property and ultimately conveyed by culvert into the stormwater detention area at Outfall 023A.

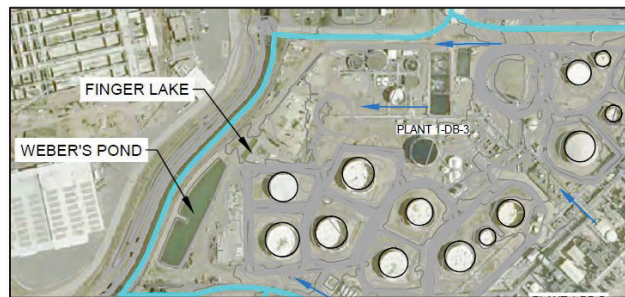
**Figure 3.** Plant 1 drainage and location of Finger Lake and Webber's Pond.

Stormwater runoff from the remaining portions of Plant 1 that does not flow to the stormwater detention area at Outfall 023A or to Outfall 025A and is not captured and conveyed to the Facility's oily water and non-oily water sewer systems which flow to the WWTP, drains to two impoundments referred to as Finger Lake and Webber's Pond located on the western portion of the Facility (refer to [Appendix A, Photographs 17 and 18](#) and Figure 3). Finger Lake is a concrete lined rectangular impoundment which collects both stormwater runoff and non-stormwater sources, including firefighting training waters. Webber's Pond is a poly-lined impoundment located approximately 50 feet east of the Burlington Ditch waterway. According to Facility representatives, stormwater that accumulates in the tank farm secondary containment areas may also be pumped to Webber's Pond to promote evaporation. Mr. Marler (Suncor's Sr. Environmental Advisor) explained that stormwater and non-stormwater that collects in these two impoundments is not discharged through any stormwater Permit (CDPS Permit No. COS0000009) outfalls. He explained that Finger Lake may be pumped to the WWTP for treatment after being sampled for WWTP effluent parameters (CDPS Permit No. COS0001147). If the samples show compliance with Permit conditions, it is pumped (refer to [Appendix A, Photograph 23](#)) directly to Lagoon 1 of the WWTP (bypassing the majority

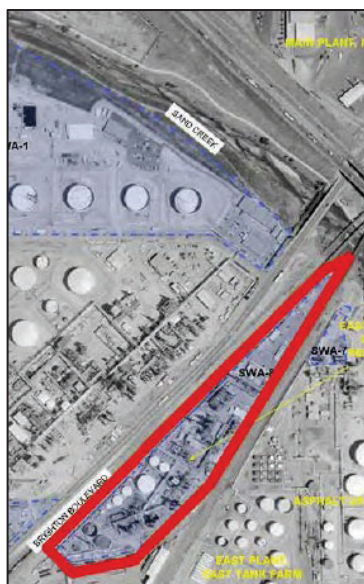
**Figure 4.** SWA No. 8.

Stormwater runoff from Plant 2 is authorized to be discharged at Outfall 024A (SWA No. 8; see Figure 4) and Outfall 28A (SWA No. 9). Refer to [Appendix B, Exhibit 2](#) for outfall locations.

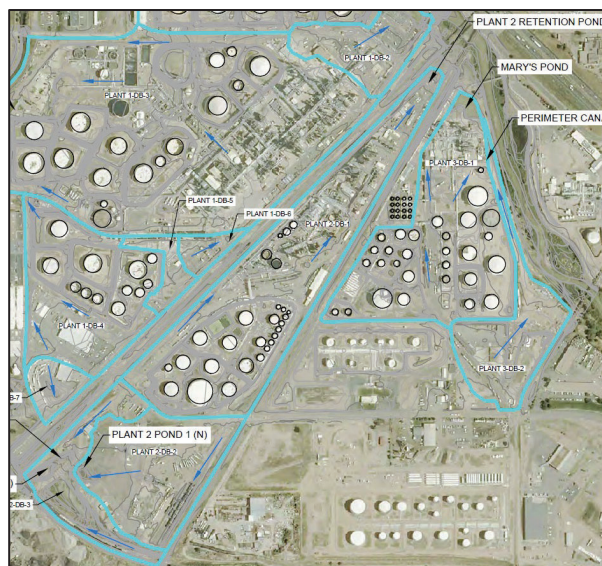
**Figure 5.** Plant 2 drainage.

Runoff at Plant 2 generally flows north and northeast toward Sand Creek; however, the south side of Plant 2 drains to the south and southwest into an unnamed tributary to the South Platte that follows a railroad right-of-way to the west along the Facility's southern boundary (see Figure 5). Stormwater runoff from Plant 2 that is not captured (primarily employee parking area) by the oily water and non-oily water sewer systems collects in a stormwater detention basin located upgradient of Outfall 024A (refer to [Appendix A, Photograph 9](#)). According to Facility representatives, this basin is normally pumped back to the WWTP headworks for treatment but can discharge to Outfall 024A via gate valve, as needed.

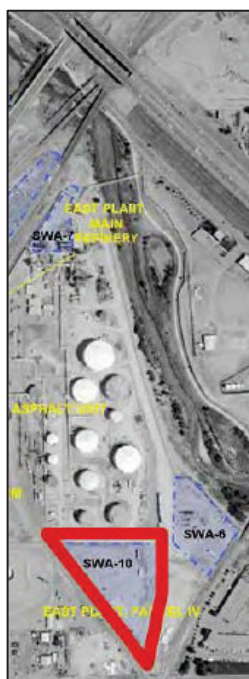
**Figure 6.** SWA Nos. 6, 7, and 10.

Stormwater runoff from Plant 3 is authorized to be discharged at Outfall 004A (SWA Nos. 6, 7, and 10; see Figure 6), Outfall 026A (SWA Nos. 6, 7, and 10), and Outfall 027A. Refer to [Appendix B, Exhibit 2](#) for outfall locations.

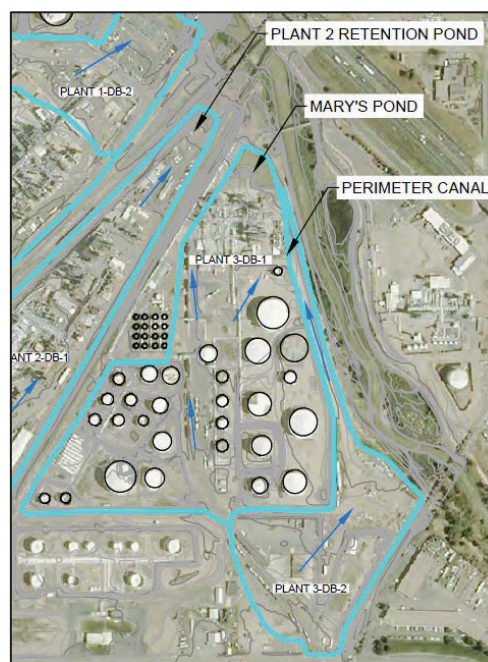
**Figure 7.** Plant 3 drainage.

Runoff at Plant 3 generally flows to the north towards Mary's Pond or Sand Creek via the north entrance road (see Figure 7). During the inspection, Facility representatives explained that Outfall 027A, a manual release outfall associated with SWA No. 6, is no longer utilized for stormwater discharges. Stormwater runoff from Plant 3 is captured in Mary's Pond, a concrete lined stormwater retention basin. According to Facility representatives, during normal conditions, all stormwater runoff captured in this pond is pumped to the WWTP headworks for treatment (refer to [Appendix A, Photographs 22 and 23](#)). During significant storm events, Mary's Pond is discharged to Sand Creek through a manually controlled valve to Outfall 004A (refer to [Appendix A, Photograph 2](#)). During significant storm events, a concrete conveyance channel flowing northwest along the eastern perimeter of Plant 3 into Mary's Pond may overtop the channel wall upstream of the inlet into Mary's Pond. Stormwater that overtops this channel overland flows north into Sand Creek (refer to [Appendix A, Photograph 10](#)). This high flow contingency discharge point has been permitted by CDPHE as Outfall 026A.
