**Region 6 - Enforcement & Compliance Assurance Division**  
**INSPECTION REPORT**

| Regulatory Program(s) | Clean Water Act – National Pollution Discharge Elimination System (Brine) | |
| Company Name: | <b>Calgary Energy, LLC</b> | |
| Facility Name: | <b>Tidal Osage Lease</b> | |

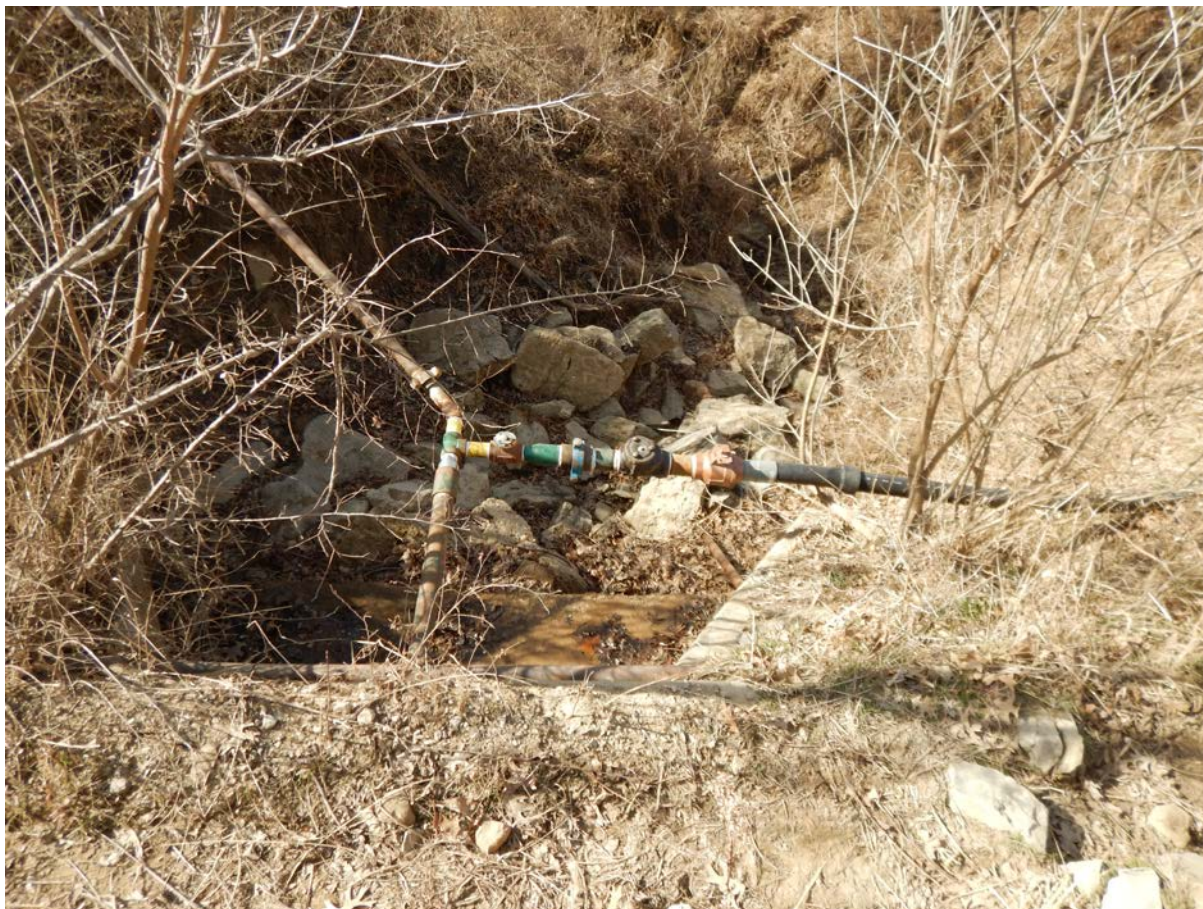
Photo No. 1

**Description:** This is a "top view" of the temporary flowline associated with the Tidal Osage I lease, which flows to injection well no. 8-7 (EPA Inventory ID No. OS6522000). Salt crystallization occurred on the flowline in this location, indicating a slow leak, or drip, occurring over time. The leak was dripping directly into a ditch that the temporary line was located above.

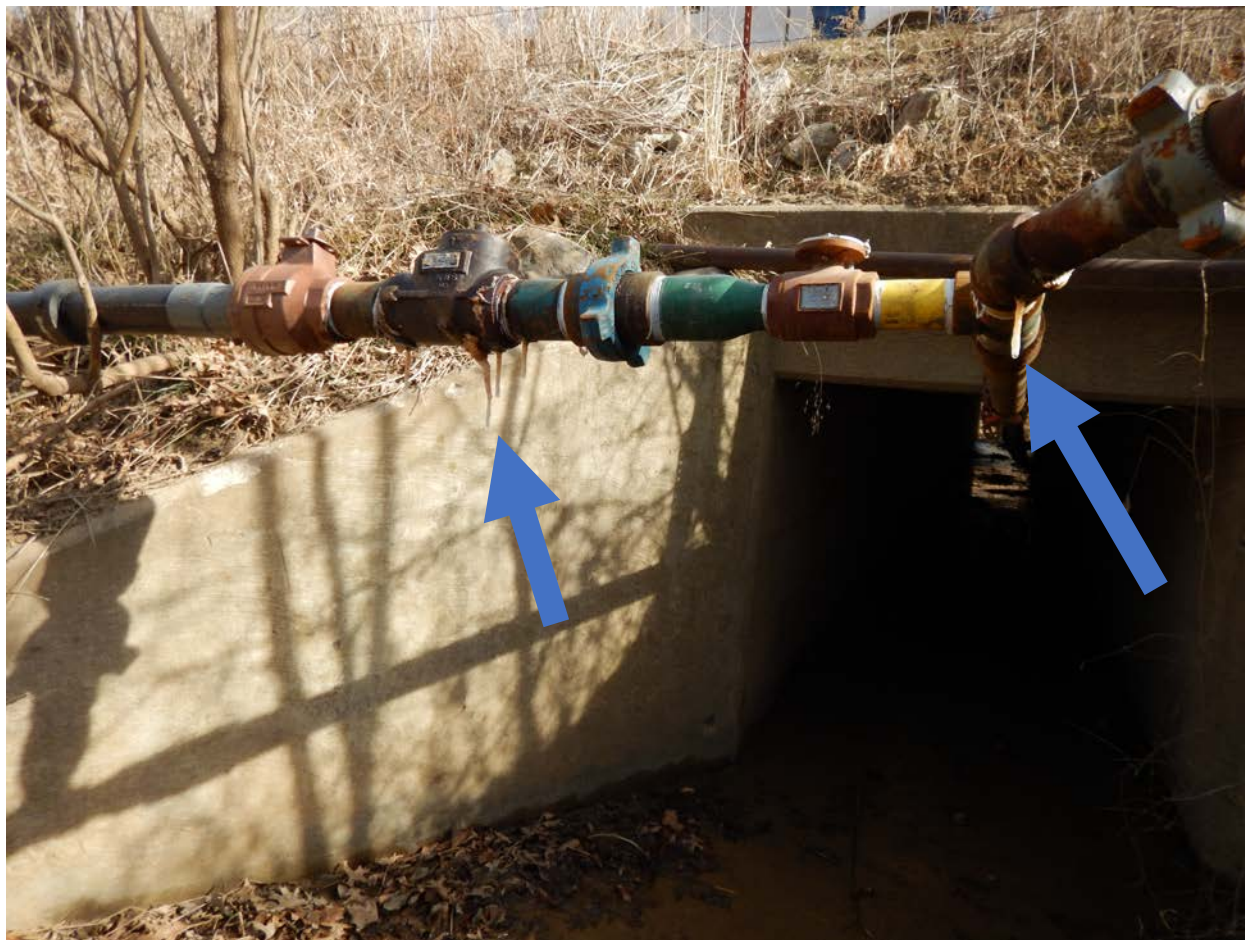
Photo No. 2

**Description:** This is a temporary flowline associated with the Tidal Osage I lease and flows to injection well no. 8-7 (EPA Inventory ID No. OS6522000). Salt crystallization occurred on the flowline in this location, indicating a slow leak, or drip, occurring over time. The leak was dripping directly into a ditch that was in a side tributary of Little Hominy Creek. Two blue arrows have been inserted in this photo to show the salt stalactites and their locations where the leak was occurring on the flowline.

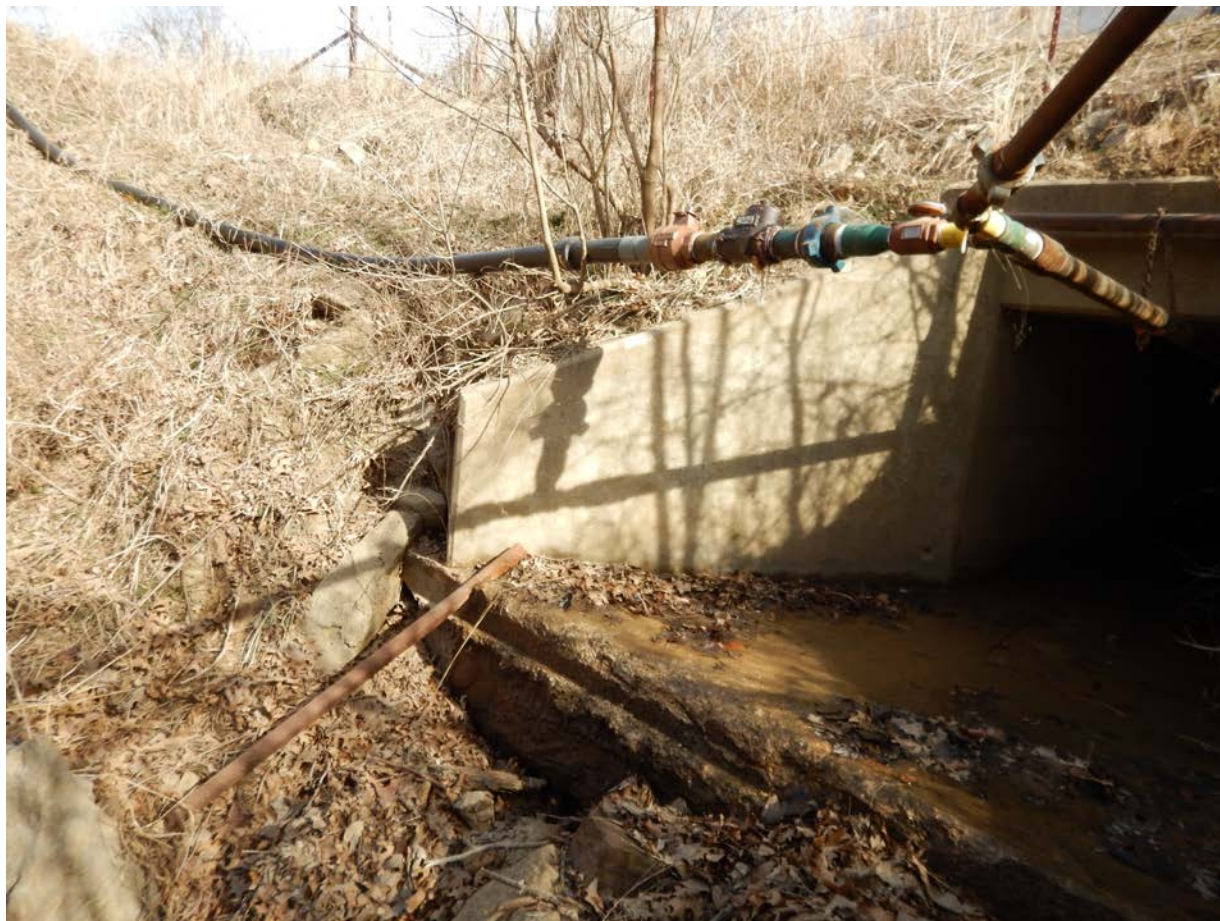
Photo No. 3

**Description:** This is a temporary flowline associated with the Tidal Osage I lease and flows to injection well no. 8-7 (EPA Inventory ID No. OS6522000). Salt crystallization occurred on the flowline in this location, indicating a slow leak, or drip, occurring over time. The leak was dripping directly into a ditch that was in a side tributary of Little Hominy Creek. The tributary was had puddles of water that were observed and appeared not to be flowing during the time of the inspection.

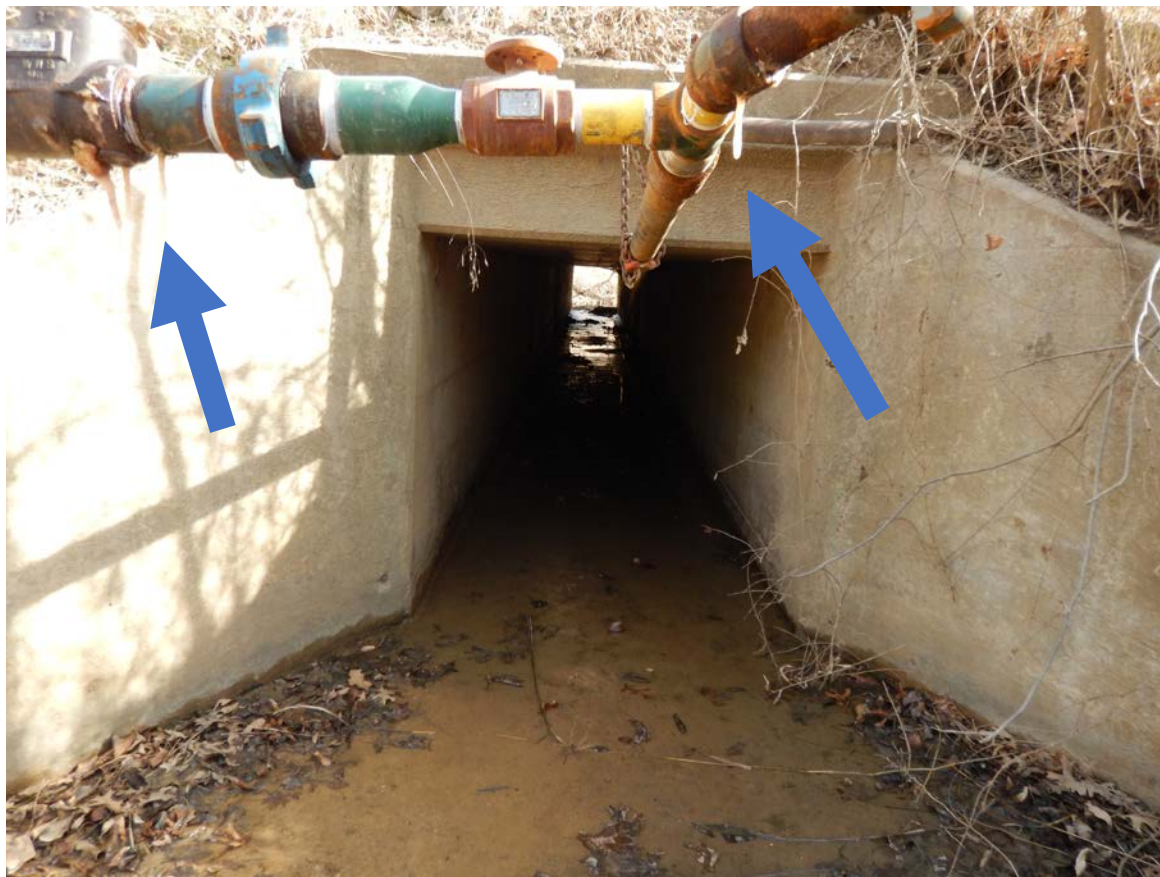
Photo No. 4

**Description:** This is a temporary flowline associated with the Tidal Osage I lease and flows to injection well no. 8-7 (EPA Inventory ID No. OS6522000). Salt crystallization occurred on the flowline in this location, indicating a slow leak, or drip, occurring over time. The leak was dripping directly into a ditch that was in a side tributary of Little Hominy Creek. The tributary was had puddles of water that were observed and appeared not to be flowing during the time of the inspection. This photo shows an upstream view of the road culvert or ditch underneath the road where water in the tributary flows west towards Little Hominy Creek and water was seen in this part of the tributary during the inspection. Two blue arrows have been inserted in this photo to show the salt stalactites and their locations where the leak was occurring on the flowline.

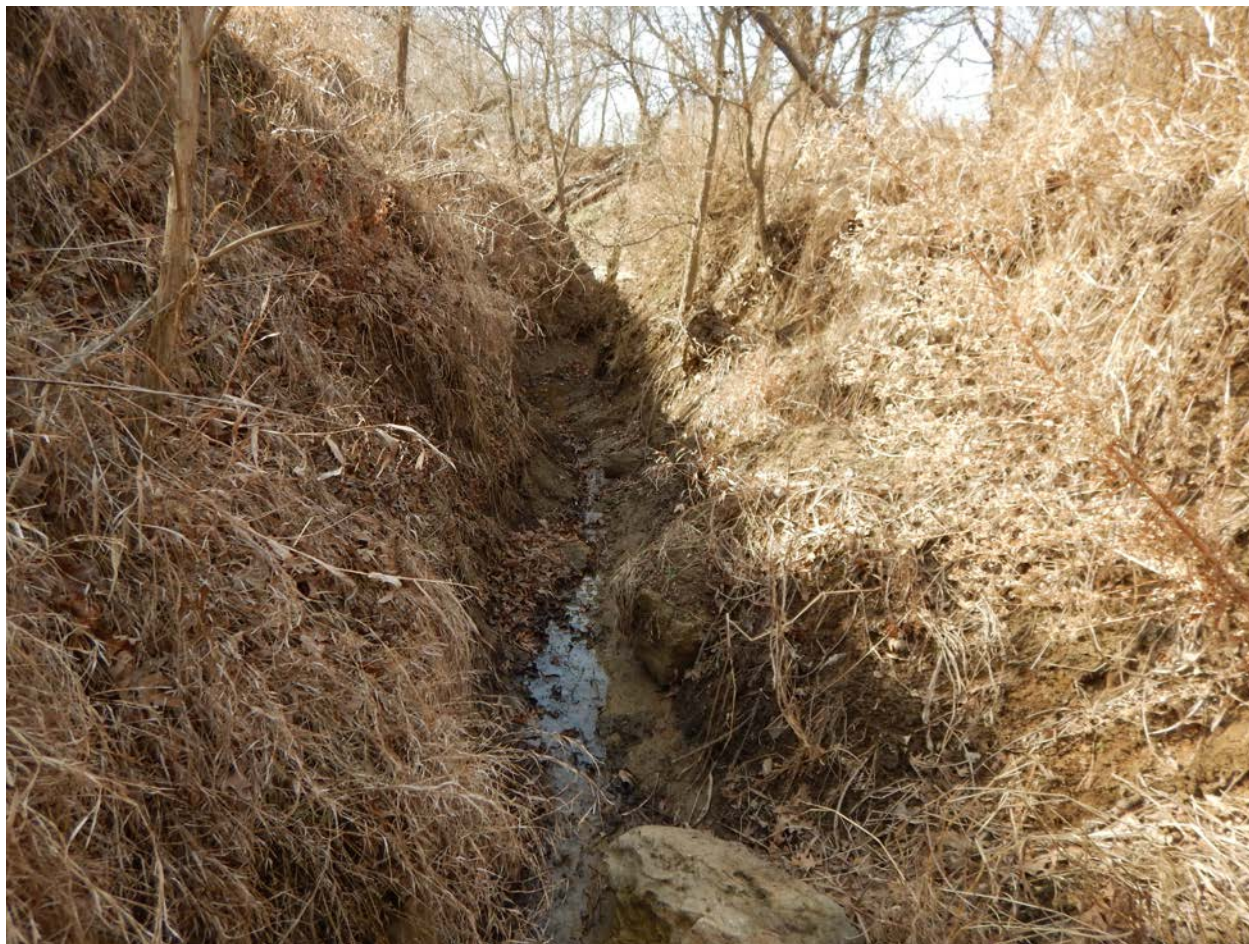
Photo No. 5

**Description:** This photo shows a downstream view of the tributary that flows west to Little Hominy Creek. During the inspection, the tributary had puddles of water that were observed and appeared not to be flowing during the time of the inspection. Conditions indicated water was flowing through this tributary were observed in the ravine of the tributary during the inspection.

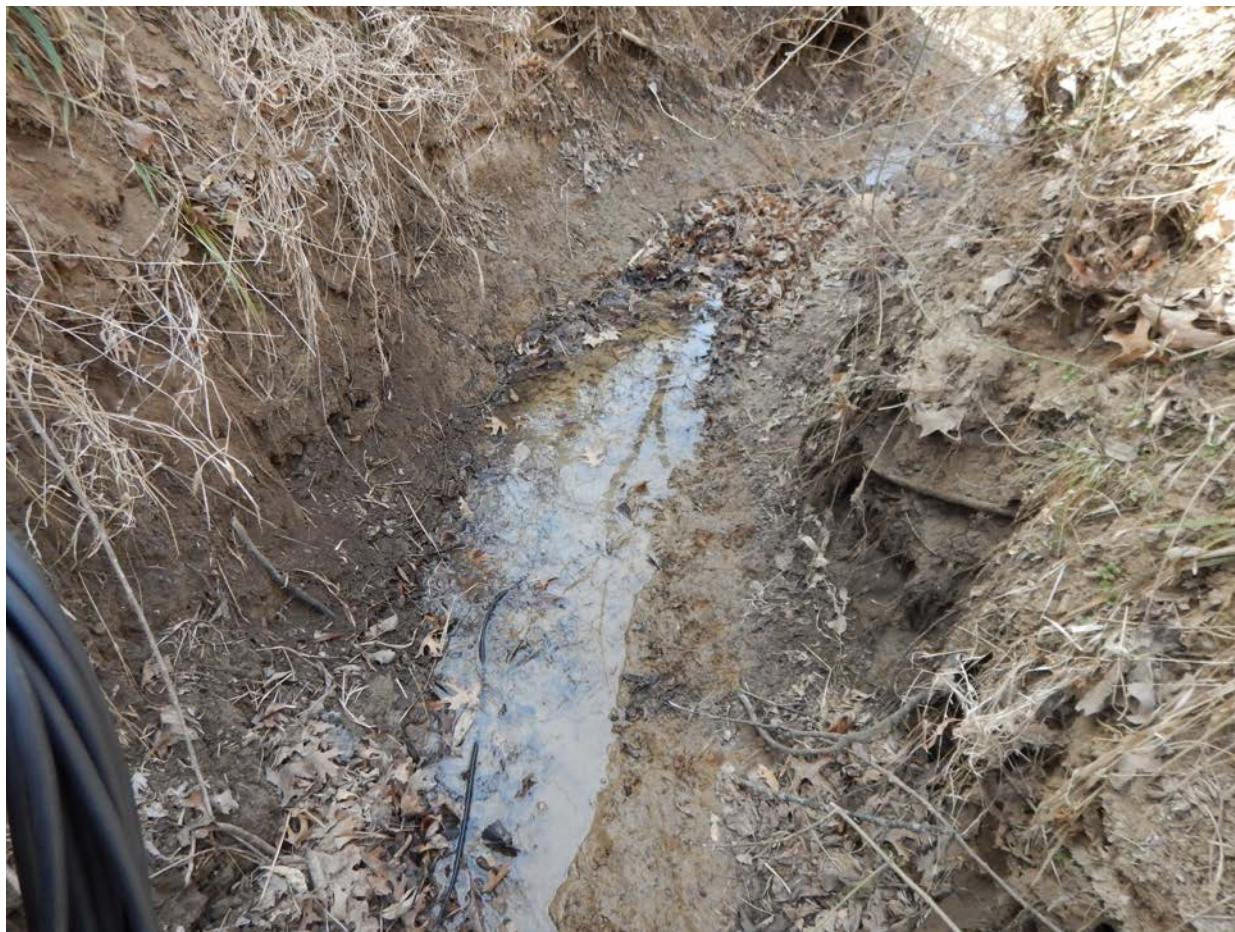
Photo No. 6

**Description:** This photo shows a downstream view of the tributary that flows west to Little Hominy Creek. During the inspection, the tributary had puddles of water that were observed and appeared not to be flowing during the time of the inspection. Conditions indicated water was flowing through this tributary were observed in the ravine of the tributary during the inspection. At this location, I was able to take a YSI Pro 30-meter reading.

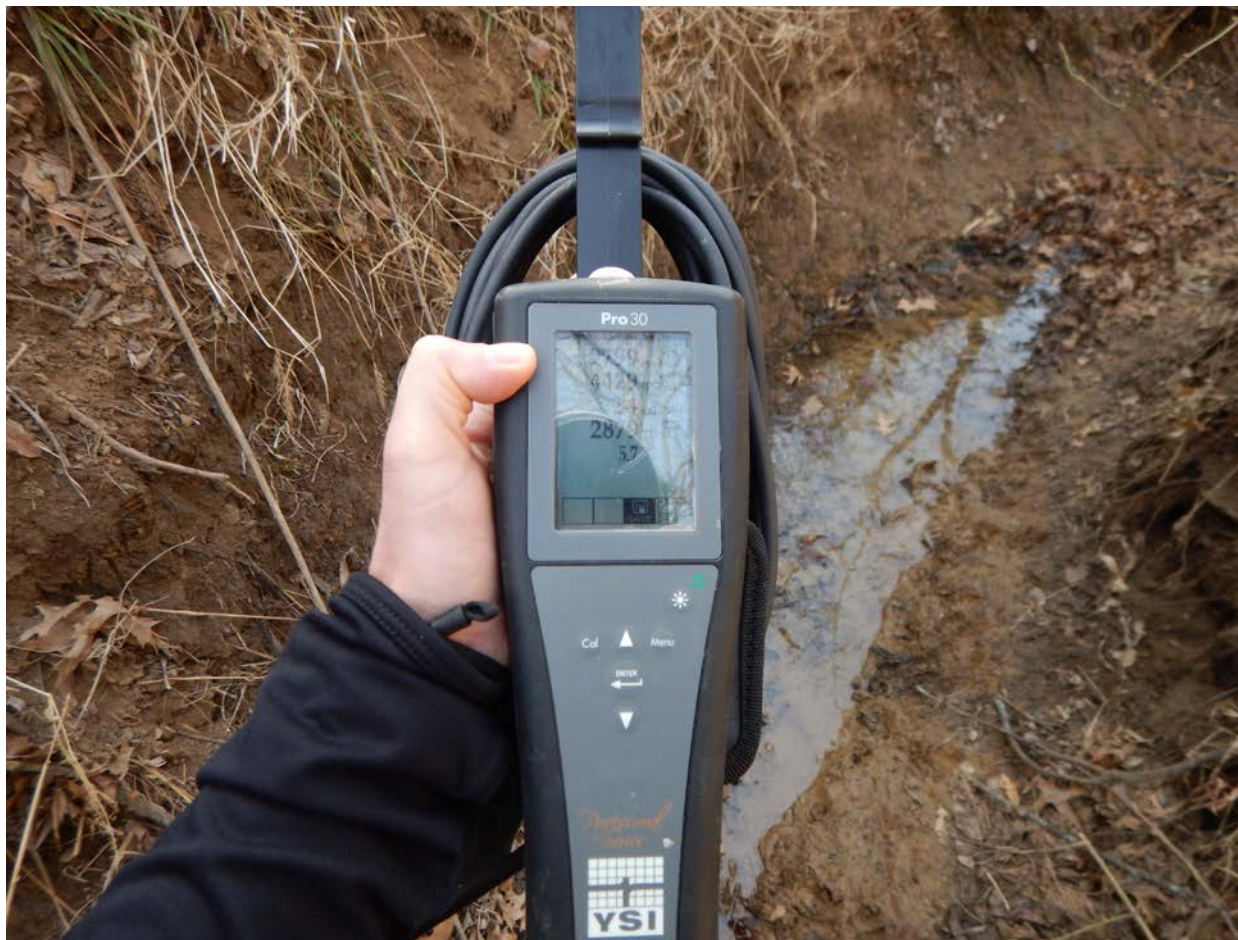
Photo No. 7

**Description:** This photo shows a picture of the meter reading at the downstream point in the tributary that flows west to Little Hominy Creek. This is the same location as Photo No. 6. During the inspection, the calibrated YSI Pro 30 conductivity meter measured 2,879 milligrams per liter (mg/L) Total Dissolved Solids (TDS) during the inspection.

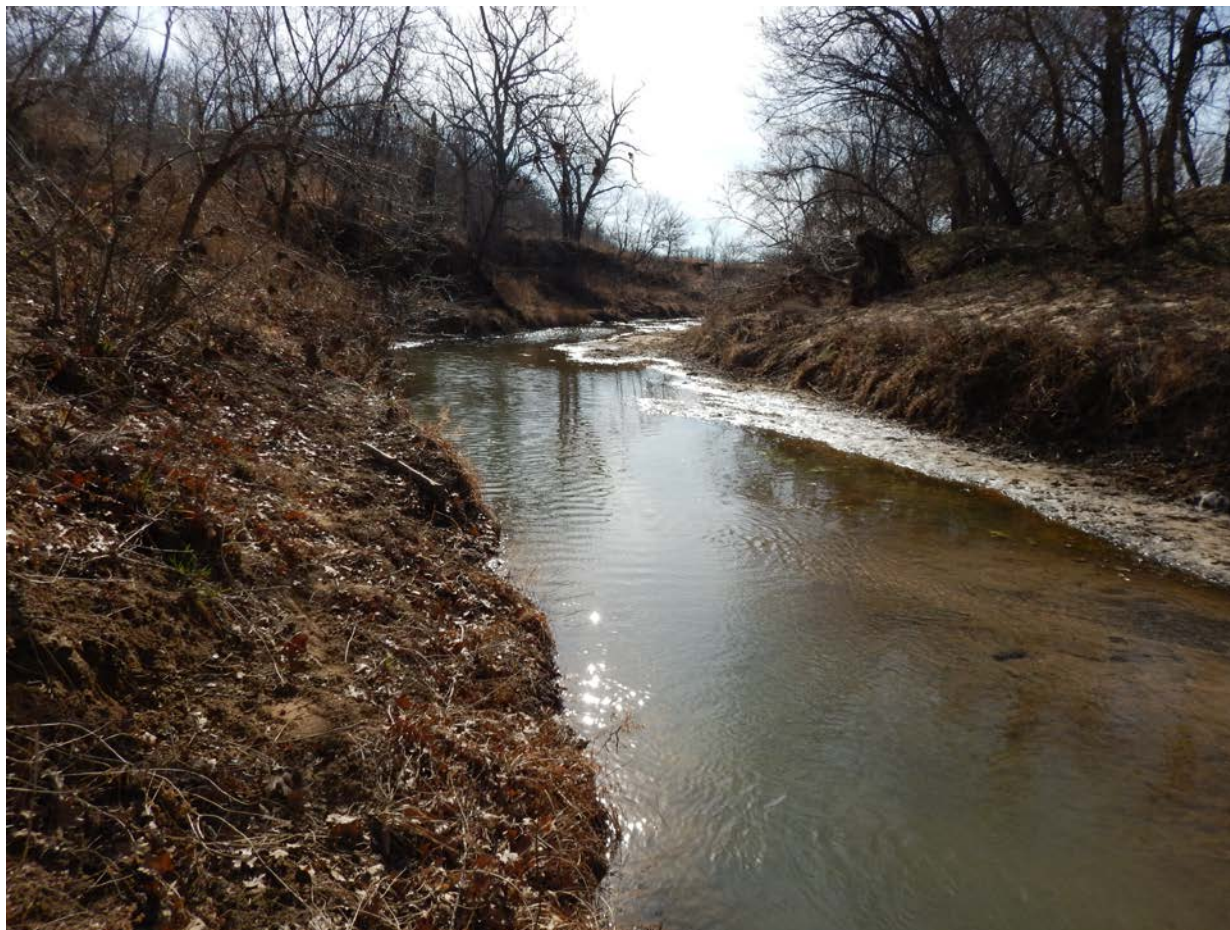
Photo No. 8

**Description:** This photo shows a downstream view of Little Hominy Creek during the inspection, at the point of entry where the tributary flows into Little Hominy Creek. Conditions indicated ongoing flow in this location of Little Hominy Creek were present, including flowing water, debris high water mark lines and tall bed/bank along the flowing creek during the inspection.

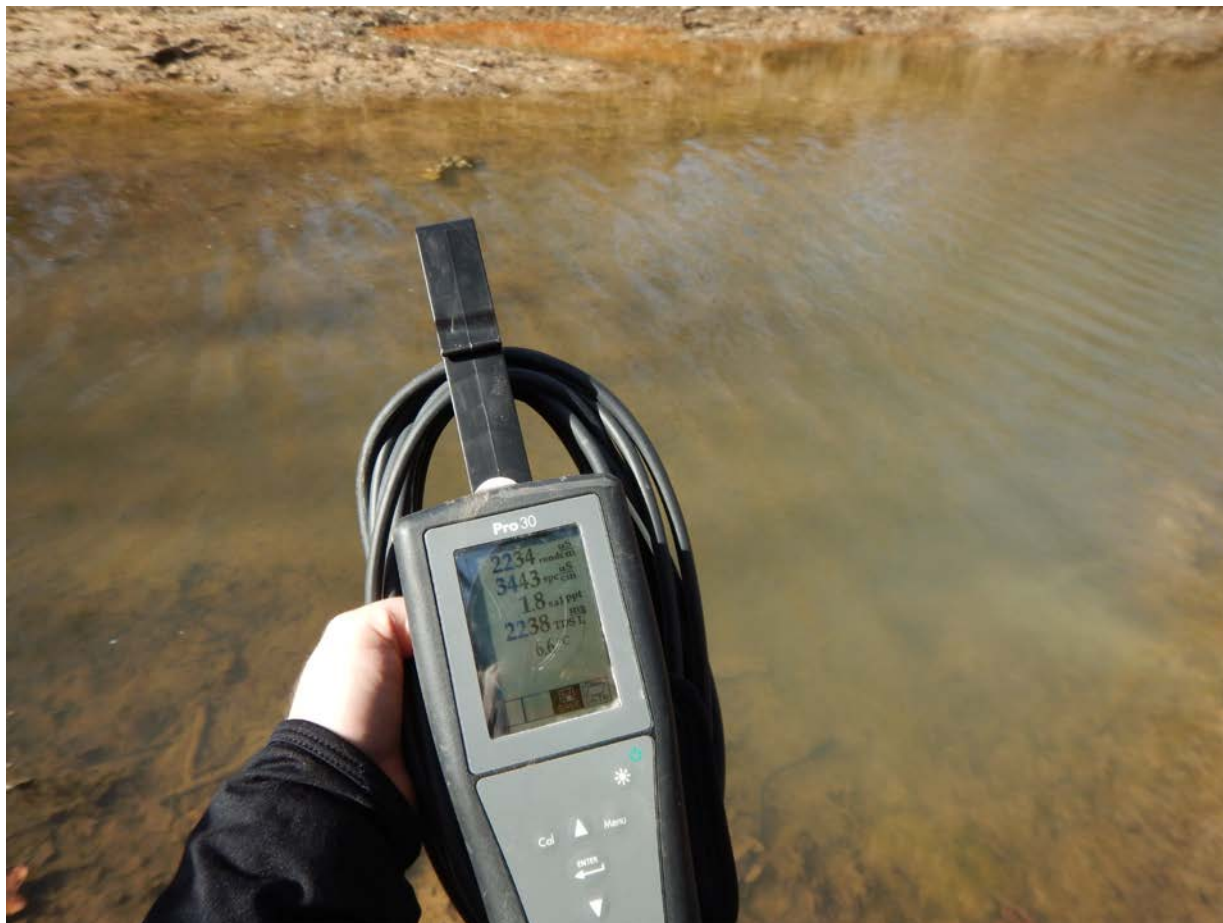
Photo No. 9

**Description:** This photo shows a picture of the meter reading at the downstream point in Little Hominy Creek after the confluence of the tributary with Little Hominy Creek that flows. This is the same location as Photo No. 8. During the inspection, the calibrated YSI Pro 30 conductivity meter measured 2,238 mg/L TDS during the inspection.

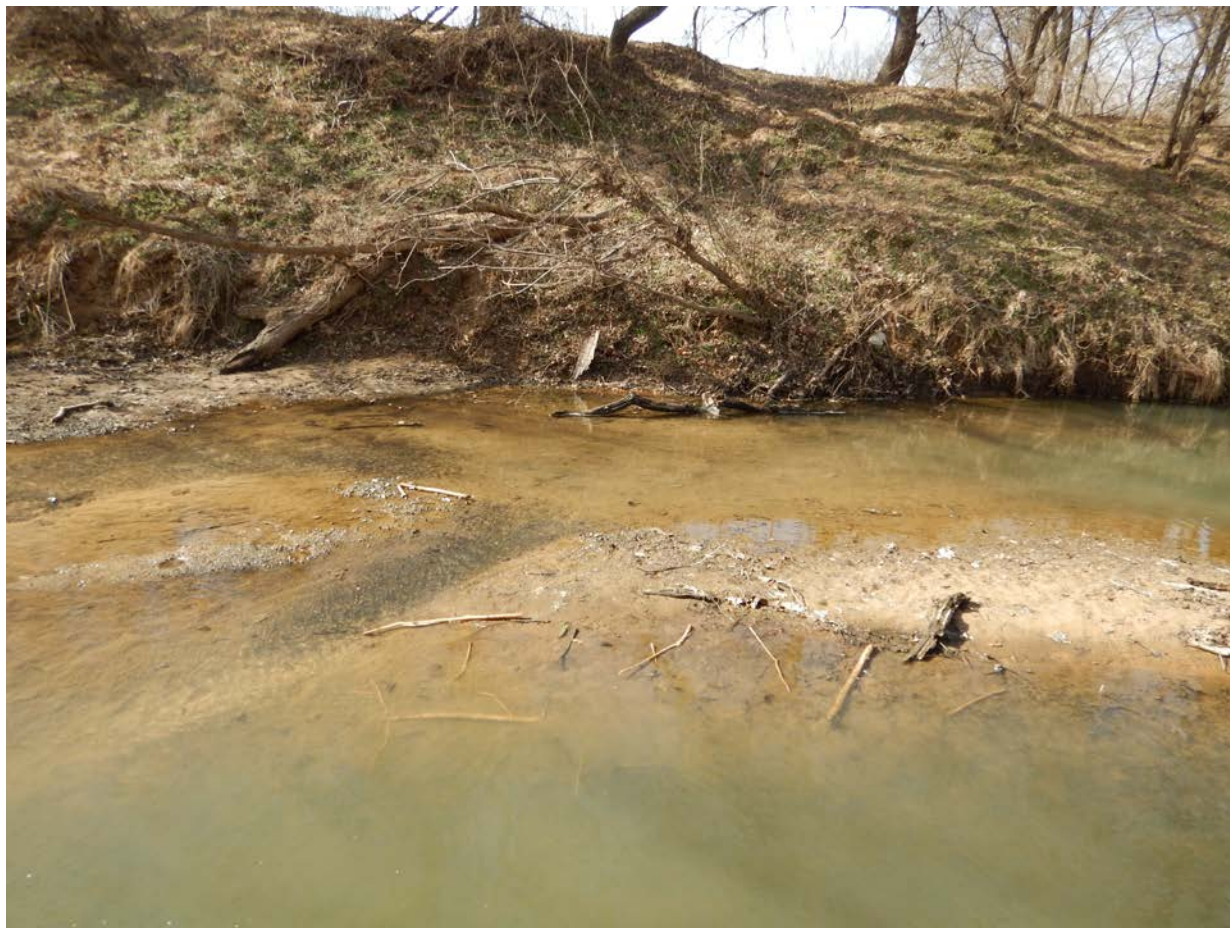
Photo No. 10

**Description:** This photo shows a cross section view of Little Hominy Creek, approximately 20 feet upstream from the location where Photo No. 8 was taken. Conditions indicated ongoing flow in this location of Little Hominy Creek were present, including debris high water mark lines and tall bed/bank along the flowing creek during the inspection. The creek at this point was approximately 25 feet across in width.

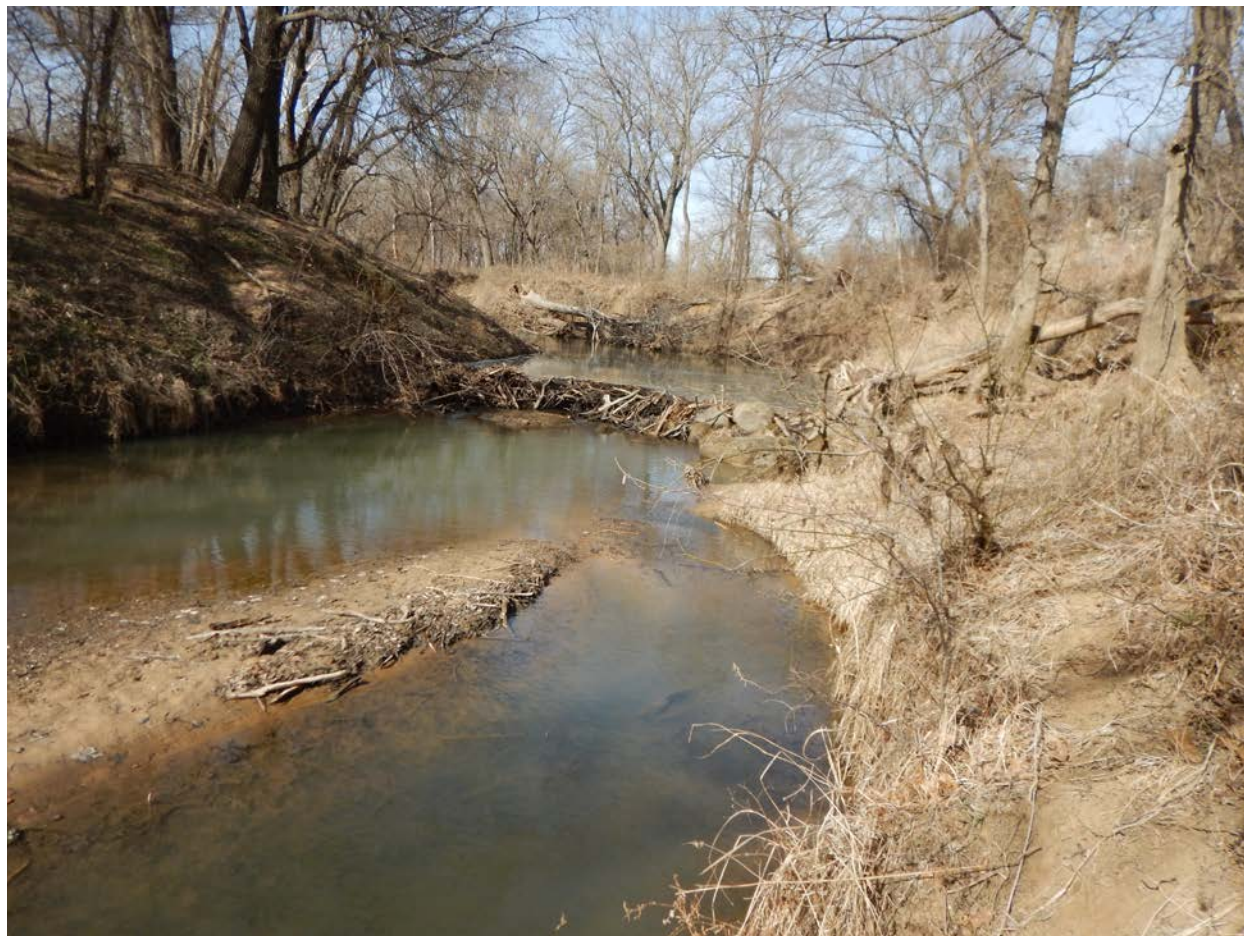
Photo No. 11

**Description:** This photo shows an upstream view of Little Hominy Creek, approximately 20 feet upstream from the location where Photo No. 7 was taken. Conditions indicated ongoing flow in this location of Little Hominy Creek were present, including debris high water mark lines and tall bed/bank along the flowing creek during the inspection. Debris dammed upstream was observed, blocking some flow downstream in Little Hominy Creek. The creek was flowing during the inspection.

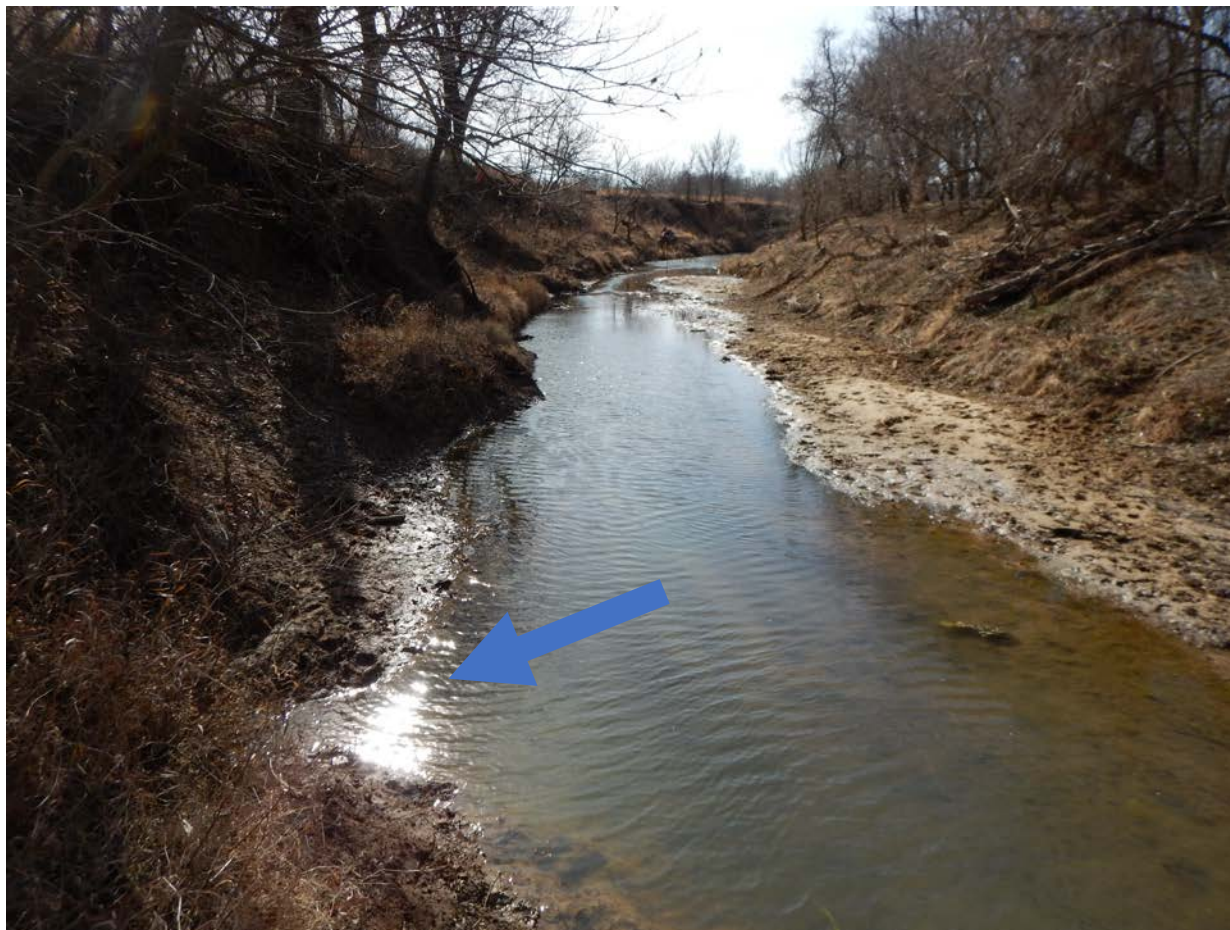
Photo No. 12

**Description:** This photo shows a downstream view of Little Hominy Creek, approximately 20 feet upstream from the location where Photo No. 7 was taken, which is above the confluence of the tributary where contamination was observed from the temporary flowline and Little Hominy Creek. Conditions indicated ongoing flow in this location of Little Hominy Creek were present, including debris high water mark lines and tall bed/bank along the flowing creek during the inspection. The confluence of the tributary and Little Hominy Creek is observed in this image, shown by the blue arrow that has been inserted. There was flow from the tributary into Little Hominy Creek during the time of the inspection.

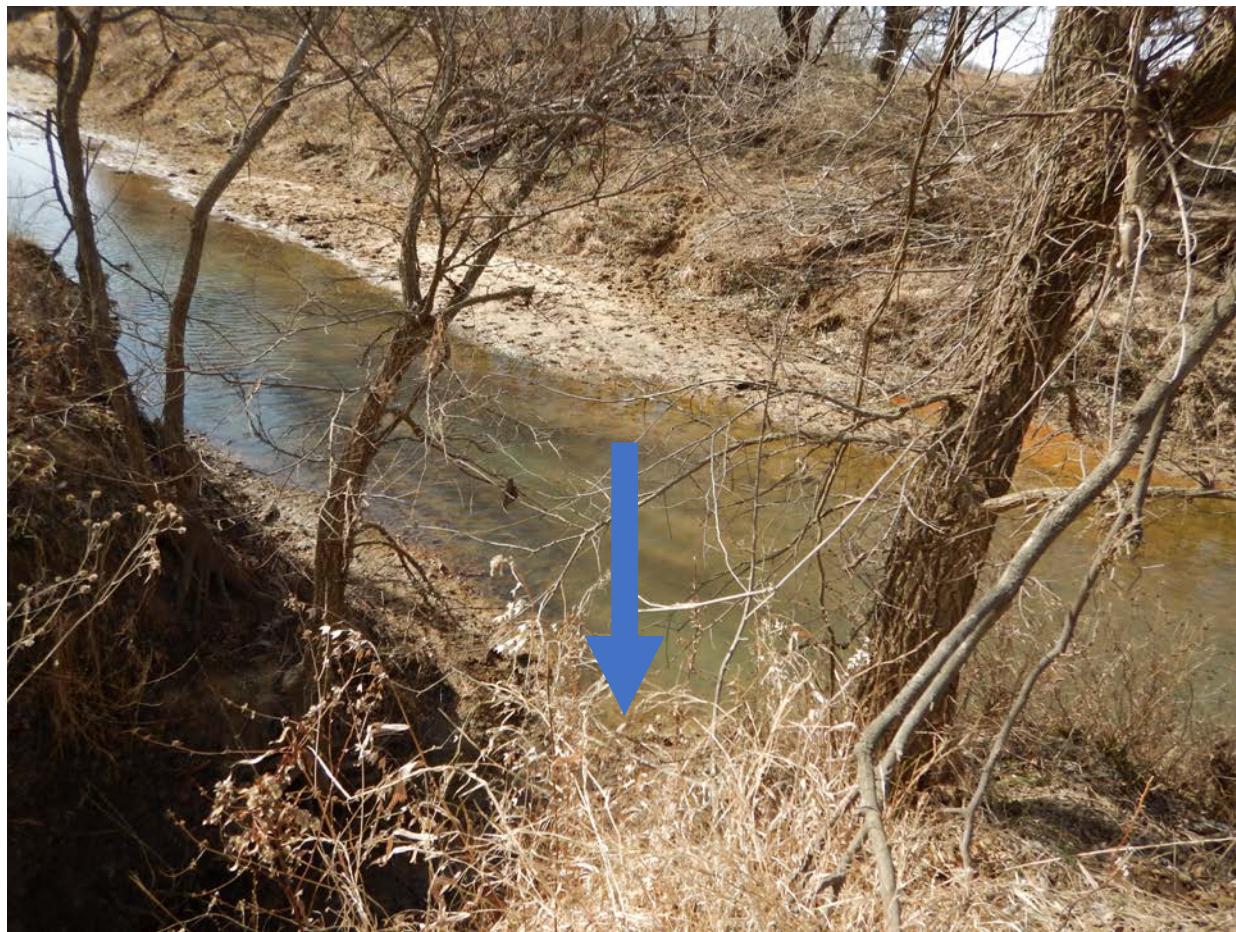
Photo No. 13

**Description:** This photo shows an additional view of the confluence of the tributary and Little Hominy Creek, described in Photo No. 12. The location where the image was taken was an overlook from above the creek confluence. A blue arrow has been inserted in the picture to indicate where the confluence was observed.

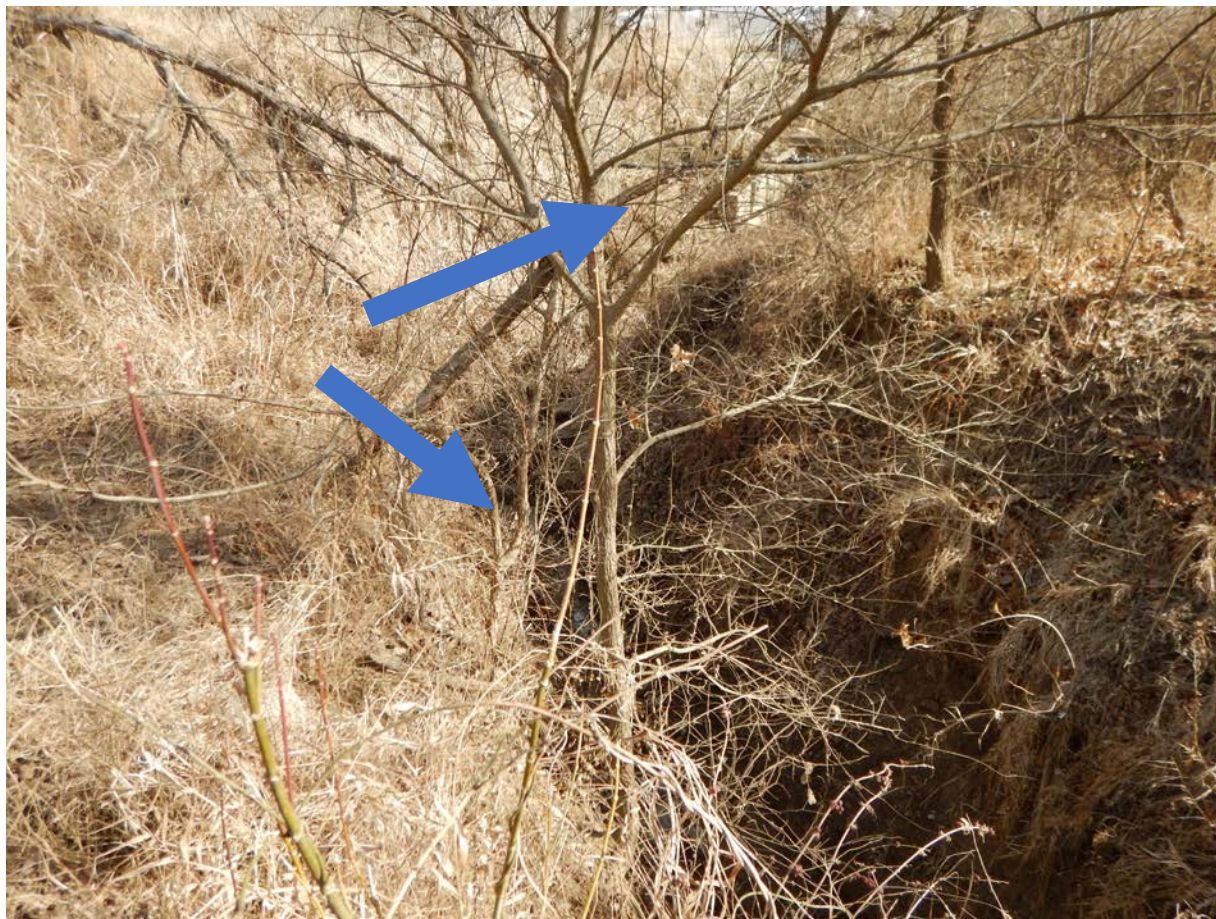
Photo No. 14

**Description:** This photo shows an upstream view of the tributary of Little Hominy Creek directly upstream from the confluence of the tributary with Little Hominy Creek shown in Photo No. 13. The location where the image was taken was an overlook from above the creek confluence. Two blue arrows have been inserted in the picture to indicate where the tributary was in the image through the vegetation observed. Some pooling of water was visible in this image during the time of the inspection and can be seen pointed to with the bottom blue arrow.

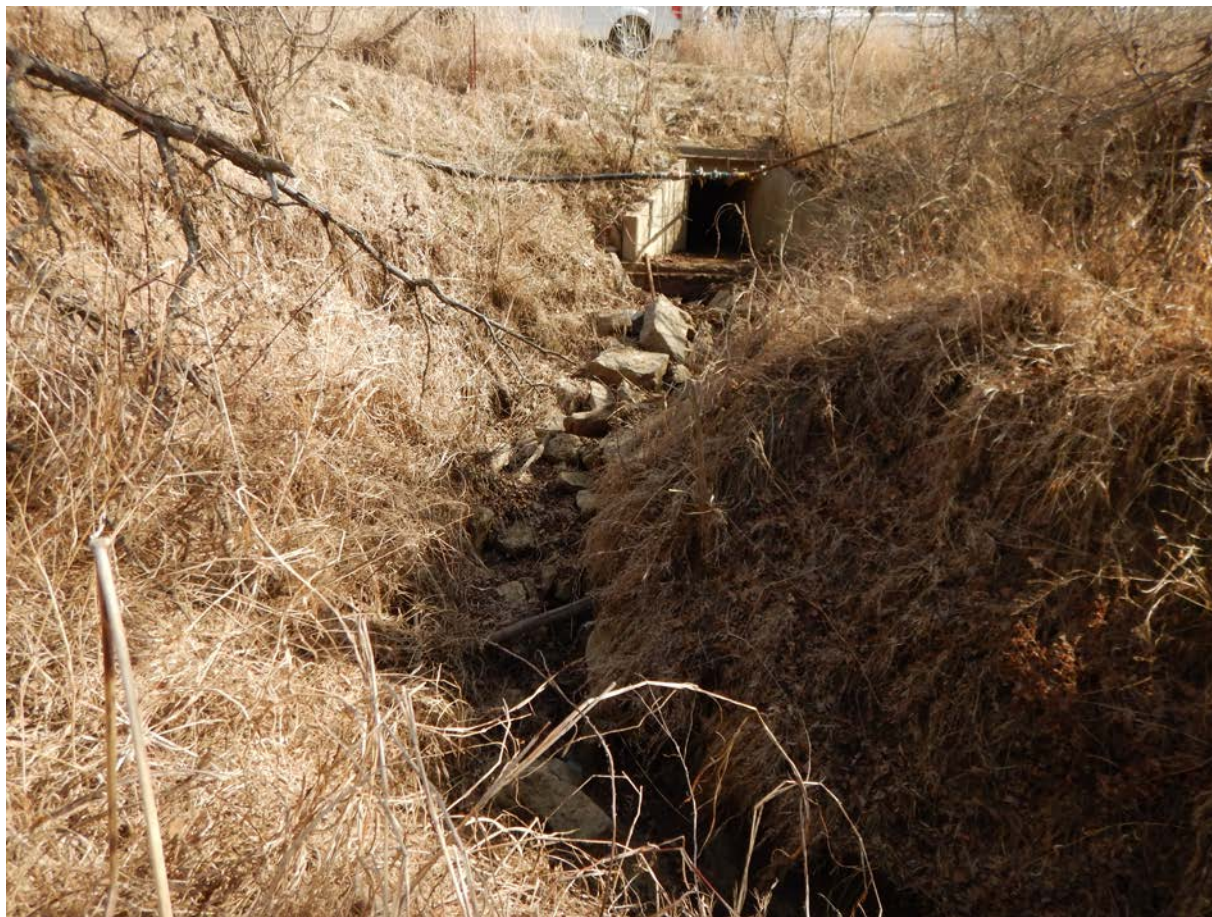
Photo No. 15

**Description:** This photo shows an upstream view of the tributary of Little Hominy Creek approximately 50 feet upstream from the discharge location shown in Photo Nos. 1-4 of this Photo Log. The location where the image was taken was an overlook from above the tributary. The bed of the tributary was observed here, as well as the man-made ditch under a county road. The flowline junction that was leaking with a drip is seen suspended over the ditch within the tributary. Large rocks and eroded bank walls were observed during the inspection.

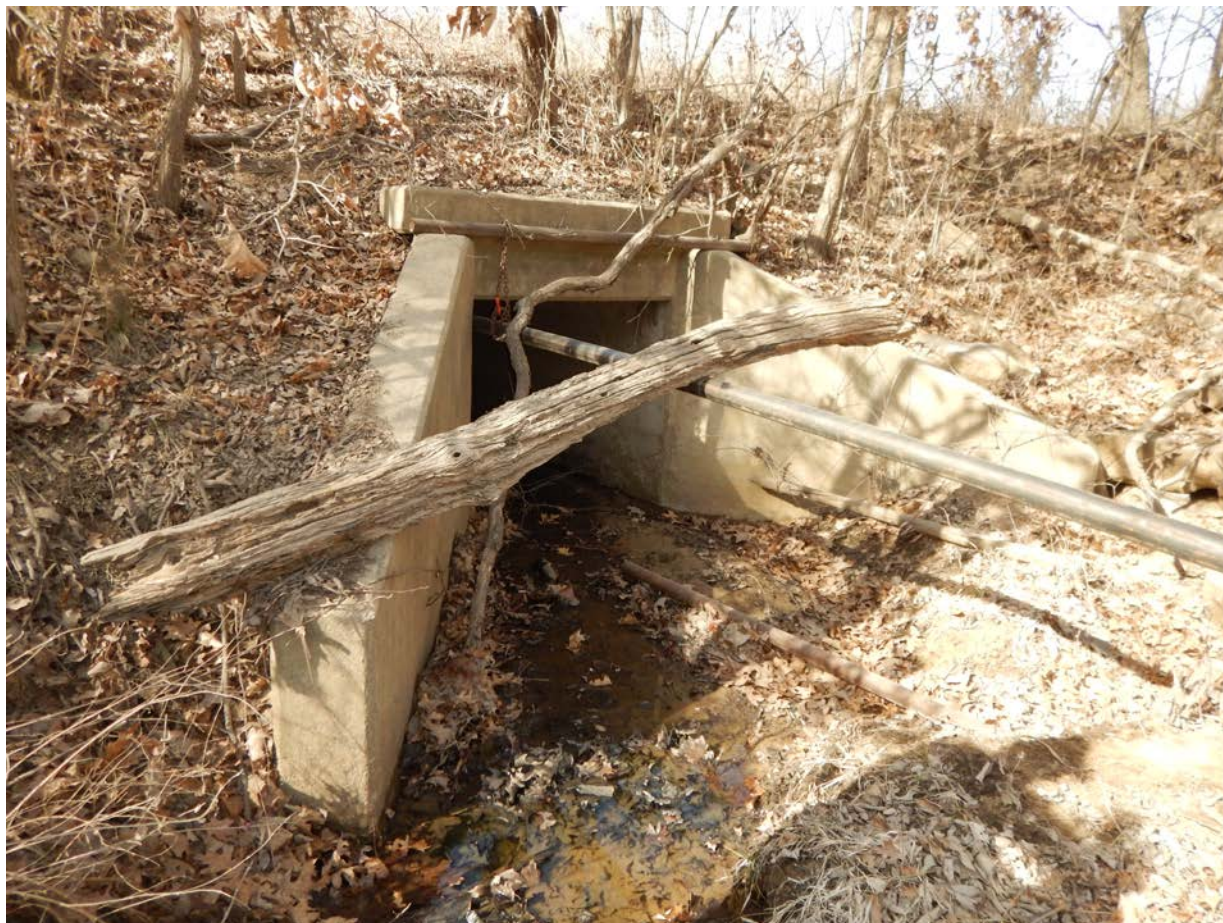
Photo No. 16

**Description:** This photo shows an upstream view of the man-made ditch, or culvert that connects the tributary underneath a county road. This location is the east side of the county road. The discharge location shown in Photo Nos. 1-4 is on the west side of this county road (downstream from Photo No. 16). This tributary flows west from this location to Little Hominy Creek. The flowline was suspended through the ditch with a small tree laying on top of the flowline.

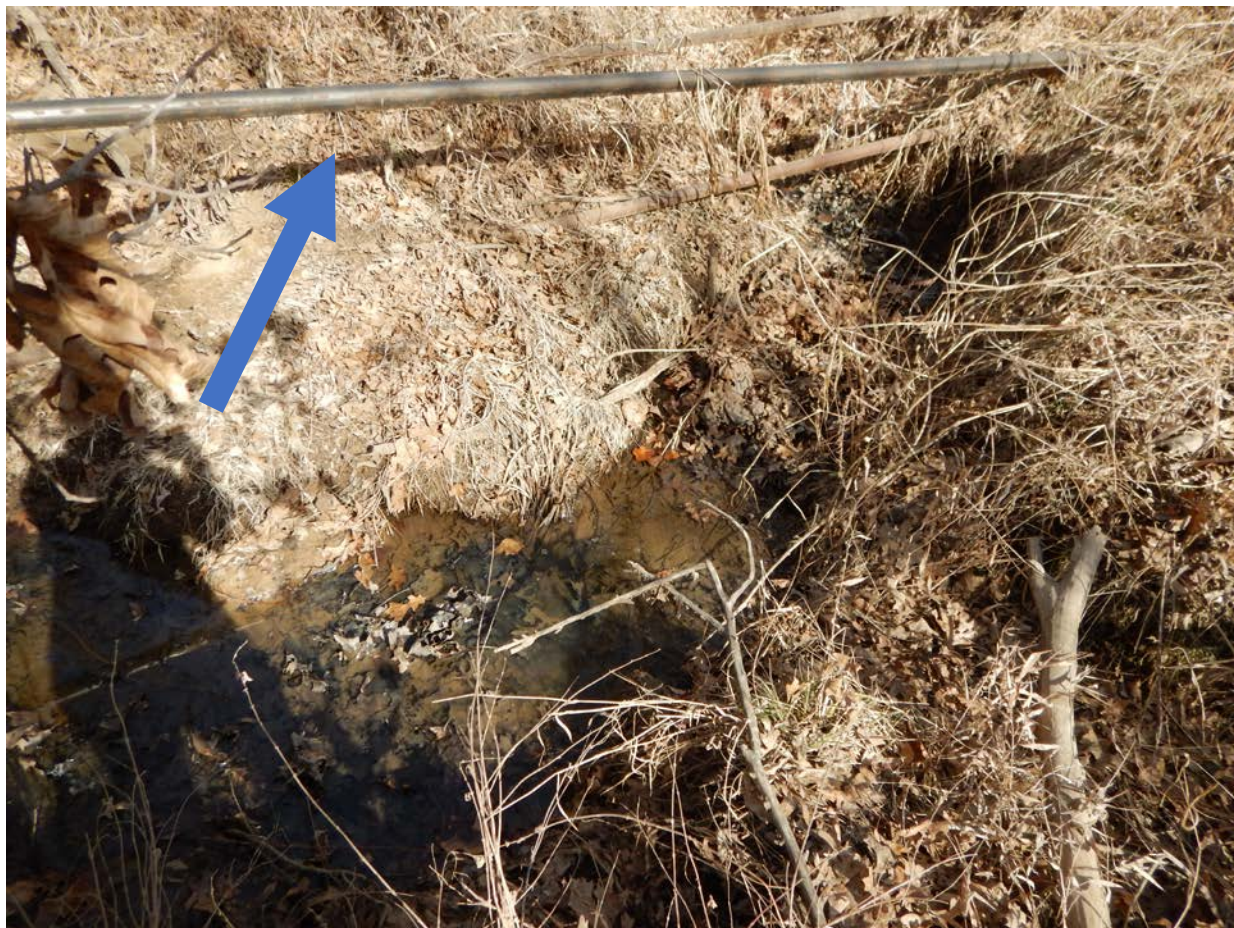
Photo No. 17

**Description:** This photo shows an additional view of the upstream location along the tributary of Little Hominy Creek. This upstream view of the tributary connects the flow from the tributary through a man-made ditch underneath a county road towards Little Hominy Creek. This tributary flows west from this location to Little Hominy Creek. The flowline was suspended through the ditch, which is identified by the blue arrow added to this picture.

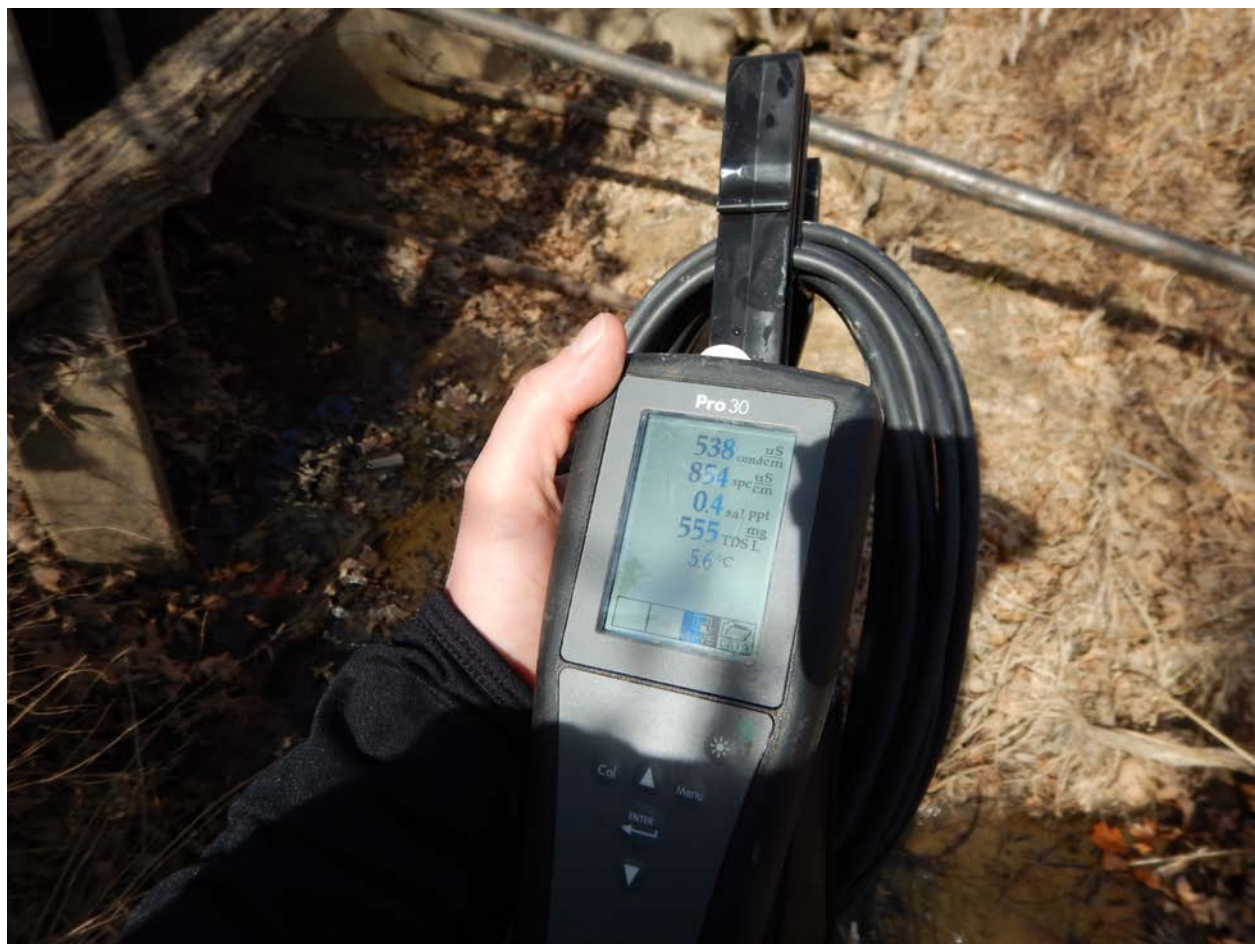
Photo No. 18

**Description:** This photo shows an additional view of the upstream location along the tributary of Little Hominy Creek. This upstream view of the tributary connects the flow from the tributary through a man-made ditch underneath a county road towards Little Hominy Creek. This tributary flows west from this location to Little Hominy Creek. The flowline was suspended through the ditch. I took a field meter reading with the calibrated YSI Pro 30 conductivity meter of 555 mg/L TDS. This field meter reading is similar to uncontaminated conditions in this watershed area, also called, "background."
