**Inspection Report Addendum for Well: MT20000-01153**  
**Inspection Date: 10/24/2023**

| <b>U.S. Environmental Protection Agency</b><br><b>Region 8</b> | | <b>UIC PHOTOGRAPHIC LOG</b> | |
| <b>Facility Location:</b><br>MT20000-01153 (9-W2), Glacier County, UT | | <b>Photographer:</b><br>Gary Wang | <b>Camera:</b><br>Ricoh WG-5 |

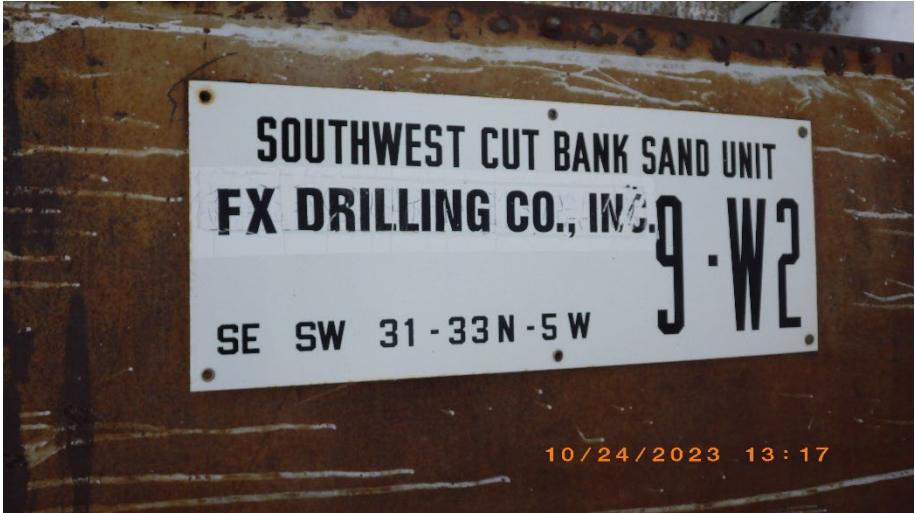
| <b>Photo No.</b><br>1 of 6 | <b>Time:</b><br>1:17 pm | | |

| <b>Photo Description:</b><br>Well sign by wellhead. | | | |

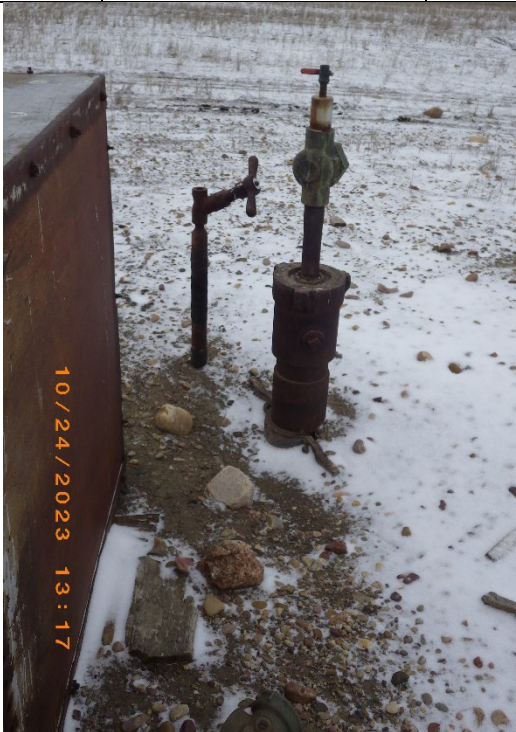
| <b>Photo No.</b><br>2 of 6 | <b>Time:</b><br>1:17 pm | | |

| <b>Photo Description:</b><br>Wellhead is observed to be disconnected from flowline (left of the well). | | | |

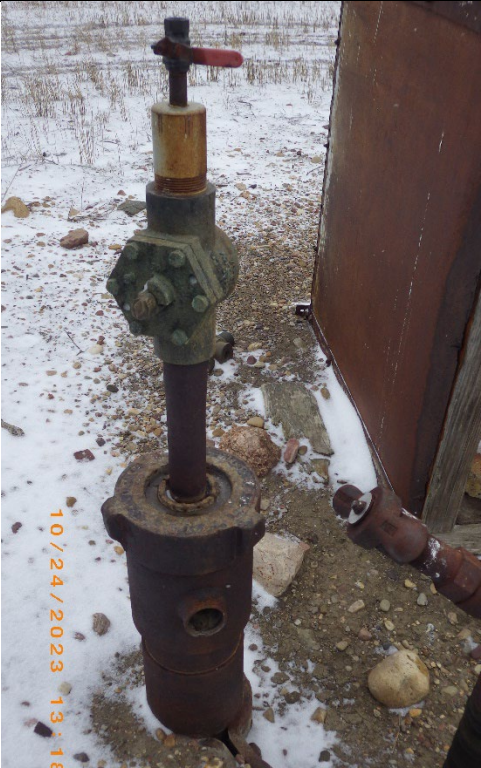
| <b>Photo No.</b><br>3 of 6 | <b>Time:</b><br>1:18 pm | | |

| <b>Photo Description:</b><br>Closer view of wellhead. Tubing master ball valve stem observed to be in open position. | | | |

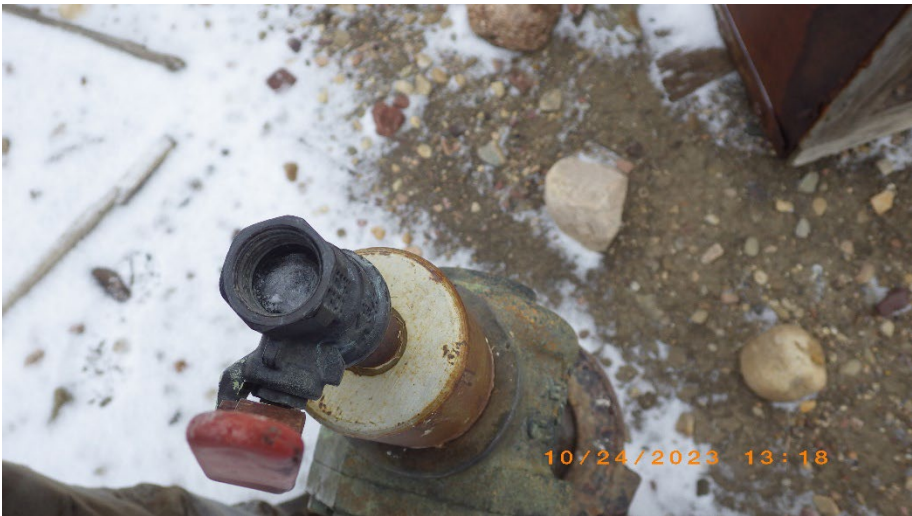
| <b>Photo No.</b><br>4 of 6 | <b>Time:</b><br>1:18 pm | | |

| <b>Photo Description:</b><br>Tubing was opened to atmosphere during inspection. However, valve was iced over, plugging communication to atmosphere. | | | |

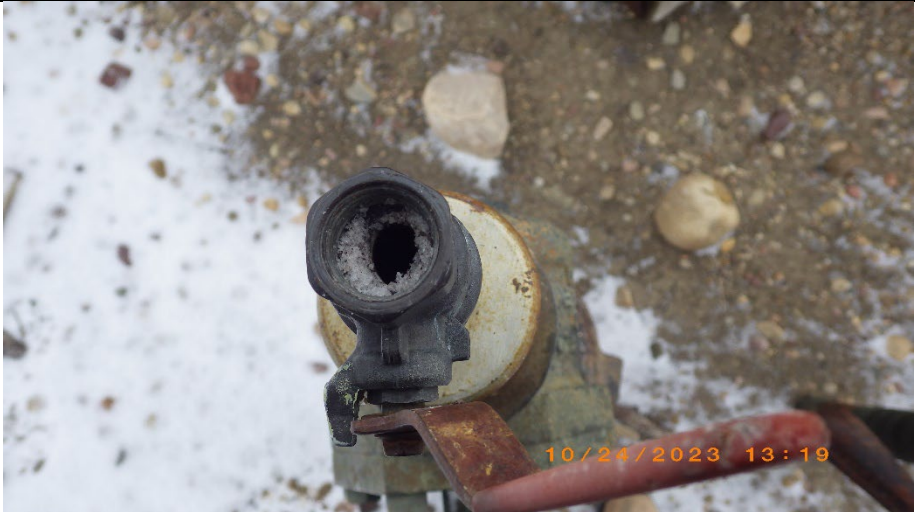
| <b>Photo No.</b><br>5 of 6 | <b>Time:</b><br>1:19 pm | | |

| <b>Photo Description:</b><br>Ice plug was removed to expose tubing to atmosphere. No pressure was observed in tubing. | | | |

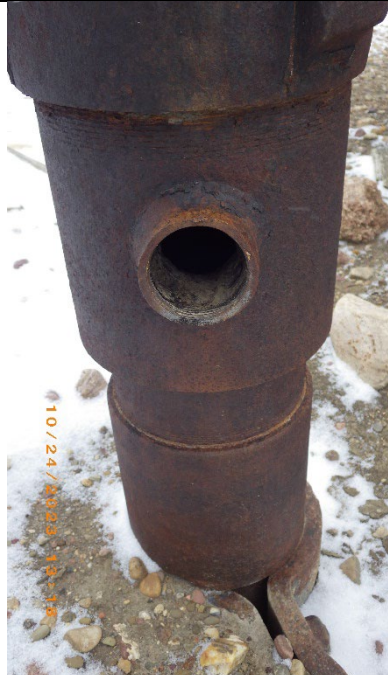
| <b>Photo No.</b><br>6 of 6 | <b>Time:</b><br>1:18 pm | | |

| <b>Photo Description:</b><br>Tubing-casing annulus observed to be maintained continuously open to atmospheric pressure. | | | |
