Kempenaar Real Estate, Ltd/Still Meadow Dairy  
Inspection Date 03/29/2022

**Region 6 - Enforcement & Compliance Assurance Division**  
**INSPECTION REPORT**

| Facility Name: | <b>Still Meadow Dairy</b> | |
| Identification/Permit Number: | TXG920117 | |

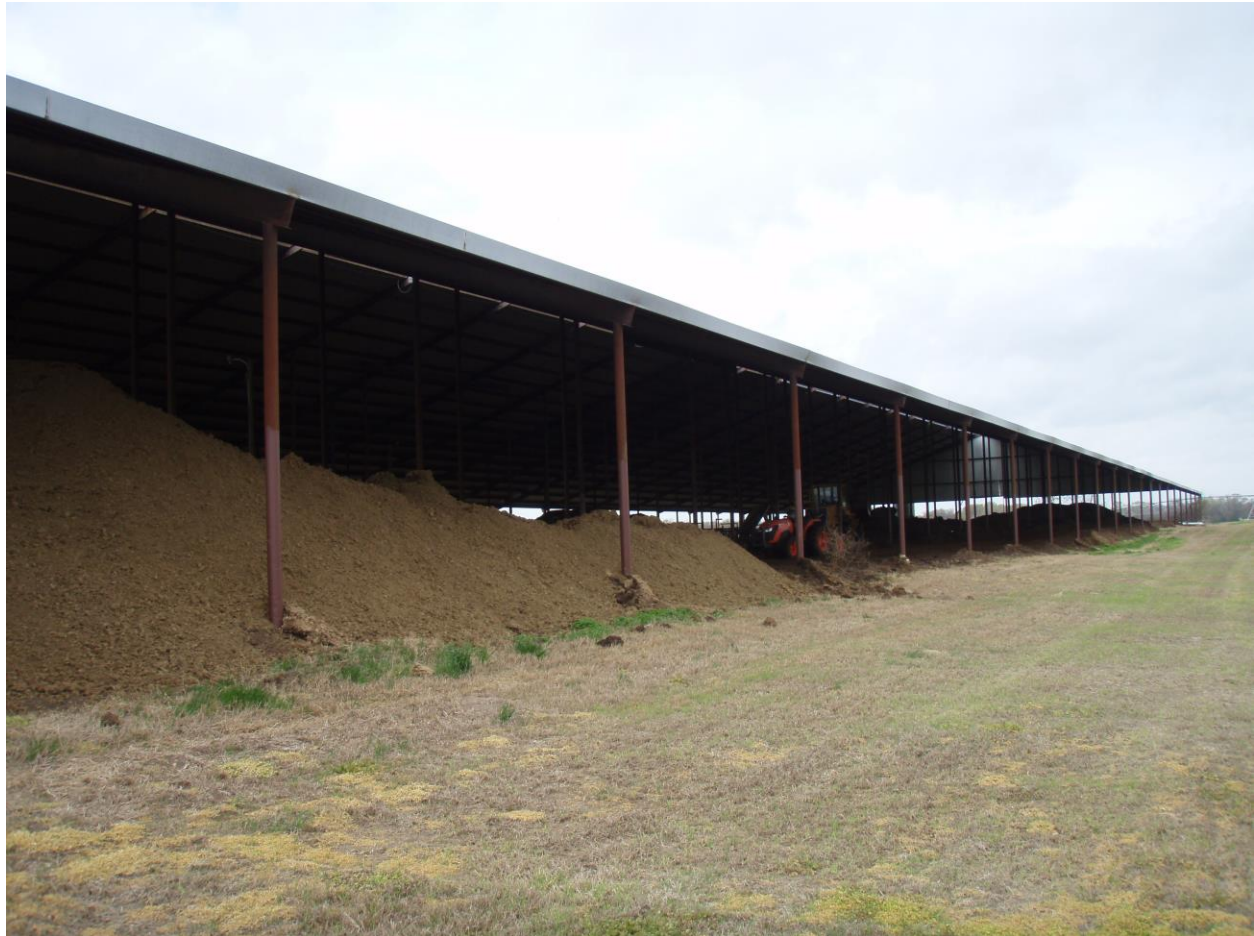
Photo No. 1

Description: The manure composting area located on the former Hux Dairy. The composting is taking place within a former freestall barn, under cover in a very large pasture. The view is toward the north-northwest.

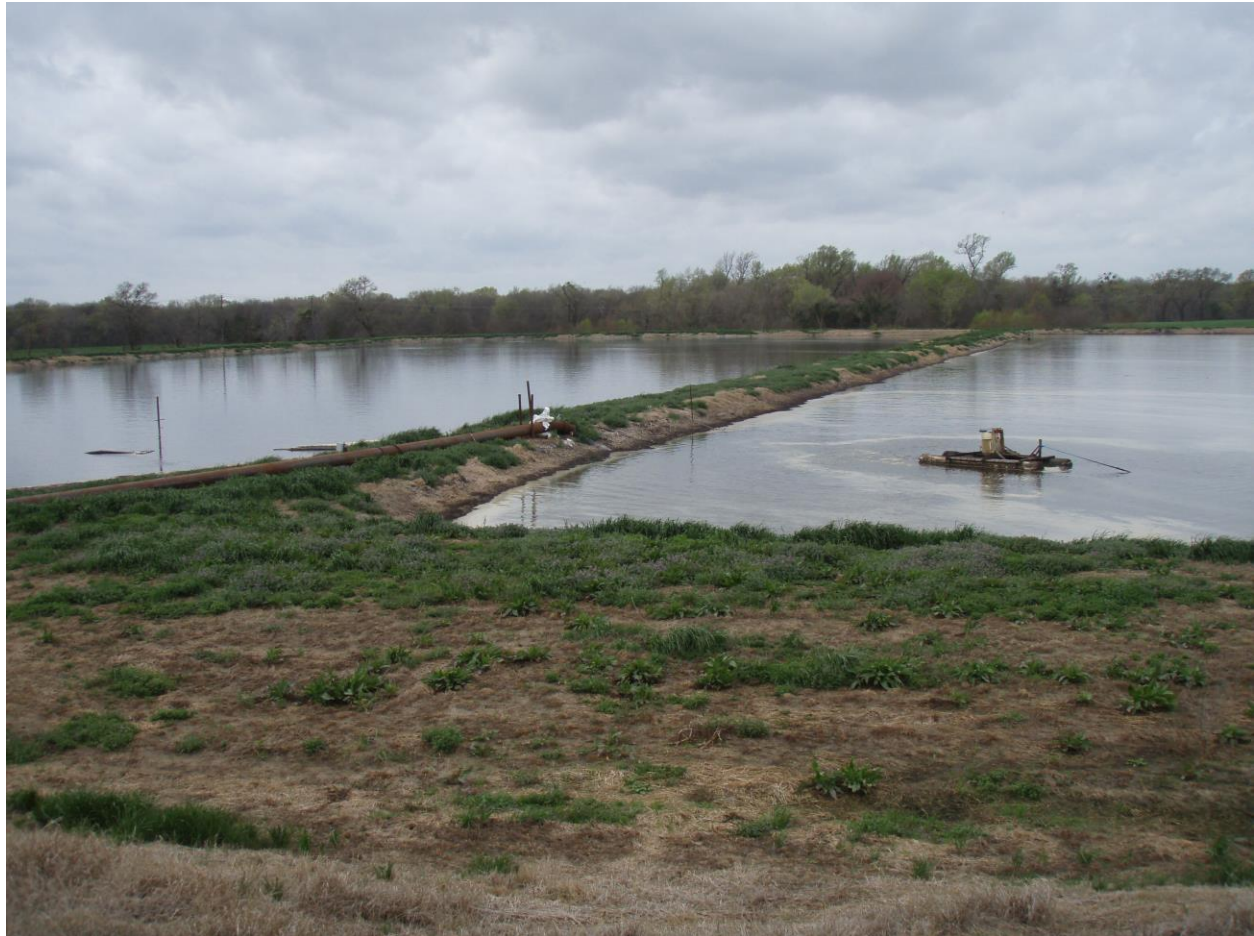
Photo No. 2

Description: RCS 2 and 3, located on the right and left respectively. Each unit has approximately 4' of freeboard, and the pole marker is seen in RCS 3. The view is toward the west-southwest.

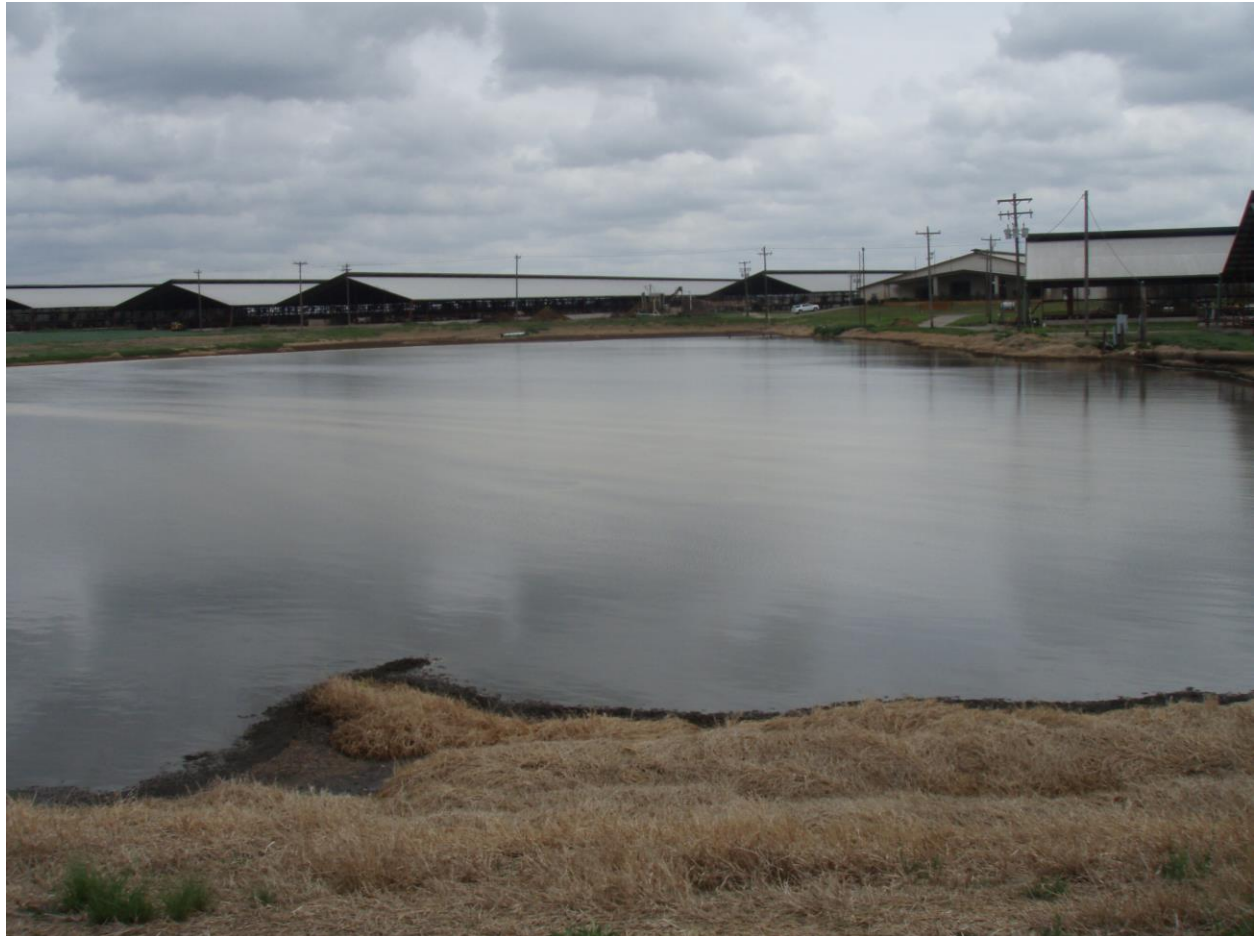
Photo No. 3

Description: RCS 1 which had about 2' of freeboard, and several freestalls and the manure screen in the background. The view is toward the east.
