AIR SAMPLING  
&  
INDUSTRIAL HYGIENE SURVEY

GENUINE PARTS COMPANY  
RAYLOC DIVISION  
ATLANTA, GEORGIA

August, 1972

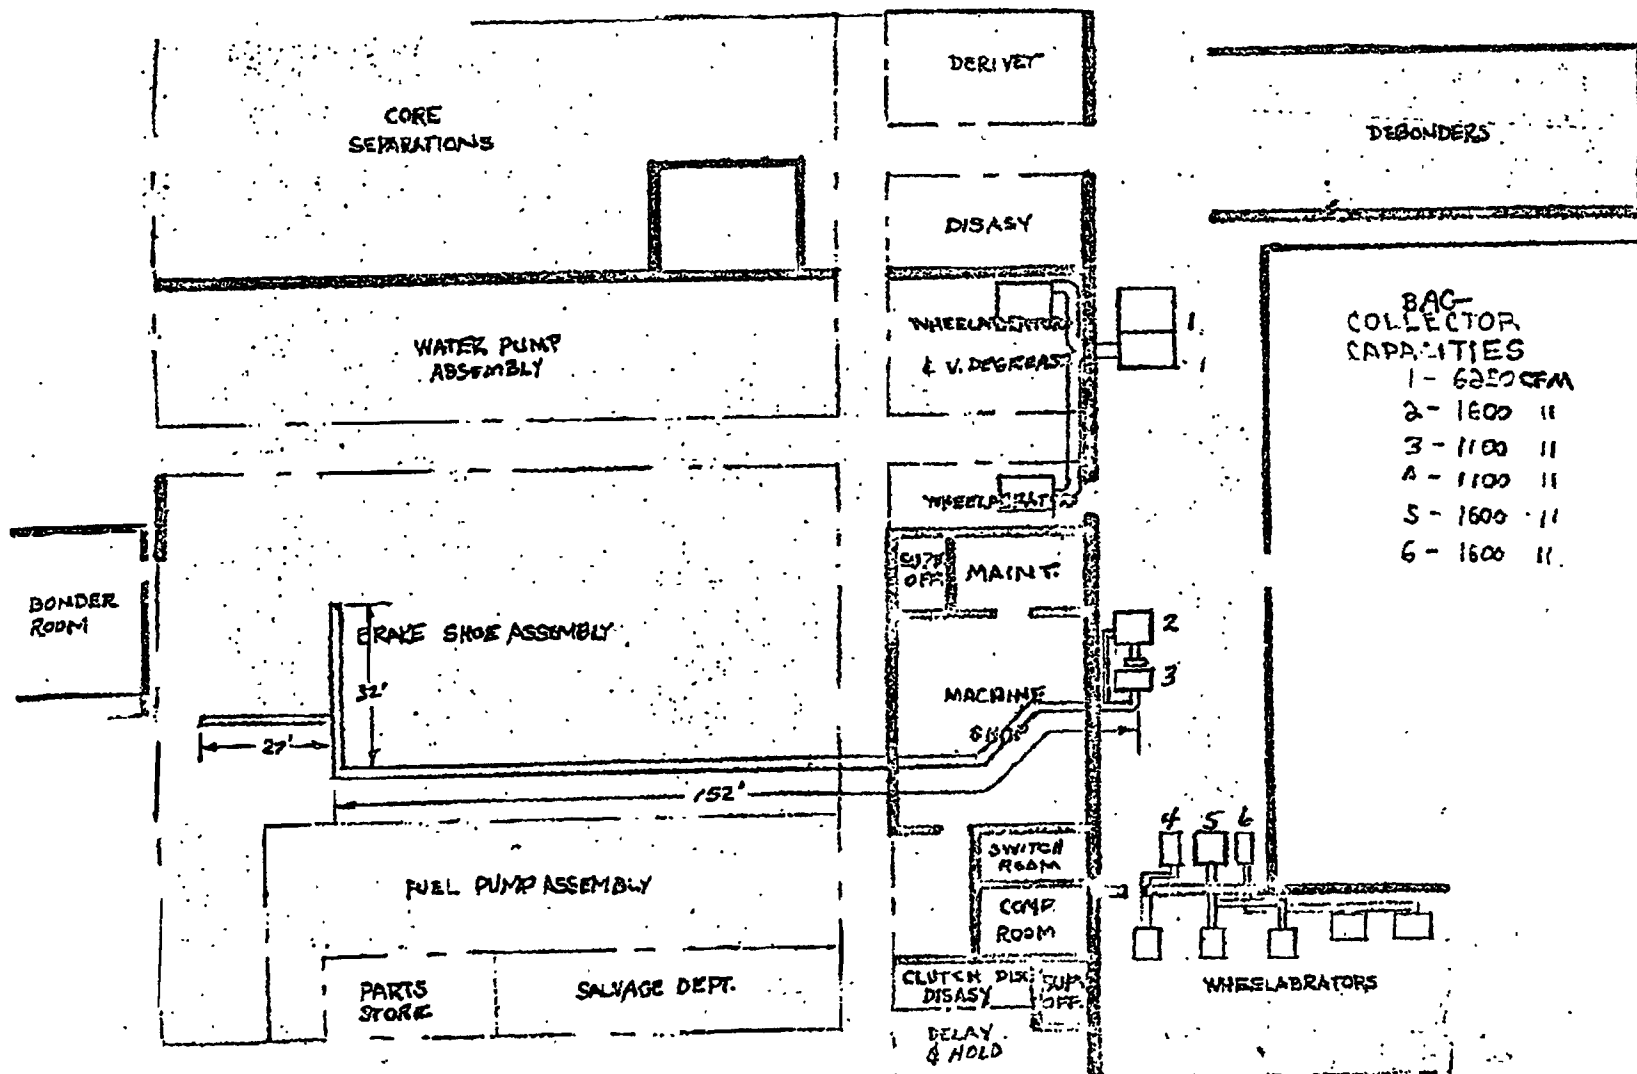
FIGURE 1: FRICTION PRODUCT LAYOUT WITH COLLECTORS

Figure 1 shows a layout of the friction products area of the plant along with locations of the dust collectors and their respective capacities.

Velocity measurements at the entrance to the grinder hoods showed velocities ranging from 600 fpm to 1100 fpm. No ventilation is provided at the clutch deriveting operation.
