**Region 6 - Enforcement & Compliance Assurance Division**  
**INSPECTION REPORT**

| <b>Inspection Dates:</b> | 7/28/2025 and 7/29/2025 | |
| <b>Company Name:</b> | <b>Duncan Public Utilities Authority – Public Water System</b> | |
| <b>Facility Name:</b> | <b>Duncan Public Utilities Authority</b> | |

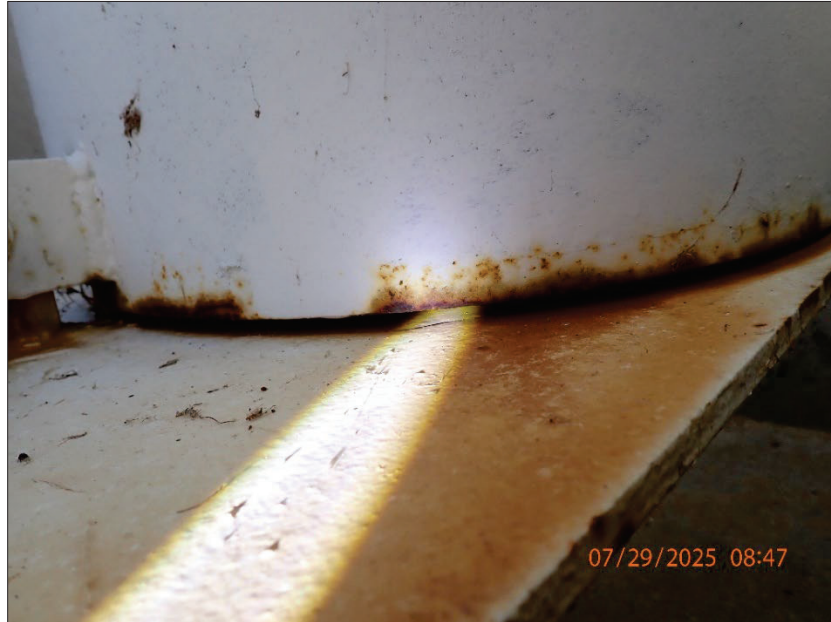
**Photograph 1. 7/29/2025 08:47 P7290243.JPG Duncan WTP Backwash Tank**  
**Description:** Metal flapper on the end of the overflow line on the backwash supply tank that does not create a proper seal.

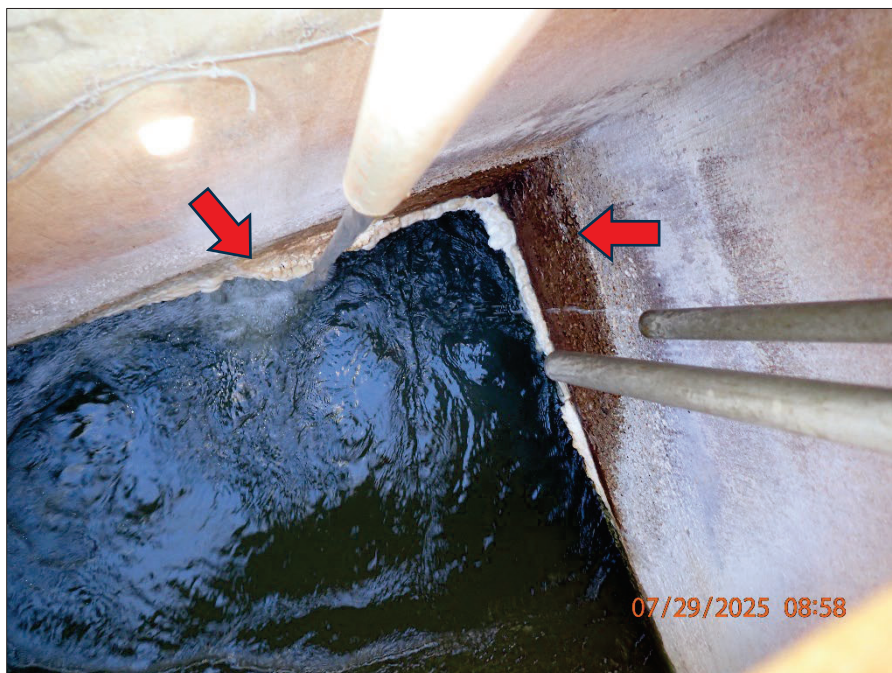
**Photograph 4. 7/29/2025 08:58 P7290263.JPG Duncan WTP Flash Mixer**  
**Description:** ACH and Polymer injection points into the flash mixer. Note the proximity to the concrete wall, chemical buildup on the wall, and erosion of the concrete.

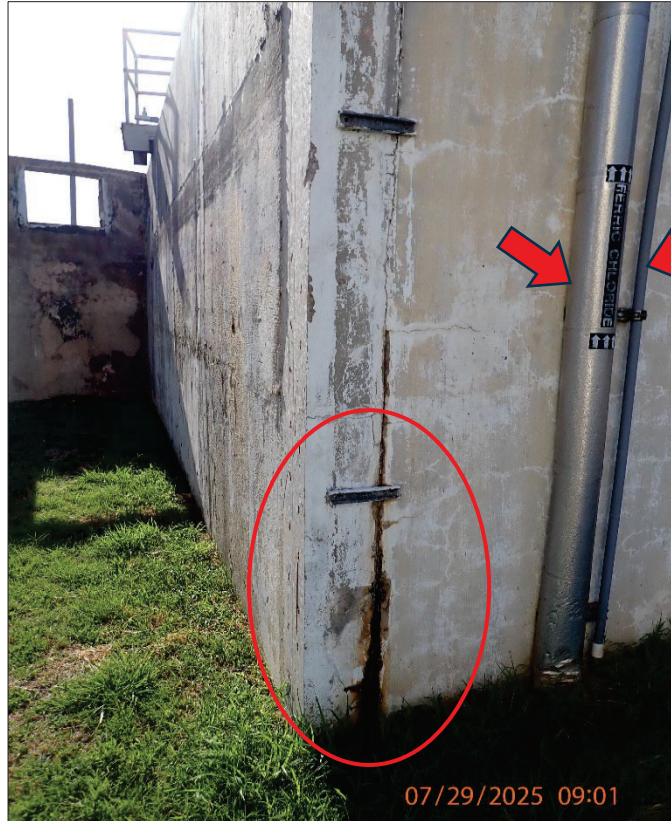
**Photograph 5. 7/29/2025 09:01 P7290269.JPG Duncan WTP Flash Mixer**

**Description:** Cracking of the outer concrete wall of the flash mix basin at the WTP, called out with red circle. ACH and Polymer feed lines not appropriately labeled, shown with red arrows.

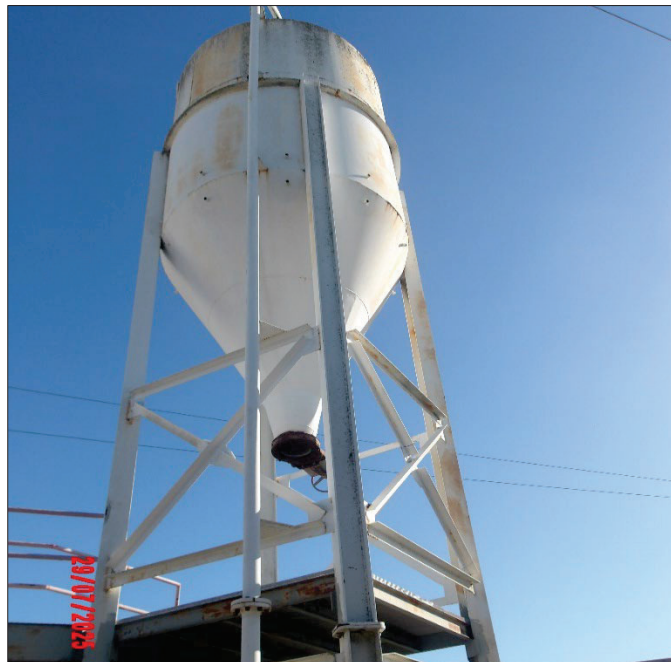
**Photograph 6. 7/29/2025 08:04 100\_0008.JPG Duncan WTP PAC Tank**

**Description:** Powdered activated carbon storage tank that was built and then abandoned.

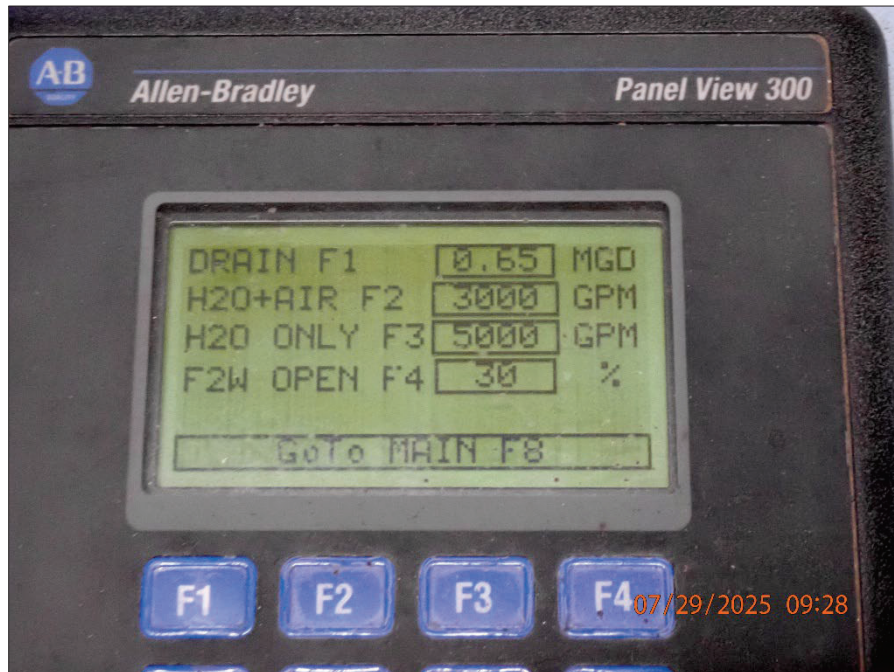
**Photograph 7. 7/29/2025 09:28 P7290309.JPG South Plant Filter 5**

**Description:** Filter backwash stages and flowrates. Note the absence of a low-rate wash after the high-rate wash.

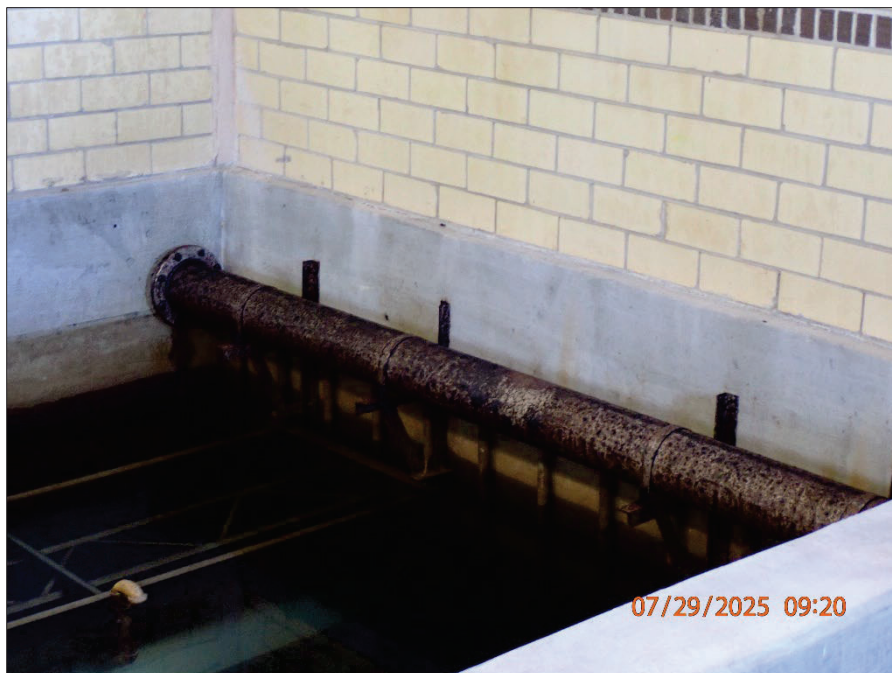
**Photograph 8. 7/29/2025 09:20 P7290302.JPG South Plant Filter 5**

**Description:** Heavily corroded air scour piping at the Water Treatment Facility.

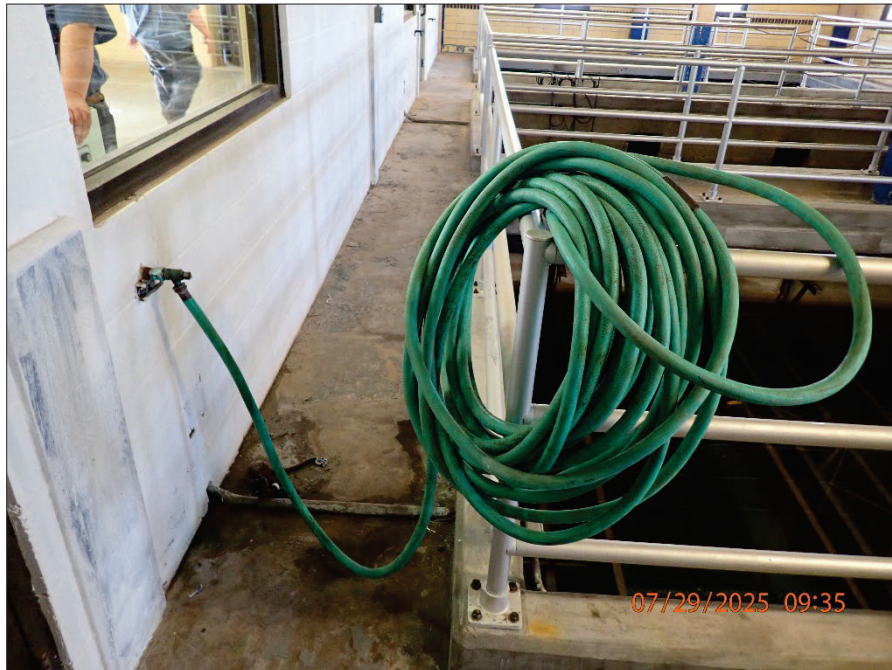
**Photograph 9. 7/29/2025 09:35 P7290322.JPG South Plant Filter 1 & 2**

**Description:** Garden hose connected to hose bib without vacuum breaker at the South Plant Filters.

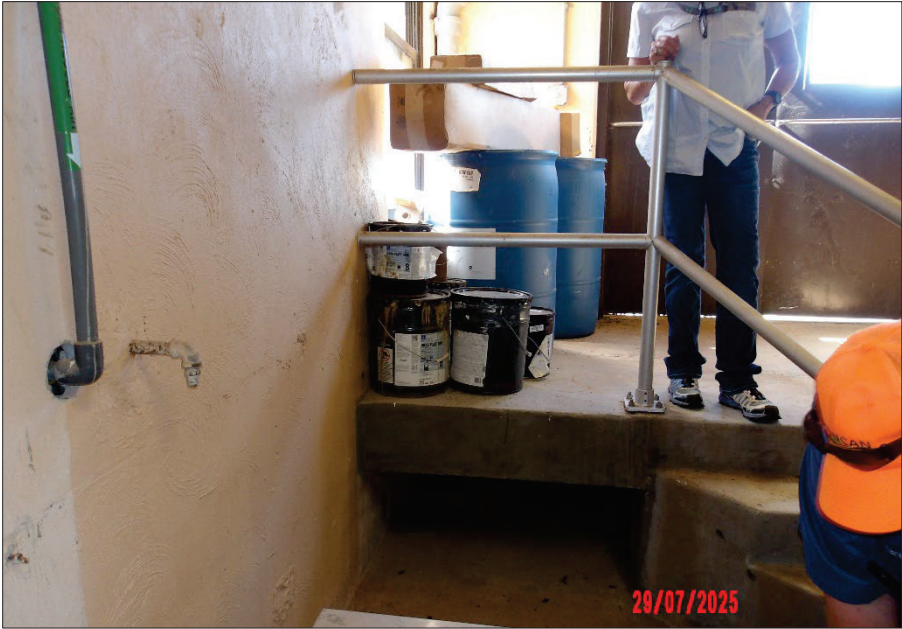
Photograph 12. 7/29/2025 08:57 100\_0044.JPG South Plant Filter Gallery

Description: Paint stored in the South train filter pipe gallery next to the 0.5 MG Clearwell access hatch.

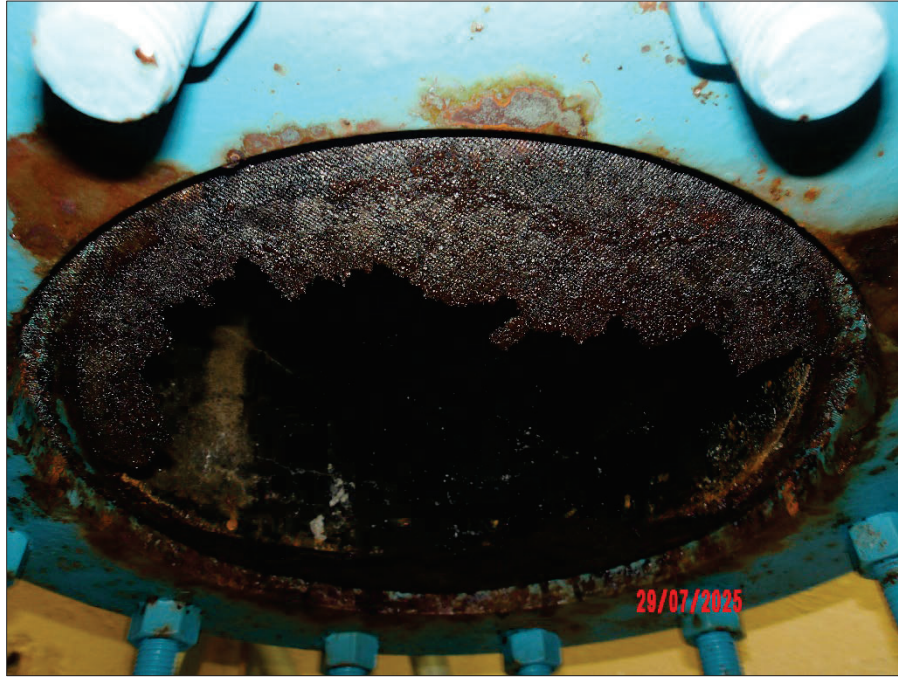
**Photograph 13. 7/29/2025 09:04 100\_0054.JPG 0.5 MG Clearwell**  
**Description:** Torn vent screen on the 0.5 MG Clearwell.

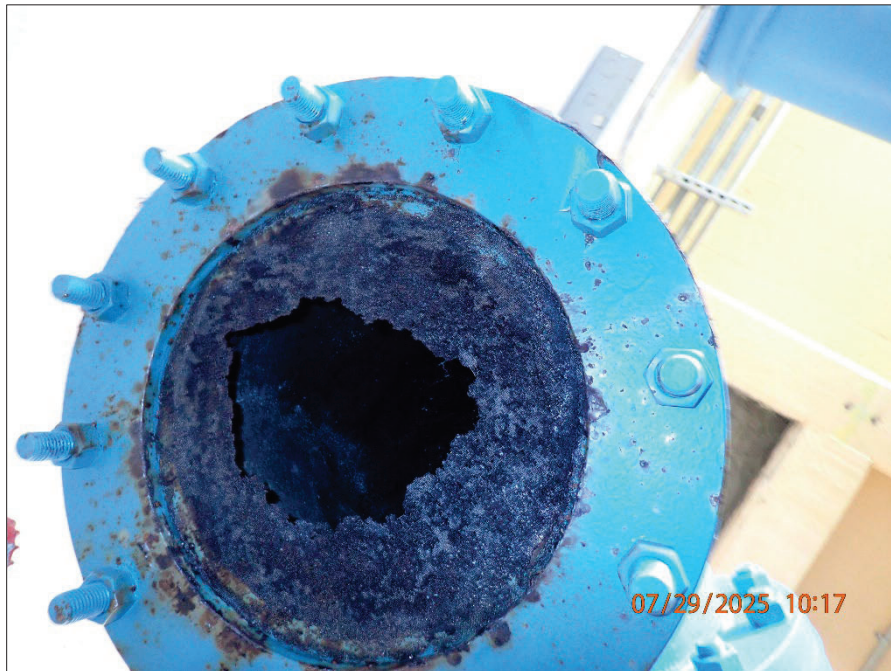
**Photograph 14. 7/29/2025 10:17 P7290405.JPG 0.5 MG Clearwell**  
**Description:** Corroded and torn vent screen on the 0.5 MG Clearwell.

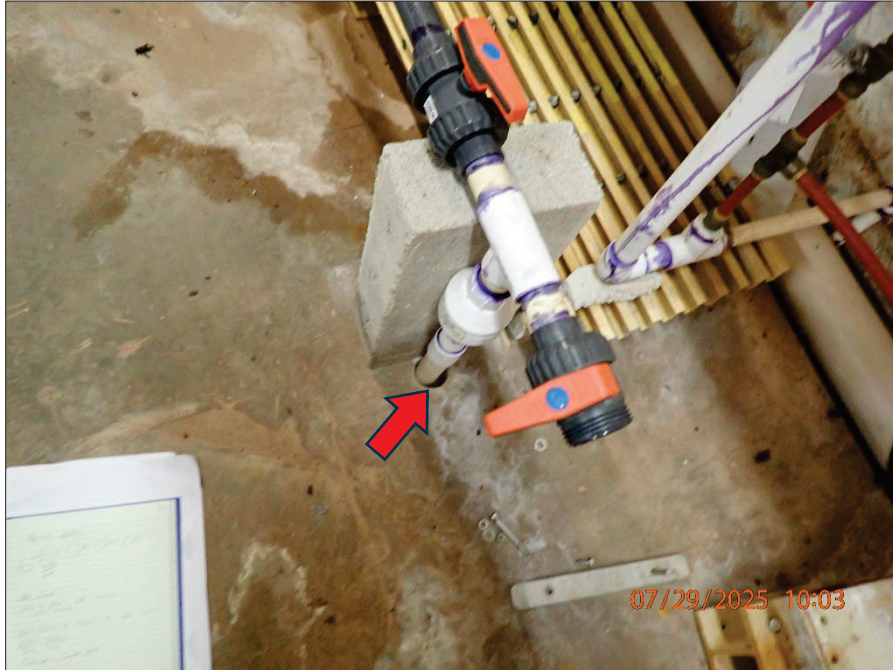
**Photograph 15. 7/29/2025 10:03 P7290379.JPG South Plant Filter Gallery**  
**Description:** Unsealed opening on roof of 0.5 MG clearwell, around sample pump access piping.

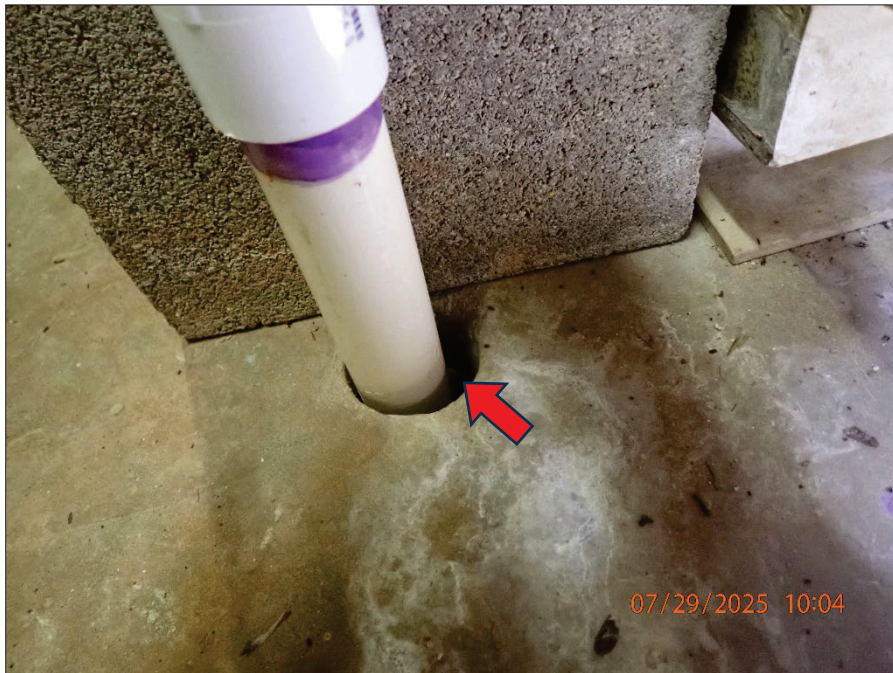
**Photograph 16. 7/29/2025 10:04 P7290380.JPG South Plant Filter Gallery**  
**Description:** Unsealed opening on roof of 0.5 MG clearwell, around sample pump access piping.

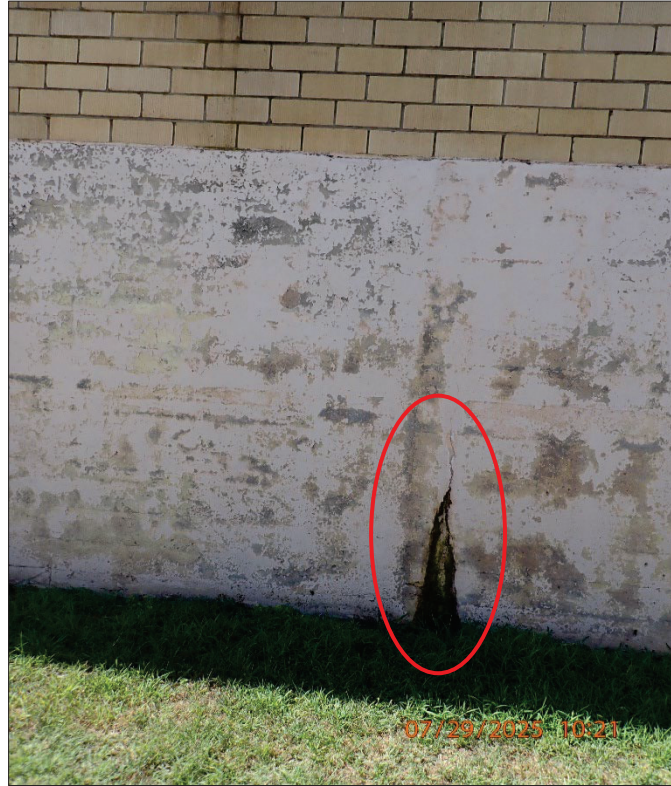
**Photograph 17. 7/29/2025 10:21 P7290415.JPG South Plant Filter 6**

**Description:** Cracking in the concrete is allowing water seepage on the outside filter wall for filter #6.

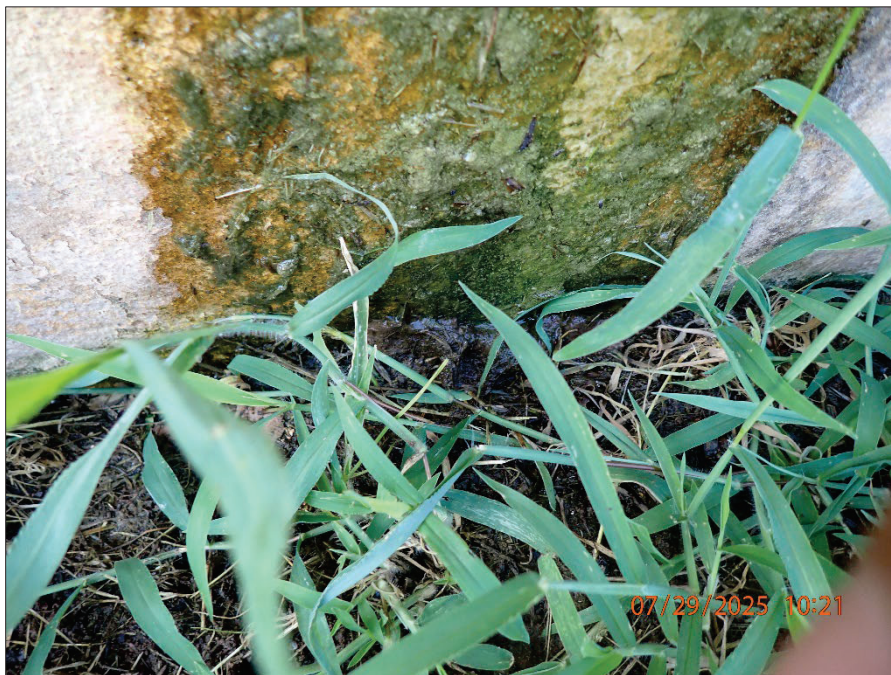
**Photograph 18. 7/29/2025 10:21 P7290416.JPG South Plant Filter 6**

**Description:** Cracking in the concrete is allowing water seepage on the outside filter wall for filter #6.

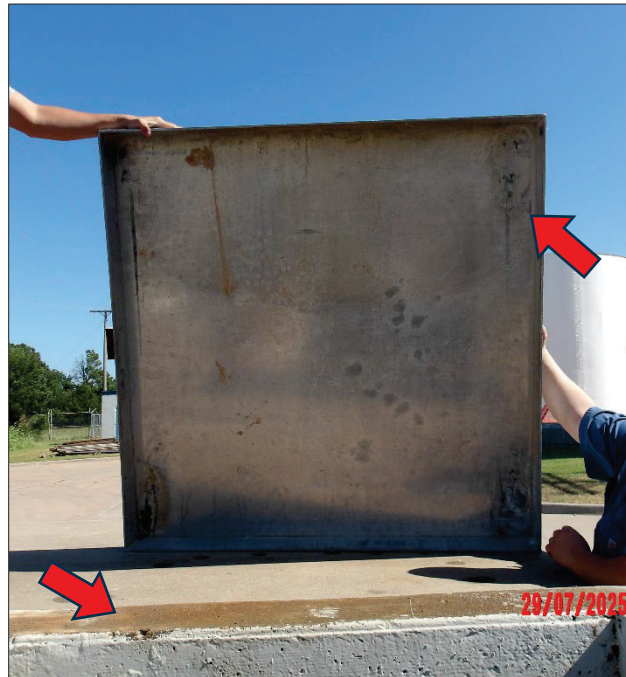
**Photograph 19. 7/29/2025 09:26 100\_0085.JPG Post Chlorine Access Pit**  
**Description:** Post chlorine pit without a sanitary seal between the hatch and concrete rim, called out with red arrows.

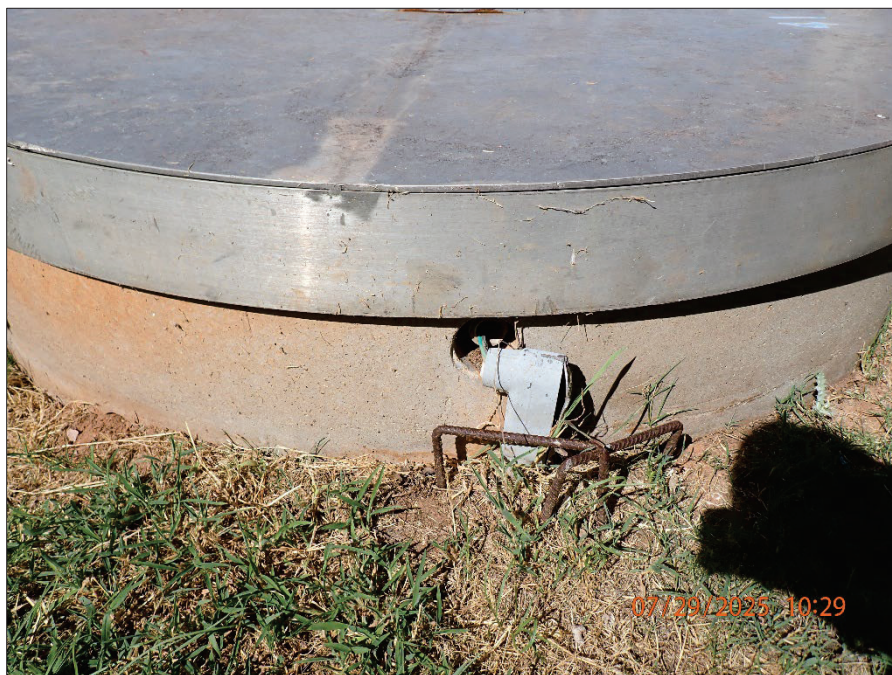
The caustic feed pit functions as the caustic soda dosing point and the pre-clearwell chlorine sample location. The EPA inspection team observed a broken electrical conduit on the side of the pit, which exposed electrical wires to the elements (Photograph 20).

**Photograph 20. 7/29/2025 10:29 P7290419.JPG Caustic Feed Pit**  
**Description:** Caustic feed pit hatch with a broken conduit on the side that allows a direct opening into the pit.

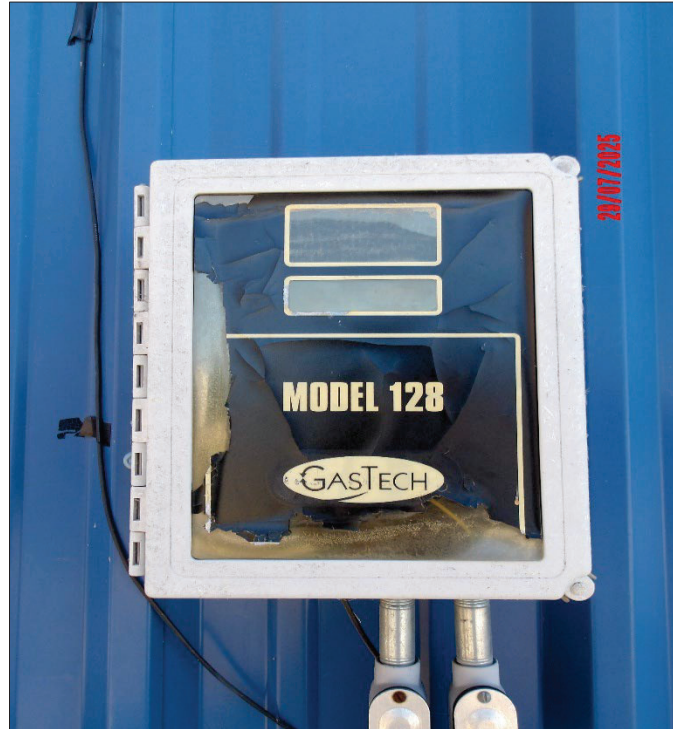
**Photograph 21. 7/29/2025 09:34 100\_0094.JPG Ammonia Feed Room**  
**Description:** Disarmed ammonia gas detection alarm at the ammonia feed room.

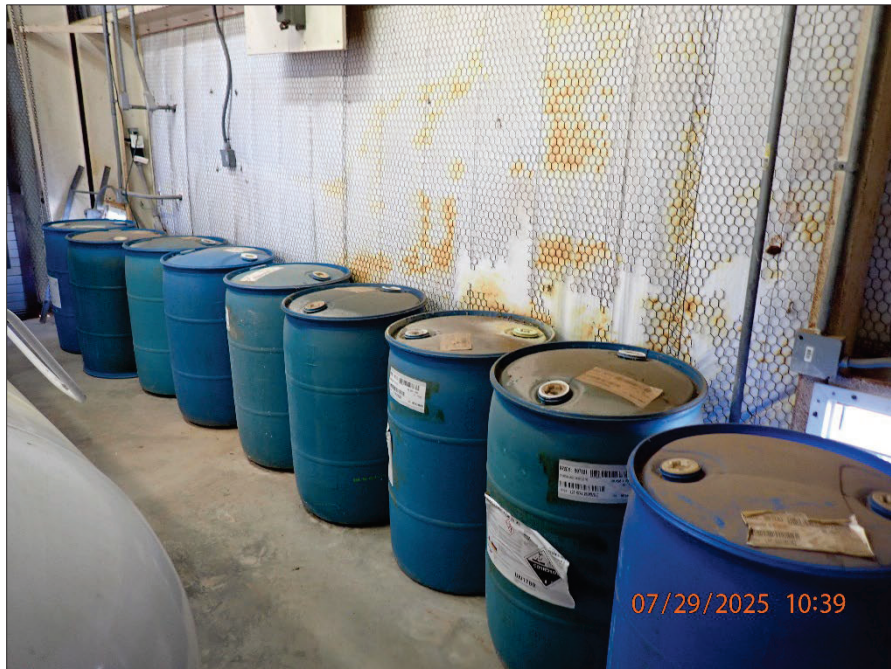
**Photograph 22. 7/29/2025 10:39 P7290449.JPG Ammonia Storage Room**  
**Description:** Hydrochloric acid drums located in the anhydrous ammonia storage room without secondary containment at the Water Treatment Facility.

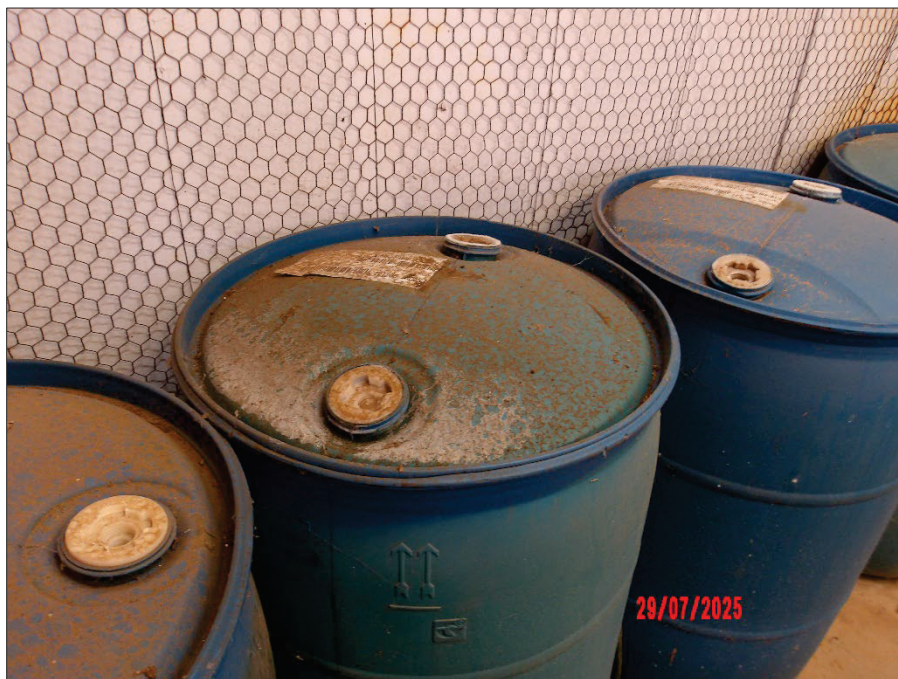
**Photograph 23. 7/29/2025 09:40 100\_0101.JPG Ammonia Storage Room**  
**Description:** Hydrochloric acid drums located in the anhydrous ammonia storage room at the Water Treatment Facility, without secondary containment, that are bulging due to increased pressure.

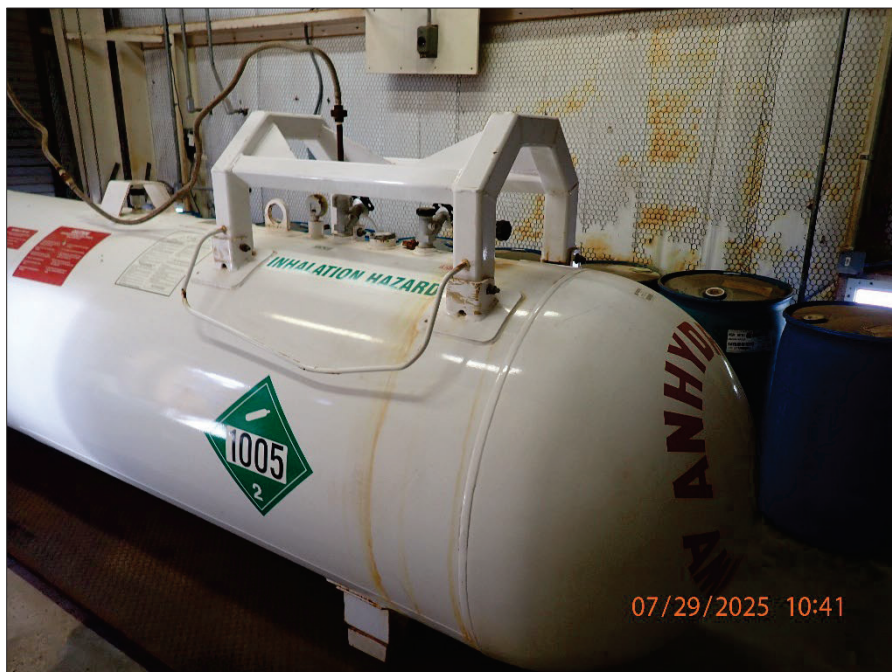
**Photograph 27. 7/29/2025 10:41 P7290458.JPG Ammonia Storage Room**  
**Description:** Hydrochloric acid and phosphate stored in the same room as anhydrous ammonia.

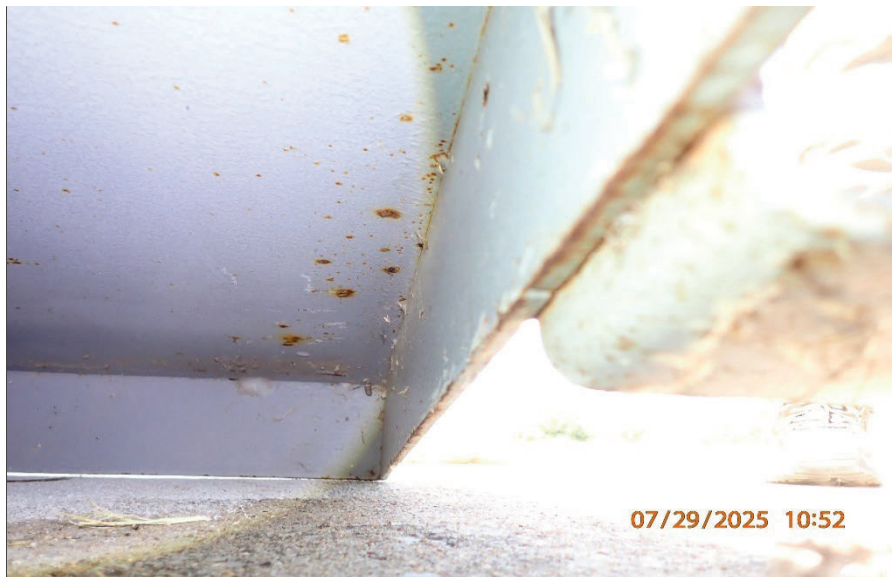
**Photograph 32. 7/29/2025 10:52 P7290484.JPG 3.5 MG Clearwell**

**Description:** Access hatch to the 3.5 MG Clearwell at the WTP without a gasket seal.

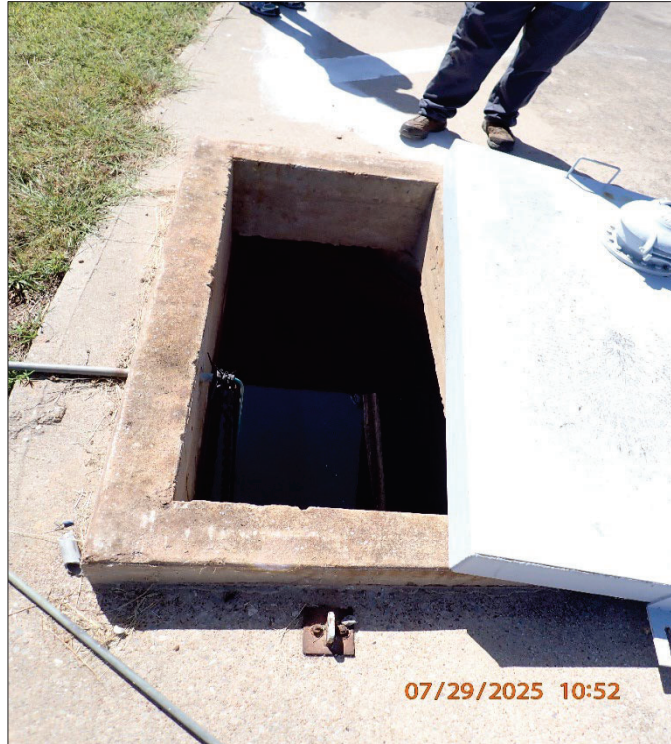
**Photograph 33. 7/29/2025 10:52 P7290485.JPG 3.5 MG Clearwell**  
**Description:** Access hatch to the 3.5 MG clearwell without a gasket seal.

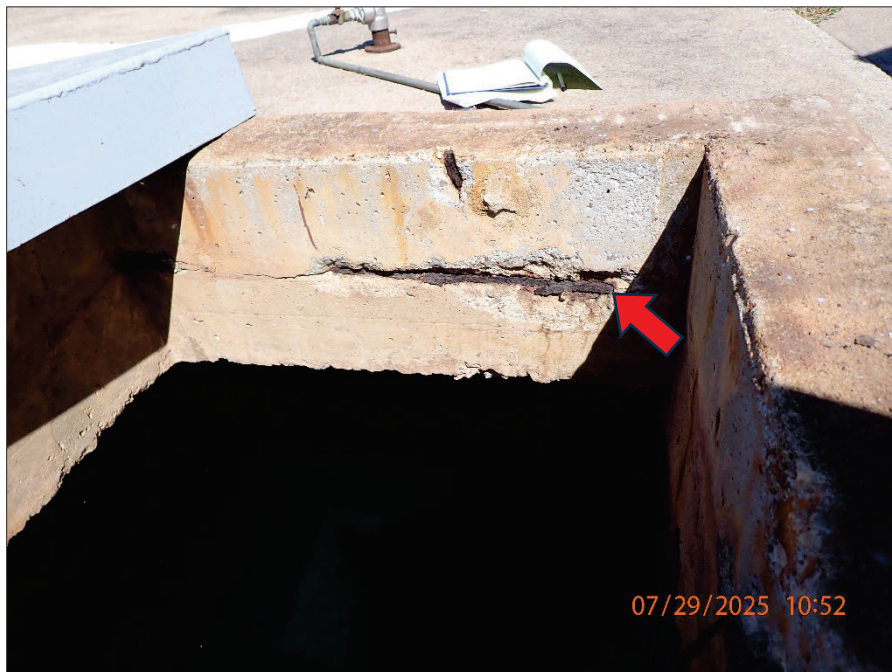
**Photograph 34. 7/29/2025 10:52 P7290488.JPG 3.5 MG Clearwell**  
**Description:** Cracked concrete and exposed rebar around the 3.5 MG Clearwell access hatch.

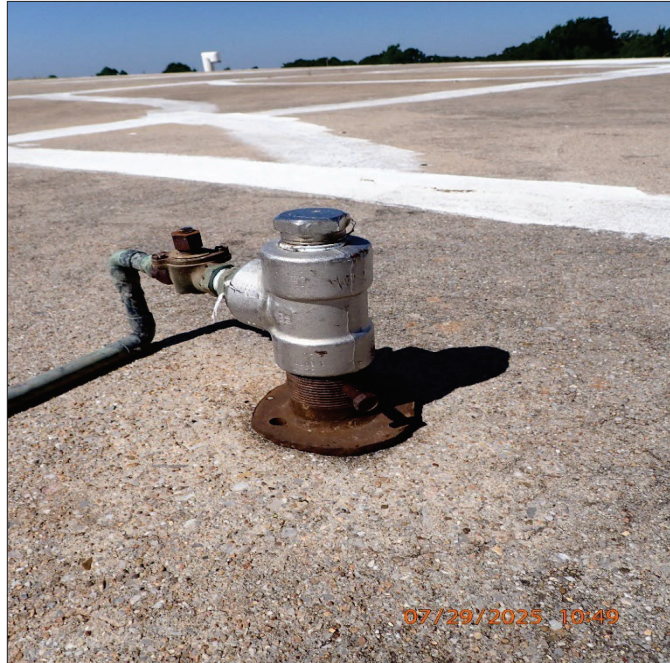
**Photograph 35. 7/29/2025 10:49 P7290477.JPG 3.5 MG Clearwell**

**Description:** Device mounted to the roof of the 3.5 MG Clearwell with unprotected openings around the screw holes.

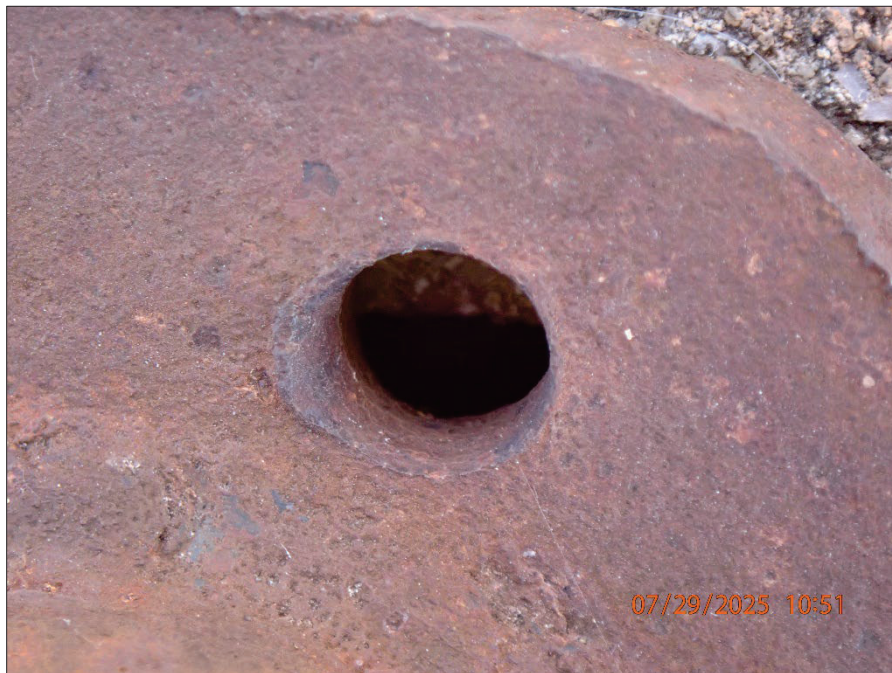
**Photograph 36. 7/29/2025 10:51 P7290481.JPG 3.5 MG Clearwell**

**Description:** Opening through the screw hole of the roof mounted device at the 3.5 MG Clearwell.

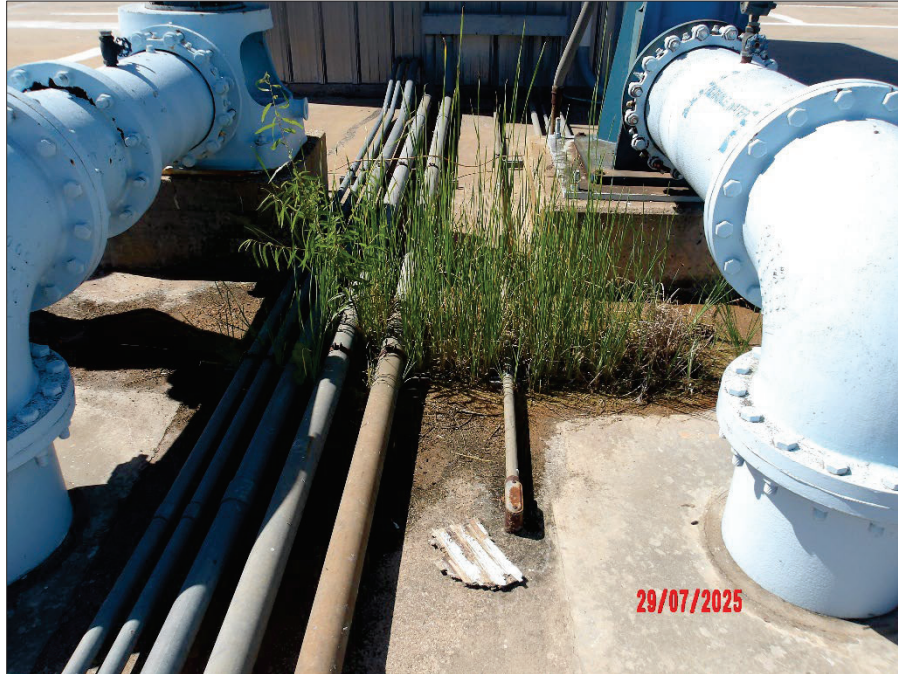
**Photograph 37. 7/29/2025 09:58 100\_0115.JPG 3.5 MG Clearwell**

**Description:** Standing water and vegetation growth around the high service and backwash supply pumps at the 3.5 MG Clearwell.

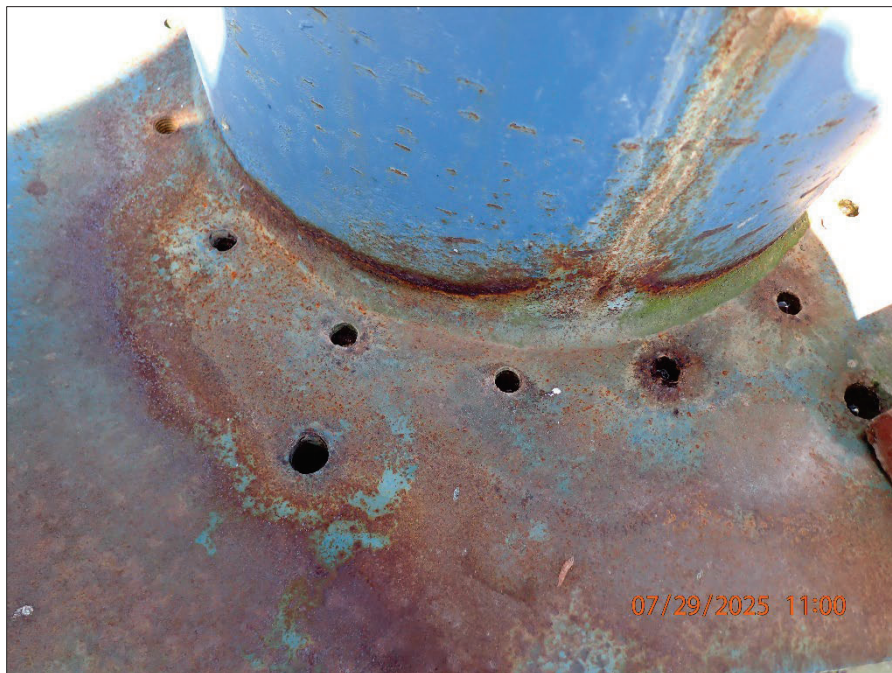
**Photograph 38. 7/29/2025 11:00 P7290503.JPG 3.5 MG Clearwell**

**Description:** Openings around the support base of the high service pumps on the roof of the 3.5 MG Clearwell.

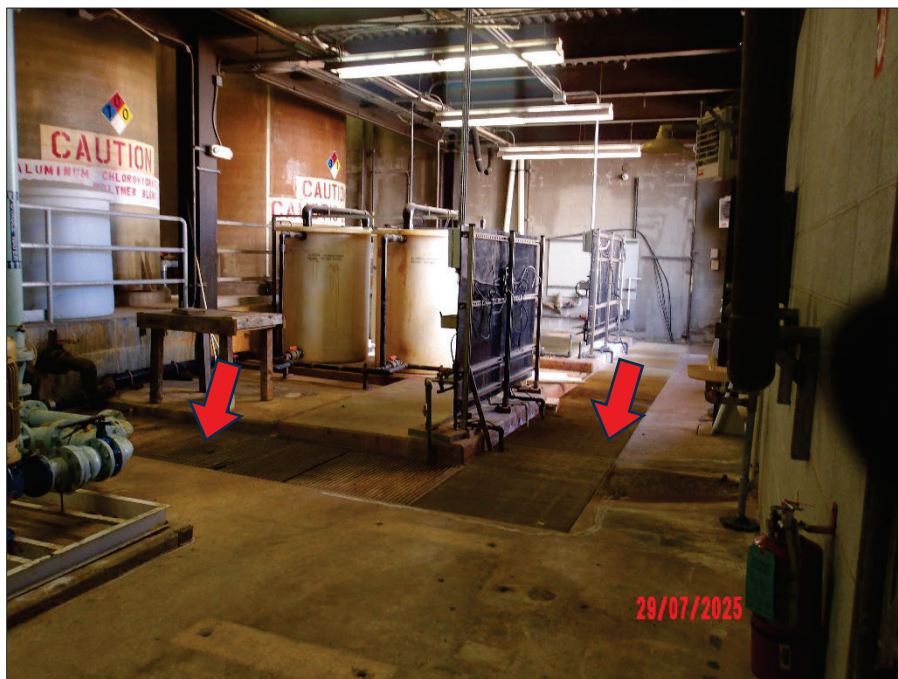
**Photograph 43. 7/29/2025 10:32 100\_0182.JPG ACH and Caustic Chemical Building**  
**Description:.** Caustic soda and ACH bulk storage tanks and day tanks with a shared drainage system for accidental spills.

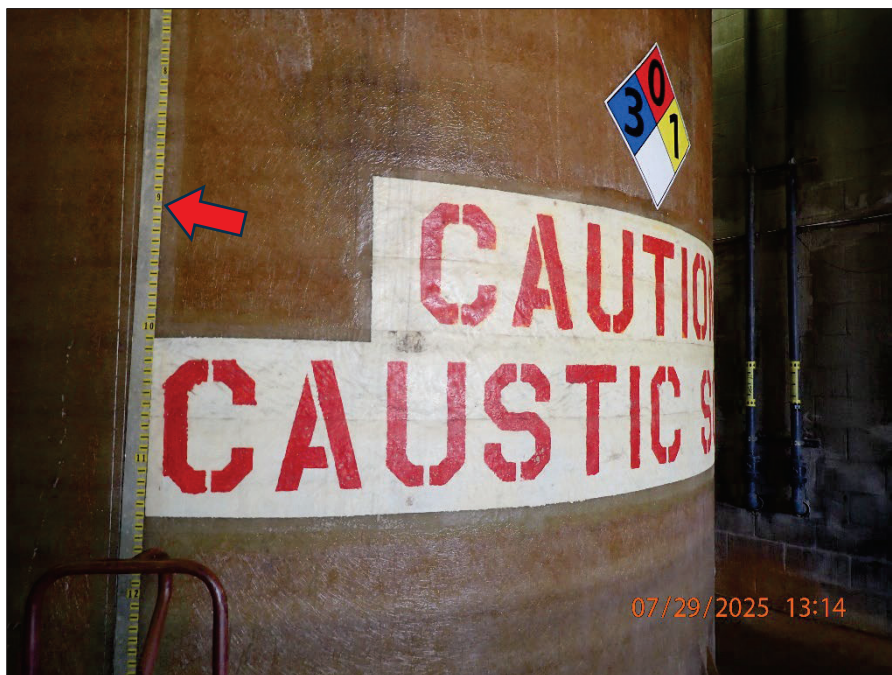
**Photograph 44. 7/29/2025 13:14 P7290533.JPG ACH and Caustic Chemical Building**  
**Description:** Caustic soda and ACH bulk storage tanks with tap measure on the side of the 8,000 gallon fiberglass storage tanks.

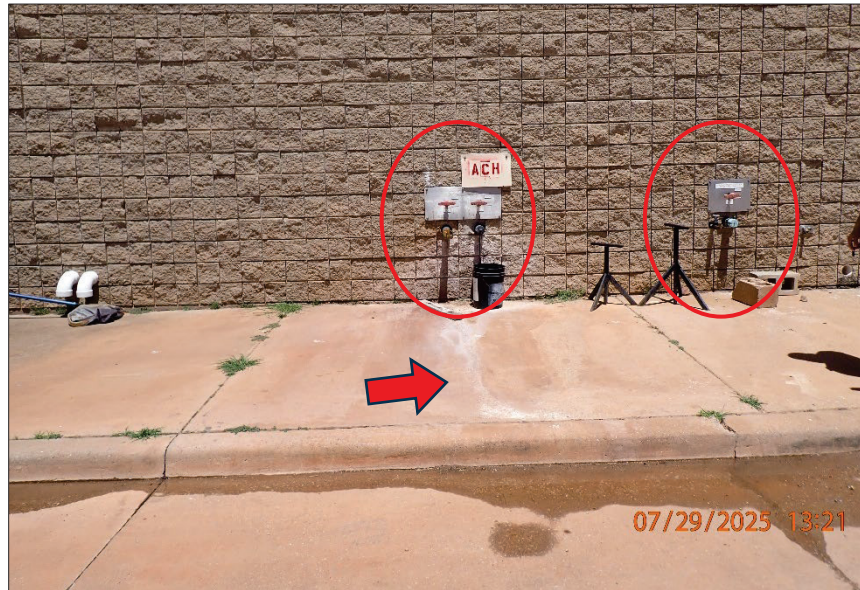
**Photograph 45. 7/29/2025 13:21 P7290544.JPG WTP Chemical Loading Zone**

The EPA inspection team also observed that the delivery truck connection site, on the exterior wall of the chemical building, lacked secondary containment in the event of a leak between the transfer hose and cam-lock connection during chemical delivery (Photograph 45).

**Description:** ACH and Caustic delivery site without secondary spill containment at the WPT loading dock. Chemical hose connections called out with red circles. Note the chemical residue stains on the concrete below the ACH hose connection, called out with red arrow.

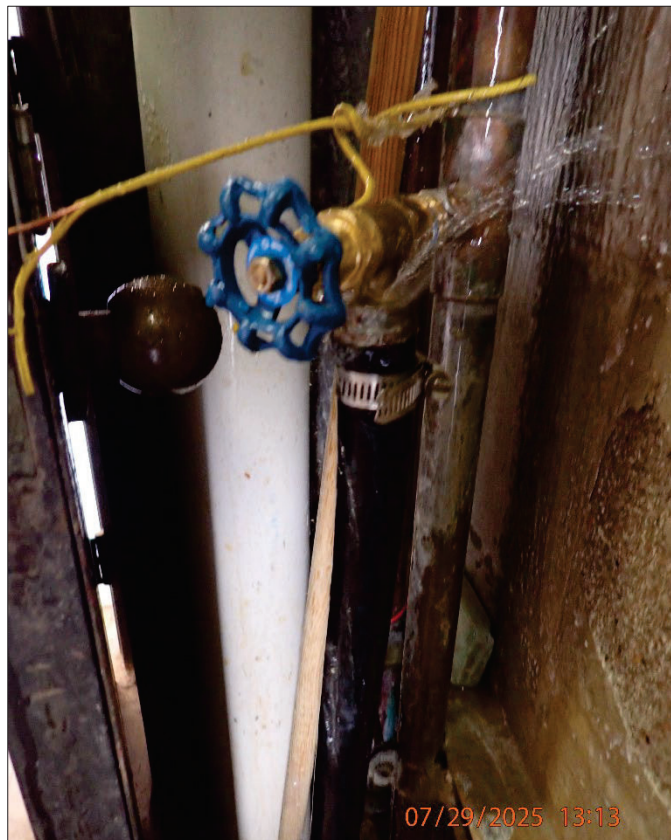
**Photograph 46. 7/29/2025 13:13 P7290526.JPG ACH and Caustic Chemical Building**

The EPA inspection team observed a garden hose connected to a hose bib without a vacuum breaker (Photograph 46).

**Description:** Garden hose connected to hose bib without vacuum breaker at the ACH and Caustic Chemical Building.

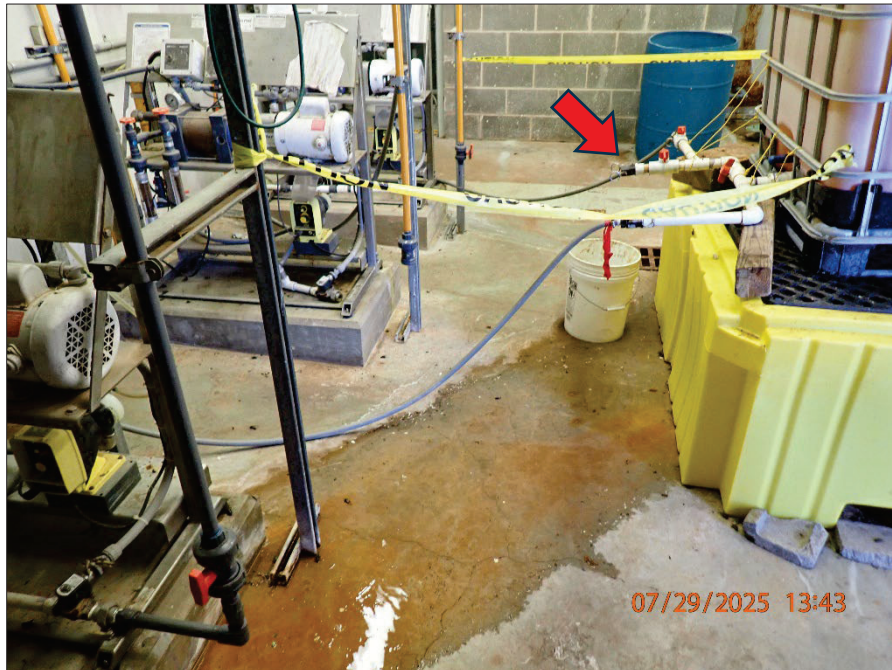
**Photograph 49. 7/29/2025 13:43 P7290595.JPG Polymer Feed and Storage Room**  
**Description:** Spill containment does not extend below the IBC tote pipe connections. Note that the liquid on the floor is ground water and not polymer.

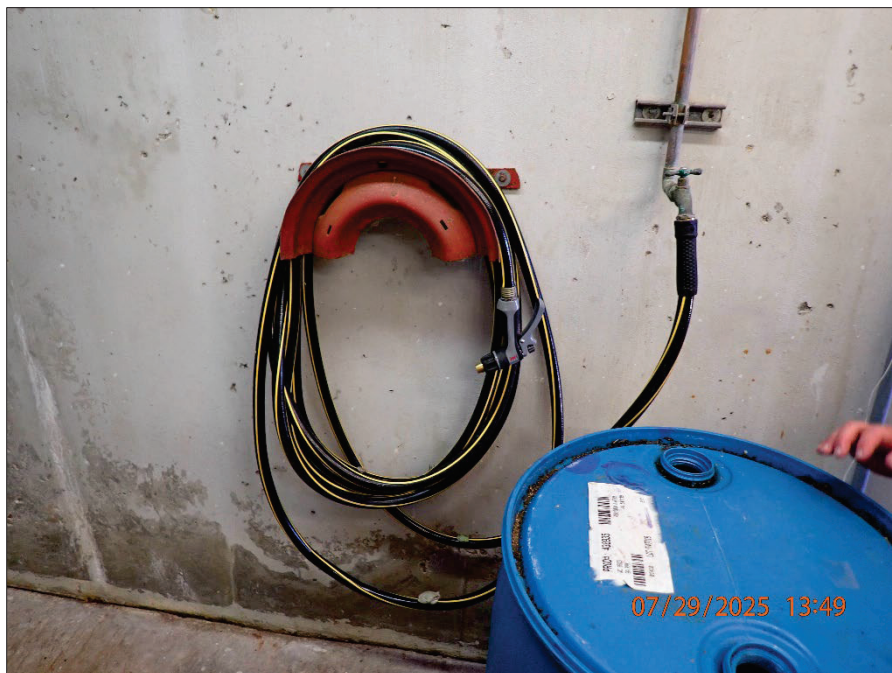
The EPA inspection team observed a garden hose connected to a hose bib without a vacuum breaker (Photograph 50).

**Photograph 50. 7/29/2025 13:49 P7290608.JPG Polymer Feed and Storage Room**  
**Description:** Garden hose connected to hose bib without vacuum breaker at the polymer storage and feed room.

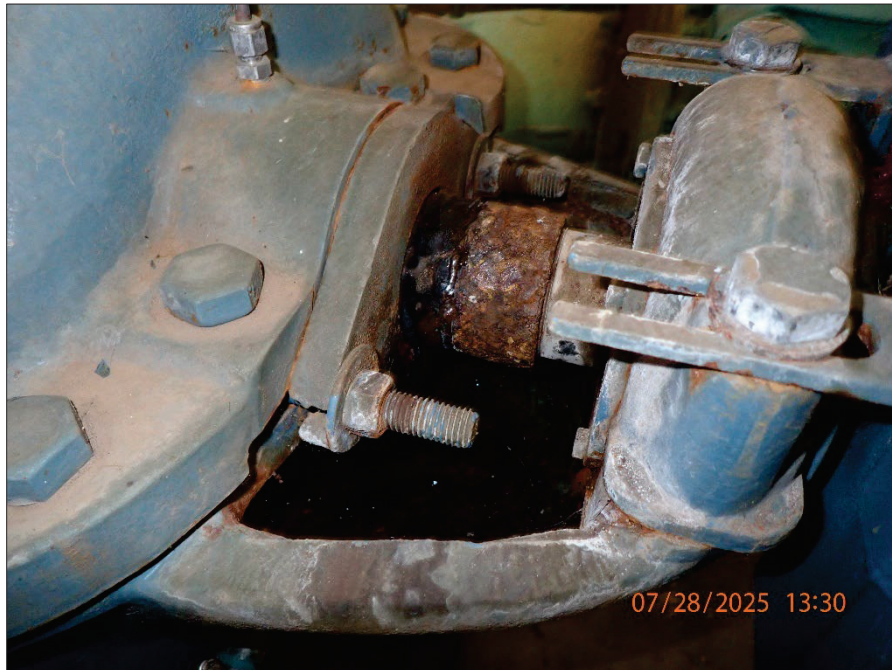
**Photograph 51. 7/28/2025 13:30 P7280015.JPG Humphreys Raw Water Pumphouse**  
**Description:** Leak from the driveshaft seal on raw water pump 2 at the Humphreys raw water pumphouse.

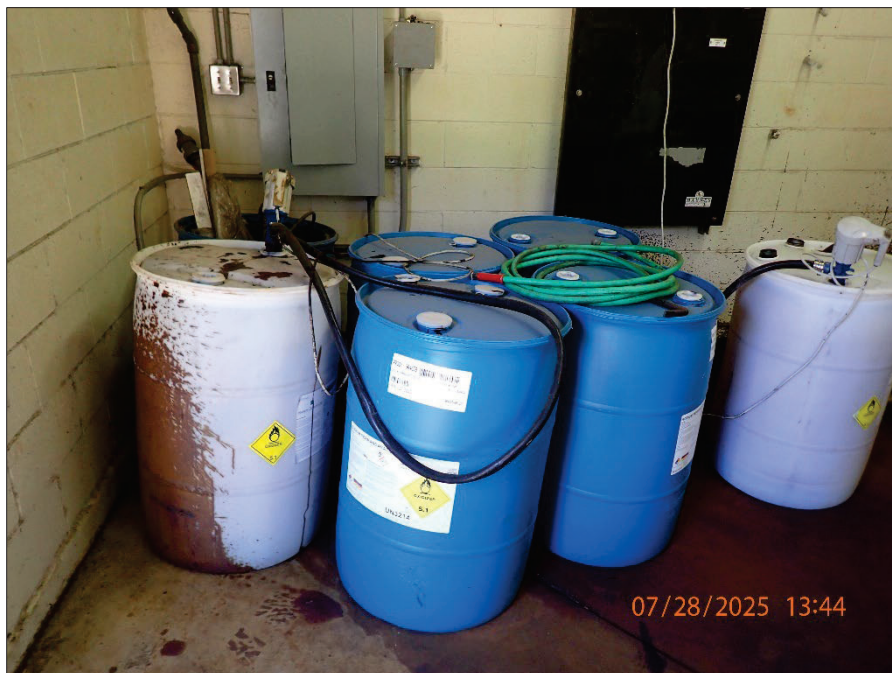
**Photograph 52. 7/28/2025 13:44 P7280049.JPG Permanganate Storage and Feed Room**  
**Description:** Sodium permanganate storage without secondary containment.

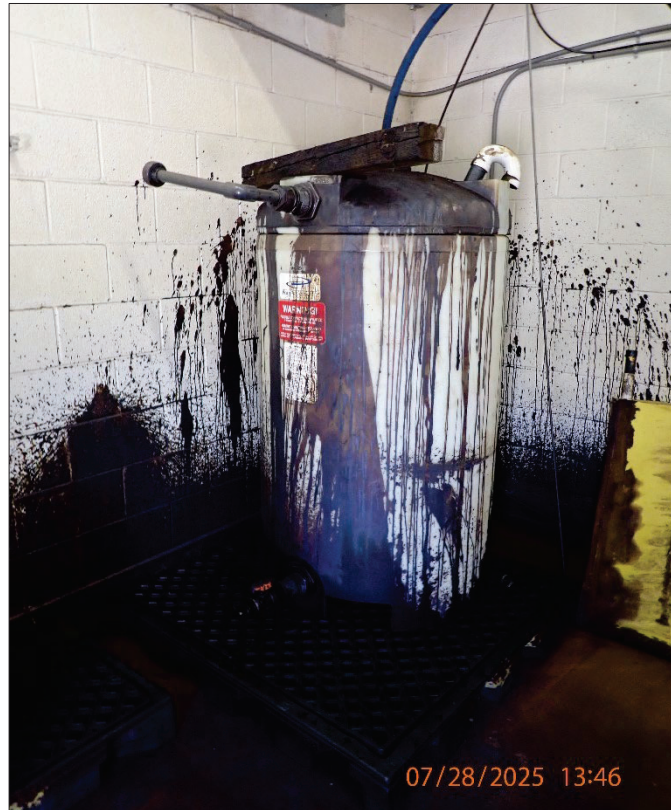
**Photograph 53. 7/28/2025 13:46 P7280052.JPG Permanganate Storage and Feed Room**  
**Description:** Spilled sodium permanganate around the sodium permanganate day tank.
