**Region 6 - Enforcement & Compliance Assurance Division**  
**INSPECTION REPORT**

| <b>Inspection Dates:</b> | 7/28/2025 and 7/29/2025 | |
| <b>Company Name:</b> | <b>Duncan Public Utilities Authority – Public Water System</b> | |
| <b>Facility Name:</b> | <b>Duncan Public Utilities Authority</b> | |

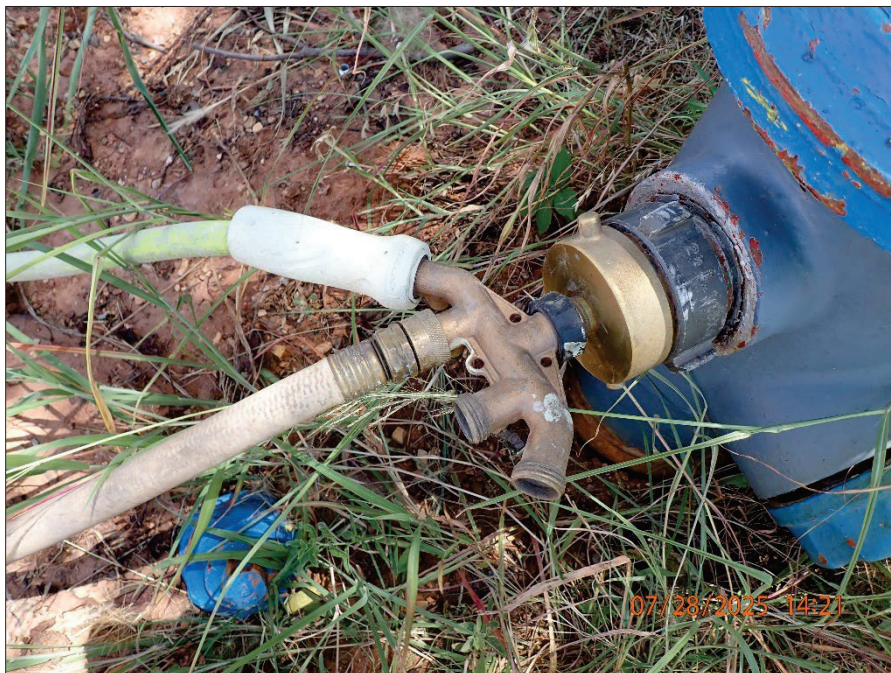
**Photograph 54. 7/28/2025 14:21 P7280077.JPG El Rancho Tower**  
**Description:** Hydrant tap used by the El Rancho Tower construction company without a backflow prevention device.

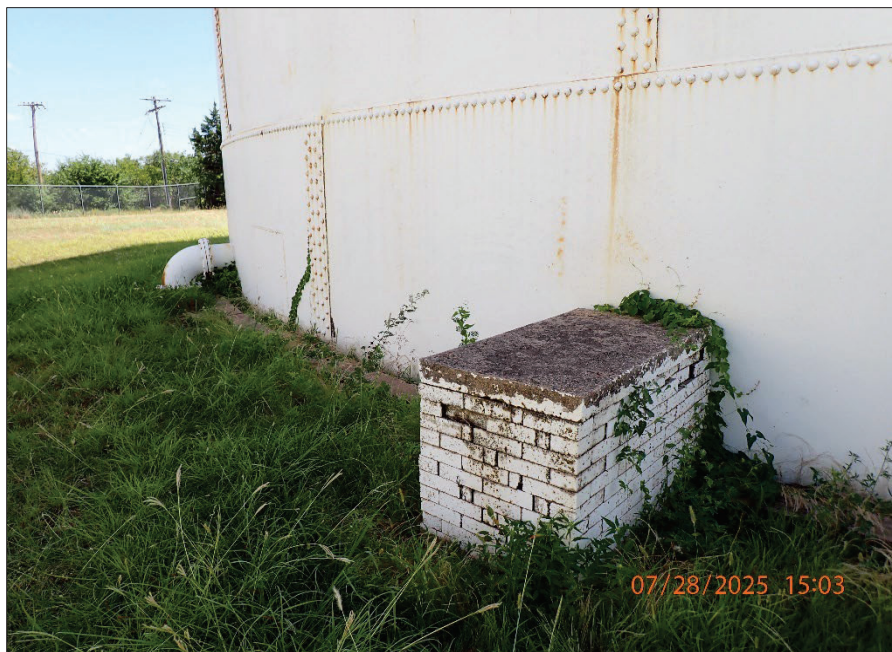
**Photograph 62. 7/28/2025 15:03 P7280162.JPG 10<sup>th</sup> and Elk South Tank**  
**Description:** Vegetation growth around the base and climbing up the 10<sup>th</sup> and Elk South Tank.

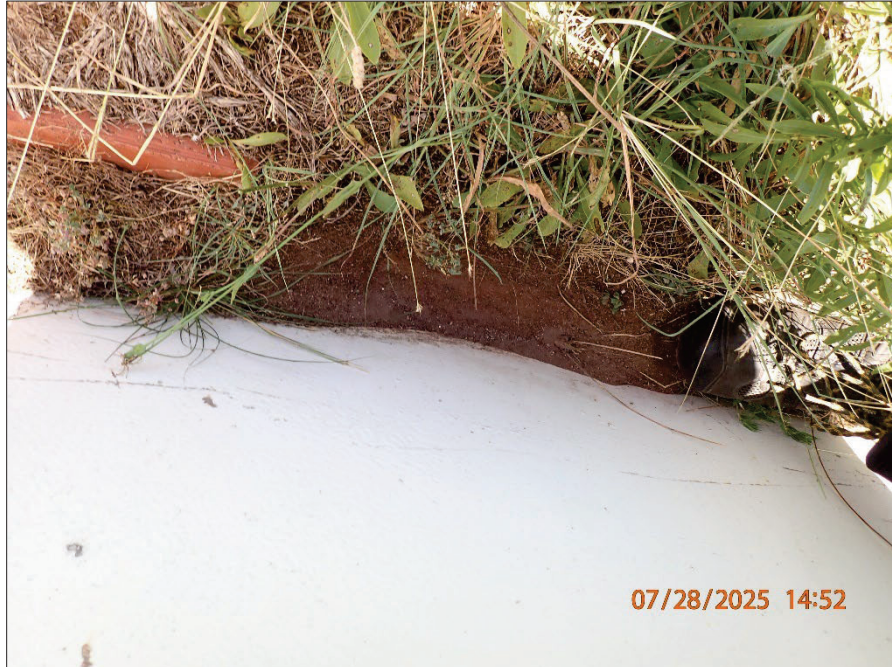
**Photograph 63. 7/28/2025 14:52 P7280125.JPG 10<sup>th</sup> and Elk N.W Tank**  
**Description:** Soil build-up at the base of the 10<sup>th</sup> and Elk N.W Tank covering the tank ring.

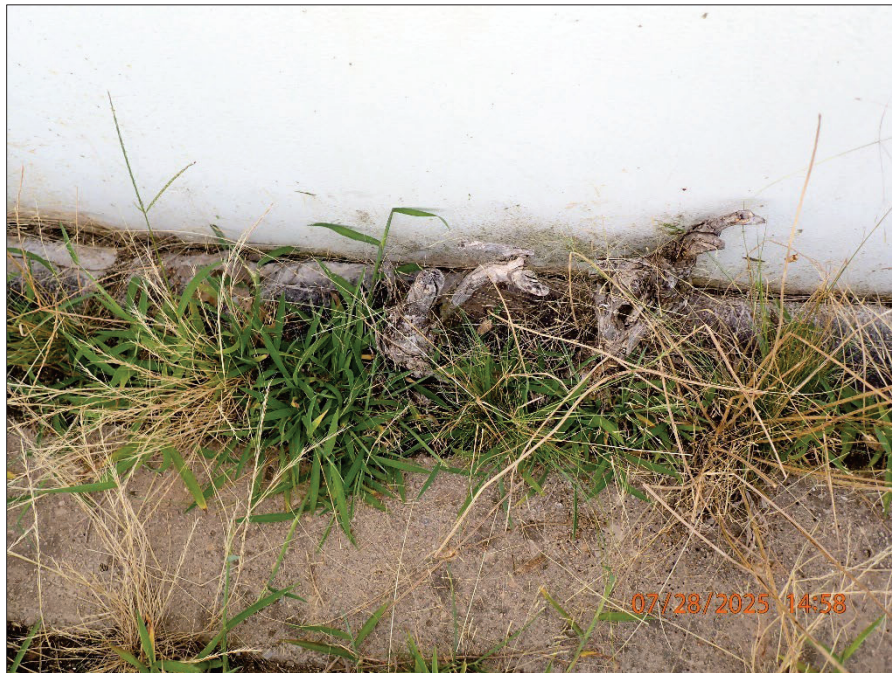
**Photograph 64. 7/28/2025 14:58 P7280145.JPG 10<sup>th</sup> and Elk N.W Tank**  
**Description:** Vegetation and roots growing around the foundation of the 10<sup>th</sup> and Elk N.W Tank.

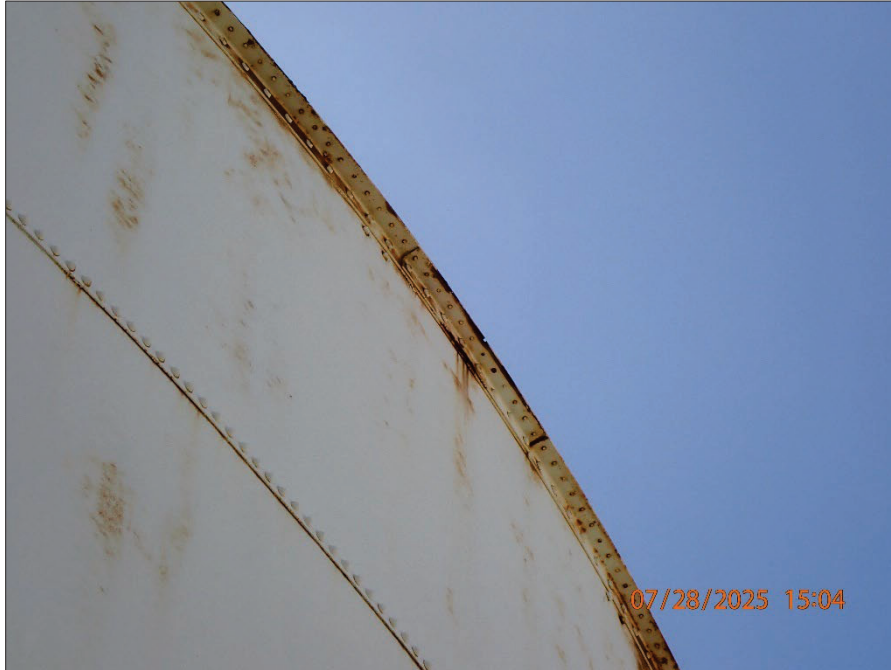
**Photograph 69. 7/28/2025 15:04 P7280170.JPG 10<sup>th</sup> and Elk South Tank**  
**Description:** Corrosion on the roof of the 10th and Elk South Tank.

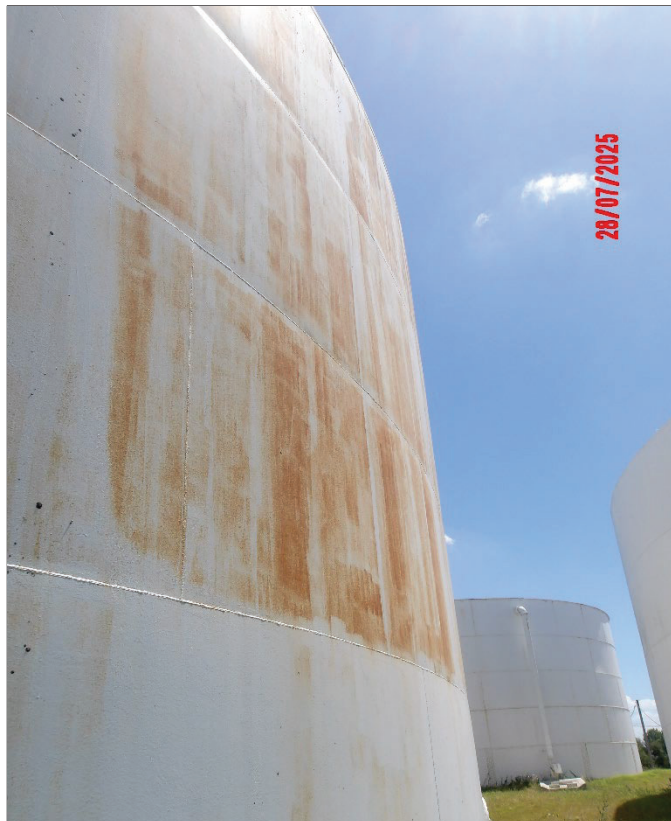
**Photograph 70. 7/28/2025 14:04 100\_0076.JPG 10th and Elk N.E. Tank**  
**Description:** Corrosion on the surface coating of the 10th and Elk N.E. Tank

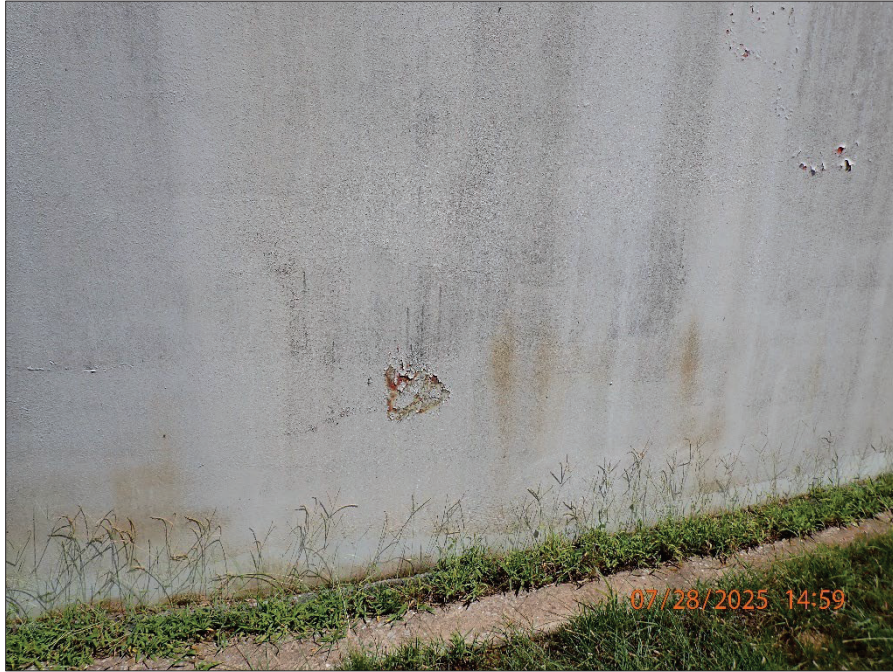
**Photograph 71. 7/28/2025 14:59 P7280148.JPG 10th and Elk N.E Tank**  
**Description:** Peeling surface coating at the 10th and Elk N.E Tank.

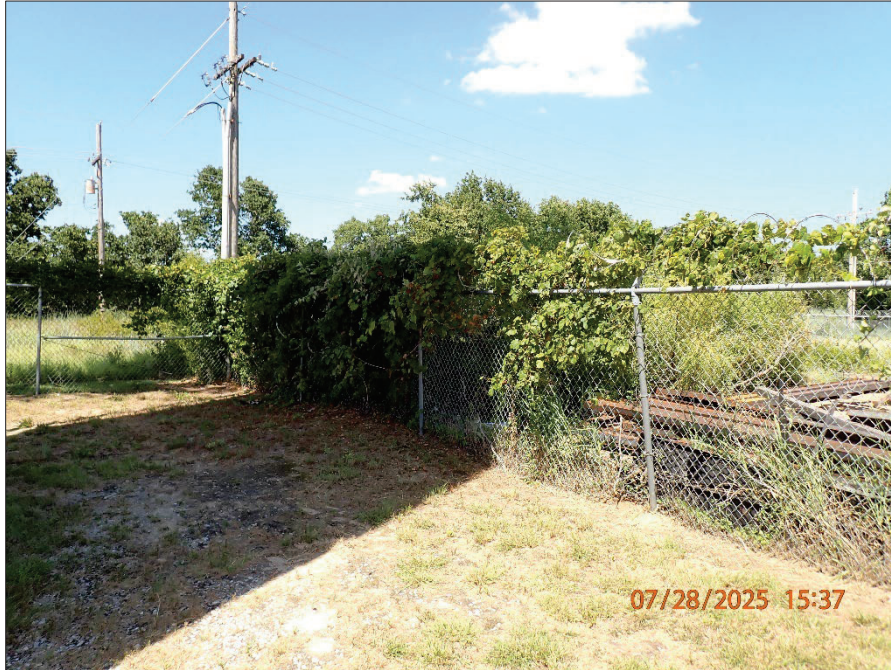
**Photograph 73. 7/28/2025 15:37 P7280213.JPG North Industrial Tower #2 (East)**  
**Description:** Vegetation growth on the security fencing around North Industrial Tower #2 (East).

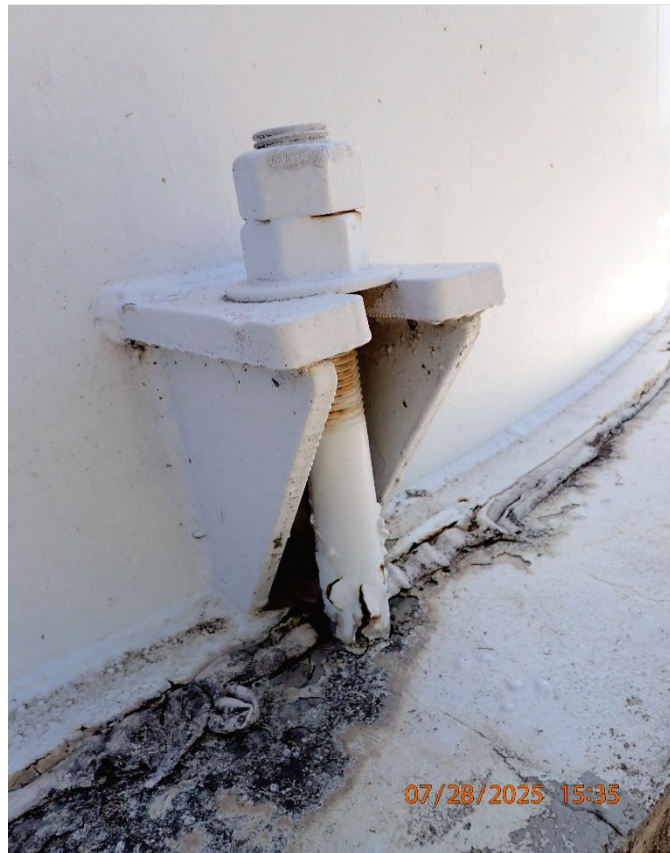
**Photograph 74. 7/28/2025 15:35 P7280206.JPG Industrial Tower #2 (East)**  
**Description:** Corrosion with metal loss on the anchor bolts at Industrial Tower #2.

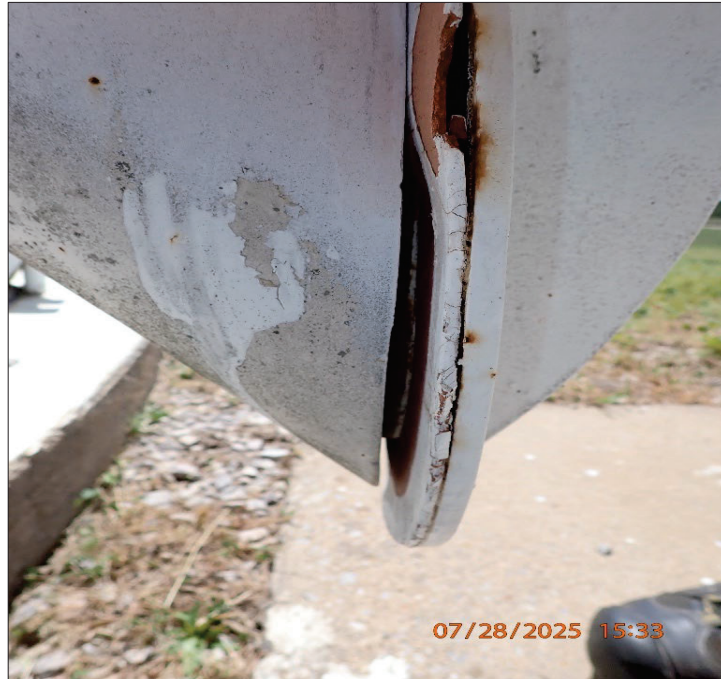
**Photograph 75. 7/28/2025 15:33 P7280202.JPG North Industrial Tower #2 (East)**  
**Description:** Metal flapper on the end of the overflow line on the Industrial #2 Tower that does not create a proper seal.

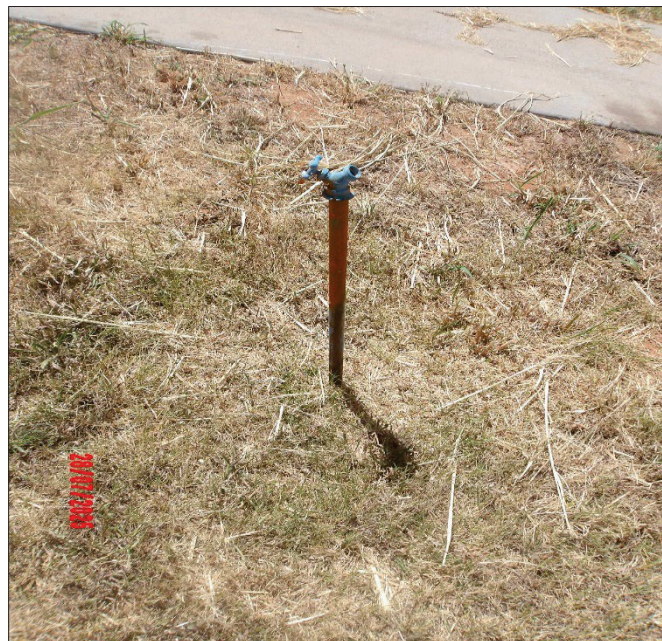
**Photograph 76. 7/28/2025 14:53 100\_0112.JPG N.W. Sector Tower**  
**Description:** Threaded hose tap at N.W. Sector Tower is missing a hose bib vacuum breaker device.

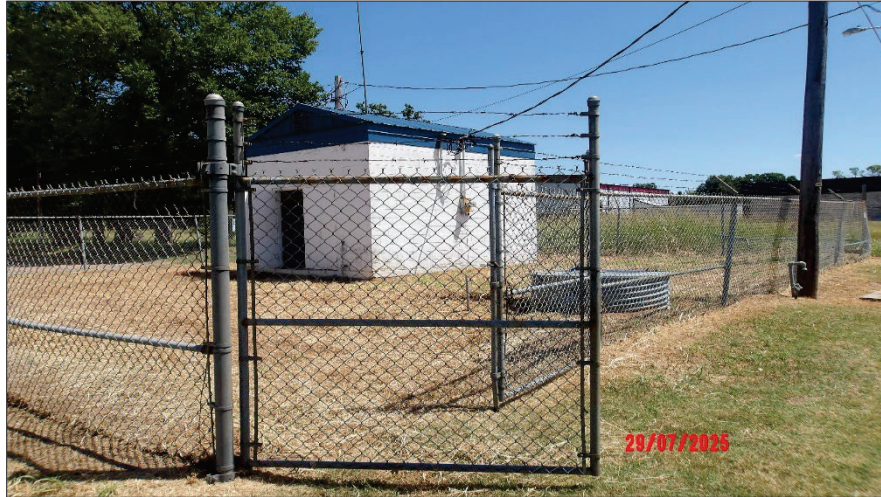
**Photograph 77. 7/29/2025 13:55 100\_0231.JPG North Highway 81 Pumphouse**  
**Description:** Security fencing at North Highway 81 Pumphouse missing proper signage.
