**Inspection Report**  
**Mechanical Integrity Test**  
**Osage DNR / Environmental Protection Agency**  
**1201 Elm Street, Suite 500**  
**Dallas TX 75270**

| <b>Operator Info</b> Ceja Corporation<br>1437 South Boulder, Suite 1250<br>Tulsa, OK 74119<br>Phone: 918-496-0770 | <b>Inventory ID</b> OS0103000<br><b>API Well No</b><br><b>Lease Name</b><br><b>Well ID</b> 3<br><b>Location</b> NE 06 25N 05E |

| <b>Type of MIT</b> Ada Pressure Test | | <b>Test Reason</b> Routine | |

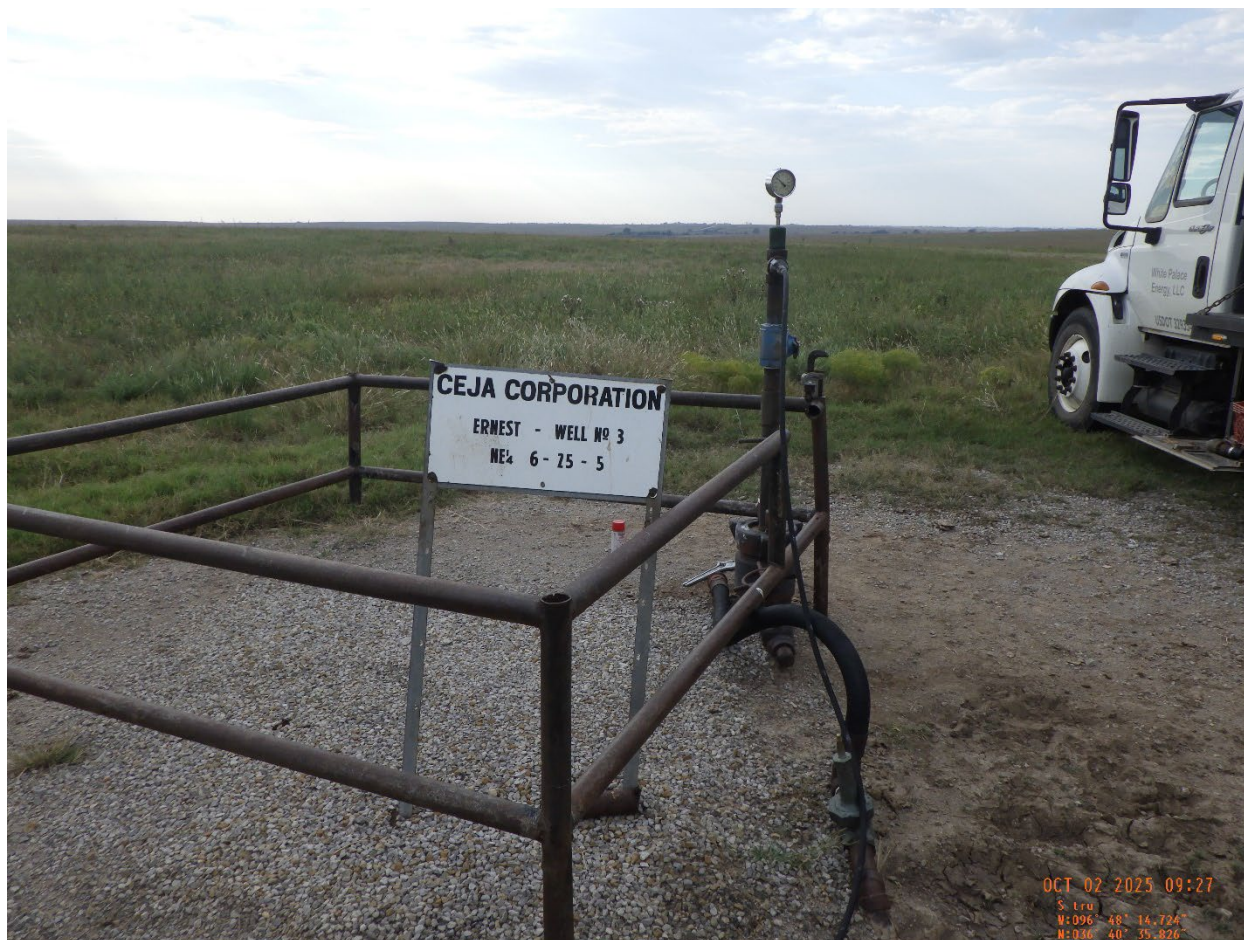
Photo No. 1

**Description:** This was well OS0103000, there were no areas of concern at the time of the inspection.
