## NPDES Compliance Inspection Report

### Tacoma Yard – DTG Recycle

Tacoma, WA

Inspection Date: February 26, 2021

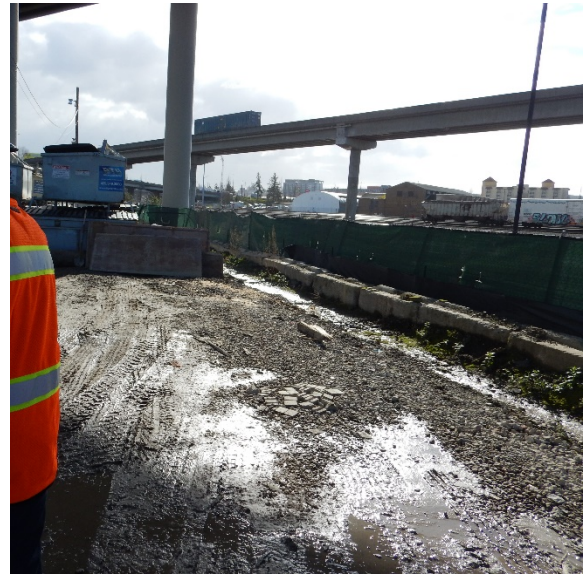
Photo #:06 (DSCN0755)  
Description: Facing south, photo of stormwater collecting in a shallow trench. Note the concrete blocks bordering the trench and property line.

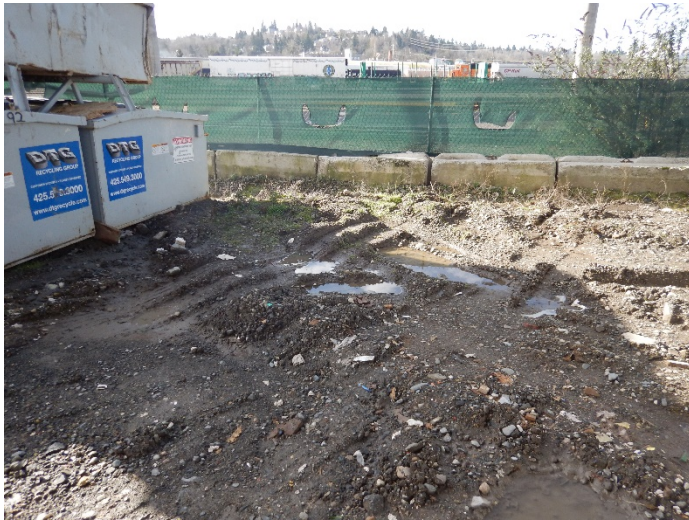
Photo #:09 (DSCN0758)

Description: Facing south, photo of stormwater pooling near the empty storage containers.

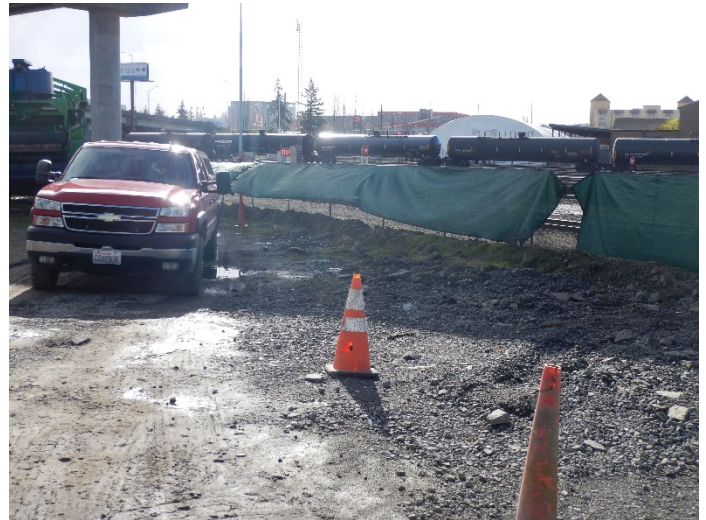
Photo #:10 (DSCN0759)

Description: Facing southeast, photo of stormwater pooling near a parked vehicle.

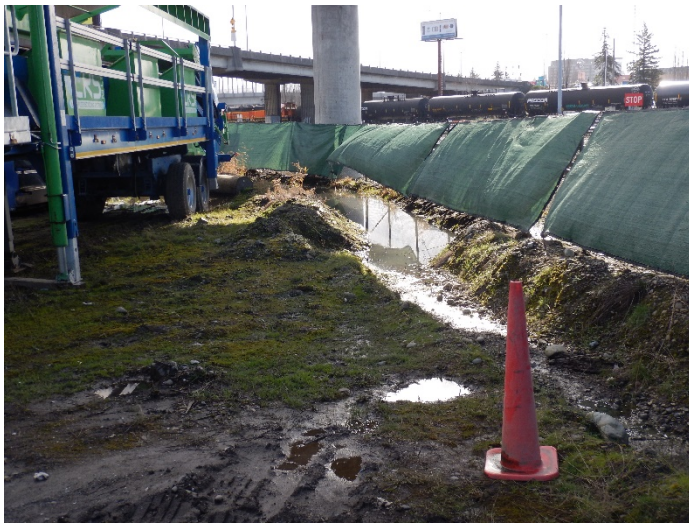
Photo #:11 (DSCN0760)

Description: Facing southeast, photo of stormwater pooling in the trench along the southern perimeter.

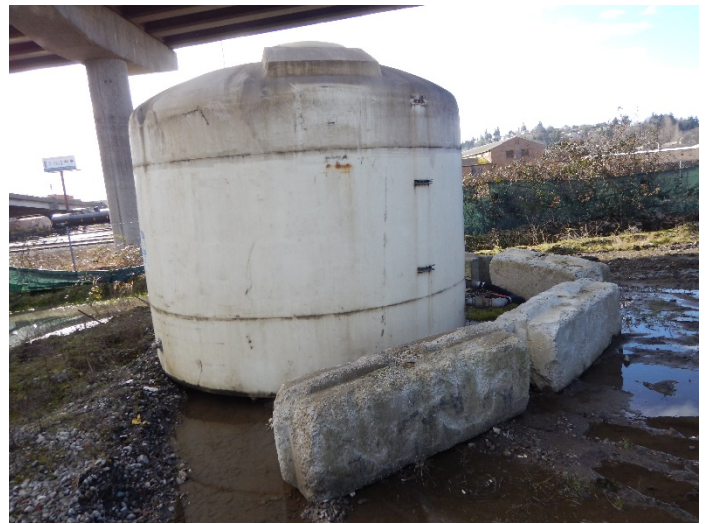
Photo #:12 (DSCN0761)

Description: Facing south, photo of an old liquid containment drum. Mr. Lawson explained that this was left on the property by the previous tenants. It was not in use at the time of the inspection.

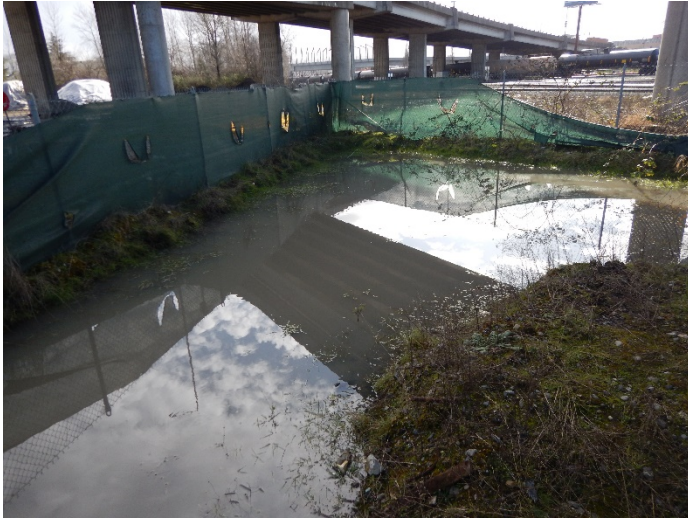
Photo #:13 (DSCN0762)

During the inspection, I noted that there didn’t appear to be a clear point of stormwater discharge at the trench that contributes to Outfall 1 (See **Attachment B, Photos 13 & 14**). I asked the facility representatives if they knew where the stormwater samples are typically collected. They explained that there hasn’t been an observable discharge since they installed the trenches in Q3 of 2019, so the exact sampling point hasn’t been identified yet. I explained that stormwater samples must be representative of the facility’s industrial activities and associated stormwater discharge. I further explained that having multiple discharge points (i.e. if the entire trench overflows) could require multiple sampling points.

Description: Facing east, photo of the stormwater trench that contributes to Outfall 1.

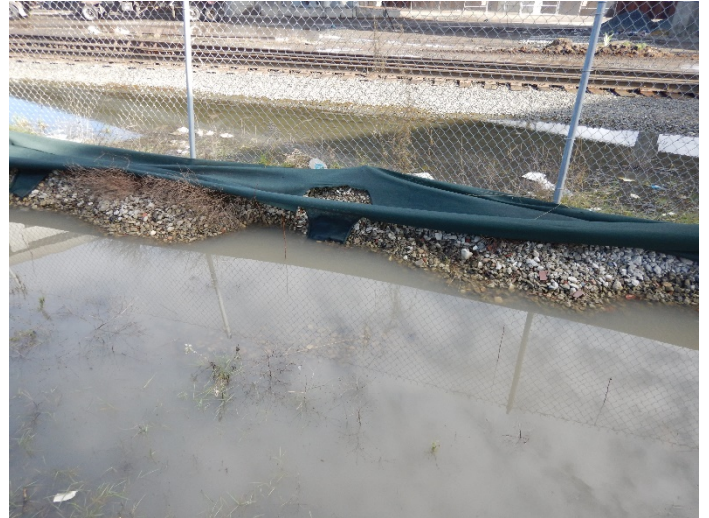
Photo #:14 (DSCN0763)

Description: Facing northeast, photo of the approximate location of Outfall 1 and the stormwater sampling point. Note the full drainage ditch on the other side of the fence line.

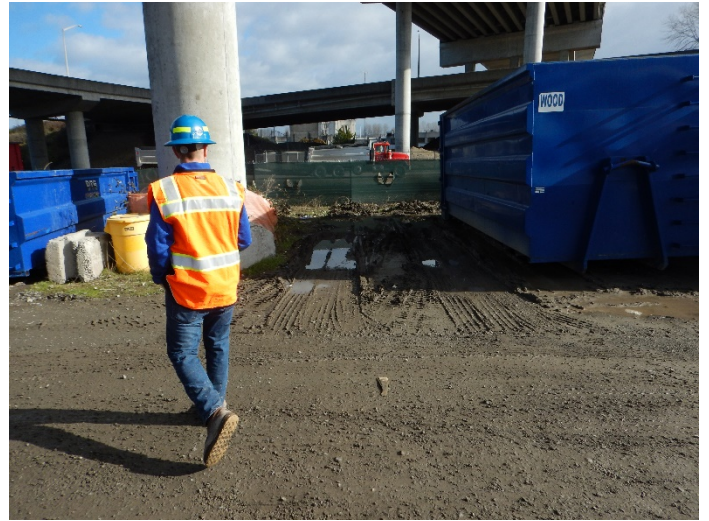
Photo #:16 (DSCN0765)

Description: Facing northeast, photo of stormwater pooling near an empty freight container.

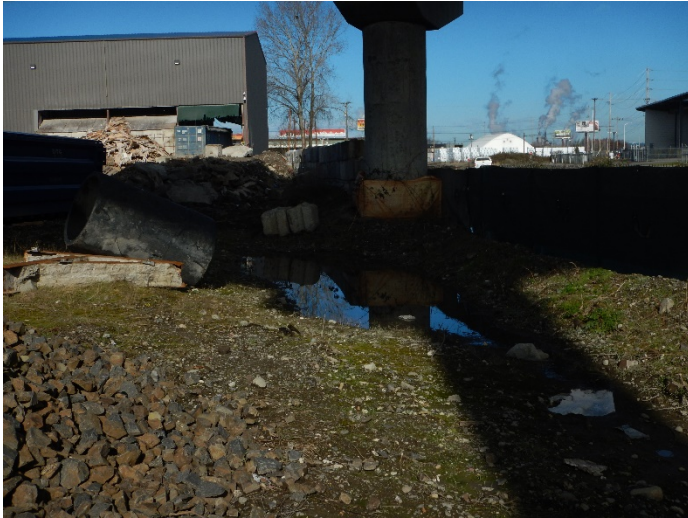
Photo #:17 (DSCN0766)

Description: Facing northwest, photo of stormwater pooling in the yard.

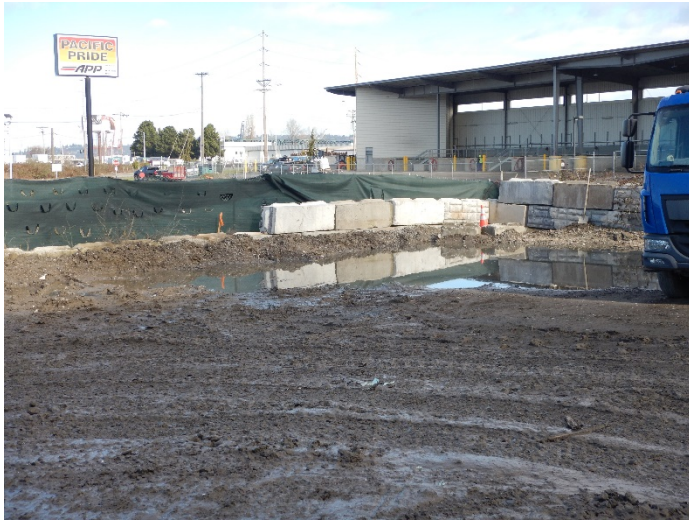
Photo #:23 (DSCN0772)

Description: Facing northeast, photo of stormwater pooling near the concrete block barrier.

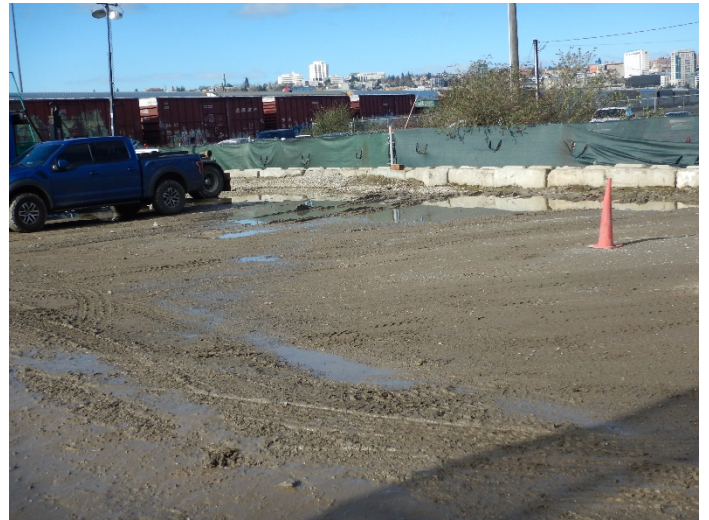
Photo #:26 (DSCN0775)

Description: Facing west, photo of stormwater pooling along the northwestern perimeter. Note the concrete blocks.

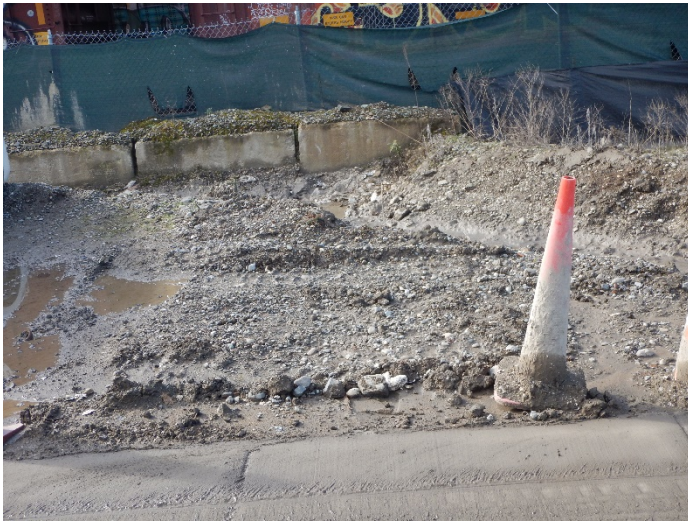
Photo #:27 (DSCN0776)

During the inspection, Mr. Lawson pointed out a location where there was potential for stormwater to be discharged off-site. This potential discharge point is located in the far western corner of the property, near the site office and facility entrance where load trucks enter and exit. (See **Attachment B, Photos 27-29**). Mr. Lawson explained that he conducts visual monitoring of this location, but stormwater sampling does not take place there.

Description: Facing southwest, photo of point of potential stormwater discharge (not currently sampled).

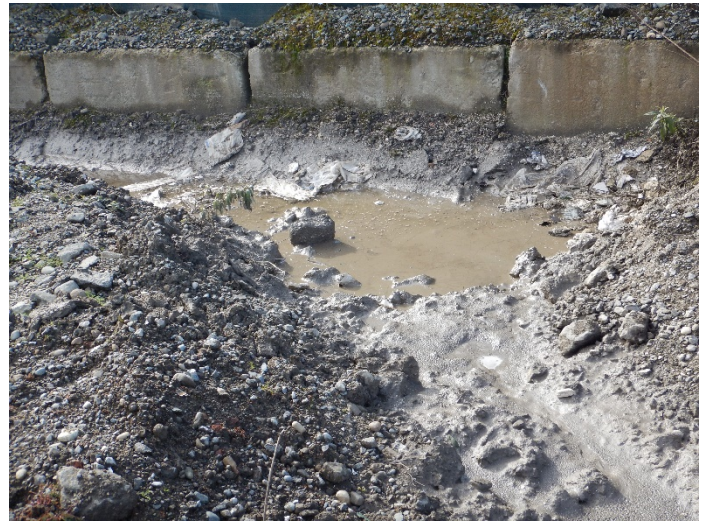
Photo #:28 (DSCN0777)

Description: Facing southwest, photo of the point of potential stormwater discharge (not currently sampled).

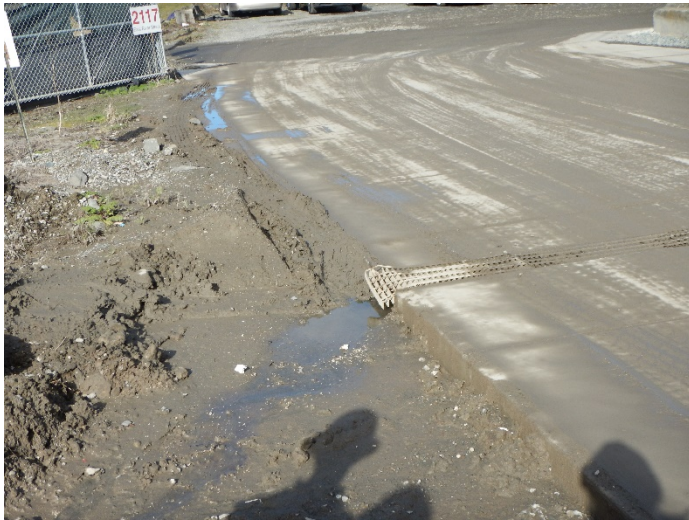
Photo #:29 (DSCN0778)

Description: Facing northwest, photo of the pattern of stormwater contributing to and potentially discharging from the unmonitored location.

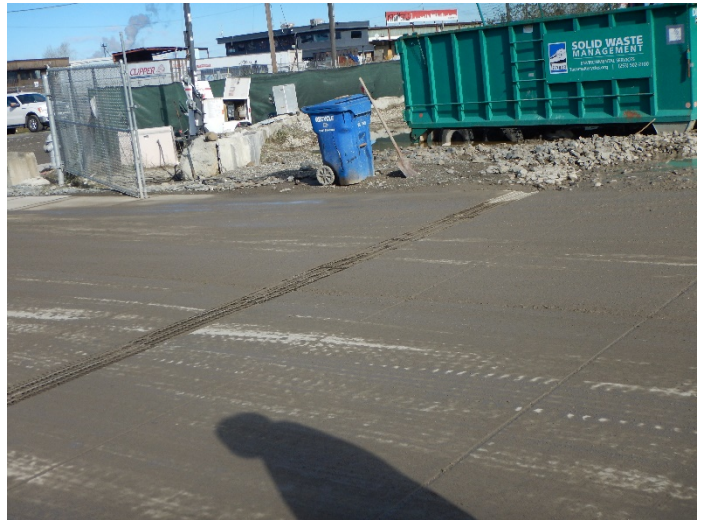
Photo #:30 (DSCN0779)

Description: Facing north, photo of the strip drain that routes water to the unmonitored potential discharge point.

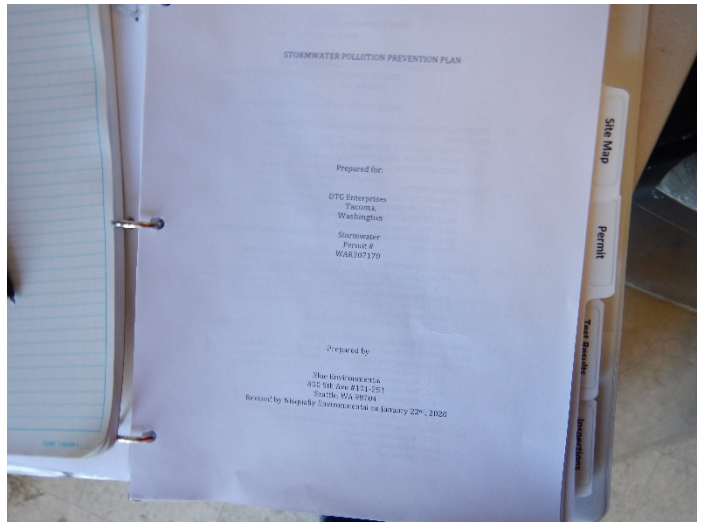
Photo #:32 (DSCN0781)

During the file review portion of the inspection, I conducted an in-depth analysis of the current SWPPP. I noted that the sampling plan did not include sampling point locations. During the closing conference of the inspection, I mentioned that the SWPPP needs to reflect the current sampling plan, including specific sampling locations. The facility representatives explained that there hasn't been an observable discharge since they installed the trenches in Q3 of 2019, so the exact sampling point hasn't been identified yet. I recommended that they identify a sampling location and update the SWPPP to reflect this information. Mr. Jerome indicated that he would work with Blue Environmental to update the SWPPP following the inspection.

During the file review portion of the inspection, I conducted an in-depth review of the SWPPP. I noted that the site map contained information regarding industrial activity and pollutant sources, but was missing information pertaining to stormwater monitoring. Specifically, direction of stormwater flow, stormwater sampling locations, and outfalls were not indicated on the map. During the closing conference of the inspection, I mentioned that the site map needs to reflect the current stormwater

Description: Photo of the cover page of the current SWPPP.
