INSPECTION REPORT

| <b>Type of inspection:</b> | CEI - Compliance Evaluation Inspection | | | | |
| <b>Facility or Site Name:</b> | Mt. Orab WWTP | | | | |
| <b>Permit Number:</b> | OH0026646 | | | | |

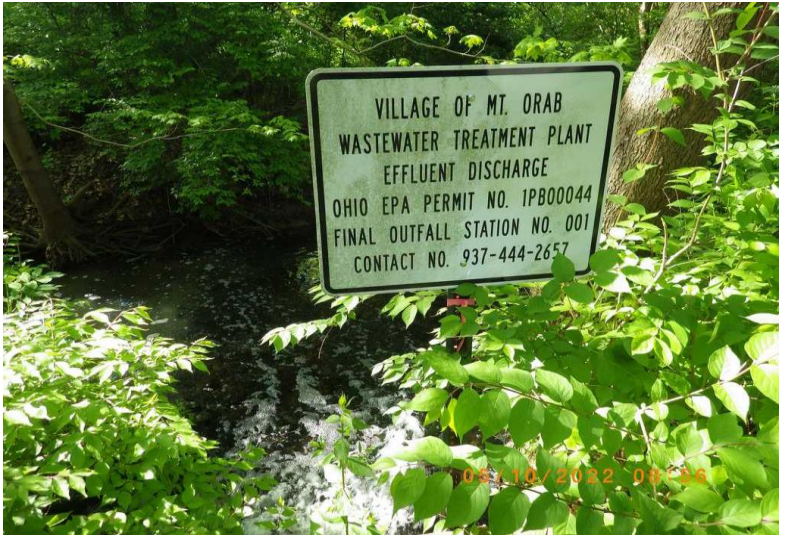
| <p>EPA observed outfall 001 discharging into Snapping Turtle Run and the outfall signage. The outfall signage was facing away from the creek, not towards the creek.</p> | |

| The outfall signage was facing away from the creek and needs to be facing the creek. |

| <p>Outfall 001</p> <p>RIMG2676.JPG</p> <p>05/10/2022 09:56 AM (ET)</p> <p>Andi Hodaj</p> <p>Outfall 001</p> <p>No CBI</p> <p>No PII</p> <p>Signage for outfall 001. Camera looking south.</p> | |

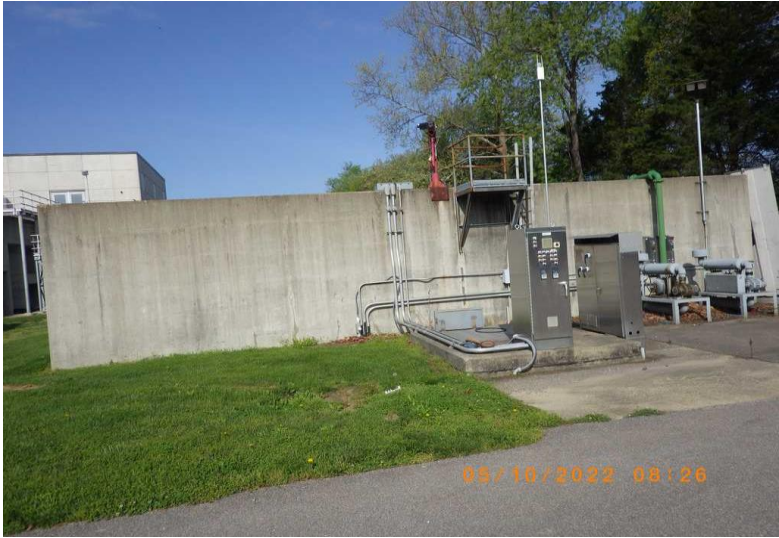
| RIMG2663.JPG | |

| <b>Is there currently any portion of the treatment train that is non-operational?</b> | Equalization (EQ) tank was out of operation at the time of inspection. |

| The EQ tank was not in operation. Camera looking west. | |

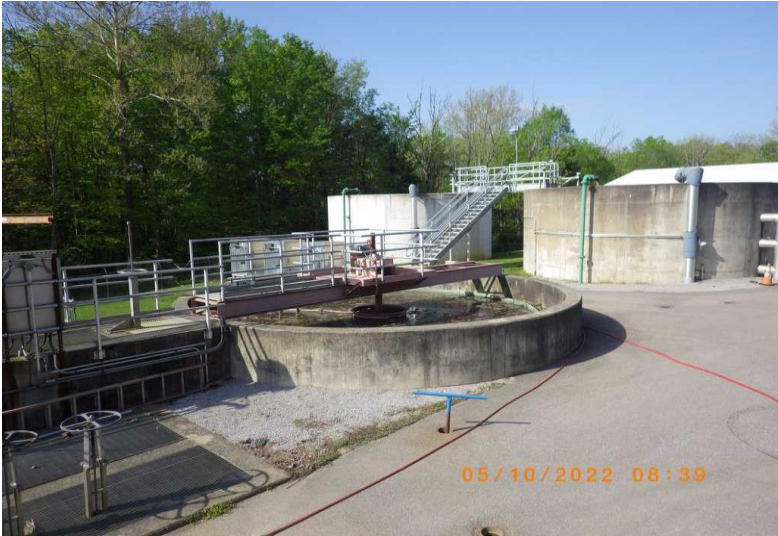
| RIMG2668.JPG | |

| EPA observed floating foam and solids on the two older clarifiers. |

| The west of the two old clarifiers. Camera looking southwest. | |

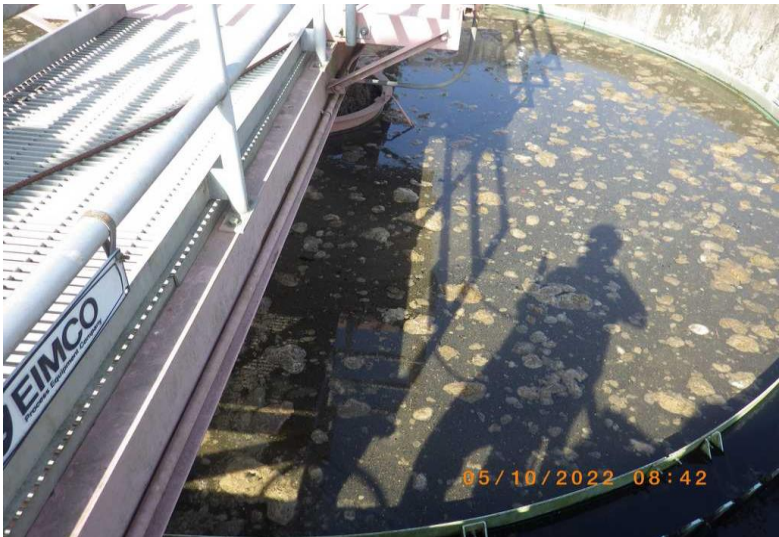
| RIMG2670.JPG | |

| The west clarifier. Camera looking west, down. | |
