**UNITED STATES ENVIRONMENTAL PROTECTION AGENCY  
REGION III**

**Report Title:** Clean Water Act, Section 404 Inspection Report for Rosedale Development Site  
**Inspection Date(s):** 06/29/2023  
**Start Time:** 8:00AM **End Time:** 10:45AM  
**Regulatory Program(s):** Inspections authorized pursuant to Clean Water Act, Sections 308 and 404 (33 U.S.C. §§ 1318 and 1344)  
**Site Name:** Rosedale Development Site  
**Site Location:** 1600 Graves Mill Road  
Lynchburg, Virginia 24502  
**Latitude:** 37.3762 **Longitude:** -79.2315  
**County/Parish:** City of Lynchburg  
**Site Owner(s):** Rosedale Investments, LLC  
T.B.P. Properties, LLC  
**Mailing Address:** P.O. Box 148  
Forest, Virginia 24551  
**Unique Project #:** 3E23WW039A

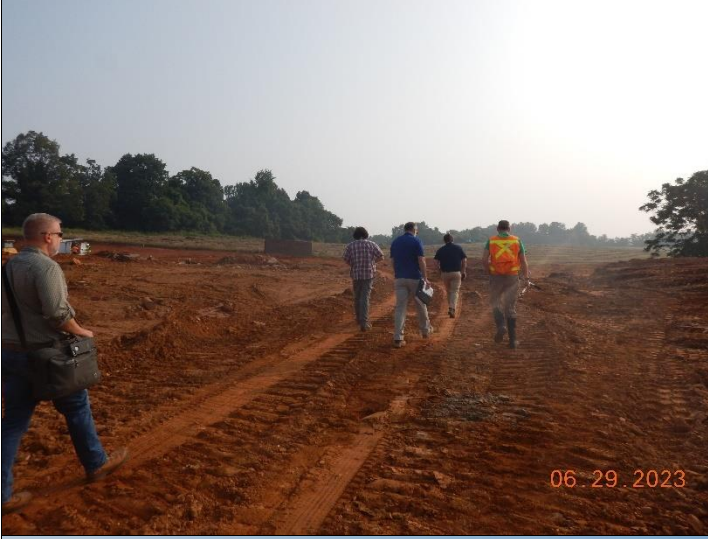
The Site is a currently an active construction site for a commercial and residential development (see Attachment 3 – Photographic Log; DSCN4695 to DSCN4697).

| | <p>Rosedale Development Site<br/>Date: 29 June 2023<br/>Photo ID: DSCN4695.JPG<br/>Photo taken by: Katelyn Almeter</p> <p>Notes: Site overview; facing north</p> |

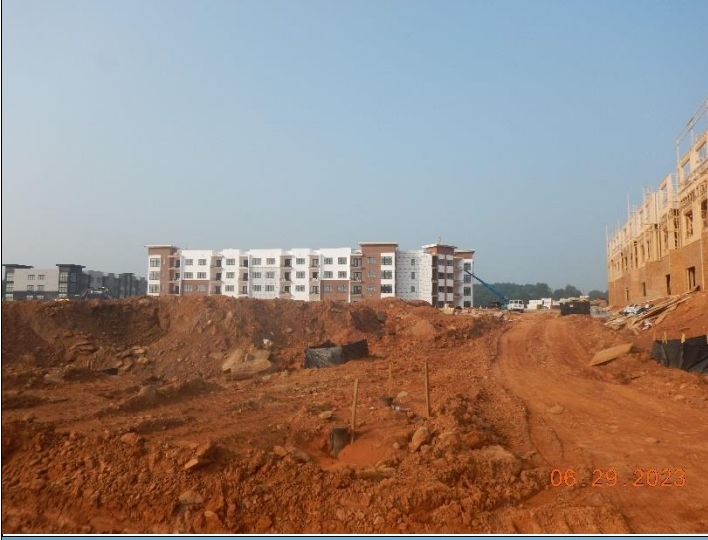
| | <p>Rosedale Development Site<br/>Date: 29 June 2023<br/>Photo ID: DSCN4696.JPG<br/>Photo taken by: Katelyn Almeter</p> <p>Notes: Construction in progress on the Site.</p> |

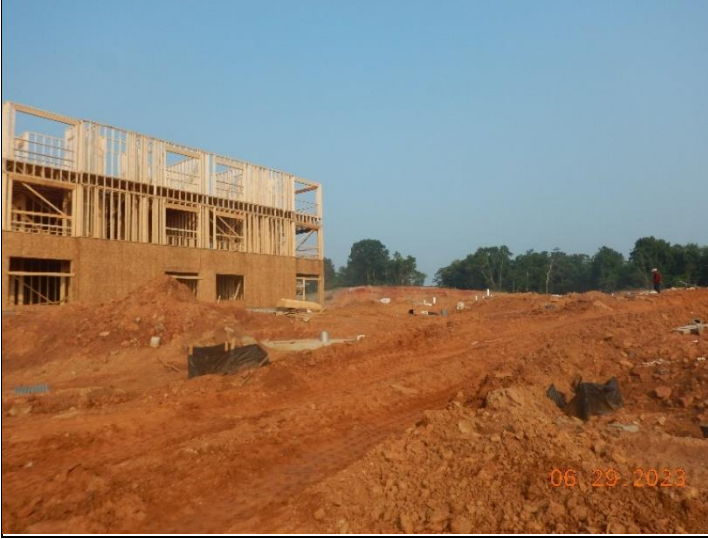
| | <p>Rosedale Development Site<br/>Date: 29 June 2023<br/>Photo ID: DSCN4697.JPG<br/>Photo taken by: Katelyn Almeter</p> <p>Notes: Construction in progress on the Site.</p> |

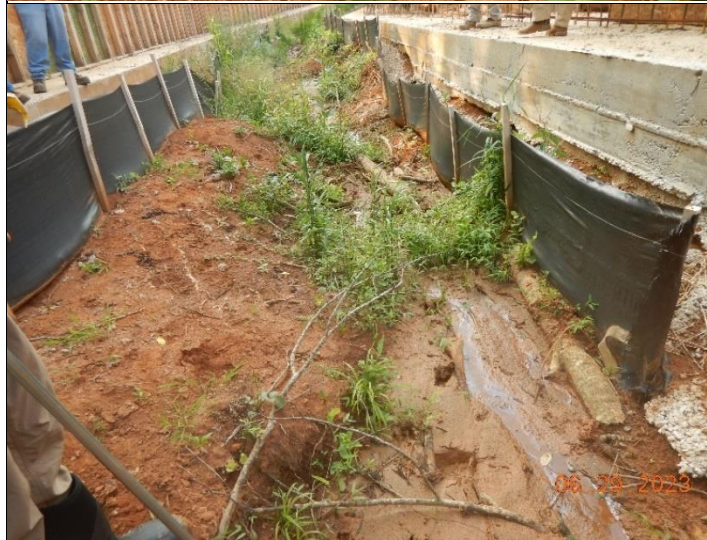
Rosedale Development Site  
Date: 29 June 2023  
Photo ID: DSCN4705.JPG  
Photo taken by: Katelyn Almeter

Near the northeastern limits of disturbance, the inspection walkthrough approached the upstream end of a stream, Unnamed Tributary 1 (UNT1) (DSCN4701). Earthmoving activity occurred in the area of UNT1 and a steeply sloped, unvegetated fill pile ran along the right descending bank (DSCN4700 and DSCN4701). Concrete abutments were observed to have been constructed at the base of the fill slope and along the limits of disturbance (DSCN4702; DSCN4704; DSCN4705). Silt fence was also present along the concrete abutments. UNT1 was observed between the two concrete abutments in a channel that contained significant sediment. Mr. Cyrus stated that the silt fence was installed prior to construction activity. UNT1 was observed to have flow originating from a groundwater seep with the presence of iron oxidizing bacteria (DSCN4702; DSCN4719). Saturated, fine sediment was observed in the stream channel (DSCN4705; DSCN4710; DSCN4713; DSCN4714; DSCN4723; DSCN4732).

Notes: View of the head of UNT1 with the discharged material along the bank and the bed of the tributary.

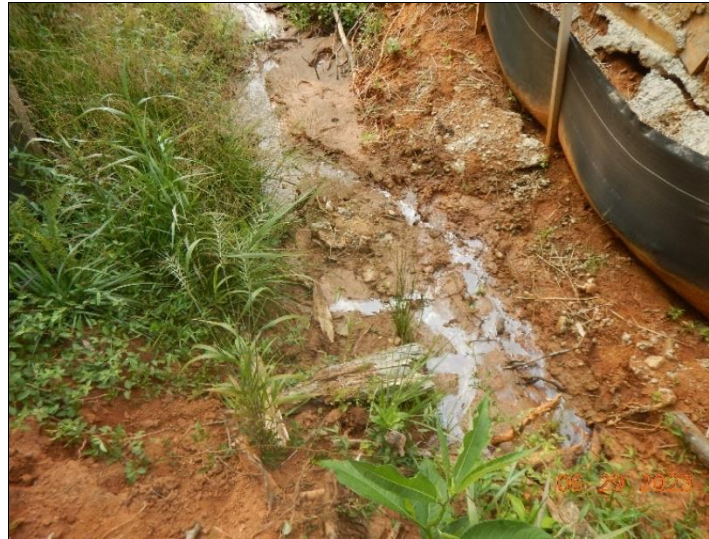
Rosedale Development Site  
Date: 29 June 2023  
Photo ID: DSCN4713.JPG  
Photo taken by: Katelyn Almeter

Notes: Northwest view of the foot of the stockpile of soil. Note the presence of fill material downgradient of the silt fence.

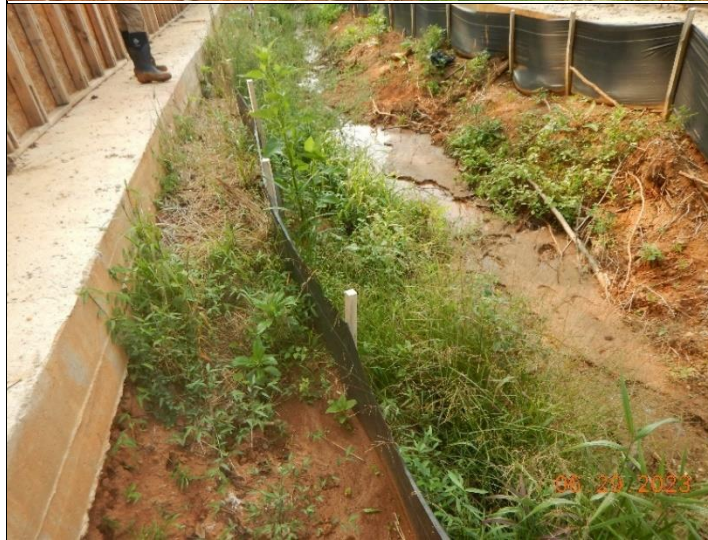
Rosedale Development Site  
Date: 29 June 2023  
Photo ID: DSCN4714.JPG  
Photo taken by: Katelyn Almeter

Notes: View of UNT1 with fill material pushing against silt fence along the upper right side of the photograph. Note the presence of herbaceous vegetation in the discharged material along the left bank.

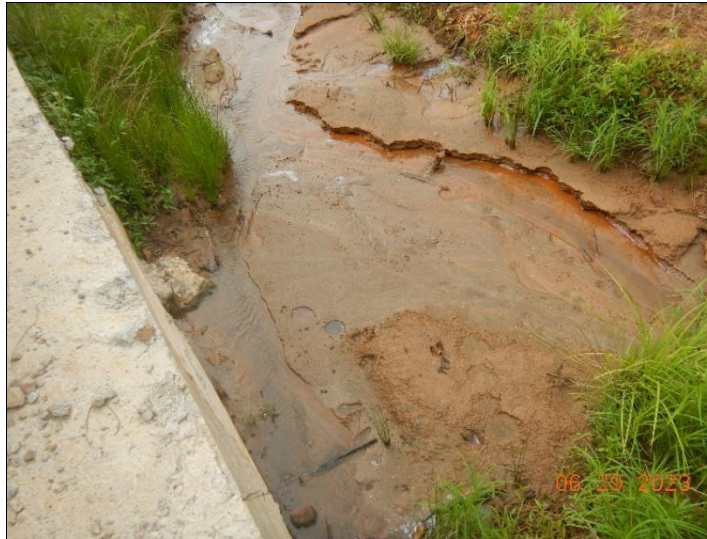
Rosedale Development Site  
Date: 29 June 2023  
Photo ID: DSCN4722.JPG  
Photo taken by: Katelyn Almeter

Approximately 75 feet downstream from the start of the concrete abutments, flow and seeping of water with iron-oxidizing bacteria was observed undercutting the abutment on the left descending bank (DSCN4719; DSCN4722; DSCN4723). On the other side between the concrete abutment and the northern limits of disturbance, a seep and pooling water, algae were observed (DSCN4726). Excess concrete and boulders were also observed (DSCN4720; DSCN4721; DSCN4725; DSCN4728). Soil boring 2 was conducted where there was the presence of 0.5 inches of standing water. In the soil profile, rocks were present through the profile measuring approximately 0.5 to 1.5 inches and the profile was described as 0-9 inches of 7.5YR4/4 saturated sandy fill with refusal at 9 inches (DSCN4727).

Notes: View of large rocks within the streambed of UNT1.

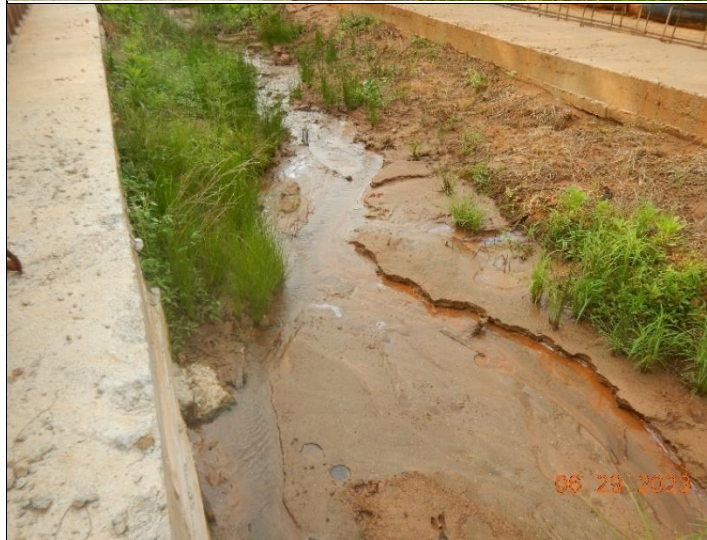
Rosedale Development Site  
Date: 29 June 2023  
Photo ID: DSCN4723.JPG  
Photo taken by: Katelyn Almeter

Notes: View of UNT1 with discharged material throughout the streambed.

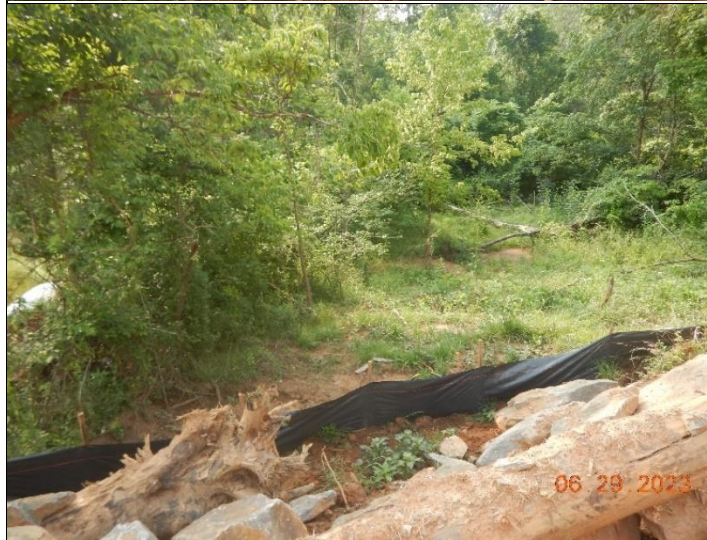
Rosedale Development Site  
Date: 29 June 2023  
Photo ID: DSCN4756.JPG  
Photo taken by: Katelyn Almeter

The inspection walkthrough continued south along a flatter bench of material in the fill pile along the eastern side of the Site (DSCN4755). On the downslope end, where the wetland and stream were mapped on the plan set, the silt fence was visible (DSCN4756). The EPA Inspectors observed a number of areas where the fence was lying on the ground, covered with dirt or sediment and/or rocks, including boulders (DSCN4758 to DSCN4763). Sediment was also observed beyond the silt fence (DSCN4756 and DSCN4757).

Notes: Southward view of the stockpiles of soil up against the forested area.

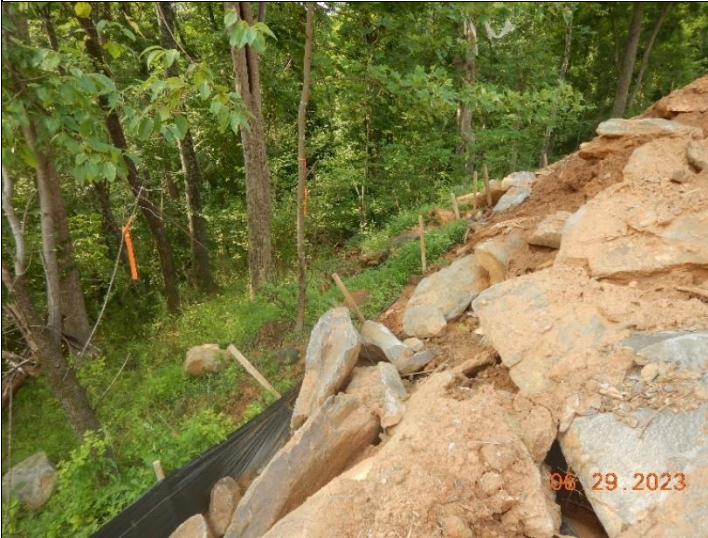
| | <p>Rosedale Development Site<br/>Date: 29 June 2023<br/>Photo ID: DSCN4759.JPG<br/>Photo taken by: Katelyn Almeter</p> <p>Notes: View of a portion of the silt fence where the stockpiled soil and rock covered the silt fence and extended into the adjacent forested area; looking southeast.</p> |

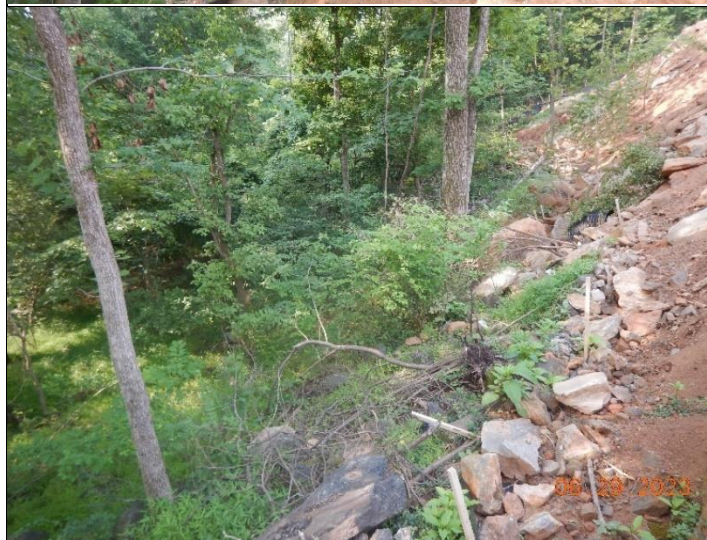
Rosedale Development Site  
Date: 29 June 2023  
Photo ID: DSCN4763.JPG  
Photo taken by: Katelyn Almeter

Notes: Large rocks and material covering the silt fence on the downgradient side of the stockpile.

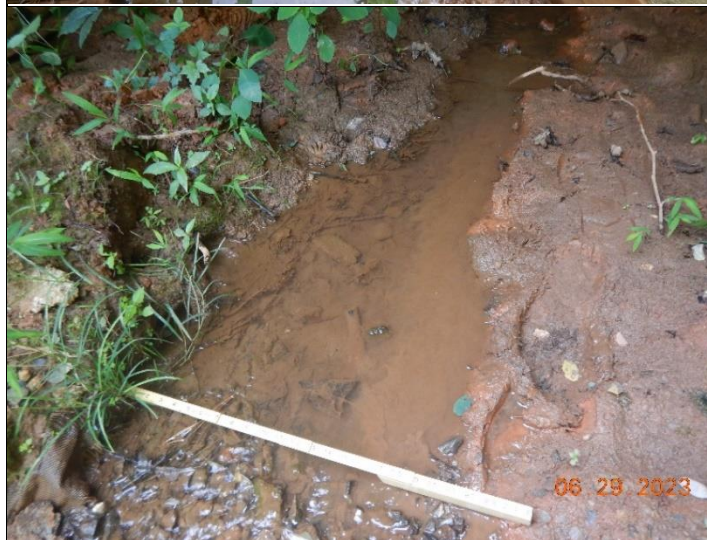
Rosedale Development Site  
Date: 29 June 2023  
Photo ID: DSCN4817.JPG  
Photo taken by: Katelyn Almeter

along the banks and bed of the active channel. The bed of the channel was primarily fine-grained (silts and sands). At the immediate upstream end of the culvert, the channel of UNT2 was 36 inches wide (DSCN4817).

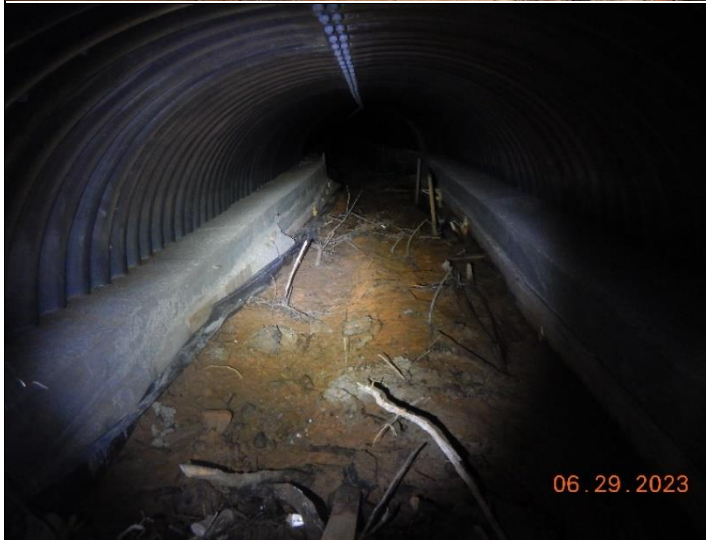
Rosedale Development Site  
Date: 29 June 2023  
Photo ID: DSCN4843.JPG  
Photo taken by: Katelyn Almeter

The Inspectors observed UNT2 within the arch culvert (DSCN4819 to DSCN4851). For the upstream portion within the culvert an actively flowing channel was present. The edges of the channel were flat, generally saturated, and mainly exposed dirt (DSCN4819 and DSCN4827). Woody roots were present and a couple of individual standing dead woody stems were observed (DSCN4821, DSCN4824, and DSCN4837). The water table was observed in gaps along the concrete abutments (DSCN4822, DSCN4823, and DSCN4826). Within the culvert, the banks and sides of the channel consisted of uneven piles of dirt with many exposed woody roots (DSCN4830 and DSCN4834). Within the culvert the channel of UNT2 measured 13 inches wide (DSCN4831). Approximately mid-way within the culvert, the active channel flowed toward and under a concrete abutment (DSCN4839 to DSCN4851). For the remainder of the culverted area there was no observable surface stream channel (DSCN4843 and DSCN4844).

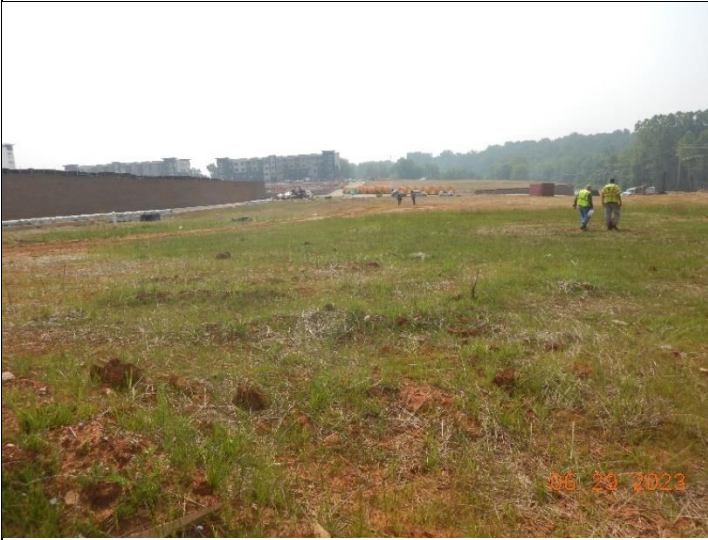
The EPA Inspectors asked Mr. Cyrus about the presence and location of the barn that the U.S. Army Corps of Engineers had referenced in their discussions with EPA. Mr. Cyrus indicated that there had been a barn, which was constructed in the 1980s, that used to be present in the southern portion of the Site, not far from the UNT2 area. Mr. Cyrus pointed out the location to the inspector (DSCN4852).

| | <p>Rosedale Development Site<br/>Date: 29 June 2023<br/>Photo ID: DSCN4852.JPG<br/>Photo taken by: Katelyn Almeter</p> <p>Notes: View of activity on the Site.</p> |

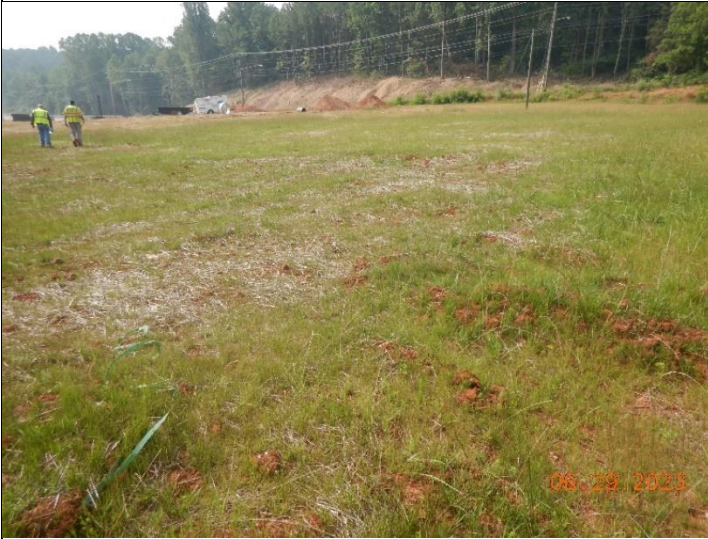
| | <p>Rosedale Development Site<br/>Date: 29 June 2023<br/>Photo ID: DSCN4853.JPG<br/>Photo taken by: Katelyn Almeter</p> <p>Notes: View of activity on the Site.</p> |
